CHIEF PLENTY COUPS HOUSE AND STORE

CHIEF PLENTY COUPS STATE PARK PRYOR, MONTANA AUGUST 24, 2022 100% CONSTRUCTION DOCUMENTS FWP PROJECT NUMBER: 7196121HS

TITLE OF SHEET CHIEF'S HOUSE & STORE PHOTOS

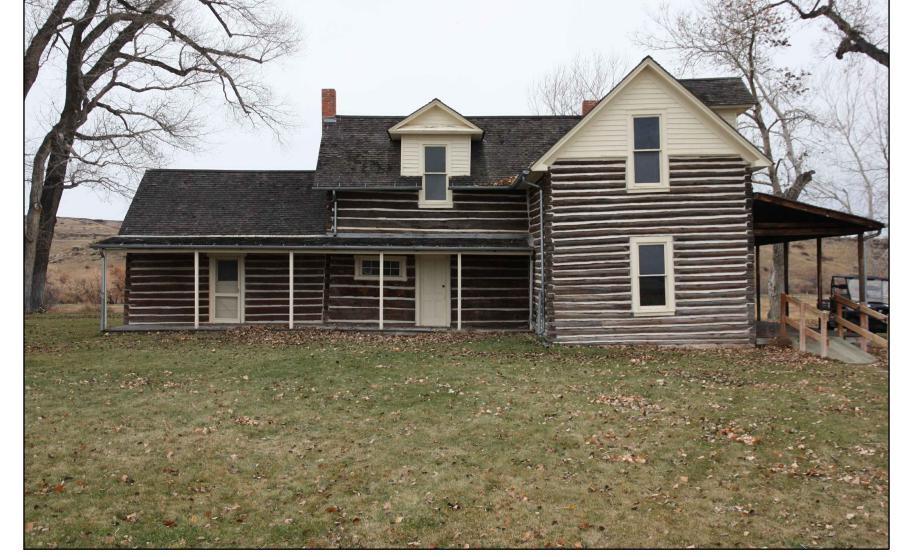
CURRENT VIEW FROM SOUTH

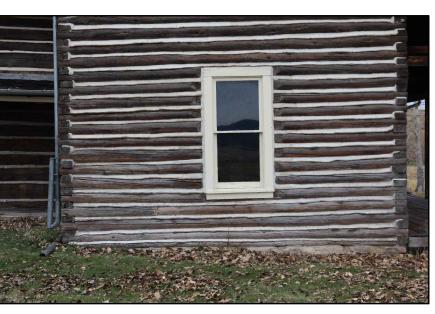
CHIEF'S HOUSE SOUTHWEST CORNER WITH SETTLING

GROUND PENETRATING RADAR WAS USED TO DETERMINE A FAILING FOUNDATION IN THIS LOCATION. SEE DETAILS. (SEE PHOTO 5)

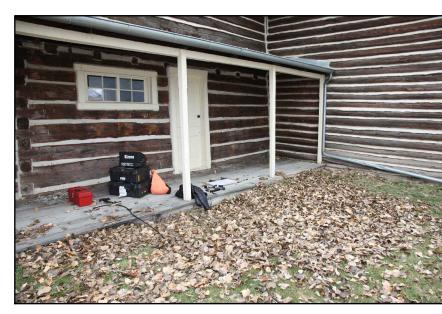
CHIEF'S HOUSE LEAVES PILED UP IN FRONT OF SOUTH PORCH 8 _____A3

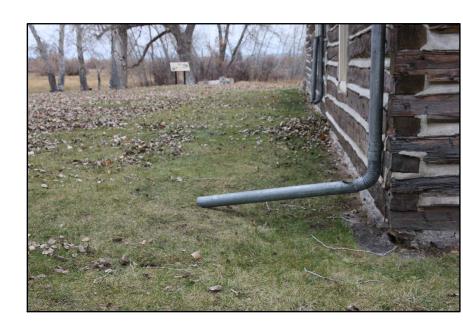
CHIEF'S HOUSE, EARTH SLOPING DOWN TOWARDS NORTH SIDE OF BUILDING

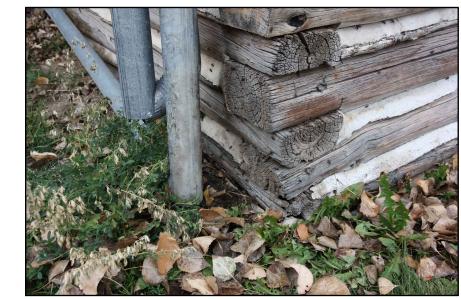
CHIEF'S HOUSE DOWNSPOUT AT SOUTHWEST CORNER A3

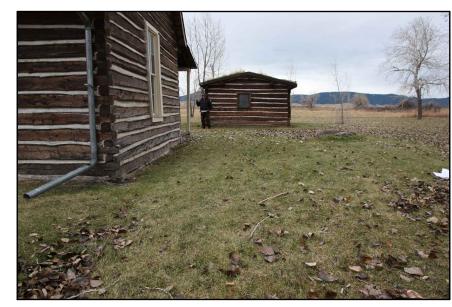
NORTHWEST CORNER, SHOWING EARTH SLOPING DOWN TOWARDS WEST SIDE ON BUILDINGS

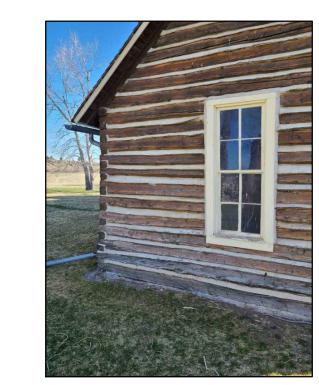
DETERIORATED WINDOW SILL ON WEST FACE 4 A5

WINDOW SILL DETERIORATION. CAREFULLY REMOVE WINDOW SILL AS (14) REQUIRED AND WITH IN-KIND FASTENING METHODS, FASTENING TYPES, PAINT,

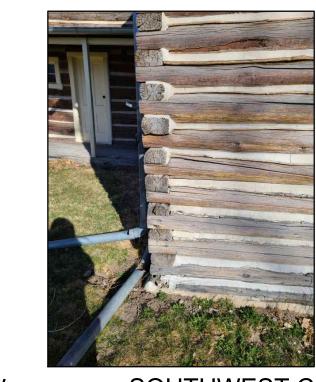
SOUTHWEST CORNER WITH SETTLING 5
