FUTURE FISHERIES IMPROVEMENT PROGRAM GRANT APPLICATION

Three Mile Creek Dam Five-Year Inspection Photos Oct. 20, 2021

Project Title: Threemile Creek Reservoir High Hazard Dam Project

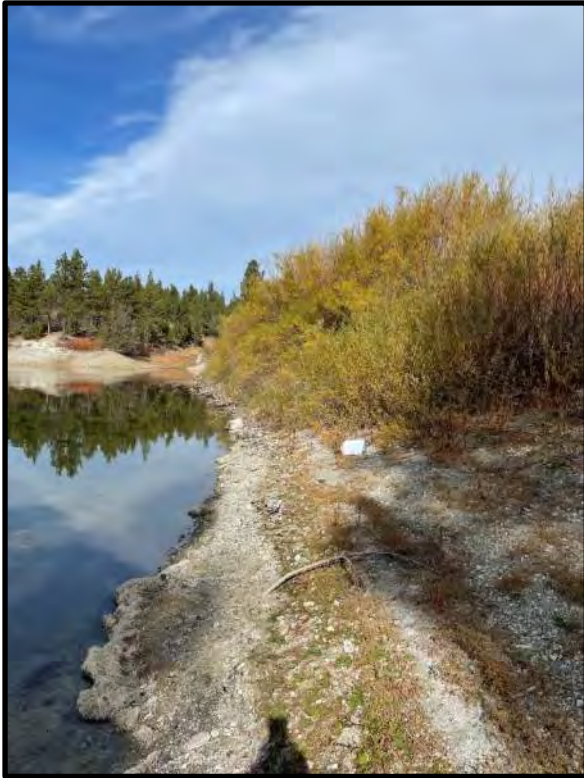
Upstream Dam Face looking west

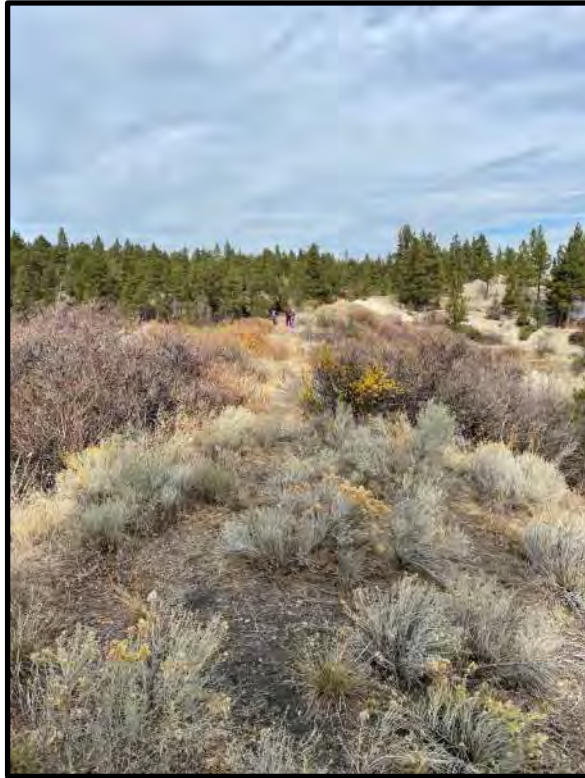
Dam Crest looking west

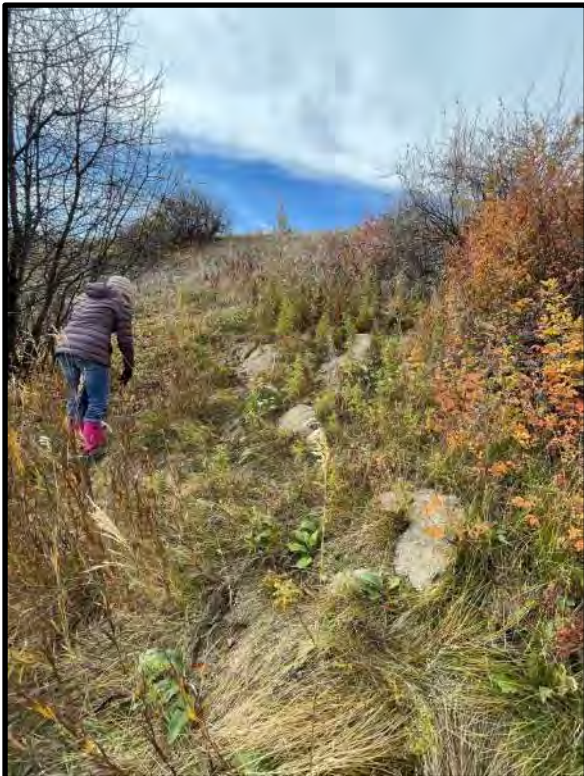
Animal burrows in left downstream groin area

Animal burrows were observed on the embankment. Especially in the left groin seepage area.

Requirement 3: Address the rodent burrows observed by the seepage pipe intake under the guidance of your licensed engineer

Fresh spoils from rodent burrows were observed in the area around the seepage pipe intake. When your engineer is on-site to supervise the vegetation removal, inspect the rodent burrows. Excavate and recompact these burrows, as appropriate. Implement methods to eradicate rodents from the dam embankment area.

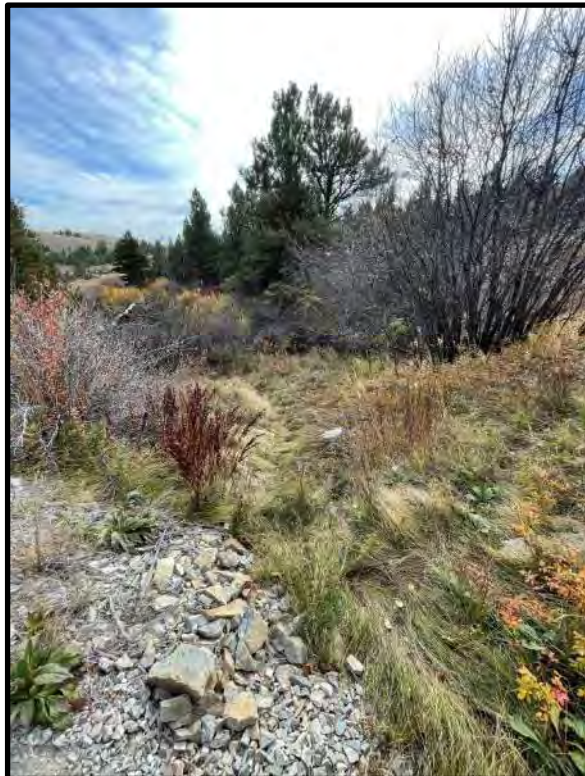
Vegetation on downstream face

Vegetation ranging from thick willows and shrubs to large, mature trees covers much of the dam embankment. Roots create preferential pathways for seepage and can be a serious dam safety concern. Thick vegetation makes visual of the dam difficult and can obscure developing problems. The 2016 engineer's inspection made this same recommendation, but it does not appear that any work has been completed. The degree of vegetation covering the dam is unacceptable, and progress is needed to control the vegetation.

As noted in the last inspection (Bondy, 2017) there is heavy vegetation on the upstream and downstream embankment slopes. The vegetation includes brush and mature trees. The vegetation severely limited the ability to observe the embankment slopes.

Condition 2: Implement the vegetation removal and management plan under the guidance of your licensed engineer**Due Date: 12/31/2022**

Your engineer recommended a specific plan to remove large vegetation. Given the large size of much of the vegetation, the work required may be substantial, and it must be completed under the guidance of a licensed engineer.

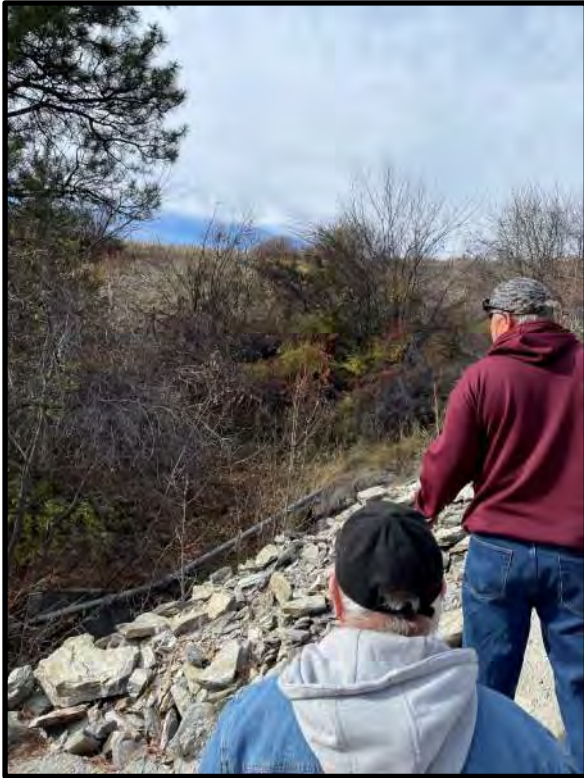
The left groin was observed to be damp and grass covered. However, seepage flow was not observed in the drainpipe. Seepage was noted in this area in the last inspection.

Seepage collection pipe on left groin.

Recommendation 2: Improve the seepage collection pipe. Clear adjacent vegetation from around the seepage collection pipe. Improve the intake to collect seepage flows more effectively. Install a measurement device – a manually read device, e.g., a flume or weir, on the downstream end of the pipe could be read each time someone visits the dam. Monitor the ground around the seepage intake.

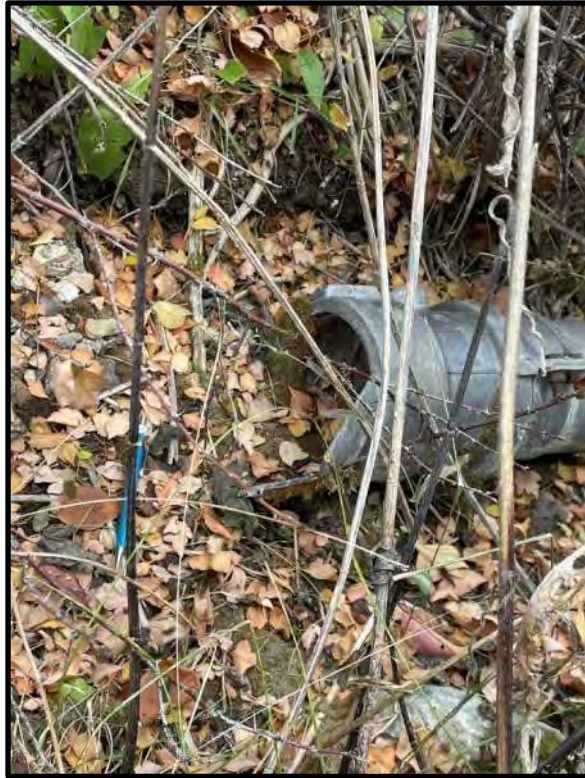
Seepage pipe inlet

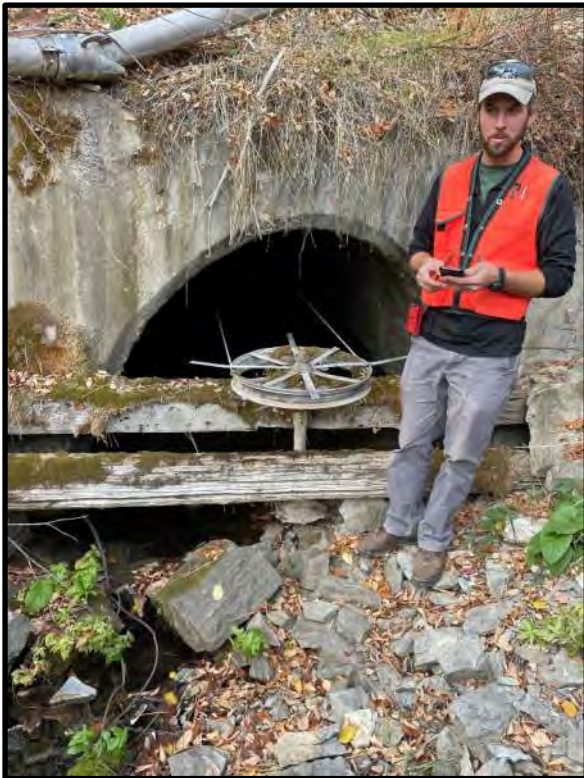
Conduit entrance, outlet pipe pulley and cable

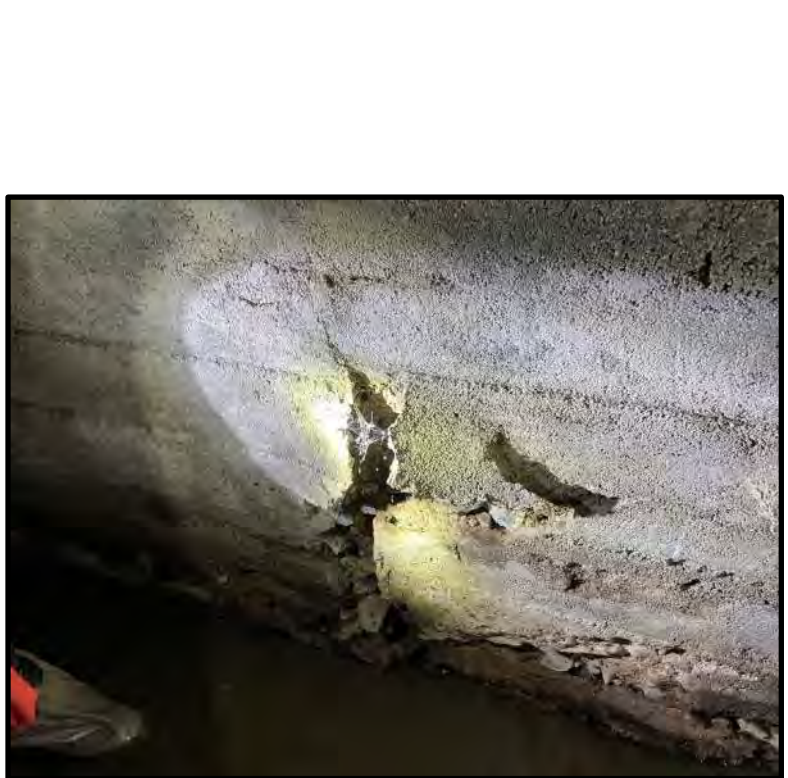
Concrete spalling on conduit wall

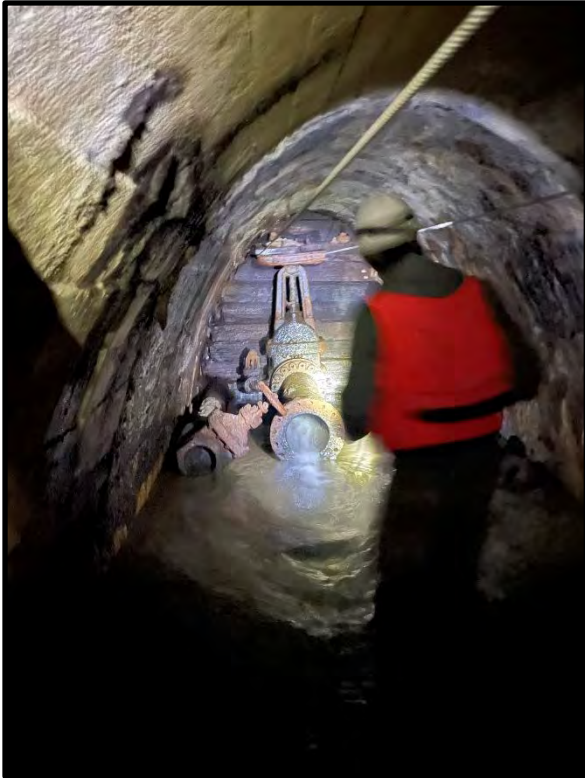
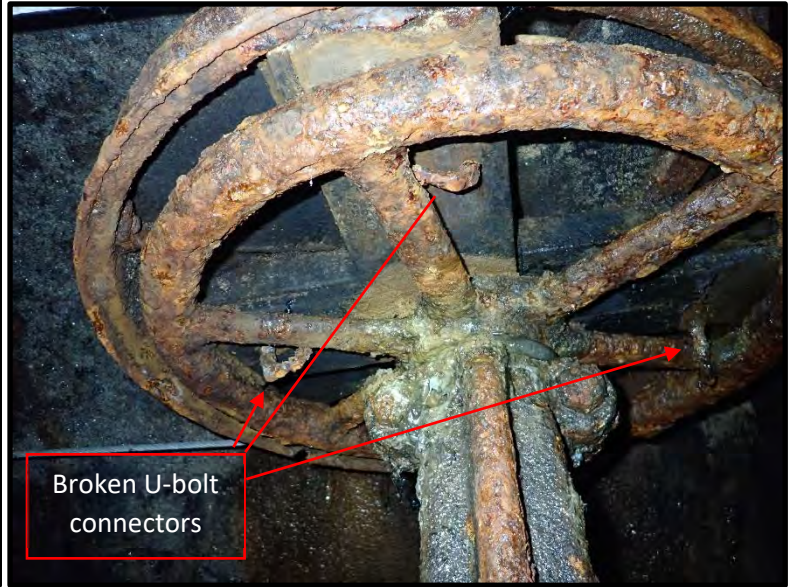
All of the U-bolt connections except for one have failed; if the remaining U-bolt fails, the gate would be inoperable or require entry into the conduit confined space to operate the gate at the wooden bulkhead.

A field inspection was conducted on October 20, 2021, accompanied by you and Bill Gehring, Brent Zundel of DNRC, and Wood engineers, Joe Souther and Randy Huffsmith. During the inspection, it was evident that many of the recommendations from the previous 5-year inspection had not been implemented. As such, the inspection was limited due to the heavy vegetation which has continued to grow on the upstream and downstream slopes of the dam. In addition, the inspection revealed that the wheel connection to the operator (gate valve handle) is broken in 5 of 6 locations.

Outlet Conduit near bulkhead showing cable and wheel on top of valve operator. Valve operator broken connections (5 of 6 are broken).

Condition 1: Repair the U-bolt connections between the wheel and cable and the operating gate stem**Due Date: Before spring 2022 operation**

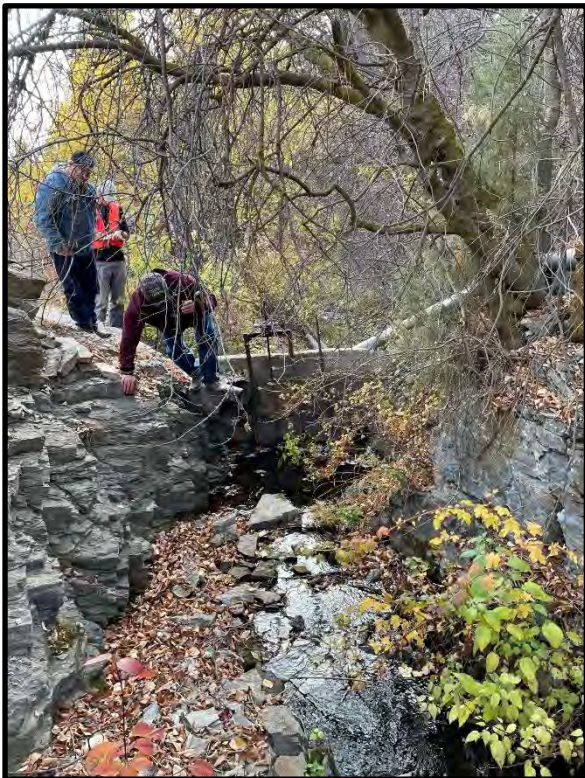
Outlet channel and irrigation headgate

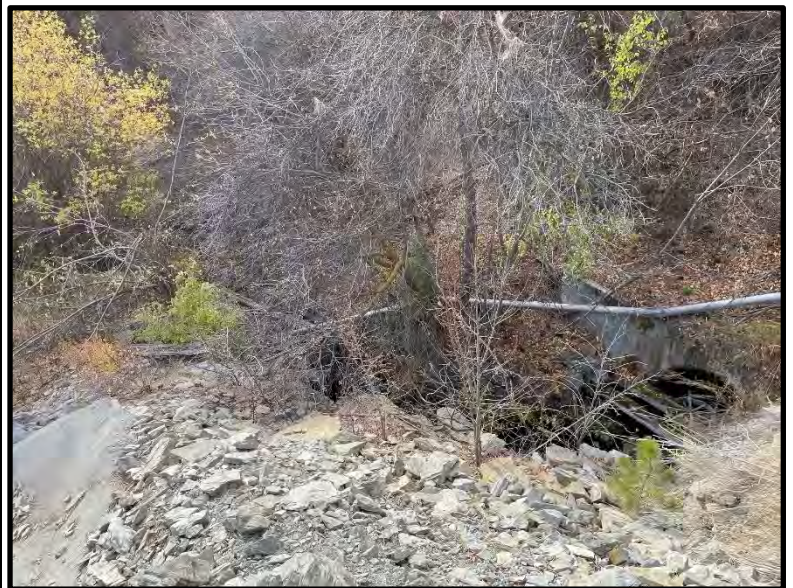
Drainage pipe discharge into outlet channel

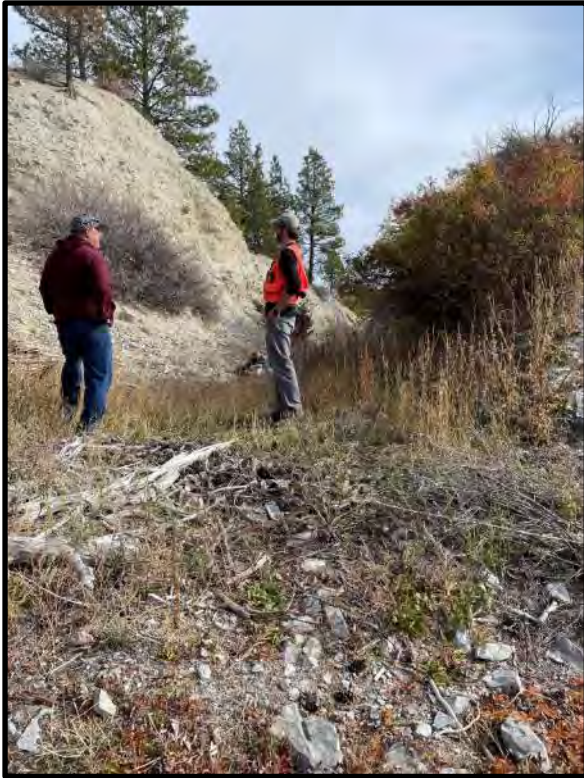
Primary spillway entrance

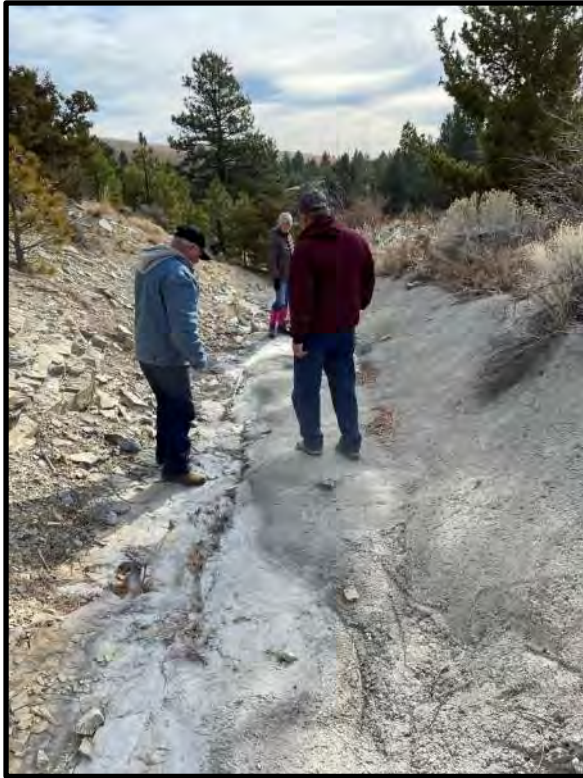
Primary spillway channel; concrete patching on right side

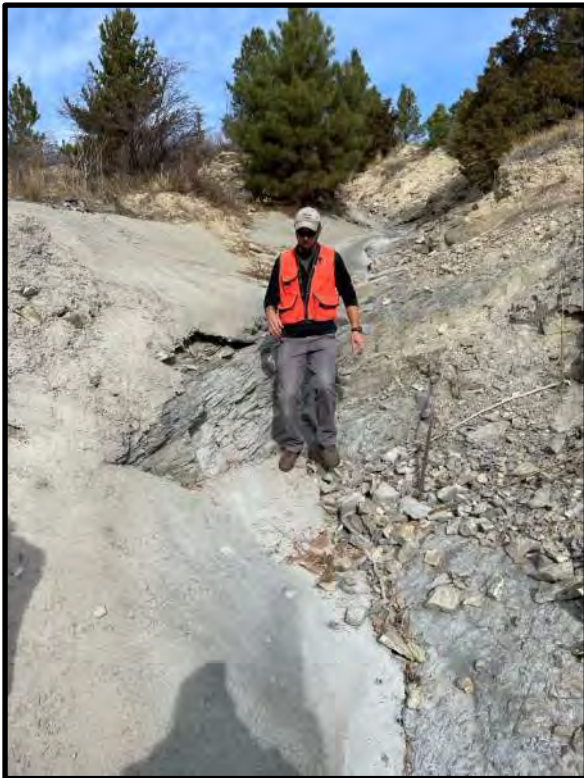
Primary spillway descends towards outlet channel

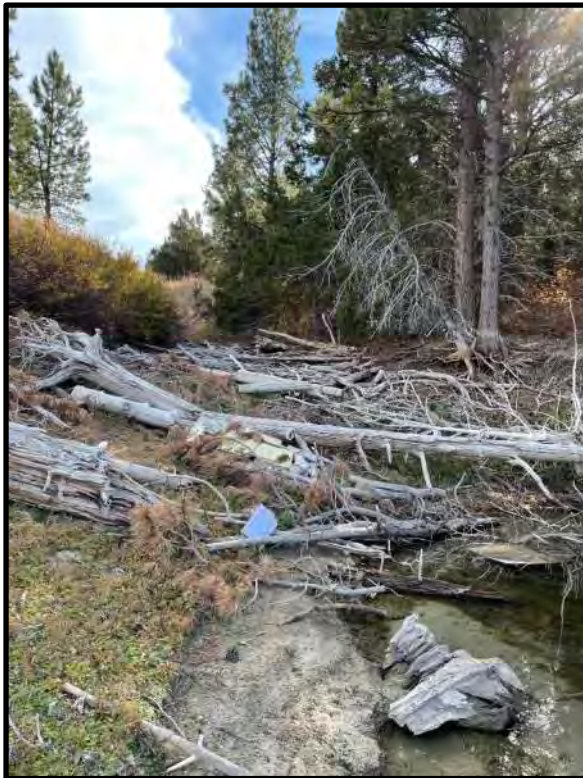
Auxiliary spillway location
