REPORT ON THE EFFECTS OF 90 MW AND 50 MW
PEAKING POWER TEST SPILLS ON LAKE HELENA,
THE CAUSEWAY, HAUSER LAKE, AND TROUT CREEK.

Test Spills from Canyon Ferry Dam

Occurring 7/21-7/23, 1981.

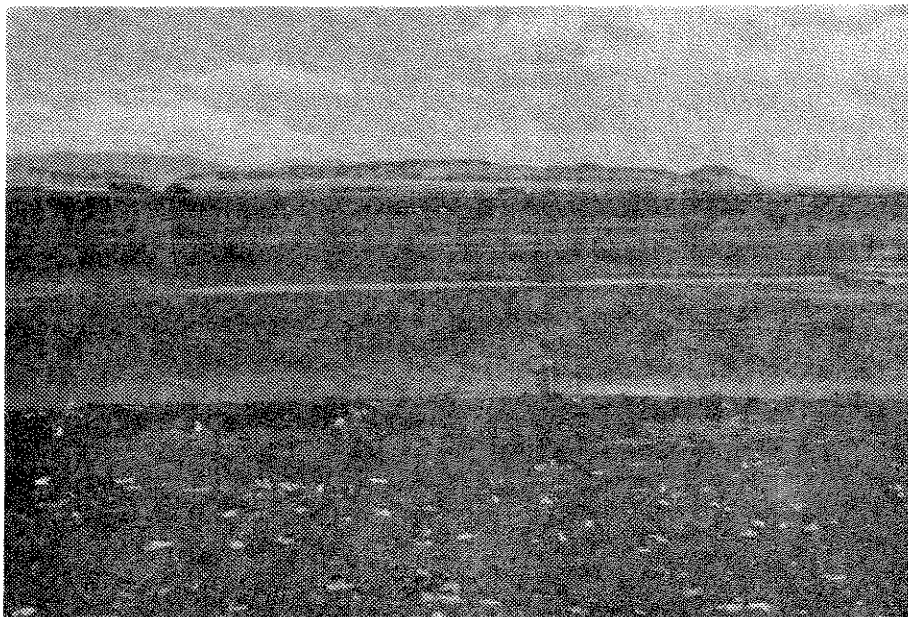
#1

Stake #6 - 7/21-4 p.m.

Showing placement of stake at water's edge in Lake Helena prior to drawdown. Note gulls resting on mud bar that is barely under water.

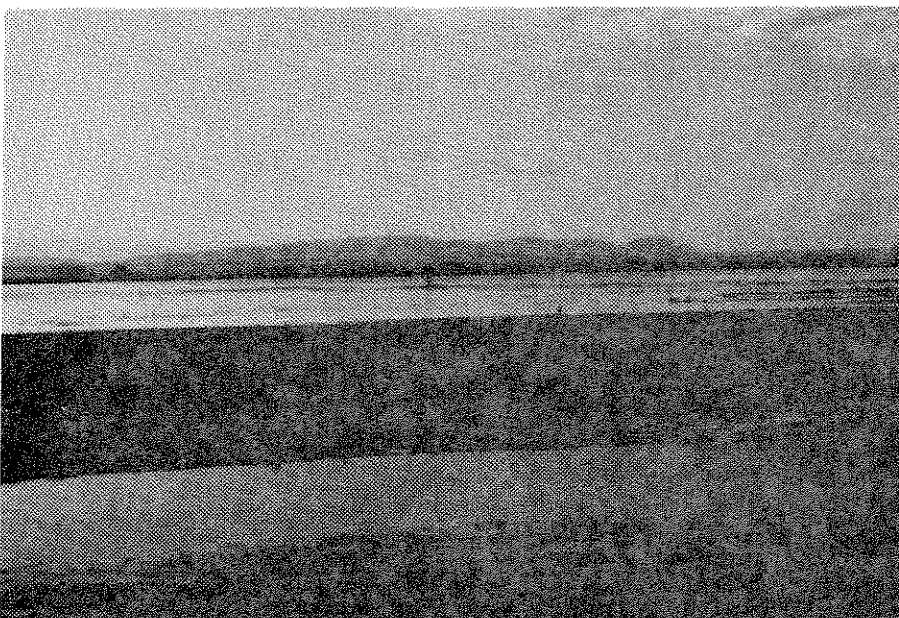
#2

Lake Helena did not fill after the 90 mw test to levels that it had achieved prior to this test and thus the amount of shoreline exposure following the 50 mw drawdown was at least as great as that occurring after the 90 mw test. All flow measurements taken at eight equally spaced stations 2.2 feet apart from Hauser side of Causeway.

Stake #6 - 7/22-7 a.m.

After drawdown for 90 mw test. Note fieldworker standing at same place as gulls in previous photo, mud bar now exposed.

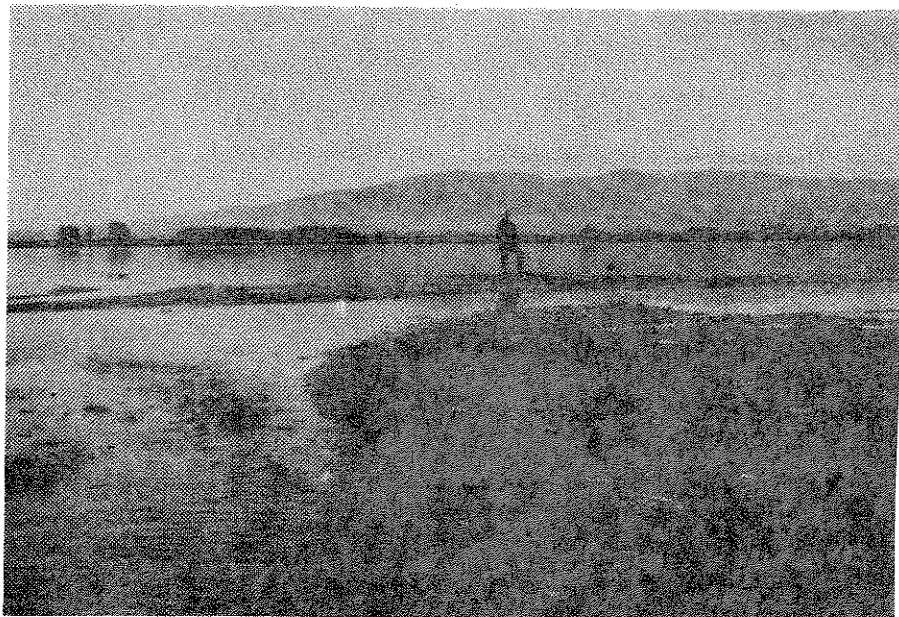
#3

Stake #4 - 7/22-7 a.m.

After 90 mw drawdown. Stake placed at water's edge on 7/21 prior to drawdown is now 84 ft. from point where fieldworker is standing.

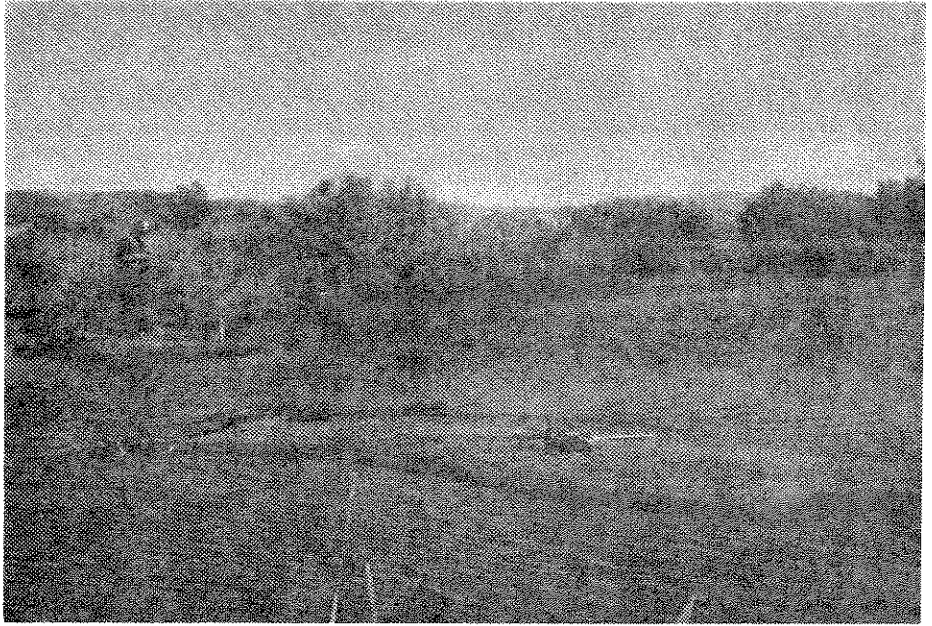
#4

Stake #11 - 7/21-4 p.m.

Showing placement of stake at water's edge, prior to test spills.

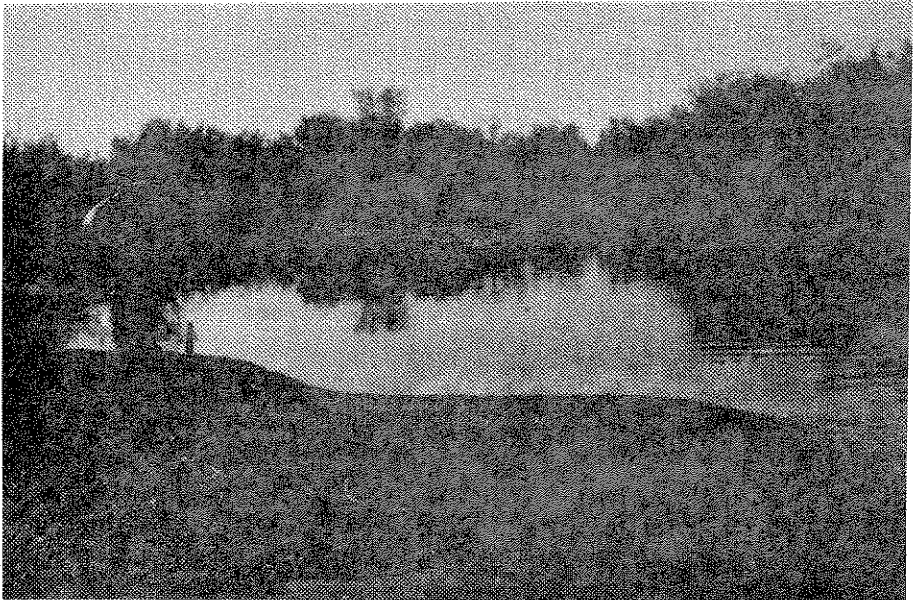
#5

Stake #11 - 7/22-7 a.m.

After 90 mw test. Stake is only 1.8 feet from water's edge but note mud flat exposed in back of bay.

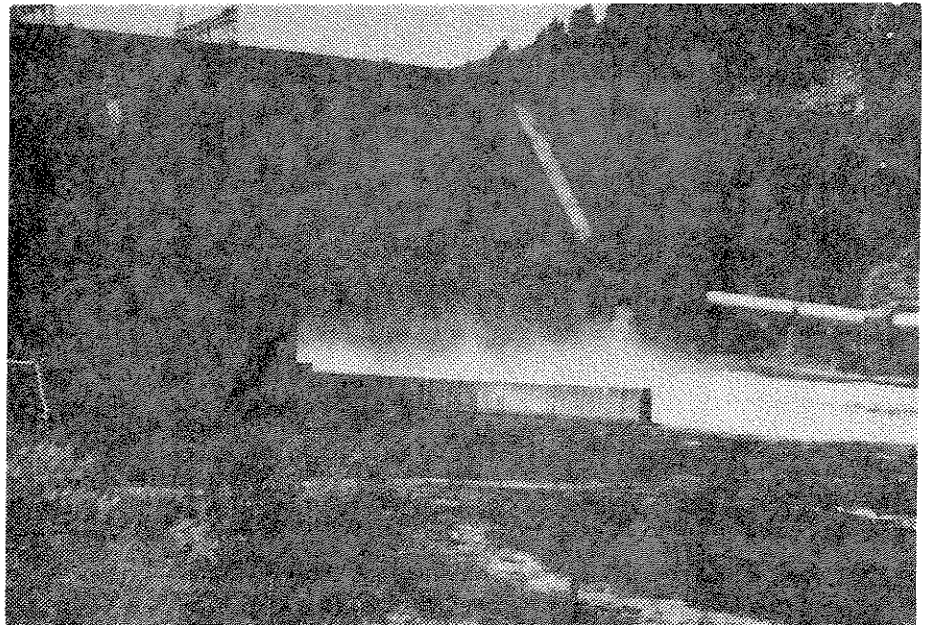
Canyon Ferry Dam at maximum discharge for 90 mw test spill, 2 p.m. on 7/22. #6

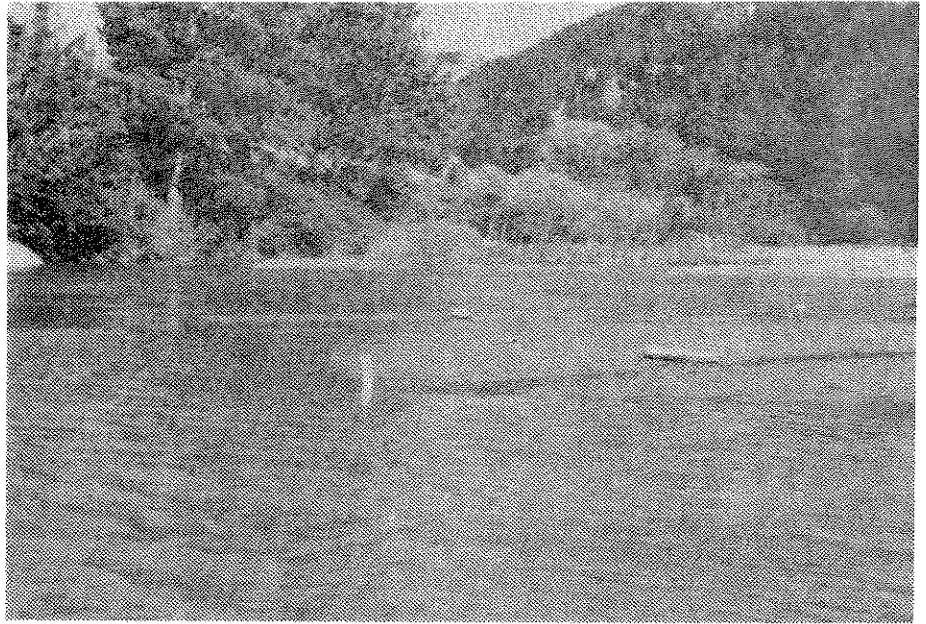
#7

Trout Creek - 7/21, 9 p.m.

Showing placement of stake at water's edge. 90 mw test has begun and some drawdown has already occurred. Note rock and log in back of stake, compare to photo at bottom of this page.

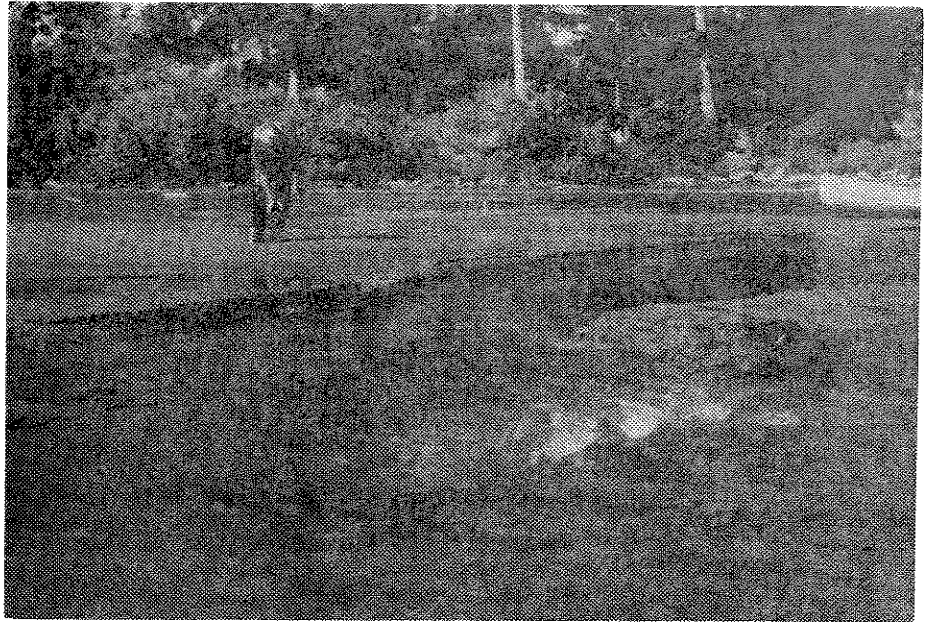
#8

On July 21 the creek spread out in a fan-shaped configuration on July 22 the fan had been reduced to three main channels as the creek cut down into the delta. Some mud and silt had been moved downstream causing increased turbidity in the immediate vicinity of the creek mouth.

Trout Creek - 7/22, 10 a.m.

Looking downstream towards mouth. This photo shows cutting that has occurred on delta. Turbidity was increased in immediate vicinity of creek mouth.

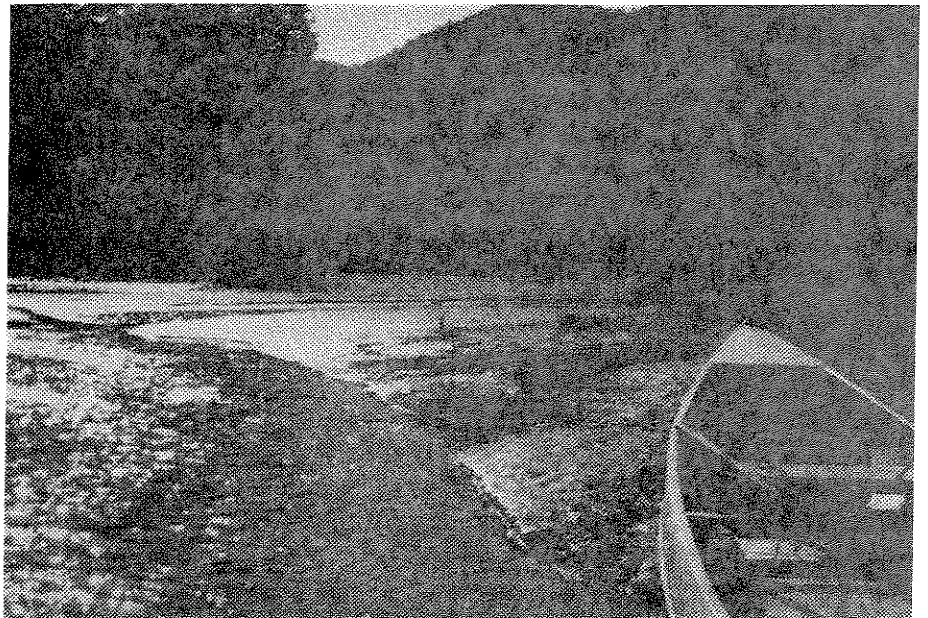
Trout Creek - 7/22, 10 a.m. #9

Note stake with rock and log in background as compared to photo at top of page. Water level is down 0.9 ft. leaving stake 25 ft. from water's edge.

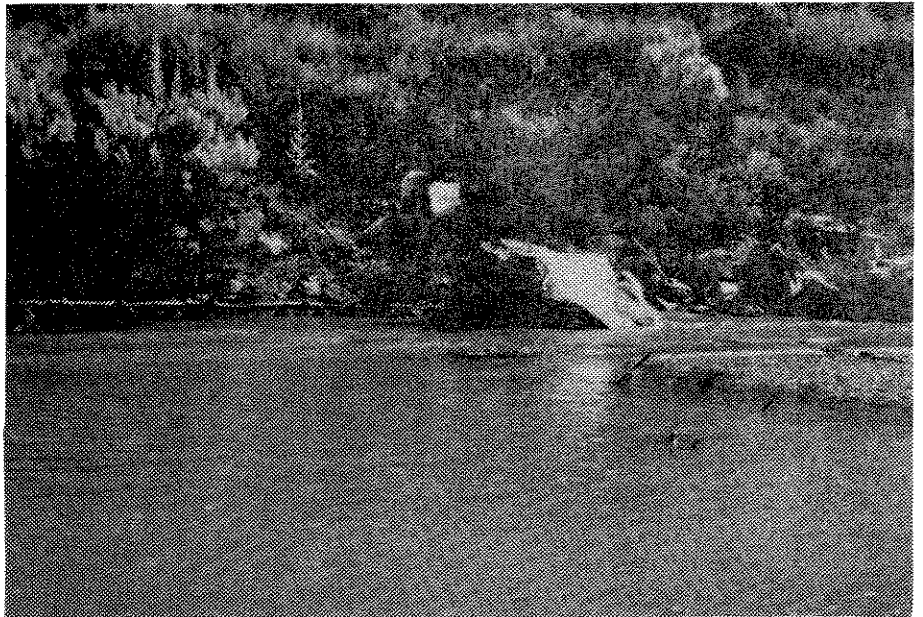
#10

Trout Creek - 7/22, 10 a.m.

After drawdown for 90 mw test.
Fieldworker is measuring
distance from high-water
mark of previous day on boulder,
0.9 ft. but has already come
up some this a.m.

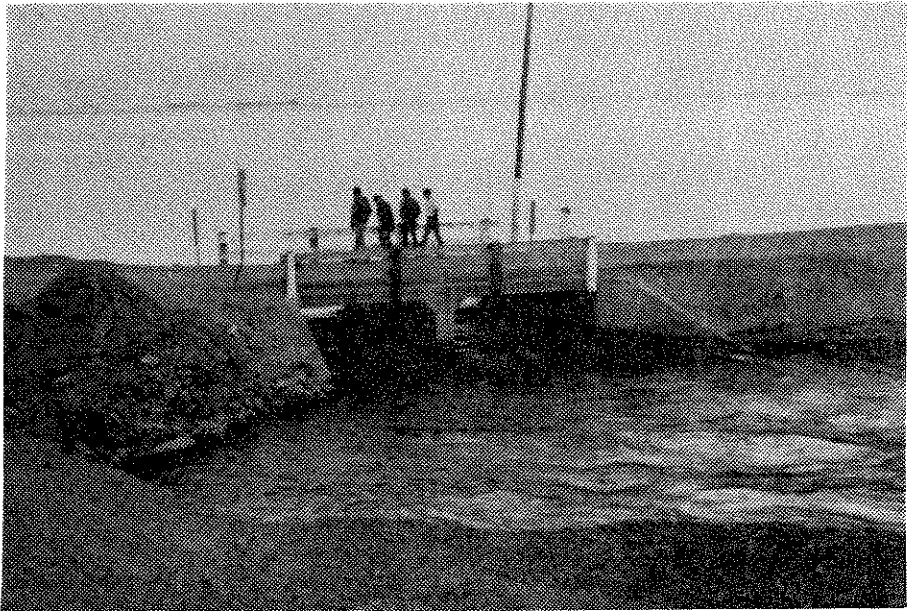
#11

Lake Helena Causeway
7/23 - 7 a.m.

Water flowing into Hauser
Lake.
