Survey of Effects of Logging Practices
on Selected Western Montana Streams

July, 1988

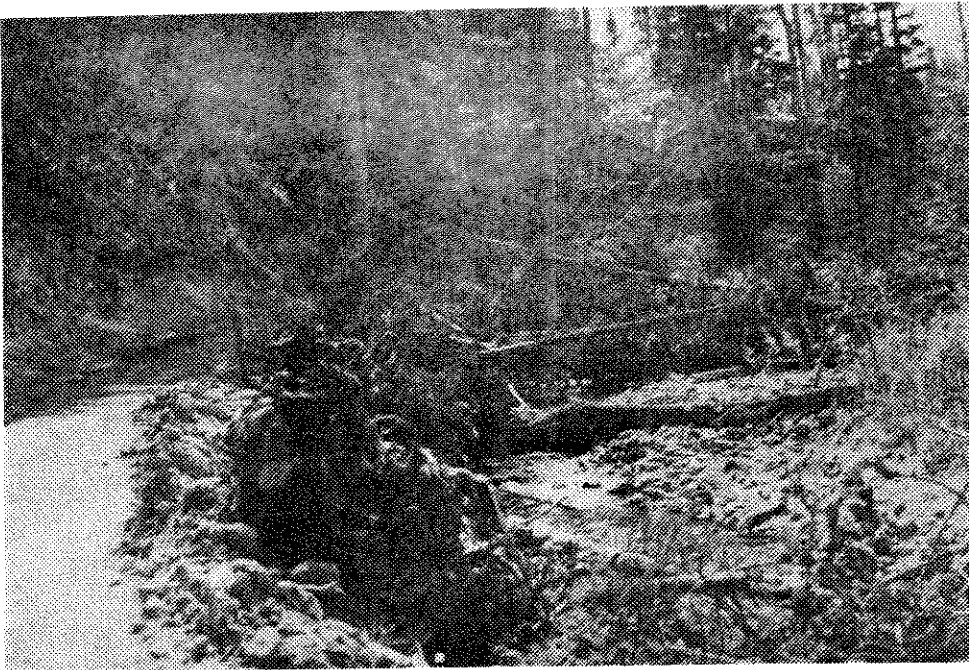
channel and is vulnerable to erosion during periods of high stream flow (Photo 1). Further riparian logging has reduced streambank stability. Fresh debris was present in the channel during our visit and was causing bank undercutting. Additionally, yarding was conducted on the streambank and some logs had fallen into the stream (Photo 2). Movement of larger size streambed material has caused channel braiding and cobble islands. The stream reach adjacent to the present logging activity received a streambank stability rating of only 109 (fair), compared to 46 (good) and 70 (good), respectively, for reaches above and below the activity.

Photo 1. Logging road encroaching on the streambank of Camas Creek.

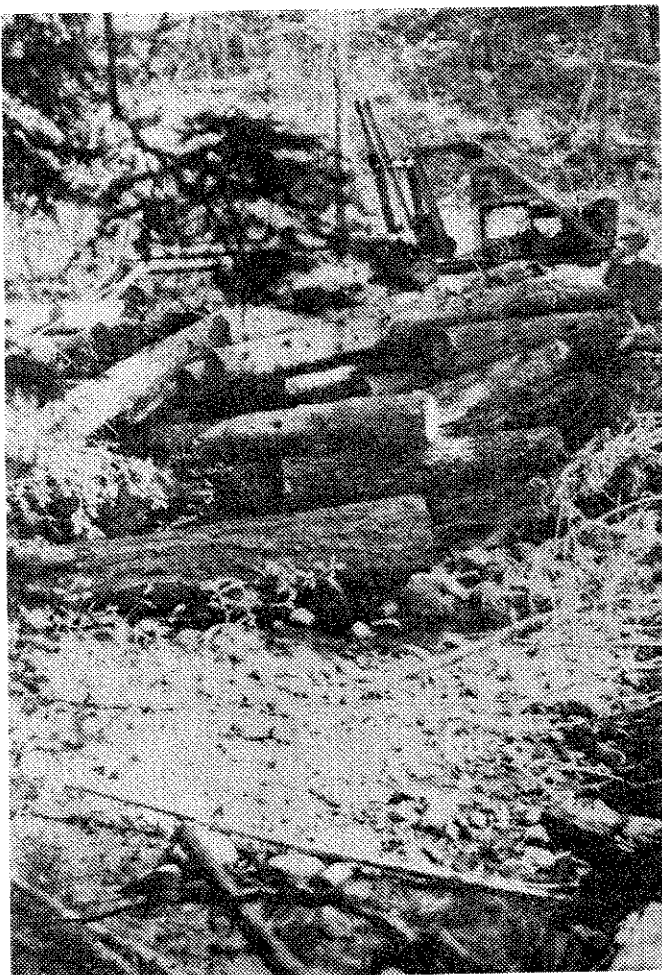
Photo 2. Yarding occurring in the channel and along the banks of Camas Creek.

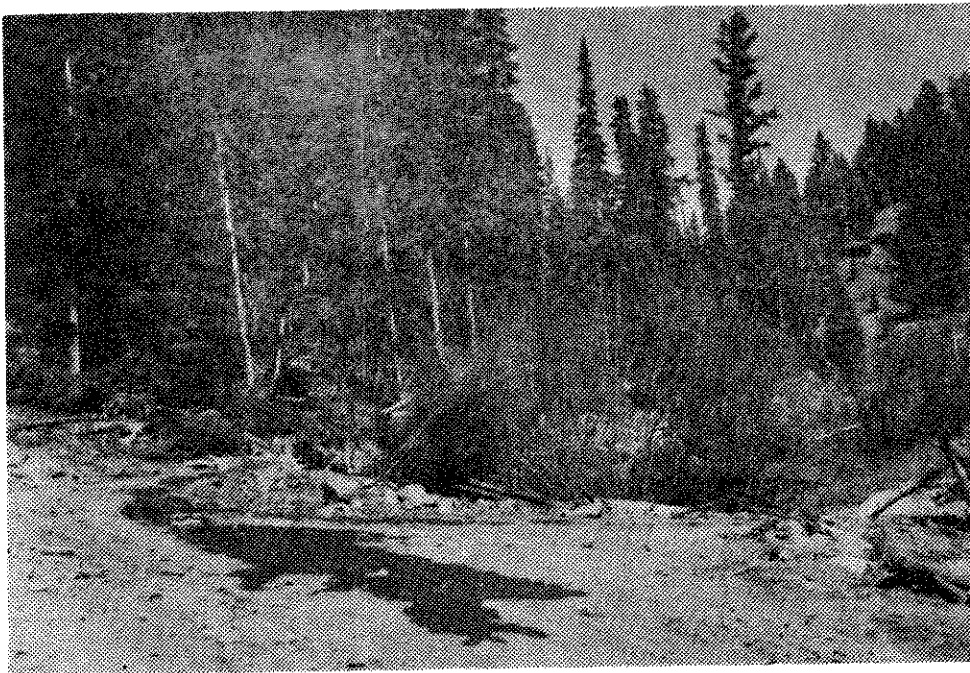
were common (Photo 3). In some places the roadbed formed the channel bank (Photo 4) and yarding had occurred in a riparian area adjacent to the creek. Large quantities of debris were present in the channel (Photo 5), and most of the channel was heavily silted in. Streamside vegetation had been disturbed, contributing to unstable banks and increased erosion. The stream reach within the timber harvest area received a poor stream stability rating (122).

Photo 3. Over road runoff and drainage into an unnamed tributary to Dry Creek.

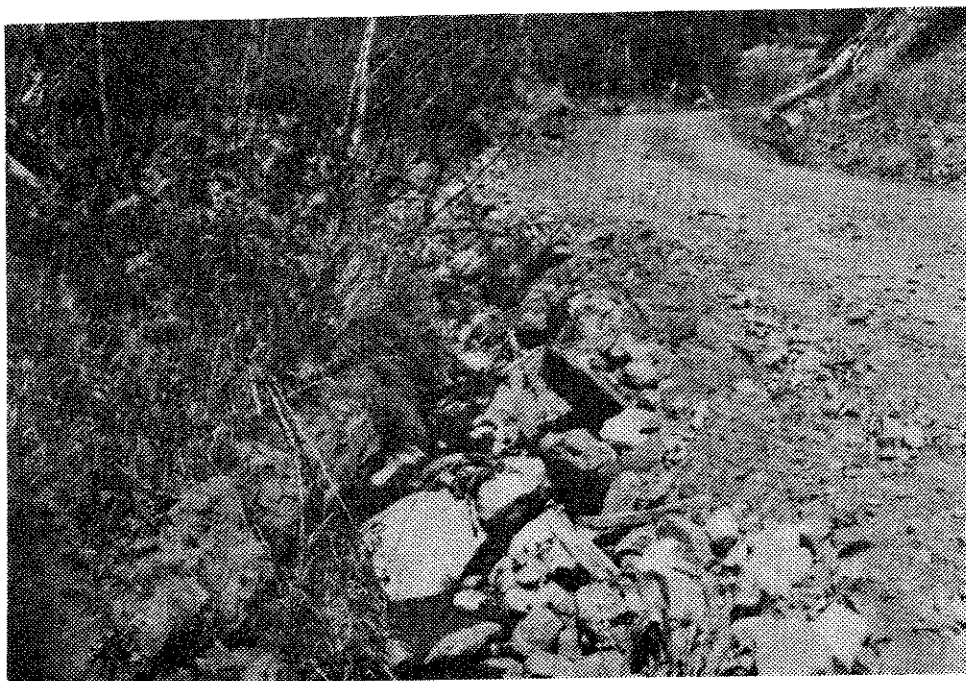
Photo 4. Roadbed, forming the streambank of an unnamed tributary to Dry Creek.

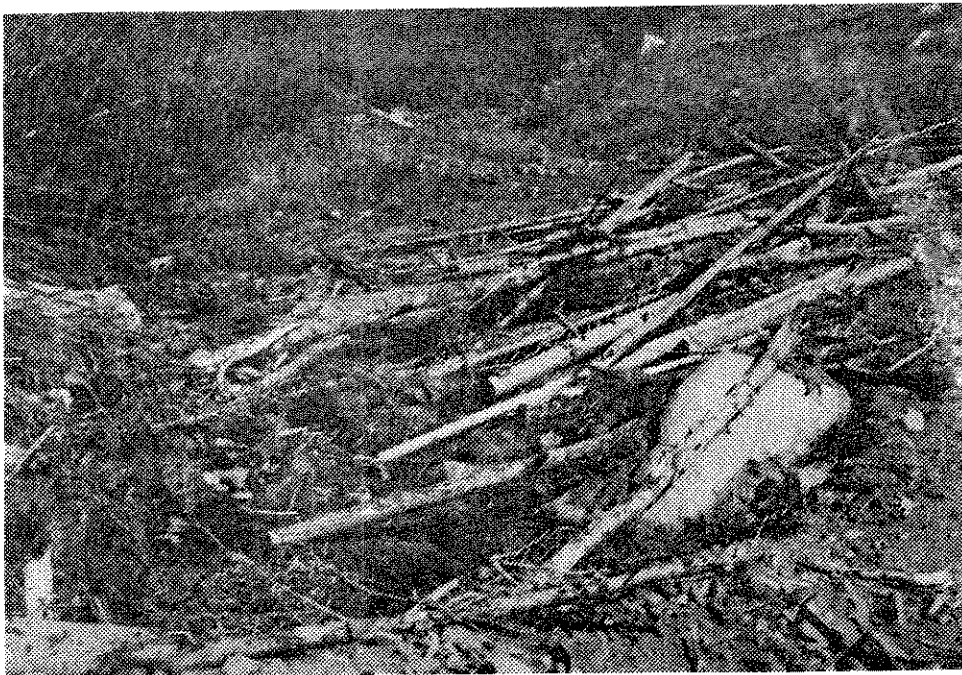
Photo 5. Slash and logging debris in an unnamed tributary to Dry Creek.

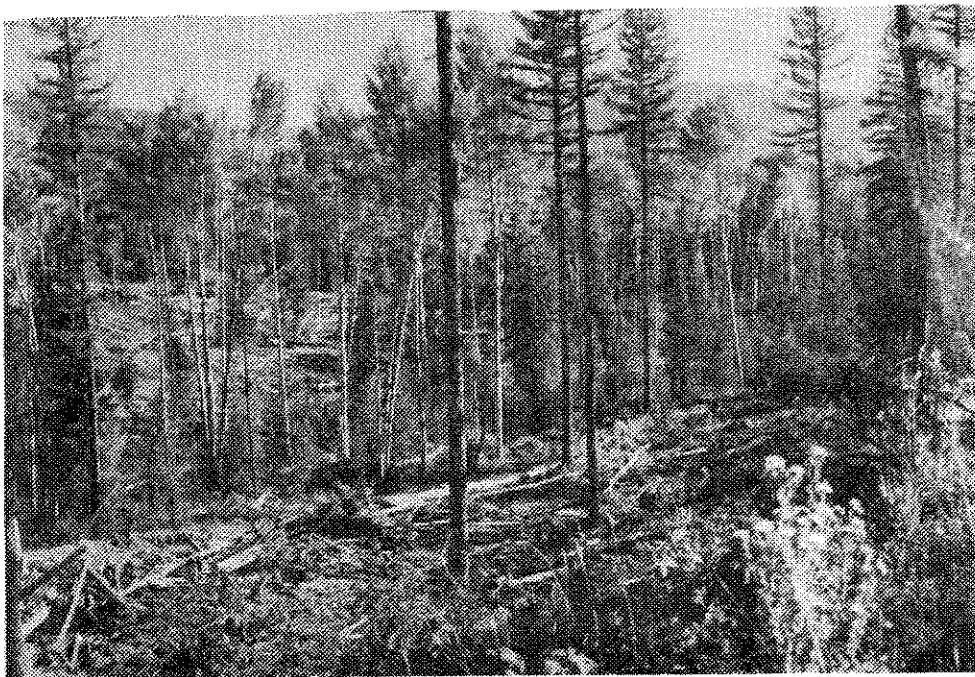
wide (Photo 6). Buffer strip width increased markedly as the stream crossed onto Forest Service land.

Photo 6. Timber harvest along Fish Creek showing the narrow buffer strip that was left to protect the stream.

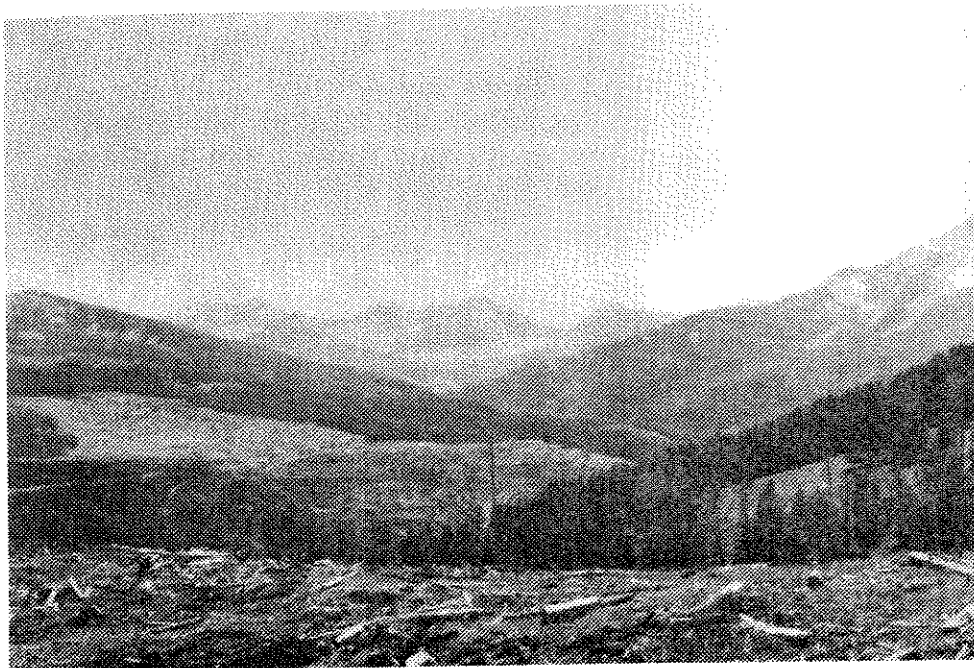
We examined the upper Jack Creek watershed on July 14, 1987. No serious problems associated with road construction were observed. Timber harvest had occurred near timberline (Photo 7) and some clearcuts approached several hundred acres. Some of the harvest had occurred on southwest-facing slopes where regeneration will be difficult.

Photo 7. Large, high elevation clearcuts in the southern portion of the Jack Creek drainage.

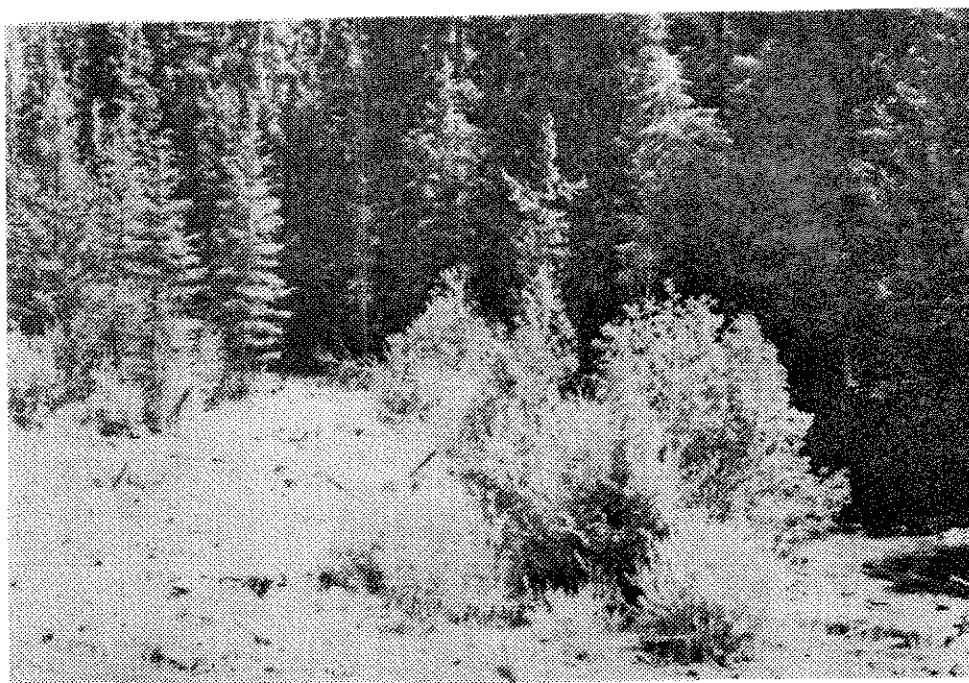
An upper reach of the mainstem of Jack Creek appeared to have recently widened; the streambanks had been undercut and there was evidence of movement of large bedload material (Photo 8). Additionally, several small tributaries entering Jack Creek from adjacent clearcuts contained high percentages of fine material. While it is not possible to definitely determine the reason for these changes, they may have been due to increased water yield caused by removing a high percentage of the forest canopy. Better techniques for evaluating and identifying stream channel changes caused by canopy removal are needed. Measures should be initiated to reforest the area as soon as possible.

Photo 8. Bank erosion and cobble deposition in the upper reaches of Jack Creek.

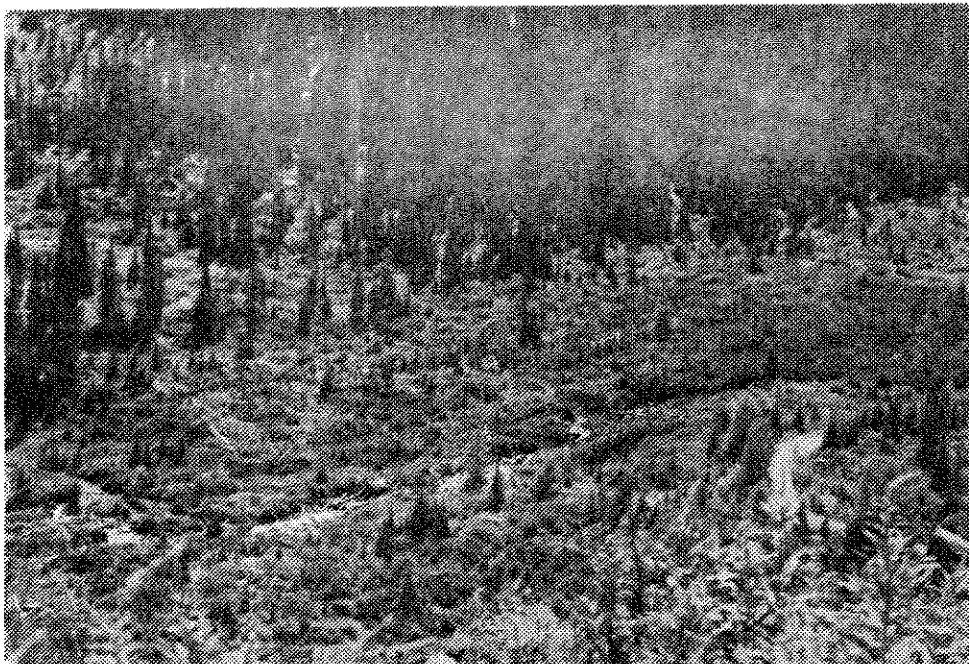
Photo 9. Clearcut near an inlet to Jim Lake. Note that no buffer strip was left.

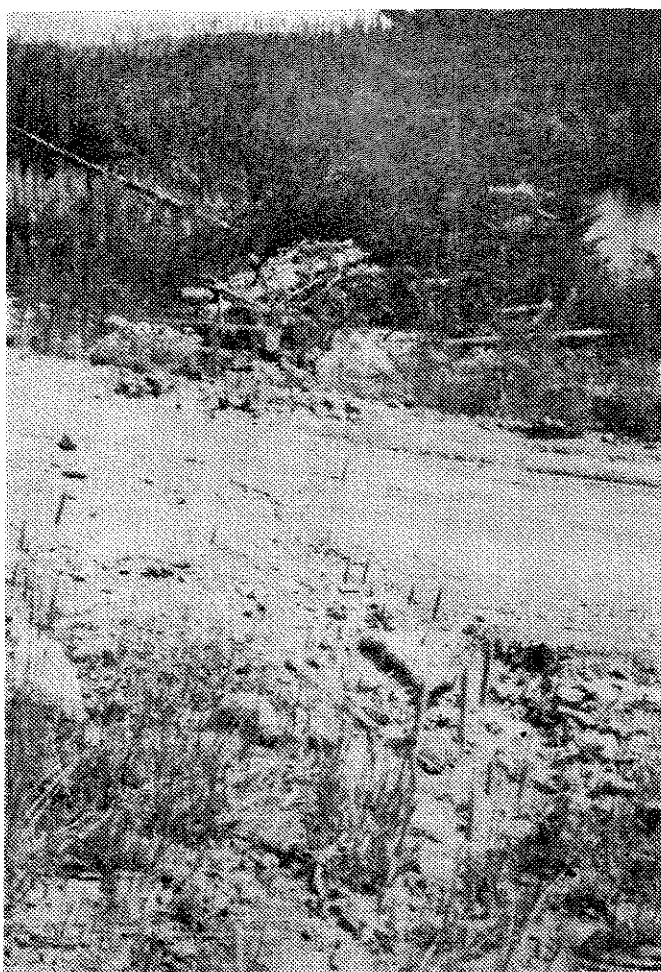
Photo 10. Gullying of road fill material near the inlet to Jim Lake.

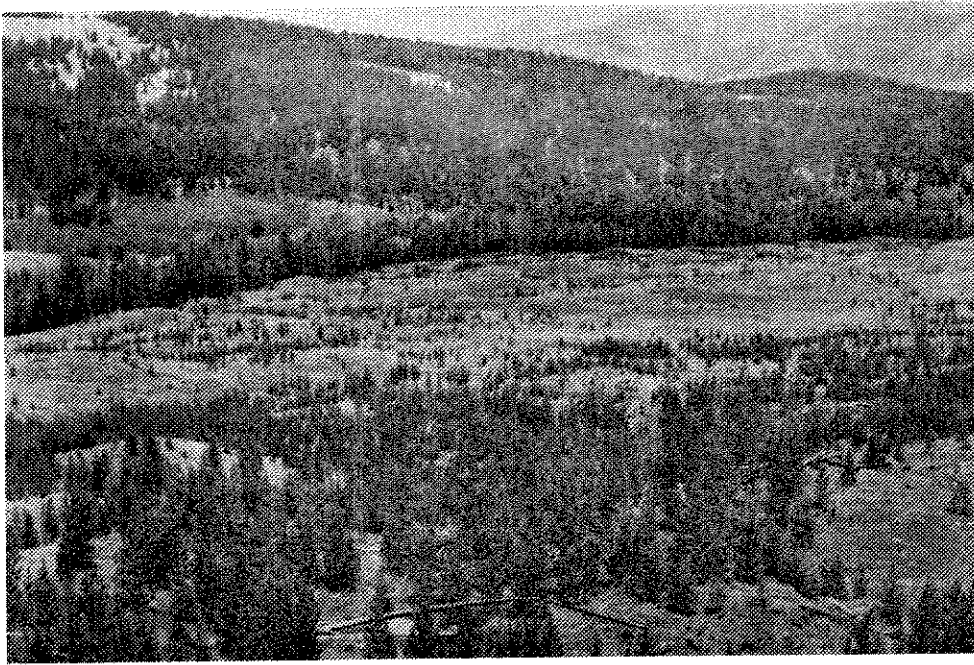
Photo 11. Seedling revegetation in large clearcut units along Gazelle Creek. Most of the trees on the slope leading to the creek have not been harvested.

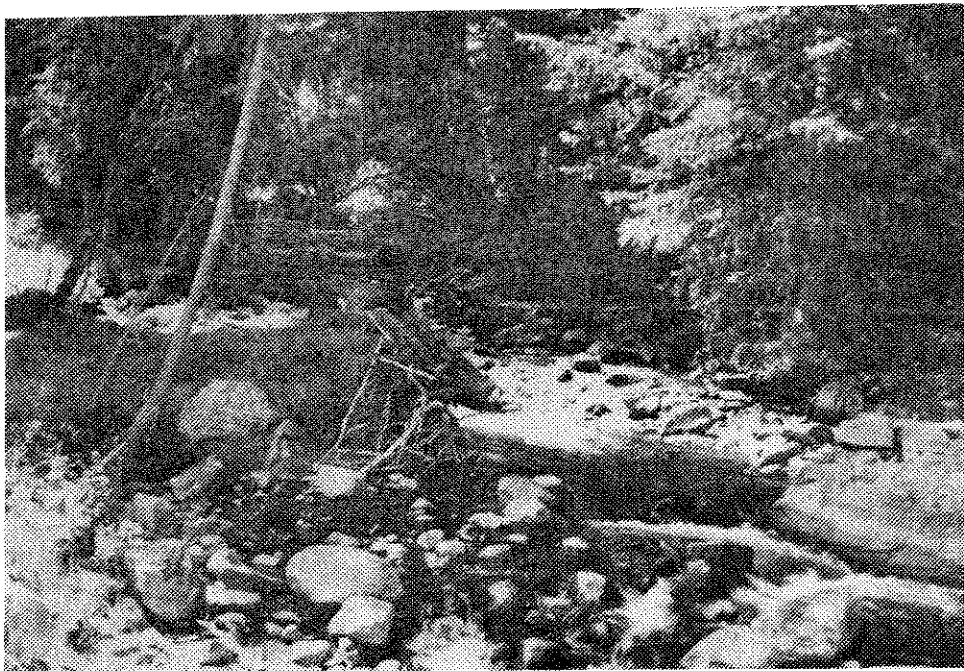
Photo 12. Stream channel of Gazelle Creek received a high stability rating.

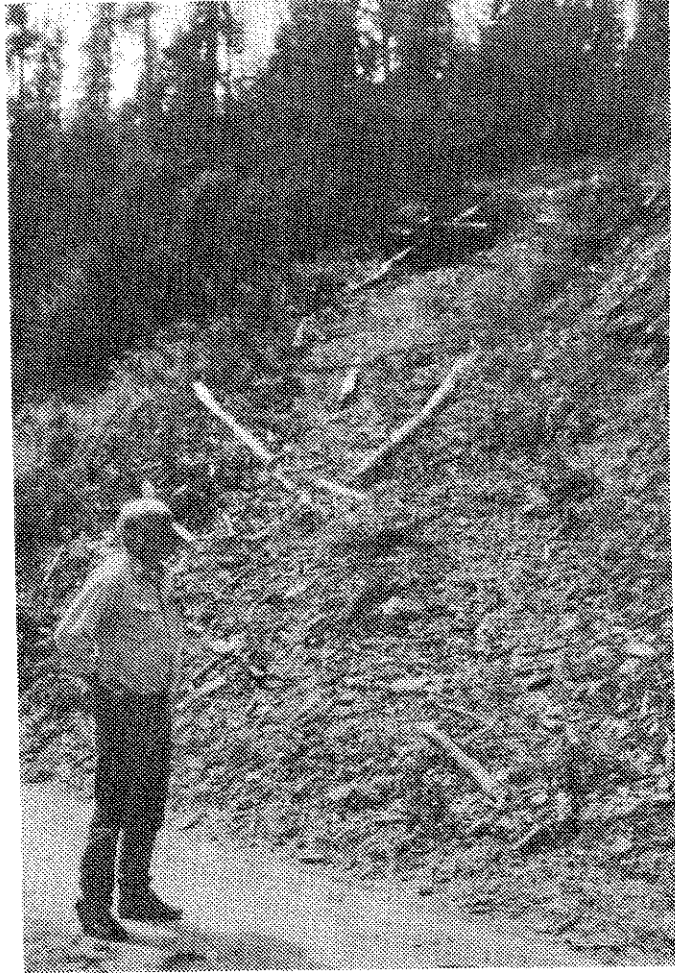
Photo 13. A well designed skid trail in the Freeland Creek drainage. The skid trail has been water-barred and debris piled to prevent runoff from being channeled to the road below.

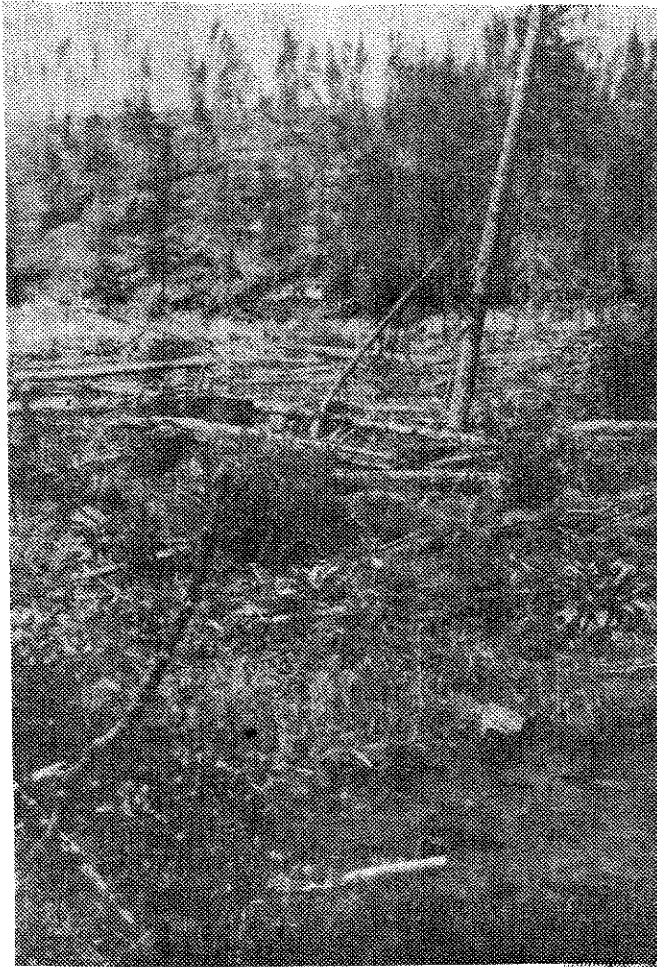
Photo 14. Timber cutting unit along Freeland Creek where no buffer strip was left.

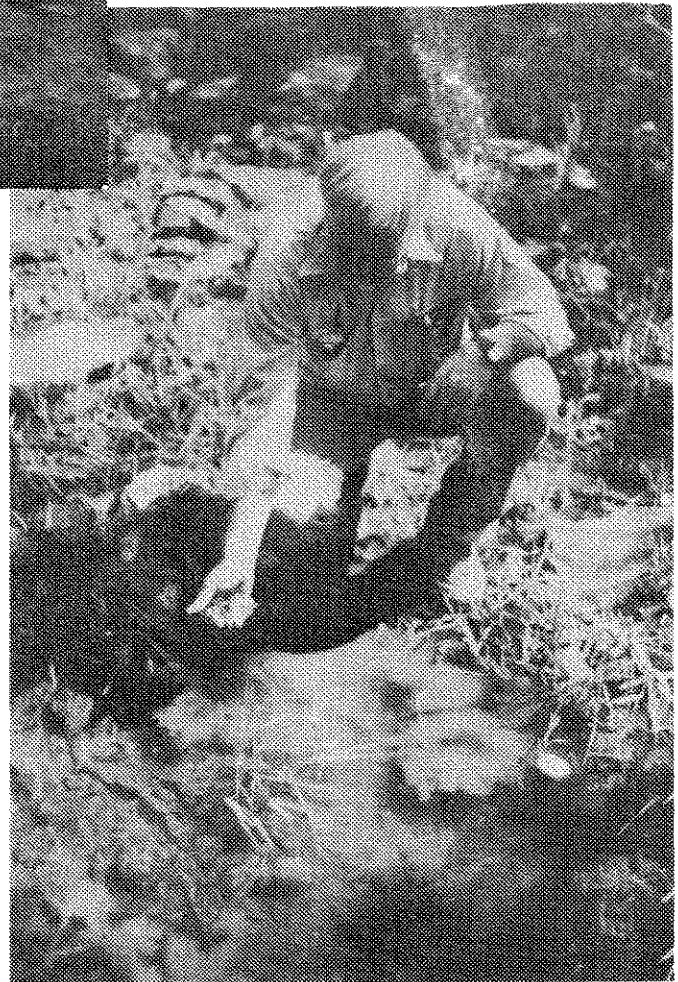
Photo 15. Fine, silty material in Freeland Creek below a clear-cut reach. This area also receives heavy cattle use.

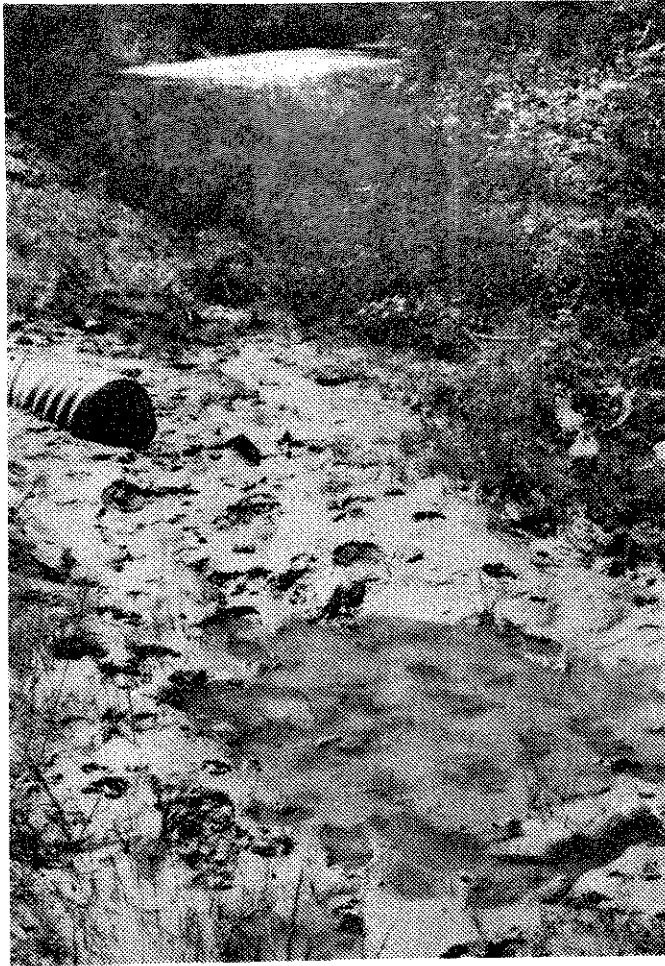
Photo 16. Sediment collecting below a culvert in the East Fork of Lolo Creek.

slopes resulting in gullying of up to four feet. Additionally, a plugged culvert in Section 1 was routing runoff across the road, causing roadbed erosion and increasing sediment transport to an ephemeral drainage (Photo 16).

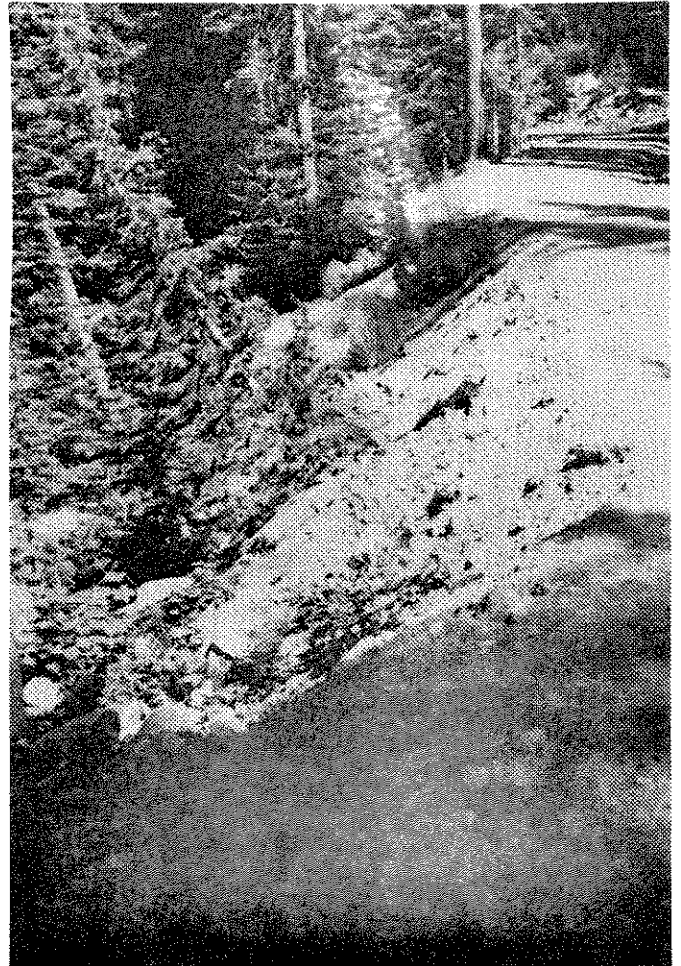
Photo 17. Unvegetated fill slope on a road adjacent to the East Fork of Lolo Creek; the road is about 15 feet from the stream.

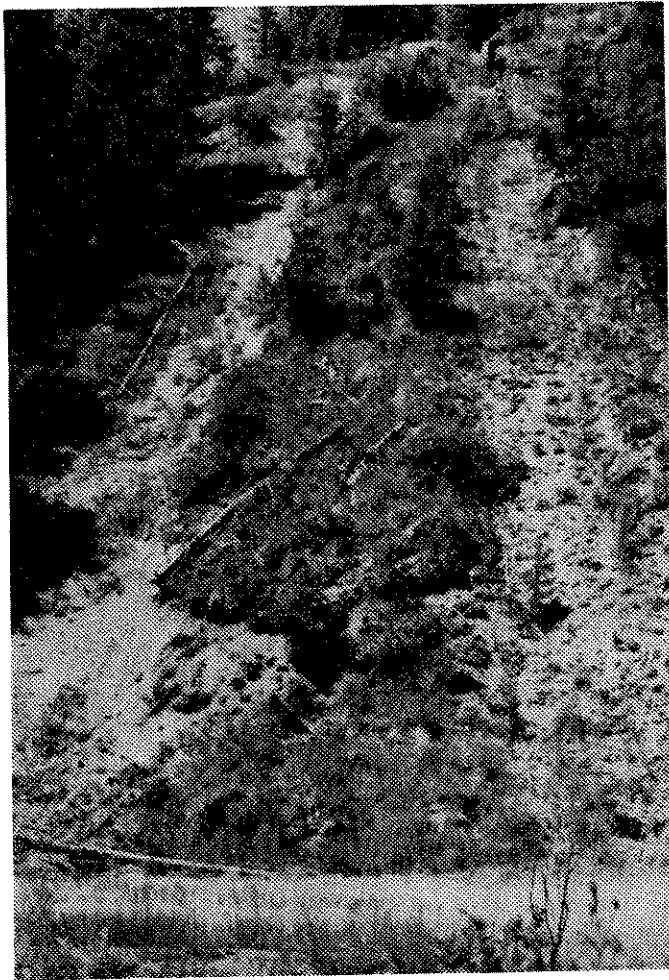
Poorly designed skid trails were another source of sediment to Lolo Creek. Skid trails in some locations (Sec. 1 and 7, T11N, R23W) had been placed on 70-80%

Photo 18. Eroding skid trails in the Graise Creek drainage.

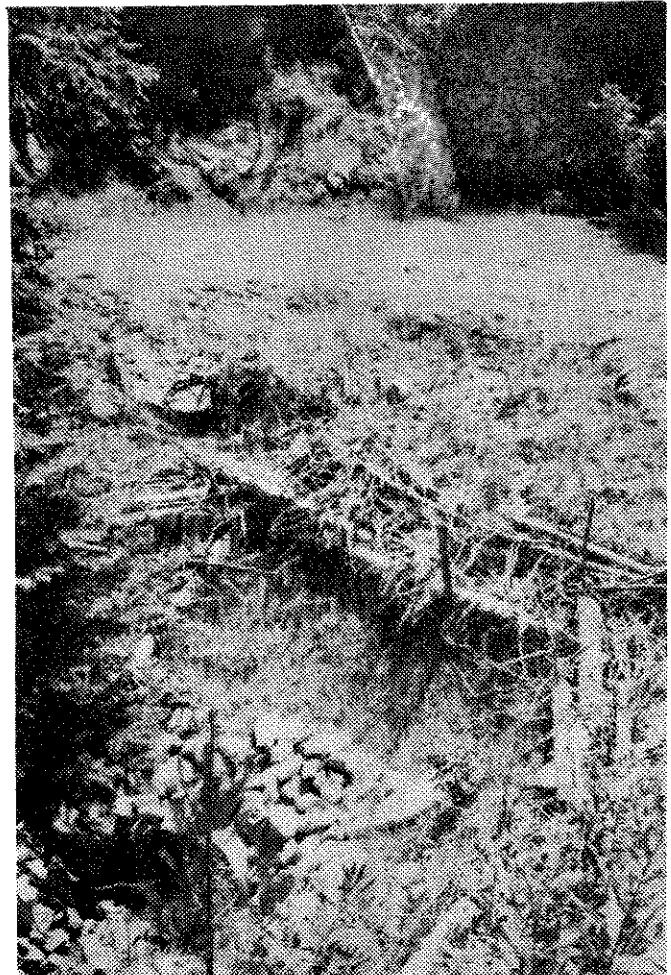
Photo 19. A well constructed road that includes an armored culvert, vegetated fill slopes, and slash filter windrows at the stream crossing.

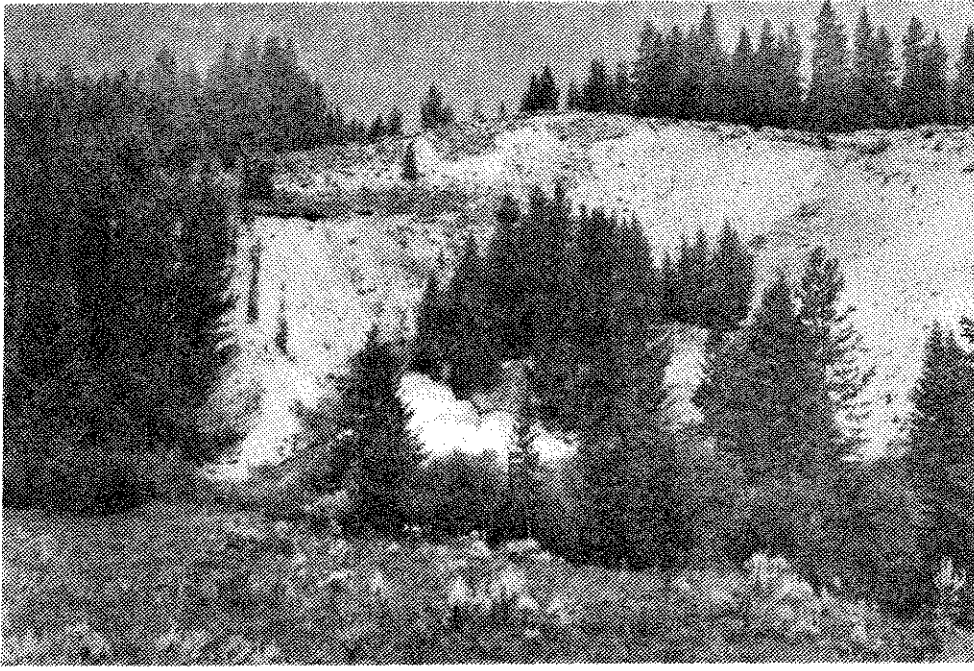
highly erodible. Several mass failures are present on the West Fork below Meridian Creek (Photo 20).

Photo 20. Mass failures adjacent to the West Fork of the Madison River.

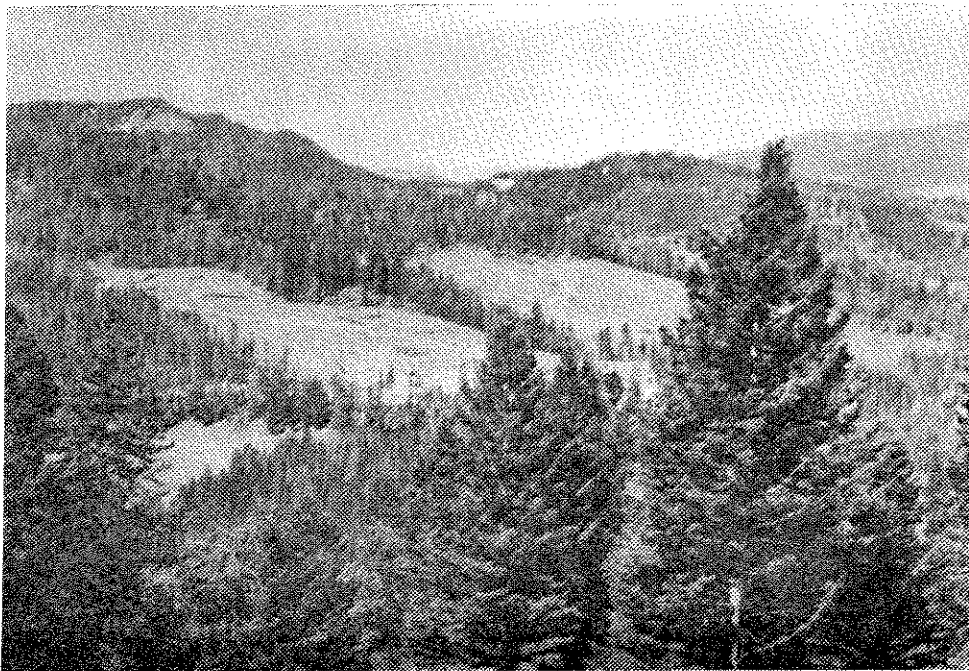
The channel bottom was comprised of 30% sand and silt which may have been augmented by cattle usage. Logging and road building did not appear to have contributed to degradation of the stream reach that we evaluated. Cutting units were designed in such a manner as to blend into the landscape giving the harvested area a more natural look (Photo 21).

Photo 21. Well landscaped clearcuts in the Meridian Creek drainage.

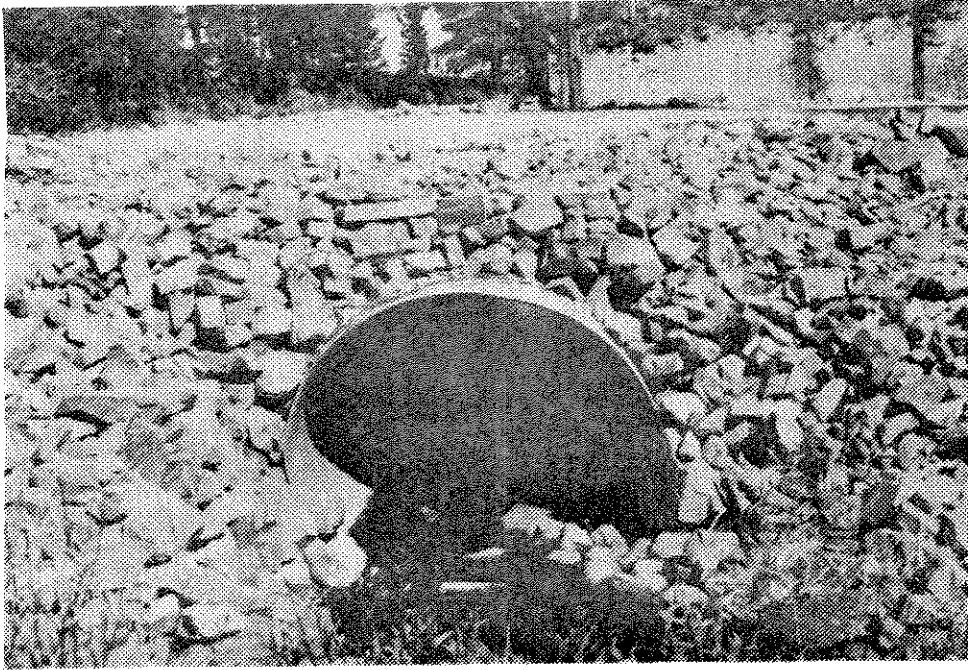
We examined two reaches of Monarch Creek on September 14, 1987. The reaches lie in the northern and southern portions, respectively, of Section 30 (T8N, R6W). In the upper reach, bottom materials were stable and culverts were well armored and designed to allow fish passage (Photo 22). Stream stability was judged to be good (60).

Photo 22. Culvert
in Monarch Creek.

Sedimentation to the stream caused by road construction could have been minimized by seeding the cut and fill slopes and by use of slash filter windrows.

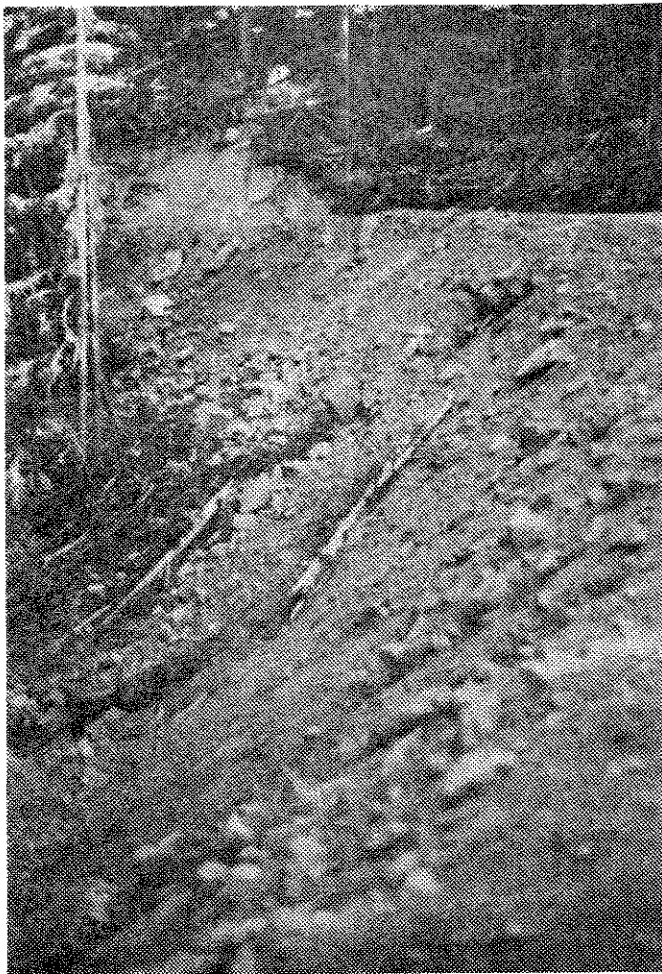
Photo 23. Exposed fill slope
adjacent to Monarch Creek.

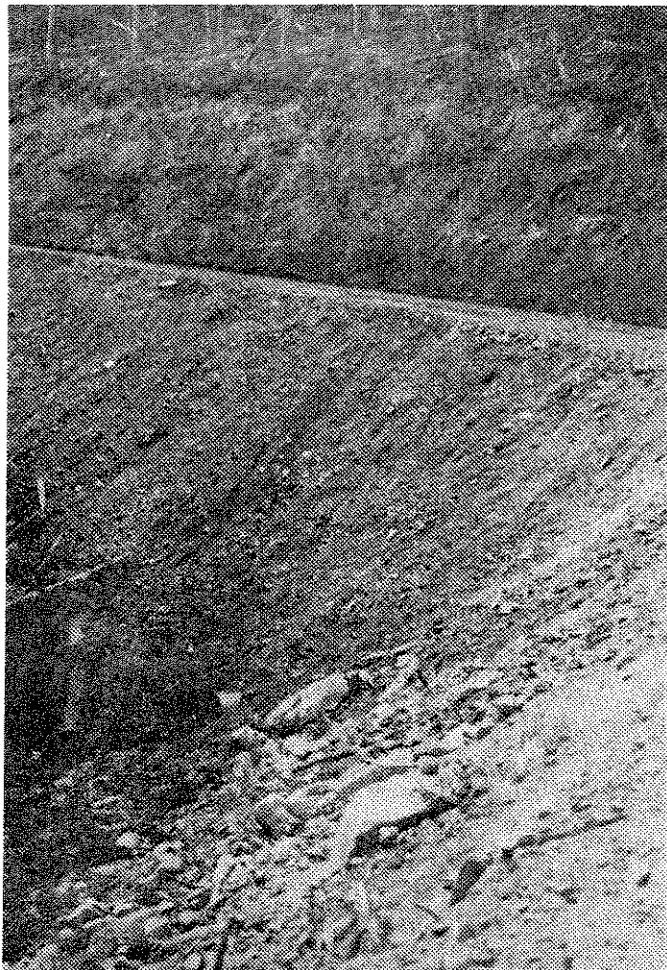
Photo 24. Steep, unvegetated, and unstable cut and fill slopes along Pickfoot Creek.

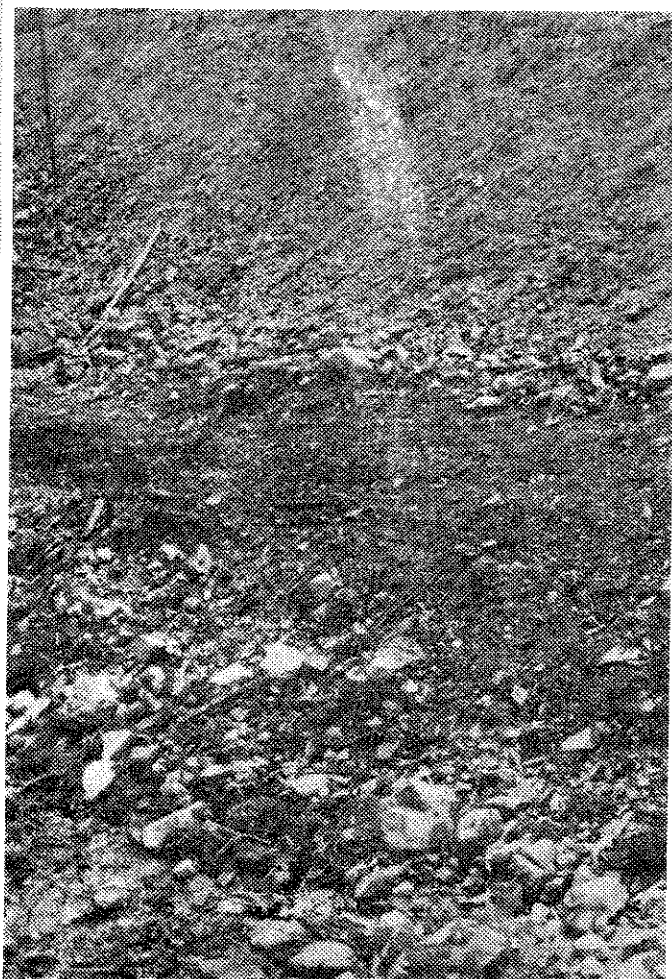
Of the three creeks traversed by the road, Atlanta Creek is judged to be the most likely to suffer impacts. Out-slope drainage off of the road into Atlanta Creek could produce sediment during wet periods (Photo 25). Stream stability was rated slightly poorer below the road than above. Some sediment deposition in pools and in backwater areas had occurred below the culvert outlet. Potential problems could have been minimized by locating the road further from the stream, and by timely reseeding or other slope stabilization methods.

Photo 25. Erosion of roadside material in the Atlanta Creek drainage. Note nearness of the road to the stream.

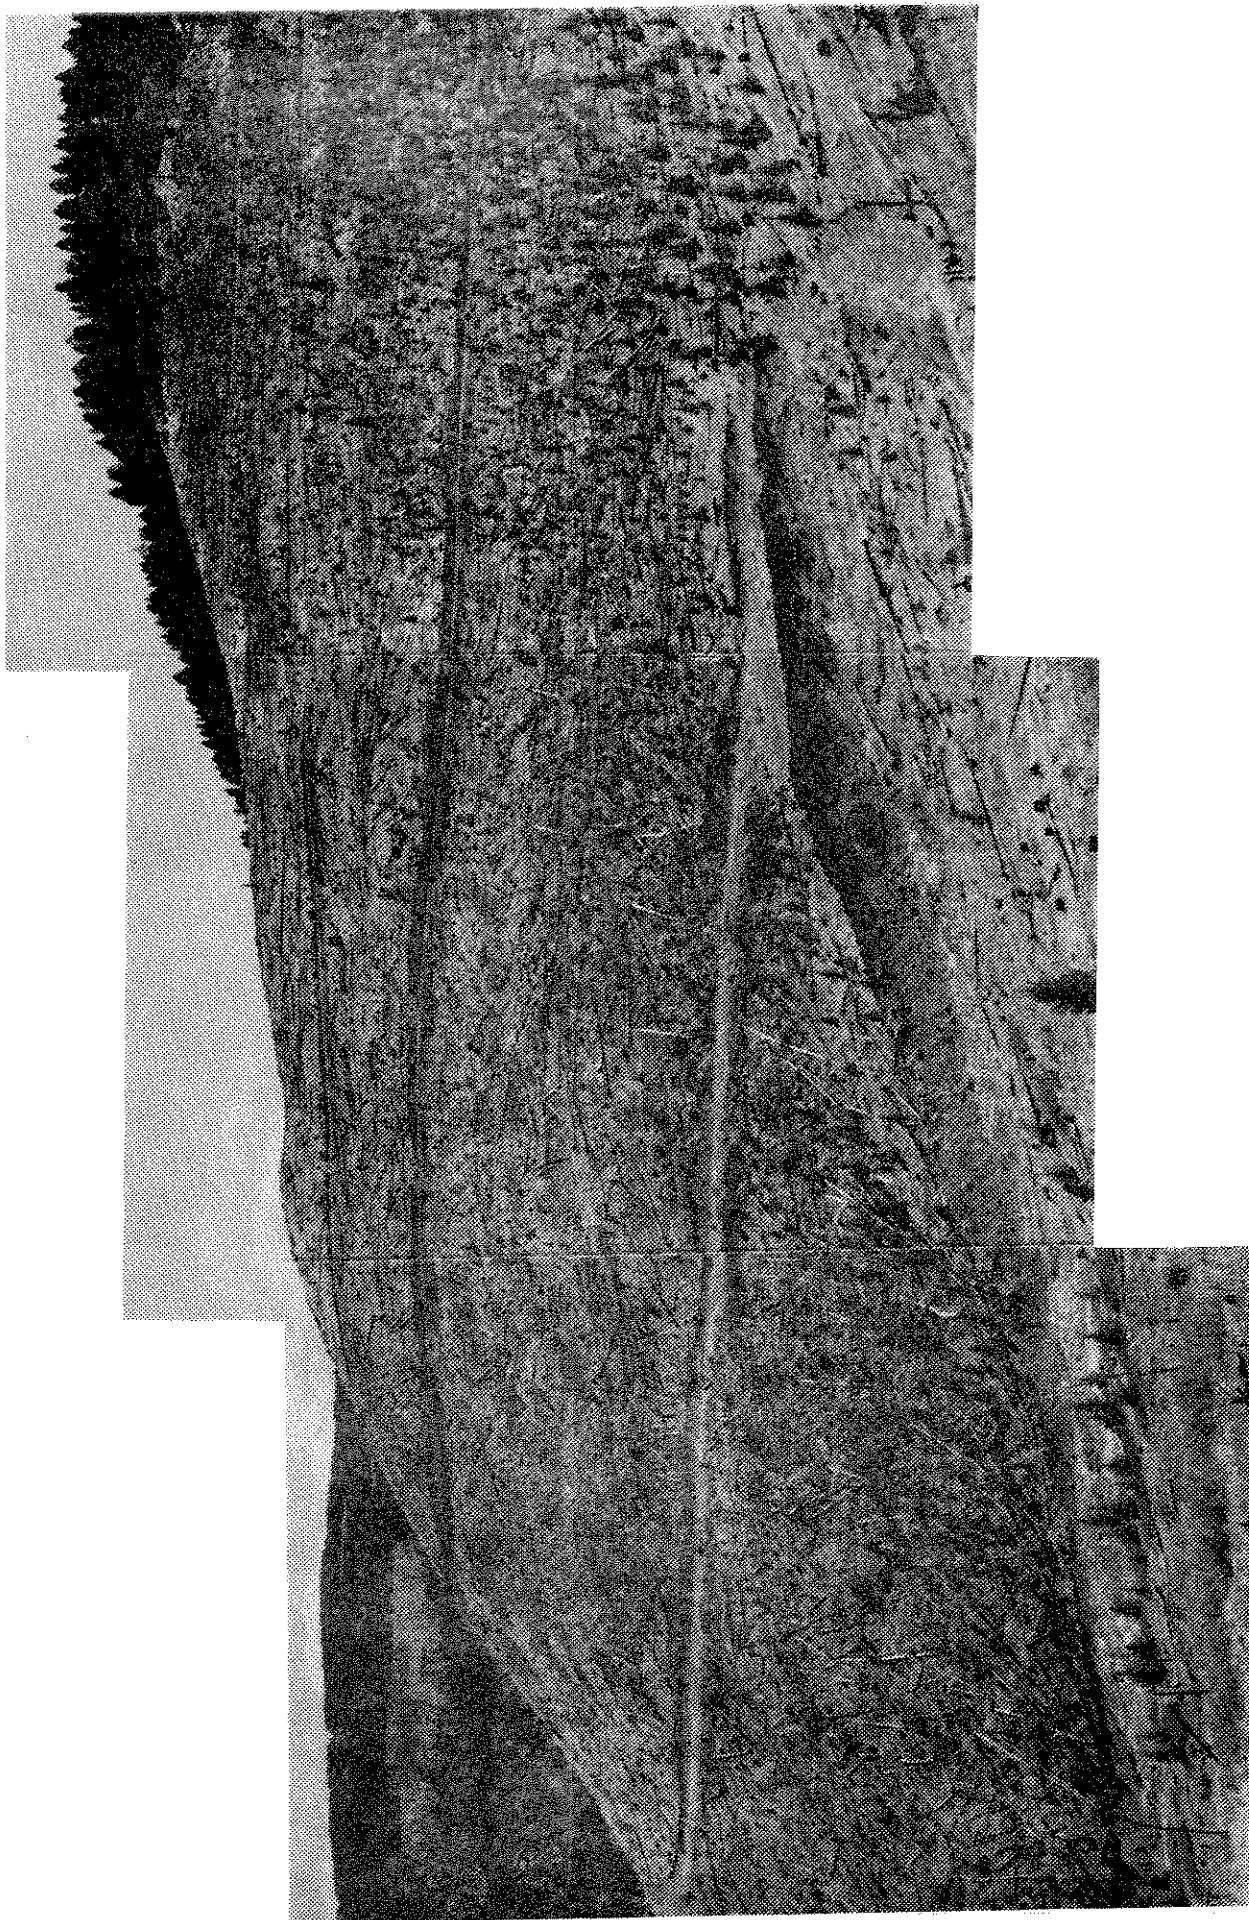
Photo 26. Large landslide in a clearcut in the Spotted Dog Creek drainage. Note that the landslide originated in a draw near a road cut.

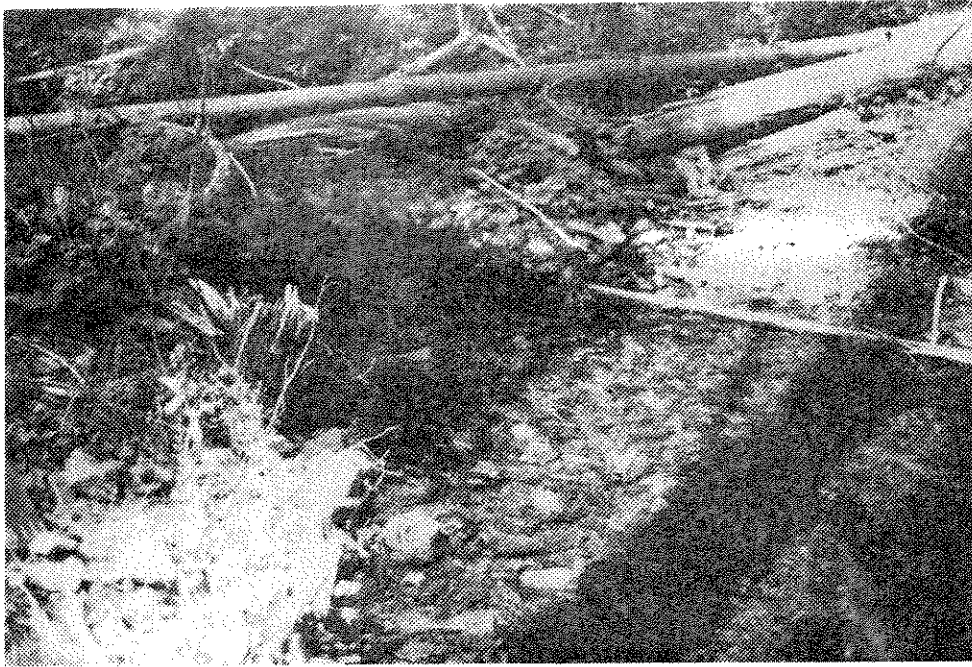
Photo 27. Spotted Dog Creek upstream of the landslide. This reach received a good stream stability rating.

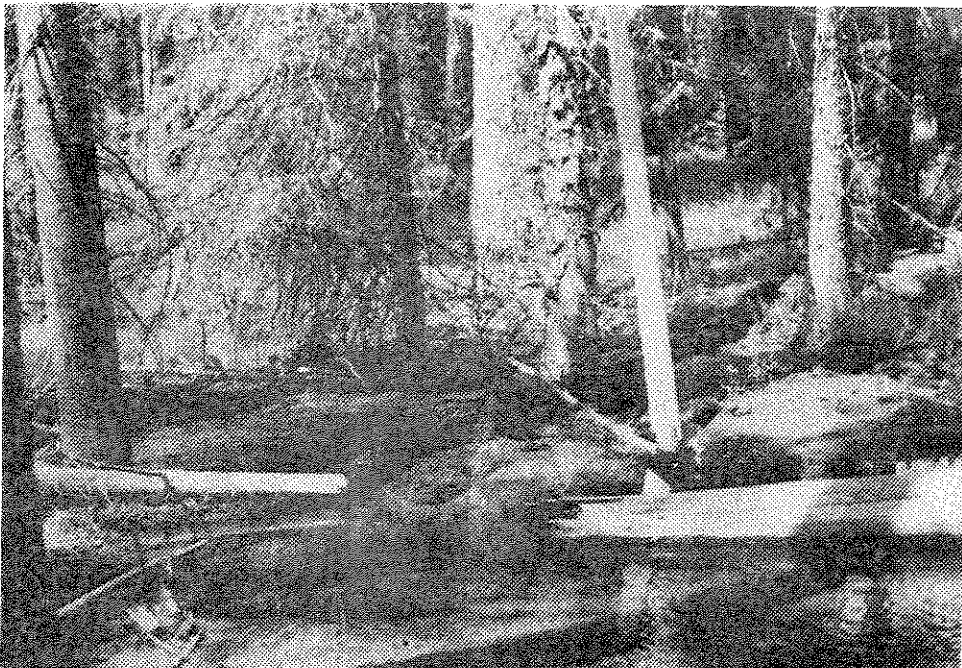
Photo 28. Spotted Dog Creek downstream of the landslide. Note the widening of the channel and the high percentage of fines.

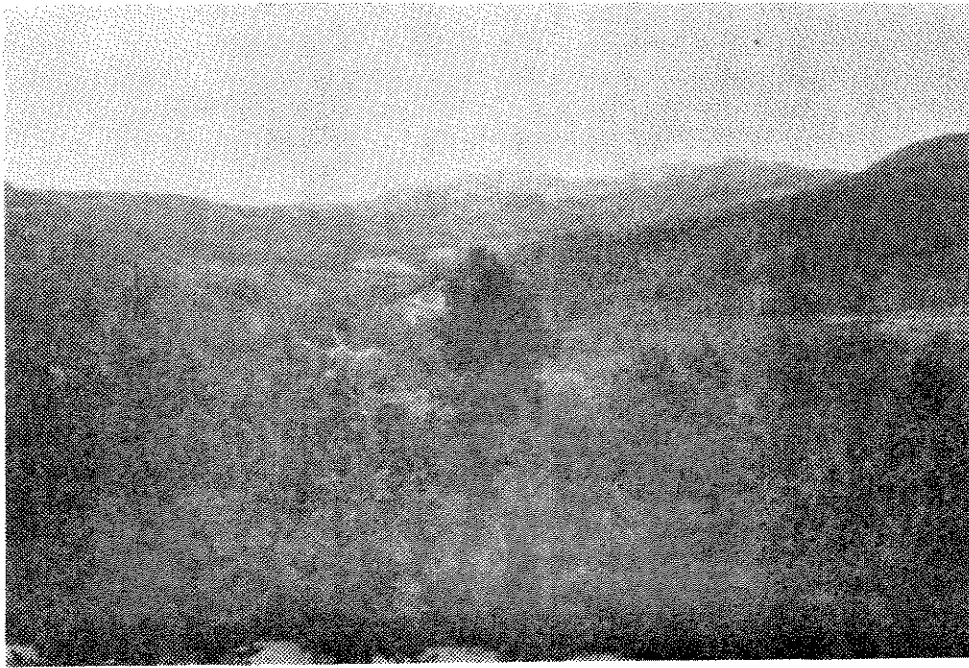
We visited the Portal Creek watershed on September 17, 1987. Timber harvest has occurred periodically over the past thirty years (Photo 29). Harvest has occurred on steep slopes and at high elevations. Some older harvest units extended to the banks of the creek. Regeneration has not begun in some cutting units and significant beetle kill is present on some of the upper slopes. Stream bank stability of Portal Creek was judged to be good (65). We observed a modest amount of debris in the channel, some raw banks, and evidence of sloughing (Photo 30). Considerable bedload movement was evident behind debris jams. The changes in the stream channel that we observed may have been due to a recent flood. It was not apparent that logging activities were responsible for any of the changes in the stream.

Photo 29. Clearcuts near the head of the Portal Creek drainage.
