Survey of Effects of Logging Practices
on Selected Western Montana Streams

July, 1988

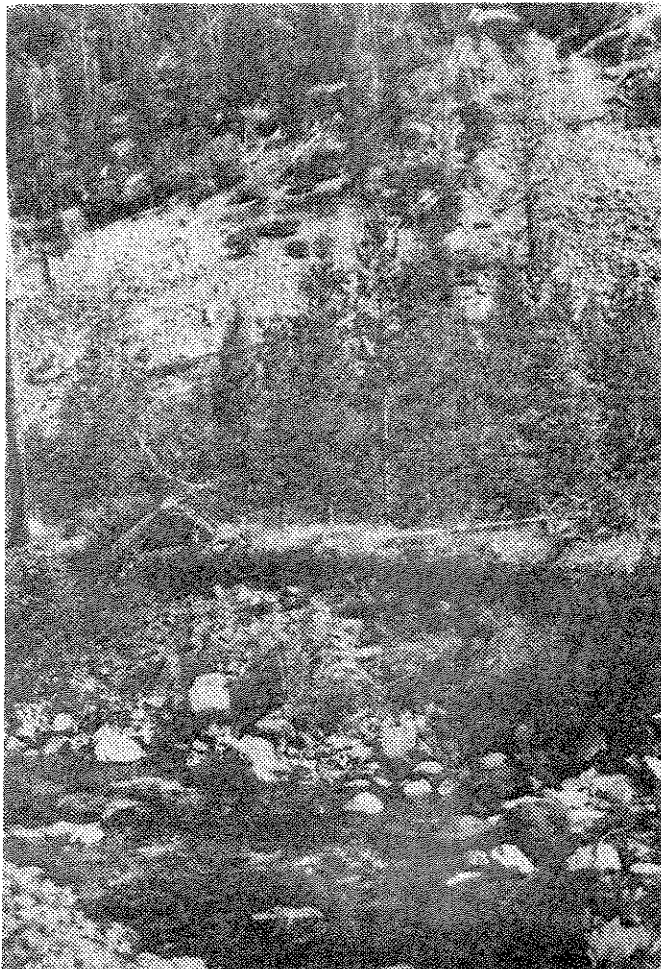
Photo 30. Streambanks of Portal Creek showing evidence of sloughing.

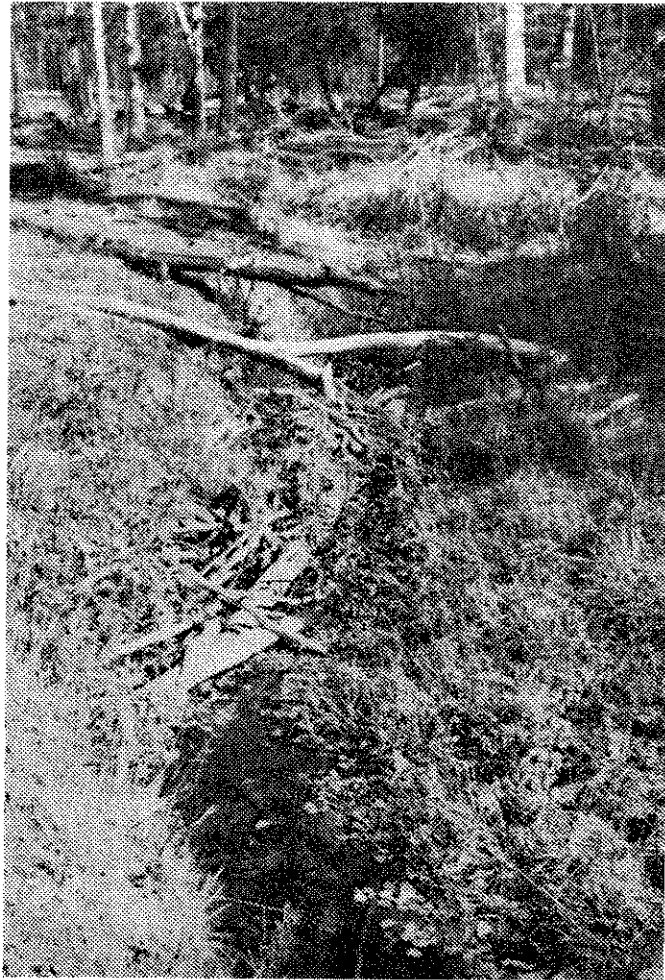
We visited Sickler Creek on September 22, 1987. Timber had been recently harvested to the banks of the stream and some slash was present in the channel (Photo 31). Heavy cattle use in the riparian pastures have resulted in trampled banks, widened stream channel, and heavy deposition of sediment. Some banks have been undercut by as much as 12-24 inches and riparian shrubs have been grazed heavily. Stream stability was rated poor (115) due to the fine-textured bottom materials.

Photo 31. Sediment deposition and slash in Sickler Creek caused by cattle grazing and recent logging.

Much of the stream damage could have been prevented by leaving an adequate buffer strip adjacent to the stream and by limiting cattle access to the area. This example illustrates that land management activities that follow (or precede) timber harvest can aggravate problems caused by logging.

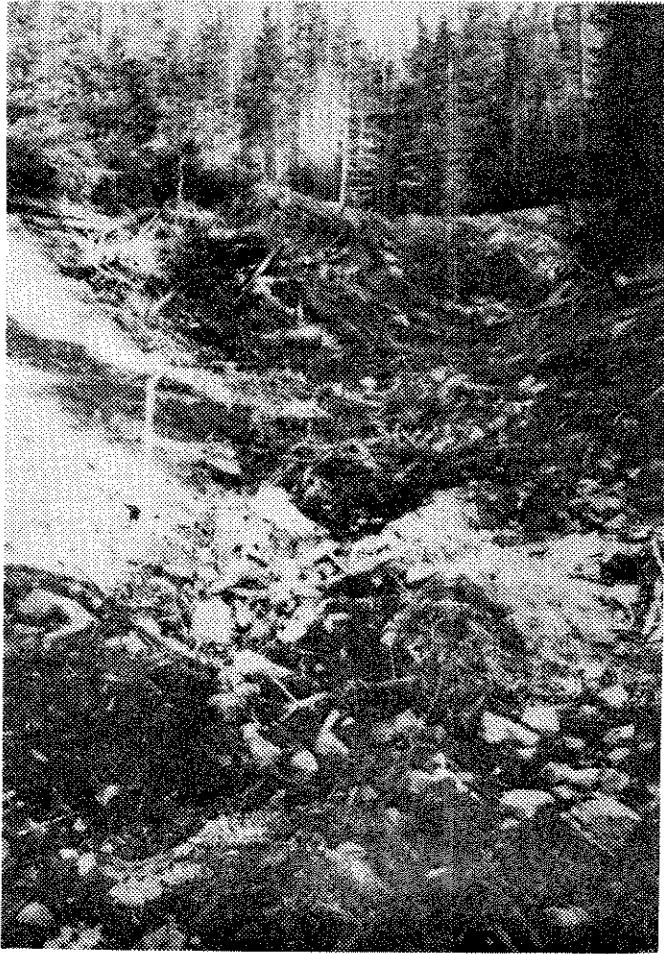
Photo 32. Skid trails located in an intermittent tributary to the South Fork of Poorman's Creek.

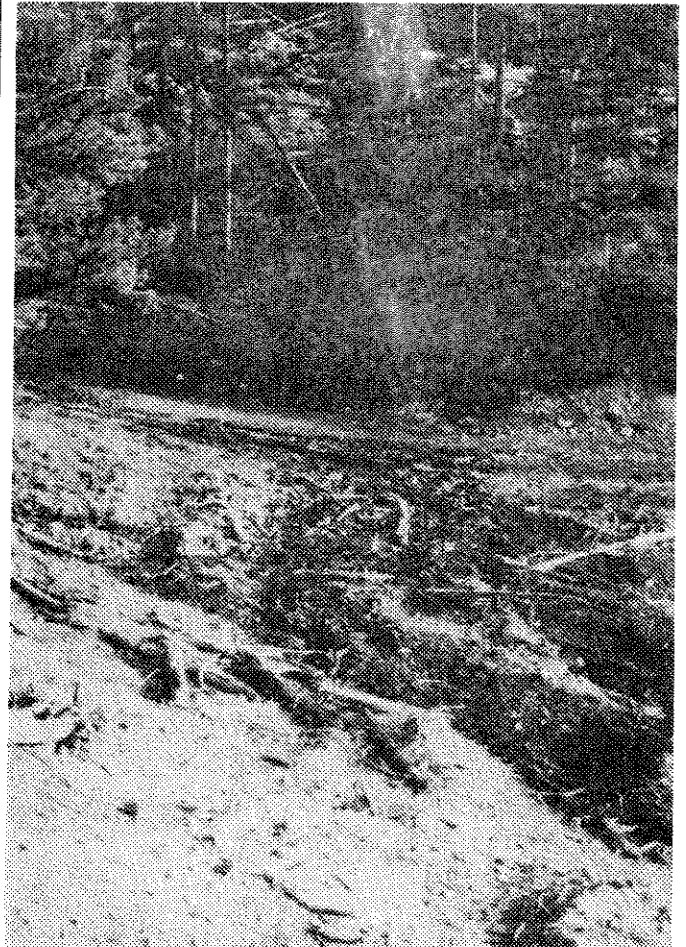
Photo 33. Road crossing an intermittent tributary to the South Fork of Poorman's Creek.

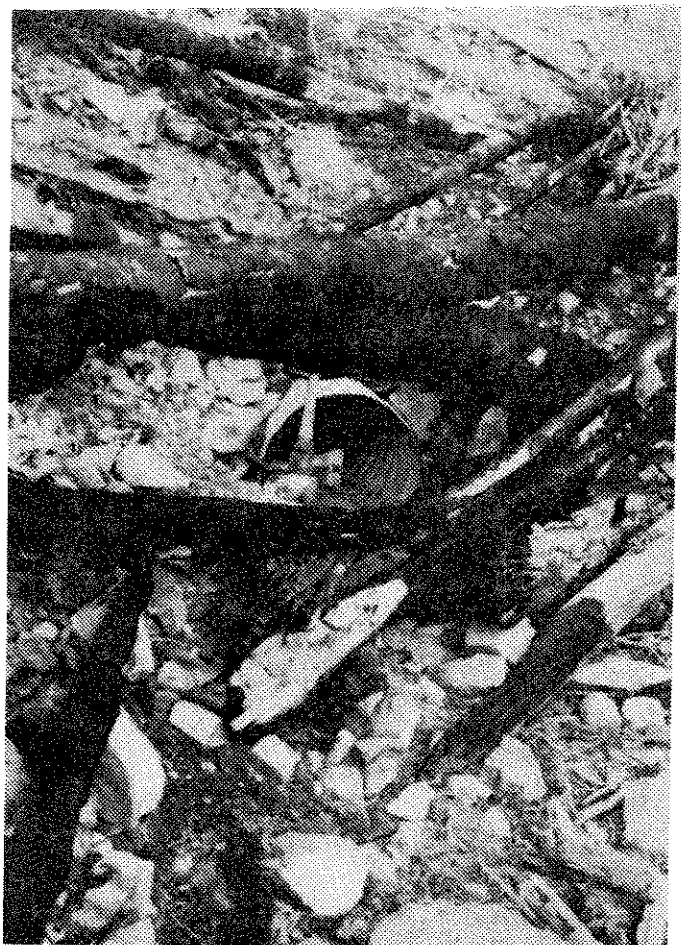
At the time of our visit, burned slash was found piled at the inlet and the outlet ends of the culvert which extends under the access road (Photo 34) and in the stream (Photo 35). Pooling of sediment below the culvert provides evidence that sediment is entering the drainage.

Photo 34. Slash disposal below a culvert in an intermittent tributary to the South Fork of Poorman's Creek.

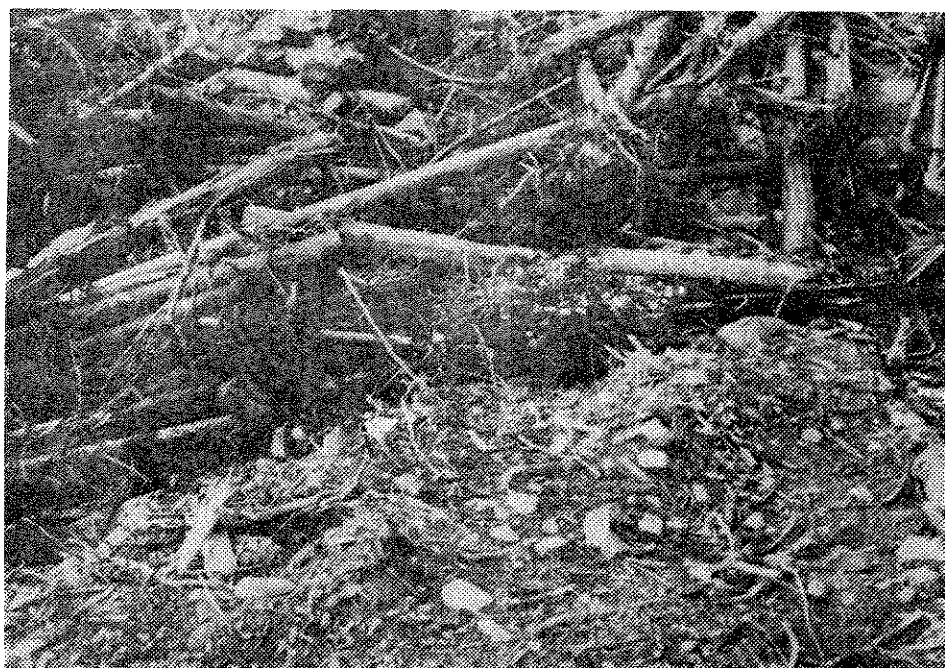
Photo 35. Slash disposal in the channel of an intermittent tributary to Poorman's Creek.

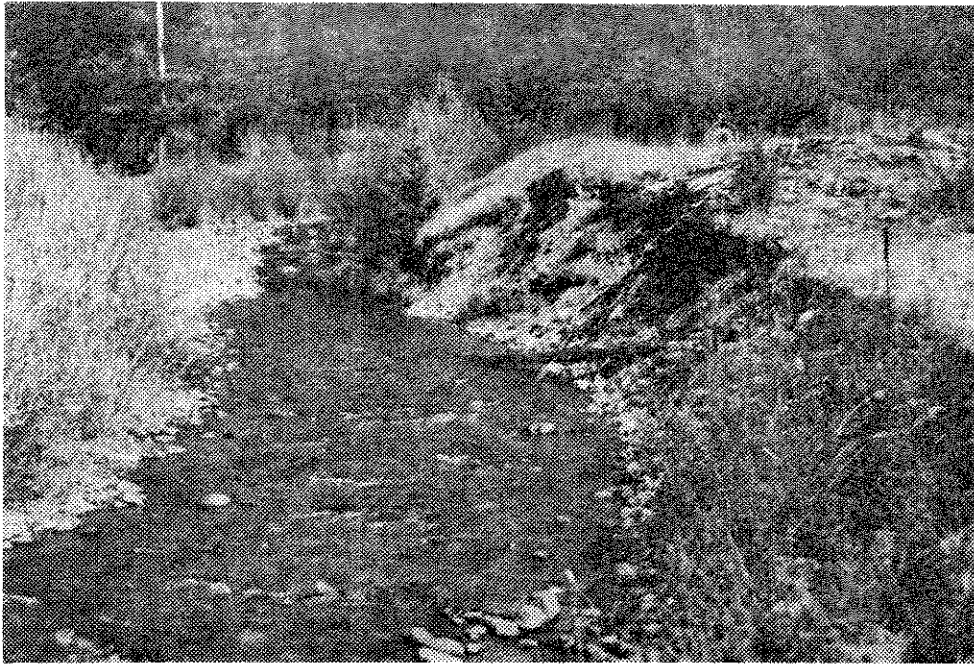
Photo 36. Portions of the Squaw Creek channel upstream of the logged area showed some signs of instability.

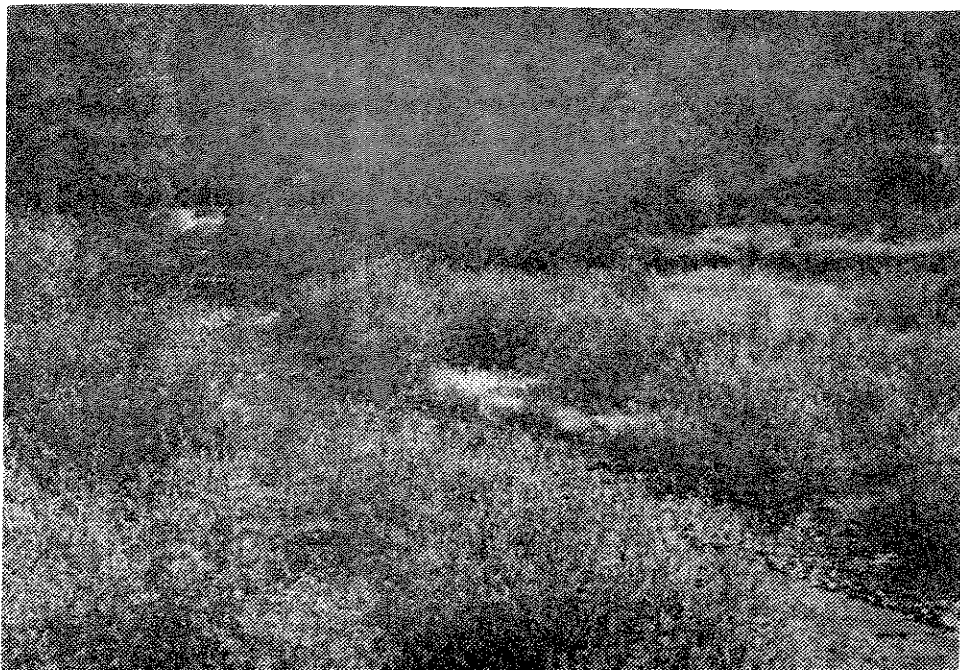
Reaches downstream of logged areas near the confluences of Orchid Creek and Lime Creek were judged to be more stable, rating 101 and 91, respectively (Photo 37). There appeared to be less bedload movement and banks were in better condition. The road approaches the creek in some places and undoubtedly contributes some sediment. However, neither the road nor logging practices appeared to be important factors in the drainage.

Photo 37. The Squaw Creek channel downstream of the logged area was in good condition.

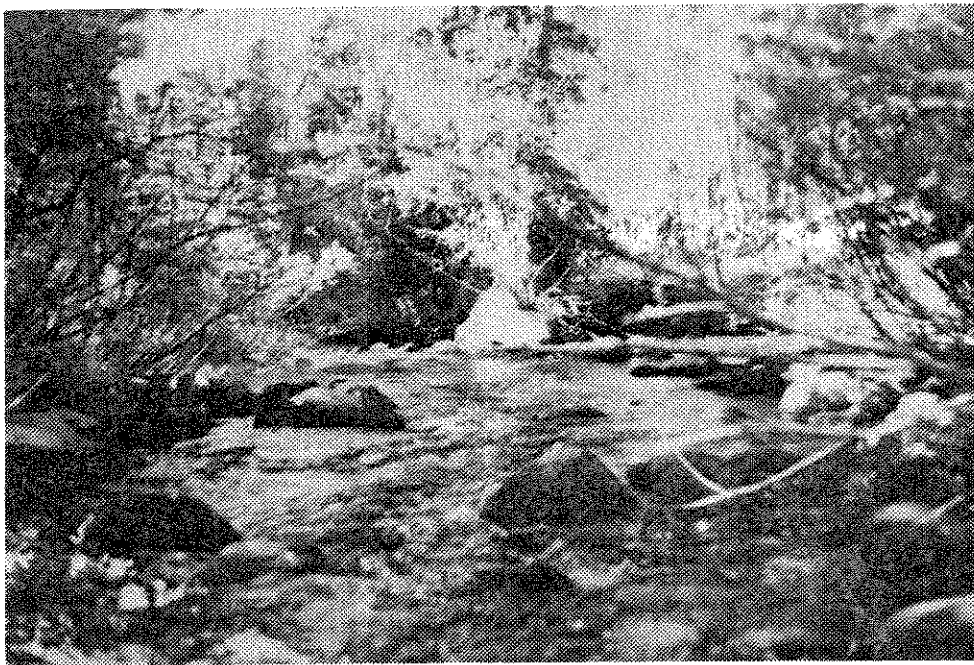
Photo 38. An undisturbed reach of Seymour Creek that is in excellent condition.

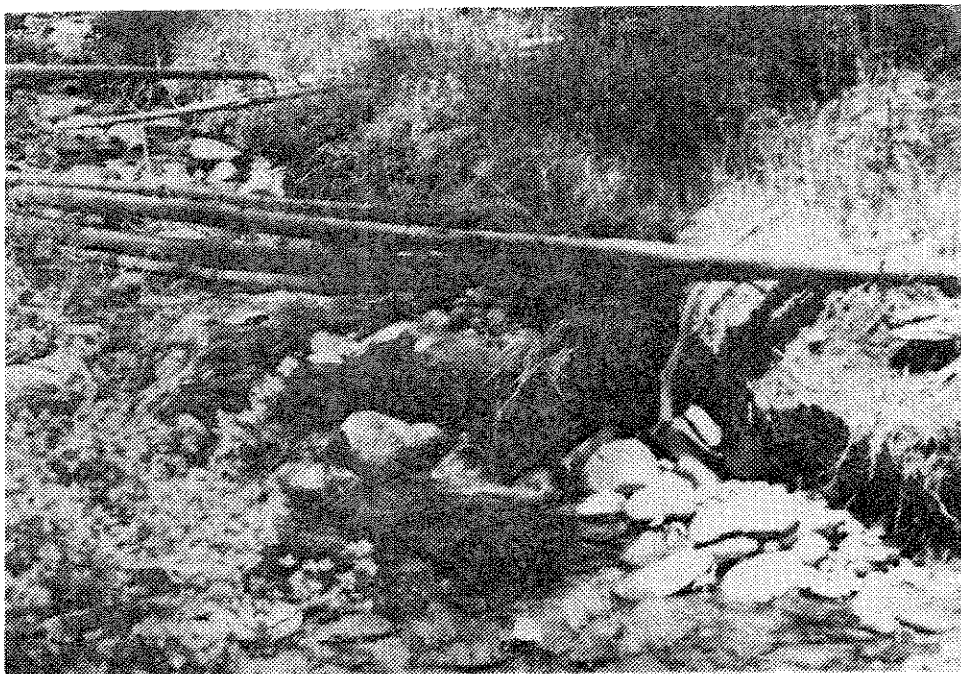
Photo 39. The lower reaches of Sullivan Creek where we observed signs of bedload movement, undercut banks, presence of fresh debris, and a shift in size distribution of bottom materials.

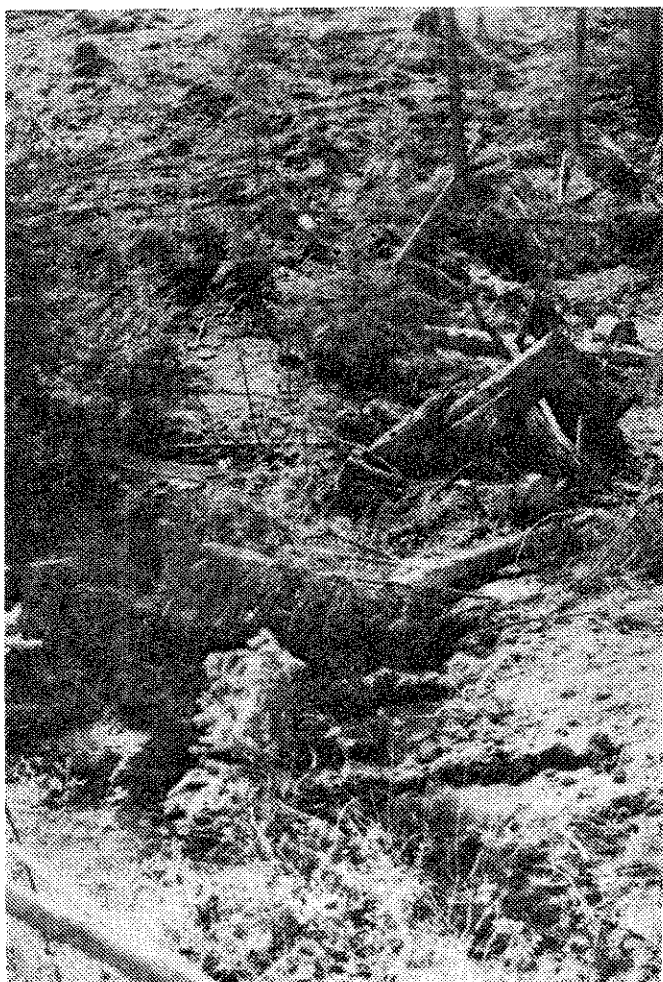
Tamarack Creek received a low stream stability rating (100), primarily due to the fine textured channel bottom materials. Damage to the stream channel had been aggravated due to trampling by livestock. Stream damage could have been minimized by leaving an adequate buffer strip along the stream and by limiting cattle access to the area.

Photo 40. Logging along Tamarack Creek.

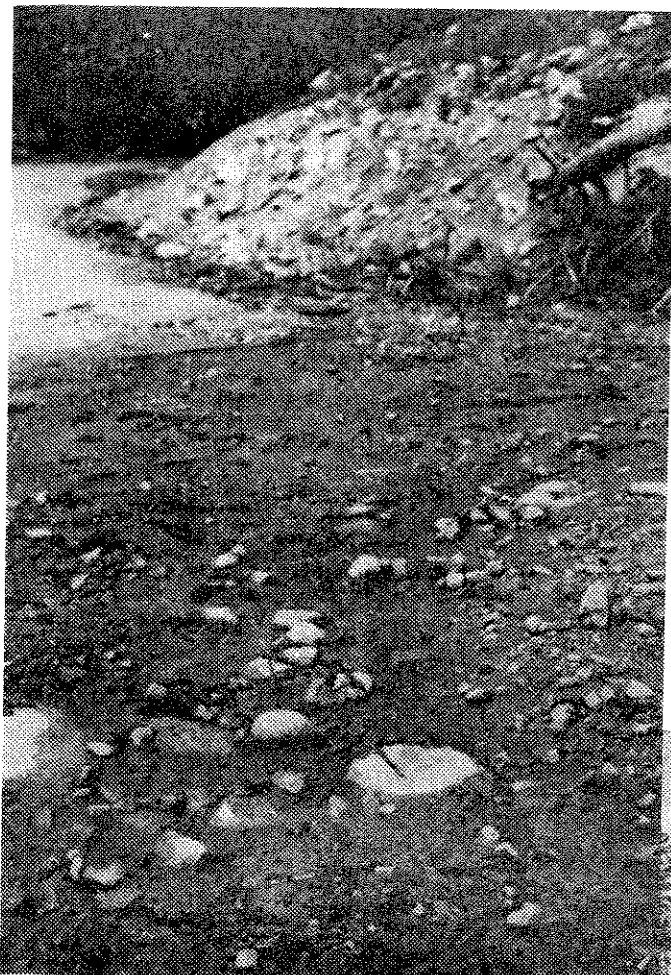
Photo 41. Erosion of road material in the Ten Mile Creek drainage.

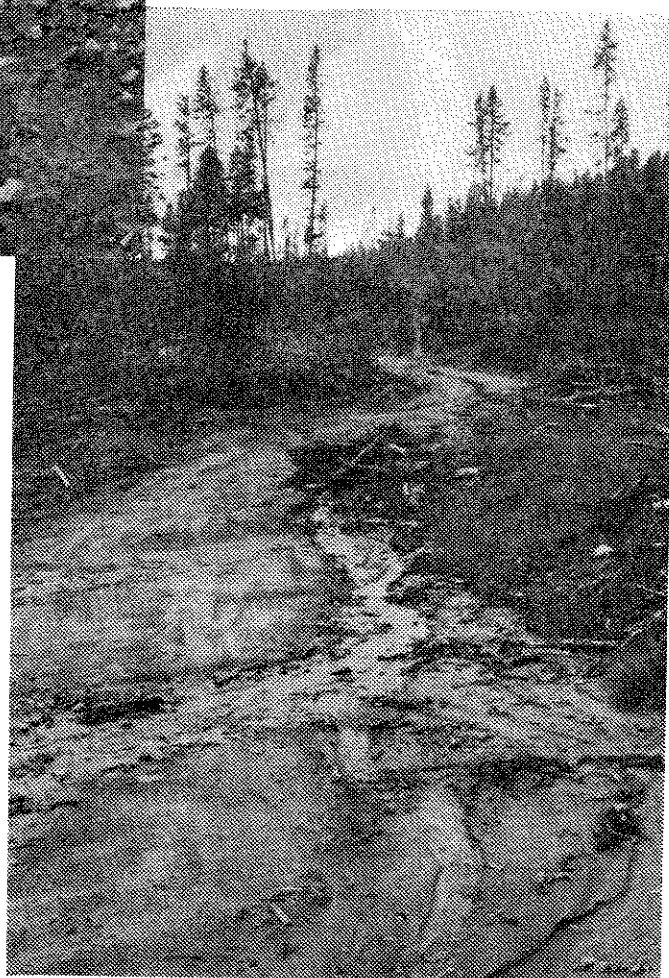
Photo 42. Gullying of road material into the Ten Mile Creek drainage.
