Report on Field Trip, June 13 to 17, 1955, to Study  
Culverts Blocking Spawning Cutthroat Trout at Hungry  
Horse Reservoir, Montana

Field Notes on Culverts at Hungry Horse Reservoir, Montana, June 13, 1955

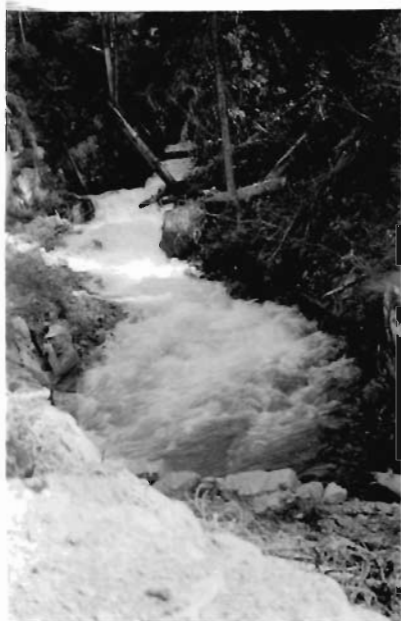
Figure 1

Steep gradient of Baker Creek above the culvert intake.

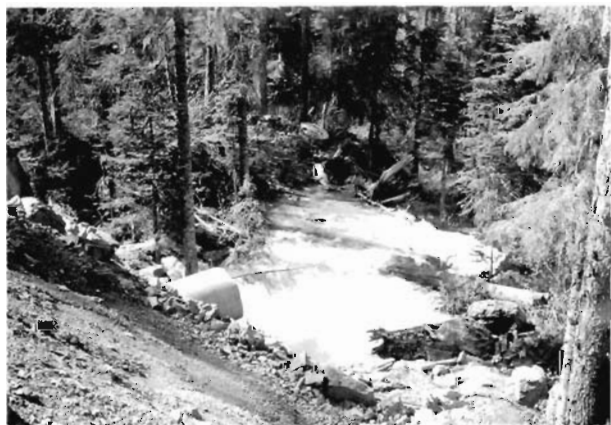
Figure 2

Steep gradient of Baker Creek below culvert outfall - also impassable drop at outfall.

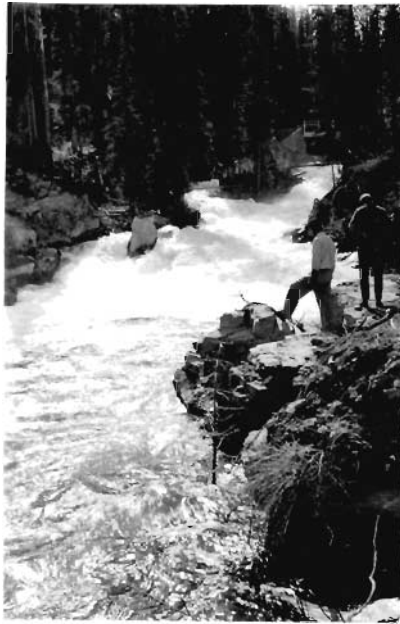
Figure 3

Steep cascades at its mouth in Hungry Horse Reservoir - below the I-beam road bridge in the upper background.

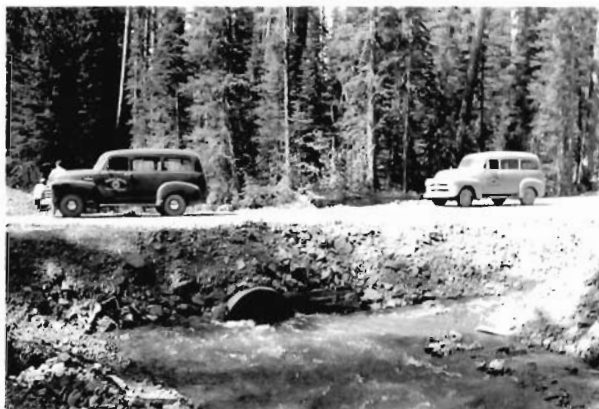
Figure 5

Clark Creek - Low gradient of  
culvert and little turbulence at  
outfall.

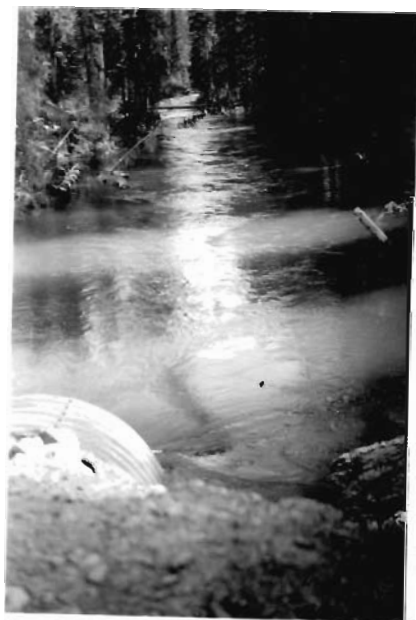
Figure 6

Wounded Buck Creek -  
Beaver pond at intake

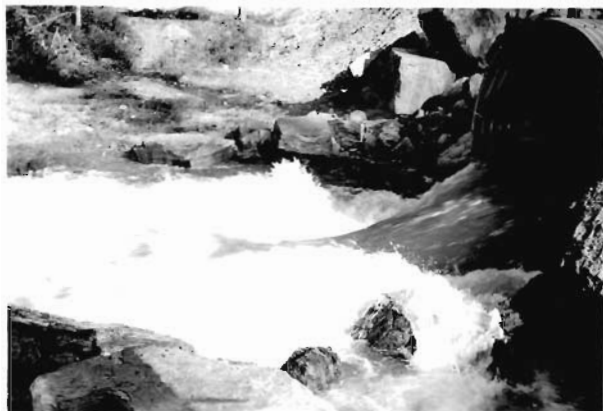
Figure 7

Wounded Back Creek - High velocity  
of culvert outfall.

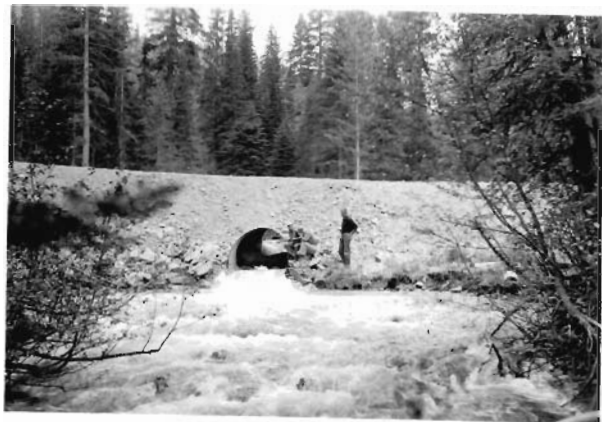
Figure 8

Margaret Creek - Outfall at culvert.

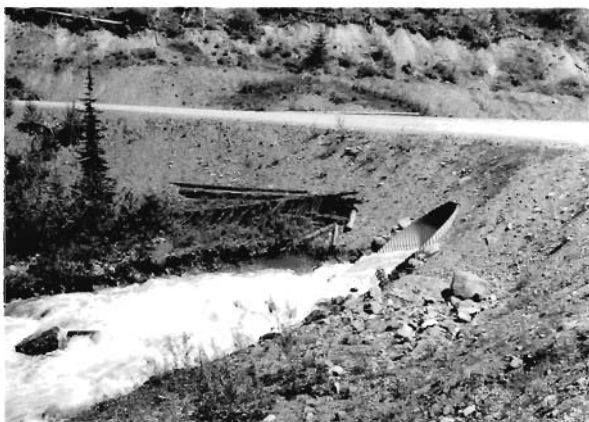
Figure 9

Riverside Creek - Outfall at  
high water.

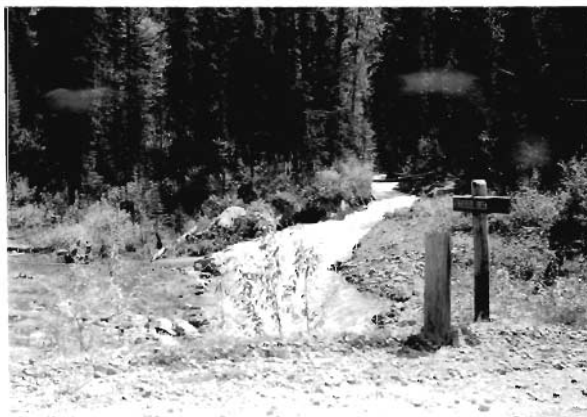
The tributary streams to Hungry Horse Reservoir are almost entirely of the stair step, cascade type--all white water due to fairly steep gradient--with the steps appearing to be for the most part about 1 or 2 feet high and seldom exceeding 3 feet in height. (See Figure 10 for typical example). Most of them had about 5 percent gradient. When the gradient exceeded 8 or 9 percent the stream appeared to be too steep for fish to ascend. One of these creeks (see Figures 1 and 2), which looked as if it was coming down at about a 45° angle, checked out at between 15 and 20 percent slope or gradient with the Abney level. The only resting pools were very small and turbulent. Most notable pool in sight upstream or downstream was usually at the outfall of the culverts. The only flat water observed in these tributaries was at Wounded Creek (Figure 5) where beavers had built a low dam in the intake of the big culvert there and at Clark Creek (Figure 4) where the stream and culvert gradient was only 2 percent.

Riverside Creek - Looking upstream  
from culvert at typical "white" water  
of these creeks.

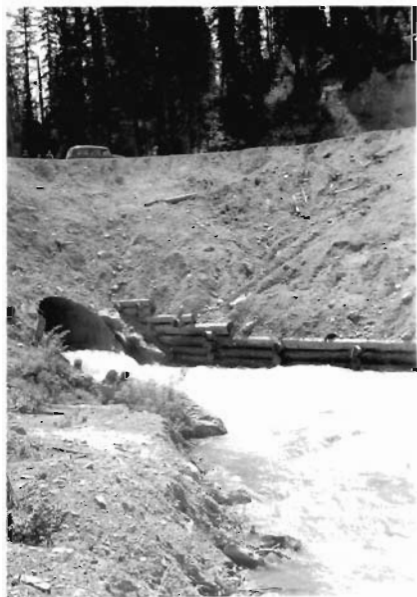
Figure 11

(5) Felix Creek is the stream most in need of culvert improvement because of its size and known run of fish, and all the evidence indicates that the culvert is an impassable barrier to a significant number of spawning cutthroat trout.

Felix Creek - Outfall  
impassible to cutthroat  
trout at high water.

Mr. Stefanich believes the best solution would be to remove the Felix Creek culvert and replace it with a bridge or a rectangular culvert (say 6' high by 15' wide in cross section) with a baffled bottom that would cut the velocity of high water and concentrate the flow of low water into a small channel deep enough for fish to swim through. Another possibility would be to build a series of baffles or dams below the outlet so that the first one would break the velocity at the outfall. These dams could have submerged orifices for fish passage or grooves in their centers for the same purpose. The culvert should have some baffles say 12" high at the center with 6-inch gaps between them to cut the velocity further. Or, as Mr. Holmes suggested, perhaps one dam with a fish ladder in it would be cheaper to construct and be just as efficient.

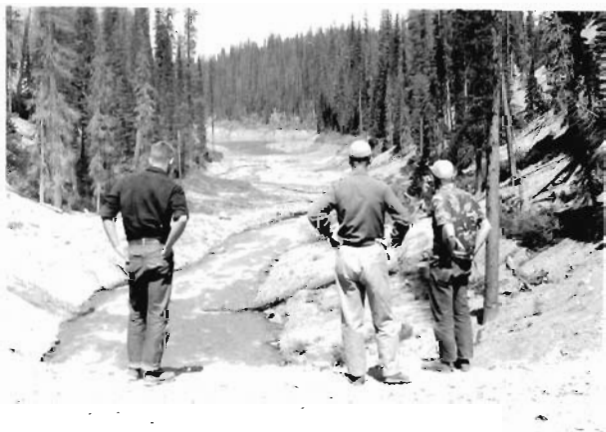
Figure 12

Felix Creek - Looking downstream  
from culvert to reservoir.

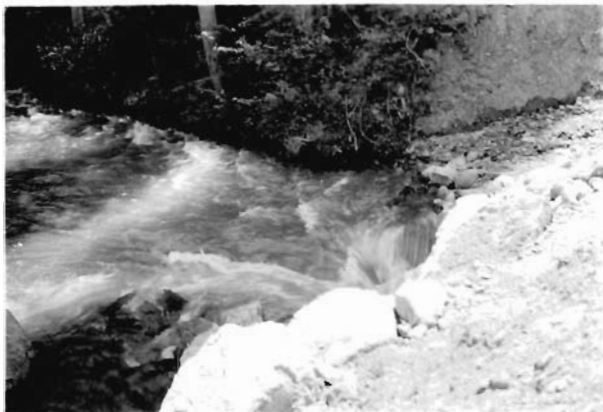
Figure 17

North Fork of Logan Creek -  
Culvert intake.

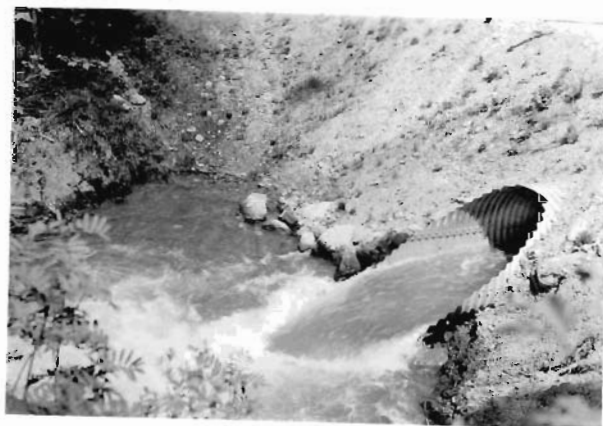
Figure 18

While studying the culvert at North Fork of Logan Creek (Figure 18) we saw two cutthroat, each about a foot long, swim in from the one side of the outfall. They could not make any headway in the center of the flow, but did at the sides where the velocity was less. We sent half the boys to watch each end, and in a few minutes both fish were seen to emerge or wash out of the downstream end of the culvert. They couldn't make it. We felt this was a convincing demonstration that these fish were being blocked by the high velocity of these outfalls; under less flow, etc., some of them probably make it. This led us to wonder if these inland cutthroats are comparatively poor jumpers and weak swimmers against high velocities compared to their coastal cousins. Apparently they are great climbers from one low cascade to another, but have difficulty overcoming a 3 or 4-foot falls.

(a) We observed two fish attempting to swim up through the culvert in North Fork Logan Creek, and both failed.

North Fork of Logan Creek -  
Culvert outfall-impassable to  
cutthroat trout.

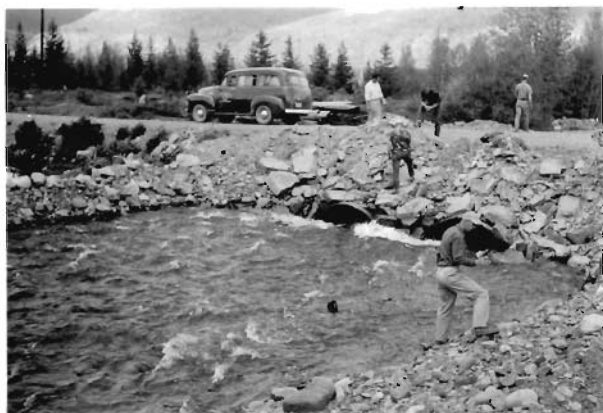
Figure 19 -

Soldier Creek - Intake of twin arch type culverts - Typical gravel bar has formed in right foreground.  
(Mr. Morris demonstrated by tossing in black marker.)

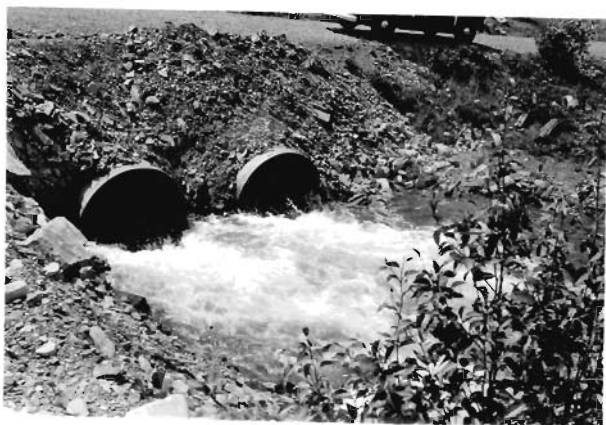
Figure 20.

Soldier Creek - Outfall of twin arch type culvert.

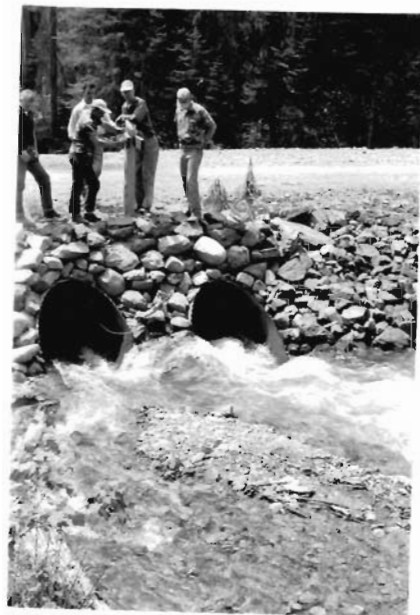
Figure 21

Tin Creek - Outfall of twin culverts (note typical bar in foreground that develops at intake outlets of these twin culverts).

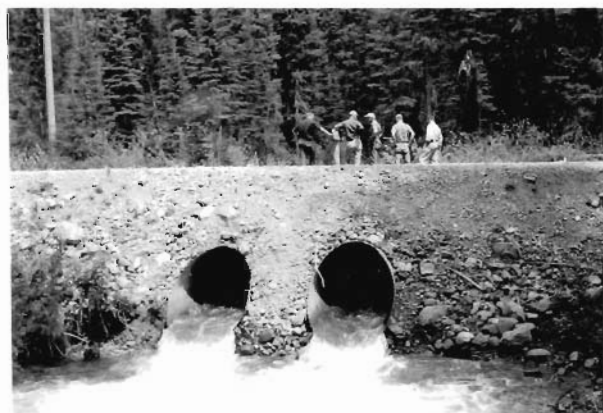
Figure 22

Deadhorse Creek - Outfall of twin culverts - at steeper gradient.
