**BRAIDED CHANNEL CONSOLIDATION
IN AN OUTWASH AND GRAVEL-MINED AREA
OF CONFEDERATE GULCH, MONTANA**

Part II of a Final Report

Project No. RIT-87-8506:
Stream Restoration on Confederate Gulch and Deep Creek

May 1992

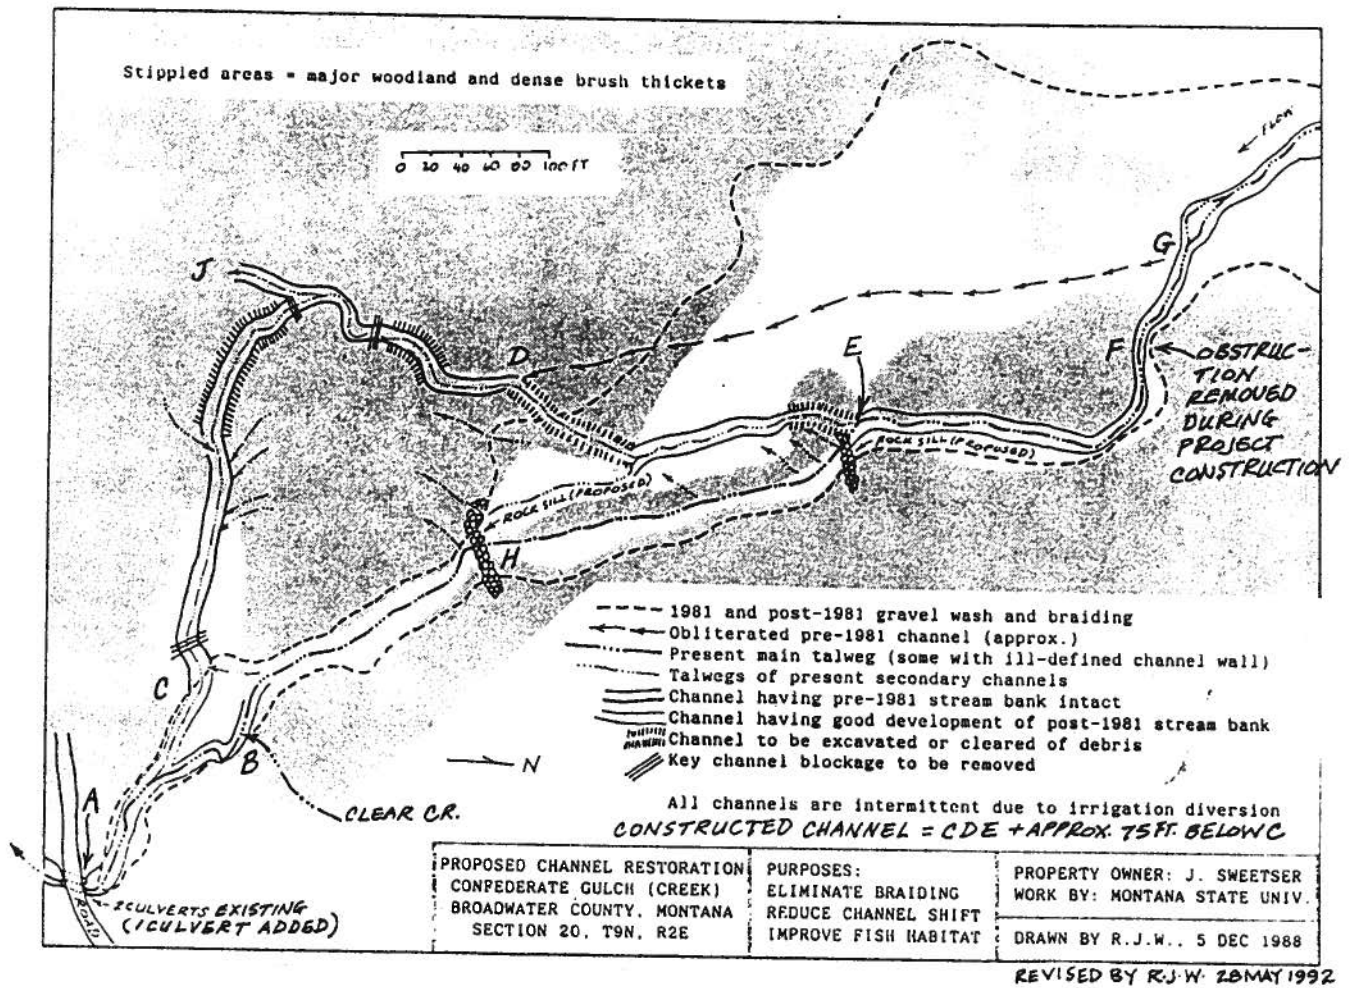
Figure 2. Project map, the Confederate Gulch lower study area.

A May 1981 flood created a tongue- or lobe-like deposit of gravel in the area (Figure 2), burying a meter or more of the trunks of many of these trees and radically changing the course of the stream. This lobe of sediment prob-

ably deposited not only because of decrease in valley slope, but also because the culverts under the driveway road at the lower end of the study area (point A, Figure 2) could not accommodate the flood water. The road embankment thus dammed the flood, exacerbating the inadequacy of water velocity in the study area to carry the gravel load. During the flood, water reportedly flowed over the road near point J of Figure 2 (J. Sweetser, personal communication).

When the gravel lobe formed, it forced a section of channel (GDC, Figure 2) to shift eastward along the edge of the new deposit, forming channel GFE. This new channel broke through one of the cottonwood rows or hedges at point F (Figure 2), where the tree roots still constrict flow and a deep pool exists. Much of this new channel was kept further shunted in that alignment by another of the cottonwood hedges from point E to H (Figure 2), although some of the flow often "leaked" back through the hedge, forming secondary channels that flowed toward the pre-1981 channel.

Regrowth of the stumps of the previously "hedged" groves of small trees removed during excavation may again block flow, if they are not periodically cut back. If the stream flowed year-round, they probably would not be regrowing, and the problem would not exist, but the 1991 inspection revealed some constriction of the channel at certain points, especially at the critical point E (Figure 2).

Our plan called for connecting the shifted channel with the old channel by excavating to deepen and enlarge secondary channels along segment DE and by blocking the post-1981 channel and several secondary channels of the braided system with rock berms, as shown in Figure 2. Also, parts of the reactivated pre-1981 channel that were obstructed by downed logs, other vegetation, and sediments would be cleared by excavation.

Construction took place in April 1989. The designed channel was staked out and excavated with a backhoe along the course shown in Figure 2. The main blockage removed was the "hedged" grove of small trees at point E. Excavation extended from several hundred feet downstream from point C along the course CDE, a total of about 760 feet. Conditions found during excavation required that the entire distance be excavated to some extent, rather than just along the planned reaches that are shown in Figure 2. Some adjustment of the "hedge" gap at point F was also done. Two berms of large rock were built, as indicated on Figure 2. The added culvert was installed at Point A.

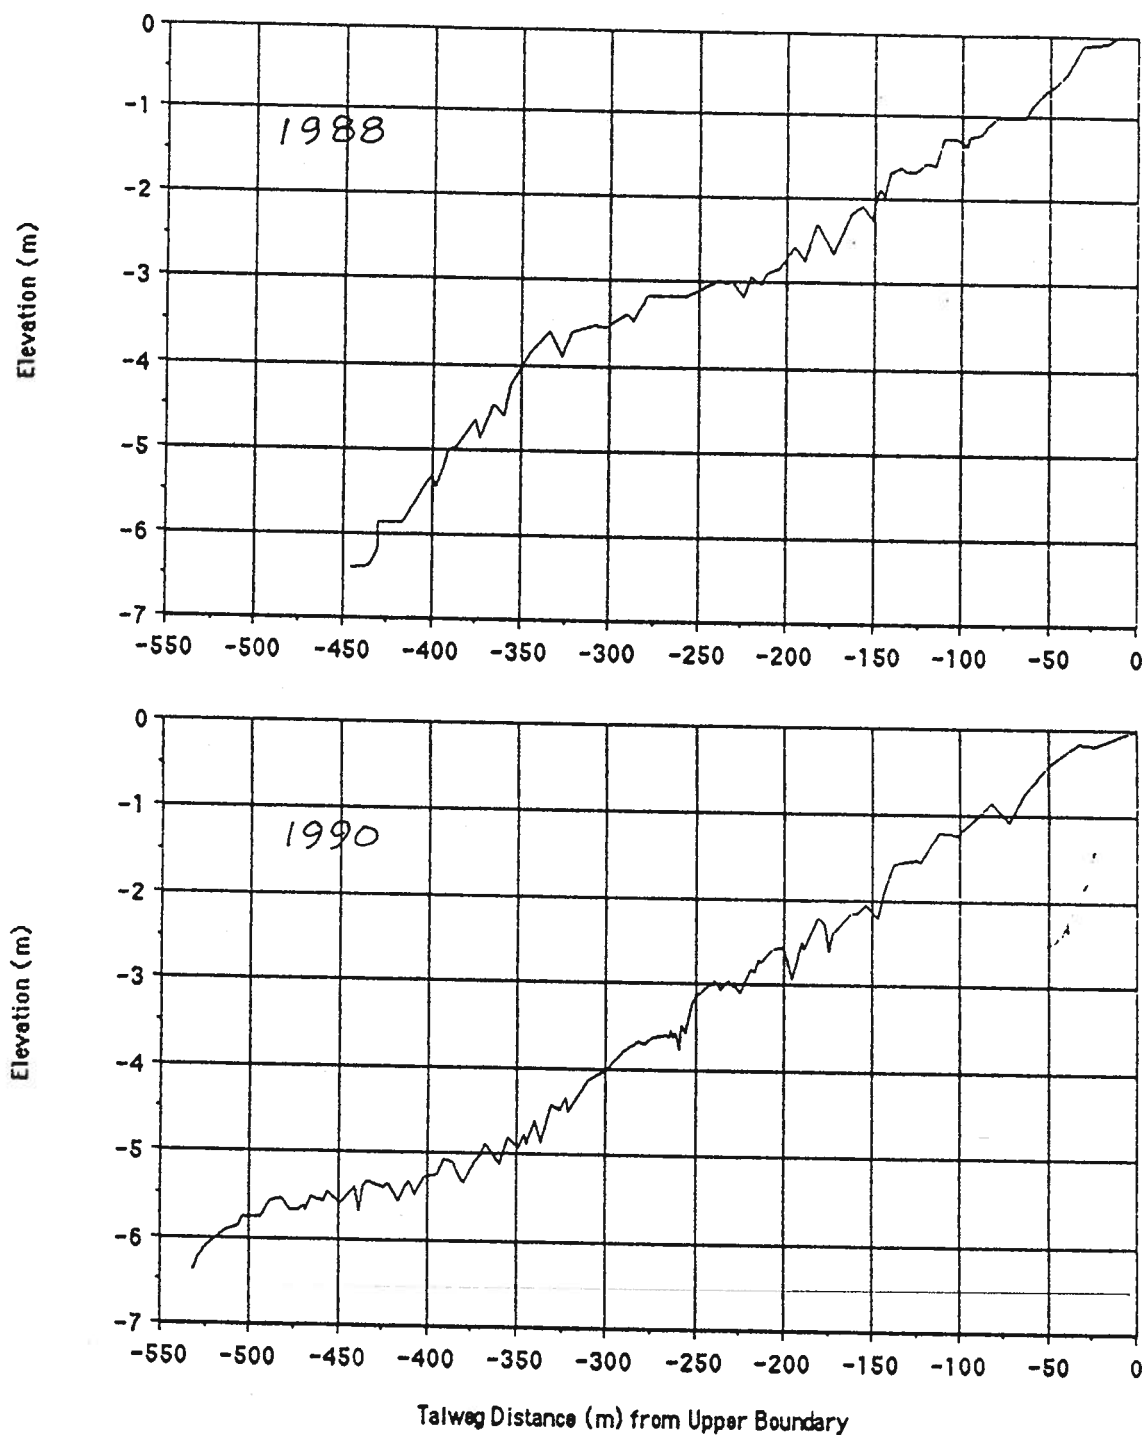
Figure 3. Streambed (talweg) profiles, Confederate Gulch lower study area, 1988 and 1990.

Project success was determined mainly by direct observation during subsequent site visits. We also have the record of channel bed (talweg, or the path of deepest cross-sectional points in the channel) profile surveyed in 1988, before construction and in 1990, after construction and flows had adjusted the channel (Figure 3). In Figure 3, the 1988 profile is of the main thread of the braided channel. It had a shorter, steeper course than the new, single channel of 1990. In both profiles, 1988 and 1990, the lower end of the curve is point A of Figure 2 and the upper end is at the north line fence of the Sweetse property.

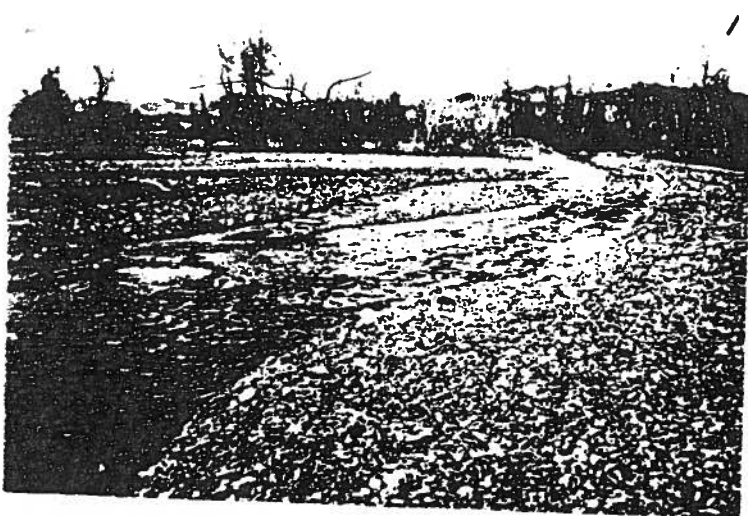
1. Looking upstream toward the upper boundary of the study area (J. Sweetser north line fence) in spring 1985. Note wide, shallow channel, lack of vegetation and other evidence of the 1981 flood.

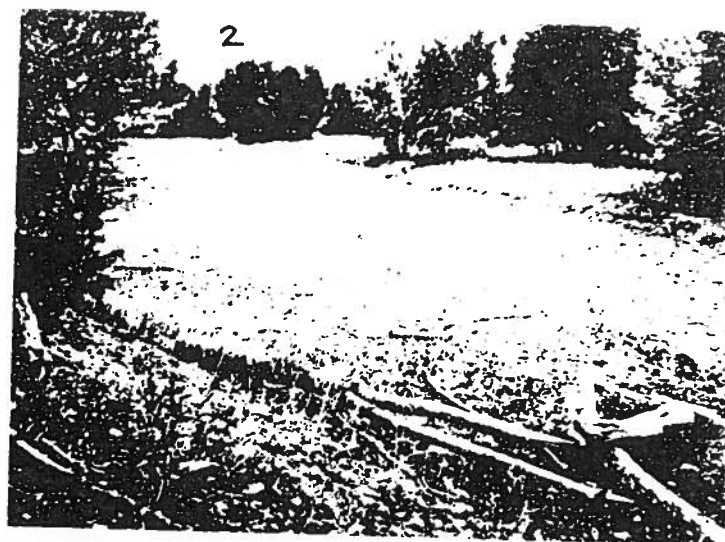
2. The same area, viewed from the other bank and from farther downstream, 1991. Note a somewhat better defined channel (downcut, with more definite banks).

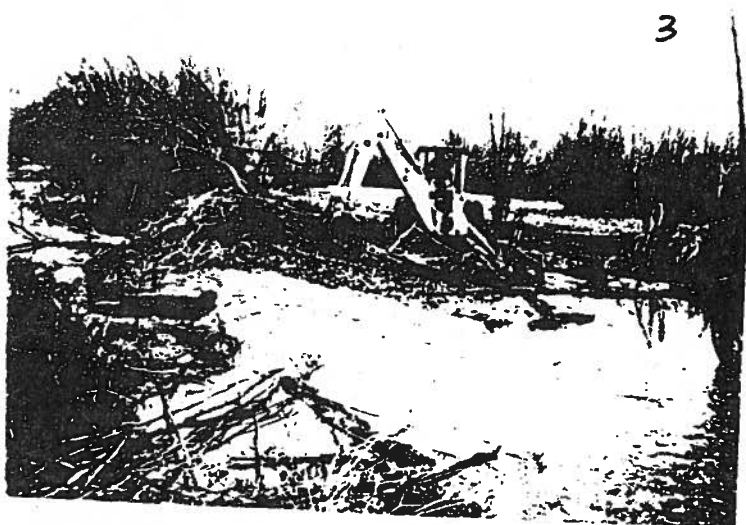
3. Excavation of the critical blockage point E (Figure 2), April 1989. Photo was taken from upstream, i.e., looking downstream. This was the upstream end of the main excavated new (largely reactivated) channel. Note that much of the stream still flows toward the left, a "perched" channel, diverted by the "hedge" of small trees in which the gap is being excavated. A few minutes later, all flow passed into the new channel that can be seen to the right of the backhoe.

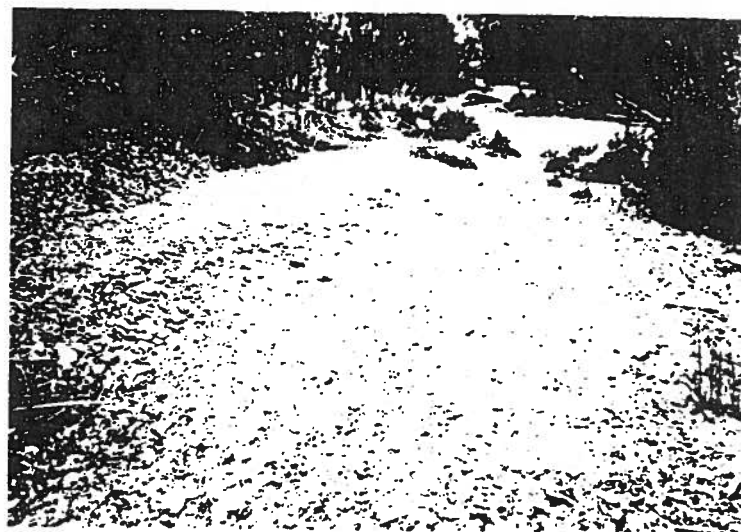
4. The same point (E, Figure 2), viewed from about the same upstream point, September 1991. Note partial regrowth of the trees.

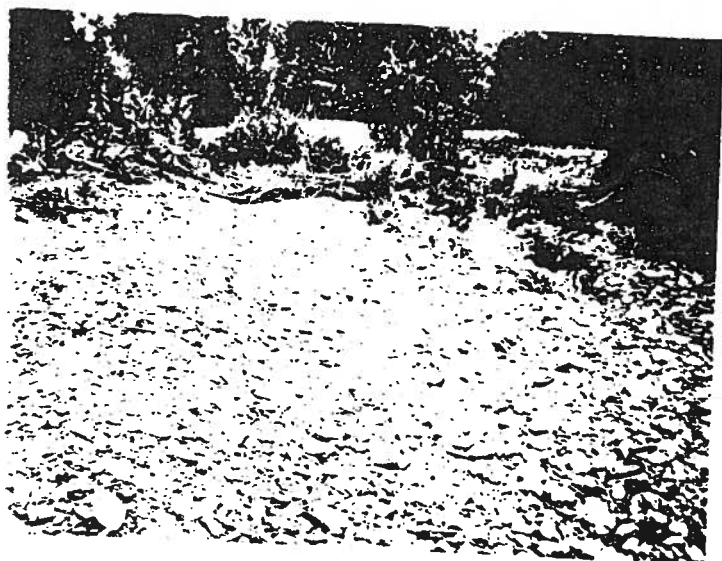
5. The same point, showing a close-up of the vegetational regrowth.

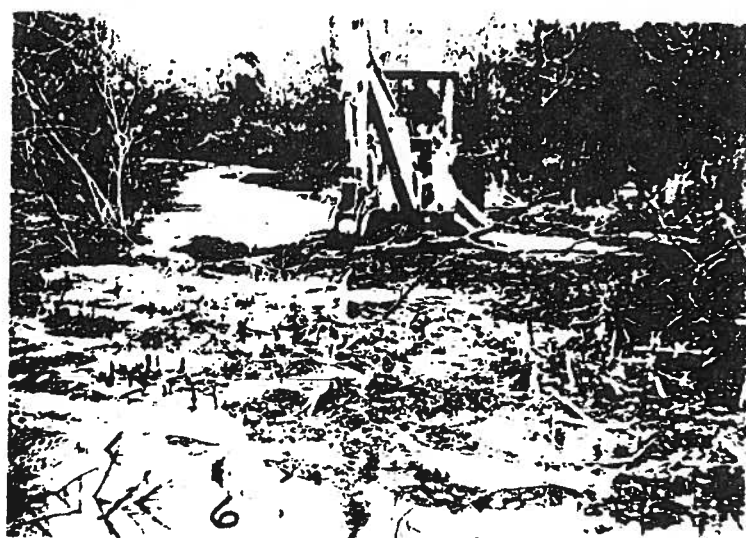
An associated problem was that the small trees in the "hedge-rows" and other groves through which some of the new channel was excavated had their roots far below the level to which we planned (or could afford) to excavate. Their trunks had been buried in gravel to depths in excess of four feet, perhaps much more. This confirmed our pre-planning interpretation that a lobe of gravel had been washed into the area, probably by the 1981 flood. But it also made it impossible to eliminate all the trees, or even most of them, completely. See accompanying photos.

6. Excavation through another hedge-grove of small trees. Note that their trunks are merely "raked" off, leaving stubs, which had to be cut by hand.

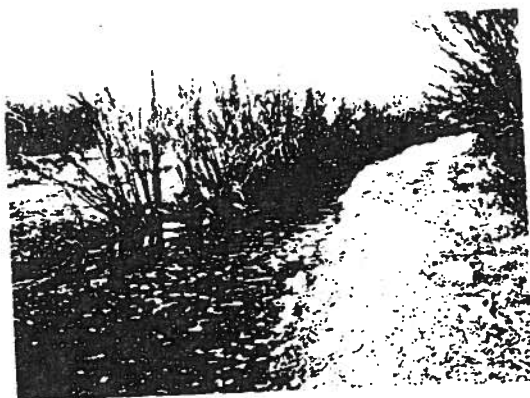
7

7. The perched channel (CHE, Figure 2) at about point H, spring 1985.

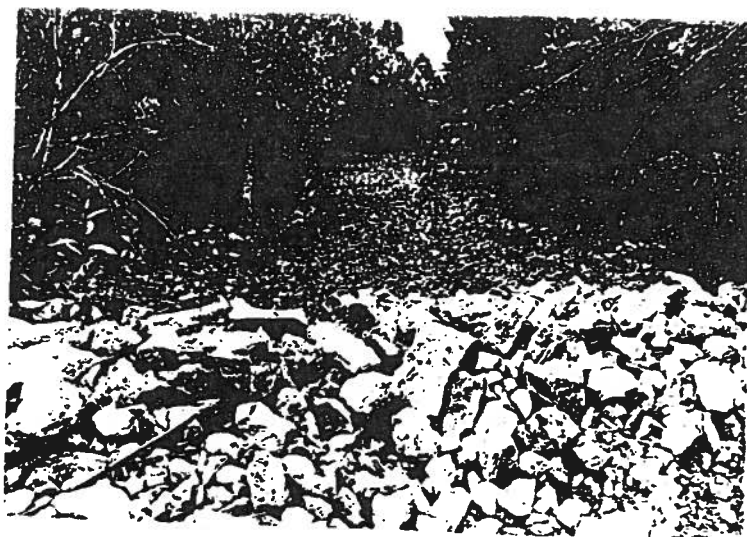
8. The same channel from about the same point, September 1991. Flow has been diverted away from it and blocked by an upstream rock berm (barely visible). In foreground is the lower berm (Figure 2), which is to divert flow, if floods overtop the upper berm.

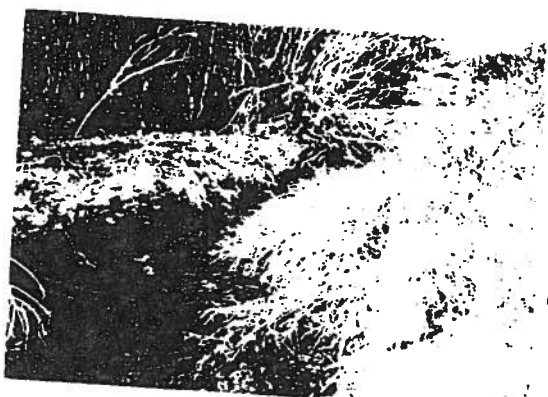
9

9. The lower part of the channel at about point C, spring 1985. At that time, over half the flow of the stream was entering point C not from the "historic main" channel, but the perched channel which enters from the right (behind vegetation at right) and is the same channel shown in photo 7. By 1988, the vegetation (probably aided by months of dewatering each year) had much further obstructed the channel at point C.

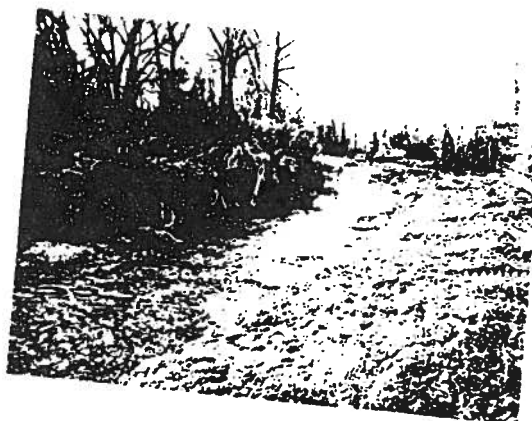
10

10. The same point (C) after excavation, spring 1988.
11. The new channel, looking upstream from about 50 ft above point C, September 1991. What had been a bed of mud during excavation is now entirely gravel, washed from upstream areas by high water. Were the stream not dewatered, this would be prime spawning grounds for trout.

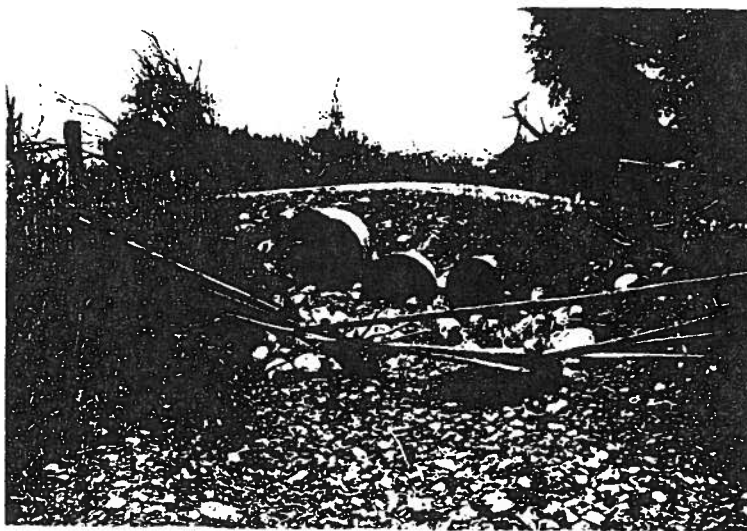
12. The culverts under the private driveway at the downstream end of the study area. The large culvert at left was installed as part of the project. The other two had been inadequate to carry high flows.
