Report on the stabilization of Lyons Creek road after the flood of 2008

Grant Grisak
Montana Fish, Wildlife & Parks
4600 giant Springs Road
Great Falls, Mt. 59405

December 2009

(PPL-Montana MOTAC Project 779-09)

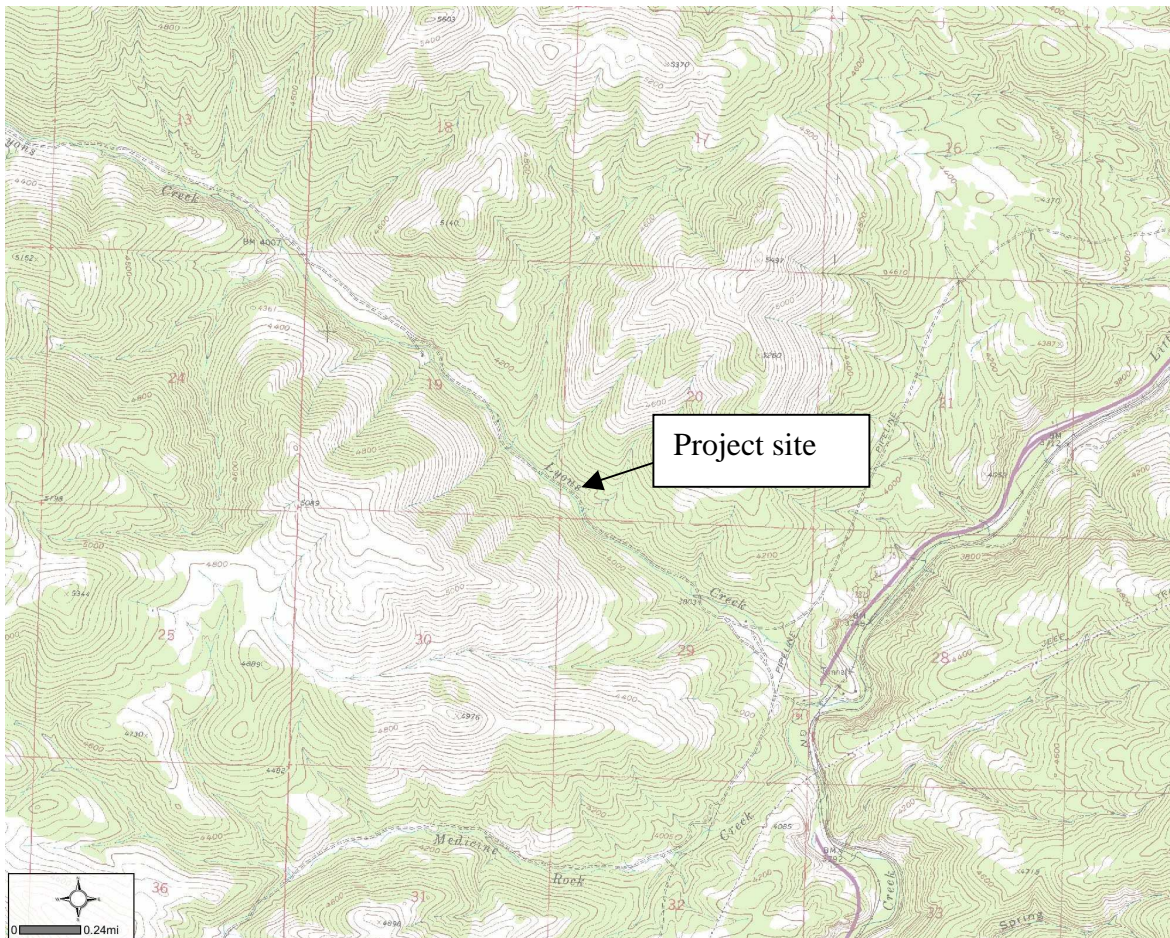
Figure 2. Area of road wash-out on Lyons Creek.

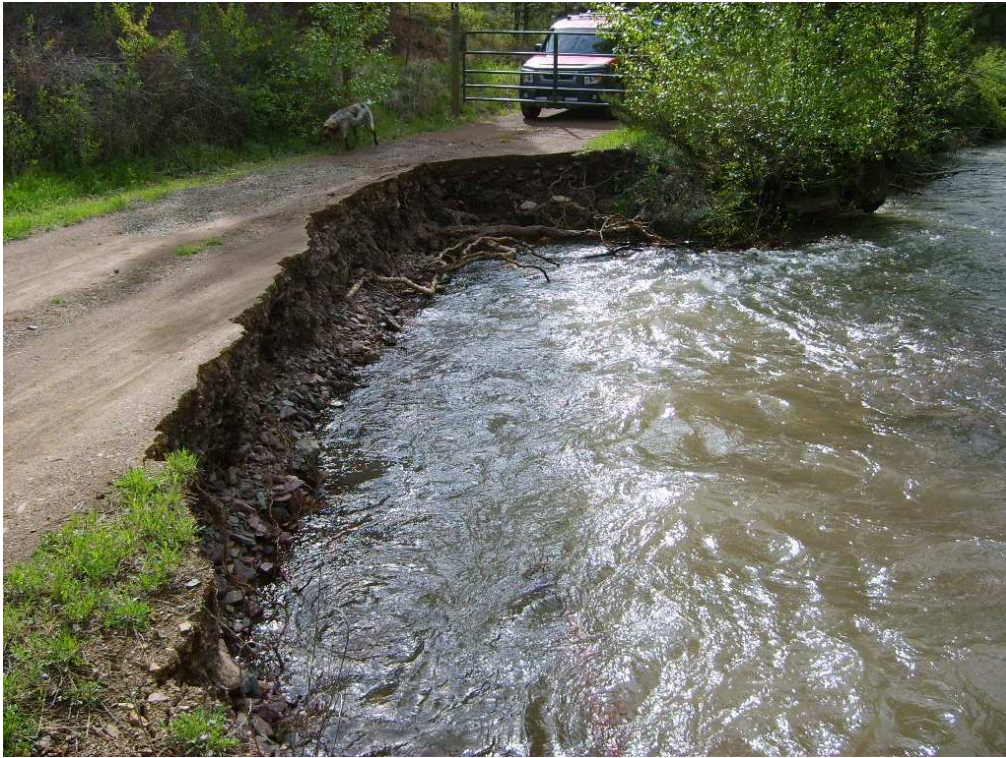
In 2008 central Montana received a number of unusually high rain events along the Rocky Mountain and Big Belt mountains which created flood conditions in the Dearborn River and Little Prickly Pear Creek. Flows in Little Prickly Pear (LPP) Creek reached 1310 cfs on May 26, which was the fourth highest flow on record for this site (Figure 1). There were several incidents of isolated flooding in the LPP subdrainage with reports of washed out roads and culverts in both Lyons Creek and Little Wolf Creek. The major damage sustained in Lyons Creek was located 1.35 miles upstream from the mouth. The eroded site was the base of a spur road in section 19 (DNRC) that provided access to a private residence in section 20 (Figure 2). The site measured 97.5 feet long by 2.5 feet (avg width) by 2.5 feet (avg depth) indicating approximately 22.5 yds³ of road material had eroded into Lyons Creek (Figure 3, Figure 4).

Figure 3. Lyons Creek erosion site looking downstream. June 1, 2009.

In June 2009, DNRC, MFWP and a private contractor met on site to develop a remediation plan and to estimate costs of the remediation. The parties agreed that the toe of the eroded slope should be armored to prevent further erosion, the eroded slope should be contoured to reduce the angle of repose, the slope should be covered with topsoil and reseeded, and the point bar formed opposite of the eroded site should be gently contoured toward the opposite bank to reduce channel constriction at this site. The estimated cost for equipment, materials and labor was \$3,600.

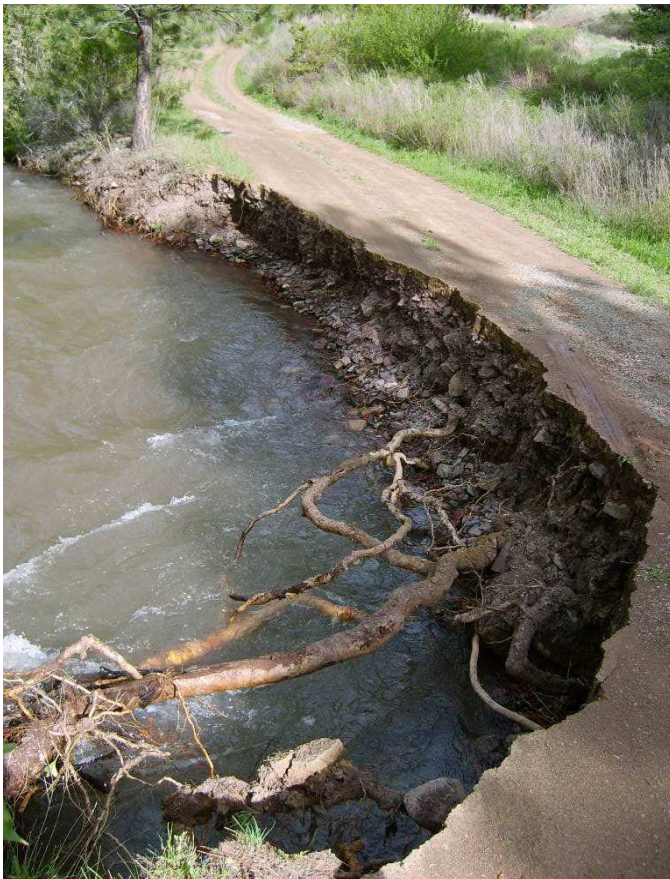
Figure 4. Lyons Creek erosion site looking upstream. June 1, 2009.

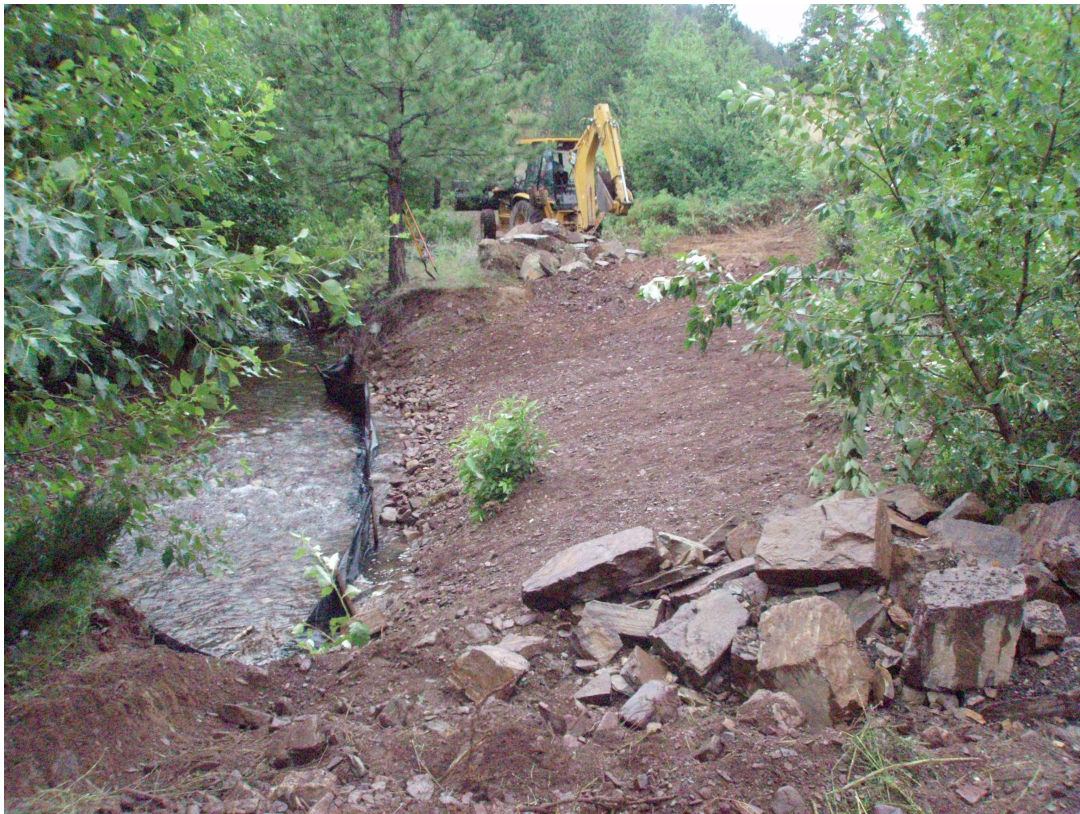
Figure 5. Construction phase of Lyons Creek bank stabilization project. Aug 19, 2009.

In September construction began and followed the plan according to the site visit and the conditions of the 124 and 318 permit. Construction started on August 18 and was completed by August 19 (Figure 5). On August 27, MFWP finished raking the topsoil, seeded the site with native grasses and applied straw for erosion control (Figure 6). MFWP used a trash pump on four occasions to apply water to the newly seeded area. By September, 17, rooted grass was firmly established at the project site (Figure 7, Figure 8). The silt fence was removed and the project was considered complete on September 24. Monitoring will continue in 2010.

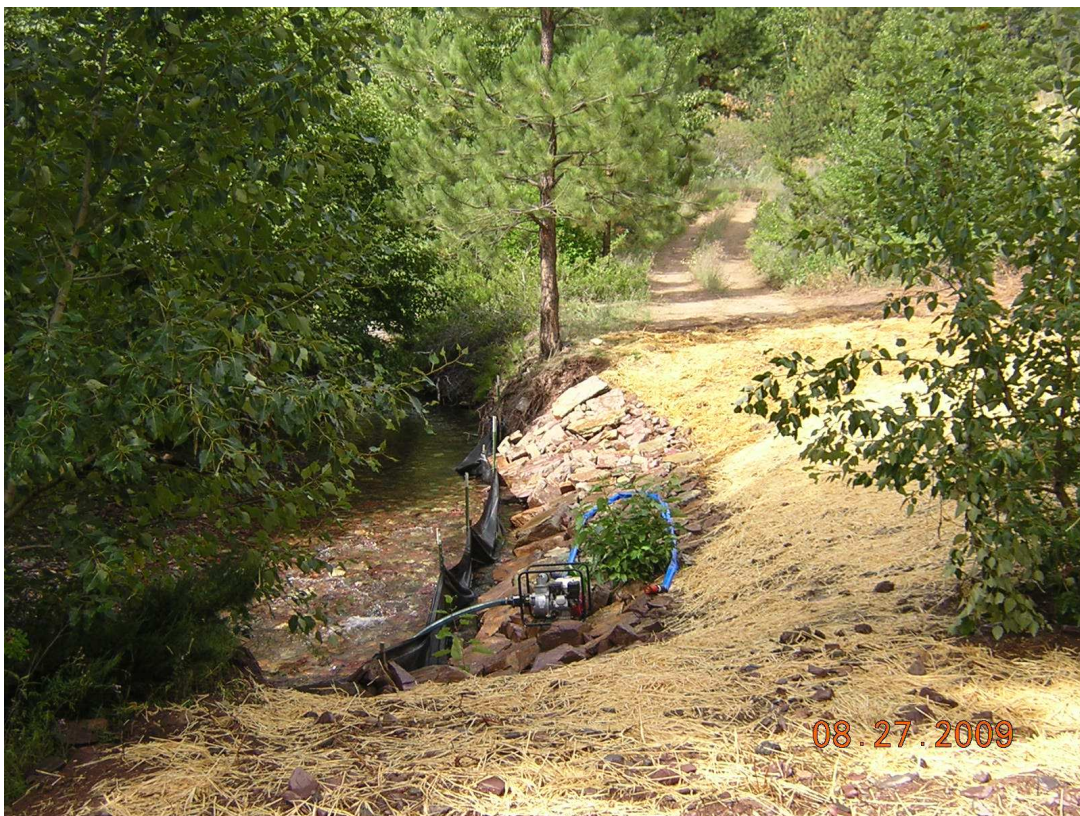
Figure 6. Lyons Creek site with topsoil, seed, straw and trash pump for watering.

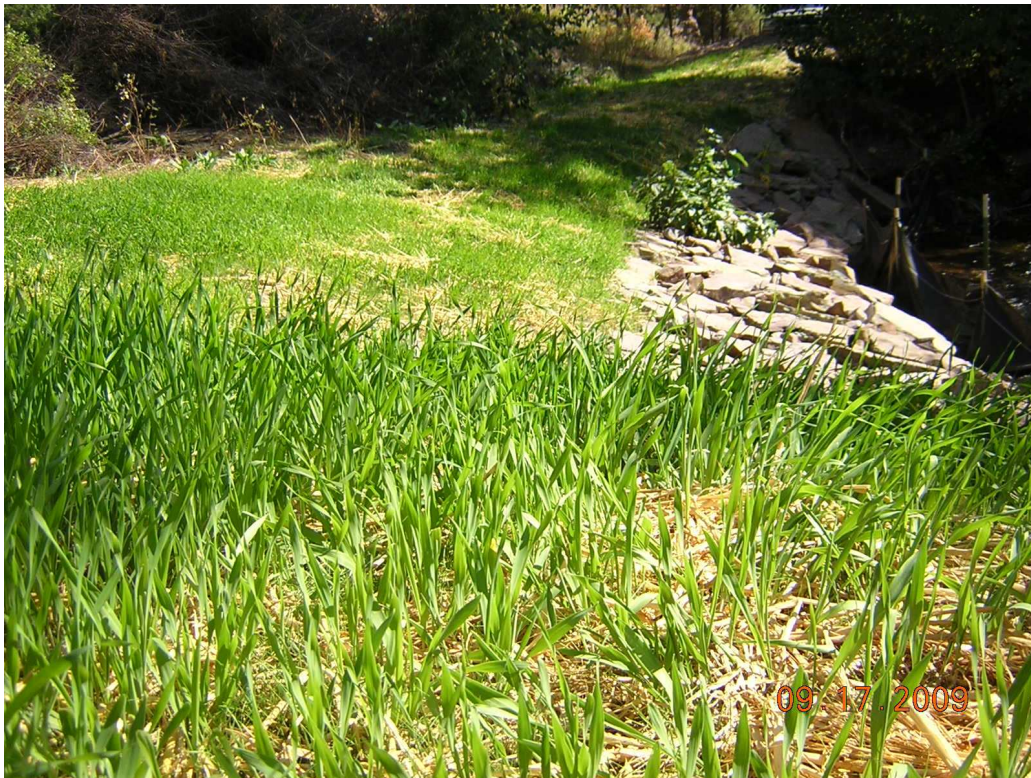
Figure 7. Lyons Creek site after four watering cycles. Grass is 6 inches high, Sept 17, 2009.

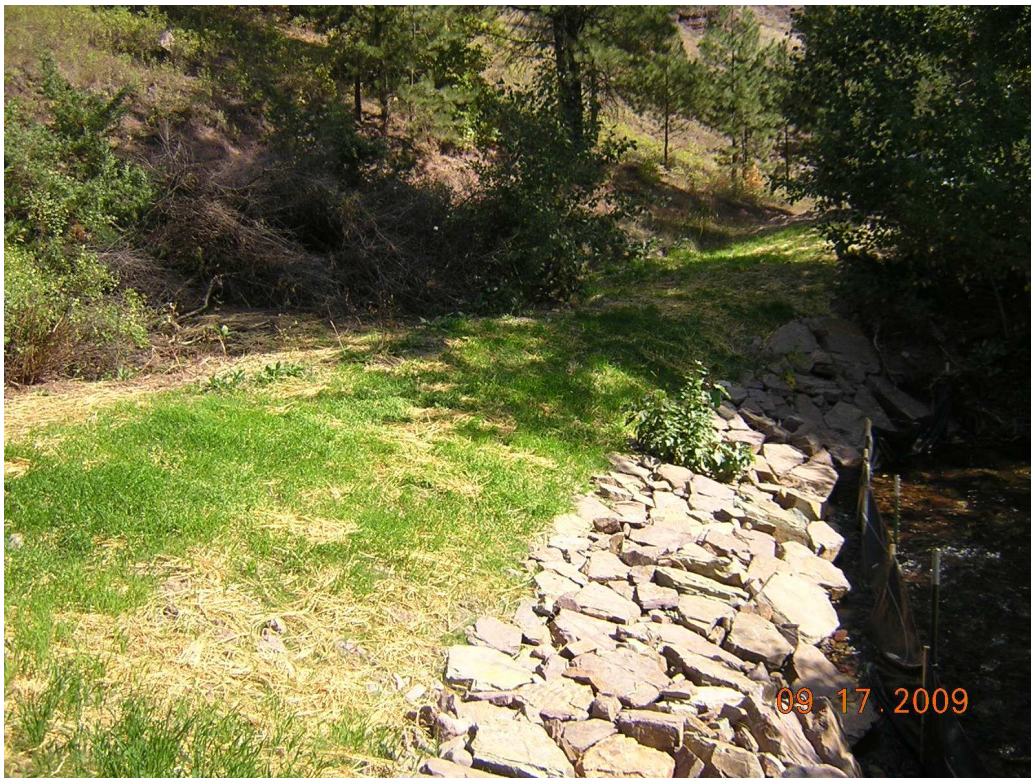
Figure 8. Lyons Creek project site with rooted grass established. September 17, 2009.
