Future Fisheries Improvement Program Monitoring

2016

Livingston Fisheries Office

Montana Fish, Wildlife & Parks

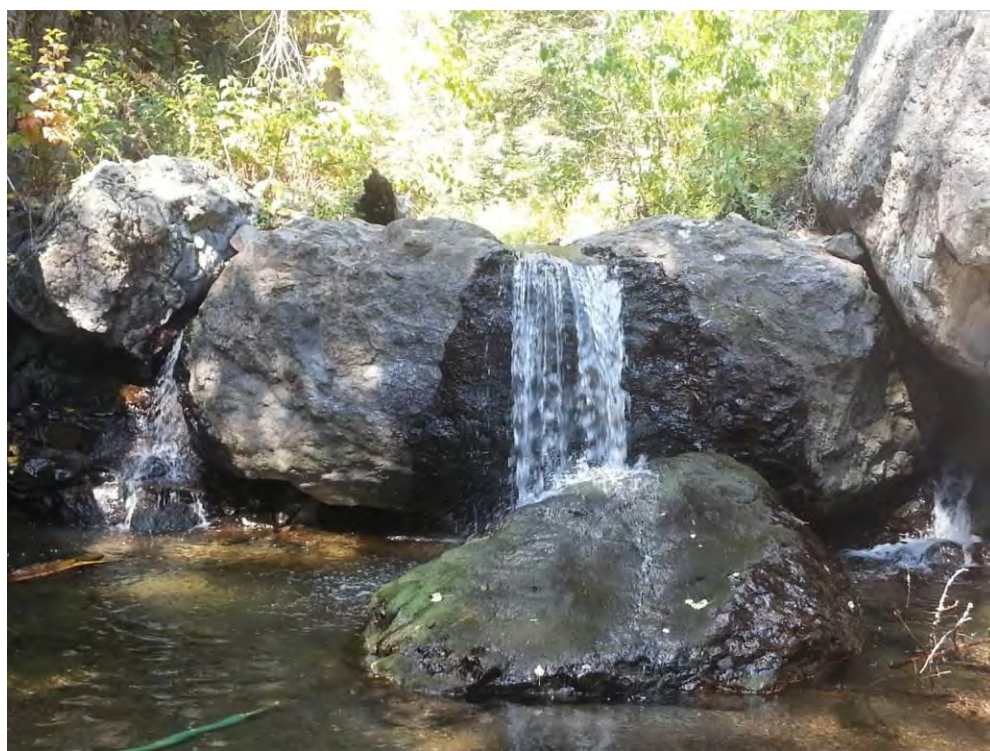
Jason Rhoten, a fisheries biologist with FWP, visited the Bad Canyon Creek barrier in July 2013, and found maintenance and repair was warranted. A log jam had formed approximately 20 yards downstream of the barrier, and had the potential to backwater flows leading up to the barrier, which could allow brown

Figure 2-5. Bad Canyon barrier after repair and maintenance.

Actions to protect the barrier's ability to block fish began in 2013, with removal of the debris jam. In 2014, several repairs were made to the barrier. Installation of large rock and concrete blocked the flows through the boulders, and prevented potential failure of the barrier. Combined, these actions preserved the structural integrity of the barrier, and eliminated the potential for backwatered flows to decrease the leap height over the barrier, which could otherwise allow brown trout to reinvade Bad Canyon Creek.

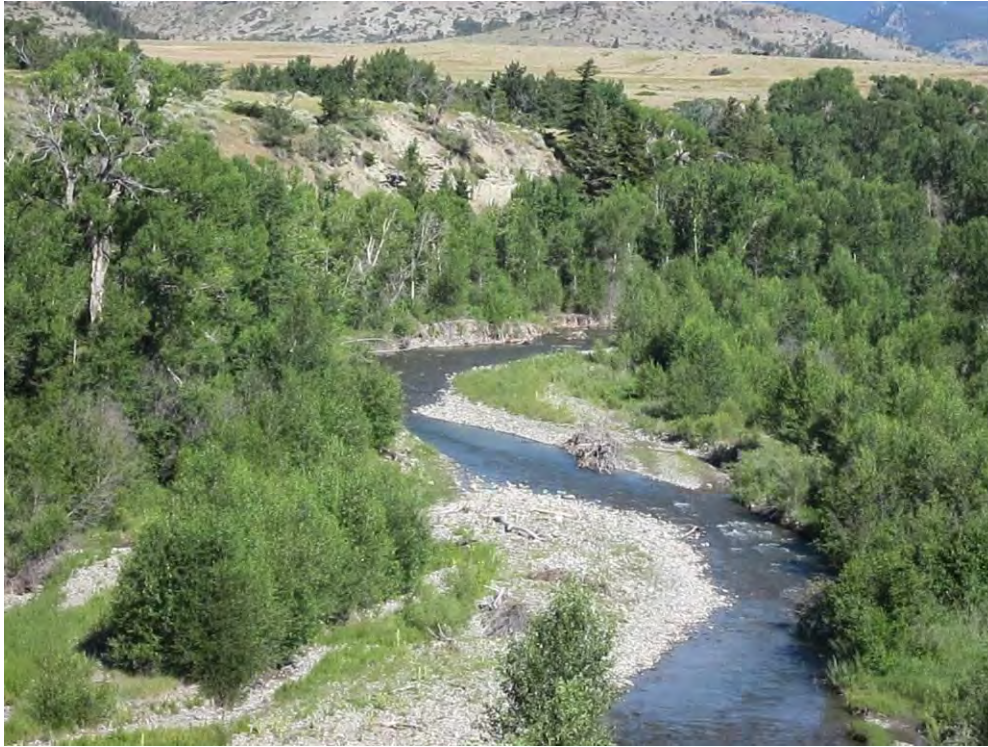
On July 6, 2016, Shannon Bockmon visited the project area, accompanied by Tom Coleman, the consultant who designed and provided oversight during the restoration. The channel was dramatically different than the pre-construction condition. Instead of the overly wide, braided, straight channel, the stream had meanders, greatly enhanced pool habitat, and recruitment of shrubs on point bars (Figure 2-7). This project was successful in restoring natural morphology to the stream, and improving fish habitat.

Figure 2-7. View of restored reach of Big Timber Creek, 2016.

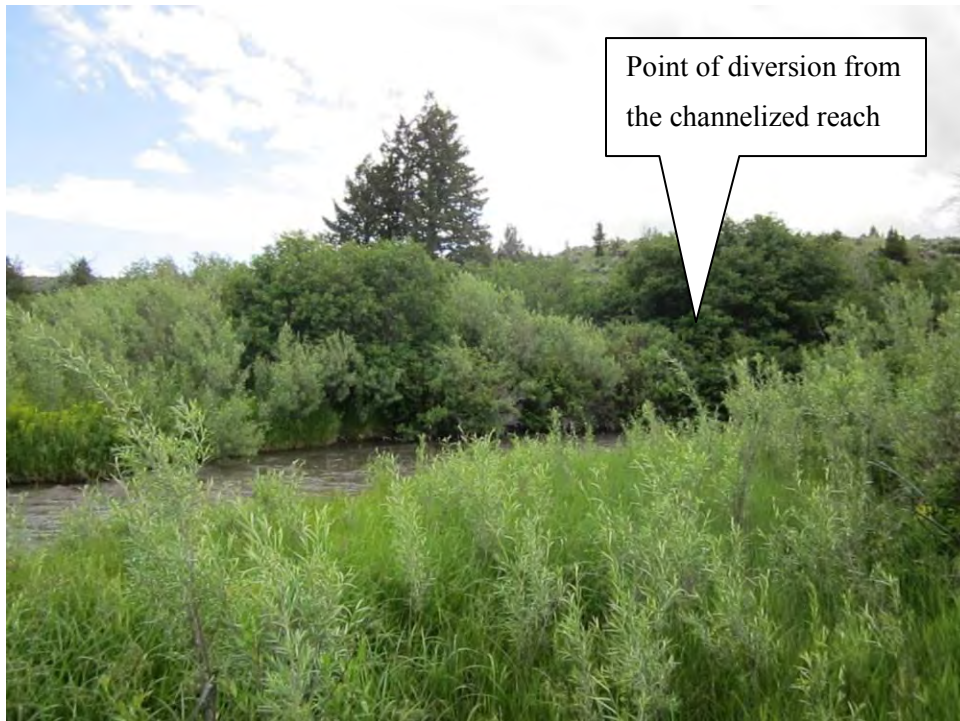
The site visit began where the plug of dense willows was placed to divert the water away from the old, straightened into the re-naturalized channel (Figure 2-11). Dense shrubs obscured the upstream end of the channelized reach, and provided an impenetrable barrier against the stream returning to its former location, and abandoning the reconstructed channel.

Figure 2-11. Location of plug that diverted water away from the old channel into the re-naturalized channel.

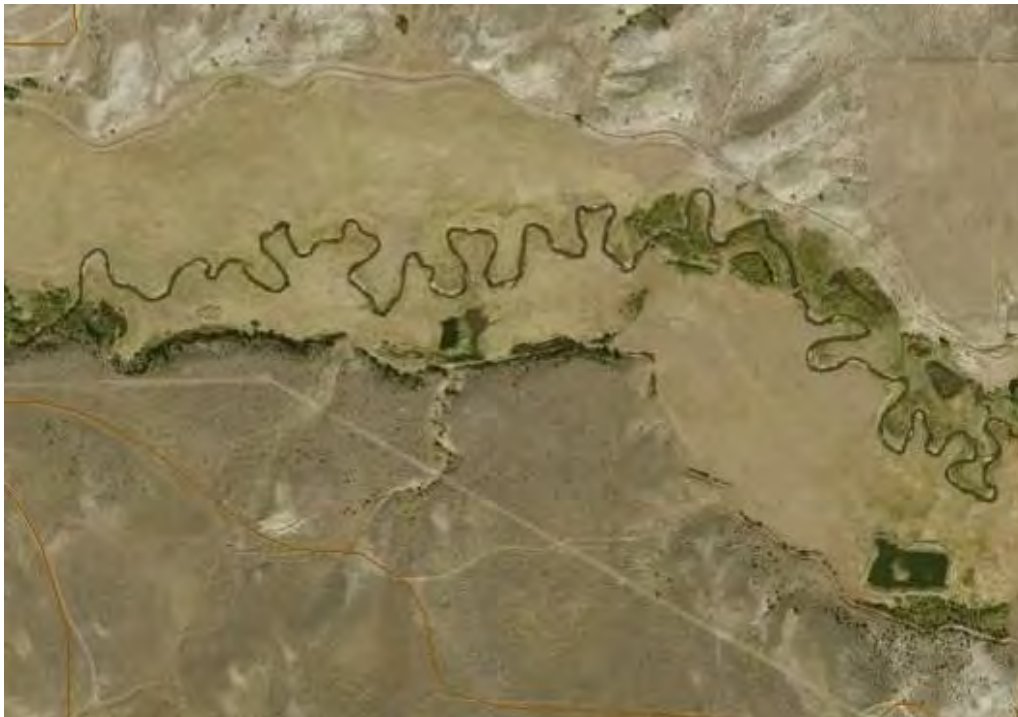
Recruitment of riparian shrubs had improved since 2007; however, most of the stream remained devoid of woody vegetation (Figure 2-12). Individual willows were sparsely distributed along much of the channel, with isolated willows showed heavy browse. Nonetheless, several stands of sandbar willow had become established since 2007 (Figure 2-13). Despite continued heavy browse pressure, willows were beginning to gain more of a foothold along the stream channel.

Figure 2-12. Aerial imagery of re-naturalized stream (2015) showing intact plan form, limited recovery of shrubs.

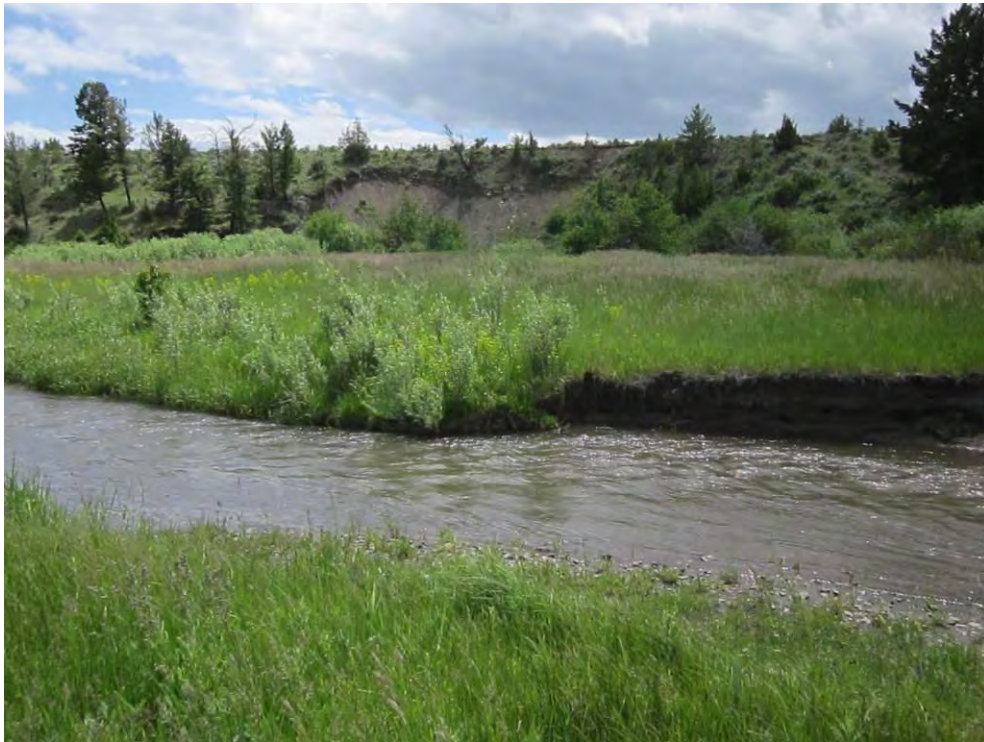
Figure 2-13. Brackett Creek showing willow recruitment on left bank. Note bank stability where sedges occupy the channel margin.

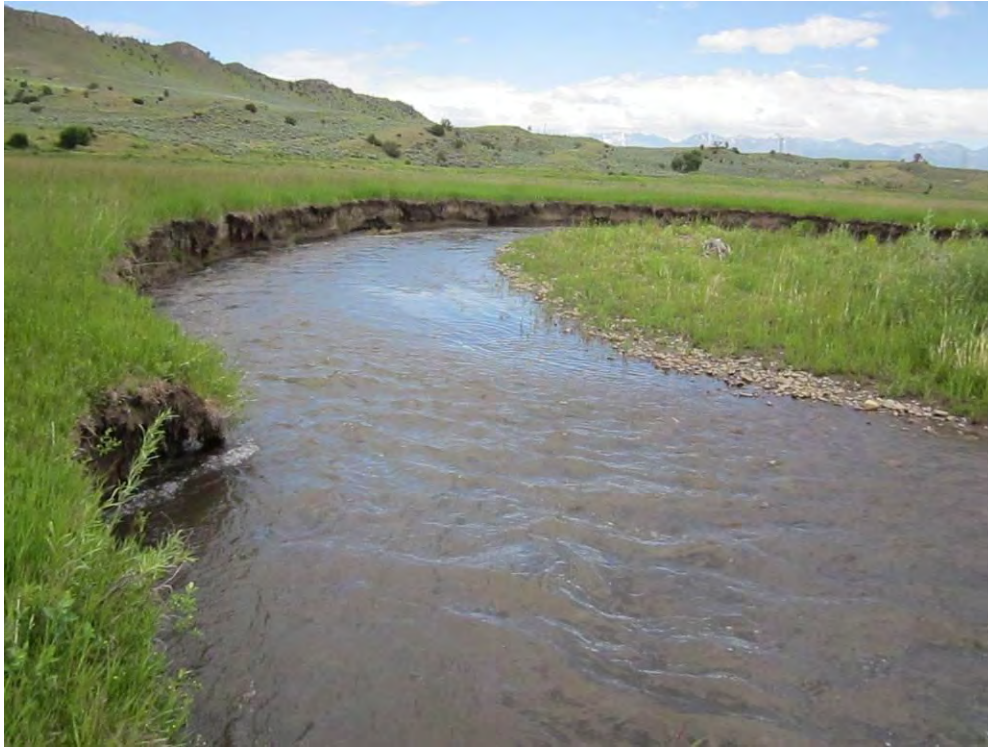
As observed in the 2007 assessment, the 80-year flood that occurred soon after channel re-naturalization resulted in considerable erosive pressure on outer meander bends, causing numerous reaches of eroding bank (Figure 2-14). Shallow-rooted grasses, such as smooth brome and Timothy, occupied the tops of banks, and these species do not contribute to recovery of banks, except in cases where clods of vegetated dirt calve into the stream. These vegetated clumps have potential to trap sediments, and build a new bank adjacent to the existing eroding bank; however, these features are vulnerable during floods. The ranch manager expressed concern over losing land from bank erosion. Other reaches of Brackett Creek have much higher bank retreat rates; however, the loss of land, delivery of fine sediment, channel widening, and loss of high quality bank line habitat for fish are legitimate concerns for fish and agriculture.

Figure 2-14. Example of eroding outer meander bend on the re-naturalized reach on Brackett Creek.

Although the re-naturalized stream is preferable to the previous, channelized condition, several problems remain. Flooding eroded considerable stretches of bank, and these have not healed. The shallow roots of nonnative grasses do not provide protection from the erosive power of high flows, and these grasses are highly competitive, so riparian species are unable to colonize these areas. The grass-lined, eroding banks are laterally mobile, and the channel is overly wide in these locations. The associated erosion contributes fine sediment, which diminishes the quality of habitat for aquatic invertebrates, and clogs spawning gravels.

Finding a solution to restore eroding banks with limited ability to heal on their own is a primary recommendation. Restoring stability to these banks would benefit water quality, fish, and protect valuable agricultural land from erosion. As a priority watershed for sediment reduction, grant funds could be available to address the erosion, subsequent sediment loading, and impairment of fish habitat.

Potential actions that would stabilize the eroding banks vary in expense and potential for failure. One approach would be to slope the banks to the angle of repose, then place wetland sod mats and sprig willows on the banks. This approach would be relatively expensive, as it would require heavy equipment to slope banks, and harvest sod mats. These banks would be vulnerable to erosion if high flows occur before the sedge mats establish the deep, dense root mass that helps maintain bank stability. The original restoration followed this approach, and would likely have been successful if not followed by a substantial flood.

Sprigging willow stems into the existing eroding banks may also assist in the stabilization of these banks. Pounded deep into the water table, at a 45° angle, the willows may provide sufficient roughness for trapping of sediments, and ultimate repair of eroding banks. Although comparatively inexpensive, this method has a high risk of failure if the stream floods before the willows become established.

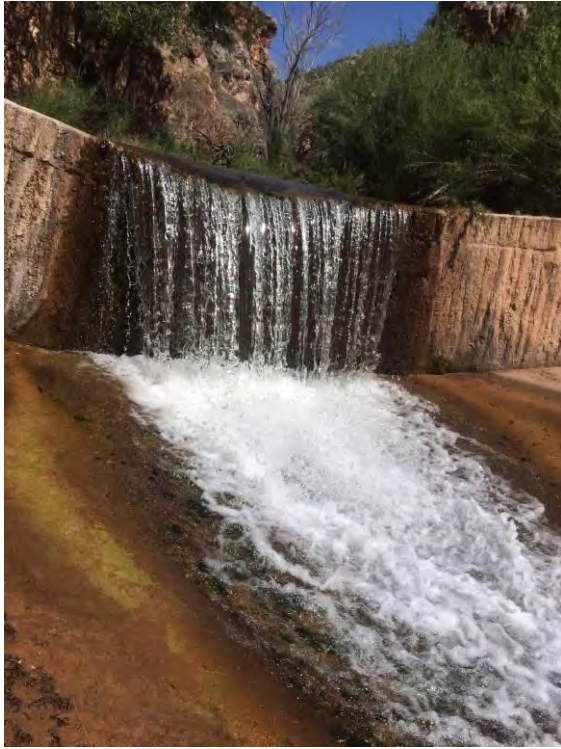
The Crooked Creek barrier showed slight signs of wear, but no structural instability. No scouring of the concrete of the apron, or splash pad, was evident (Figure 2-21). In the first decade after construction, bed load had been relatively slow to fill in behind the front wall of the weir, with fine sediment being the dominant particle size, and water remaining deep behind the wall for several years. By 2016, larger material had accumulated within the impounded portion of the stream, and it is now possible to walk across the accumulated cobble and gravel (Figure 2-22).

Figure 2-21. Splash pad of the Crooked Creek barrier.

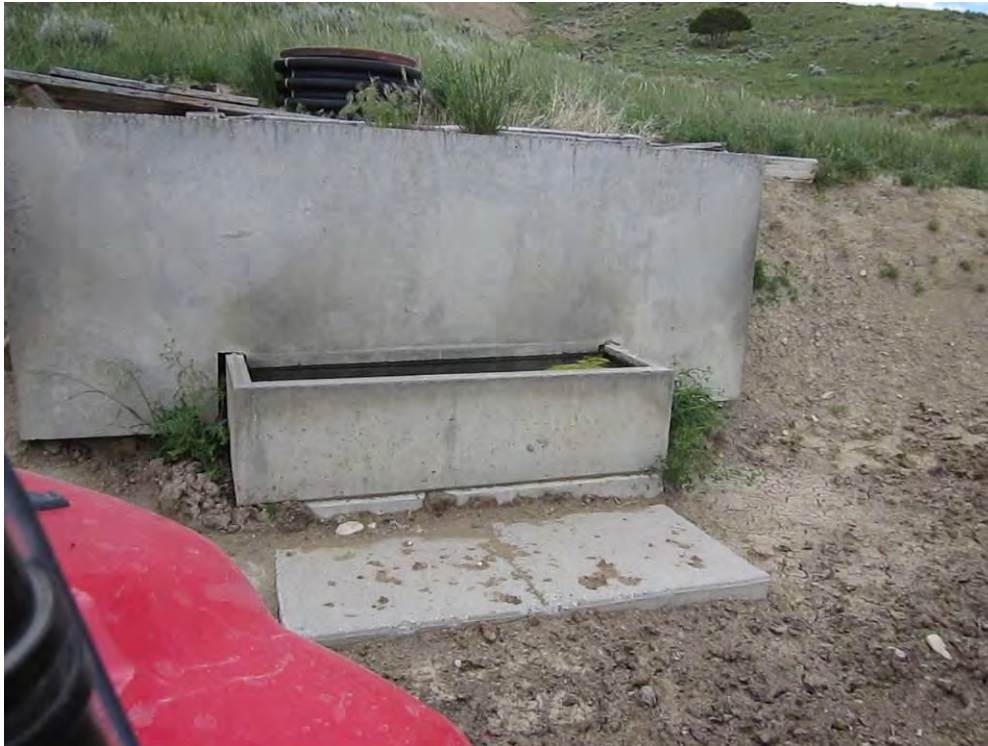
On June 14, 2016, Shannon Bockmon visited the project site to evaluate if project goals had been met, and if the conditions of the agreement were met. The landowner had installed 3 off-channel watering devices (Figure 2-25). Fencing excluded livestock from the stream channel, and thick stands of willows or

Figure 2-25. Example of off-stream stock water.

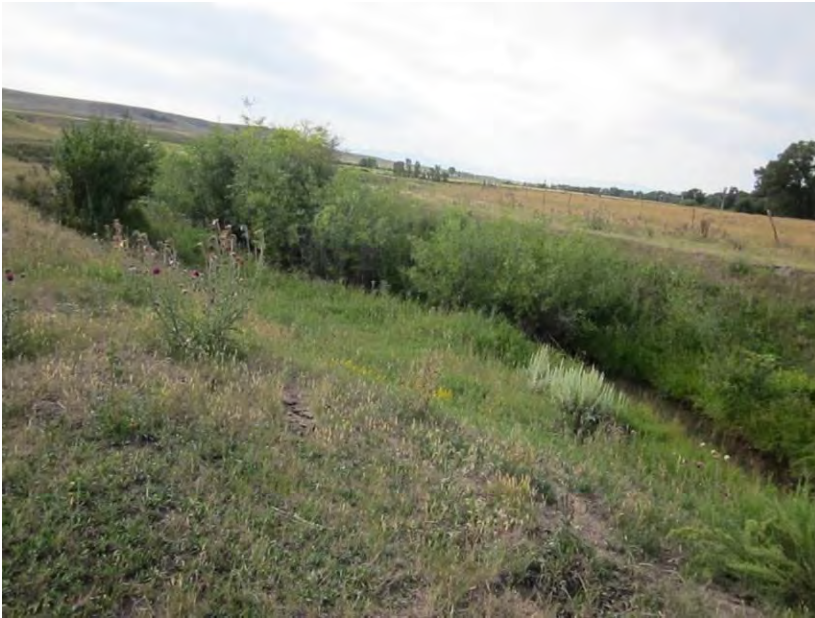
On August 9, 2016, Shannon Bockmon visited the project site with the landowner. All components had been implemented at this time. The riparian area has made a strong recovery in both streams (Figure 2-32), and grazing is limited to light grazing during the non-growing season. Remaining banks that had not been sloped have not migrated, and are minor features, especially compared to pre-restoration conditions.

Figure 2-32. Example of reduced erosion and recovery of riparian vegetation along a mechanically sloped bank.

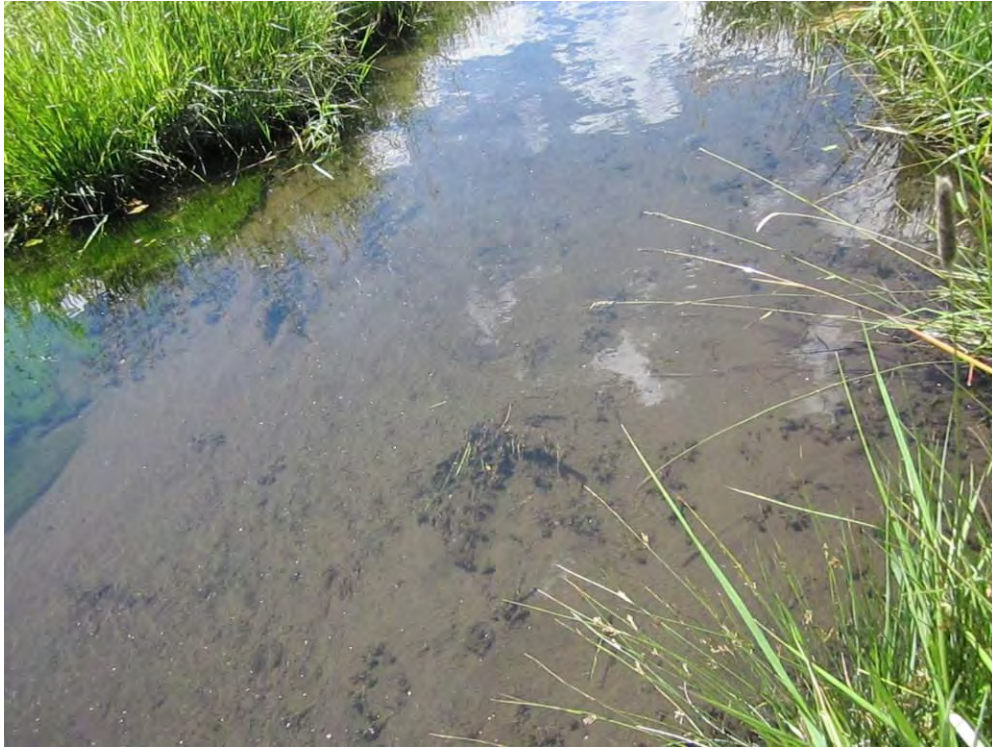
A substantial change in bed material occurred since the 2007 assessment. In 2007, clean spawning gravel was present along most of the restored reach, and in relatively high gradient reaches downstream of the restored reach. By 2006, the gravel bed in the restored reach had been buried under 4 to 6 inches of muck, which rendered this reach unsuitable for spawning (Figure 2-37). Suitable spawning gravel remains in the higher gradient reach downstream of the restored reach (Figure 2-38).

Figure 2-37. Example of extreme siltation of streambed in restored reach.

Multiple sources may be contributing to accumulation of fine sediment within the restored reach. Given enough time, atmospheric deposition of fines may be sufficient to create the current conditions, and as a spring creek, the stream does not experience flushing flows to transport fines out of the stream.

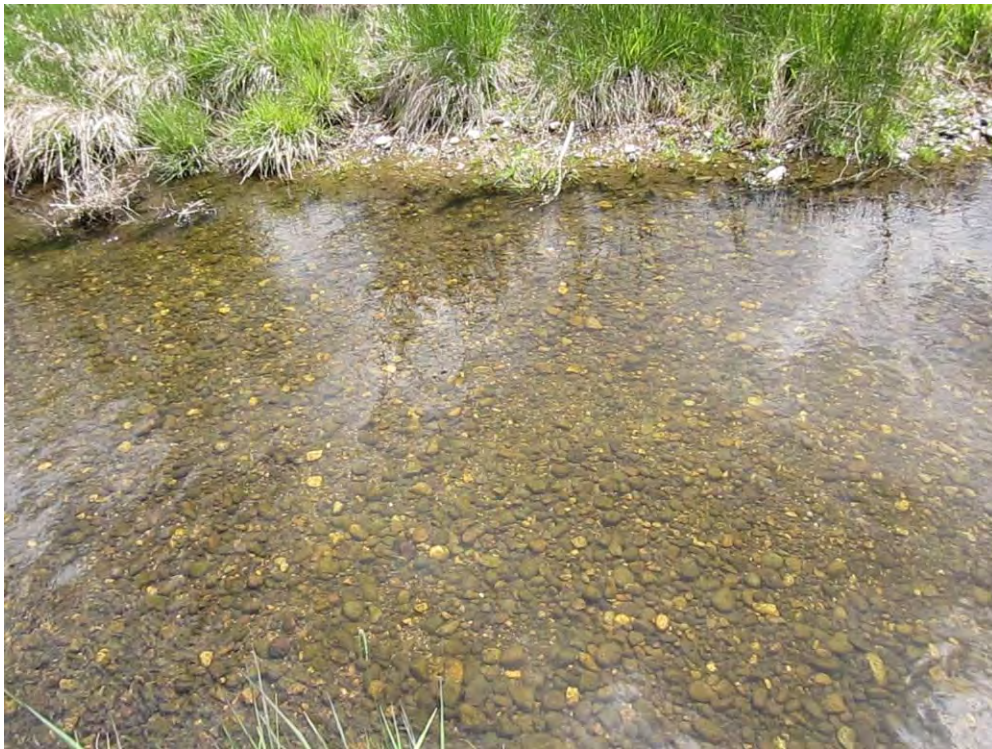
Figure 2-38. Gravel suitable for spawning downstream of the restored reach.

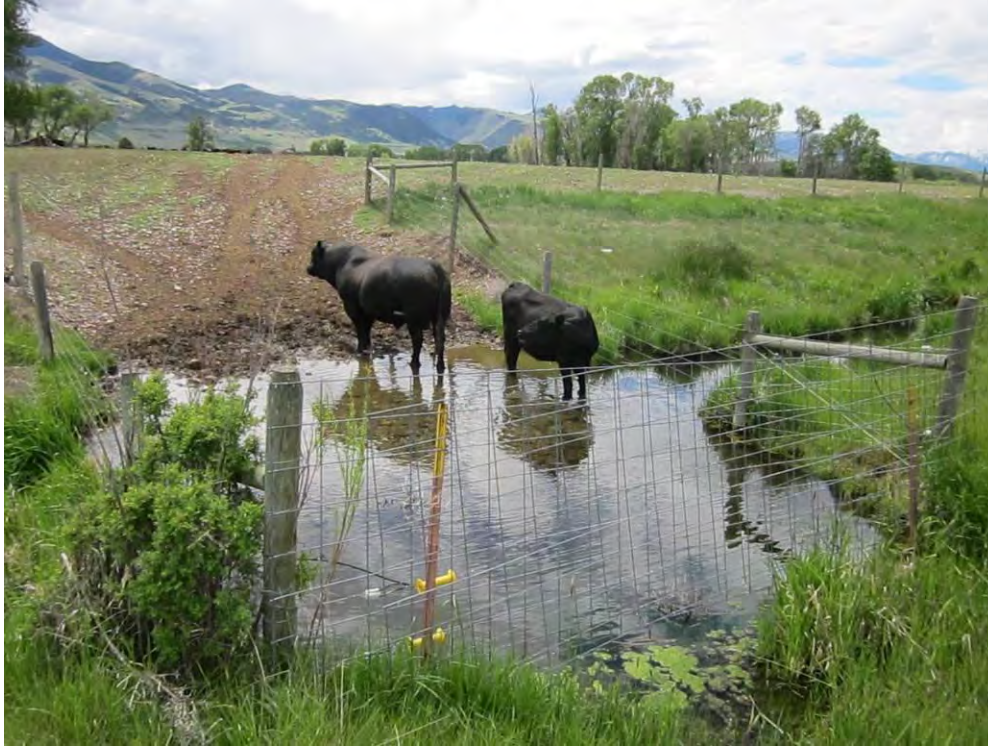
A component of the grazing management plan was installation of a water gap to allow cattle limited access to the stream (Figure 2-39). The water gap is effective at controlling livestock, while providing stock water. The water gap restricts cattle to about 20 feet of stream in order to access water.

Figure 2-39. Water gap allowing cattle access to water.

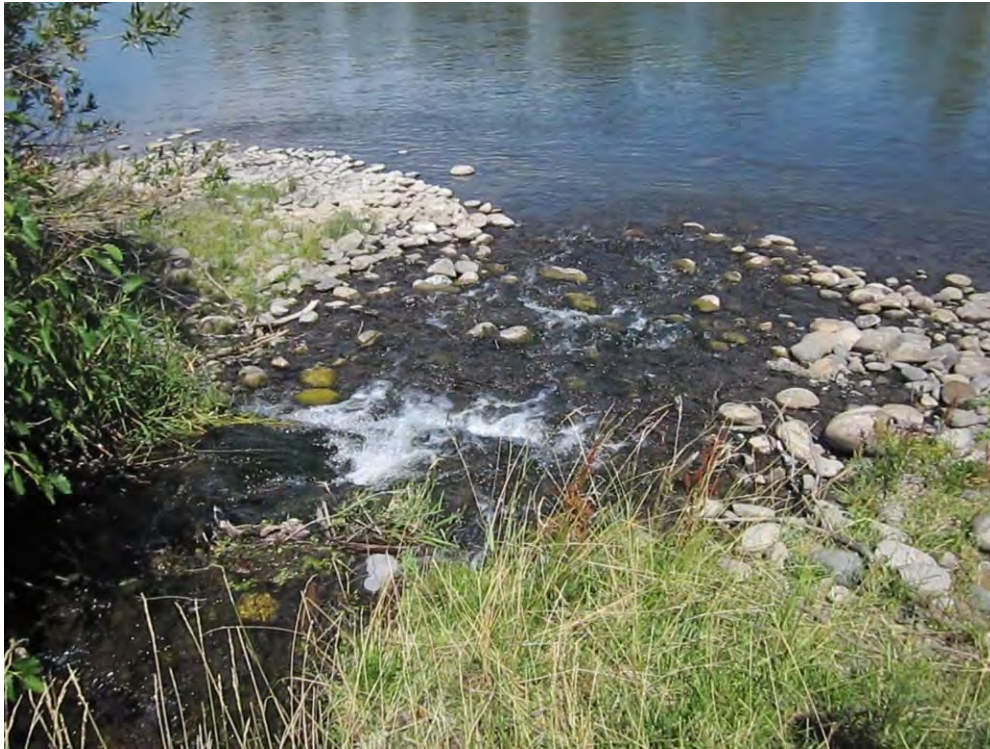
Figure 2-41. Confluence of Esp Spring Creek with the Yellowstone River, showing absence of constructed step-pools.

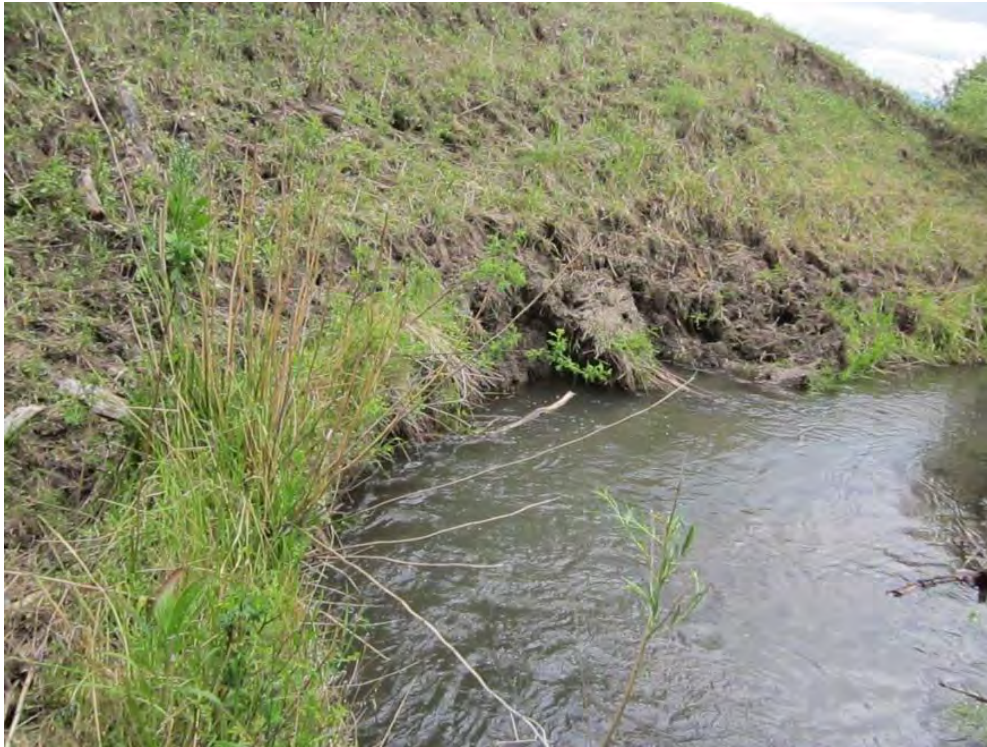
Figure 2-54. Bank trampling and stock trails on Fleshman Creek.

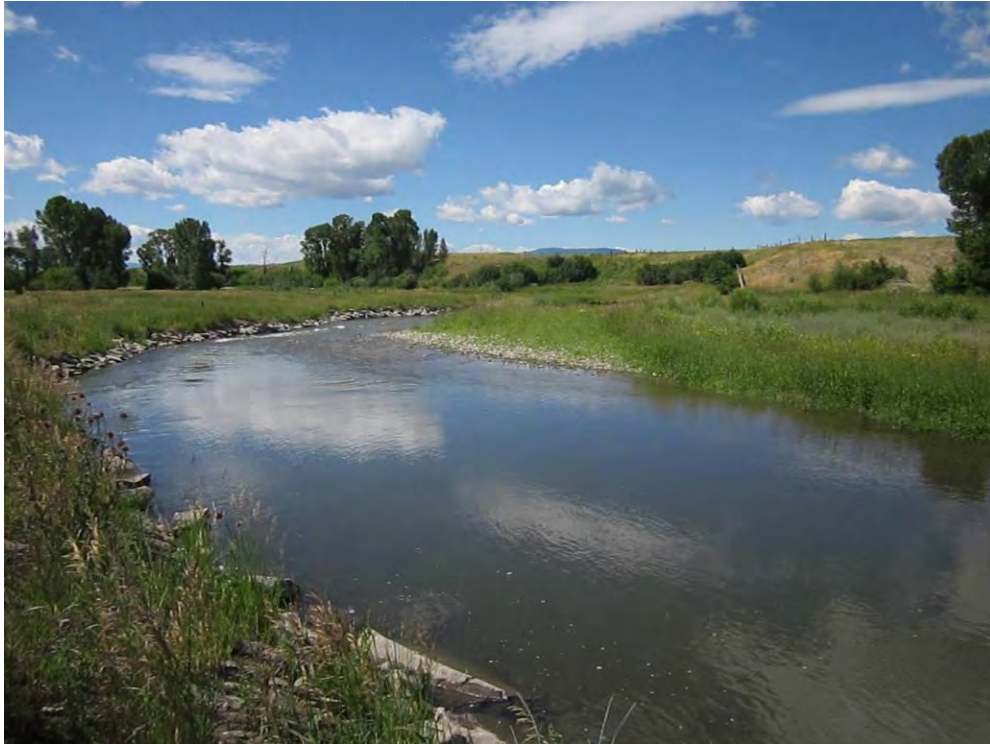
Figure 2-80. Example of bank stabilization on the Shields River after failure of the root wads and tree revetments.

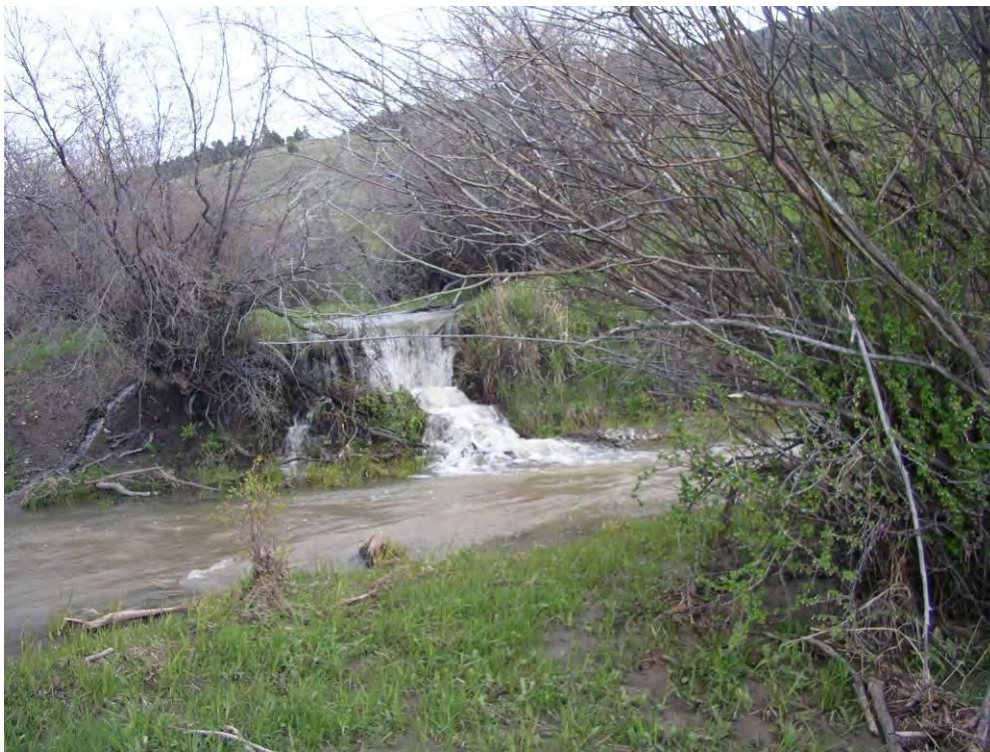
Figure 2-89. Head cut on South Fork Horse Creek caused by flood.

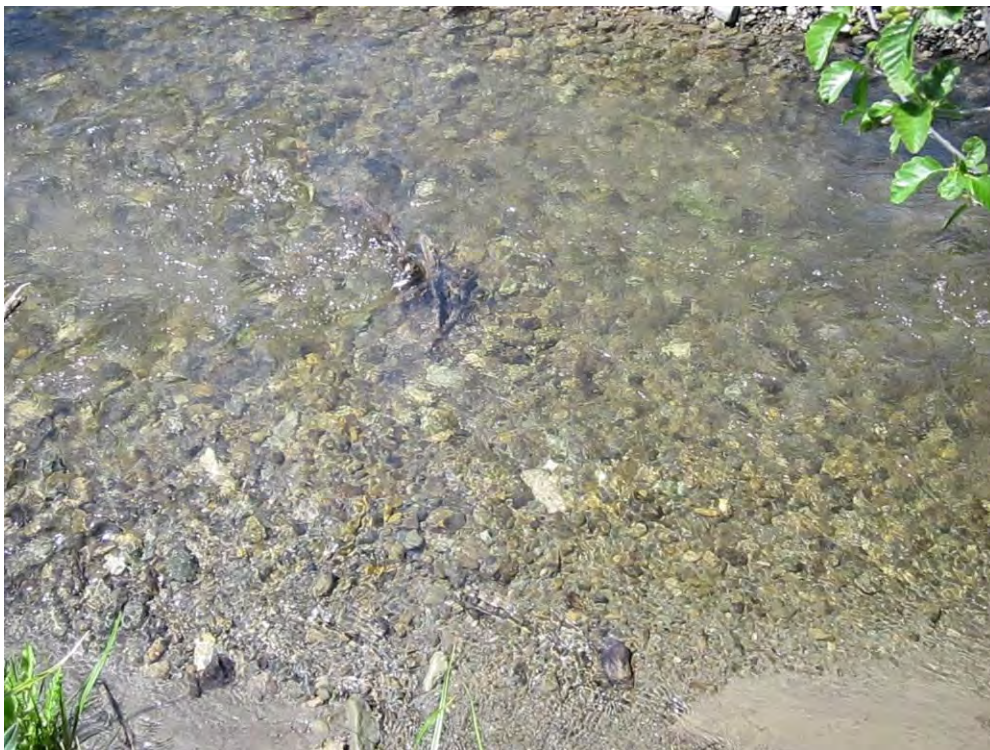
Figure 2-93. Example of streambed 5 years after project implementation showing marked decrease in fine sediment (compare to Figure 2-87).
