4 Appendix: Completed Field Forms and Associated Photos

4.1 Bad Canyon Creek barrier repair (003-2005)

FFIP 2016 Field Monitoring Appendix
Field Forms and Geo-referenced Photos
Yellowstone River Watershed

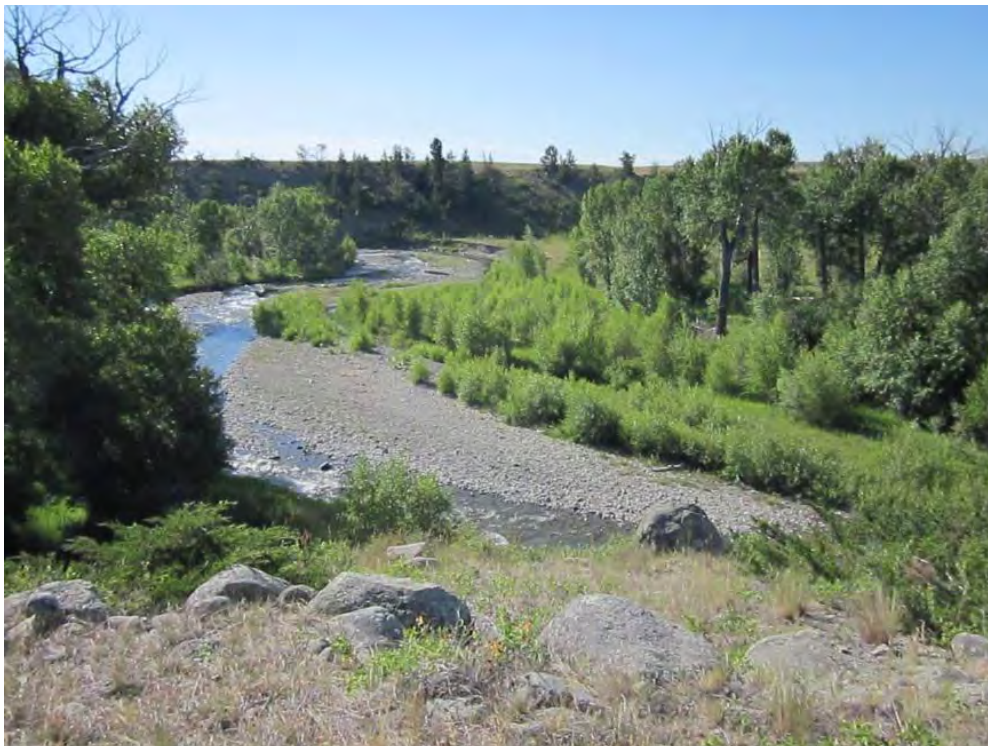
Photo 1. Overview from start of project looking down stream.

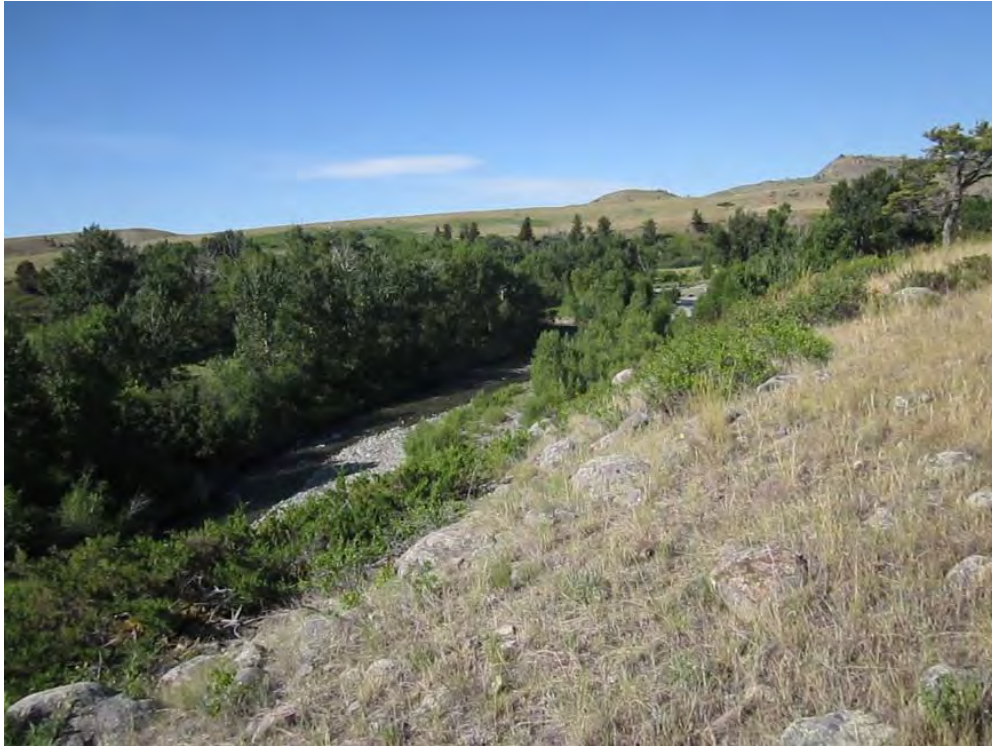
Photo 2. Overview of upper part of project.

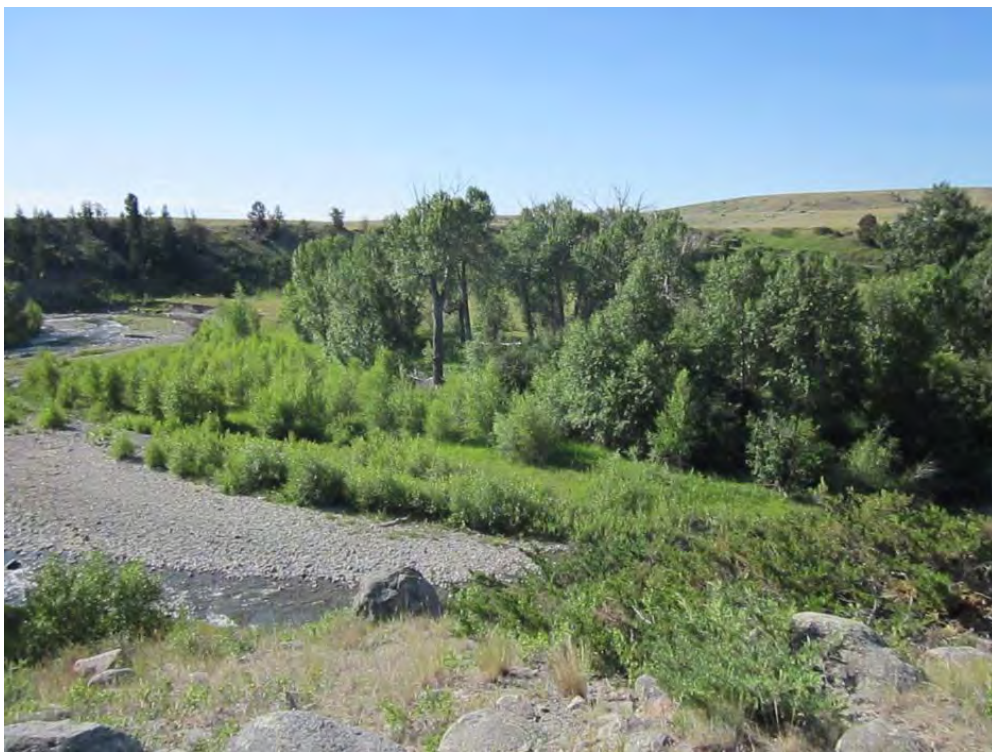
Photo 3. Gravel bar with cottonwood recruitment

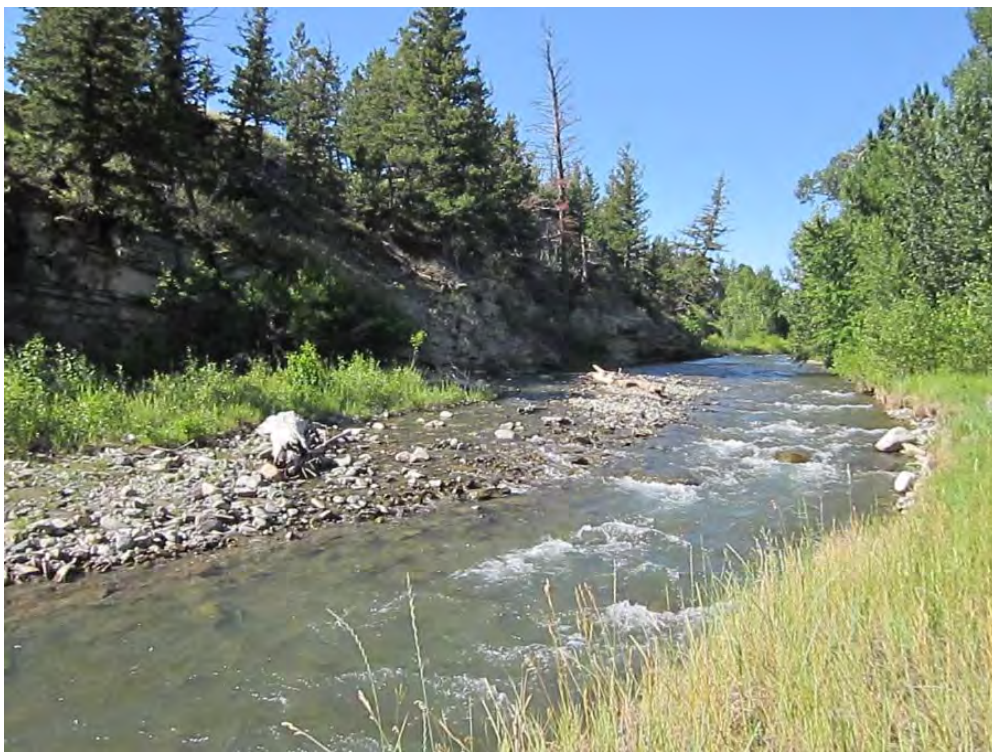
Photo 7. Vegetation recruiting on point bar.

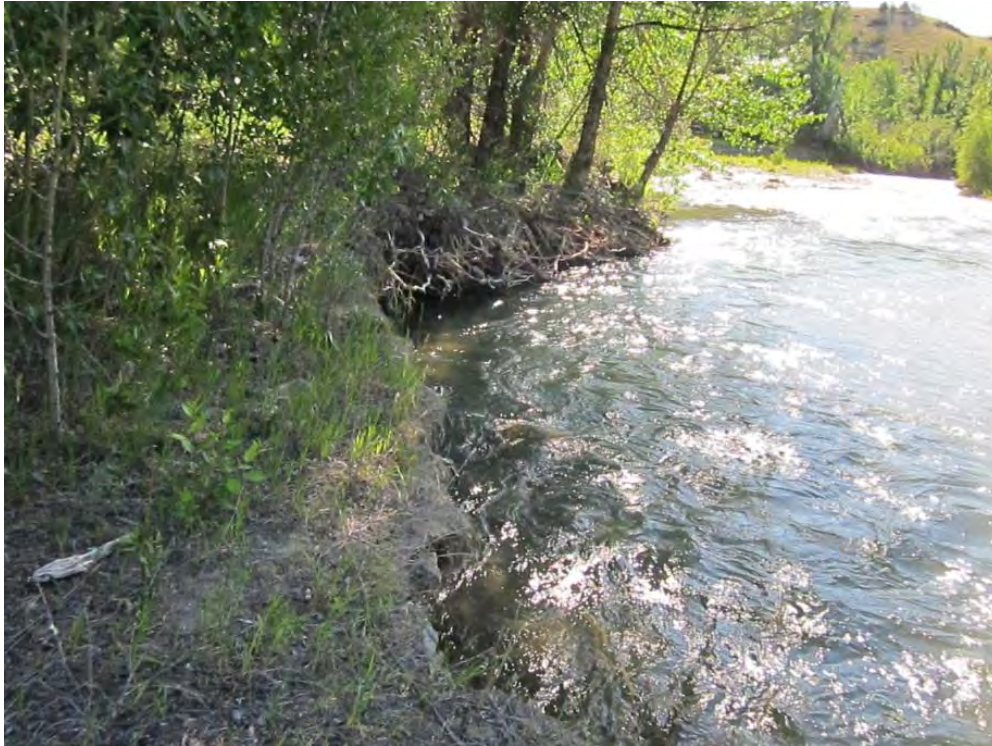
Photo 8. New vegetation, lateral channel mobility, and pool with undercut bank.

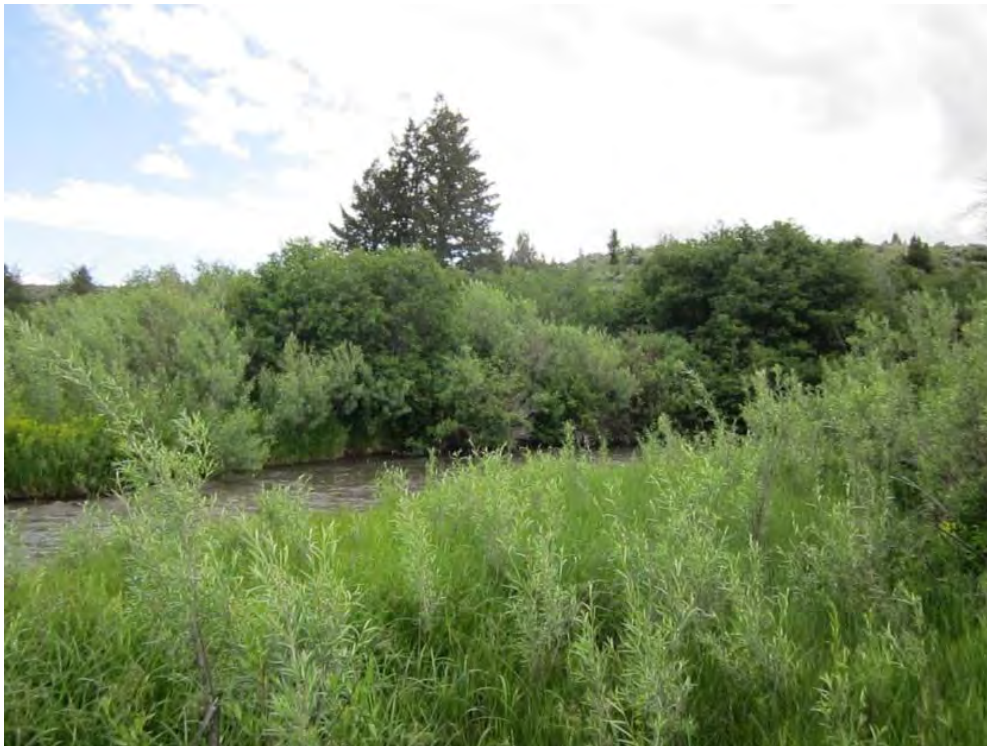
Photo 1. Start of project (the plug)

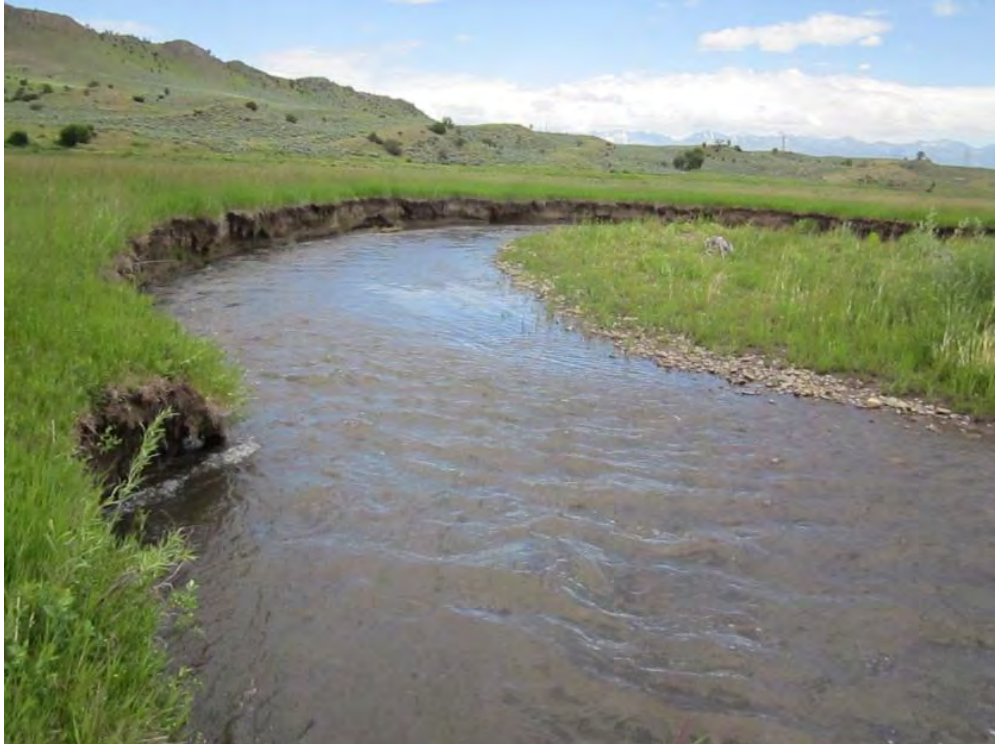
Photo 1. Eroding bank and point bar with willow recruitment

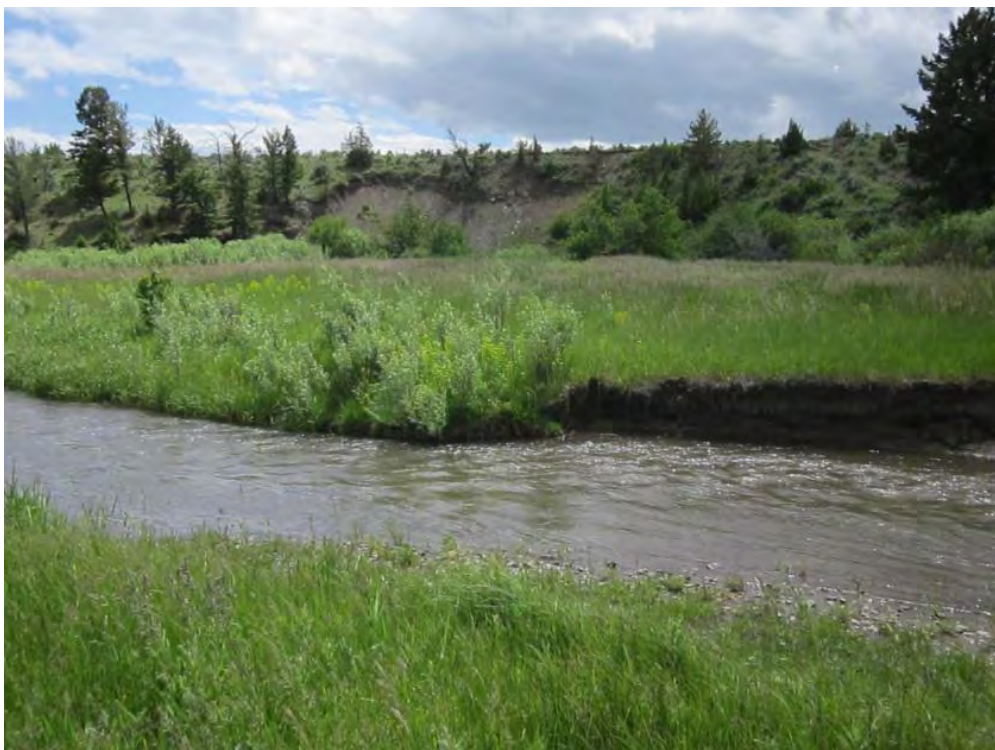
Photo 2. Evidence of willow stabilization

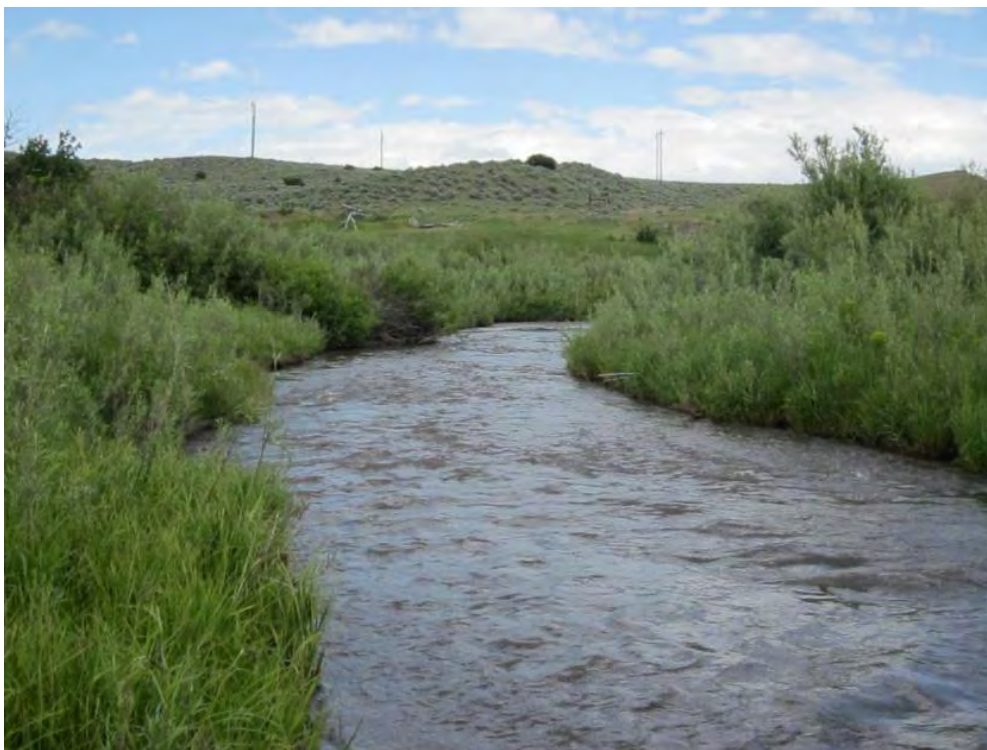
Photo 7. Functioning section of reconstructed channel with substantial willow growth.

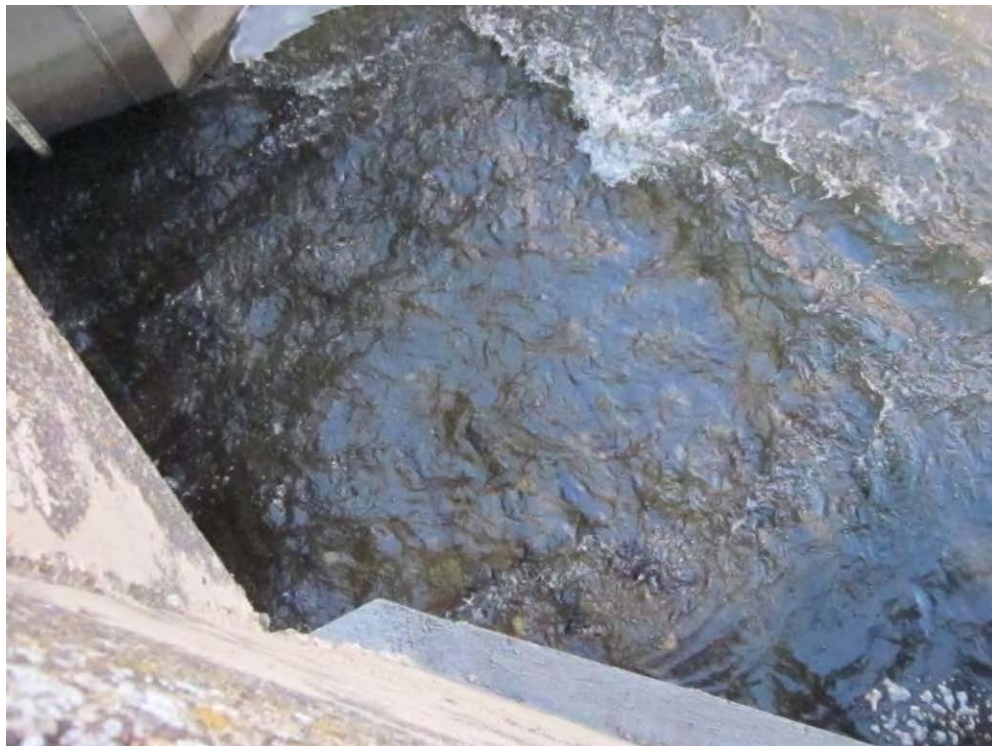
With the amount of over growth it was hard to access the stream, but could see that the step pools as well as the large rocks along the stream banks are still in working conditions.
 Pool at base of culvert is even with the bottom of the culvert that was previously a plunge pool.
 Plant recruitment is high, thus the lack of decent pictures.
 Some evidence of rock movement with in project area, but pools are still present.

Photo 1. Bridge with pool up to bottom of culvert.

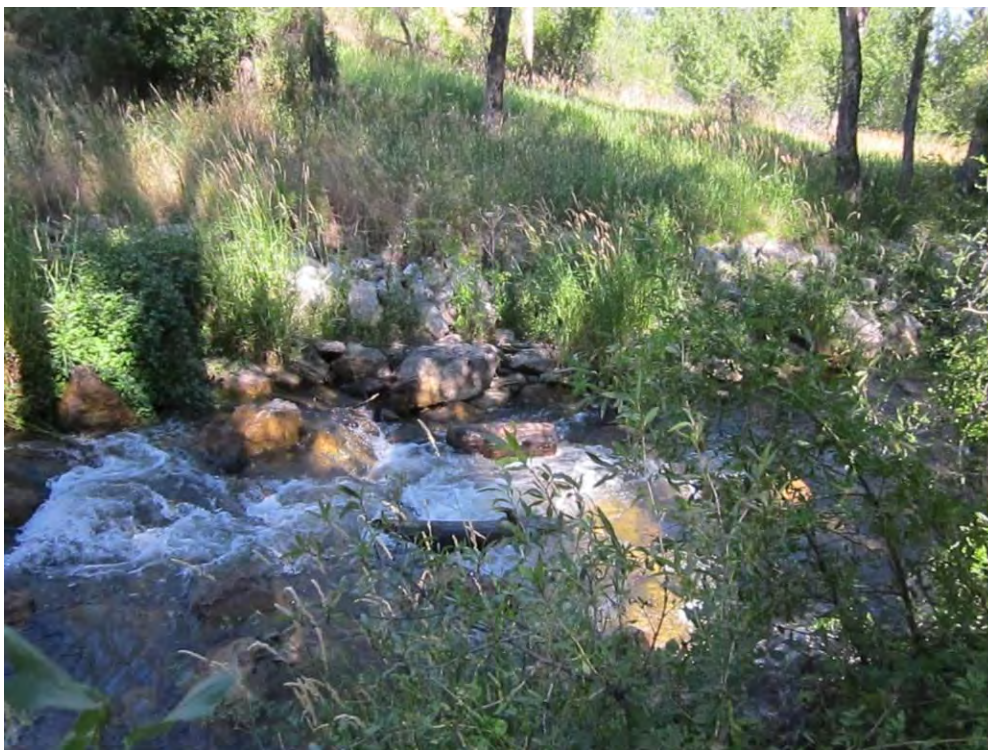
Photo 5. Another view of step-pools.

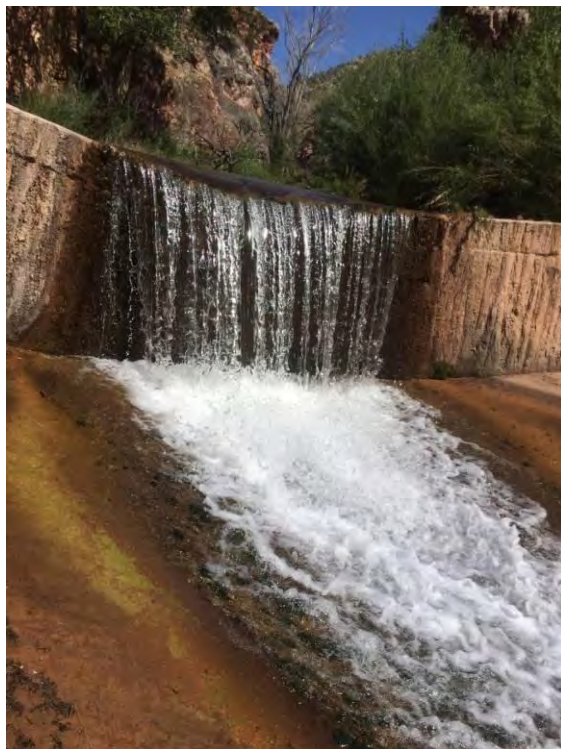
Photo 1. Splash pad in good condition, and not providing passage over structure

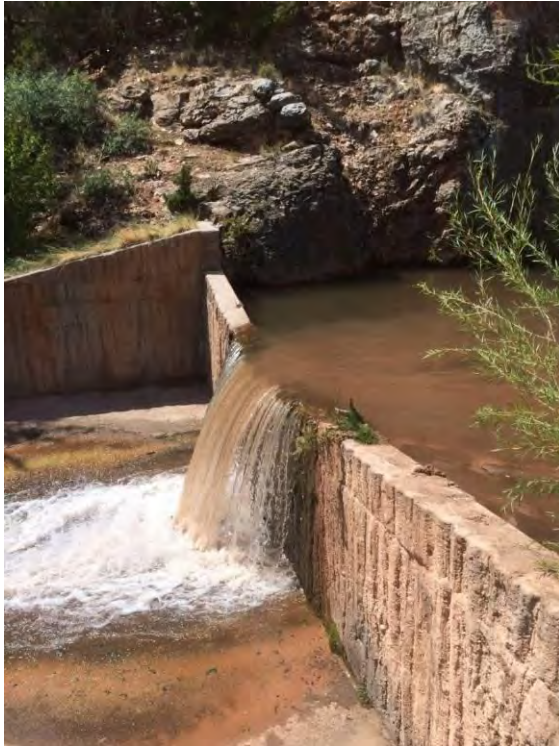
Photo 2. Accumulation of gravel behind wall of barrier forming a solid surface.

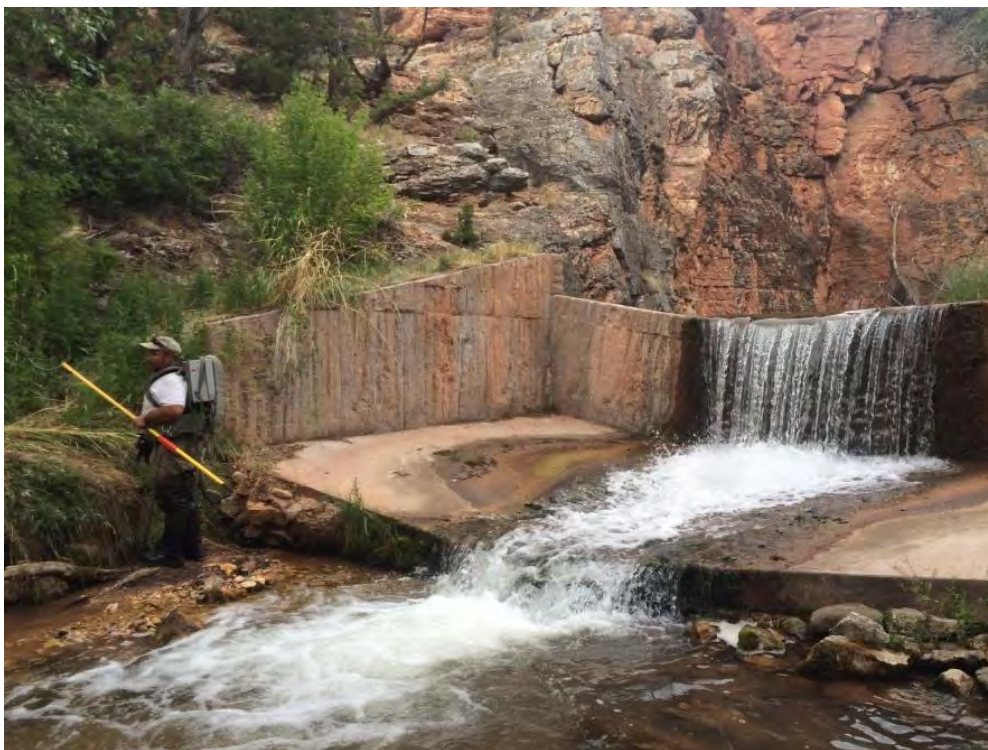
Photo 3. Slight amount of scour at downstream of apron, but not deep enough to allow to leap.

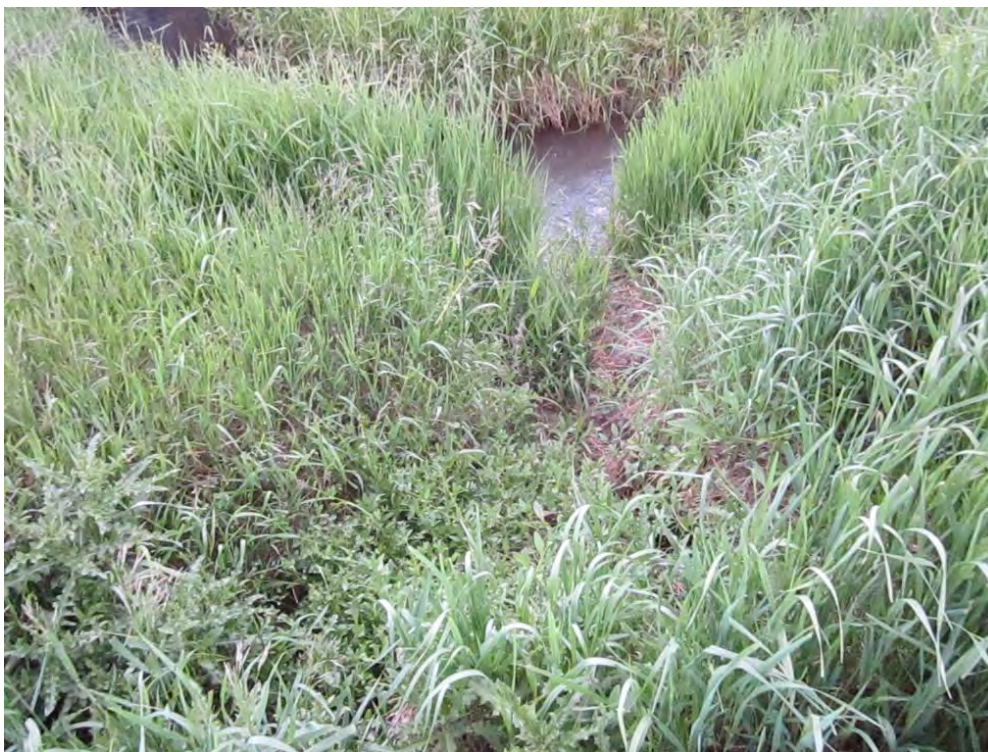
Photo 7. Murky water and cattle trail.

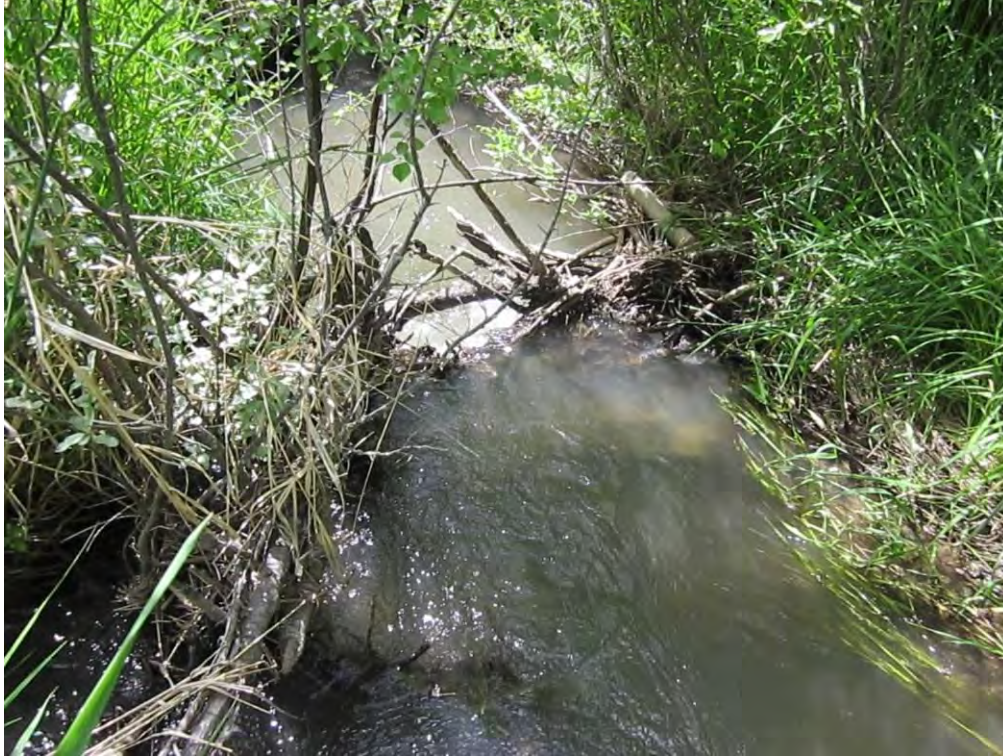
Photo 8. Small head cut.

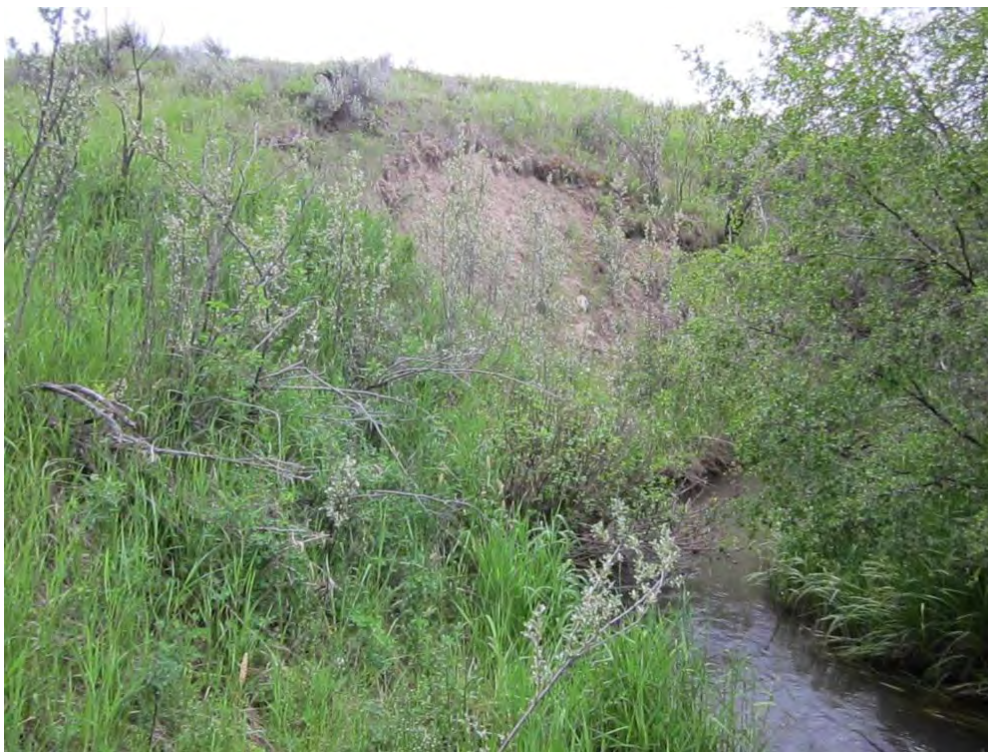
Photo 11. Old eroding bank now healing and has access to floodplain

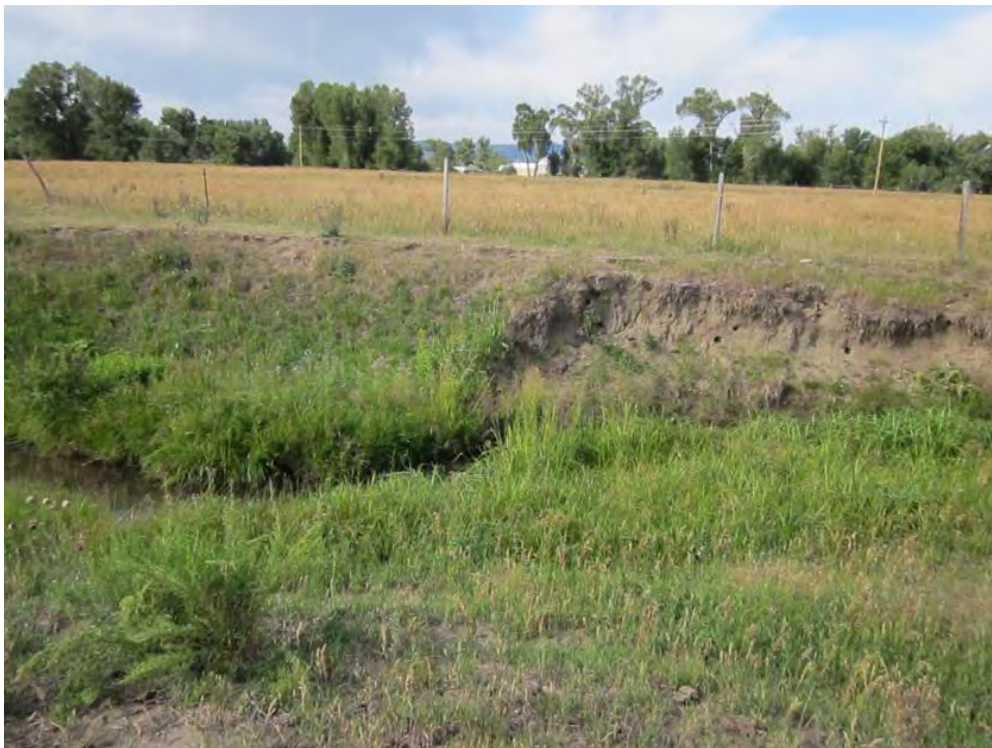
Photo 11: Evidence of 2011 flood demolishing part of the bank.

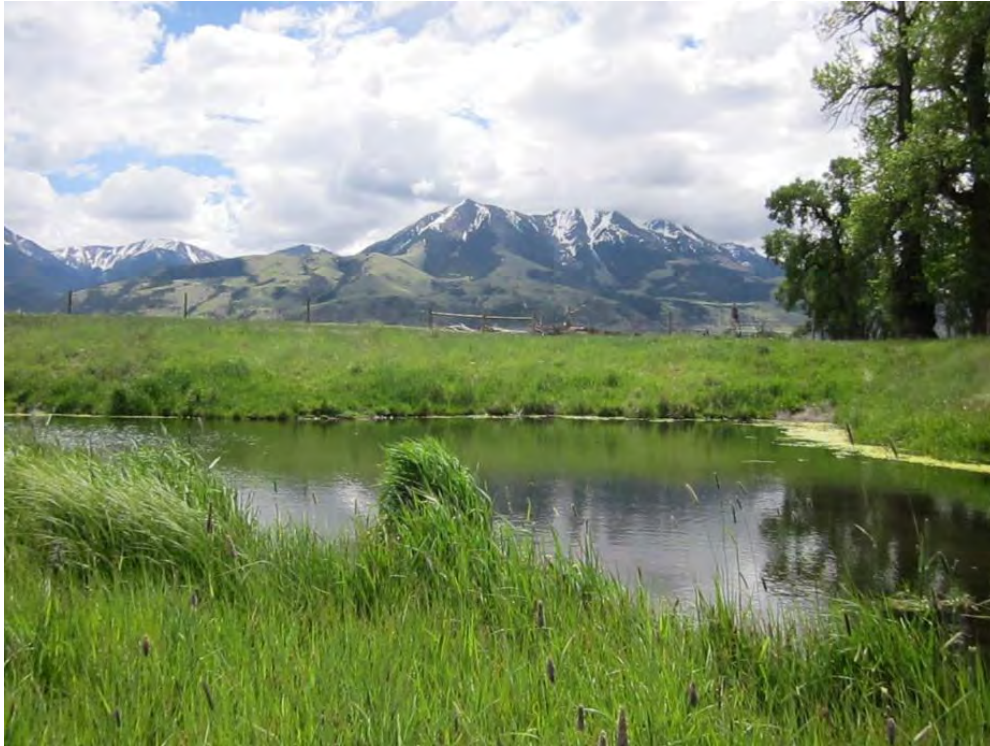
Photo 6: Large area of standing water connected to stream.

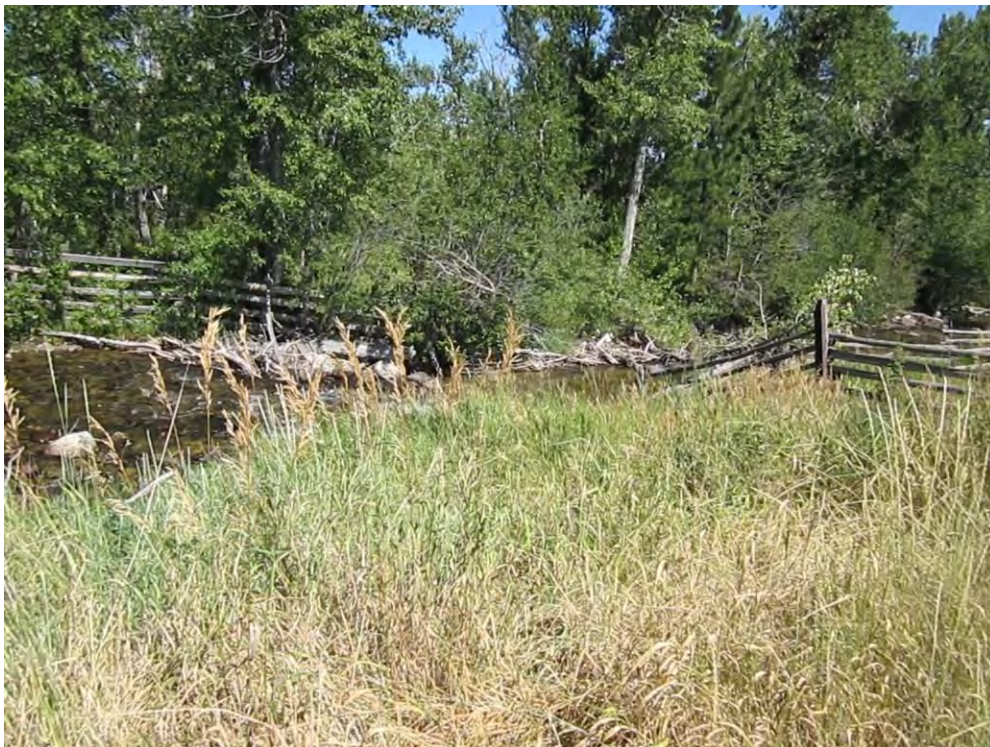
Photo 3: Old fence and recovering riparian area.

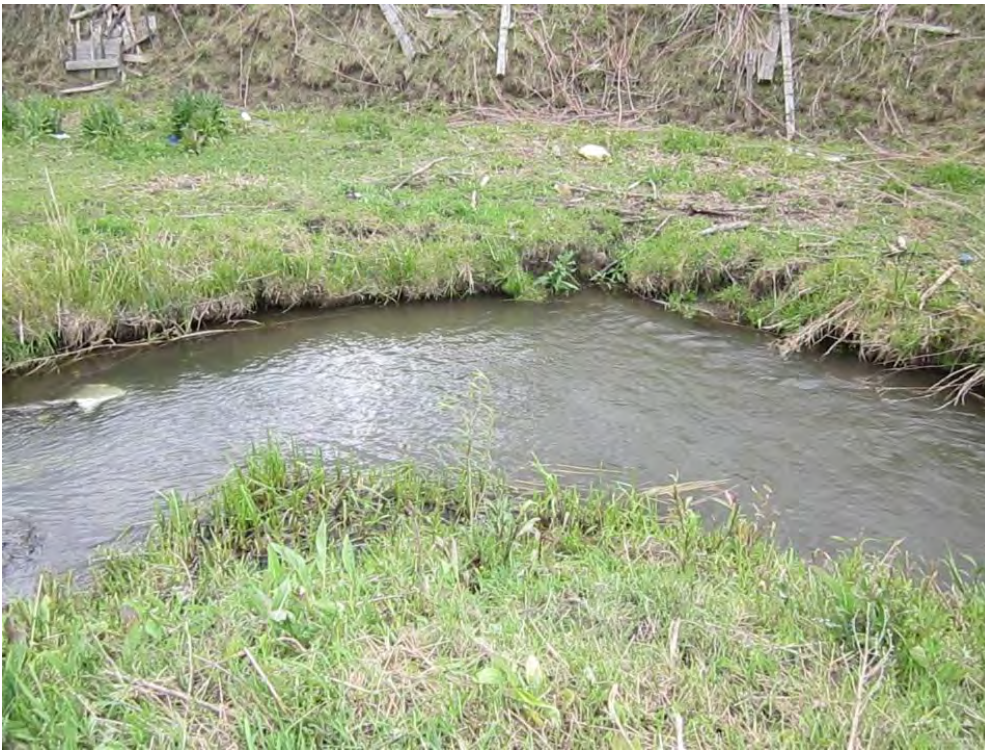
Photo 3: Some bank sloughing.

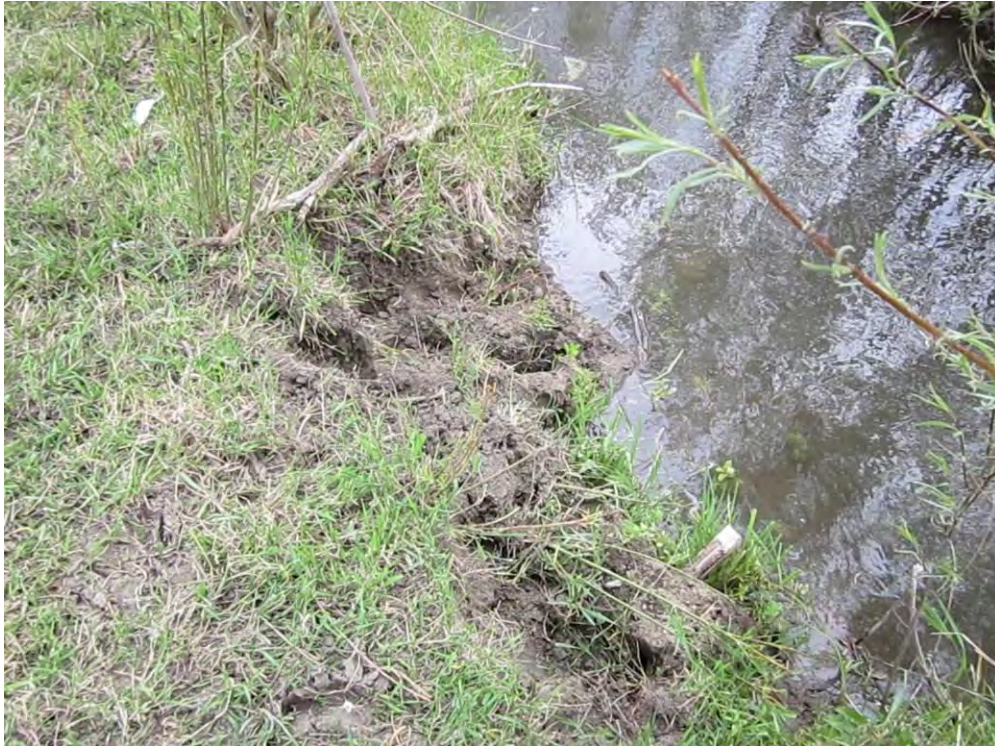
Photo 4: Some hoof shear. (Similar though out project)

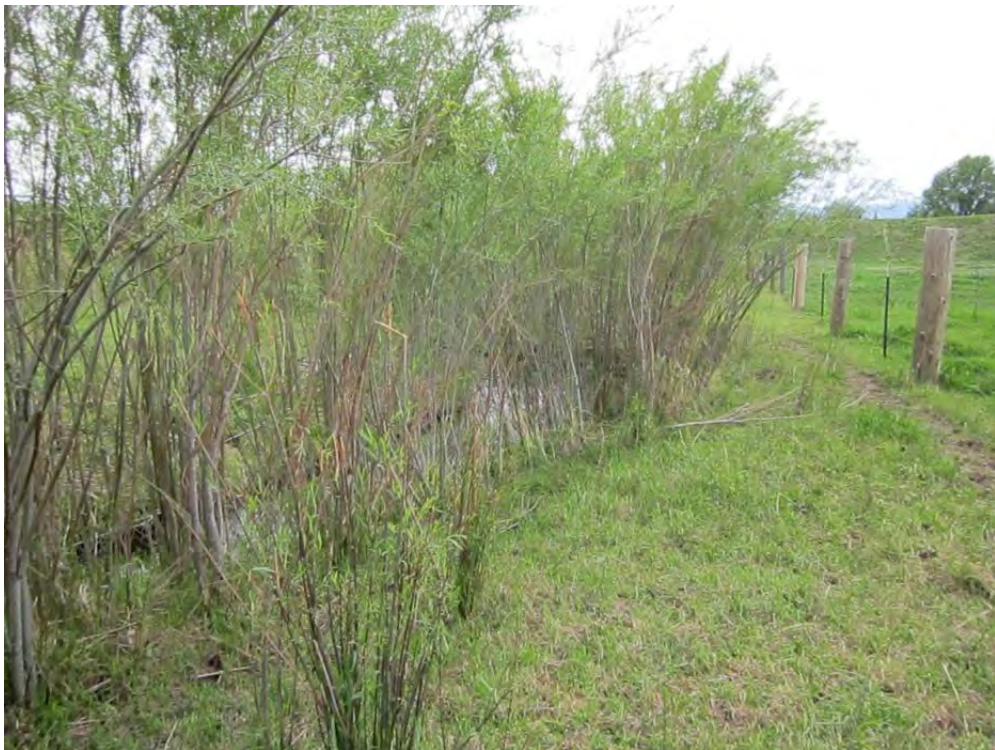
Photo 5: Willow survival and recruitment.

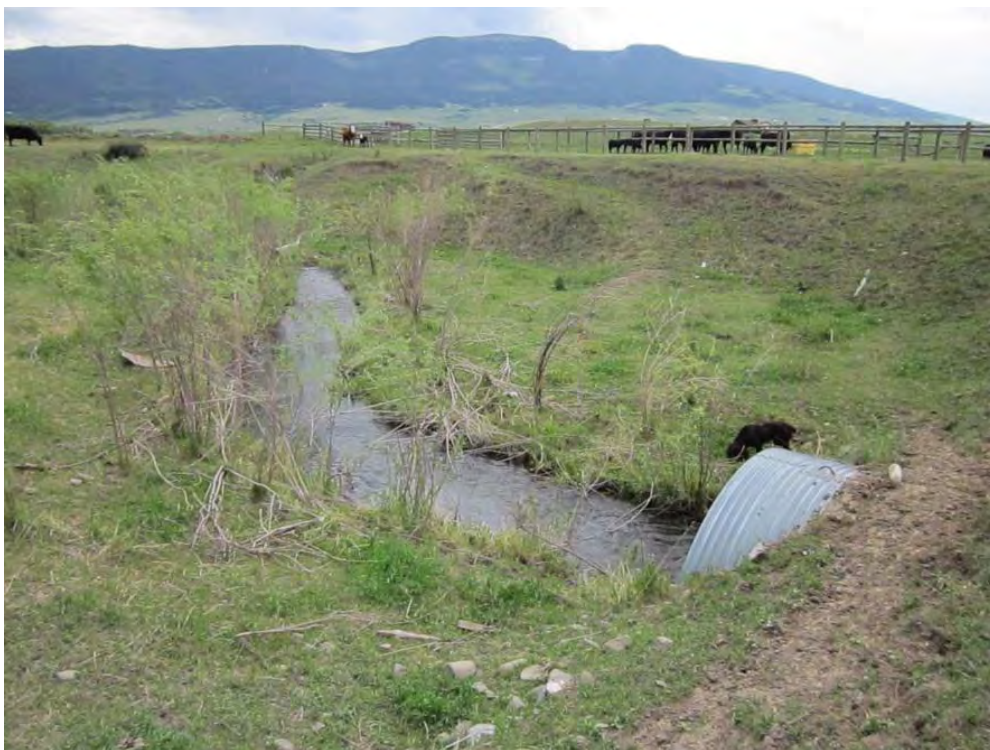
Photo 7: Terrace banks show vegetation re-growth.

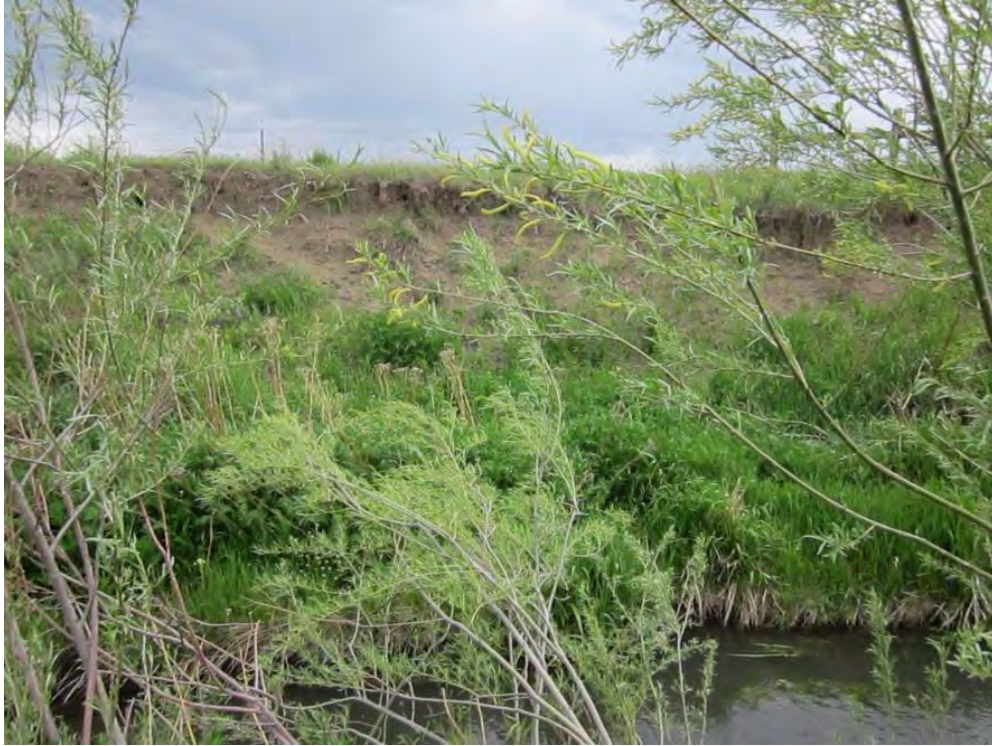
Photo 10: Floodplain bench still in working condition.

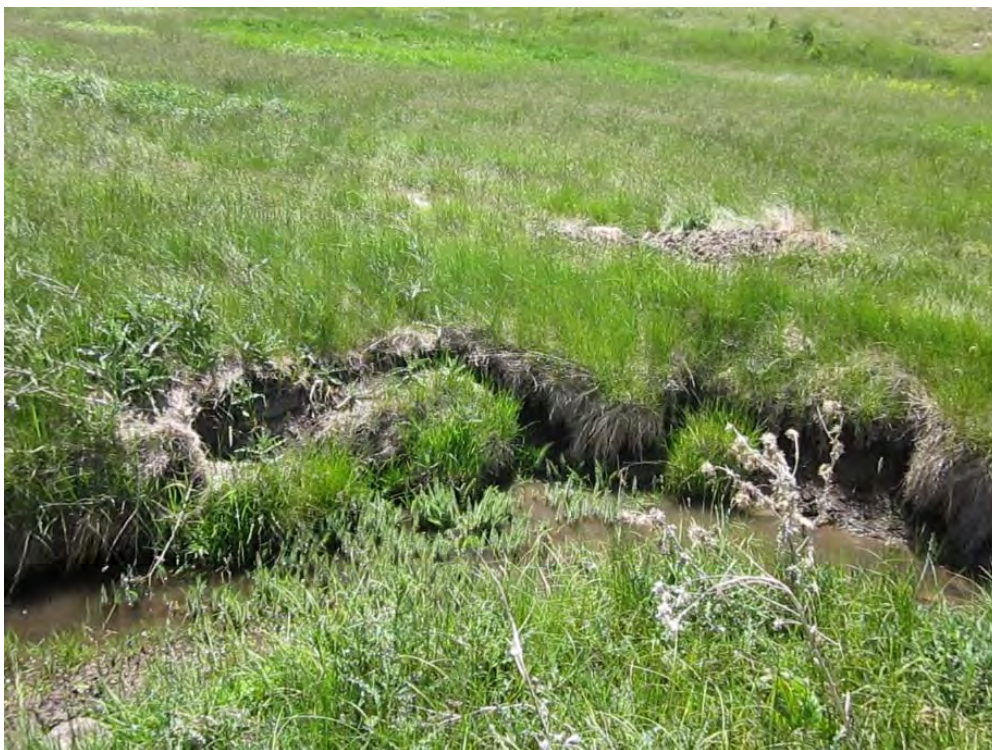
Photo 3: Sloughing of stream bank.

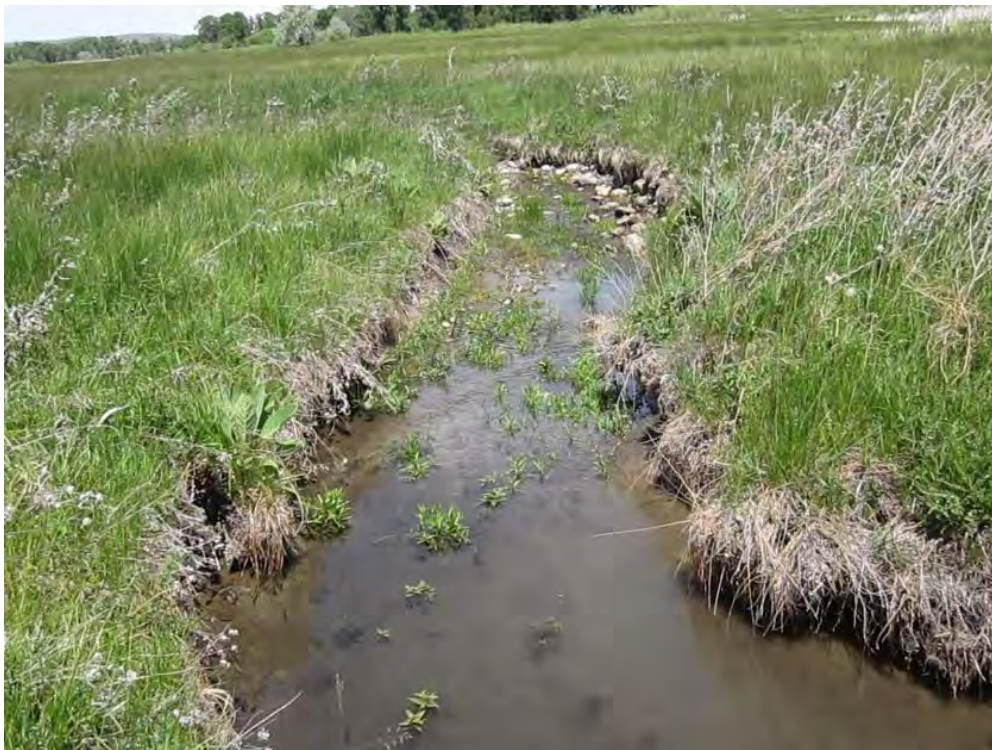
Photo 7: Pool full of sediment, higher grade=exposed gravel.
