4.13 Nelson/Dana Spring Creek channel restoration (012-2005)

Project #:	012-05		Project Title:	Nelson/Dana Sprin	g Creek ch	annel n	estorat	ion	
Date:	7/6/2016		Evaluator: S	hannon Bockmon					- 19
Waterbox	dy Name:	Yellowston	e River	Project Type:	Enhanc	e spav	vning		7

FFIP 2016 Field Monitoring Appendix Field Forms and Geo-referenced Photos Yellowstone River Watershed

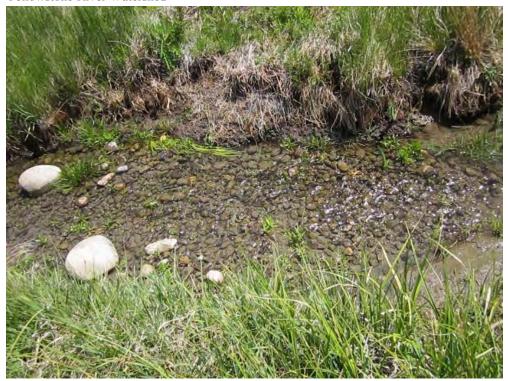
Photo 6: Possible spawning gravel.

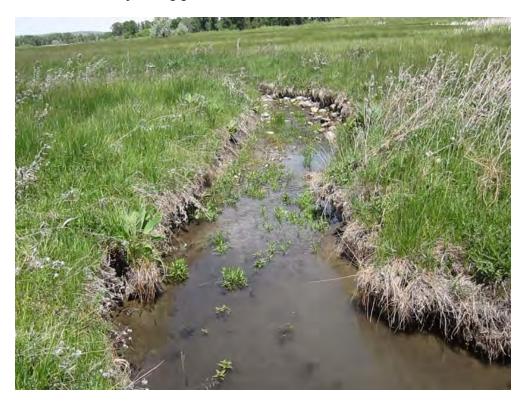
Photo 7: Pool full of sediment, higher grade=exposed gravel.

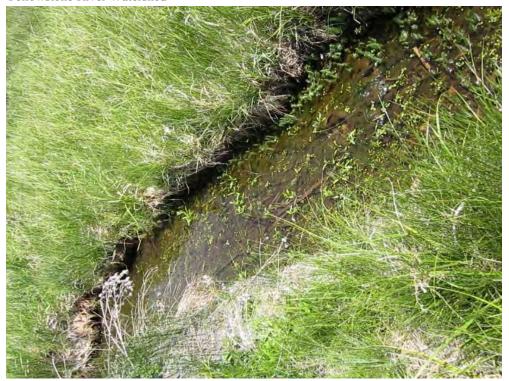
Photo 8: Ideal channel, width/depth ratio.

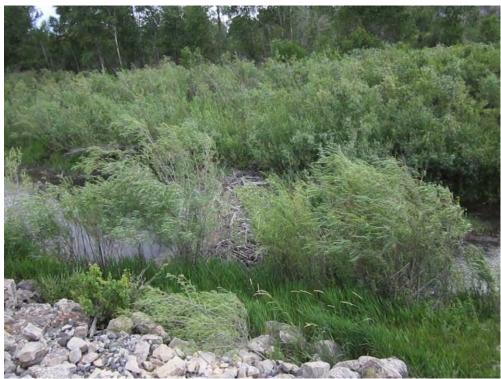
Beaver darn at mouth preventing passage up stream. Landowner stated that due to low flows of the Yellowstone River the dam was not blown out like previous years allowing cutthroat passage during spawning

Photo 1: Beaver dam downstream (not within project area).

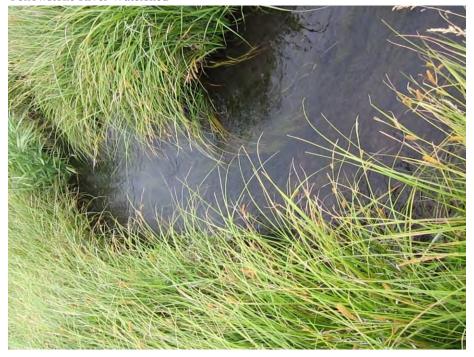
Horses (~5) do pasture here but very little evidence of hoof shear. (wouldn't show up on camera) Some aquatic plants within channel but with current flows it is enough to keep graveled areas open Nice undercut banks (did spot several fish using them)

Photo 4: Undercut bank with gravel and aquatic plants visible.

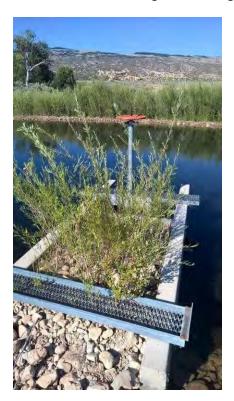
Photo 3. Willows growing on one of the irrigation stand pipes

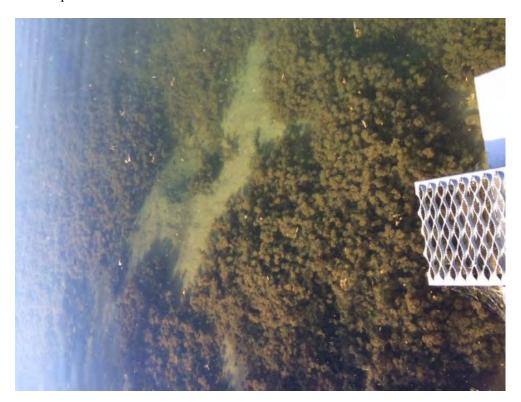
Aquatic plants growing on bottom of pond

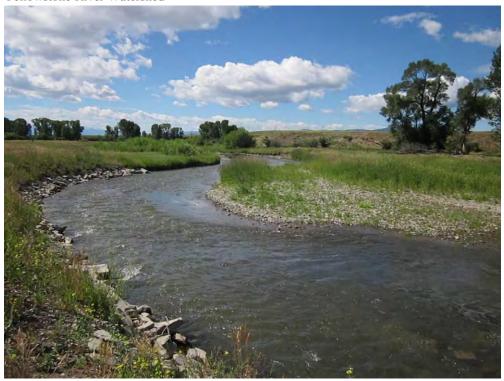
Armoring/bank stabilization is not putting much pressure on downstream banks.

sloped at about a 45 angle.

Photo 3. Rock armoring at toe of bank.

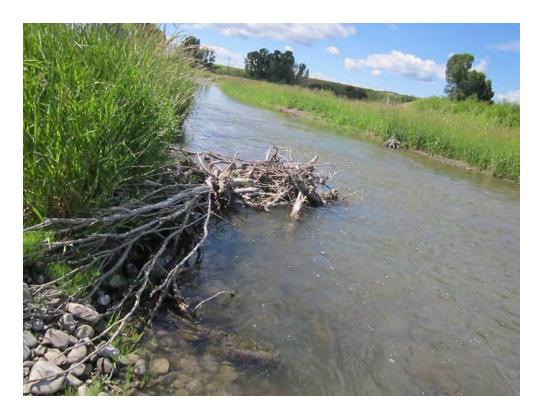
Planted willows never took, but existing willows migrated onto recently deposited gravel bars. Parts of old project still remain, but most of the tree/root wads have been washed out over the years due to high flow events and the river changing course.

Photo 4. Root wad and tree revetment.

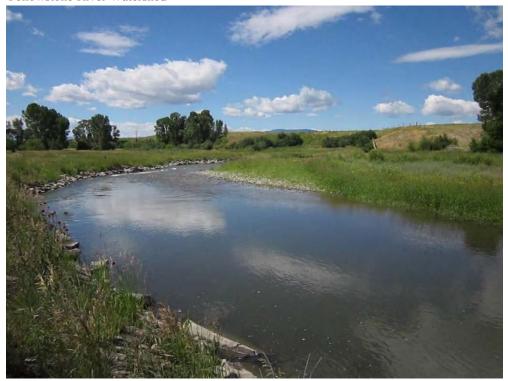
No grazing with in enclosure from cattle, but some from game. Very little evidence of game brows. Gravel bar building may be from a channelized reach above project causing significant bed load transport which deposits once it hits the restored stretch.

Photo 7. Small point bar and bank armoring.

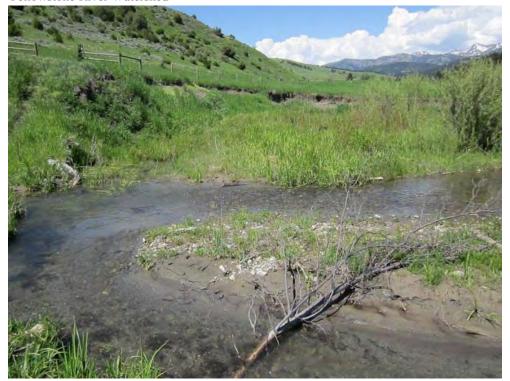
Photo 5: Floodplain bench that the stream moved away from.

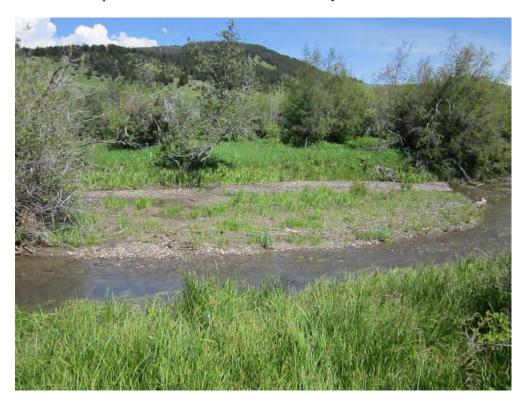
Photo 6: Braided stream bed, vegetation present on gravel bar.

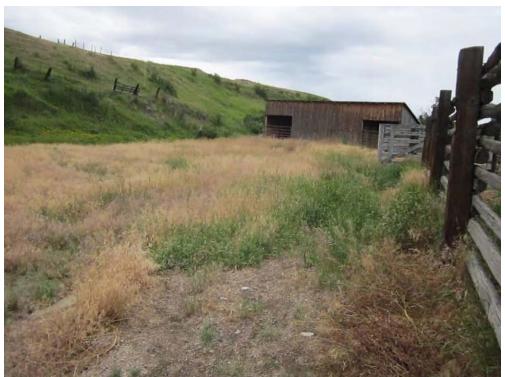
Stream banks where the old corral was removed are healing with grasses and look to be stabilizing. No willows are present yet, but just down stream there are willows growing where riparian fencing was placed.

Photo 1: Old corral area

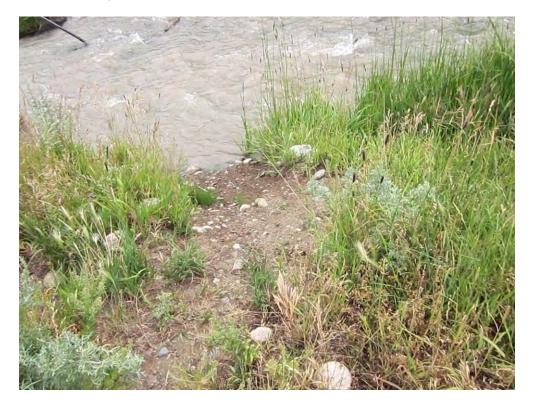
Some hoof shear is present in the area where the old corral was, but very little and done not look to be of much harm to the stream.

Photo 3: Light hoof shear.

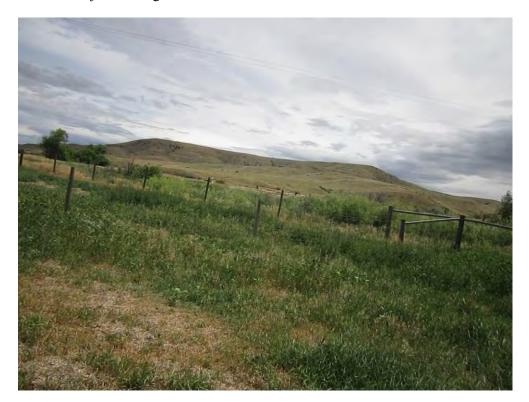
Photo 9: Riparian fencing with willow recruitment.

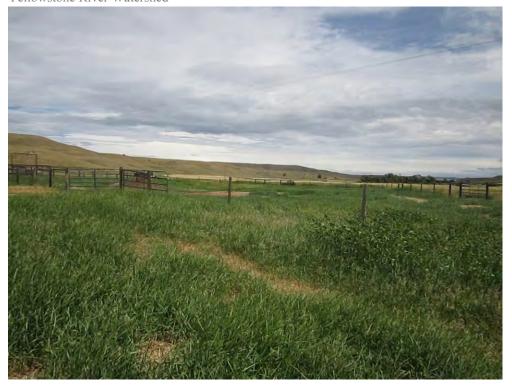
Photo 10: Corral drainage out towards the field rather than into the stream.
