Future Fisheries Improvement Program Monitoring

2017

Future Fisheries Improvement Program
Project Monitoring 2017

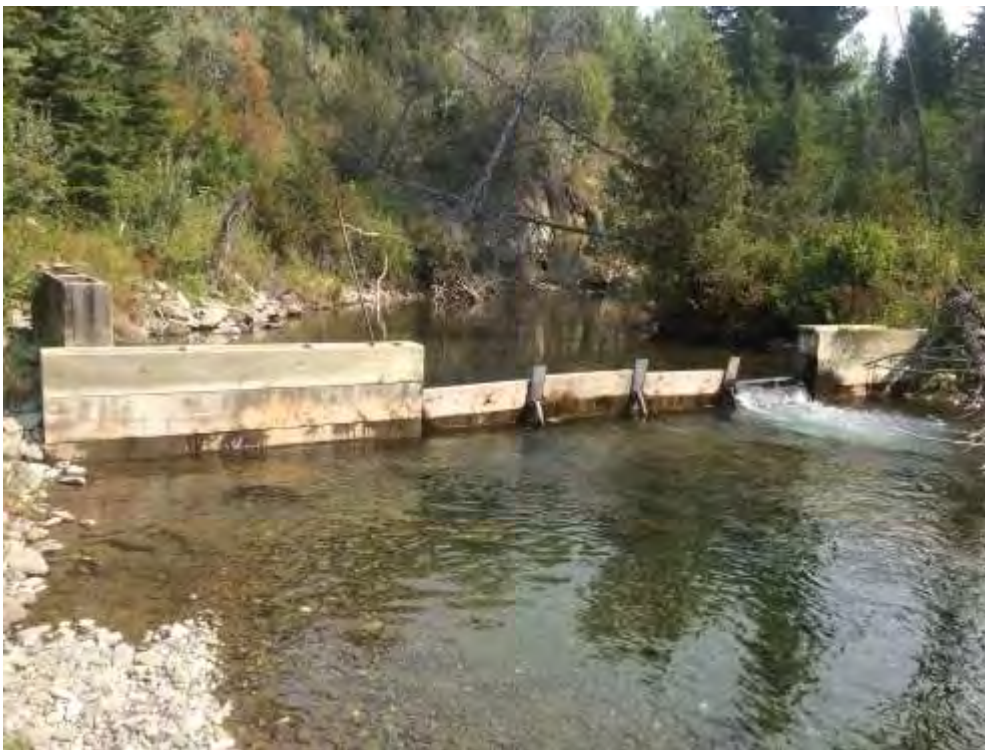
Figure 5. Irrigation diversion on Cottonwood Creek.

This project did not meet the design or contractual requirements of the FFIP grant program. The existing structure does not provide the same level of fish passage as a Denil fish ladder, and the check boards in the head gate allow water to continue to leak. This project provided no benefit to fish in Cottonwood Creek.

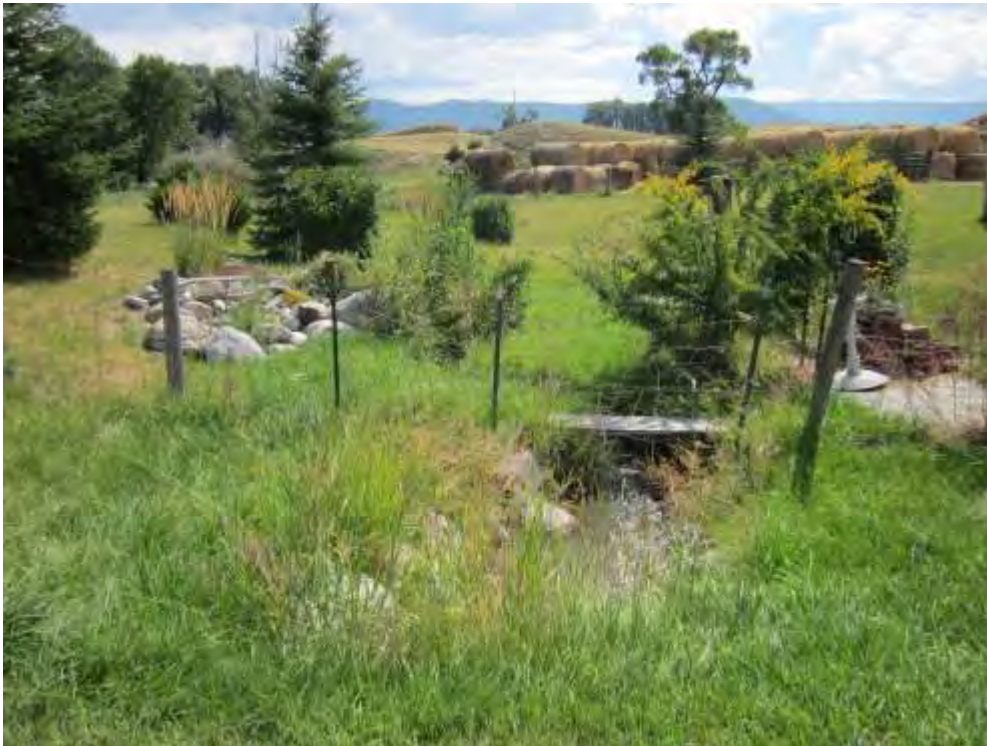
Figure 8. Current view of the relocated spring creek.

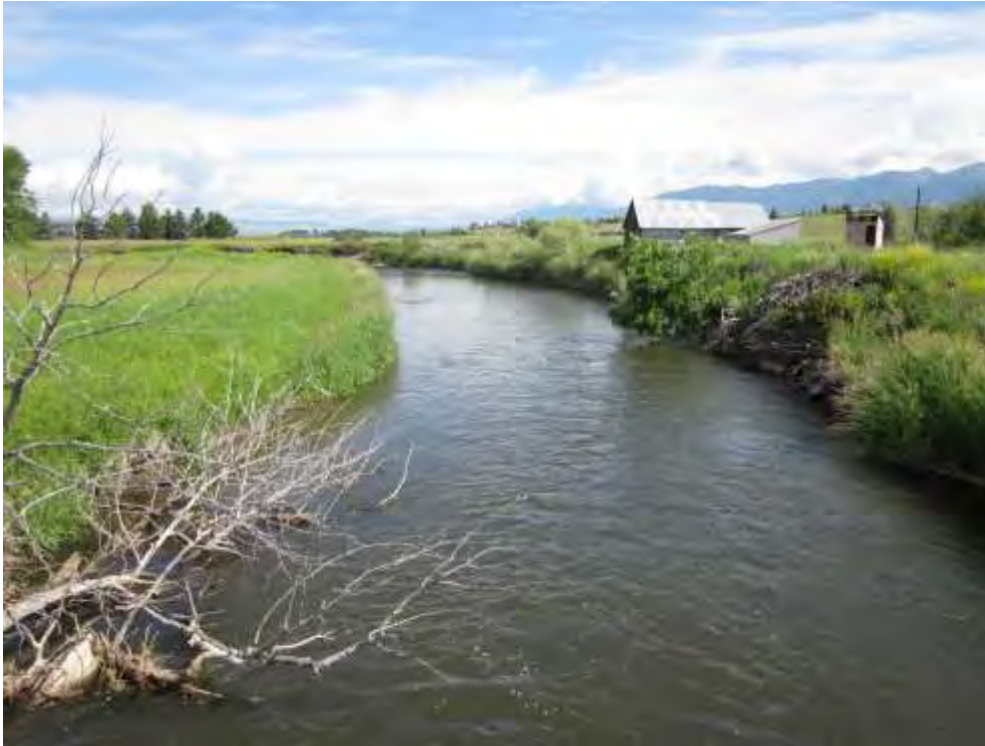
As described above, bank 1 was re-sloped, covered with erosion control fabric, revegetated, and stabilized at the toe with installation of rock modeled to be mobile at a 20-year recurrence interval event. This bank was stable with grasses and sedges providing most of the vegetative cover (Figure 17). The erosion control fabric was no longer visible and had likely decomposed with recovery of the bank vegetation, as is the intent when using this biodegradable material. The bank margin was vertical, with a 10-inch, 90° bank angle. The rock placed at the toe had been transported from under the bank, resulting in a stable undercut, which is an important habitat feature for fish. Fencing protected the bank from livestock over-use, and hoof shear or obvious types of disturbance from livestock were absent. A gravel bar had formed closed to the opposite bank; however, it was considerably smaller than the bar that had been excavated, and was not apparently exerted erosive force on banks 1 and 2.

Figure 17. Bank 1 on the East Gallatin River bank restoration project, viewed from downstream.

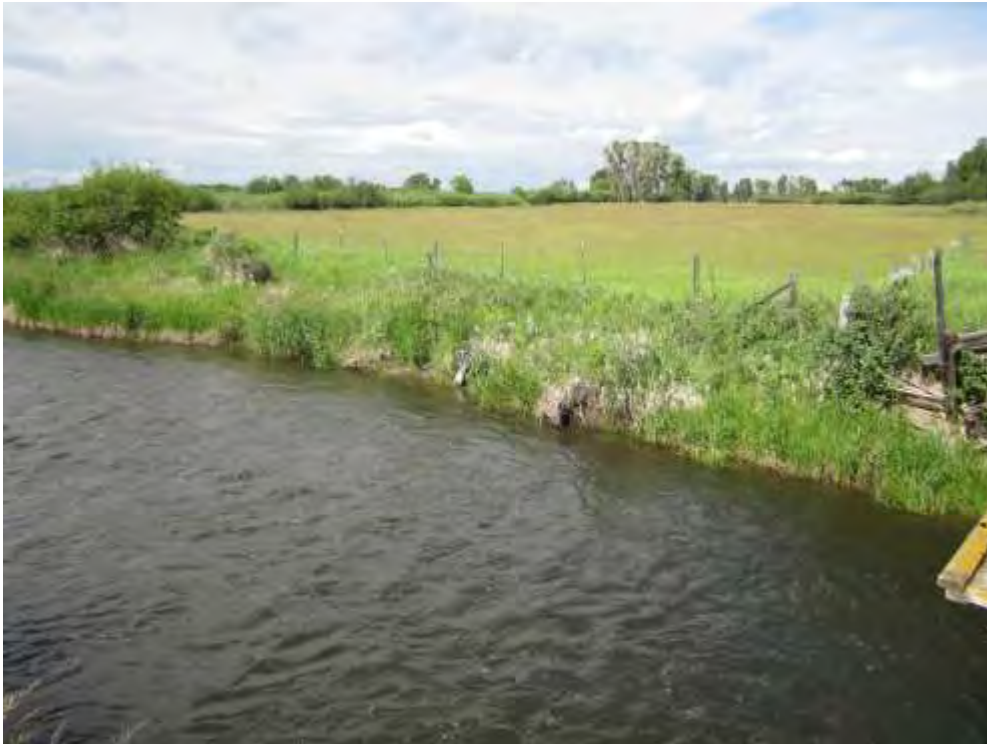
The second bank was treated with soil lifts encapsulated with erosion control fabric, revegetated, and cobbles large enough to be mobilized by a 50-year recurrence interval flood were placed at the toe of the bank. This treatment resulted in conditions like the first bank, with a bank angle of 90°, banks stabilized with grasses and sedges. The erosion control fabric decomposed with establishment of vegetation, and according to the landowner, the fabric has not been visible in years (Figure 19). Like the first bank, the rock toe had been transported away, resulting in an undercut bank.

Figure 19. Bank 2 on the East Gallatin River restoration project.

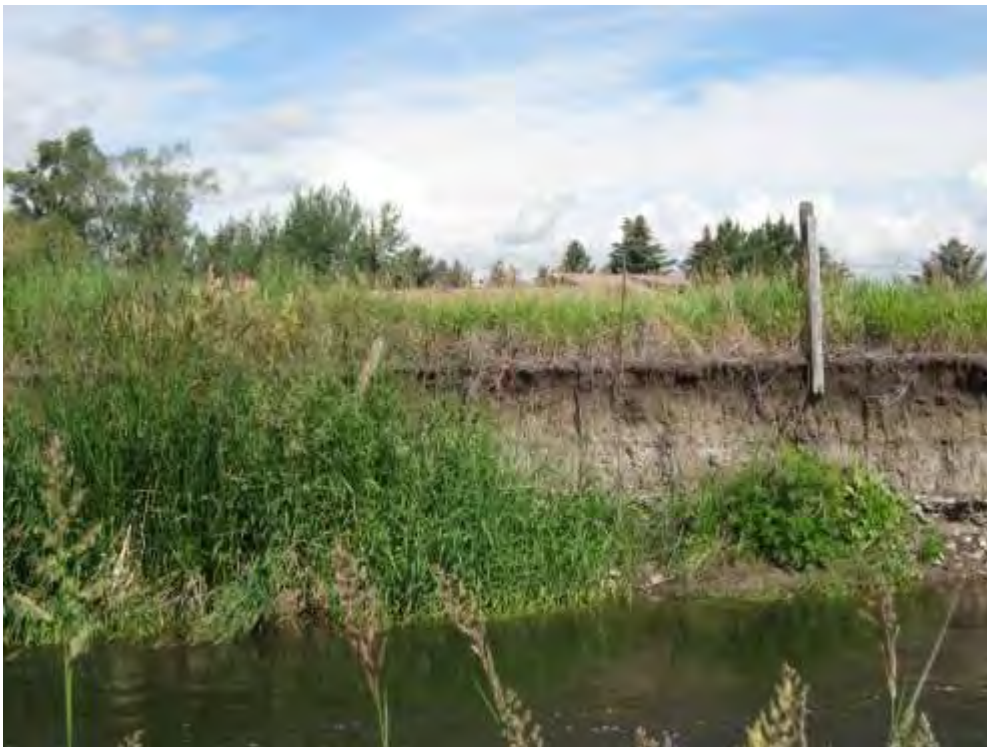
Figure 21. Vertical exposed stream bank and evidence of lateral movement, as indicated by the hanging fence post.

Despite the failure of bank 3 to remain stable, this project was a suitable use of FFIP funds. The project demonstrated softer approaches to bank restoration can be effective and showed revetments to be a practice with considerable potential to fail. FFIP monitoring in 2016 found similar results for cottonwood revetments installed in the Shields River.

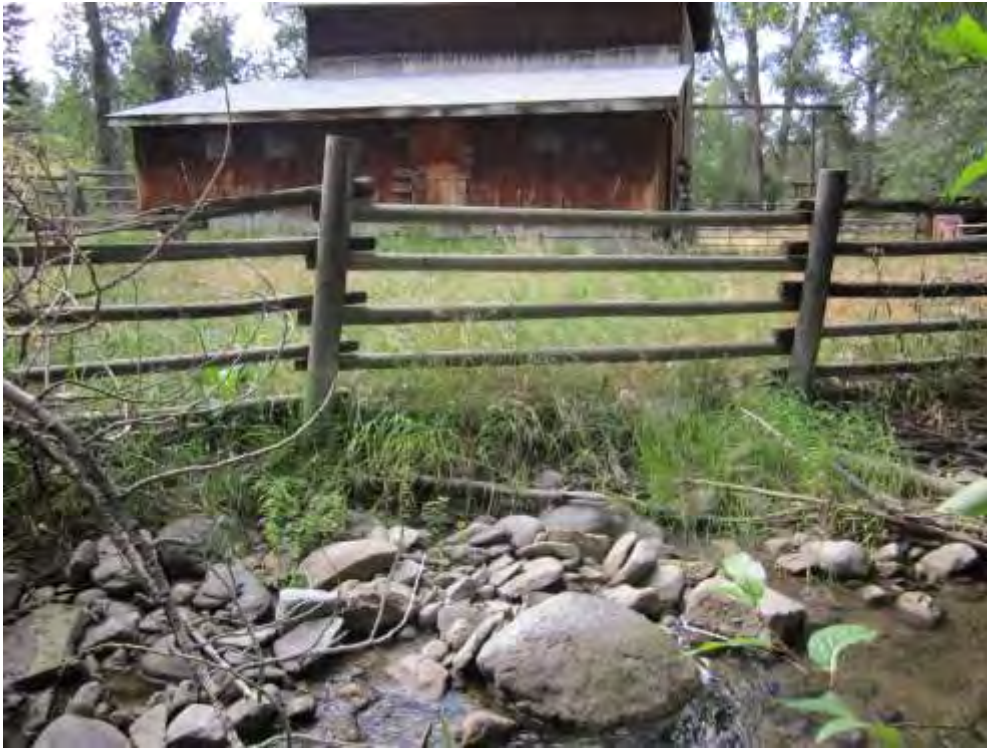
On August 16, 2017, Kyrsten Wolterstorff visited the Elk Spring Creek bypass project. She noted that fencing to protect Elk Creek had been installed, and although in slight disrepair, it was functioning to control livestock's access to the stream channel (Figure 23). The riparian area supported abundant shrubs, and all age classes of shrubs were present. This area appears to be the 50-ft. buffer between the

Figure 23. Riparian fencing limiting livestock access to Elk Creek and the buffer strip between the corrals and surface water.

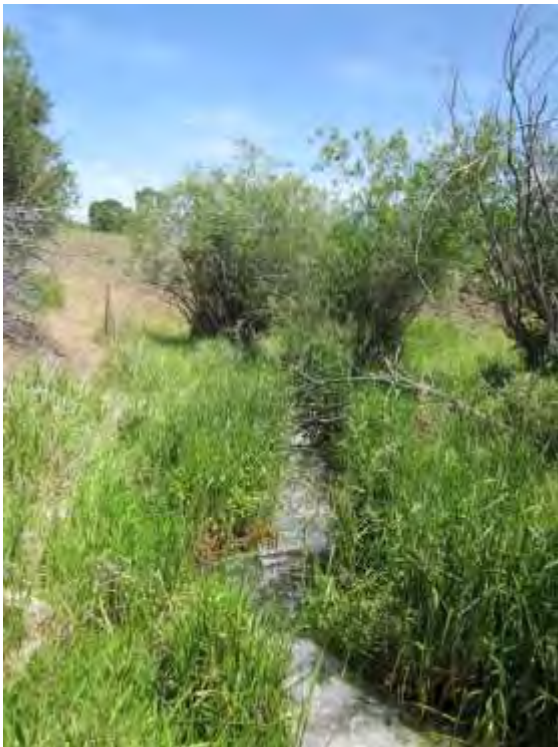
Figure 30. North Fork Fridley Creek downstream of siphon under Park Branch Canal.

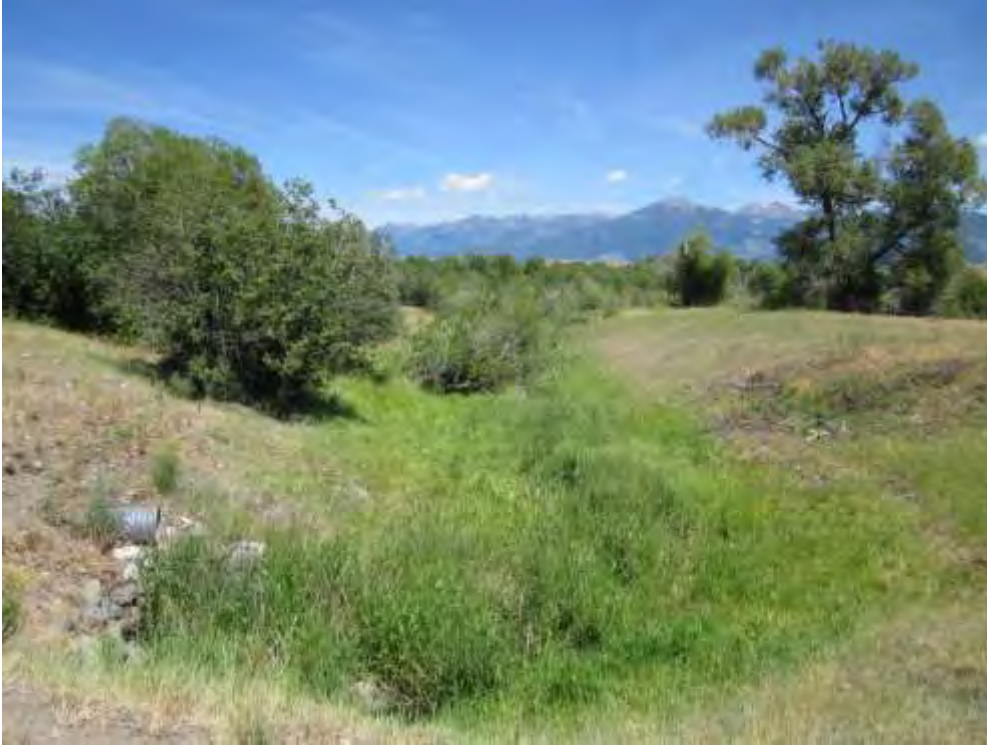
Figure 31. North Fork Fridley Creek emerging from downstream end of siphon under Park Branch Canal.

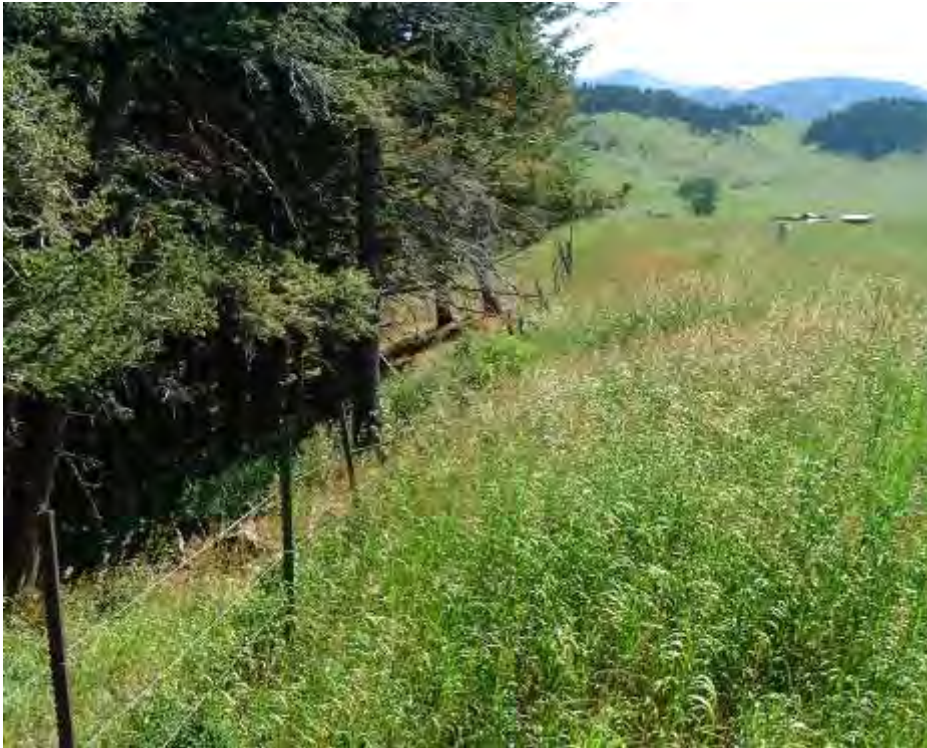
Figure 36. Fence at top of bench in need of repair.

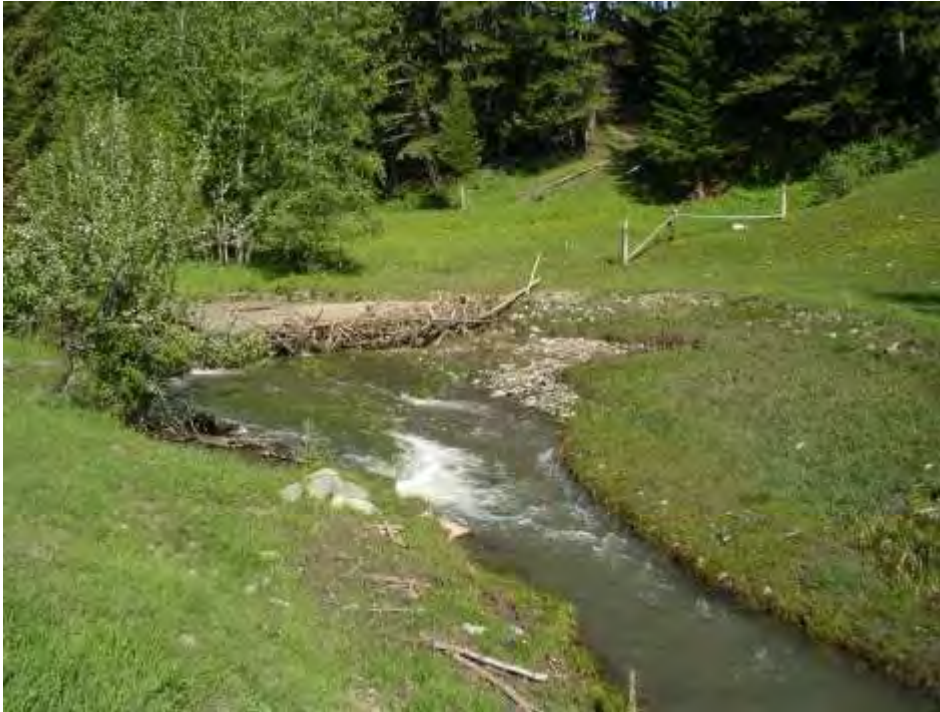
Figure 37. Evidence of incompatible livestock grazing on North Fork Horse Creek.

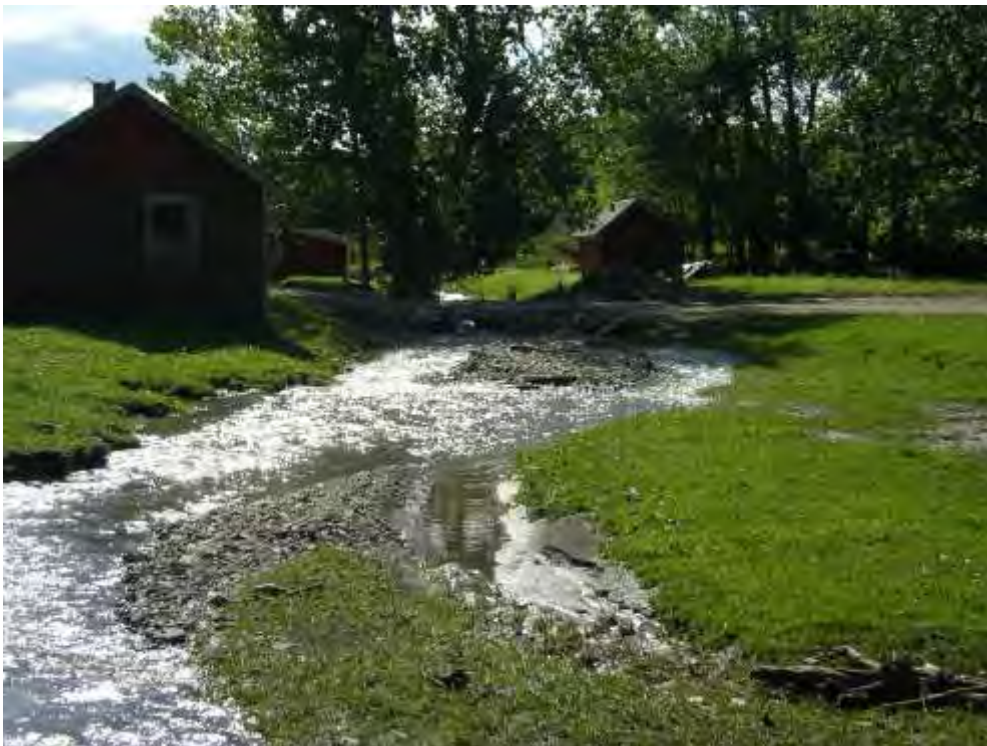
Figure 38. Degraded stream habitat

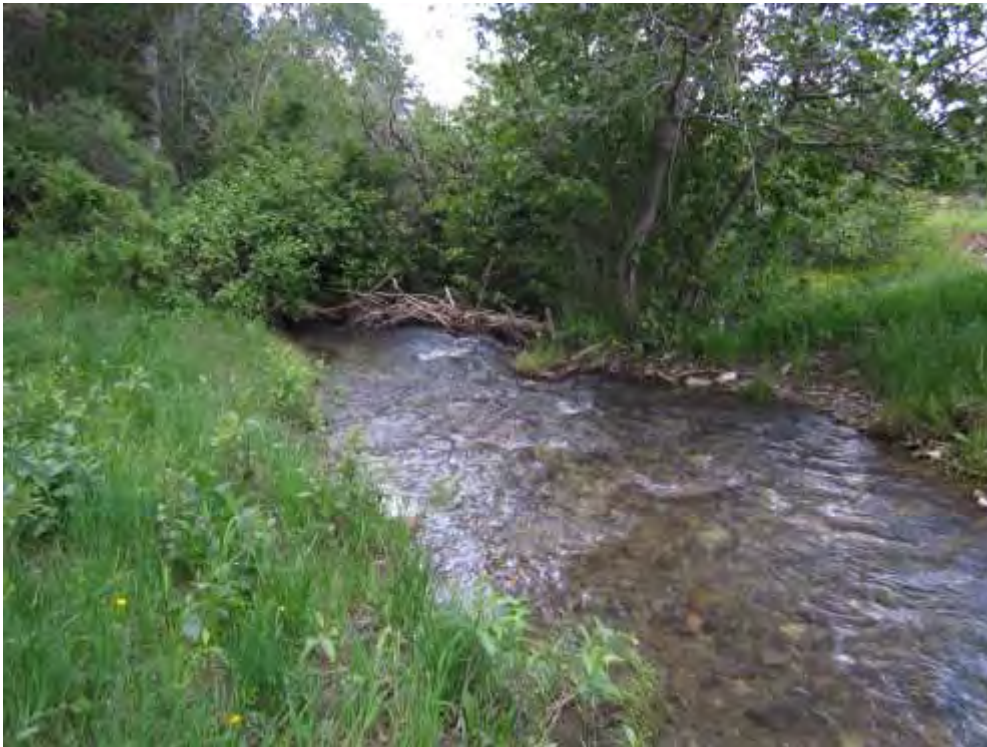
North Fork Horse Creek apparently benefited from reduced disturbance from livestock accessing the stream from the bench. The stream was a healthy foothills stream with a gravel streambed, stable banks, and a robust riparian area vegetated with sedges, forbs, and dense shrubs (Figure 42). The opposite bank is under different ownership, and the residence is relatively close to the stream. This residential reach lacked a dense shrub community; however, herbaceous vegetation maintained bank stability, and the stream channel was stable. The conditions on the cross-stream neighbor's property had improved with implementation of the project.

Figure 42. Typical view of North Fork Horse Creek in reach protected by fence installed on the bench.

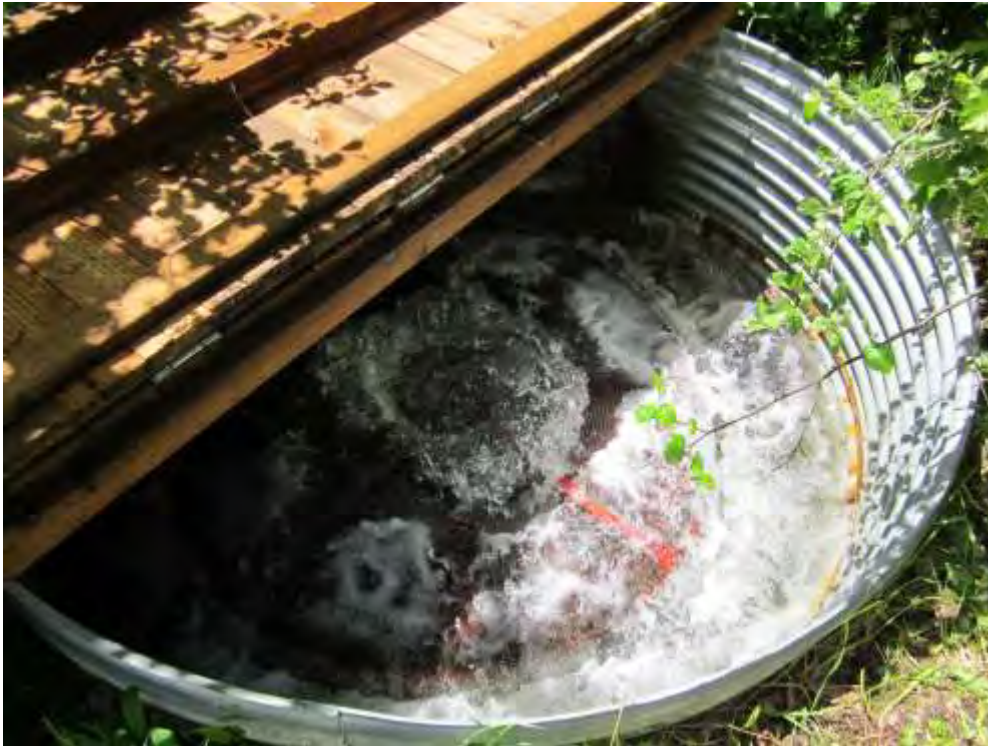
On June 22, 2017, Kyrsten Wolterstorff and Carol Endicott checked on the function of the screen. The turbulence was substantial and appeared to be sufficient to move detritus and fish off the screen (Figure 51). A substantial amount of water flowed through the bypass pipe (Figure 52). The check boards were in place and were likely a temporary barrier to fish movement (Figure 53).

Figure 51. Turbulent fountain screen on North Fork Horse Creek in use.

Recommendations for this project, along with the complementary actions of water savings and riparian fencing, address the opportunity to evaluate the response of the Yellowstone Cutthroat Trout population in North Fork Horse Creek to the cumulation of conservation actions. A follow-up fish survey would be informative. Likewise, installing a trap at the out flow of the bypass pipe on the fish screen would be useful in evaluating if fish are being bypassed, and if the screen causes injury.

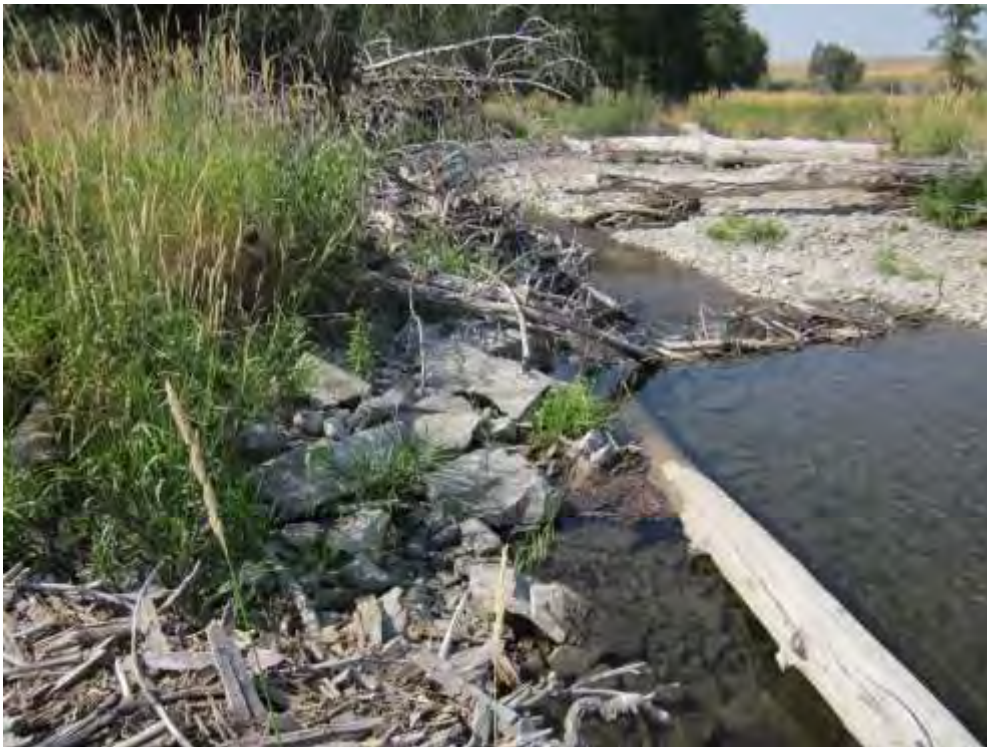
On August 22, 2017, Kyrsten Wolterstorff and Carol Endicott visited the project site. As noted, determining the bank that had been treated was problematic. A portion of the bank considered most likely to be the treated bank supported a community of nonnative grasses and Canada thistle (Figure 65). A cobble toe was present, as opposed to the raw dirt that was present before treatment. Nevertheless, the bank had receded several feet. Large woody debris had been deposited at the site and was providing bank protection. More aggressive efforts at bank stabilization were apparent with riprap being present at the downstream end of the bank (Figure 66).

Figure 66. Bank armoring and large woody debris.

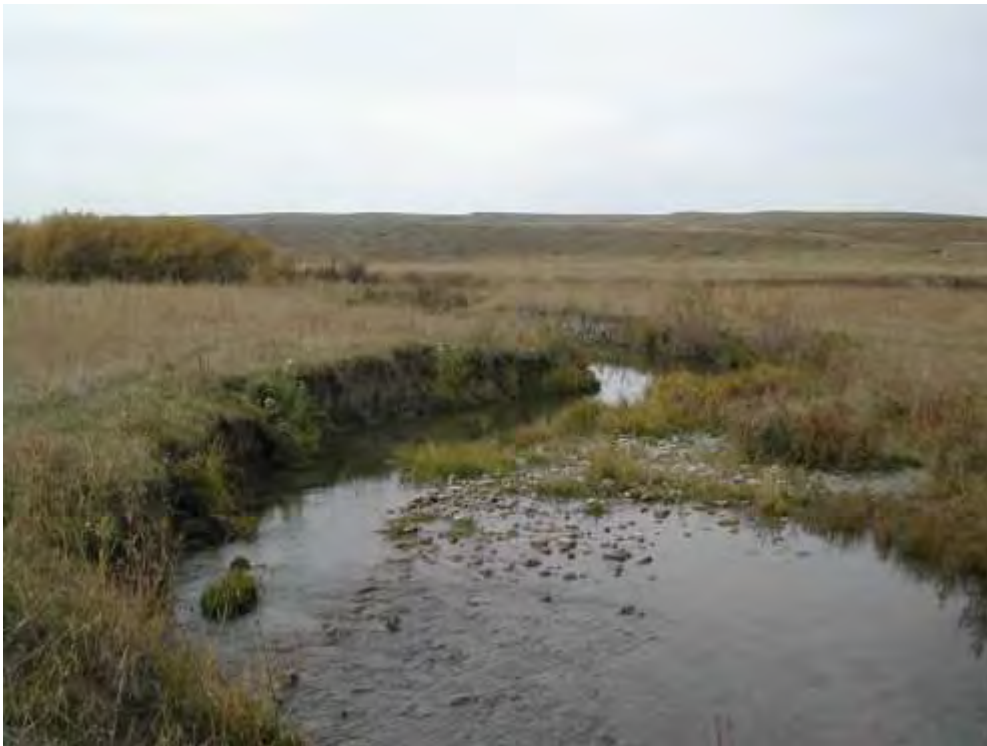
Figure 72. Overly wide channel, bank erosion, and riparian degradation on Elk Creek 2002.

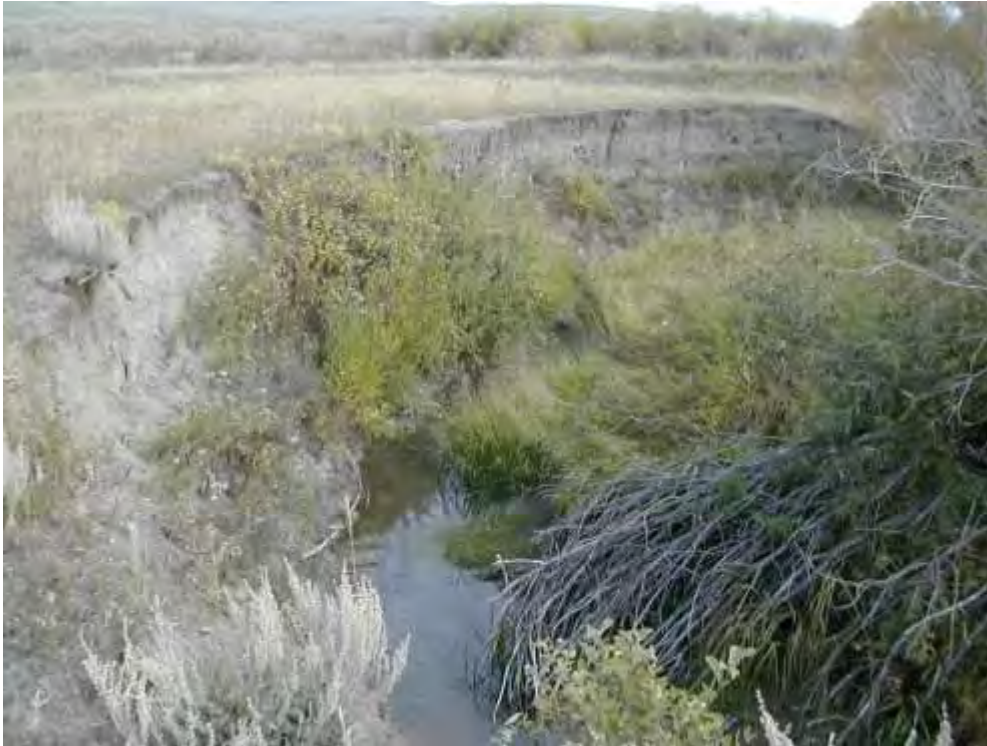
Figure 73. Channel downcutting on Elk Creek in 2002.

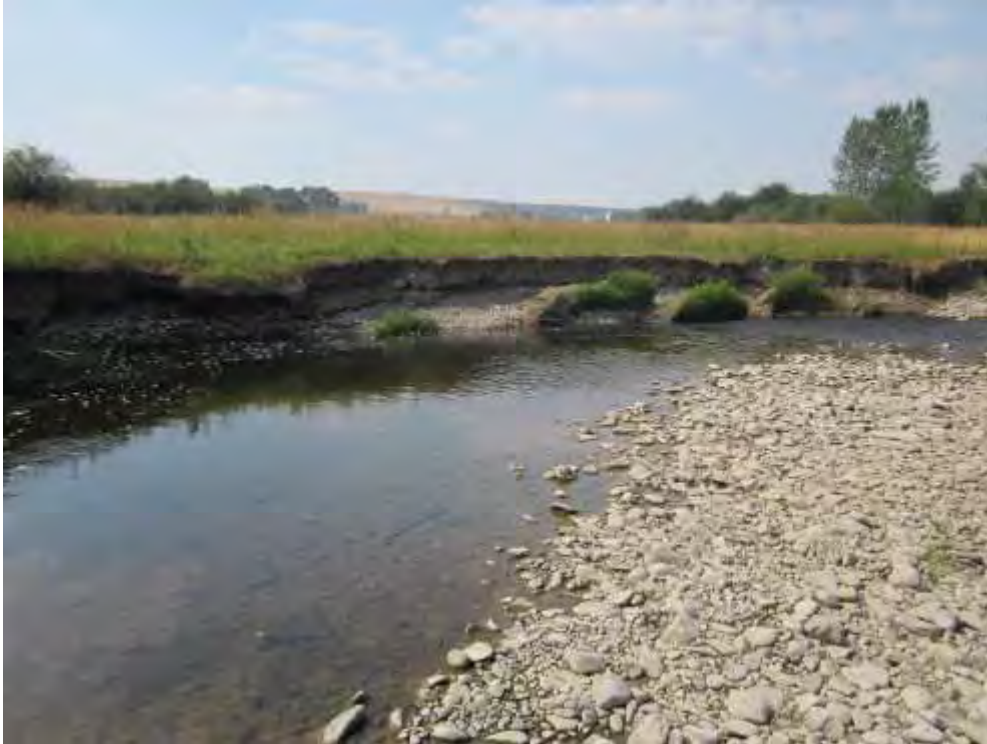
Figure 80. Hay pasture on west bank of river and bank erosion.

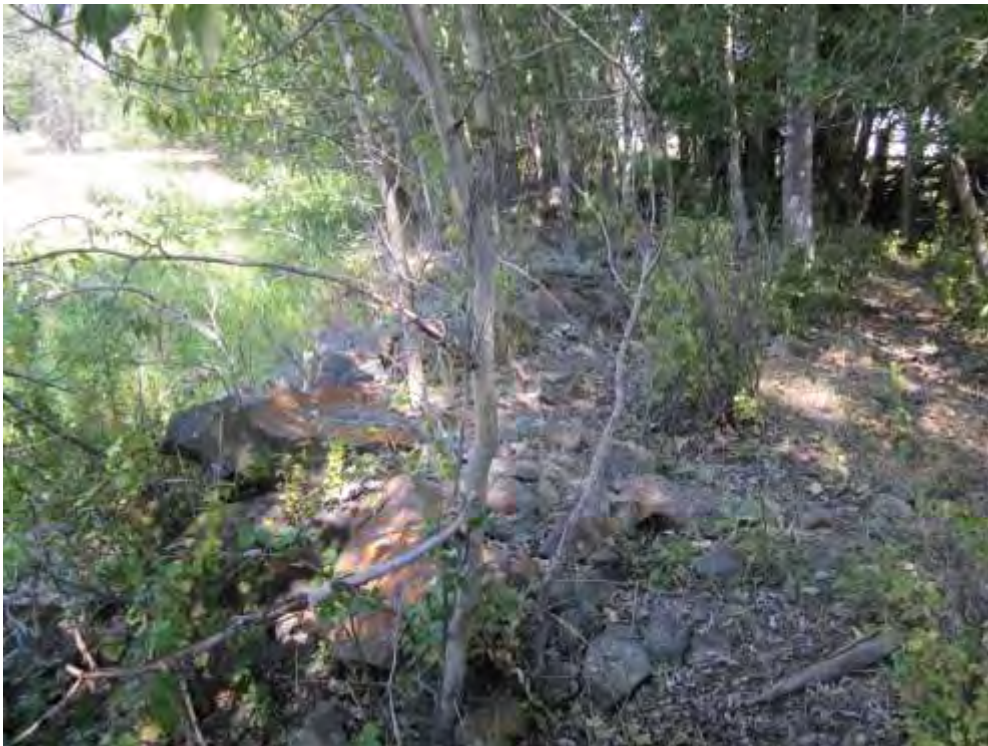
Figure 83. Old riprap that was no longer near the channel.

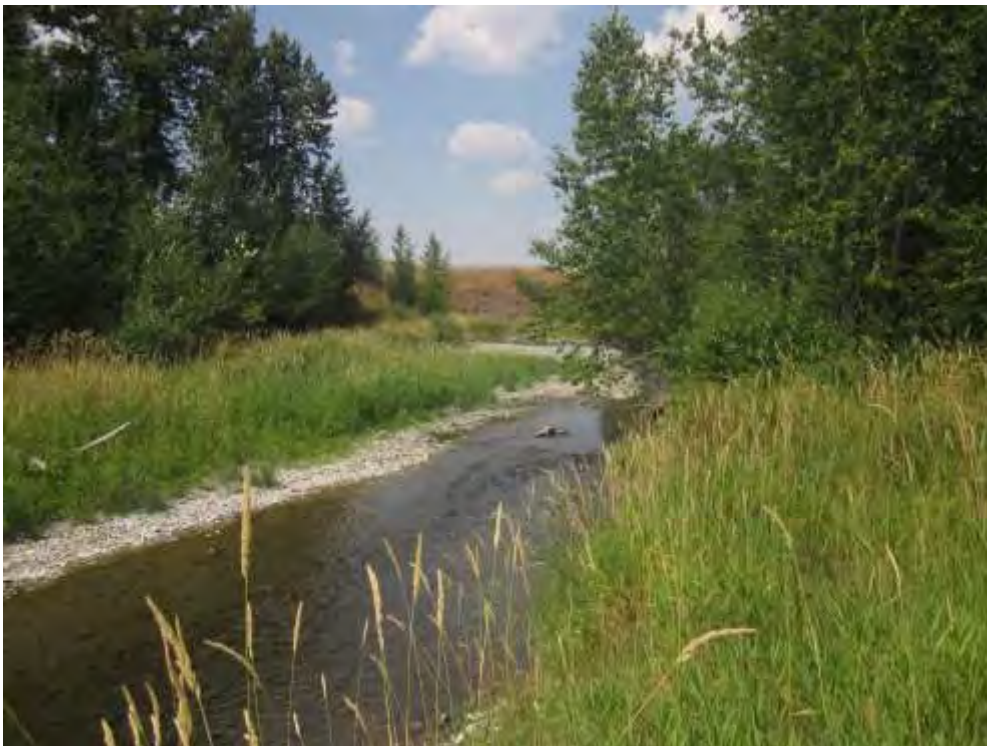
Figure 87. Infestation of reed canary grass on property 3.

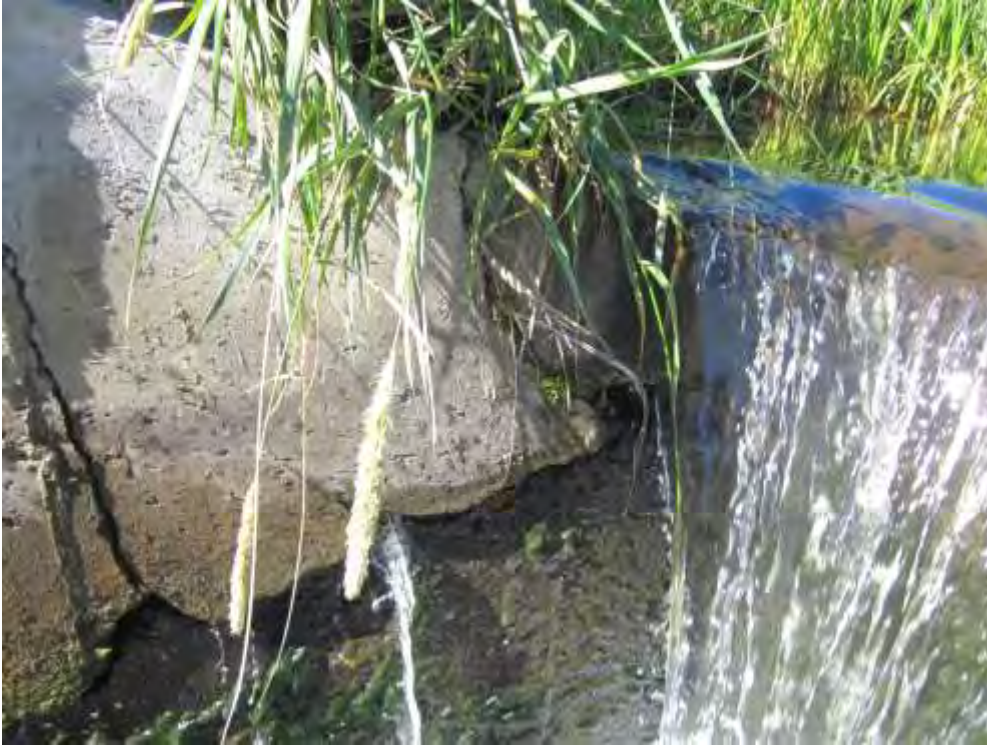
Figure 104. Crumbling concrete on right side of barrier.

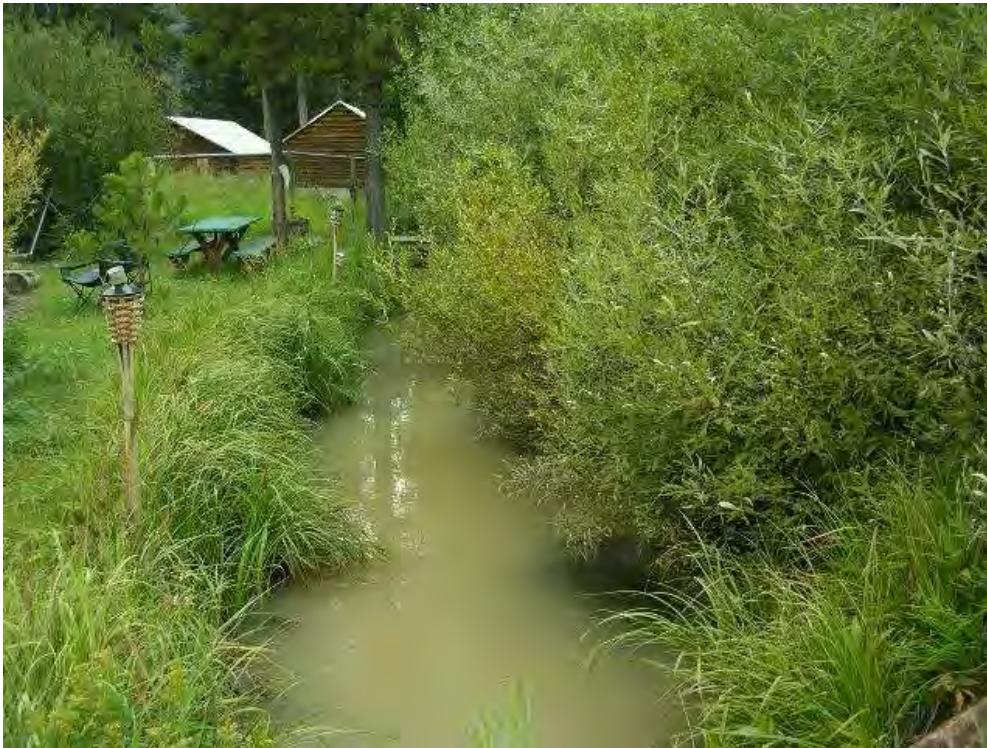
Figure 110. View of Willow Creek showing the overly wide configuration typical of much of the channel.
