FFIP PROJECT & LAND USE MONITORING FORM

Project #:	004-08	Project Title:	Cottonwood Creek Irrigation Diversion
Date:	8/23/2017	Evaluator:	Kyrsten Wolterstorff
Waterbody Name:	Cottonwood Creek	Project Type:	Irrigation Diversion

Cottonwood Creek Diversion Replacement (004-08)

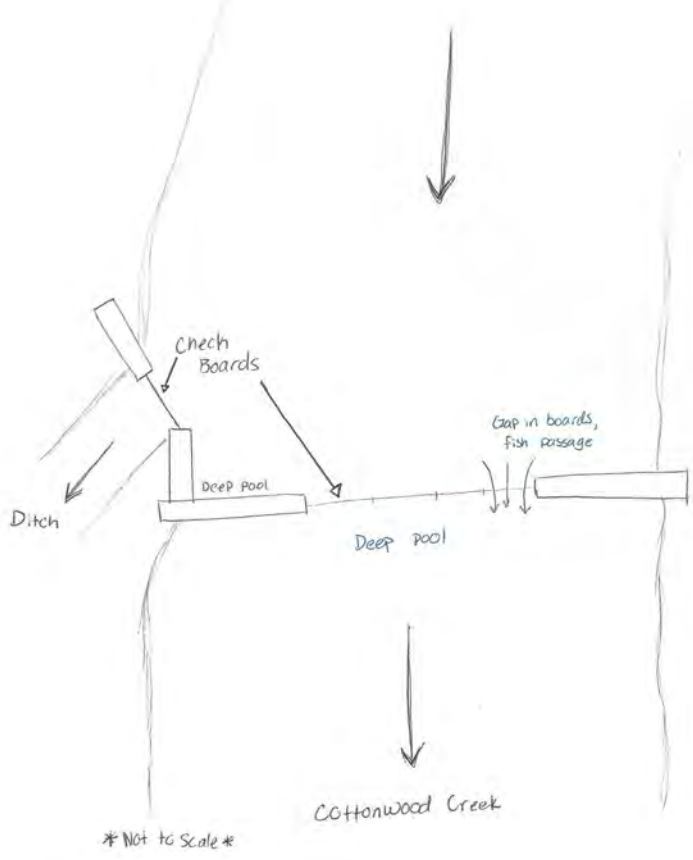
Sketch of diversion/dam structure

Deep pools formed below diversion and above on west side (see project sketch).
 Moderate/heavy sedimentation, does not impede function of diversion or fish ladder.
 Diversion and ladder appear to be in good, working condition with the exception of some leakage into the ditch when check boards are in place (2-5 inches of water throughout ditch). Although it is mostly functional, this is not what the application described.
 No fish seen in ditch

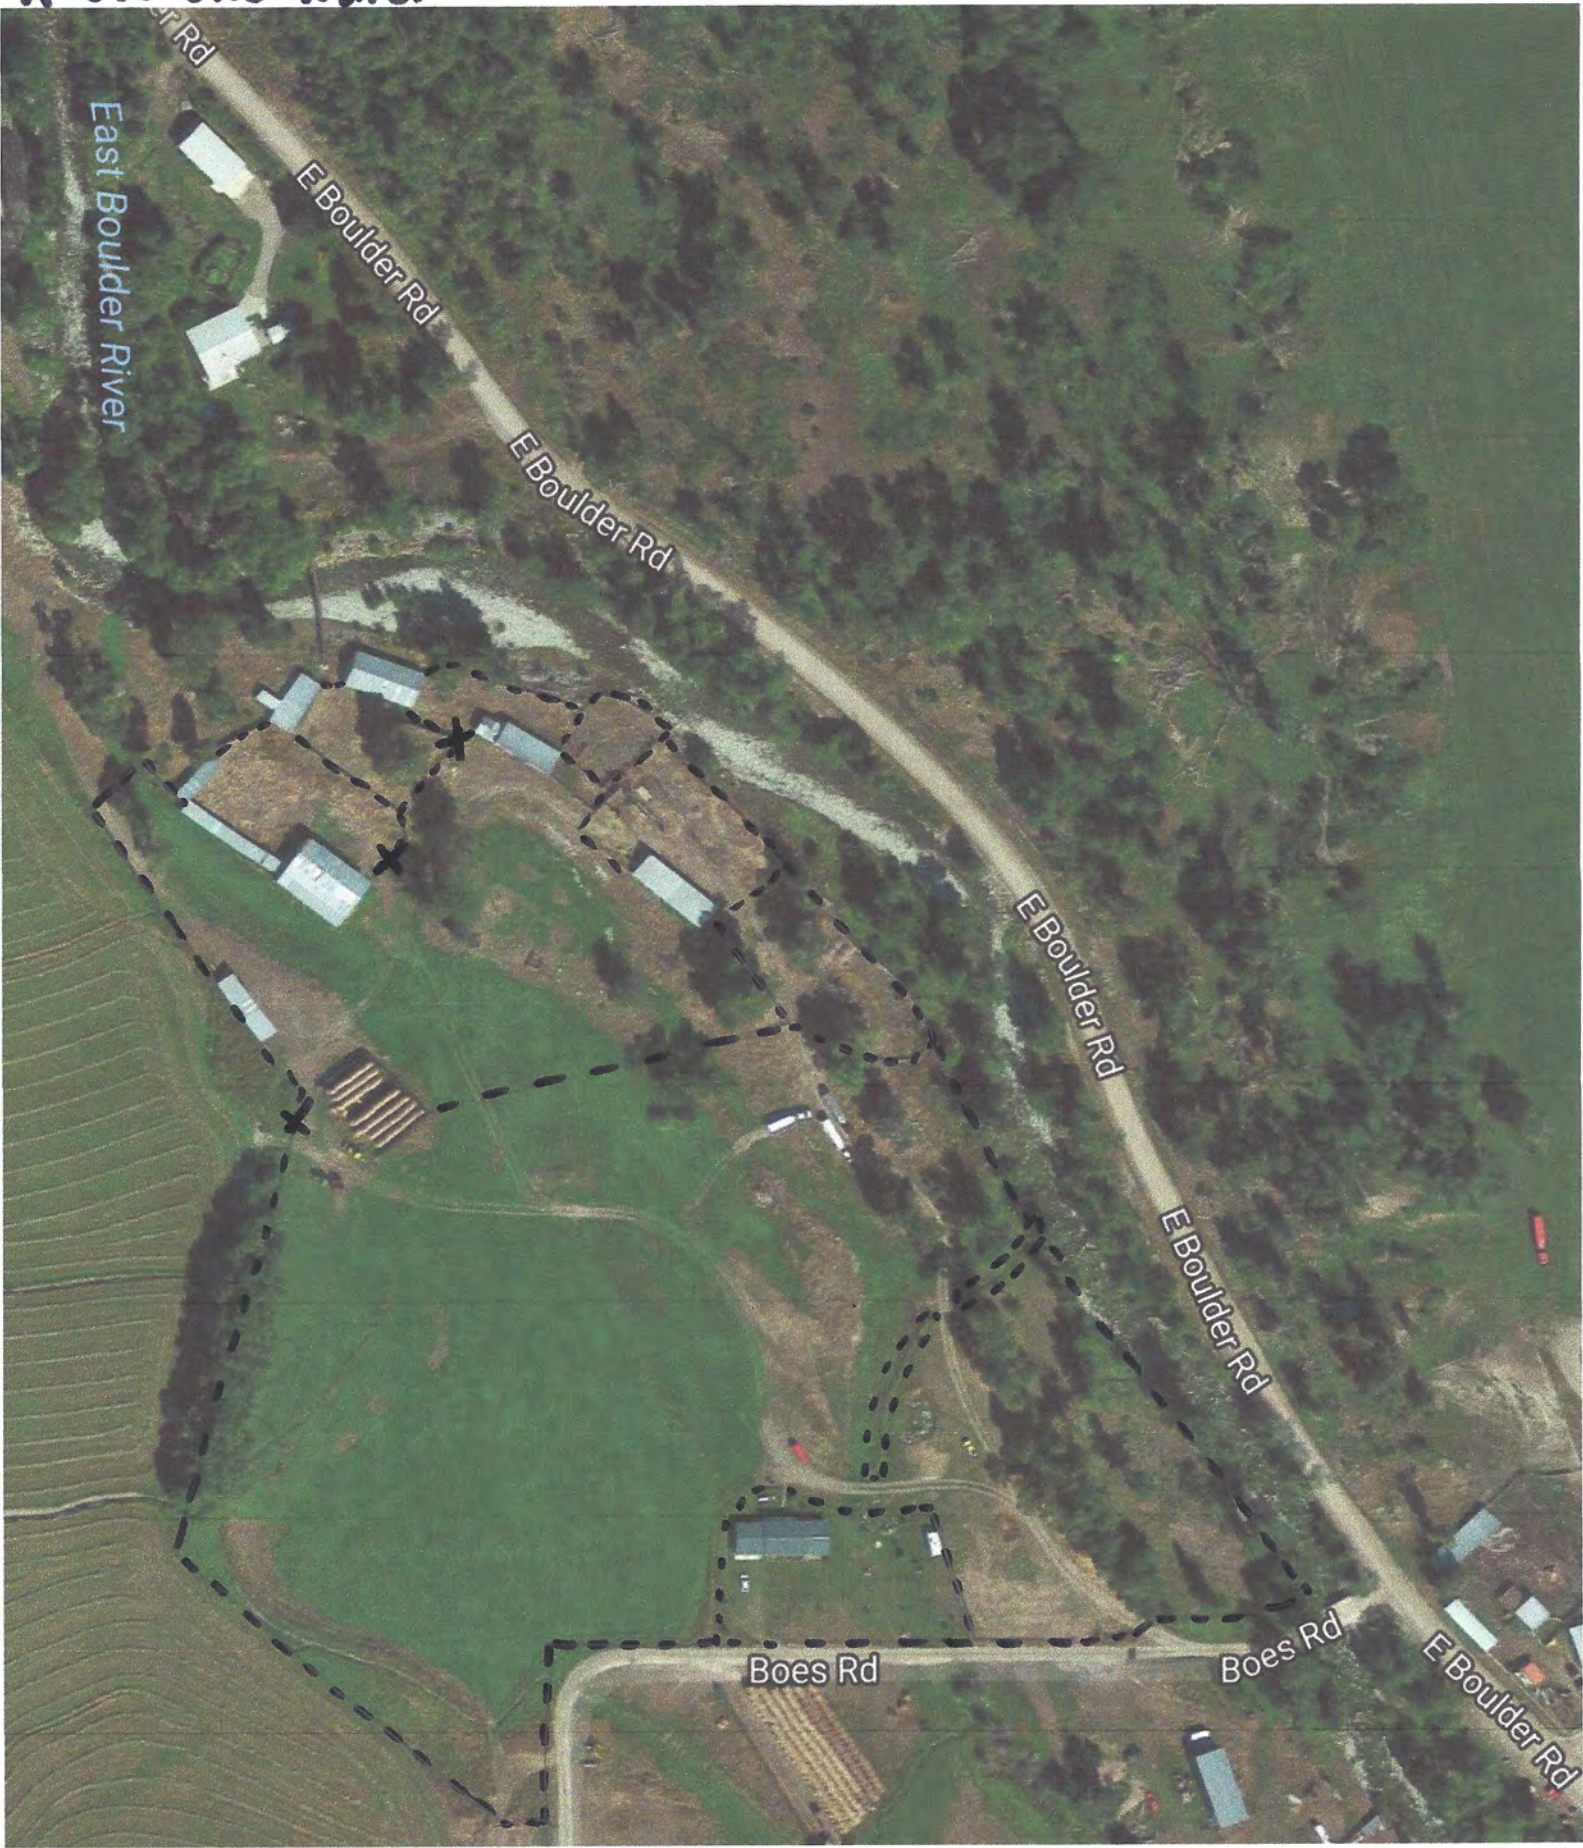
X = off-site water - - - = Fence

Cattle have no access to creek.
 Not much riparian shrub recruitment, but the few that are present appear to be healthy and with no grazing.
 Off-site livestock waterers had no water at the time of visit, but there were no cattle on the property. They appear to be in good condition.
 Old creek channel still very green and some standing water/mud behind barn, no flowing water though.

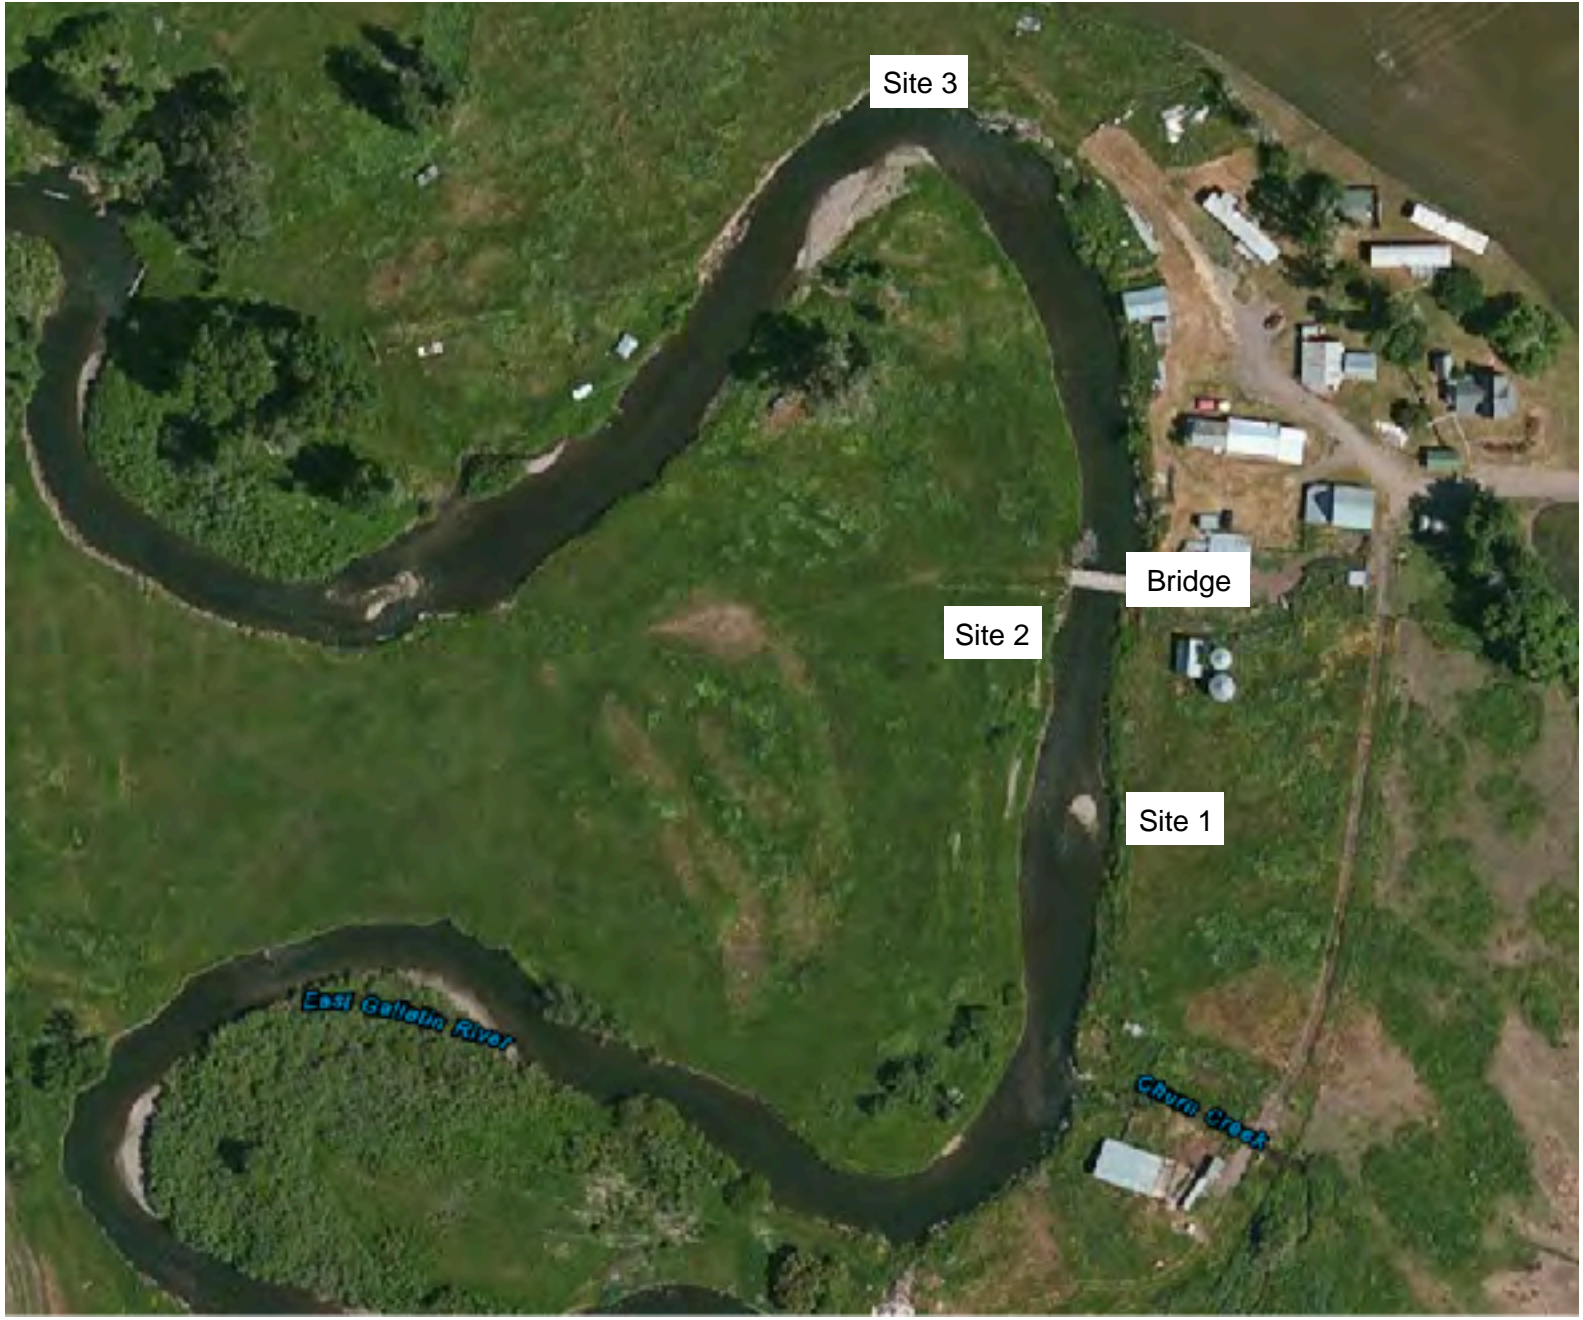
Reed canary grass and leafy spurge present along banks and in pasture. Few willows and dogwoods present
 Banks still steep with a 10+ inch 90 degree drop off to water level at sites 1 and 2. Banks stable until drop off, then slightly undercut. Owner says she is unsure if they were ever re-sloped as described in plans.
 Owner reports erosion mats were installed at sites 1 and 2, but plants have taken root now and they are no longer visible
 Cottonwoods at site 3 have mostly washed away, cannot tell if straw bales were ever attached as planned. Banks about 5 feet tall and undercut.
 Rock bar at site 1 has reformed

Has this project been beneficial to you?	Sites 1 and 2 yes. Site 3 no, lose ground every year even in low water.
Has project improved stream/riparian conditions?	yes
Effects on land use?	Bank at site 3 still erodes badly, fences need moved back
Weeds?	N/A
Noticable change in fishery?	N/A
Thoughts for future work?	N/A

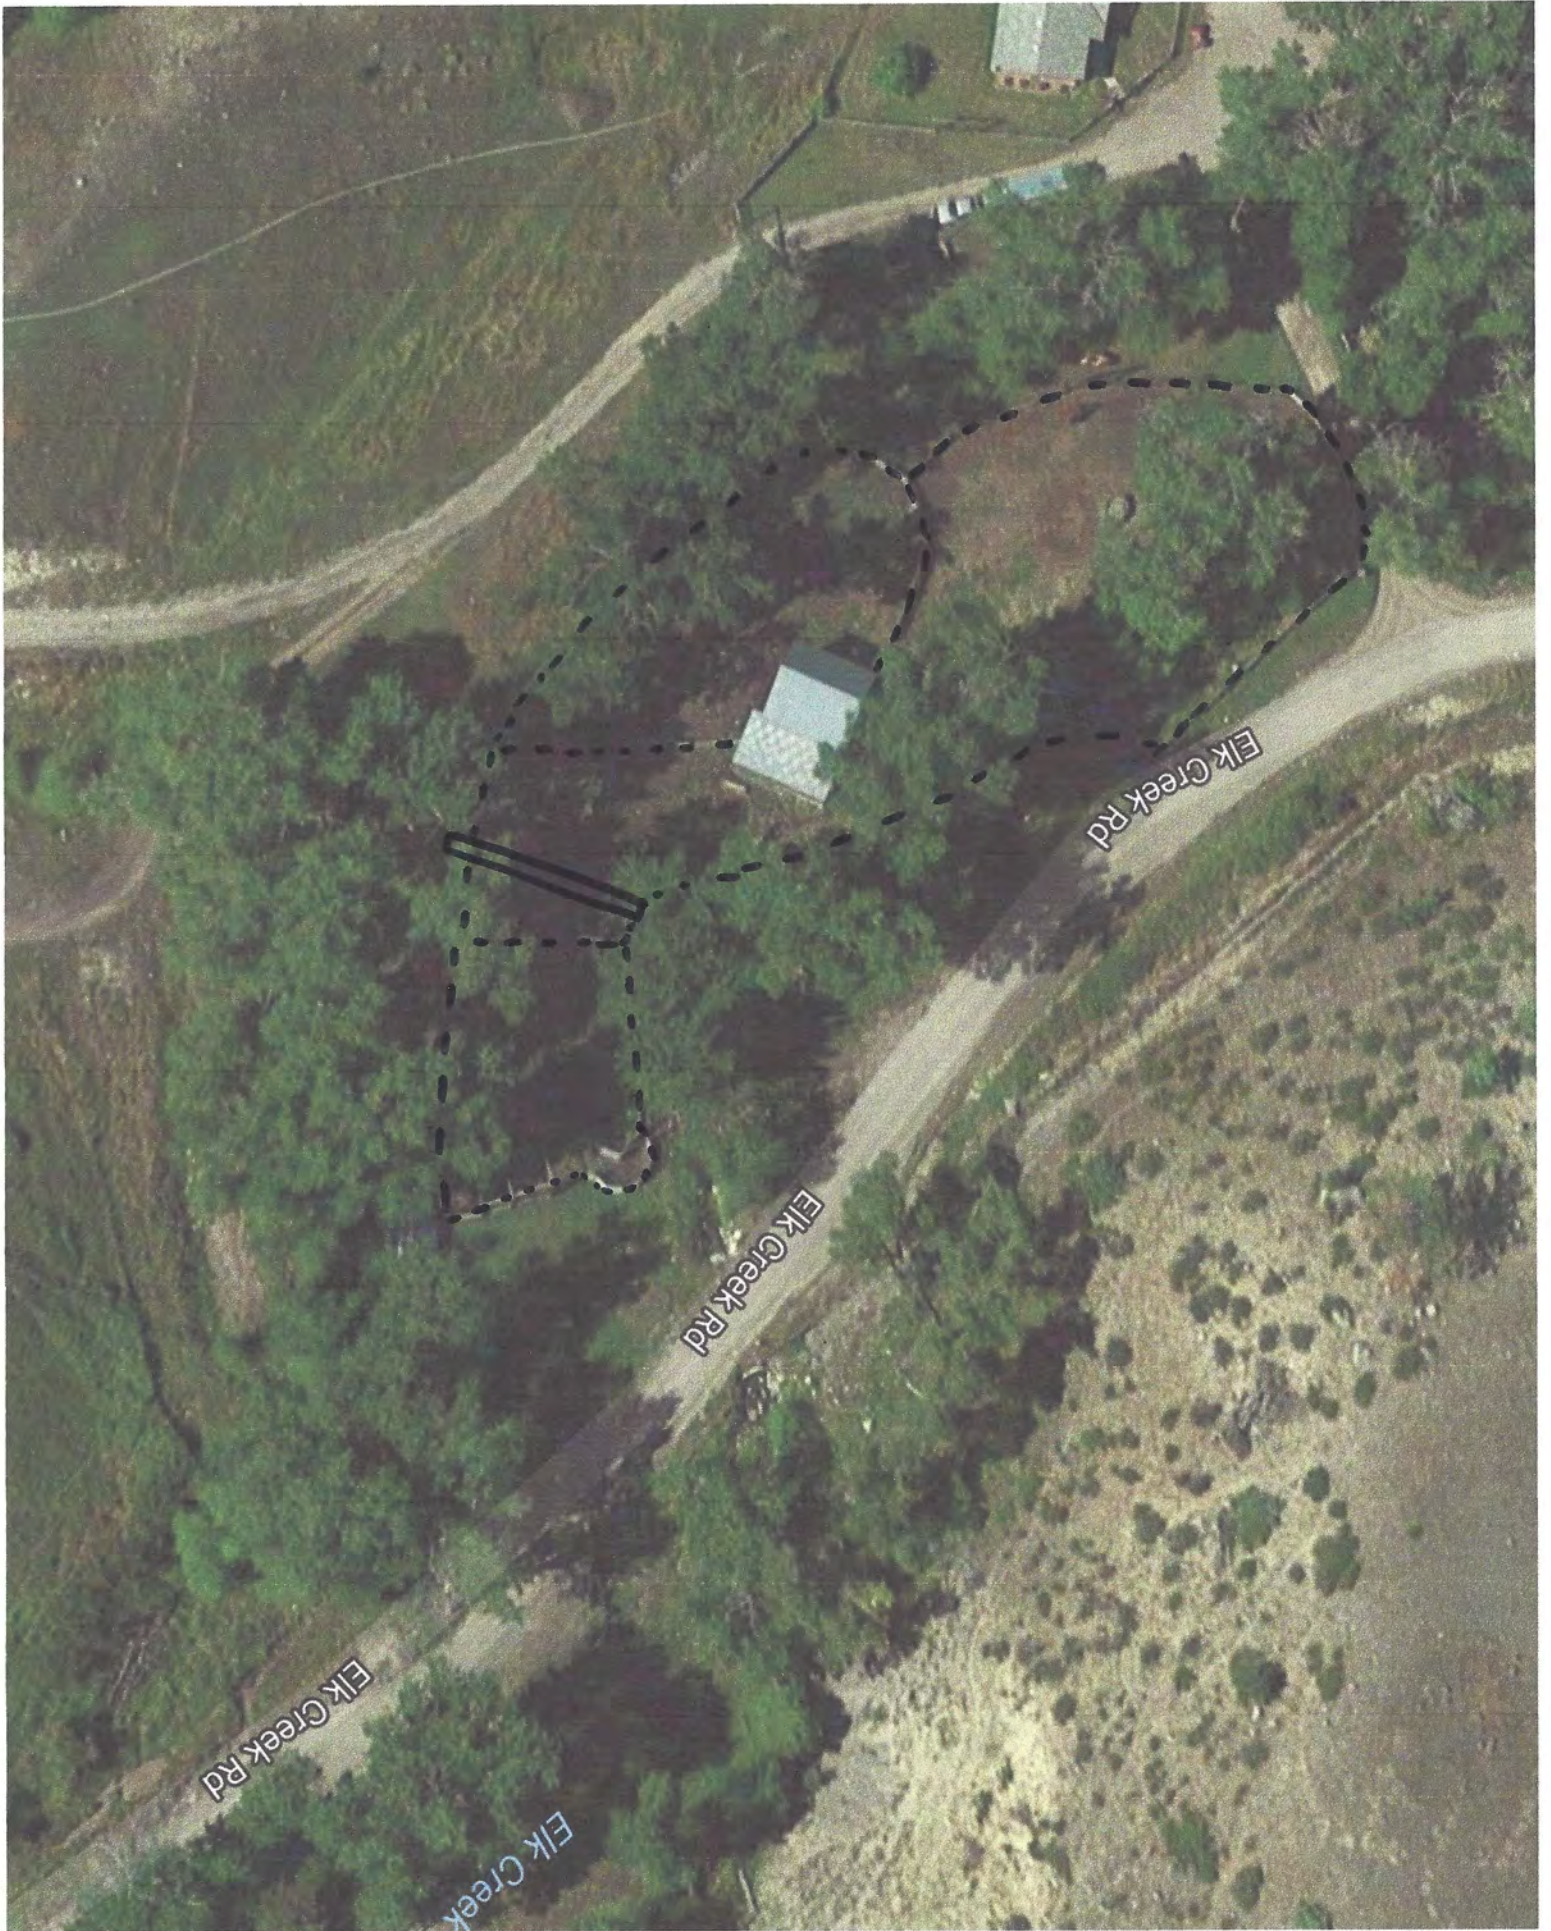
Water flows through pipe under corral. No runoff through corrals.
 Some trees/shrubs in front of pipe ends, but does not impede flows in any way.
 No cattle access to creeks from corrals. Fences within corral in slight disrepair, but nothing so bad livestock could access creeks.
 Automatic stock waterer had water in it. Ranch hand says it occasionally plugs up, but we think there may be something stuck in the drain pipe. This did not seem to be of much importance and could probably be remedied with routine maintenance.

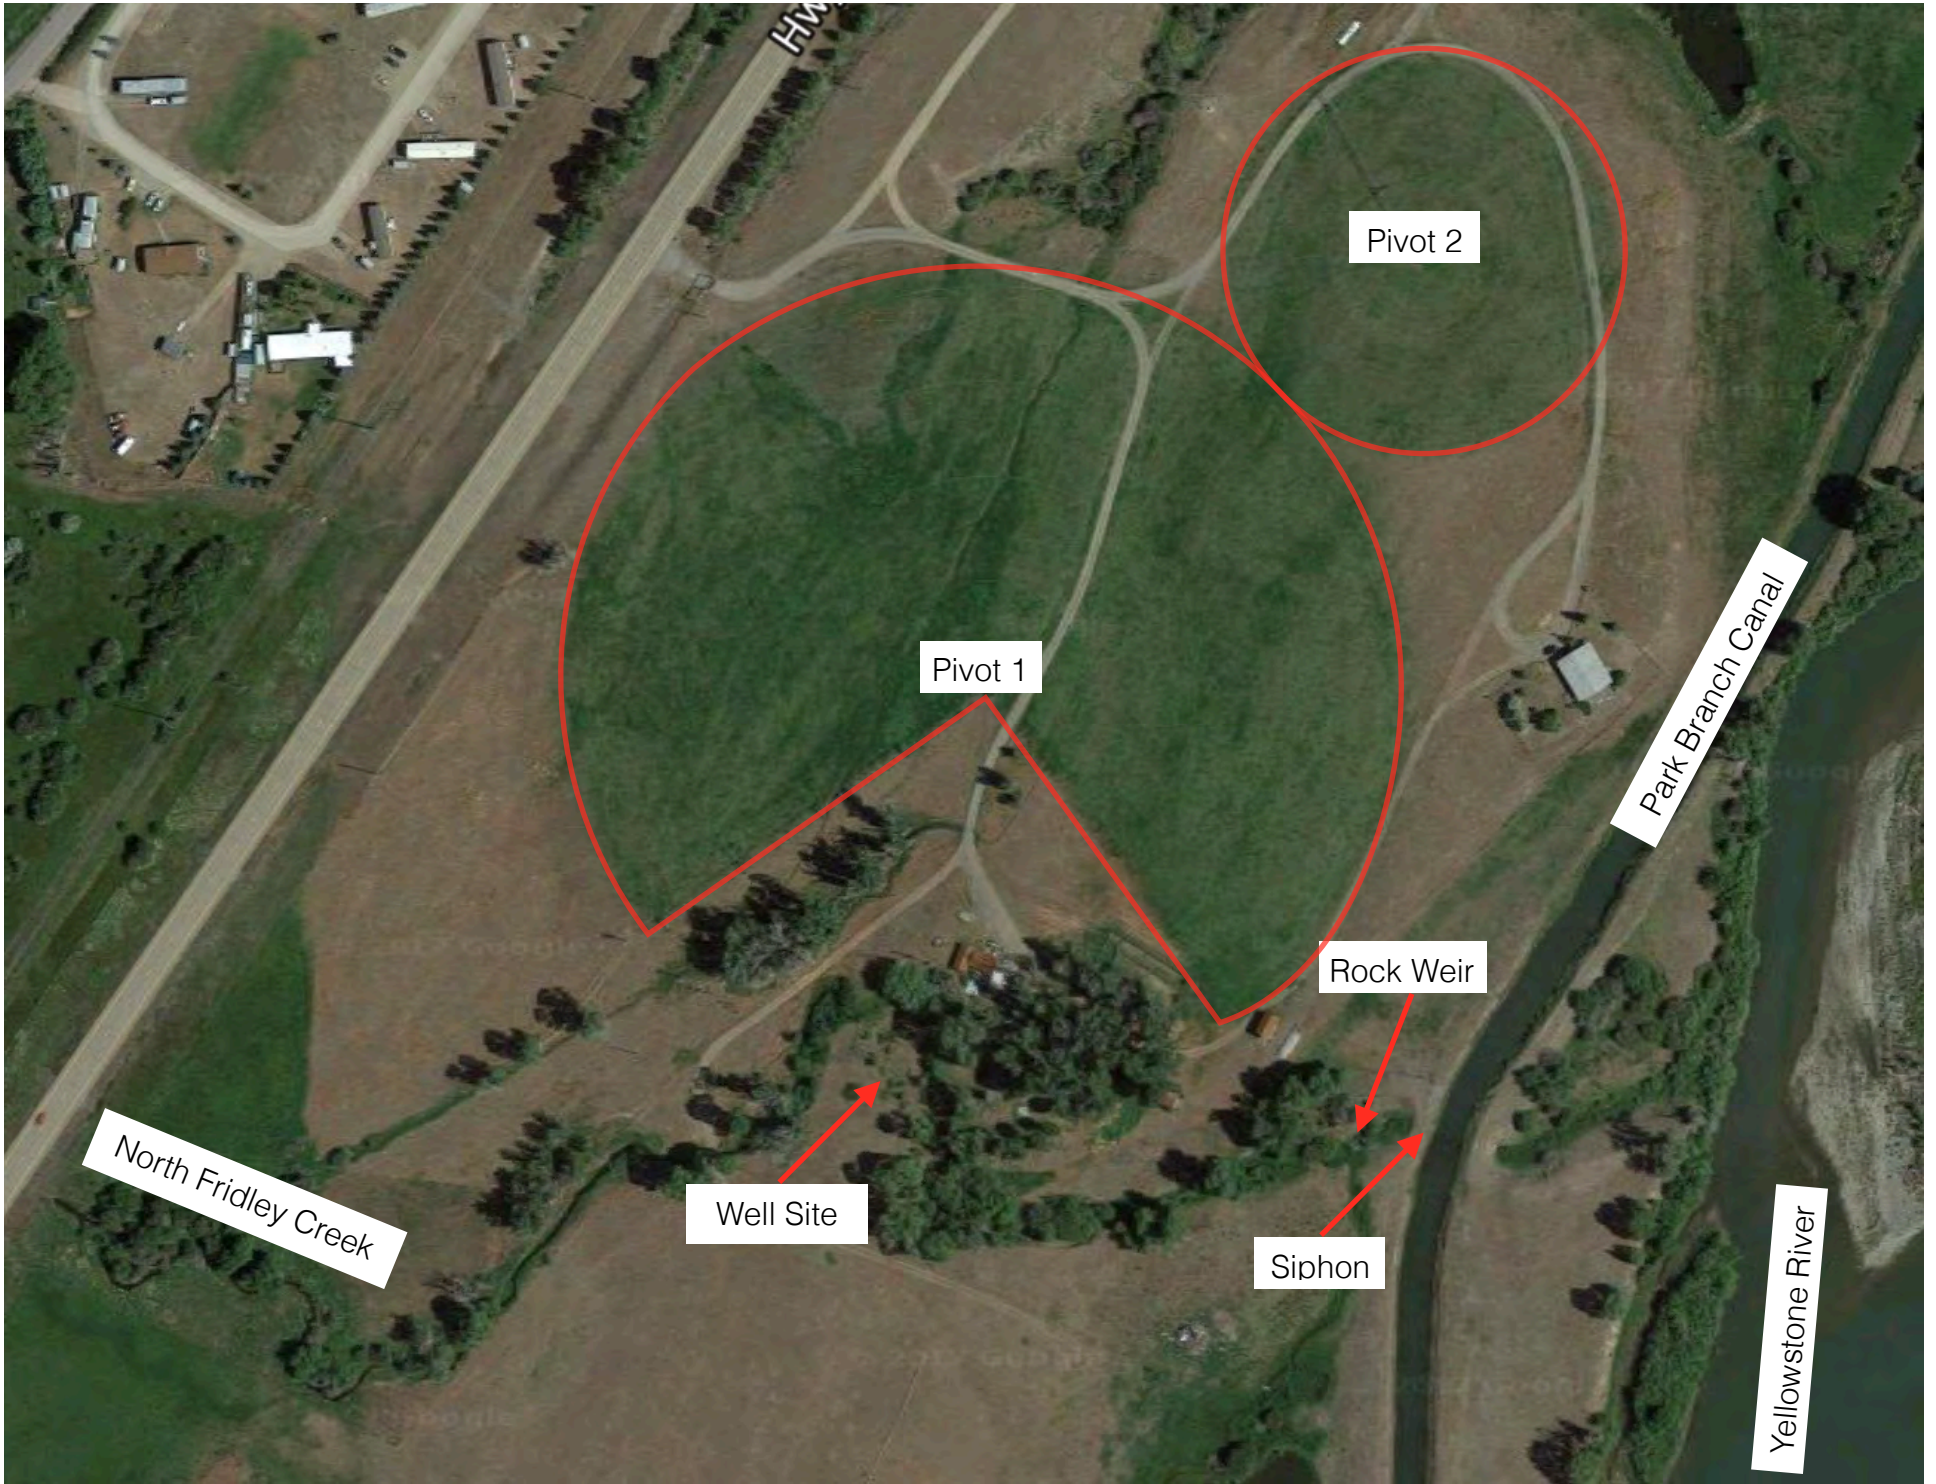
Rock Weir

Hotwire fence installed to keep cattle out, but they still have access. Hoof prints and feces present.
 Abundant cottonwood trees, alder trees, range grasses, and some willows
 Stream bed a mix of silt and gravel of all clasts, majority silt
 Area above bridge and below culvert mostly unshaded and banked by range grasses and scattered trees, area in middle densely wooded.
 No fish seen. 3 redds seen 7/24
