FFIP PROJECT & LAND USE MONITORING FORM

Project #:	016-01	Project Title:	Shields River
Date:	8/22/2017	Evaluator:	Carol Endicott, Kyrsten Wolterstorff
Waterbody Name:	Shields River	Project Type:	Bank Stabilization

Project #:	047-03	Project Title:	South Fork Fridley fish ladder
Date:		Evaluator:	Carol Endicott, Kyrsten Wolterstorff
Waterbody Name:	Shields River	Project Type:	Passage

Project #:	018-07	Project Title:	SF Ross Cr habitat and wetland enhancement
Date:	8/4/2017	Evaluator:	Kyrsten Wolterstorff
Waterbody Name:	South Fork Ross Creek	Project Type:	Channel Reconstruction

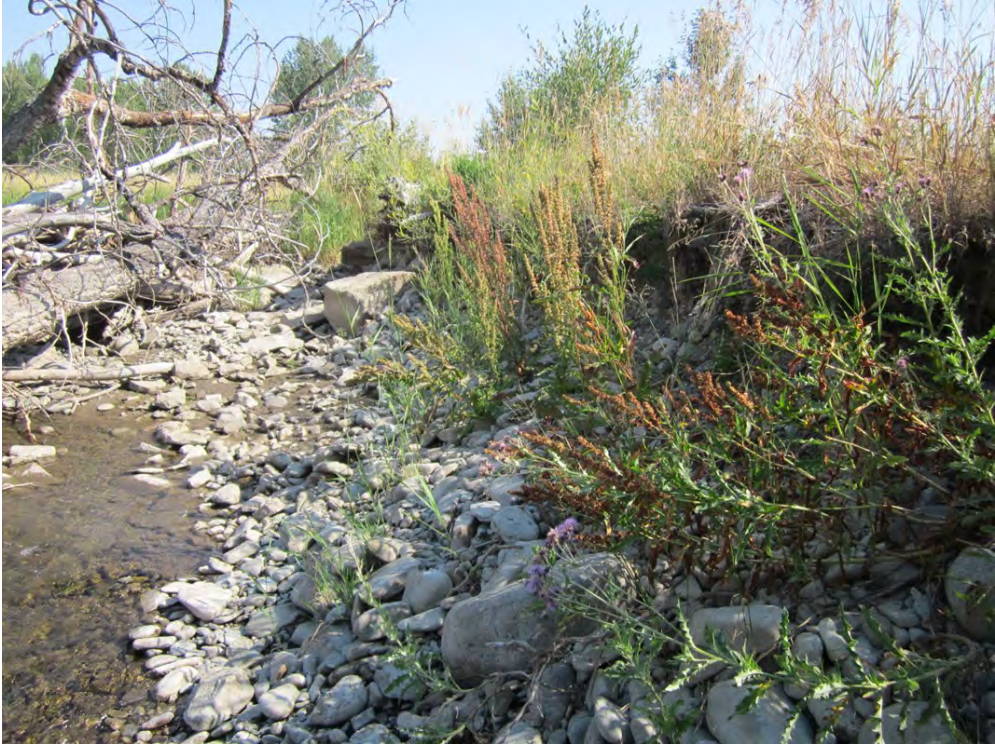
Figure 1

Frame #	Lat	Long	Facing?	Scene description/Previous Photo
1	46.06894	-110.63403	North	Debris, looking upstream towards project area
2	46.06894	-110.63403	South	Debris, looking downstream
3	46.06894	-110.63403	Northwest	Looking upstream towards moose on project site
4	46.06894	-110.63403	Northwest	Close up of moose on project site
5	46.06897	-110.63403	South	Looking downstream
6	46.06897	-110.63403	South	Riprap
7	46.06879	-110.63410	North	Floodplain with cottonwood recruitment
8	46.06880	-110.63412	North	Large woody debris
9	46.06880	-110.63412	North	Steep bank with cobble toe and large woody debris

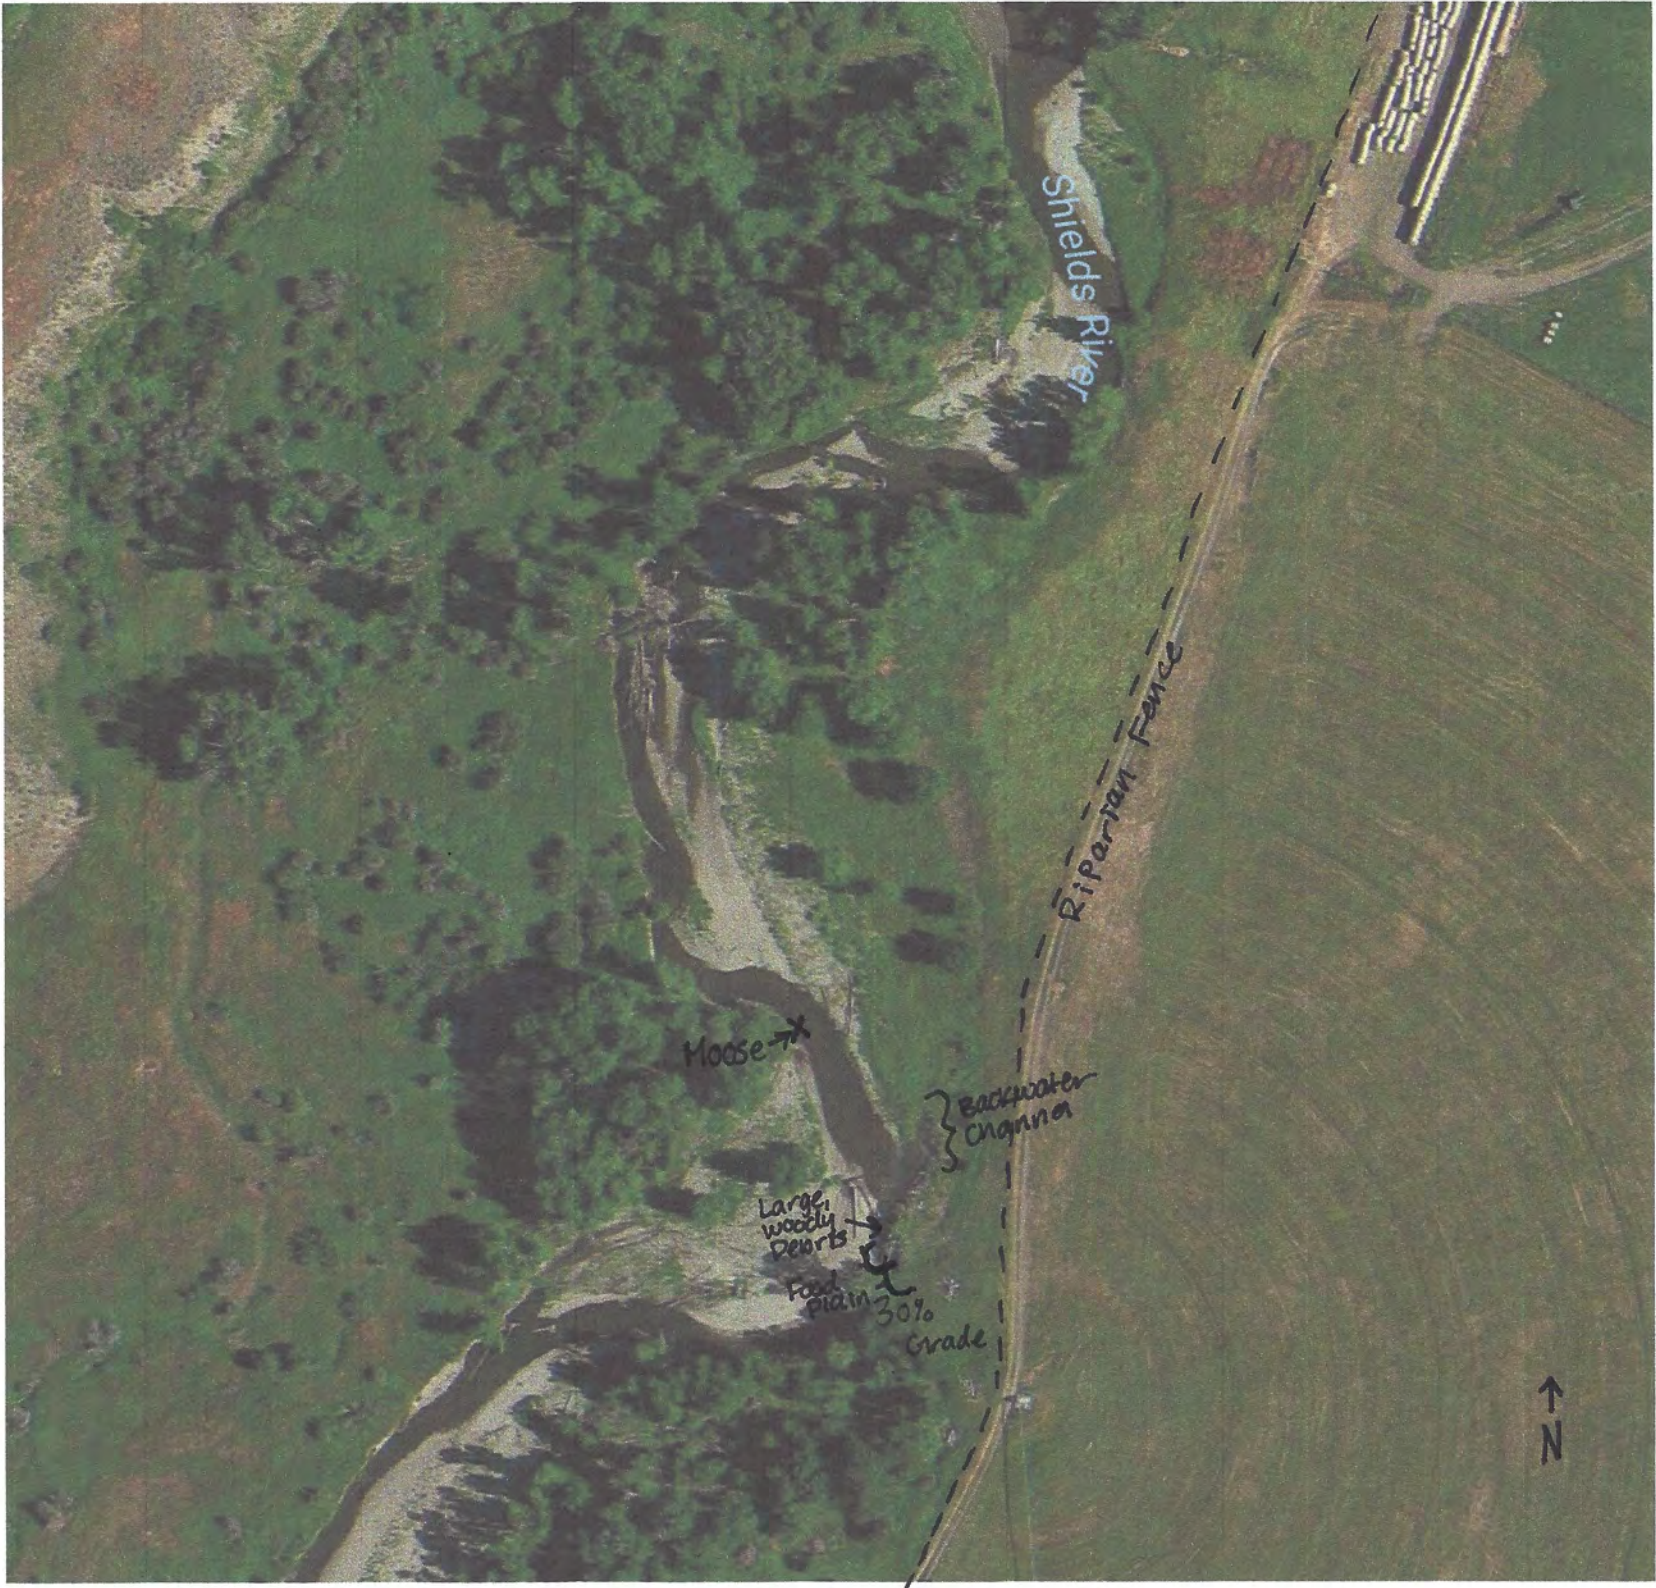
Cottonwood recruitment on floodplain, no willows seen
 Cobbles imbricated
 Riparian fence if five-strand barbed wire and loosely strung
 Large, unnatural riprap downstream of project as well as large woody debris. May be a combination of natural flood debris and human intervention to prevent erosion.
 Beaver may be trying to establish a dam
 Reed canary grass dominant in area
 Large point bars with gravel and vegetation, excellent riparian access
 Unclear where exactly bank treatments were, but all looks healthy. It does appear that the area we believe was treated has significantly eroded and a backwater channel formed (see project overview).

Backwater channels

Large woody debris →

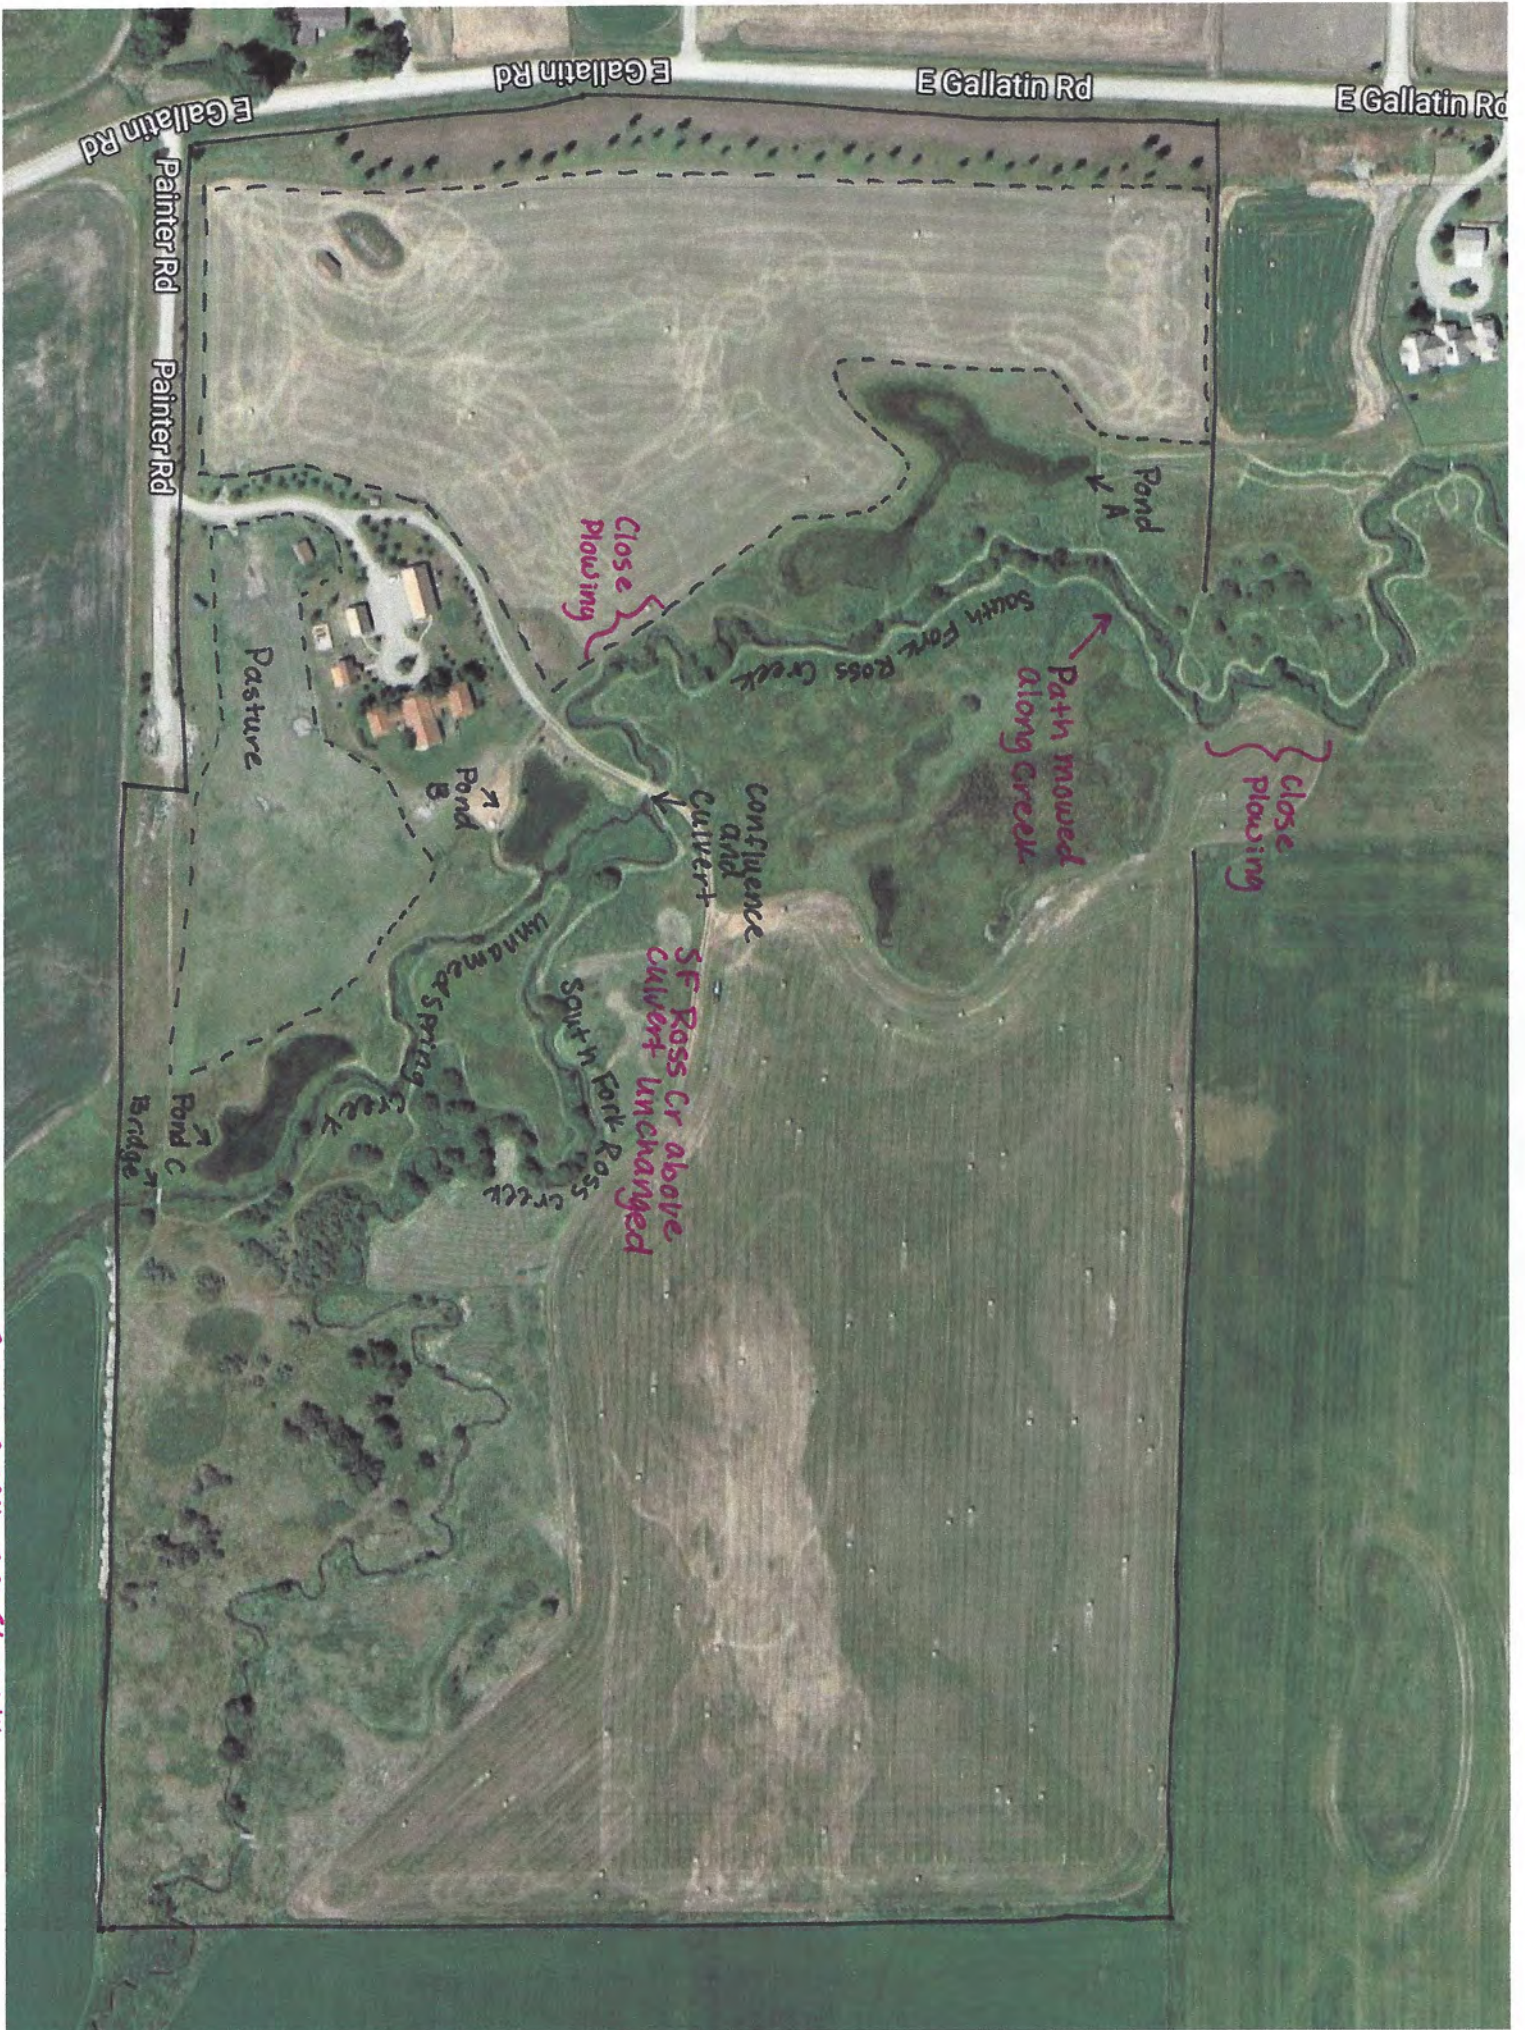
South Fork Ross Creek Restoration and Fencing (018-07)

Horse access to unnamed spring creek
 Minnows present in pond B
 Not many shrubs for cover
 SF Ross is deeper, murky, and more silty than the unnamed creek
 Many ducks present
 Unnamed spring creek very straight and entrenched upstream from project. SF Ross Creek upstream from culvert not included in project.

SF Ross Cr above culvert unchanged

Spring creek very straight and not reached upstream

Could benefit from more riparian shrubs and settling ponds

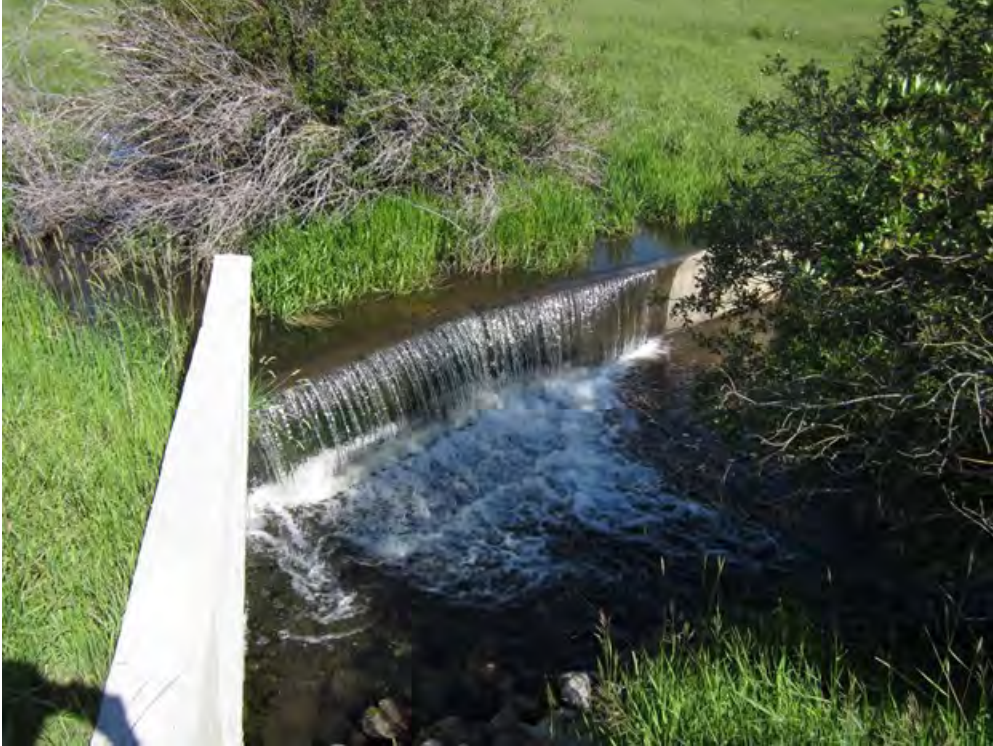
Figure 1

Frame #	Lat	Long	Facing?	Scene description/Previous Photo
1	45.280287	-109.347159	North	Overview of barrier
2	45.280287	-109.347159	Northwest	Overview of barrier from downstream river right
3	45.280287	-109.347159	East	Looking downstream from river right
4	45.280287	-109.347159	Southwest	Looking upstream from river left
5	45.280287	-109.347159	Southwest	View of crumbling concrete on right side of barrier
6	45.280287	-109.347159	Southwest	View of crumbling concrete on right side of barrier
7	45.280287	-109.347159	West	Riparian condition directly upstream

May not withstand a large water event
 Left wing wall may not prevent stream from circumventing barrier
 Apron appears to be made of concrete, rather than steel as plans state. Appears to be narrower than the described 9 feet.
 Only Brook Trout and Sculpin found in the stream when electrofished, no Yellowstone Cutthroat Trout

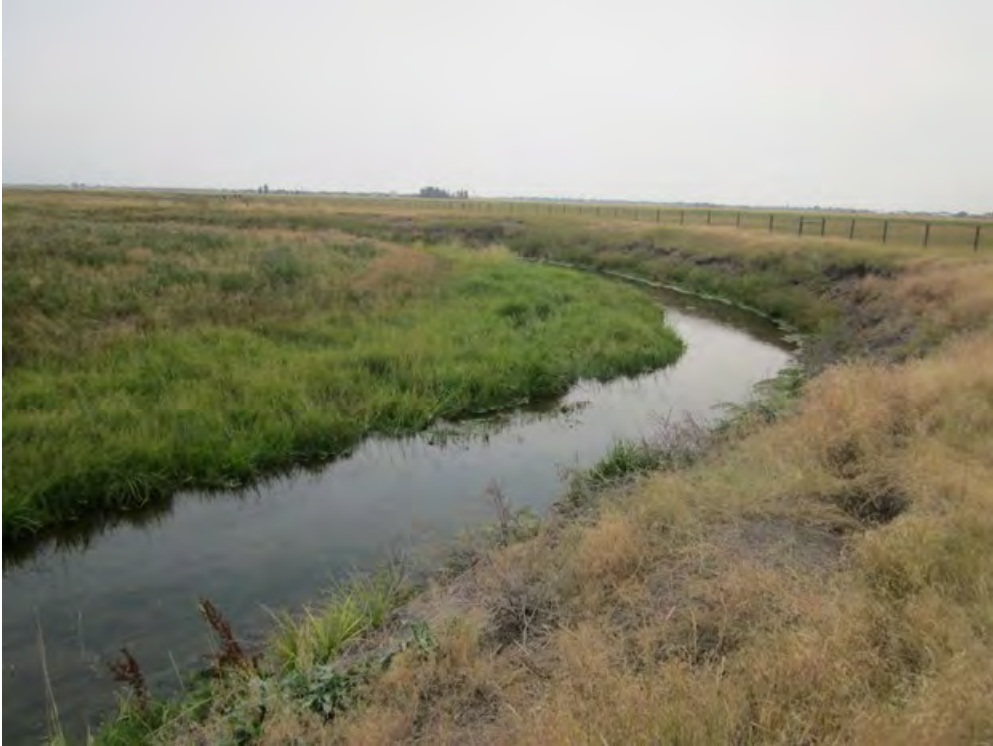
Figure 1

Frame #	Lat	Long	Facing?	Scene description/Previous Photo
1	45.81669	-111.15673	South	New fencing
2	45.81643	-111.15643	South	Steep, but stable bank
3	45.81677	-111.15530	East	Hoof marks in stream
4	45.81677	-111.15530	East	Gravel
5	45.81549	-111.15603	Southwest	"Heavy Use" area(on original map)
6	45.81381	-111.15604	East	Armored stanchion water access
7	45.81377	-111.15589	East	"Heavy Use" area(on original map)
8	45.81455	-111.15643	East	Slight grazing near stream
9	45.81455	-111.15643	North	Difference in grazing (left is pasture right is near stream)

Cows in pasture area near stream, looks like a recent move. Hoof shear and manure present, but not much grazing pressure. Unsure if in compliance with grazing plan.
 Very silty stream, little gravel visible.
 Fence in good condition. Not as plans describe, but property is under new ownership.
 No riparian shrubs present on property, but neighboring properties also have few/none.

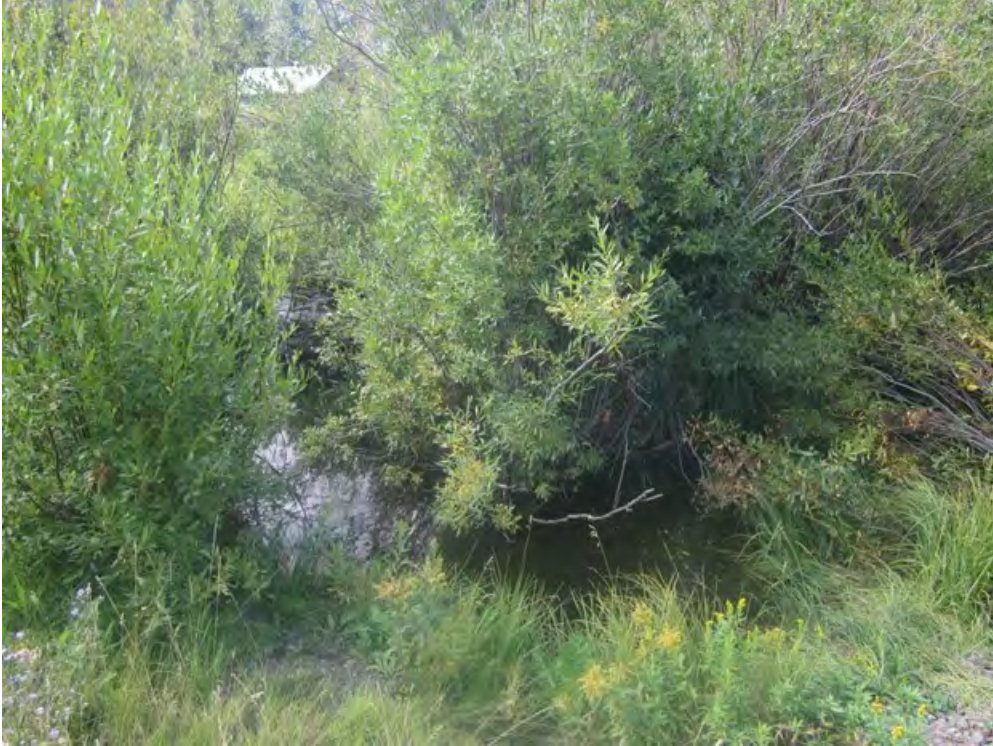
Figure 1

At upstream end: Beavers moved in shortly after project was complete, obscuring most of the constructed channel and causing slow moving water. Unable to take matching photo looking downstream towards culvert 1 due to marsh.

Frame #	Lat	Long	Facing	Scene description
1	45.00748	-109.98814	South	Upstream end of project reach
2	45.00720	-109.98827	North	Facing upstream from culvert 1
3	45.00720	-109.98827	South	Facing downstream from culvert 1
4	45.00717	-109.98832	West	Sedges downstream from culvert 1 on old Burdette property
5	45.00717	-109.98832	South	Bridge on old Burdette property, matches old photo
6	45.00706	-109.98857	North	Facing upstream from culvert 2
7	45.00706	-109.98857	South	Facing downstream from culvert 2, culvert 3 in background
8	45.00702	-109.98867	North	Facing upstream from culvert 3, culvert 2 in background
9	45.00702	-109.98867	South	Facing downstream from culvert 3
10	45.00698	-109.98885	South	Facing downstream towards Olson property
11	45.00690	-109.98892	South	Facing downstream on Olson property, culvert 4 at road crossing, matches old photo
12	45.00680	-109.98905	East	Spawning gravel on Olson property

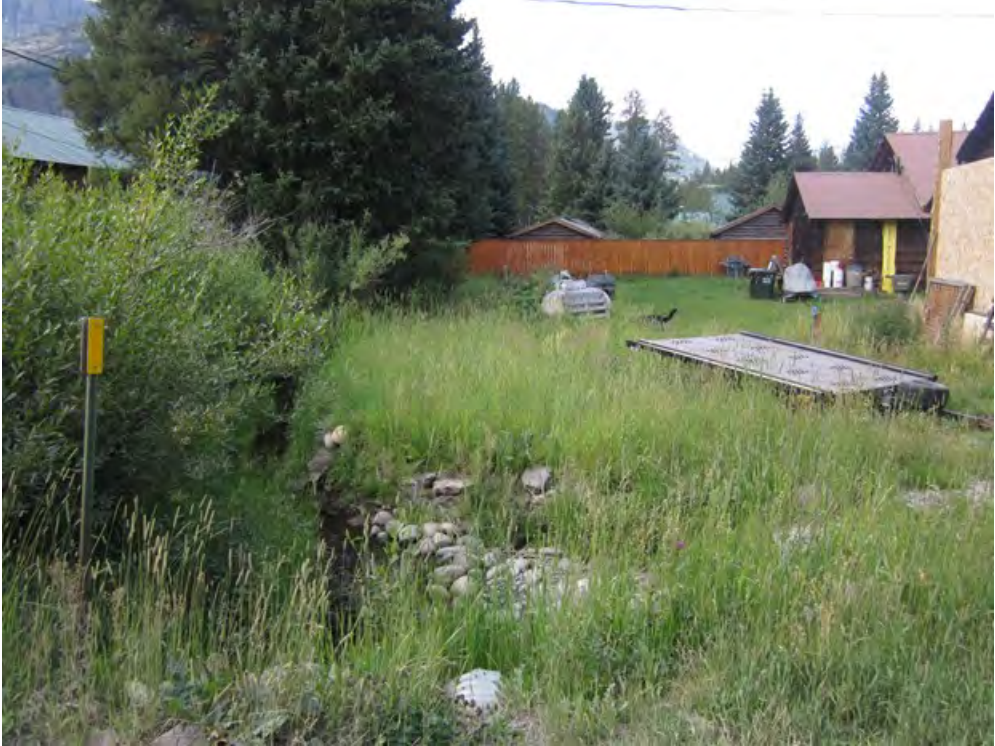
Figure 13

Culvert 4: Good spawning gravel is silted in and unused. Wattles and stakes visible, but grown over by plants. Spotted frog seen. Good stream bed and gravel, especially with gradient increase. Landowner says no fish present in years, believes fish may not be able to access creek unless high water (we believe differently).

13	45.00674	-109.98923	North	Facing upstream from culvert 4 towards Olson property, matches old photo
14	45.00674	-109.98923	South	Facing downstream from culvert 4, matches old photo
15	45.00665	-109.98939	South	Facing downstream, taken from south of culvert 4 by blue propane tank, matches old photo
16	45.00652	-109.98962	South	Facing downstream, taken from south of culvert 4, showing exposed wattles
17	45.00637	-109.98980	North	Facing upstream, taken from south of culvert 4 by jack-leg fence, matches old photo
18	45.00637	-109.98980	West	Spawning gravel
19	45.00637	-109.98980	North	Looking upstream from jack leg fence, showing exposed wattles
20	45.00626	-109.98991	South	Looking downstream, taken from just north of culvert 5, showing exposed wattles in the shade
21	45.00626	-109.99012	North	Looking upstream from culvert 5
22	45.00626	-109.99012	South	Looking downstream from culvert 5
23	45.00602	-109.99032	West	Looking downstream towards confluence with Soda Butte Creek
