## FFIP PROJECT & LAND USE MONITORING FORM

<b>Project #:</b>	045-04	<b>Project Title:</b>	North Fork Horse Creek
<b>Date:</b>	6/22/2017	<b>Evaluator:</b>	Kyrsten Wolterstorff
<b>Waterbody Name:</b>	North Fork Horse Creek	<b>Project Type:</b>	Water savings

<b>Project #:</b>	048-2003	<b>Project Title:</b>	North Fork Horse Creek
<b>Date:</b>	6/22/2017	<b>Evaluator:</b>	Carol Endicott, Kyrsten Wolterstorff
<b>Waterbody Name:</b>	North Fork Horse Creek	<b>Project Type:</b>	Riparian

<b>Project #:</b>	022-04	<b>Project Title:</b>	North Fork Horse Creek fish screen
<b>Date:</b>	6/22/2017	<b>Evaluator:</b>	Carol Endicott, Kyrsten Wolterstorff
<b>Waterbody Name:</b>	North Fork Horse Creek	<b>Project Type:</b>	fish screen

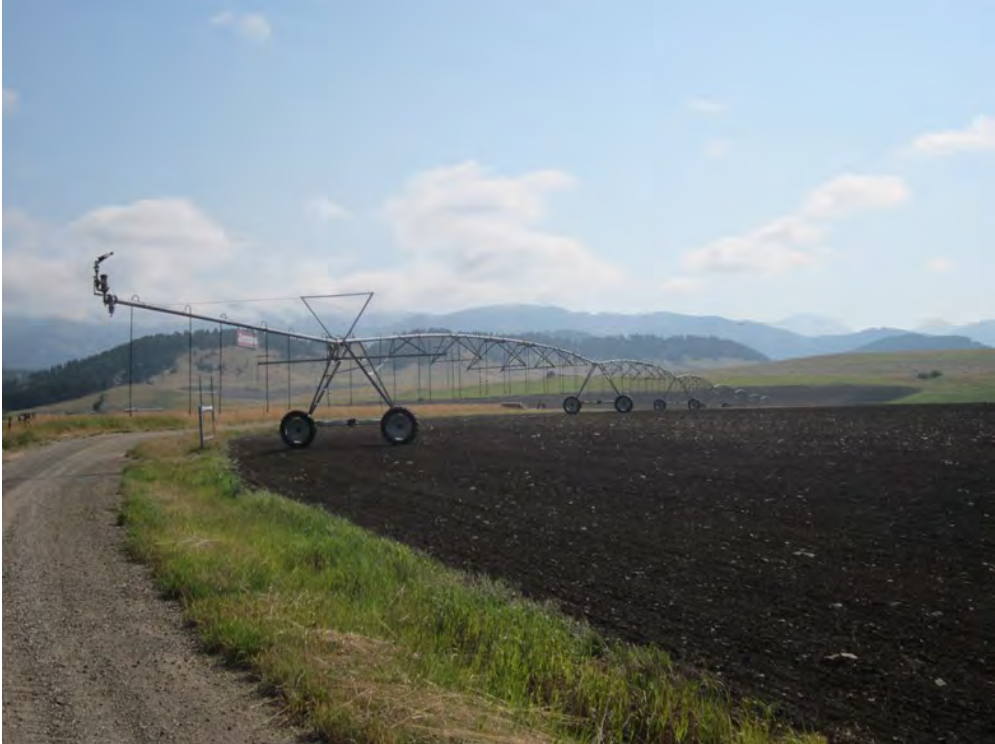
Figure 1

Frame #	Lat	Long	Facing?	Scene description/Previous Photo
1	46.024041	-110.513823	East	Pivot in use
2	46.020598	-110.517663	East	Second Pivot

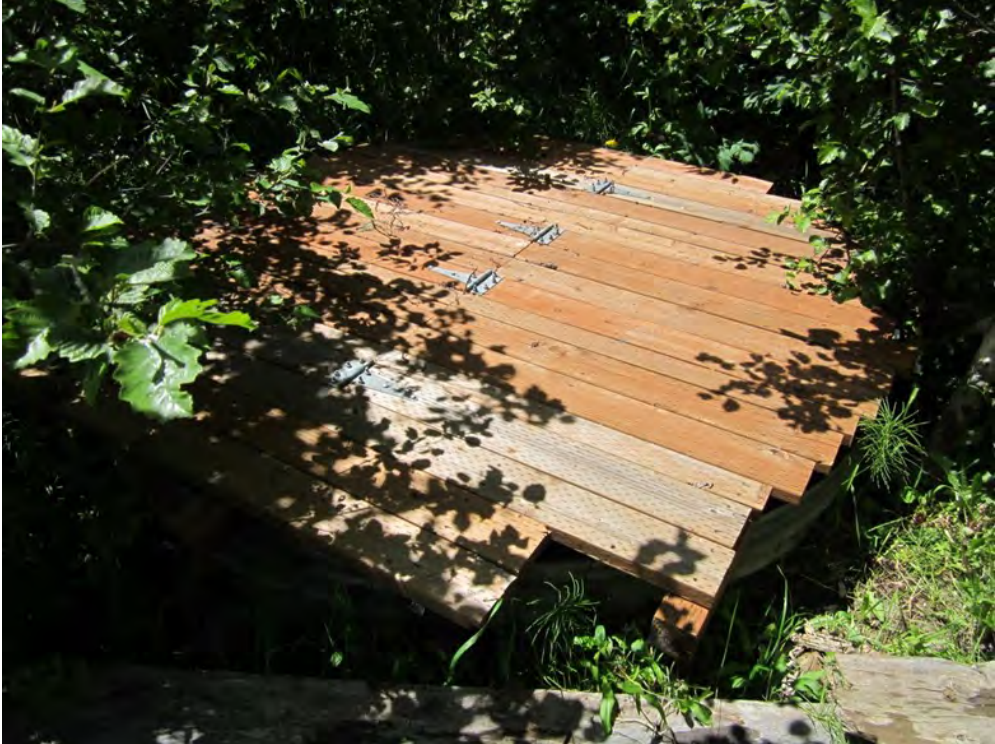
Figure 1.

Frame #	Lat	Long	Facing?	Scene description/Previous Photo
1	46.03412	-110.49886		Fish screen with cover
2	46.03412	-110.49586		Fish screen showing fountain
3	46.03412	-110.49586		Check dam with screw gate
4	46.03412	-110.49586	downstream	downstream of check dam
5	46.03412	-110.49586	upstream	screw gate
6	46.03412	-110.49586	downstream	downstream of bypass pipe
7	46.03412	-110.49586	downstream left bank	bypass

Fish screen in operation. Flows through fountain pipe caused sufficient turbulence to move detritus and presumably fish off the screen.

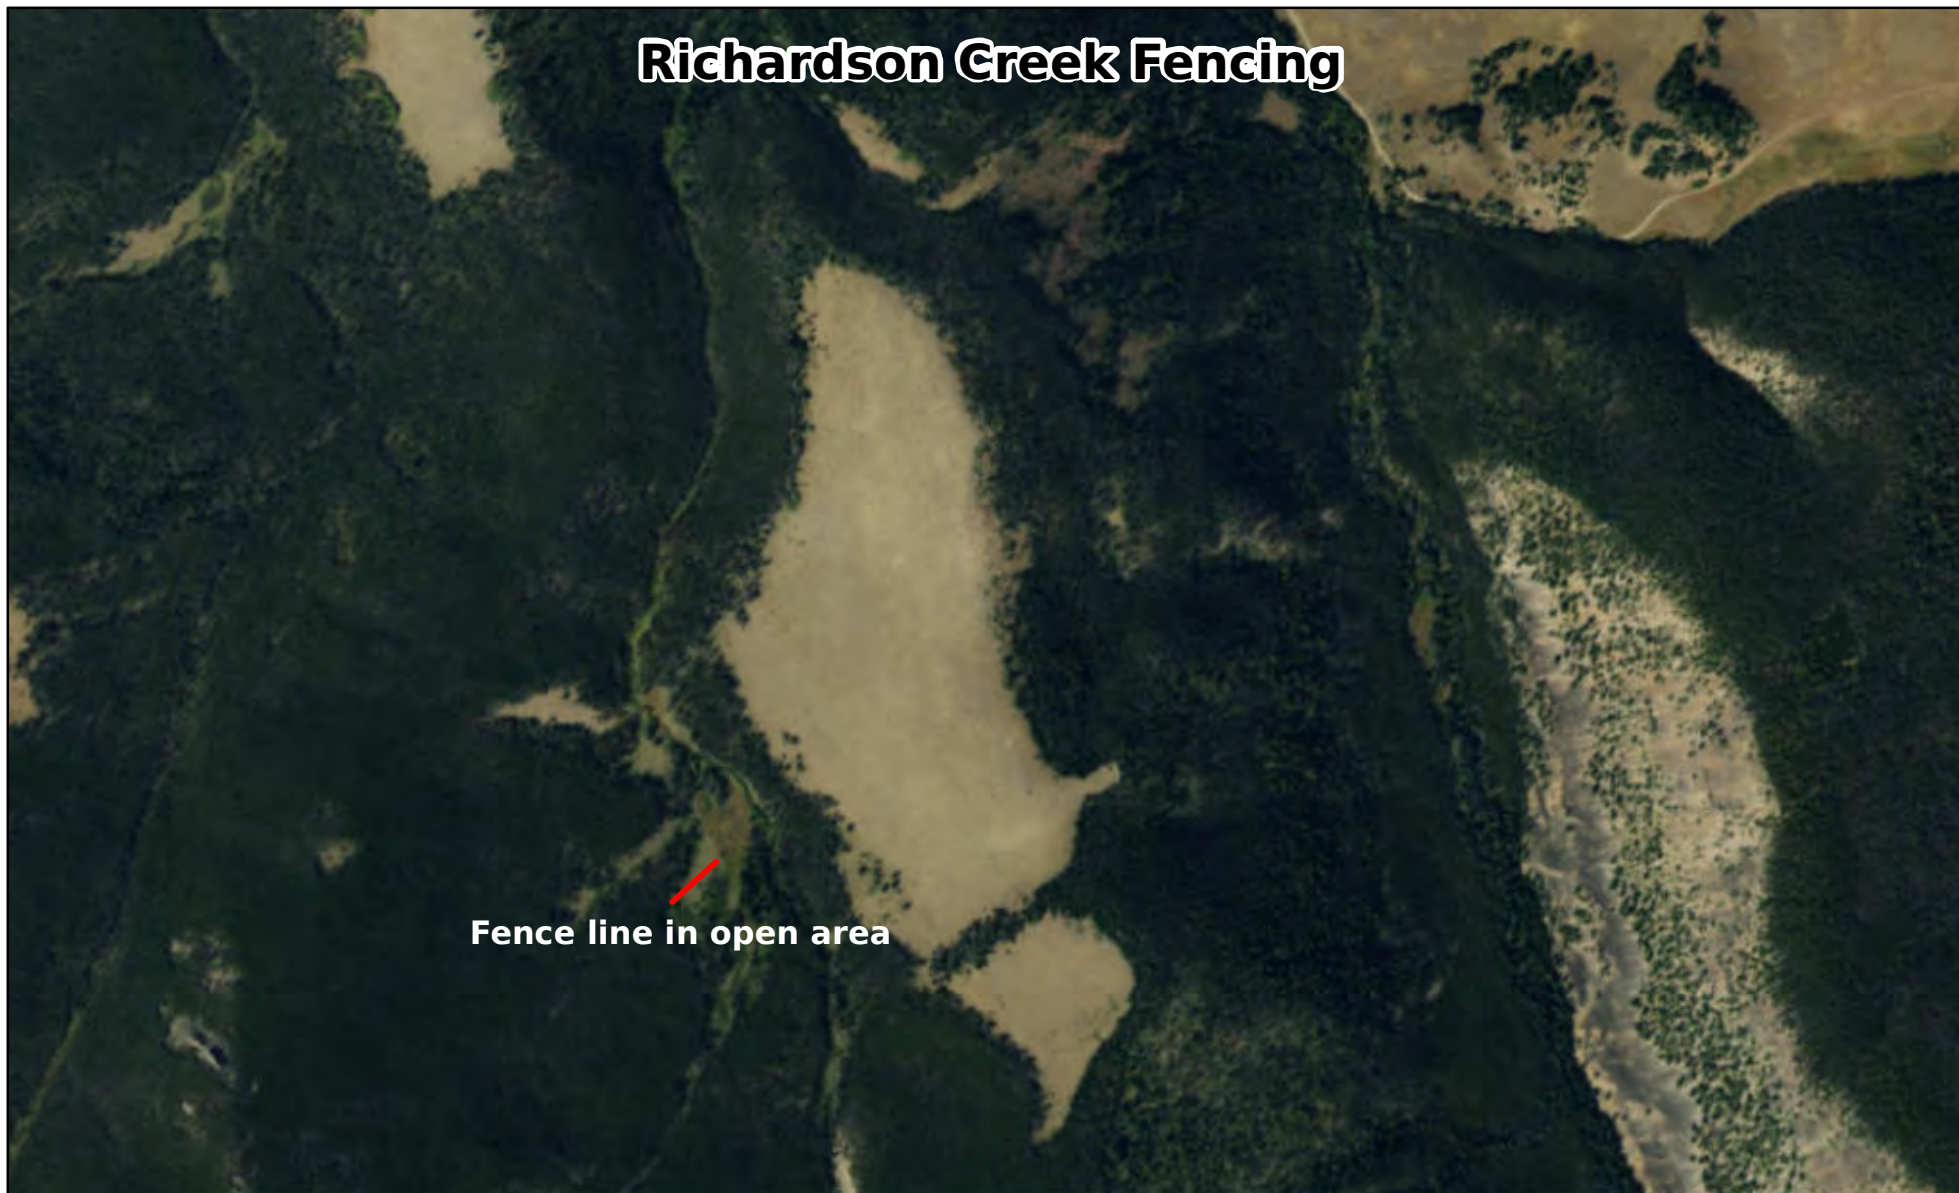
Fence line in open area

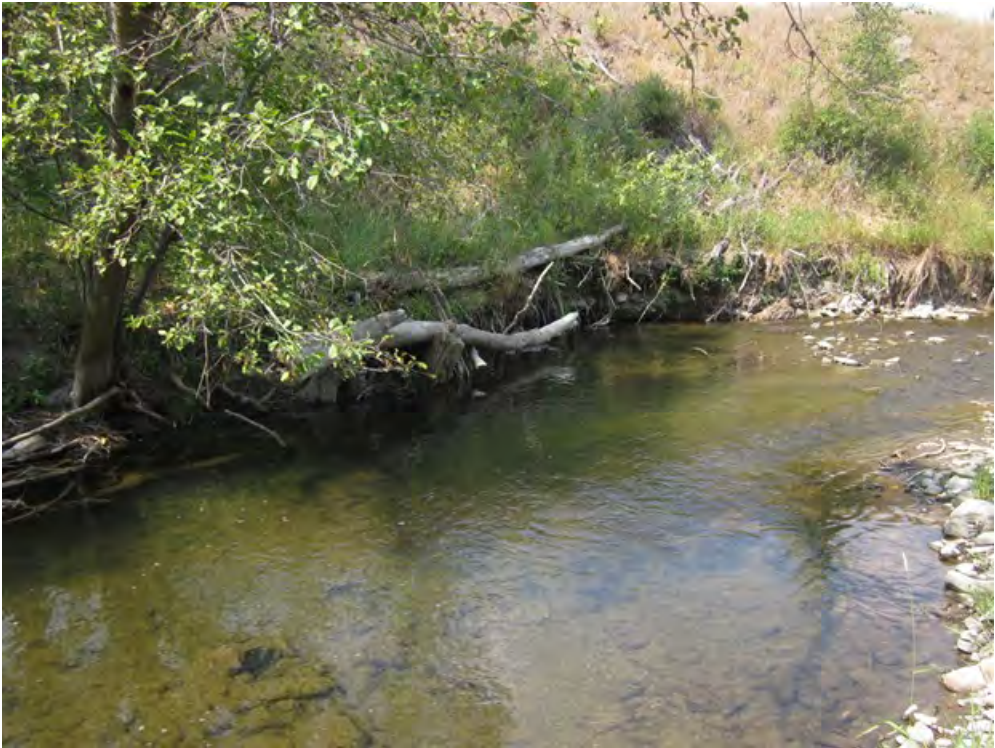
Figure 1

Frame #	Lat	Long	Facing	Scene description
1	46.05409	-110.64162	West	Erosion on bank
2	46.05409	-110.64162	North	Floodplain with willows and reed canary grass, looking upstream
3	46.05447	-110.64155	North	Riparian area, looking upstream
4	46.05472	-110.64142	North	Steep banks, looking upstream
5	46.05503	-110.64161	North	Reed canary grass, looking upstream
6	46.05644	-110.64233	West	Diversion
7	46.05724	-110.64236	North	Steep banks, looking upstream
8	46.05819	-110.64229	North	Looking upstream, riparian area
9	46.05819	-110.64229	South	Looking downstream, riparian area
10	46.05853	-110.64140	North	Looking upstream towards cow and calf moose
11	46.06035	-110.64053	North	Cut bank at bottom of image, reach in back with riprap and possibly mechanically straightened
12	46.06097	-110.64017	North	Upstream end of project, looking upstream
13	46.06097	-110.64017	South	Upstream end of project, looking downstream

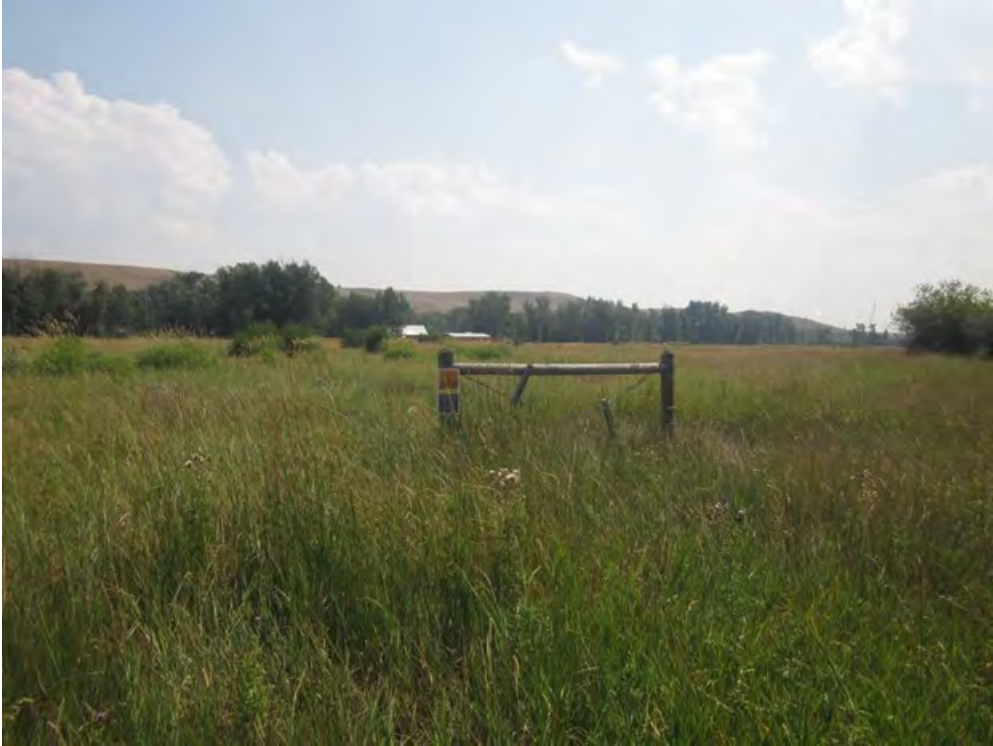
Figure 14

14	46.06097	-110.64017	East	Fencing with no wire
15	46.06054	-110.64024	North	Fencing with no wire
