Middle Fork Horse Creek Site Visit

Mountain Foothills Ranch LLC
Mass Wasting Event Site Visit 2018

Carol Endicott
Yellowstone Cutthroat Trout Conservation Biologist

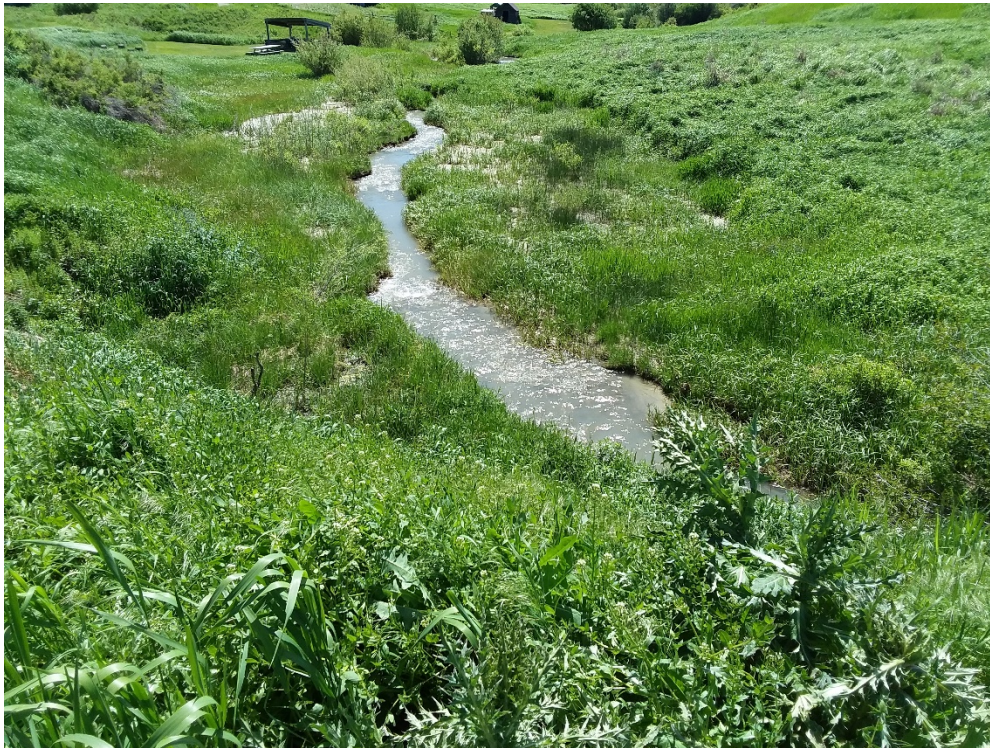
On June 13, 2018, Carol Endicott visited Middle Fork Horse Creek. The restored reach of Middle Fork Horse Creek withstood flooding with no damage (Figure 1). The channel remained deep and narrow, and the constructed floodplain was intact, with willows continuing to recruit. The formerly vertical, bare terrace (Figure 2) had continued to settle into an angle of repose. Earlier site visits found an invasive weed (probably *Galium*) covered much of the settled slope; however, grasses and forbs had largely displaced this early invader. The constructed floodplain bench allowed the stream to spread across the floodplain on both sides of the stream, making this reach resilient to flooding.

Figure 1. View of the constructed channel and floodplain bench, June 13, 2018.

The restored reach downstream of the area of mass wasting was unaffected by high flows or sediment loading from erosion upstream. The narrow, deep channel effectively transported the augmented sediment load, and the constructed floodplain bench prevented scour along the formerly eroding terrace. Middle Fork Horse Creek has experienced 2 floods since restoration of this reach, with the first flood occurring the following spring. Its continued resilience to flooding demonstrates this restoration approach to be effective at taking pressure off highly erodible areas and allowing the stream to access a floodplain, which dissipates flow energies and allows transported sediments to filter through streamside vegetation.

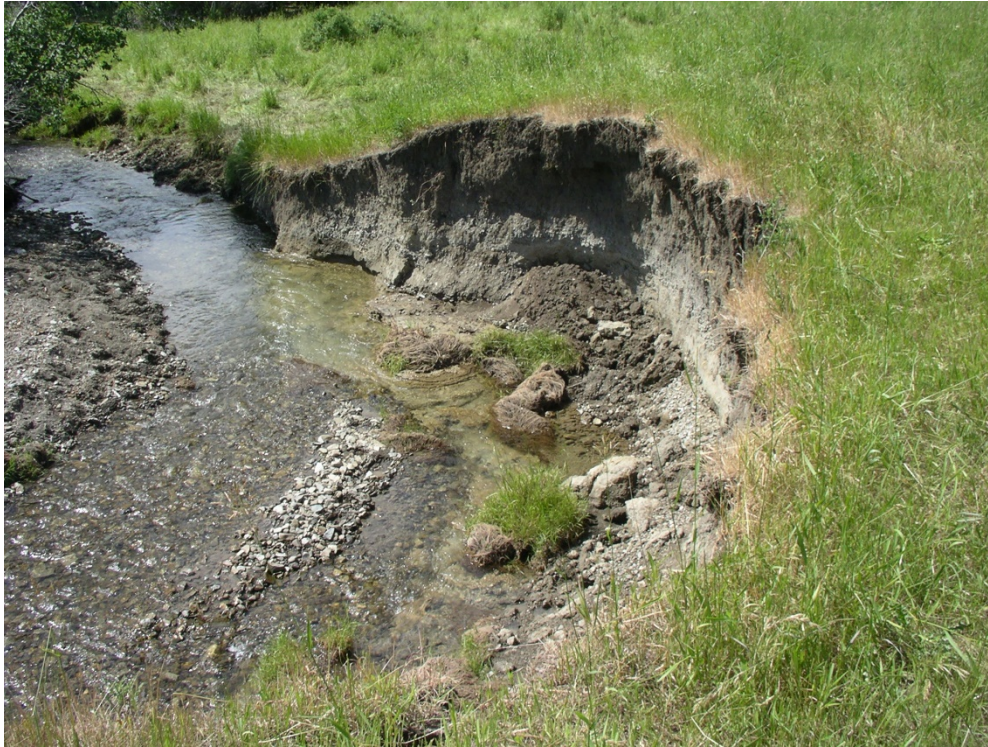
Figure 2. Middle Fork Horse Creek terrace pre-restoration 2009.

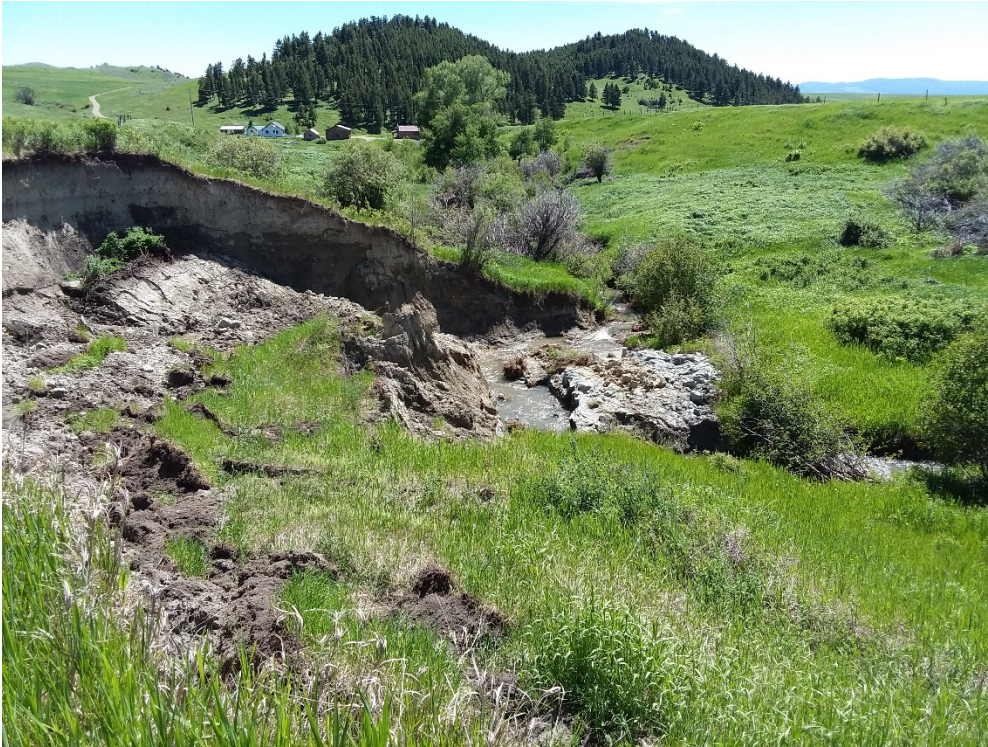
The area of erosion was upstream of the restored reach, and the landowner's description of massive erosion was accurate. Flooding and wet soils resulted in a mass wasting event that eroded about 75 feet the top of the terrace towards Middle Fork Horse Creek (Figure 3). A large amount of terrace soils traveled across the stream (Figure 4). The soils had high clay content and resembled concrete. Despite the cohesiveness of the clay-dominated soils, Middle Fork Horse Creek had cut a channel through this material by mid-June (Figure 5). The date of the mass wasting event is unknown; however, gage data from the U. S. Geological Survey gage near the mouth of the Shields River shows the Shields River exceeded flood stage twice in the month before the site visit.

Figure 3. View of slump from top of terrace, looking downstream.

As this area is not under grazing pressure or other human disturbance, the terrace will eventually restabilize, although it will be a natural source of sediment loading until the slope settles into an angle where vegetation can establish. Middle Fork Horse Creek will rework the channel through this reach and eventually reestablish a channel with access to its floodplain. Allowing this area to recover naturally is the recommended approach.

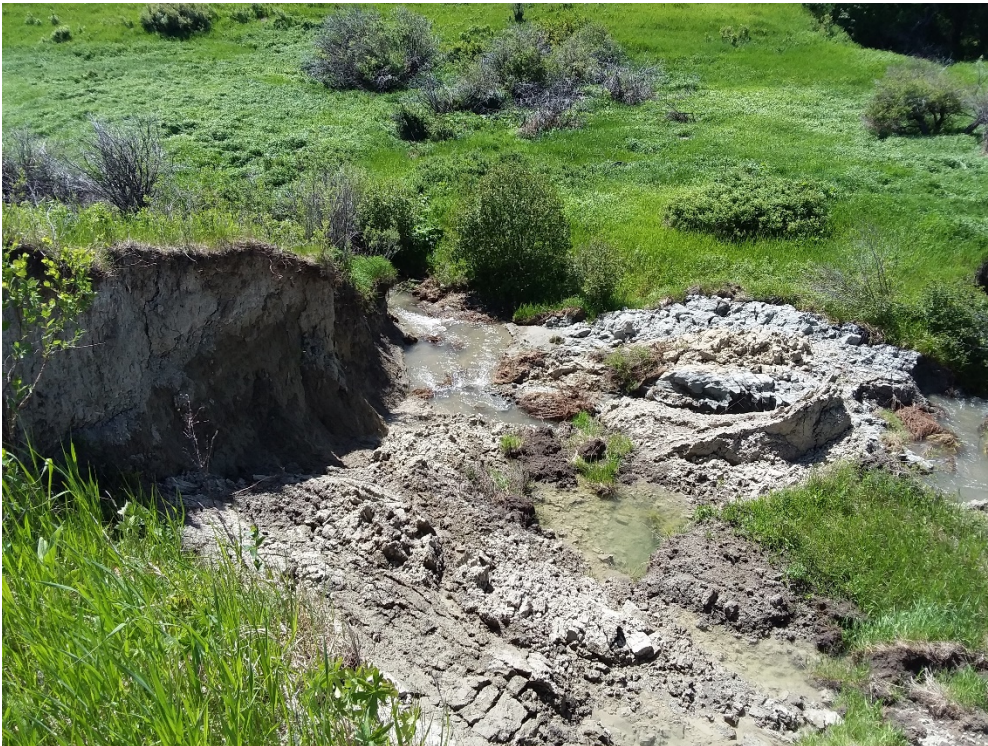
Figure 4. View of slump showing terrace soils spilled across the stream channel.

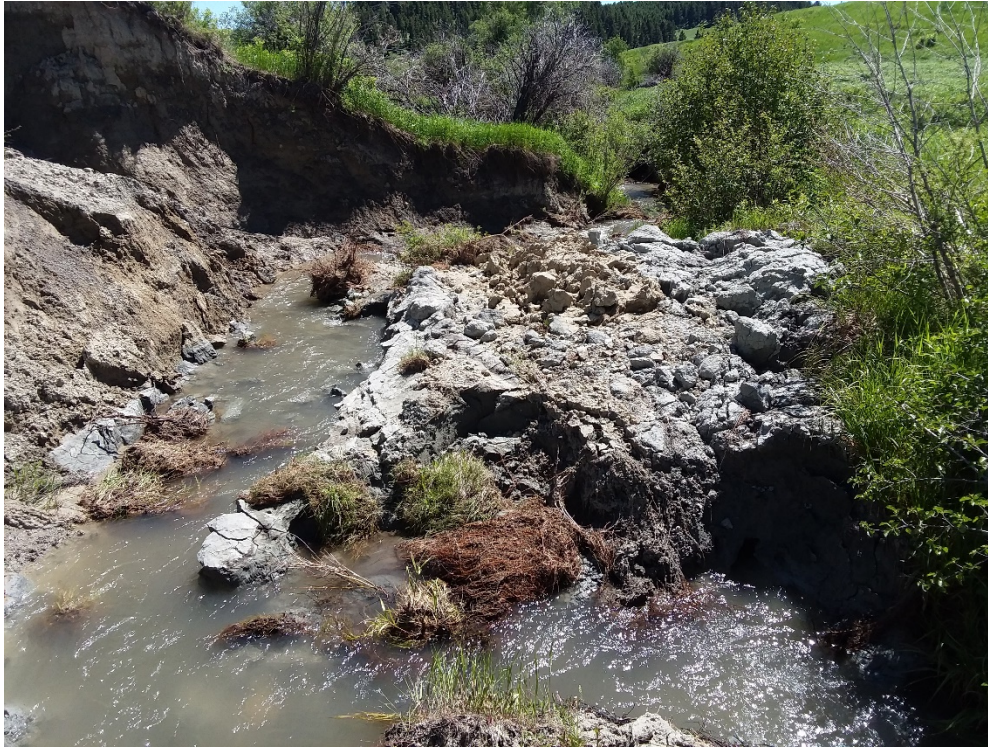
Figure 5. Channel cut through materials slumped into stream during mass wasting event.

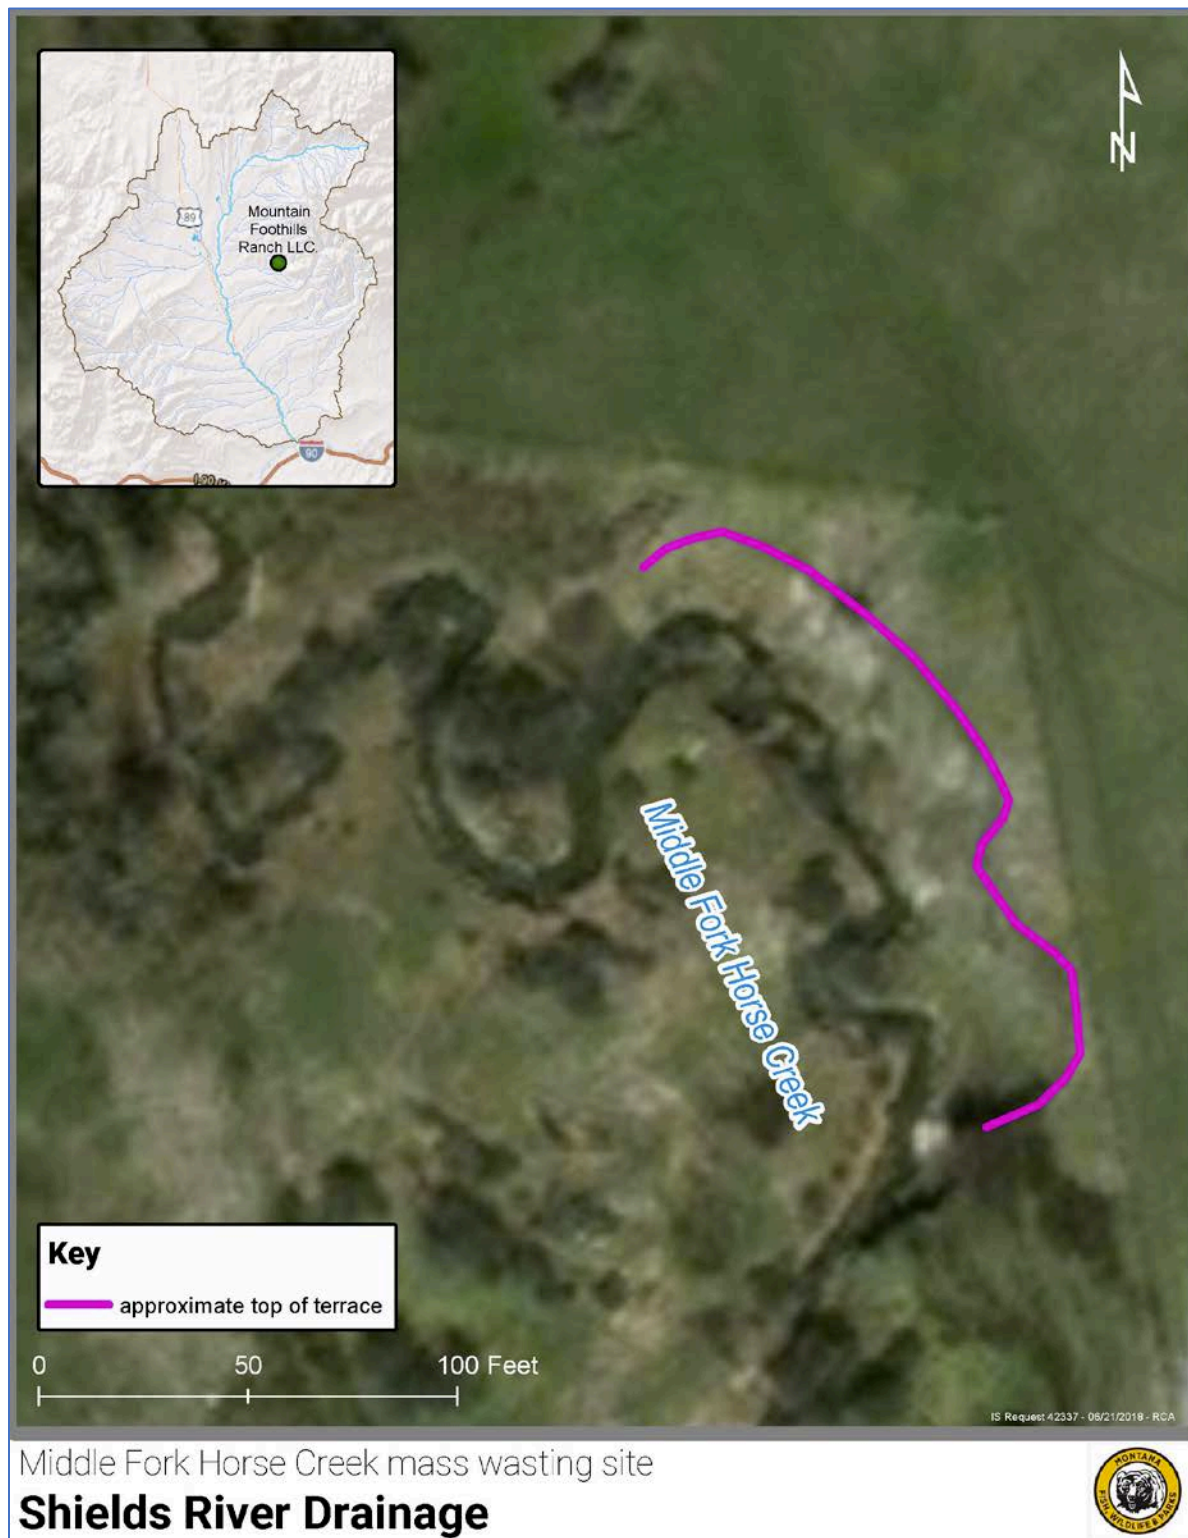
An aerial photo from 2017 provides additional perspective on the extent of erosion at this mass wasting site (Figure 6). The photo shows the top of the terrace in August 2017. The mass wasting event resulted in lateral movement of the rim of the terrace that cut up to 20 feet into the terrace. The fence line is visible in the aerial photo, and the landowner had to rebuild the fence away from the rim, as much of it was overhanging the slump.

Figure 6. Aerial photo of the area of mass wasting showing the location of the top of the terrace before the event (August 9, 2017).
