Habitat Assessment for Miller Creek Missoula County, Montana

October 2018

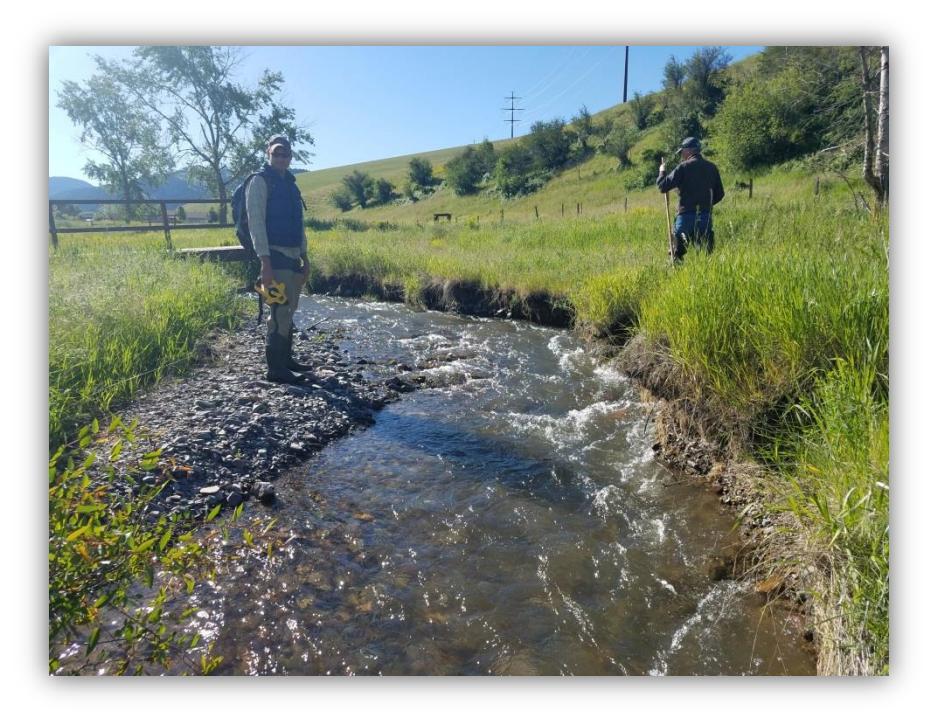
Figure 2. Conditions in the upstream end of reach NWE_1.

This reach of Miller Creek flows through property that is owned by Northwestern Energy and contains one streamflow diversion at the upstream end of the reach, where the water right is owned and operated by Oxbow Cattle Company. Reach length is 0.26 miles. The stream appears to have been straightened throughout most of the reach, as the sinuosity is very low, the slope of the stream is very steep for the location within the watershed, and there are very few pools within the reach. This reach is dominated by fast water (riffles). This section is clearly a sediment transport reach, as the dominant substrate is cobble and there are very few depositional zones. There is a definitive lack of riparian hardwood vegetation in this reach and the dominant riparian vegetation is grasses. The stream is incised one to two feet throughout the reach.

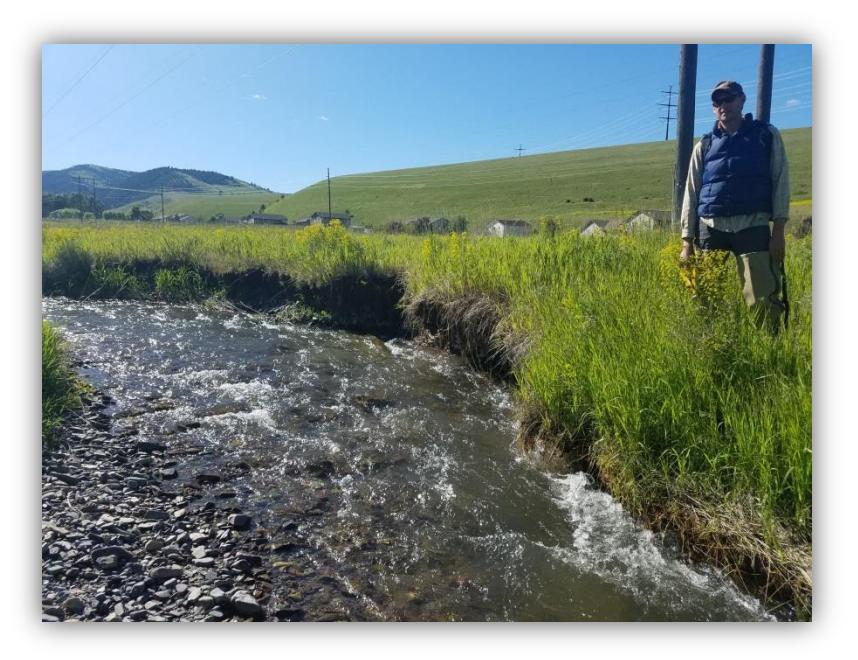
Figure 3. Conditions in reach NWE_2.

This reach of Miller Creek flows through property that is owned by Northwestern Energy. Reach length is 0.33 miles. The stream appears to have been straightened throughout most of the reach, as the sinuosity is very low, the slope of the stream is very steep for the location within the watershed, and there are very few pools within the reach. This reach is dominated by fast water (riffles). This section is clearly a sediment transport reach, as the dominant substrate is cobble and there are very few depositional zones. There is a definitive lack of riparian hardwood vegetation in this reach and the dominant riparian vegetation is grasses. The stream is incised one to two feet throughout the reach.

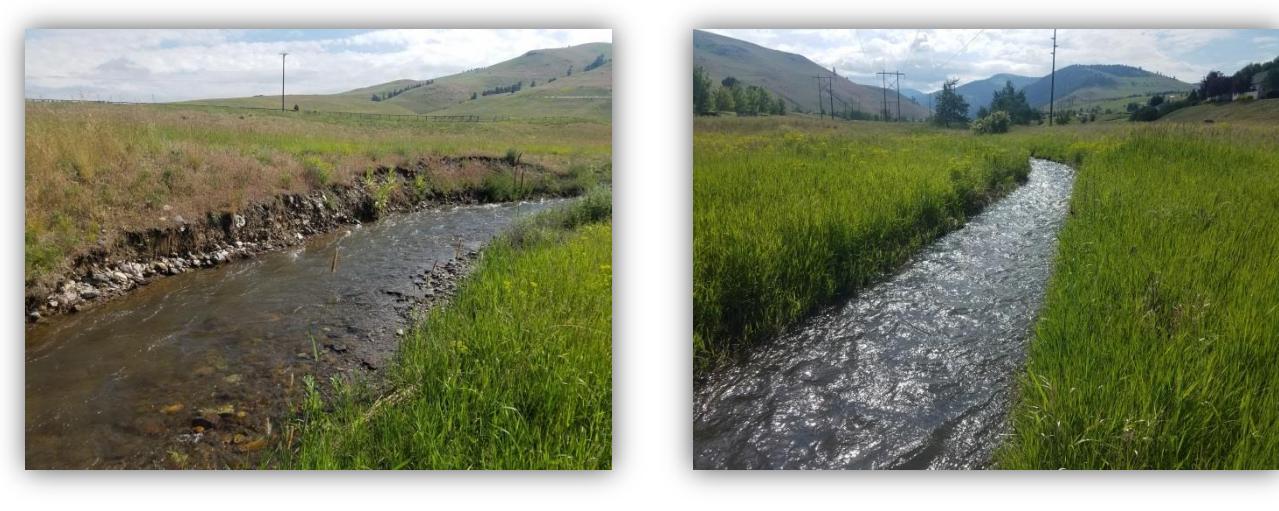
Figure 4. Conditions in Stillwater_1 reach.

This reach of Miller Creek flows through property that is owned by Stillwater Addition Homeowners. Reach length is 0.5 miles. The stream appears to have been straightened throughout most of the reach, as the sinuosity is very low, the slope of the stream is steep for the location within the watershed, and there are no pools within the reach. This reach is one long continuous riffle. This section is clearly a sediment transport reach, as the dominant substrate is cobble and there are very few depositional zones. There is a definitive lack of riparian hardwood vegetation in this reach and the dominant riparian vegetation is grasses. The stream is slightly incised throughout the reach. Lateral bank erosion was visible along the outside bends where banks were 4-5' tall and eroded.

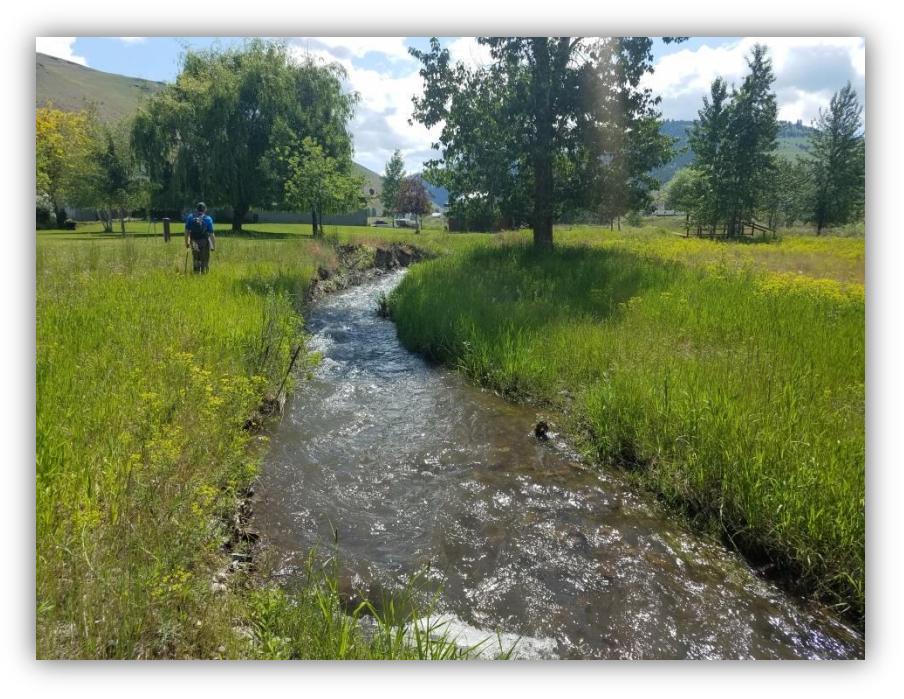
Figure 5. Conditions in Capon_1 reach.

This reach of Miller Creek flows through property that is owned by a private entity and Missoula County. Reach length is 0.12 miles. The stream appears to have been straightened throughout most of the reach, as the sinuosity is very low, the slope of the stream is steep for the location within the watershed, and there are no pools within the reach. This reach is one long continuous riffle. This section is clearly a sediment transport reach, as the dominant substrate is cobble and there are very few depositional zones. There is a definitive lack of riparian hardwood vegetation in this reach and the dominant riparian vegetation is grasses. The stream is incised 2 to 3 feet throughout the reach, and there was minimal lateral bank erosion. Habitat Assessment Results: Lower-Middle Reaches

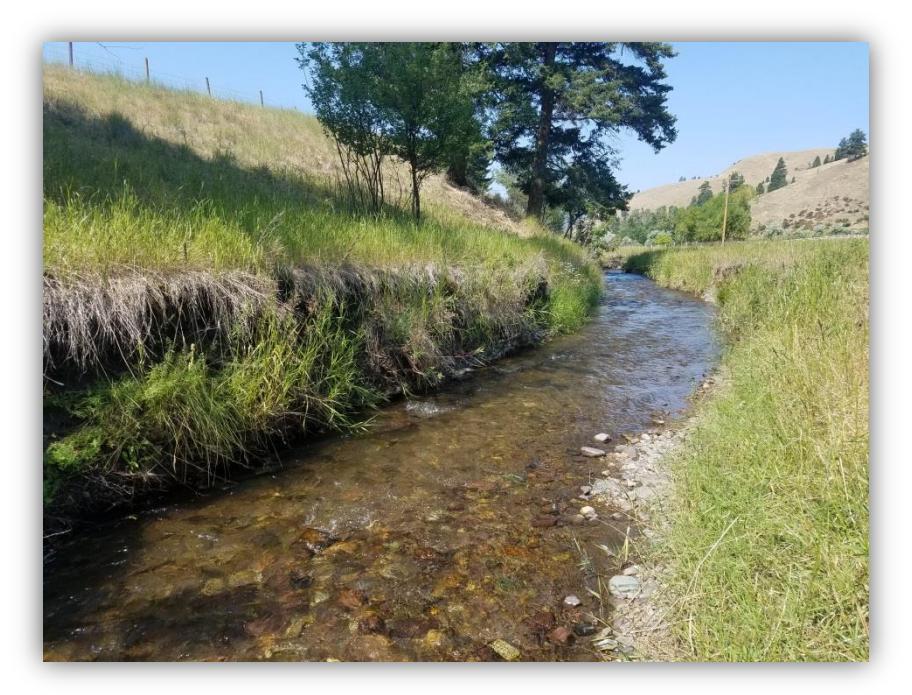
Figure 6. Conditions in Singletree_1 reach.

This reach of Miller Creek flows through property that is owned by two private entities. Reach length is 0.19 miles. There are few pools (4) within the reach, and there is a definitive lack of riparian hardwood vegetation in this reach and the dominant riparian vegetation type is grasses. The stream is incised an average of 5 feet throughout the reach, and lateral bank erosion was evident throughout the reach as the channel is actively widening. There was an increased amount of fine sediment observed in this reach.

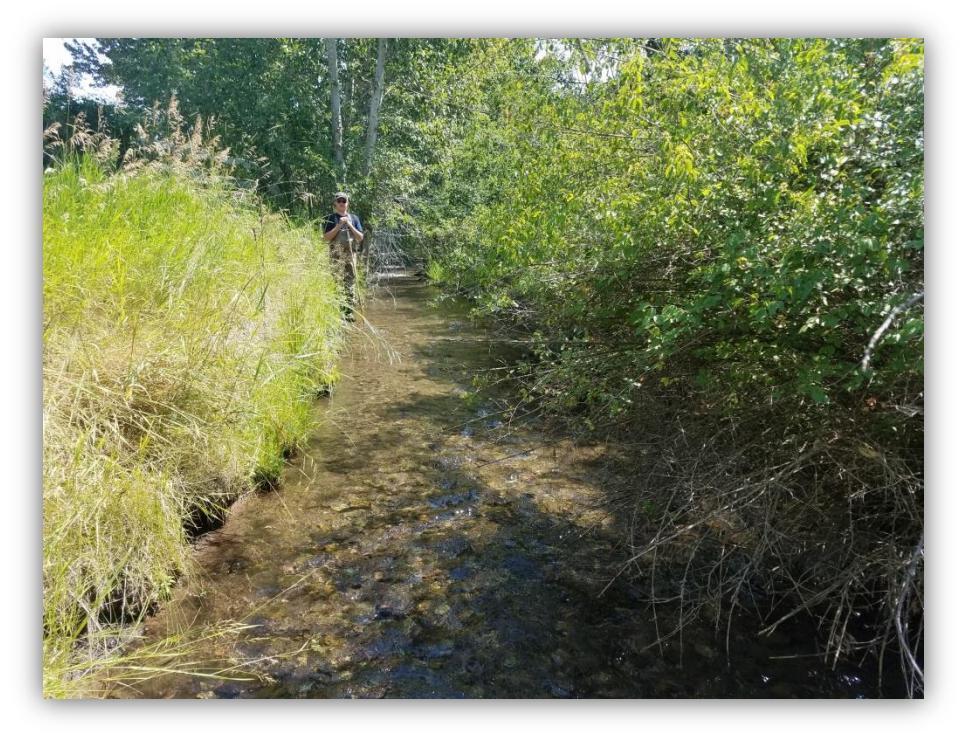
Figure 7. Conditions in Singletree_2 reach.

This reach of Miller Creek flows through property that is owned by a private entity and Missoula County. Reach length is 0.19 miles. There are six pools within the reach, and there was an increased amount of fine sediment observed in this reach. Channel incision observed in this reach begins with a 4 foot average on the downstream end, and generally decreases as you move upstream, giving an average of 3 feet throughout the reach. Lateral bank erosion was evident throughout the reach as the channel is actively widening. Riparian vegetation increased in this reach, with cottonwood, chokecherry, aspen, and willow as the dominant hardwood riparian vegetation present.

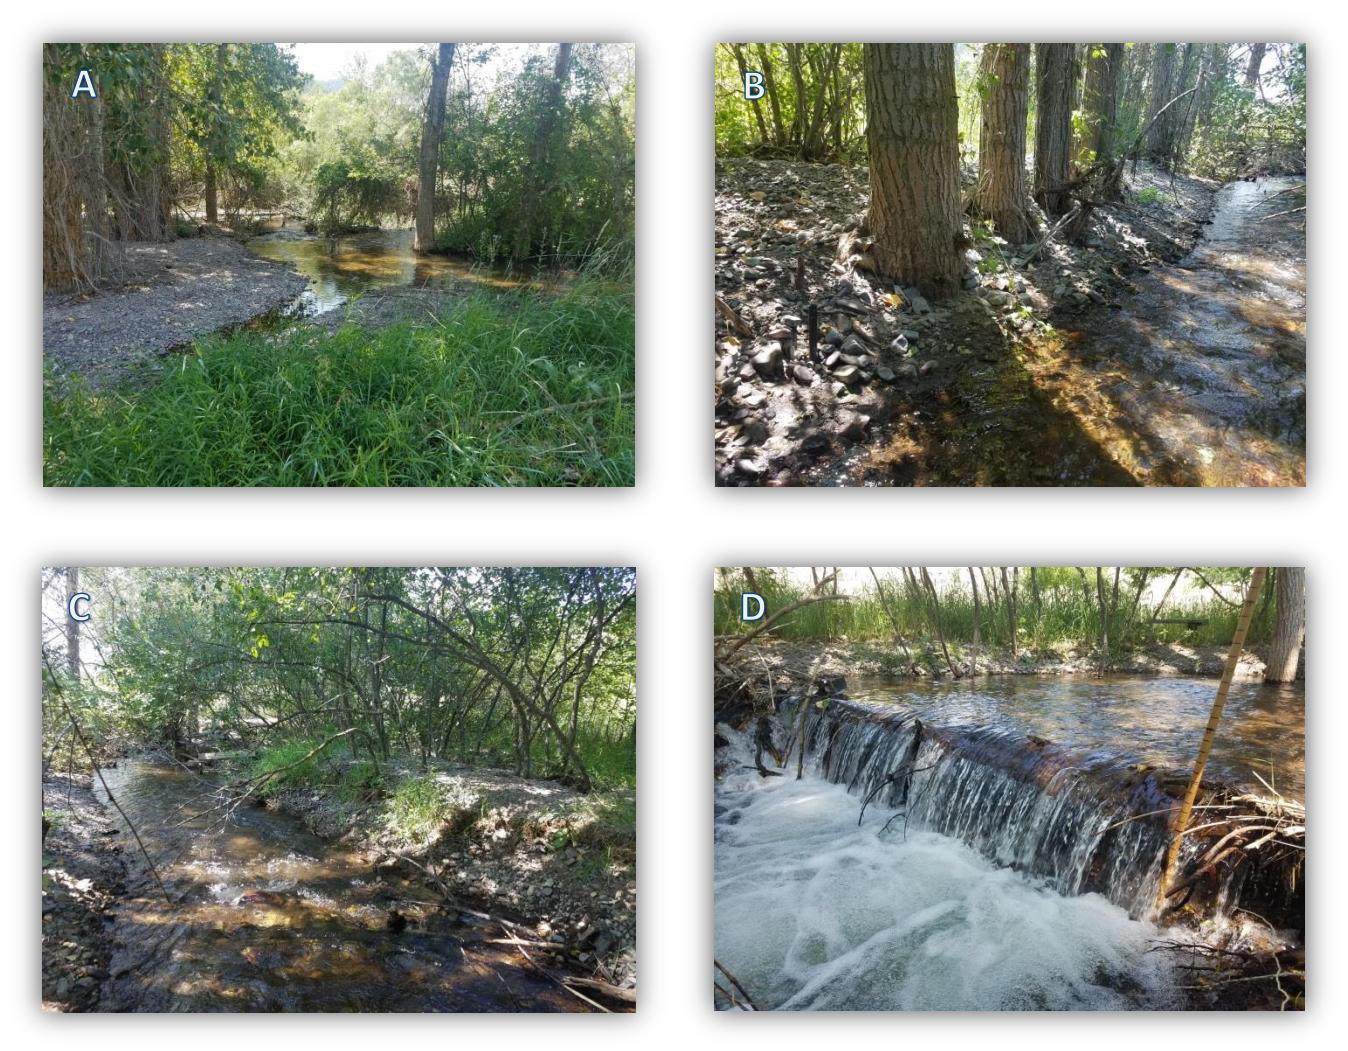
Figure 8. Photo A: Sediment deposition and channel avulsion occurring downstream of the Singletree Lane crossing. Photos B&C: Large sediment plug that has deposited approximately 4 ft of sediment for 400 ft upstream of the crossing. Photo D: Channel spanning log causing a potential fish passage barrier with a 1.8 ft fish jump height.

This reach of Miller Creek flows through property that is owned by two private entities and Missoula County. Reach length is 0.25 miles. The crossing with Singletree Lane has caused major sediment issues in this reach. A large plug of sediment has deposited upstream and downstream of the crossing due to

the fact that the aged, double barrel culverts at the crossing are severely undersized and partially plugged (see fish passage survey results and photos). Based off of the size of the sediment plug, this issue appears to have been ongoing for decades. Approximately 1185 cubic yards of sediment have been deposited upstream of the crossing, and much more has been deposited downstream. The channel has avulsed downstream of the crossing, and a portion of the water was flowing into Singletree Lane at the time of survey (July 18, 2018). Although there were sandbags placed in the stream to prevent this from happening, some flow was still escaping into the road and traveling 500 feet along the road before flowing back into Miller Creek. Based off of visual assessment, it appears the elevation of Singletree Lane is lower than the stream channel, which explains why the stream flows here (as the road is in the floodplain). The channel is braided and extremely widened downstream of the stream crossing due to the sediment deposition. There were nine pools in the reach, and overall are shallow due to the excess sediment. The slope of the stream ranged throughout the reach from 0.5-6.0%, with an average of 1.5%.

- 1. Replace the Singletree Lane culverts with a bridge.
- 2. Reconstruct the channel upstream and downstream of the culvert to control the grade and prevent the sediment plug from eroding and delivering downstream. This includes the removal of the fish passage barrier shown in photo D (Figure x).
- 3. Move Singletree Lane out of the floodplain.
- 4. Revegetate open areas in the riparian zone that have been covered in years of depositional gravel.

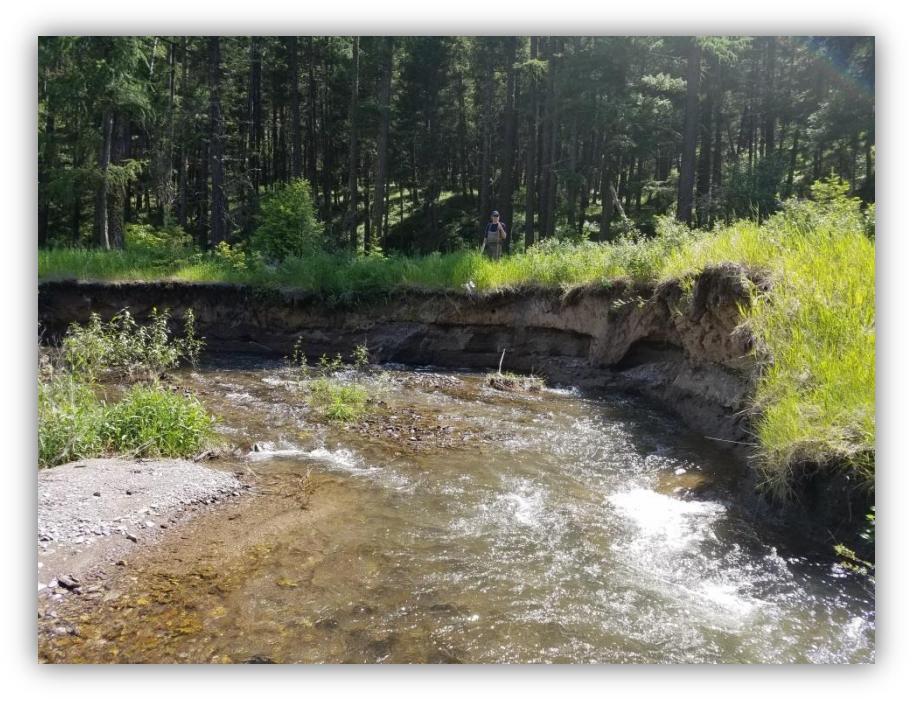
Figure 9. Conditions in the Wustner_1 reach. Note person standing on bank for scale of incision.

This reach of Miller Creek flows through property that is owned by a private entity. Reach length is 0.35 miles. The stream has been relocated to the south side of the valley and straightened throughout most of the reach. This section of stream in very incised and is actively widening. Banks were actively sloughing throughout the reach. The stream is incised 8-10 ft on average throughout the reach – the worst seen in the watershed. The floodplain is disconnected throughout the reach, and dead riparian vegetation was visible because of this. An inset floodplain is forming inside the incised channel (see photo). Pools were minimal in this reach, and there was minimal shade and cover for fish.

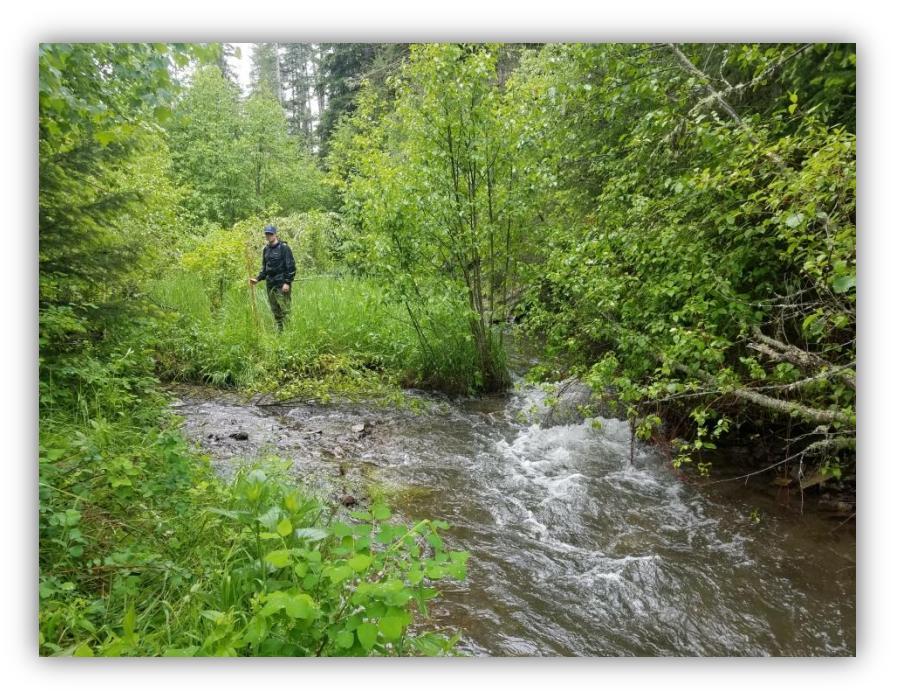
Figure 10. Conditions in the DNRC_1 reach.

This reach of Miller Creek flows through property that is owned by the MT Department of Natural Resources and Conservation. Reach length is 0.13 miles. This reach can be characterized as an incising channel with a thick riparian zone. Although not shown well in the photo for the reach, incision is approximately 6-7 ft on average throughout the reach, with very few bars and low sinuosity in most places. It appears that the channel has been moved to the west side of the valley. The reach consists of mostly fast water, with a slope of 2%, however some wood formed pools were present. Shade is not a limiting factor in this reach, but if incision continues, the floodplain could become more disconnected and the riparian zone could die off.

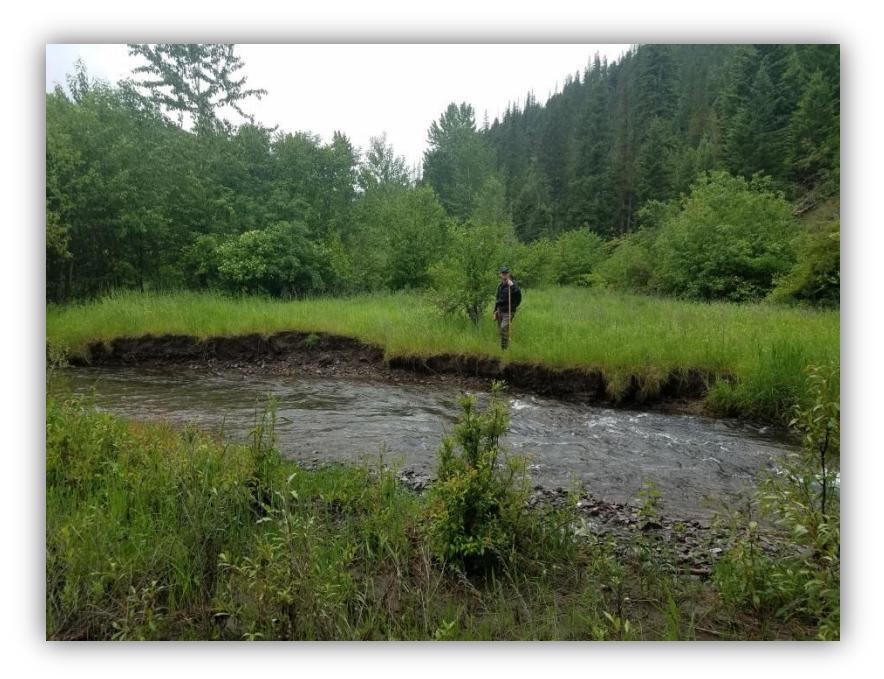
Figure 11. Conditions in the DNRC_2 reach.

This reach of Miller Creek flows through property that is owned by the MT Department of Natural Resources and Conservation. Reach length is 0.22 miles. This reach can be characterized as an actively incising and widening channel with a thick riparian zone. Incision is approximately 2-3 ft on average throughout the reach and there was an extensive amount of lateral bank erosion occurring. The channel moves away from the valley edge, overall is wider, has an inset floodplain, and a decreased slope. However, there were few pools observed in this reach. Shade is not a limiting factor, but if incision continues, the floodplain could become disconnected.

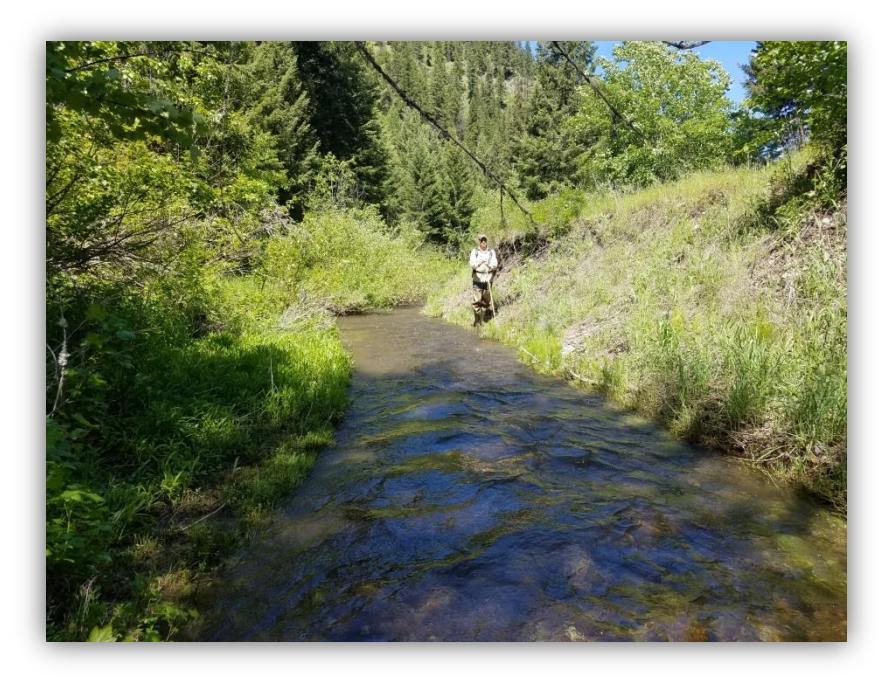
Figure 12. Conditions in the DNRC_3 reach.

This reach of Miller Creek flows through property that is owned by the MT Department of Natural Resources and Conservation. Reach length is 0.25 miles. This reach can be characterized as an incised and widened channel with a thick riparian zone growing on the inset floodplain. The stream here appears to be recovering from a historic incision and widening event. Incision is approximately 5-6 ft on average throughout the reach and there was a minimal amount of active lateral bank erosion occurring. There was an even mix of deep, shallow, large, and small pools observed in this reach. Gravels were partially embedded, and shade was not a limiting factor.

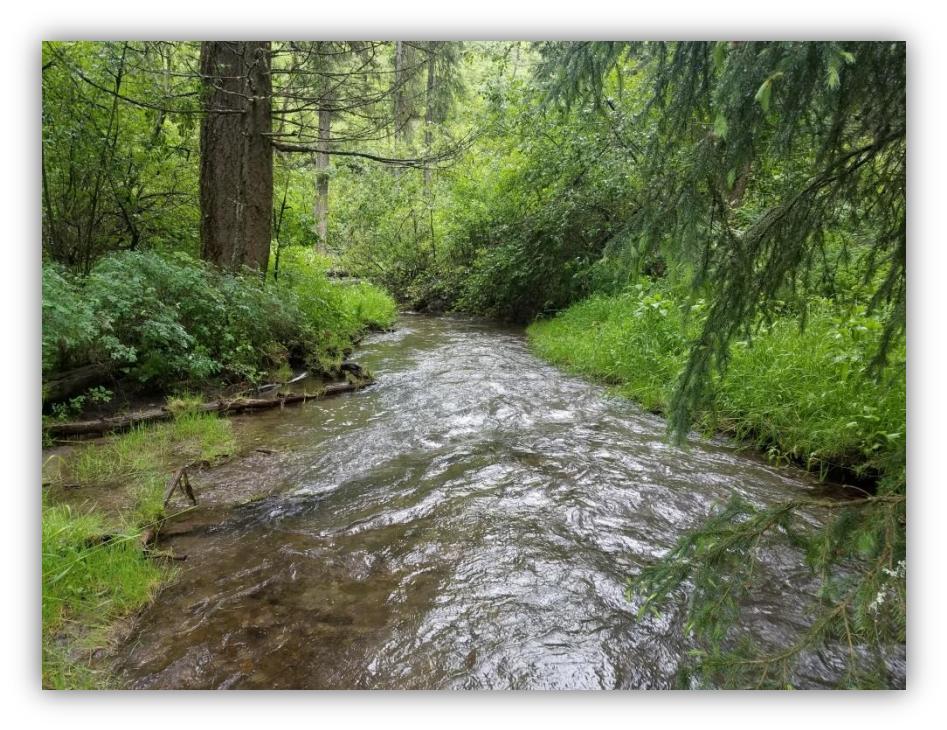
Figure 13. Conditions in the MPG_1 reach.

This reach of Miller Creek flows through property that is owned by the MPG Ranch. Reach length is 0.54 miles. This reach can be characterized as a slightly incised and widened channel with a thick riparian zone growing in the floodplain. Incision is approximately 1-2 ft on average throughout, and an inset floodplain is in the formation process here. The riparian zone was very diverse and thick, with all age classes present. There was an even mix of deep, shallow, large, and small pools observed in this reach. Gravels were partially embedded, and shade was not a limiting factor.

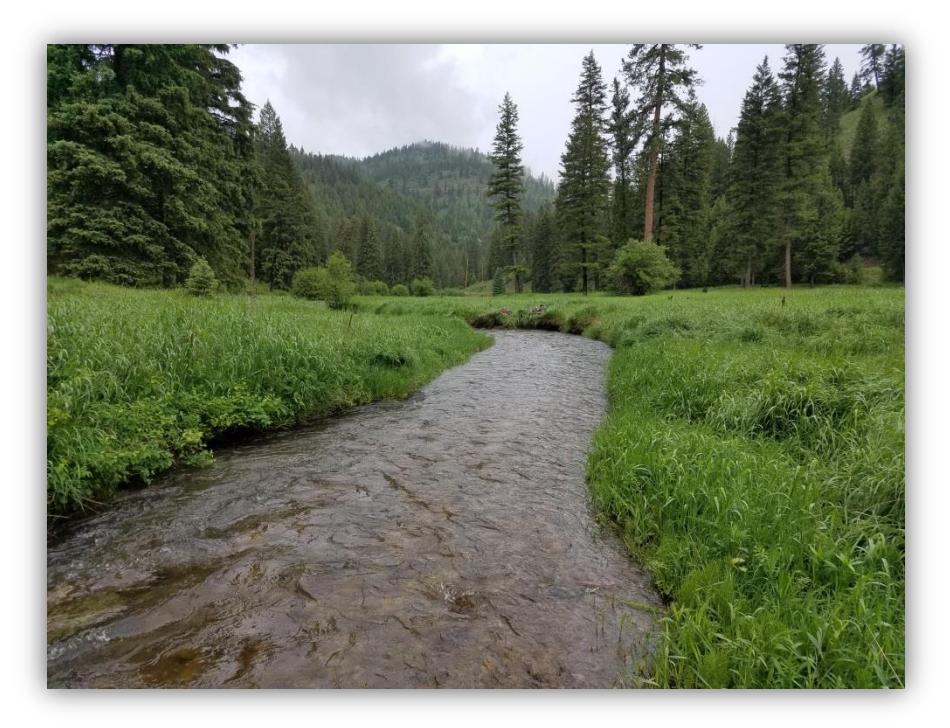
Figure 14. Conditions in the MPG_2 reach.

This reach of Miller Creek flows through property that is owned by the MPG Ranch. Reach length is 0.33 miles. This reach can be characterized as a slightly incised and widened channel with a sparse riparian zone. The riparian zone was dominated by conifer and grass, with very little hardwoods present. Incision is approximately 1-2 ft on average throughout, and increases to 4 ft at the upstream end of the reach (as shown in Figure x). There was an even mix of deep, shallow, large, and small pools observed in this reach. Gravels were partially embedded, and shade was not a limiting factor.

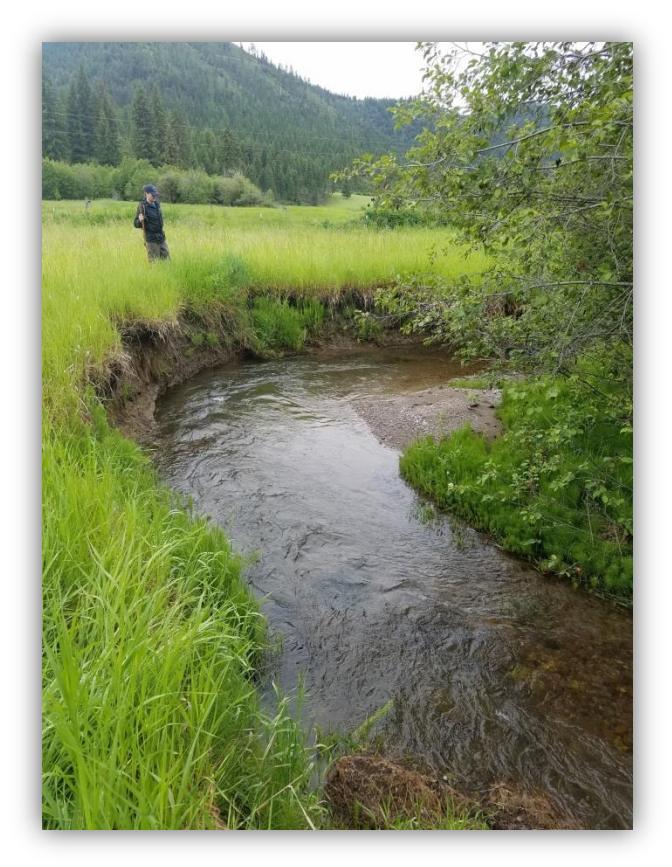
Figure 15. Conditions in the Spooner_1 reach.

This reach of Miller Creek flows through property that is owned by a private entity. Reach length is 0.73 miles. This reach can be characterized as an actively incising and widening channel with a riparian zone beginning to establish in an inset floodplain. Incision is approximately 4-5 ft on average throughout the reach and there was an extensive amount of active lateral bank erosion occurring. There is a definitive lack of riparian hardwood vegetation in this reach and the dominant riparian vegetation is grasses.

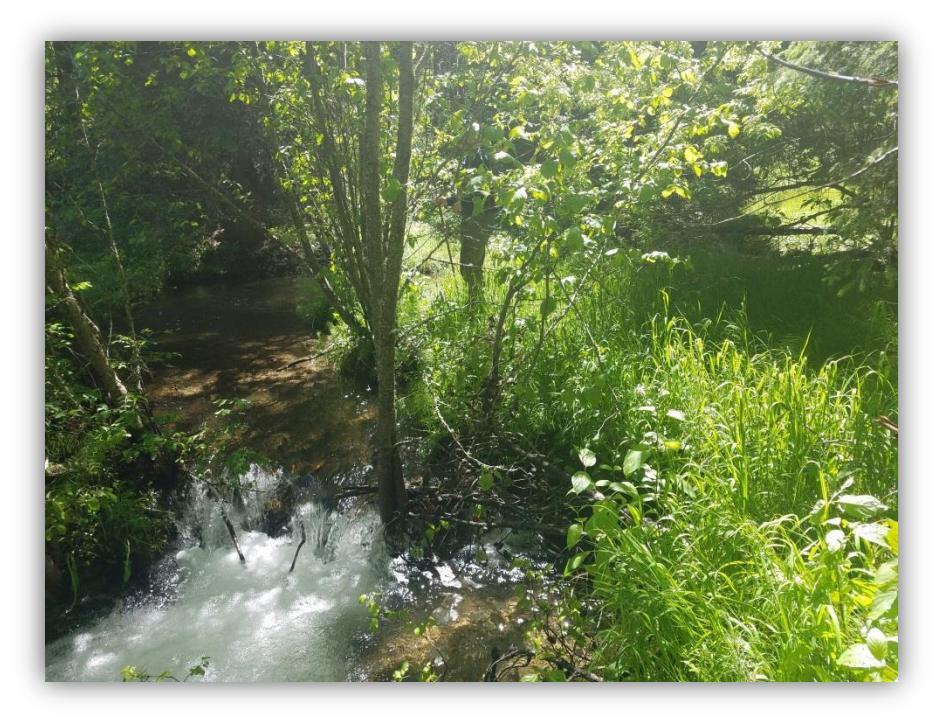
Figure 16. Conditions in the USFS_1 reach.

This reach of Miller Creek flows through property that is owned by the U.S. Forest Service. Reach length is 0.19 miles. This reach can be characterized as an actively incising narrow channel with minimal lateral bank erosion. Incision is approximately 2 ft on average throughout the reach. The riparian zone consists mainly of alder with a conifer overstory. Shade is not a limiting factor in this reach. Gravels were embedded in fine sediment and there was a lack of bars present. The instream habitat in this reach was homogenized with few pools present, likely due to incision.

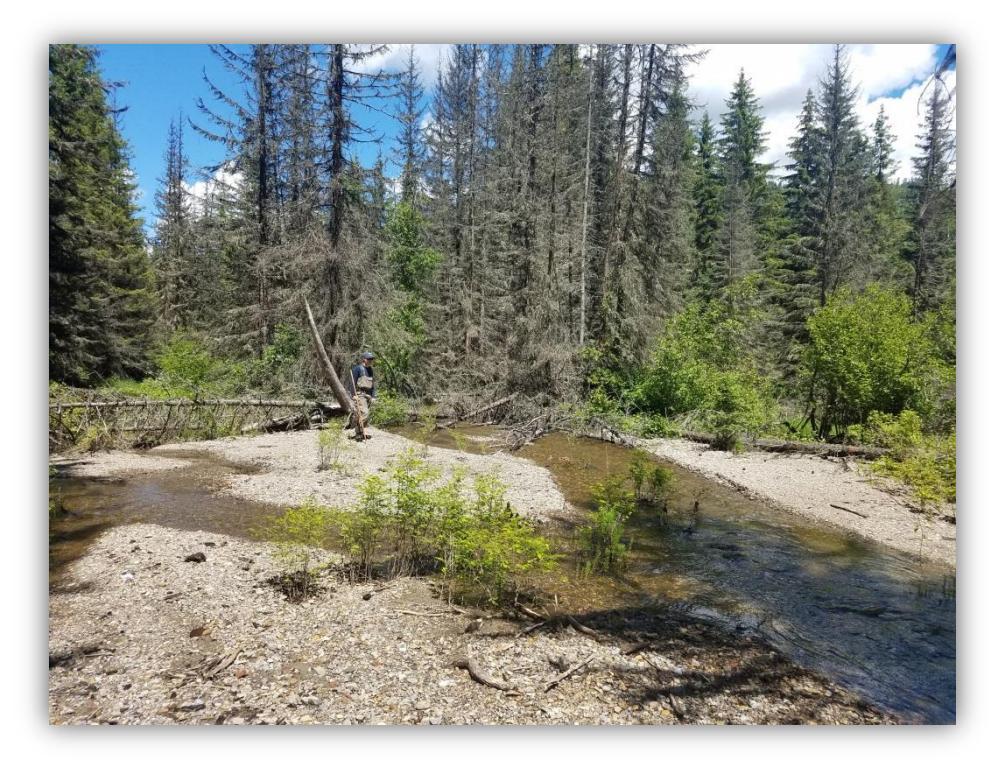
Figure 17. Conditions at the upstream end of the USFS_2 reach.

This reach of Miller Creek flows through property that is owned by the U.S. Forest Service. Reach length is short, at 0.11 miles. This reach is recovering from a large input of sediment. It can be characterized as a highly braided network of channels with a decadent riparian zone. As you move upstream, the channel type goes from a DA with 2-3 gravel bed channels, to a D type with many unstable, newly formed, soil bottom channels. The sediment plug causing this was clearly visible at the upstream end of the reach (shown in Figure x). The source of the sediment was not easily found, and the reason for its deposition is suspected to be the location in the watershed. The valley walls widen in this section, so perhaps this is a naturally occurring location for sediment deposition. The riparian zone consists mainly of alder with a conifer overstory, which is dying in the upstream end of the reach (shown in Figure x). Shade is not a limiting factor in this reach.

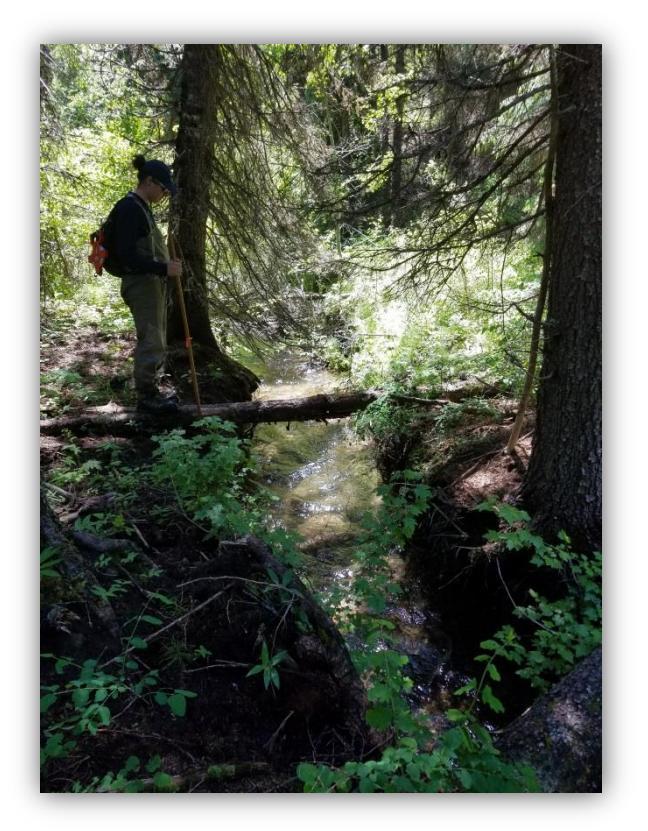
Figure 18. Conditions in the USFS_3 reach.

This reach of Miller Creek flows through property that is owned by the U.S. Forest Service. Reach length is 0.07 miles. This reach can be characterized as an actively incising narrow channel that is beginning to widen in portions of the reach. Incision is approximately 3 ft on average throughout the reach and was as high as 6' in some places. The lowermost 30-40 ft of the reach was dammed up with water, and the channel was filled to bankfull as a backwater effect from the sediment plug at the upstream end of reach USFS_2. Fish were observed in this backwater section. The riparian zone consists mainly of snowberry, with an alder understory and conifer overstory in some places. Gravels were embedded in fine sediment. The instream habitat in this reach was homogenized with few pools present, likely due to incision.

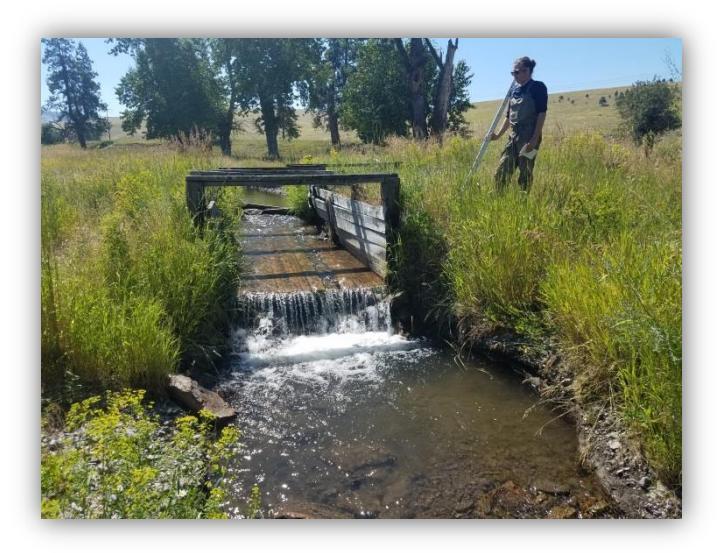
The fish jump height at the lower Oxbow Cattle Company stream diversion was measured at 2.2 ft and the water surface slope from downstream of the diversion to upstream of the diversion was measured at 4.5%.

Figure 19. The lower Oxbow Cattle Company stream diversion.

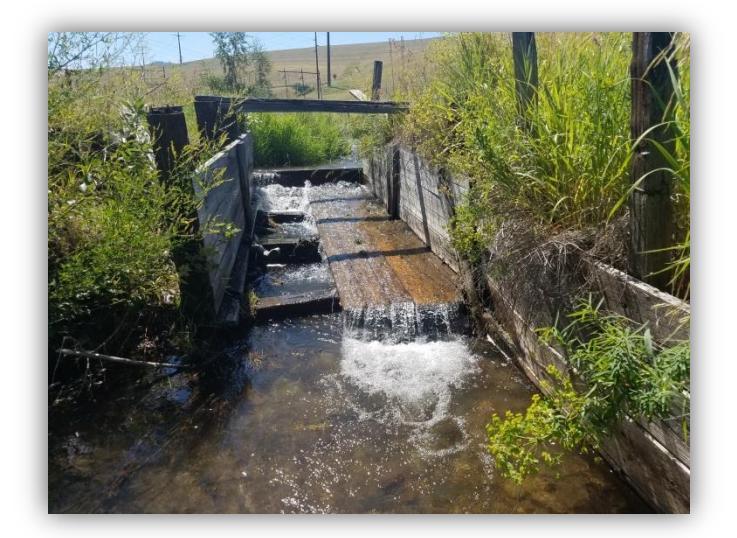
The fish jump height at the middle Oxbow Cattle Company stream diversion was a combined 2.7 ft and the water surface slope from downstream of the diversion to upstream of the diversion was measured at 4.0%.

Figure 20. The middle Oxbow Cattle Company stream diversion.

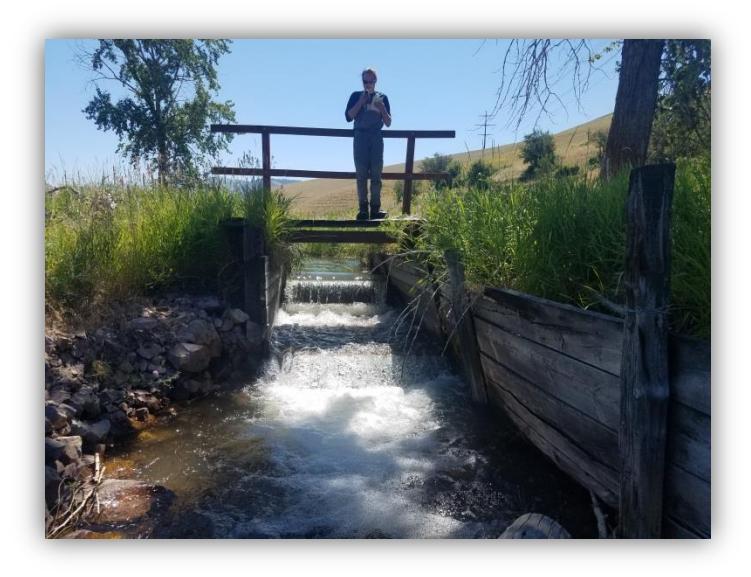
The fish jump height at the upper Oxbow Cattle Company stream diversion was measured to have a combined fish jump height of 3.4 ft and the water surface slope from downstream of the diversion to upstream of the diversion was measured at 7.0%.

Figure 21. The upper Oxbow Cattle Company stream diversion.

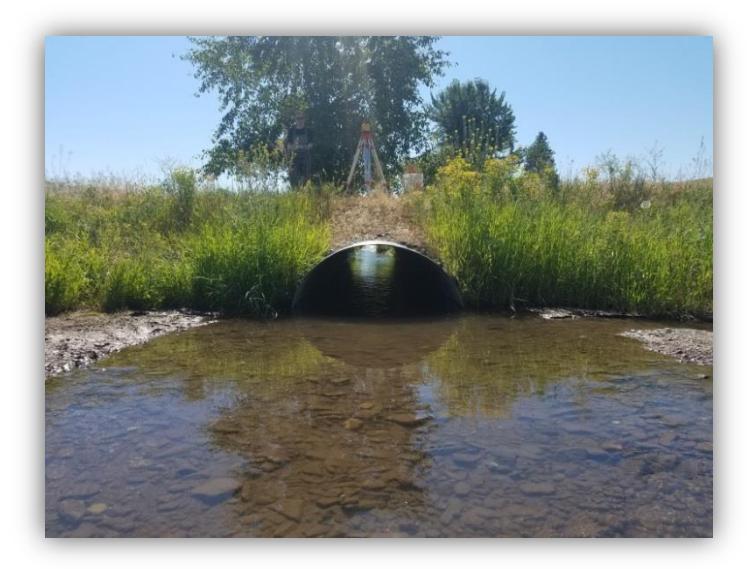
The Haugan Drive culvert is an open bottom arch culvert that was placed at grade, as there was no fish jump at the outlet. The gradient of the stream through the culvert was 0.5%. Based off of USFS fish passage evaluation criteria (USFS, 2008), this crossing was rated as "Gray" because the culvert width to bankfull width ratio was less than 0.7 and there was no resting habitat immediately upstream of the crossing. Further analysis will have to determine the exact barrier type, but this crossing is likely a velocity barrier to juvenile salmonids at high flows.

Figure 22. The outlet of the Haugan Drive crossing.

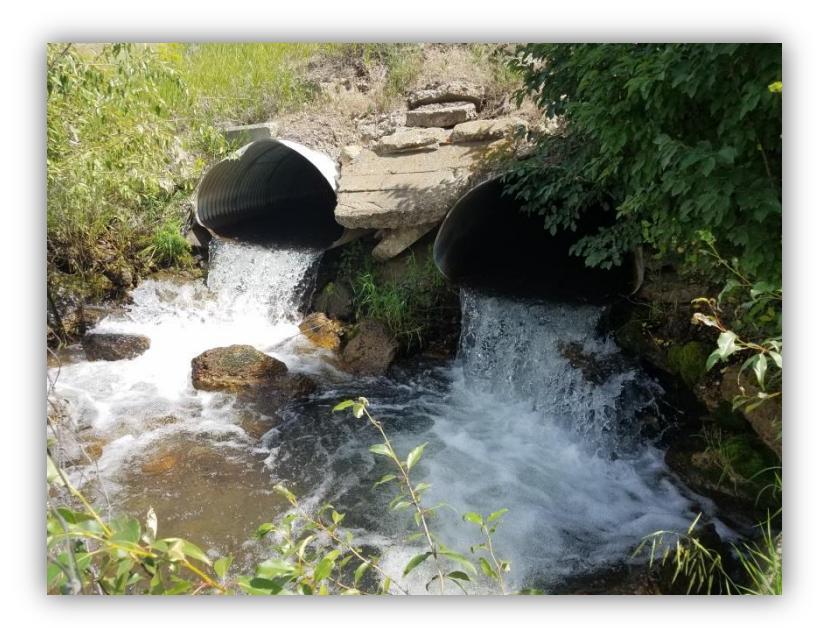
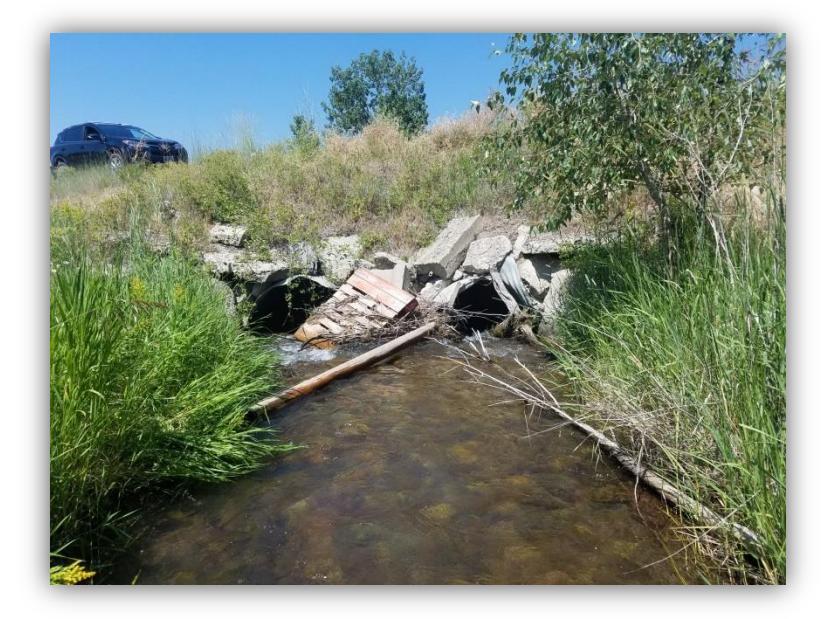
The Trails End Road crossing is a double barrel style crossing consisting of two corrugated metal pipes that are 3.9 (right bank) and 4.8 ft (left bank) in diameter. The outlet of the left bank culvert had a fish jump height of 2.1 ft and the gradient of the culvert was measured to be 2.5%. The outlet of the right bank culvert had a fish jump height of 2.3 ft and the gradient of the culvert was measured to be 3.7%. Based off of USFS fish passage evaluation criteria (USFS, 2008), both culverts were rated as total barriers to all life stages of salmonids due to the fish jump height at the outlets, and the slope, length, and diameter of the culverts.

Figure 23. The outlet (top photo) and inlet (bottom photo) of the Trails End Road crossing.

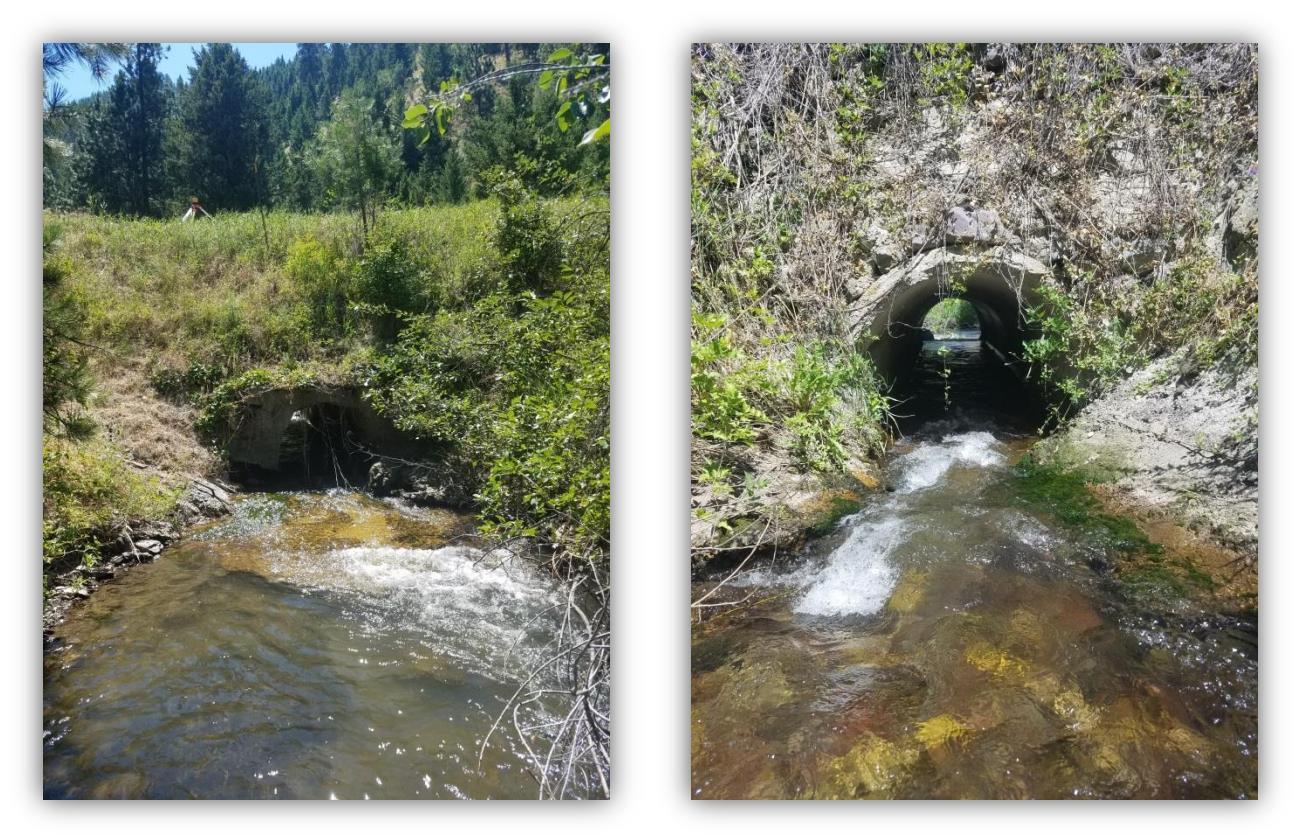
The Krempel Private Drive culvert is a 4.3 ft diameter concrete culvert with a concrete apron at the outlet. While there was no change in elevation at the outlet of the culvert, there was a 0.9 ft change in elevation (i.e. fish jump height) at the outlet of the apron. The gradient of the culvert was measured to be 1.2%. This crossing did not appear to be a fish passage barrier at the outlet of the apron at these flows (date of survey was July 23, 2018), but at base flows the apron could be an impediment to fish passage. There was visual evidence of water ponding up at the inlet, causing scour of the road fill, indicating that this culvert is undersized. Based off of USFS fish passage evaluation criteria (USFS, 2008), this crossing was rated as "Red" (total barrier) to juvenile salmonids based off of the fish jump height at the apron outlet, and the slope, length, and diameter of the culvert.

Figure 24. The outlet (left) and inlet (right) of the Krempel Private Drive crossing.

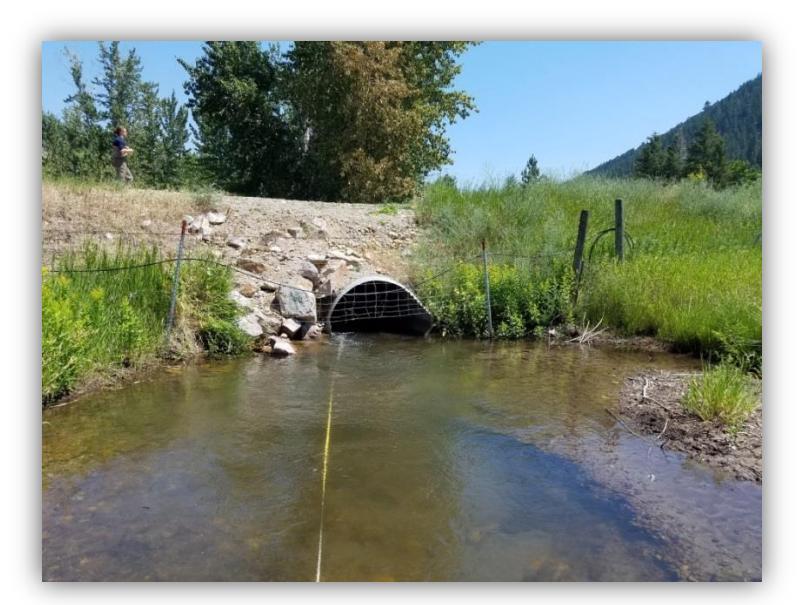
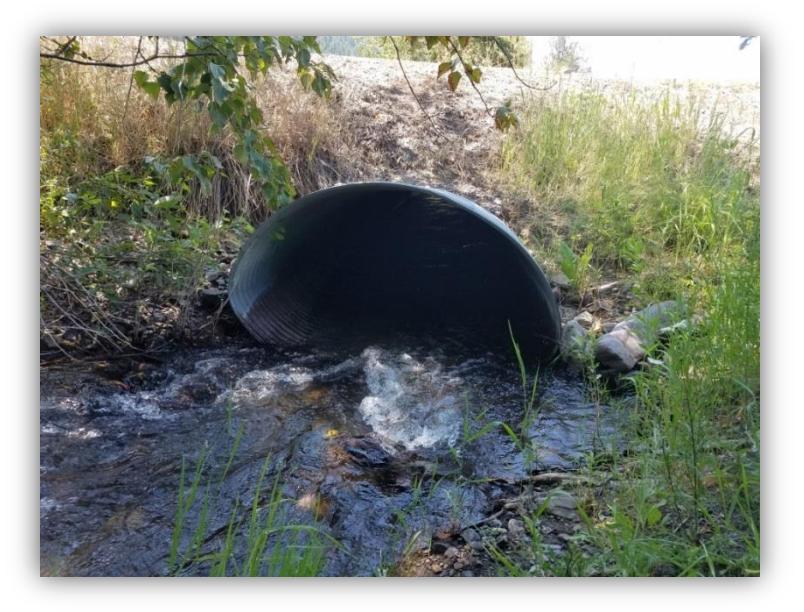
The Lost Mine Loop Road has two crossings with Miller Creek. The lower crossing is a 5.5 ft diameter squashed corrugated metal pipe (the upper crossing is a bridge and was not surveyed). While there was no drop in water at the outlet of the culvert at these flows, there was a 0.3 ft change in elevation from the outlet of the culvert to the channel bed. The slope of the culvert was measured to be 4.4%. Based off of USFS fish passage evaluation criteria (USFS, 2008), this crossing was rated as "Gray" because the culvert width to bankfull width ratio was less than 0.7 and the residual inlet depth is less than 0.34 ft. Further analysis will have to determine the exact barrier type, but this crossing is likely a velocity barrier to juvenile salmonids at high flows.

Figure 25. The outlet (top photo) and inlet (bottom photo) of the lower culvert on Lost Mine Loop Road.

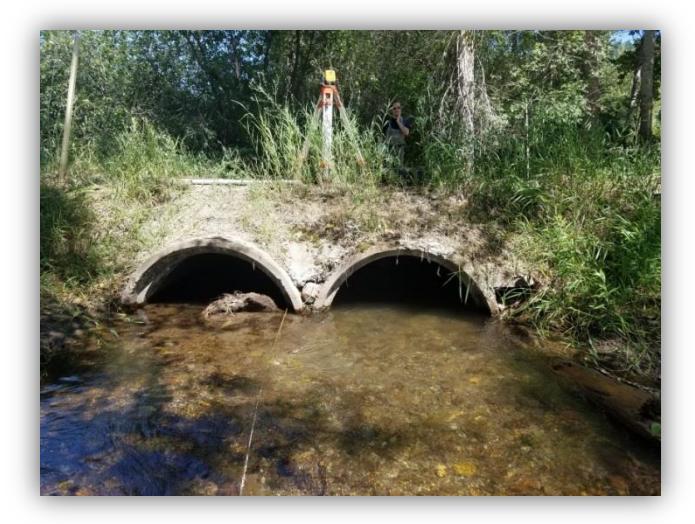
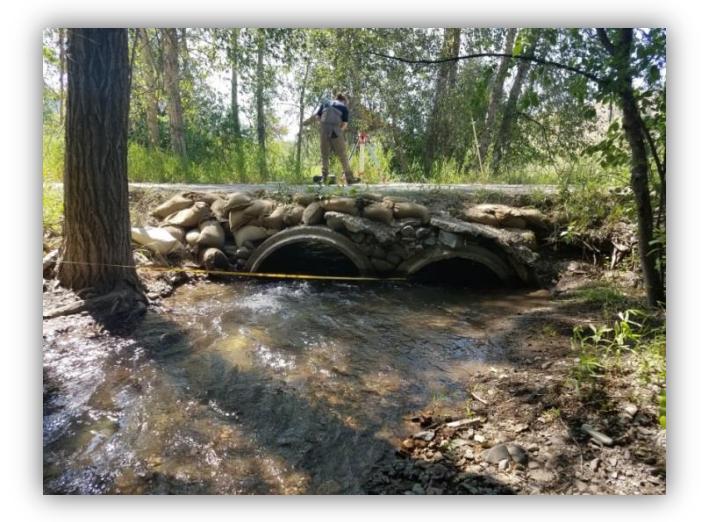
The Singletree Lane crossing consists of two aged double barrel concrete culverts that are 3.5 ft in diameter each. Both culverts are partially plugged with sediment (Figure x) and are clearly undersized as there is an extremely large amount of sediment (~1185 cy) deposited upstream of the crossing, and much more has been deposited downstream. Based off of the size of the sediment plug, this issue appears to have been ongoing for decades. Due to the large amount of sediment deposited downstream of the crossing, the channel has avulsed there, and a portion of the water was flowing into Singletree Lane at the time of survey (July 18, 2018). Although there were sandbags placed in the stream to prevent this from happening, some flow was still escaping into the road and traveling 500 feet along the road before flowing back into Miller Creek. Additionally, upstream of the crossing, during high flows, the stream has formed a side channel that flows over the road, and into the avulsion downstream along the road. Sandbags were also placed around the inlet to prevent erosion of the road fill (Figure x). Based off of USFS fish passage evaluation criteria (USFS, 2008), this crossing was rated as "Gray" because the culvert width to bankfull width ratio was less than 0.7 and there was no resting habitat immediately upstream of the crossing. Further analysis will have to determine the exact barrier type, but this crossing is likely a velocity barrier to juvenile salmonids at high flows.

Figure 26. The outlet (left photo) and inlet (right photo) of the Singletree Lane crossing.
