REPORT ON THE EFFECTS OF 90 MW AND 50 MW  
PEAKING POWER TEST SPILLS ON LAKE HELENA,  
THE CAUSEWAY, HAUSER LAKE, AND TROUT CREEK.

Test Spills from Canyon Ferry Dam

Occurring 7/21-7/23, 1981.

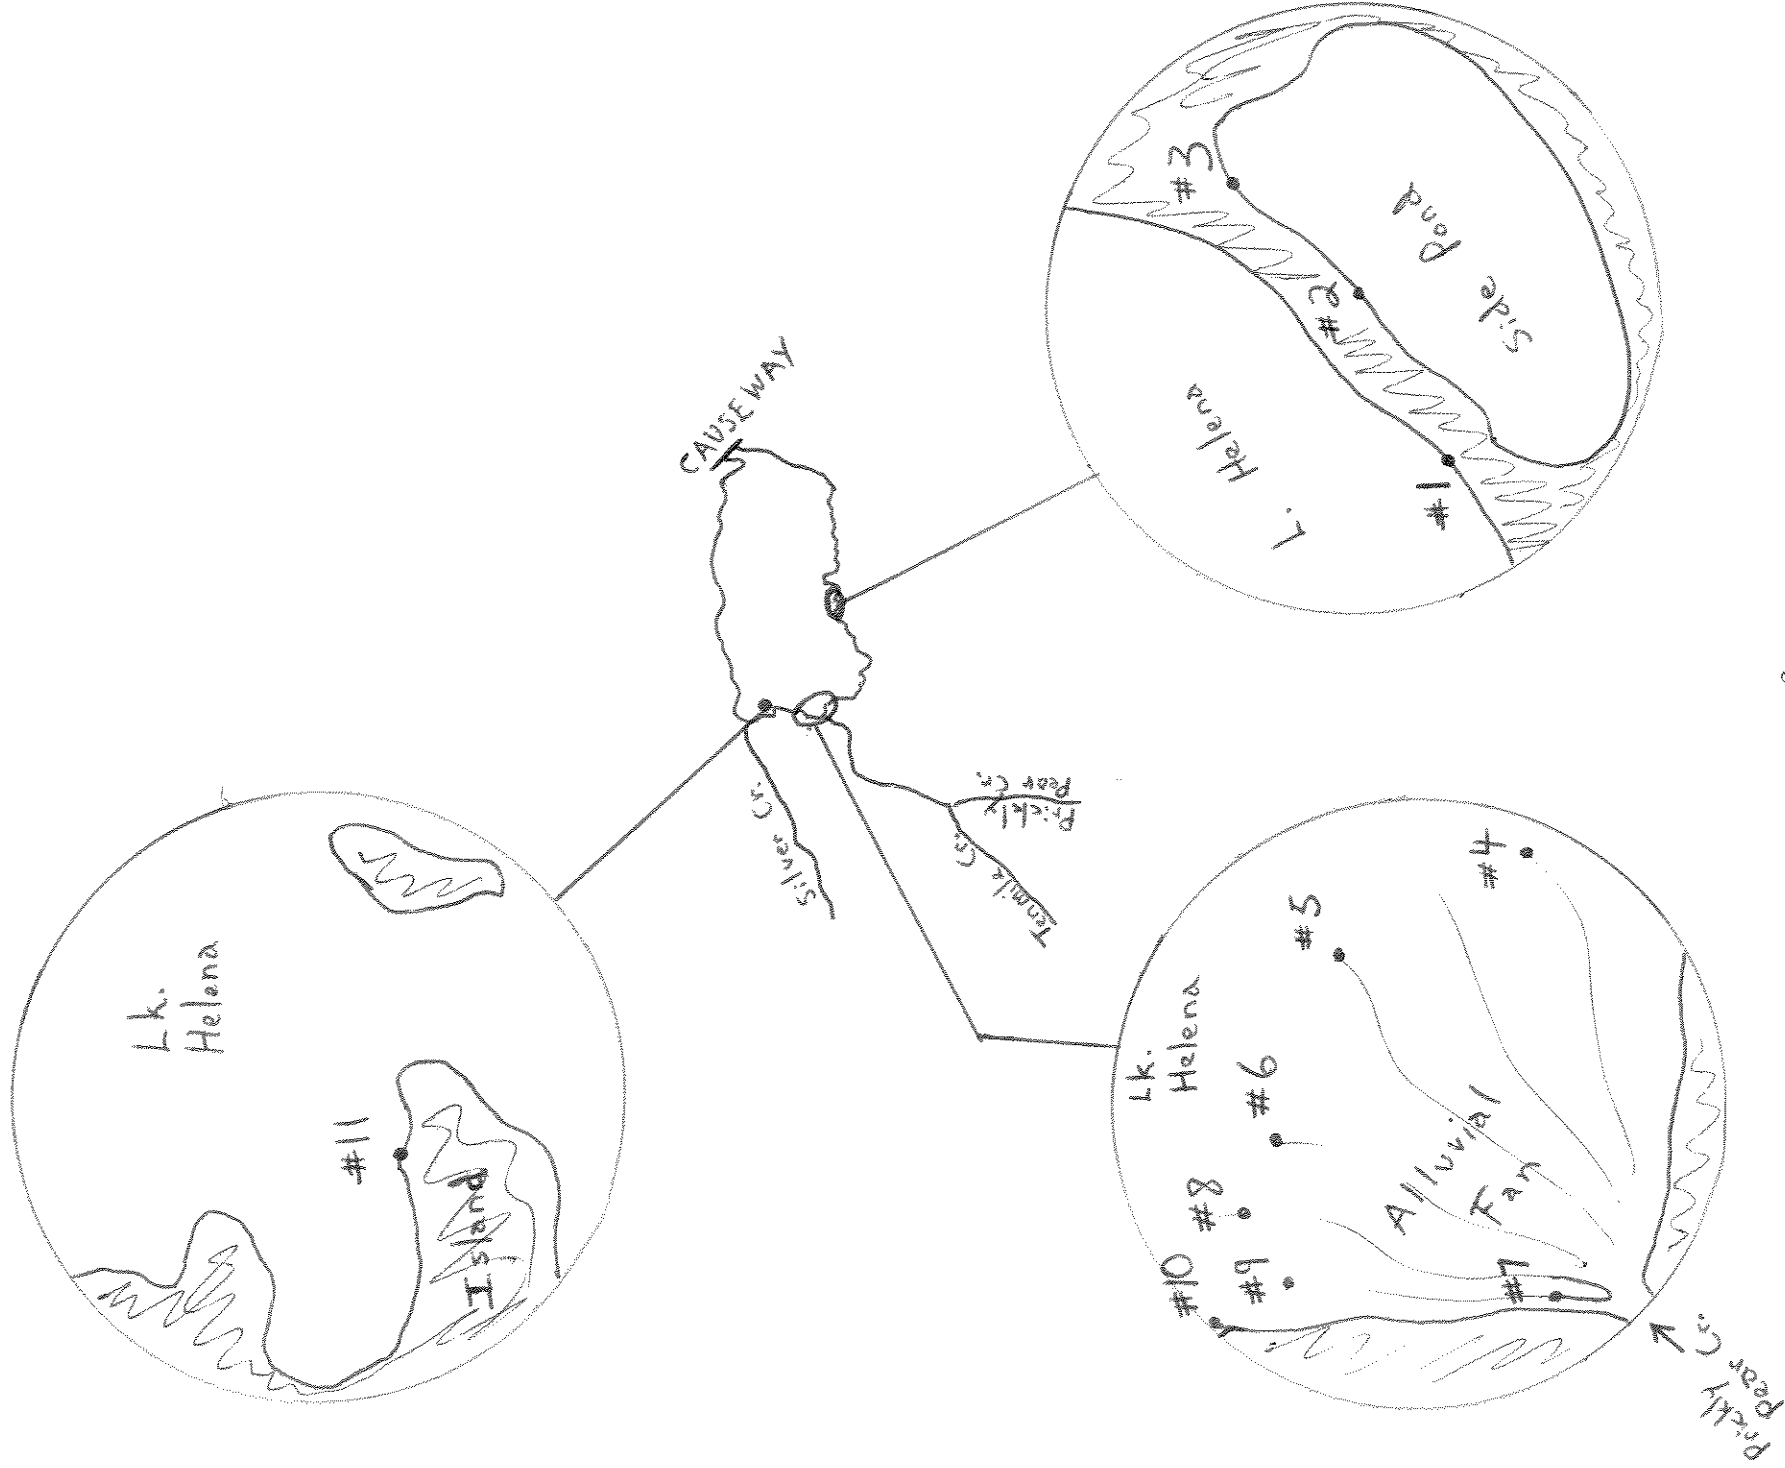
# Locations of 11 Stakes in Lake Helena :

Eleven stakes were placed in Lake Helena at about 4 p.m. on July 21, 1981 prior to drawdown for the 90 mw test spill. These stakes were placed at the waters edge on the maximum extension of point bars wherever possible. The distance from the stakes to water's edge was measured at about 7:00 a.m. on July 22 following the drawdown of the 90 mw test and again at about 7:00 a.m. on July 23 following drawdown for the 50 mw test. Results of this were as follows:

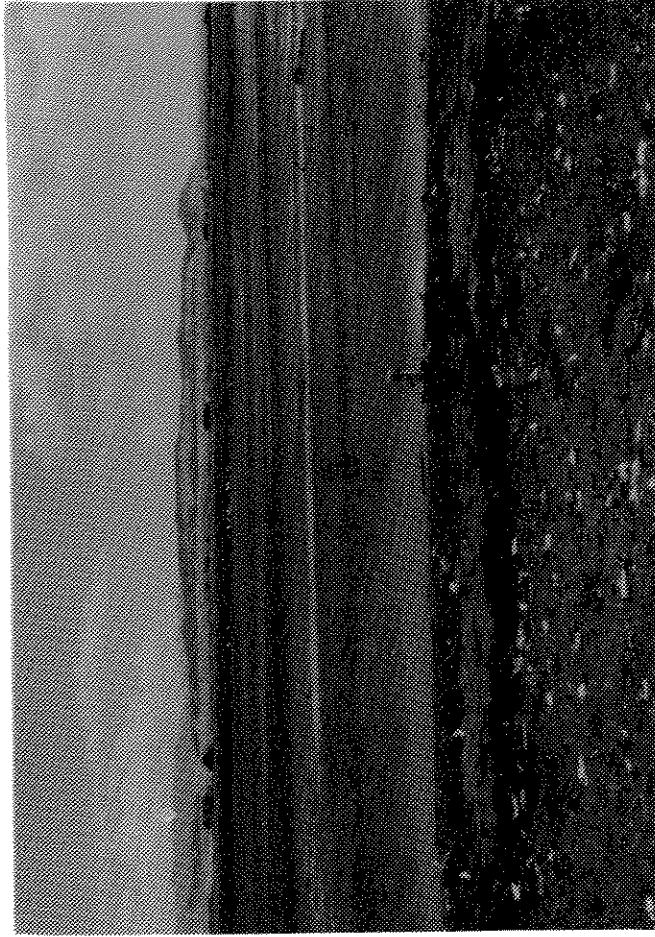
#1

Stake #6 - 7/21-4 p.m.

Showing placement of stake at water's edge in Lake Helena prior to drawdown. Note gulls resting on mud bar that is barely under water.

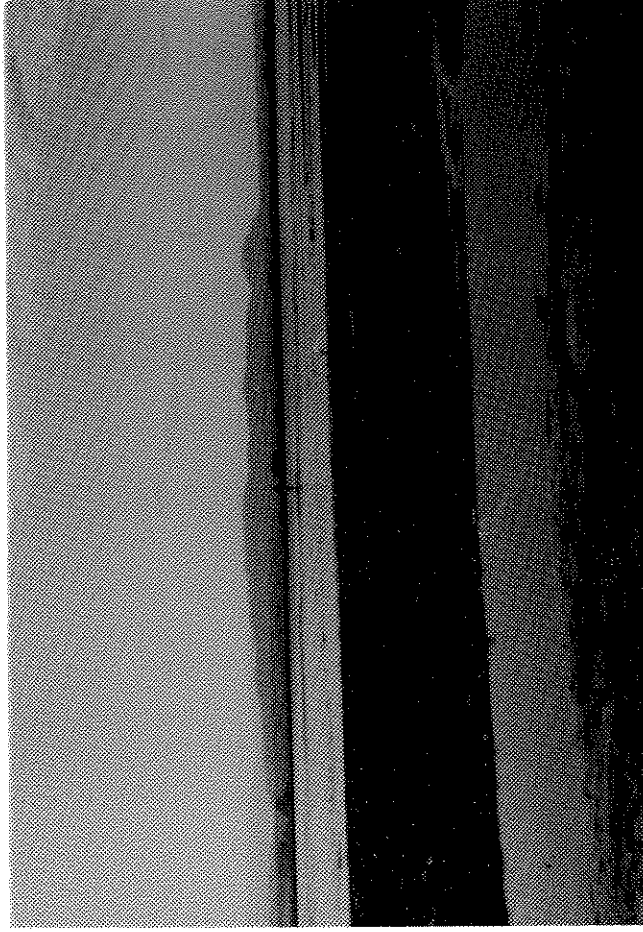
#2

| Stake No. | Distance to Water's Edge | |
|---|---|---|
| ** 6 | 284.0 | 282.0 |

Stake #6 - 7/22-7 a.m.

After drawdown for 90 mw test. Note fieldworker standing at same place as gulls in previous photo, mud bar now exposed.

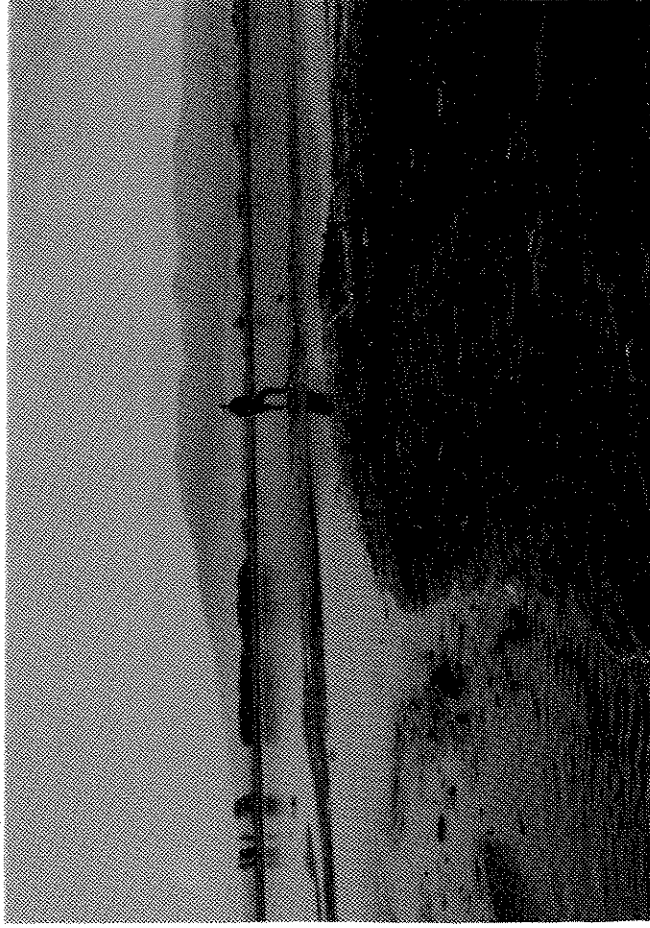
#3

| Stake No. | Distance to Water's Edge | |
|---|---|---|
| * 4 | 84.0 | 86.0 |

Stake #4 - 7/22-7 a.m.

After 90 mw drawdown. Stake placed at water's edge on 7/21 prior to drawdown is now 84 ft. from point where fieldworker is standing.

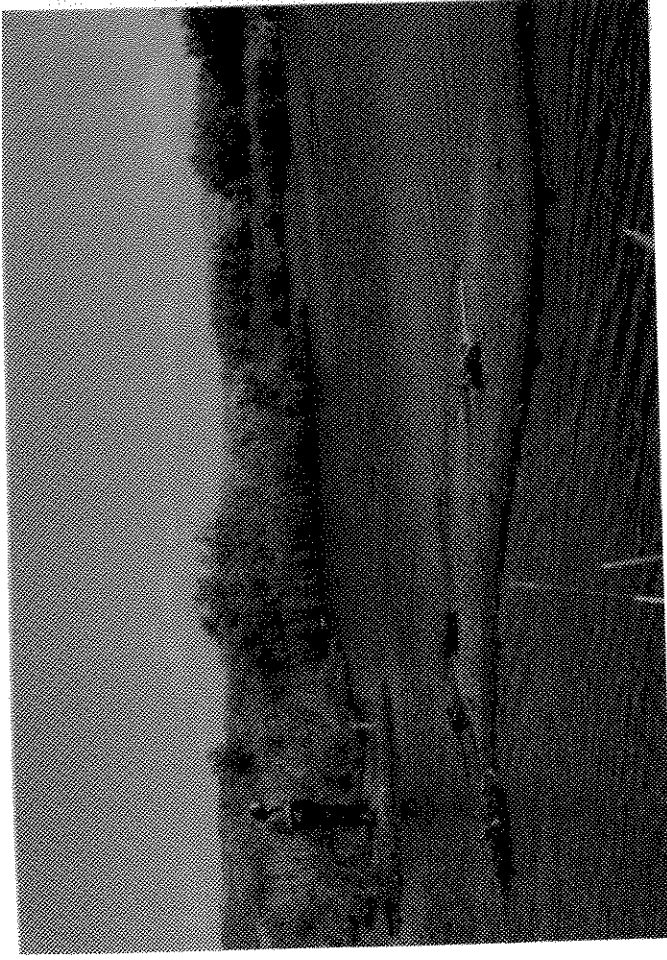
#4

Stake #11 - 7/21-4 p.m.

Showing placement of stake at water's edge, prior to test spills.

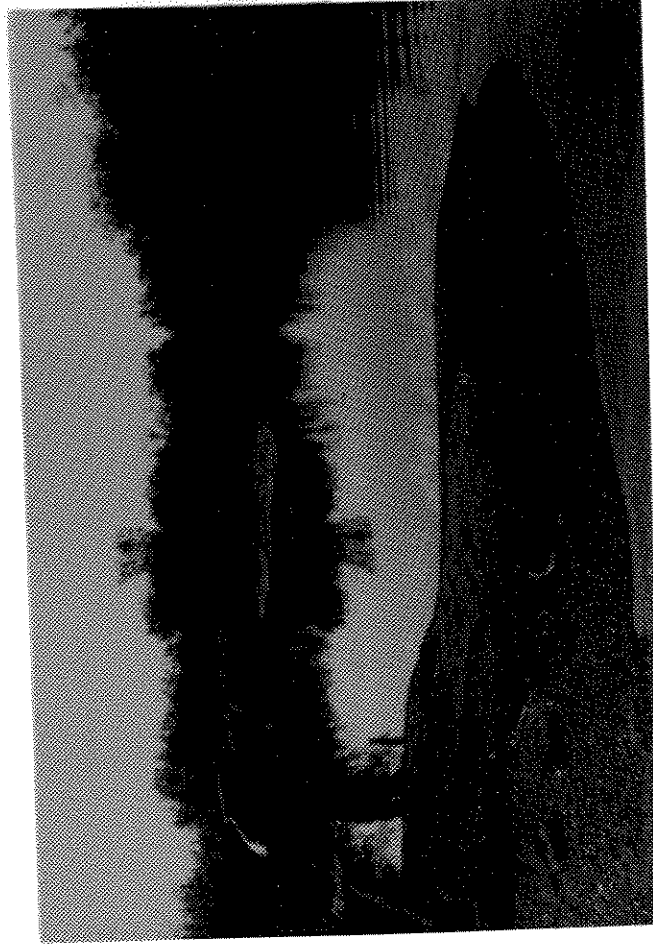
#5

| Stake No. | Distance to Water's Edge | |
|---|---|---|
| *** 11 | 1.8 | 1.9 |

Stake #11 - 7/22-7 a.m.

After 90 mw test. Stake is only 1.8 feet from water's edge but note mud flat exposed in back of bay.

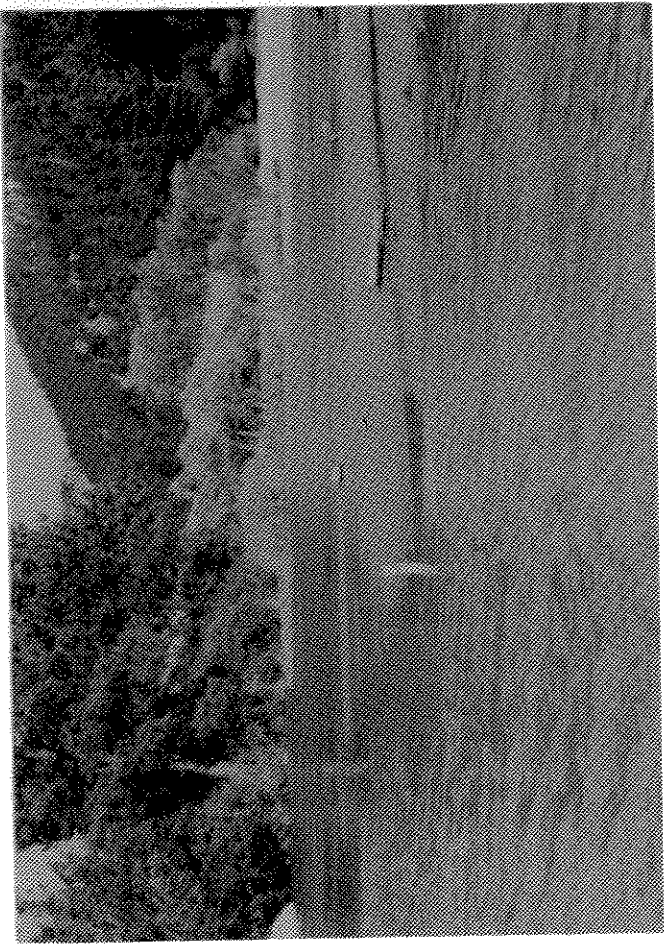
#7

The delta at the mouth of Trout Creek was examined before and after the 90 mw test drawdown. At about 9 p.m. on July 21 the drawdown had already begun and two stakes were placed on point bars at the mouth of the creek. We returned to the site at about 10 a.m. on July 22 after the water level of Hauser Lake had already begun to rise again following drawdown for the 90 mw test spill. The two stakes were 16' and 25' from the water's edge at this point and the water level was down 0.9 feet from the previous day.

Trout Creek - 7/21, 9 p.m.

Showing placement of stake at water's edge. 90 mm test has begun and some drawdown has already occurred. Note rock and log in back of stake, compare to photo at bottom of this page.

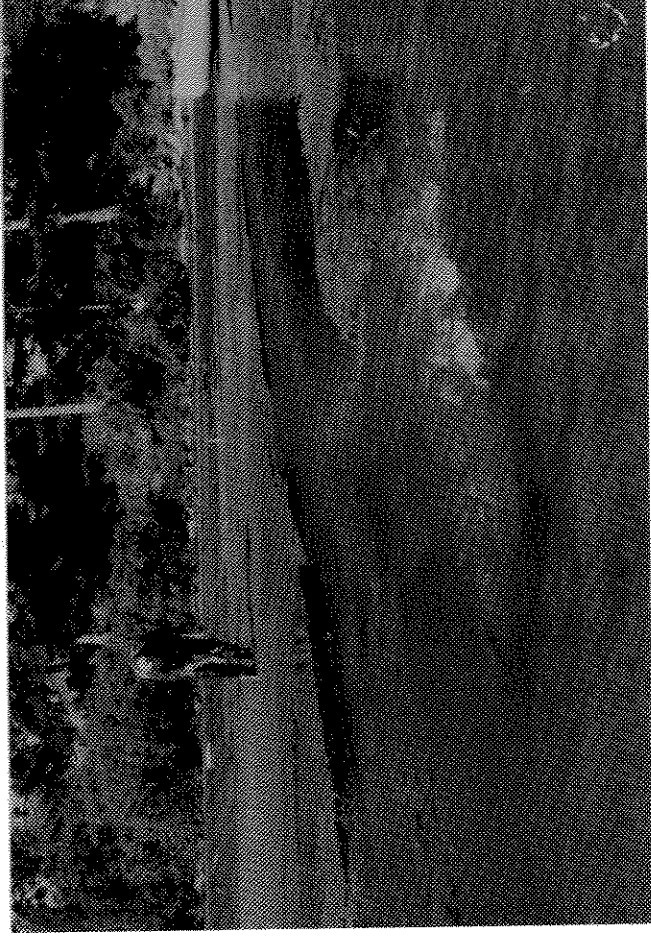
On July 21 the creek spread out in a fan-shaped configuration on July 22 the fan had been reduced to three main channels as the creek cut down into the delta. Some mud and silt had been moved downstream causing increased turbidity in the immediate vicinity of the creek mouth.

Trout Creek - 7/22, 10 a.m. #8

Looking downstream towards mouth. This photo shows cutting that has occurred on delta. Turbidity was increased in immediate vicinity of creek mouth.

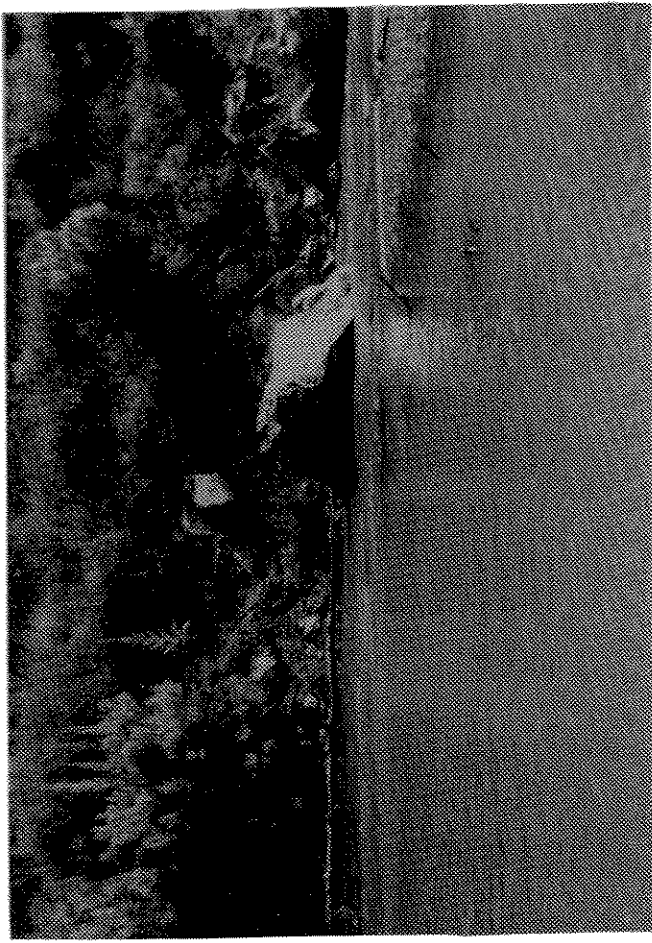
#10

Trout Creek - 7/22, 10 a.m.

After drawdown for 90 mw test.  
Fieldworker is measuring  
distance from high-water  
mark of previous day on boulder,  
0.9 ft. but has already come  
up some this a.m.

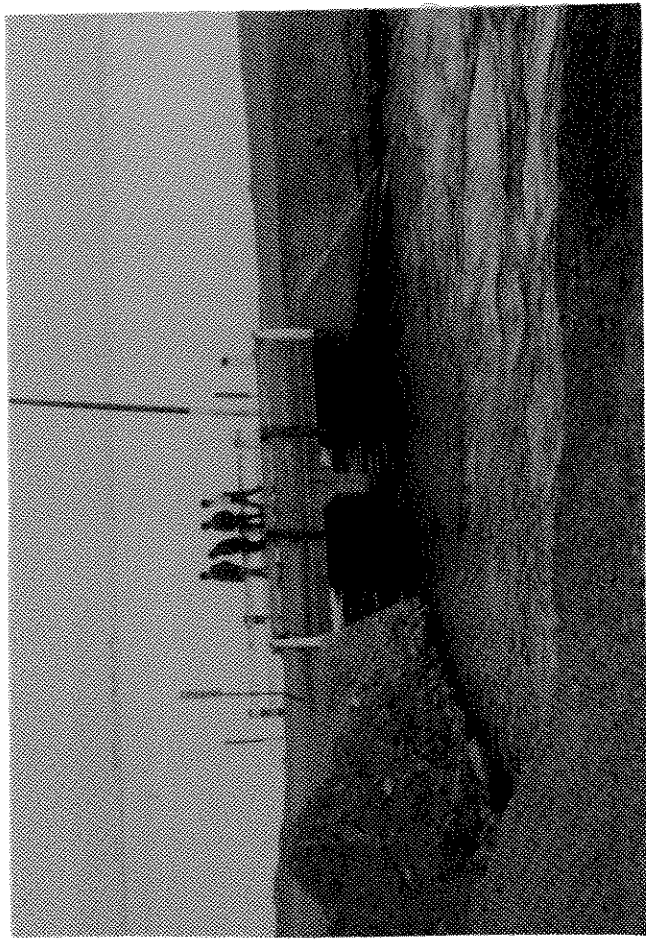
#11

Rectangular concrete - Water depth varied from 8.8-9.8 ft. at various levels. See photo #11.

Lake Helena Causeway

7/23 - 7 a.m.

Water flowing into Hauser  
Lake.
