## Restoration of Little Prickly Pear Creek at Sieben Ranch, Montana

Status Report for PPL-Montana FERC Project 2188

MoTAC Project 760-13

January 2015

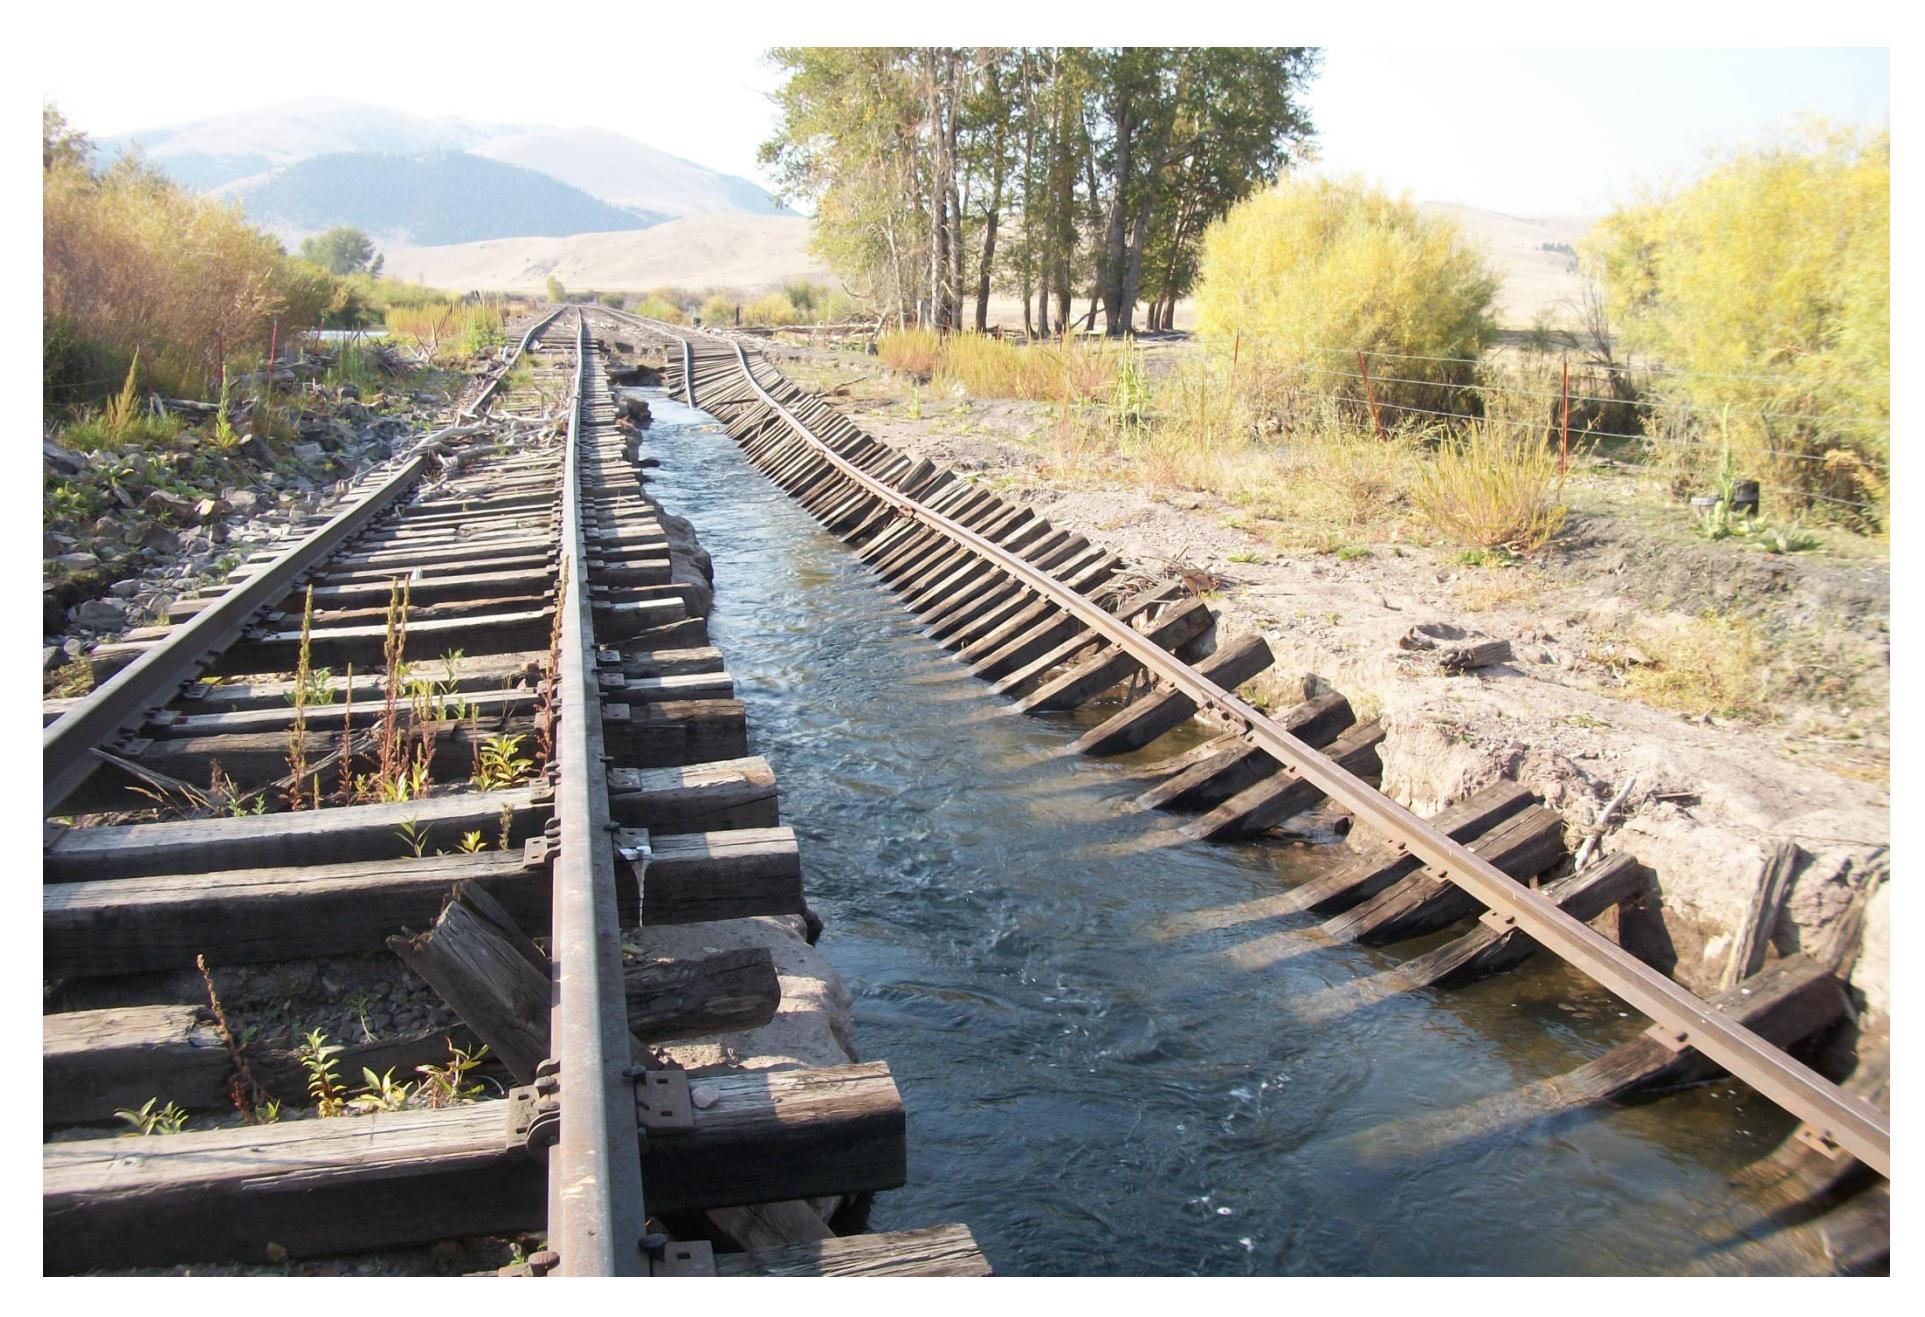
Figure 2. LPP Creek at Sieben showing erosion into BNSF railroad grade and stream flowing through railroad ties. site #3 Sieben, Mt.

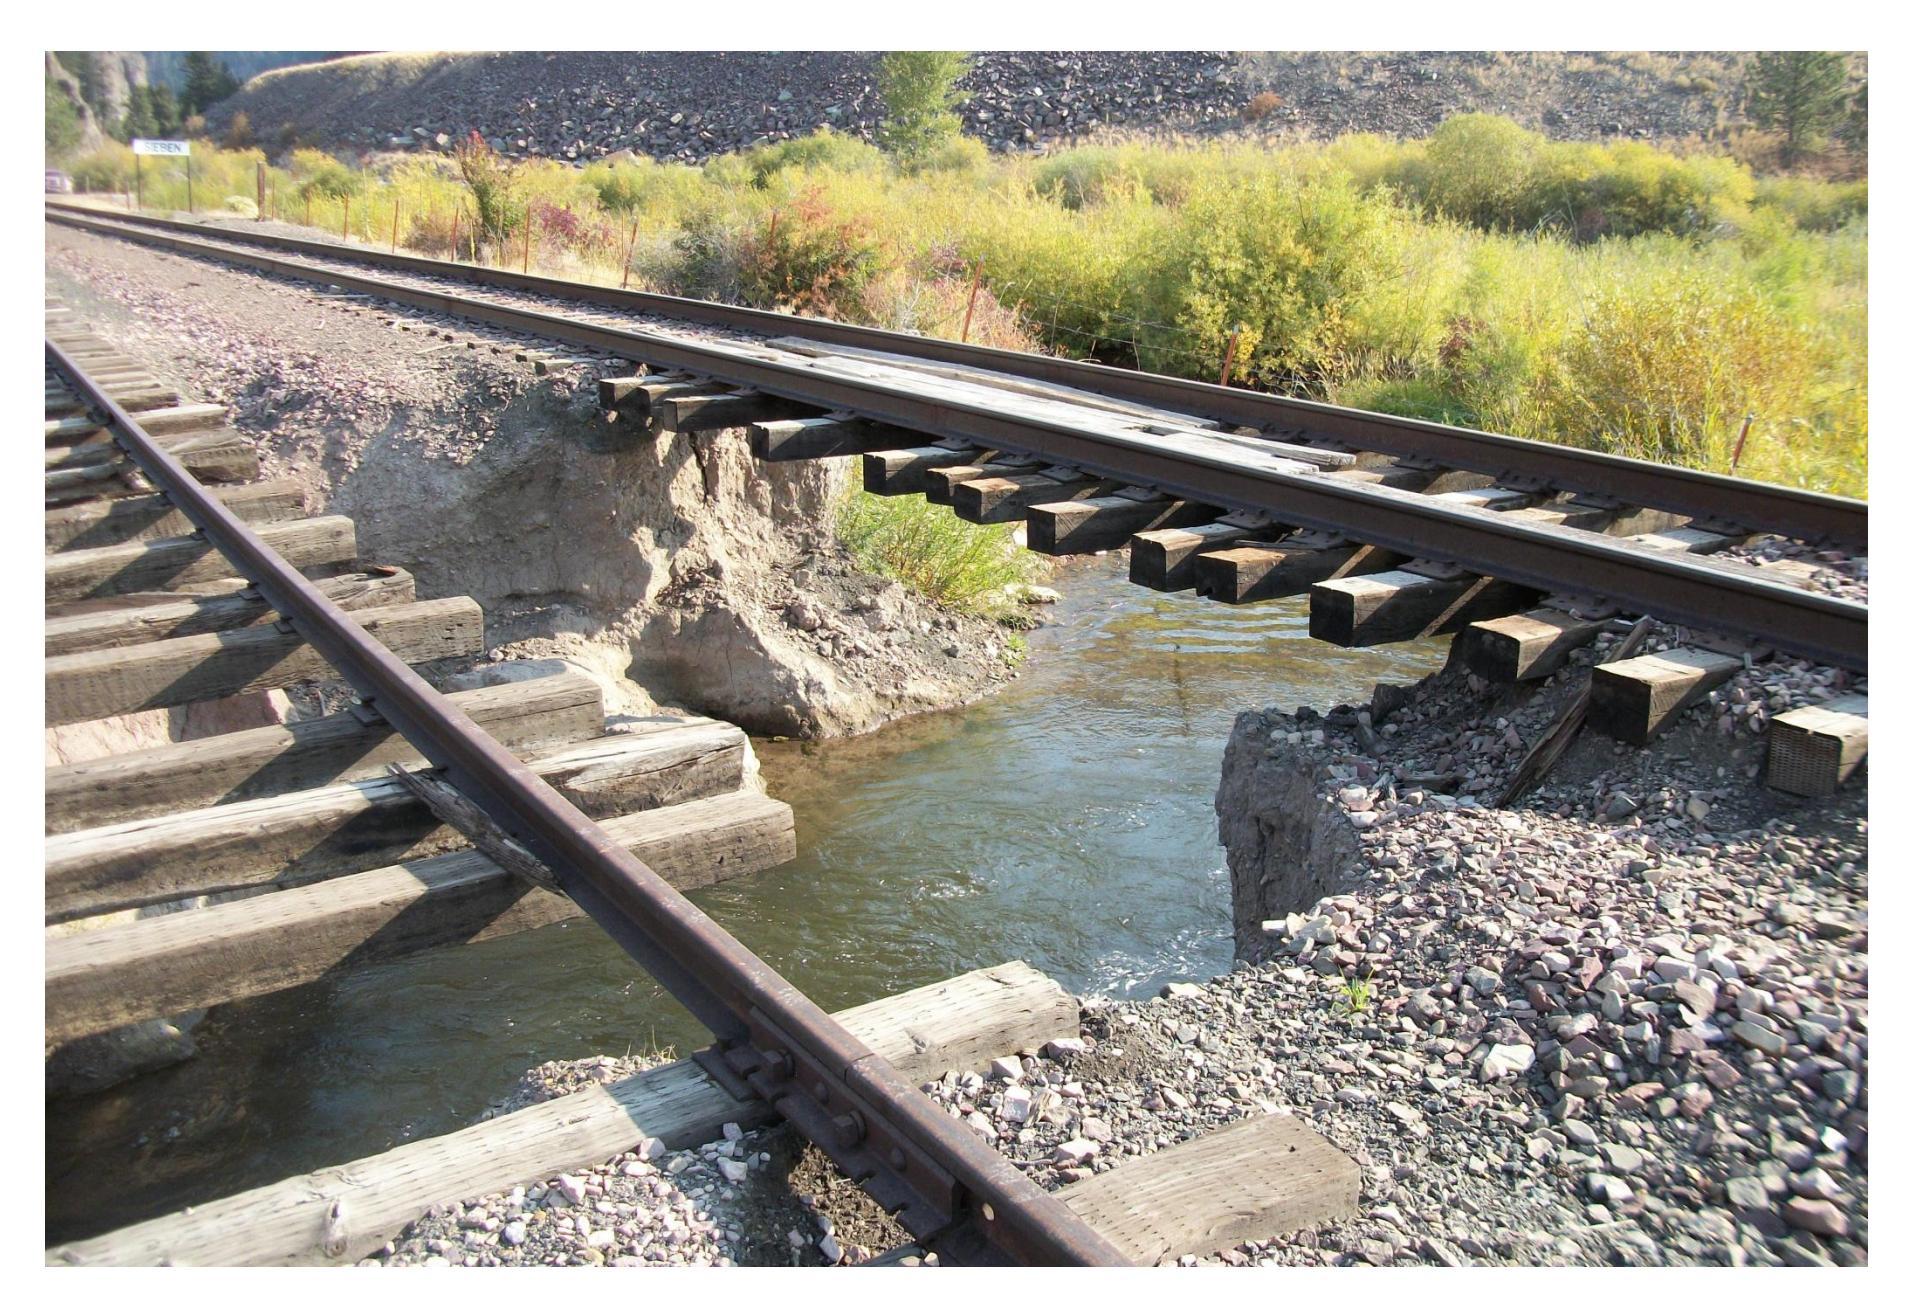
Figure 3. LPP Creek erosion into BNSF railroad grade construction site #3, where stream returns to historic channel, Sieben, Mt.

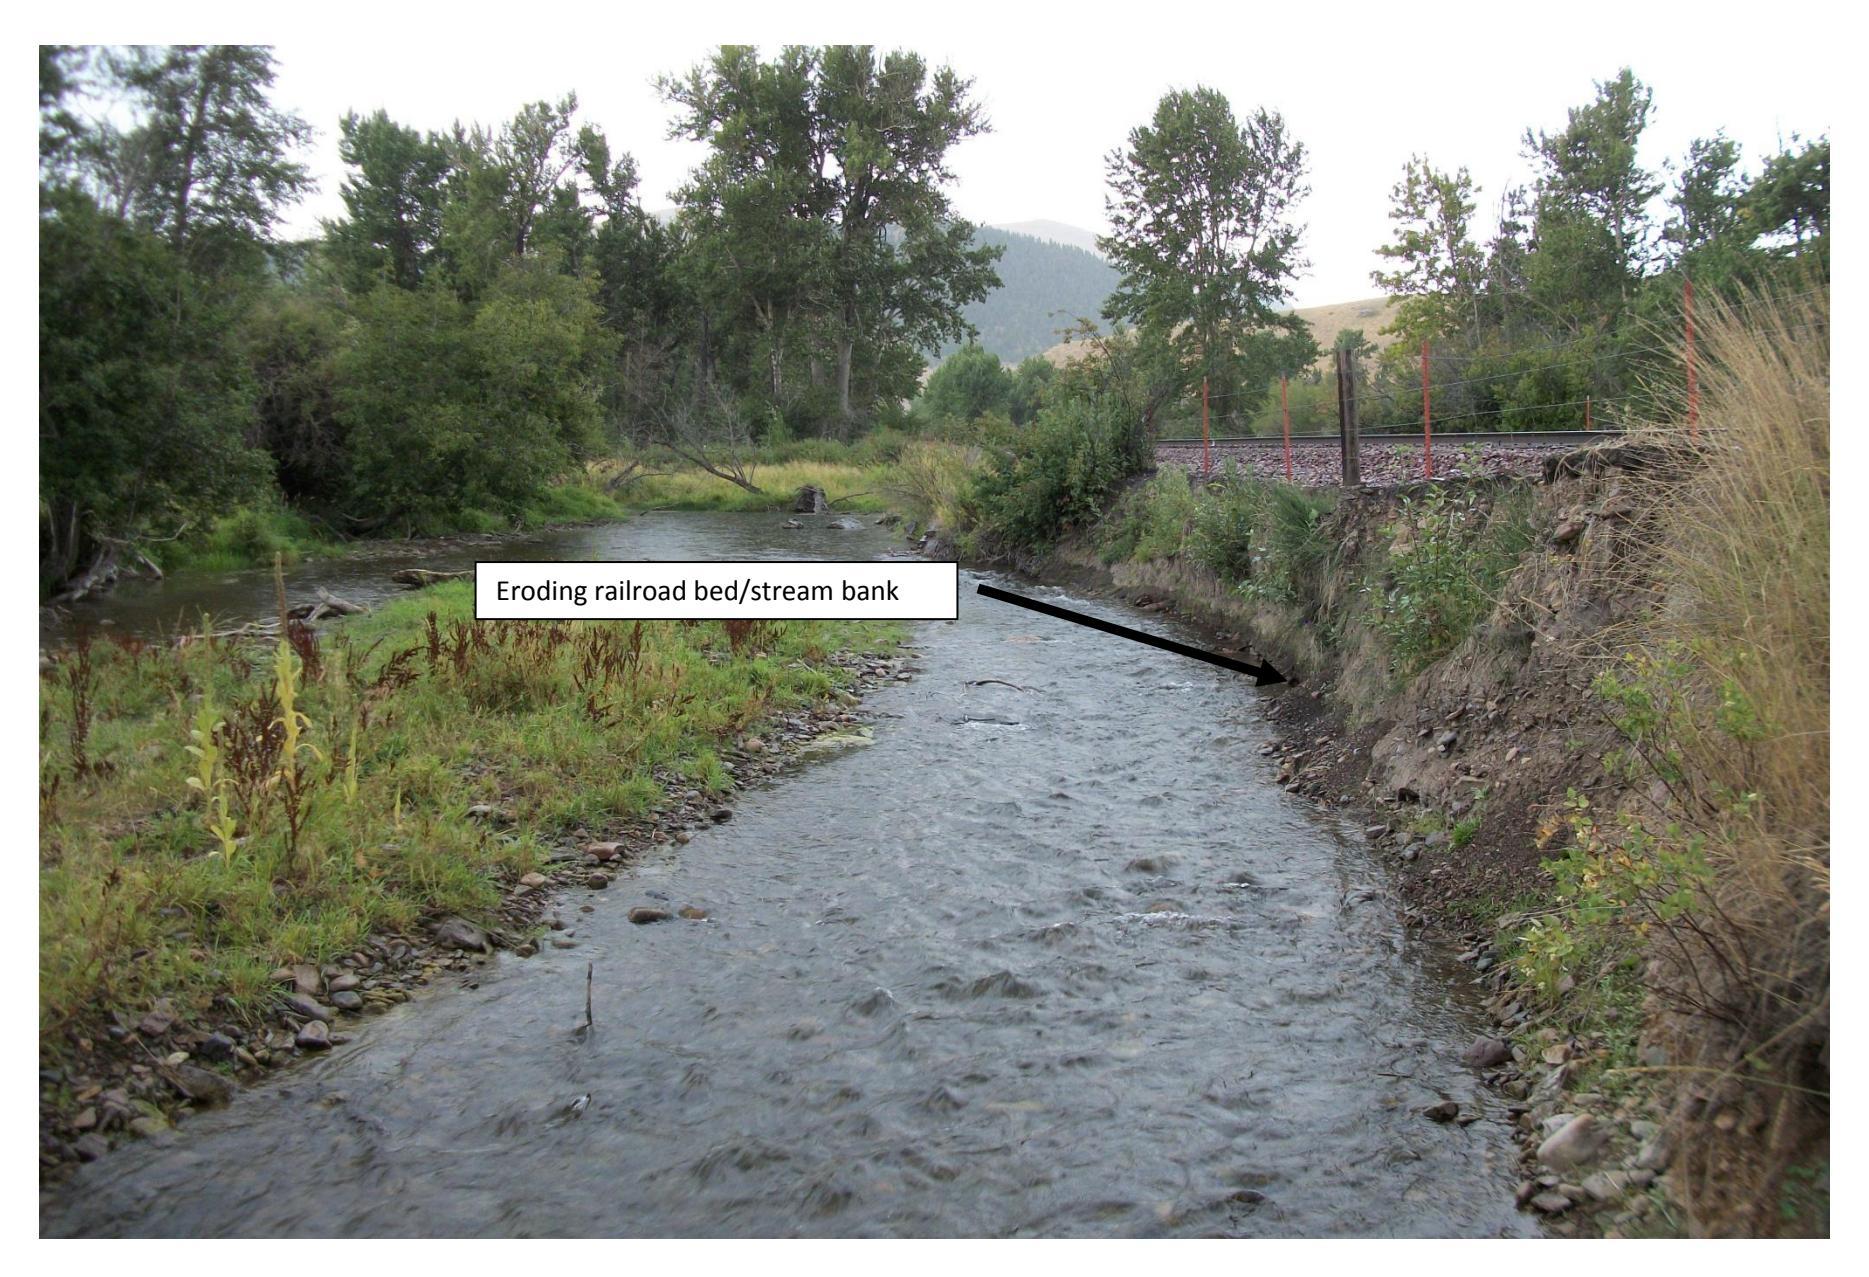
There are 3 sites that require channel alterations (Figure 4). Site # 1 (Figure 5) involves armoring an 126 foot section of LPP Creek where it is eroding into the rail road grade and in jeopardy of destroying a fence (Figure 5). Site #2 (Figure 6) involves constructing 490 feet of new channel, installing a natural log/rock plug to prevent the stream form capturing an historic channel, install a gradient control structure to prevent the stream from headcutting upstream of this site, and remove a portion of a point bar at the lower reach of this meander. Site #3 (Figure 7) involves constructing 2,992 feet of new channel, abandoning the old channel, repurposing overburden into the old channel, installing two grade control structures in the lower reach of the new channel, installing log/rock armor in the outside bends of the newly constructed meanders.

Figure 5. Site # 1 showing erosion into the railroad bed, fence that is compromised and location of 2 channels.

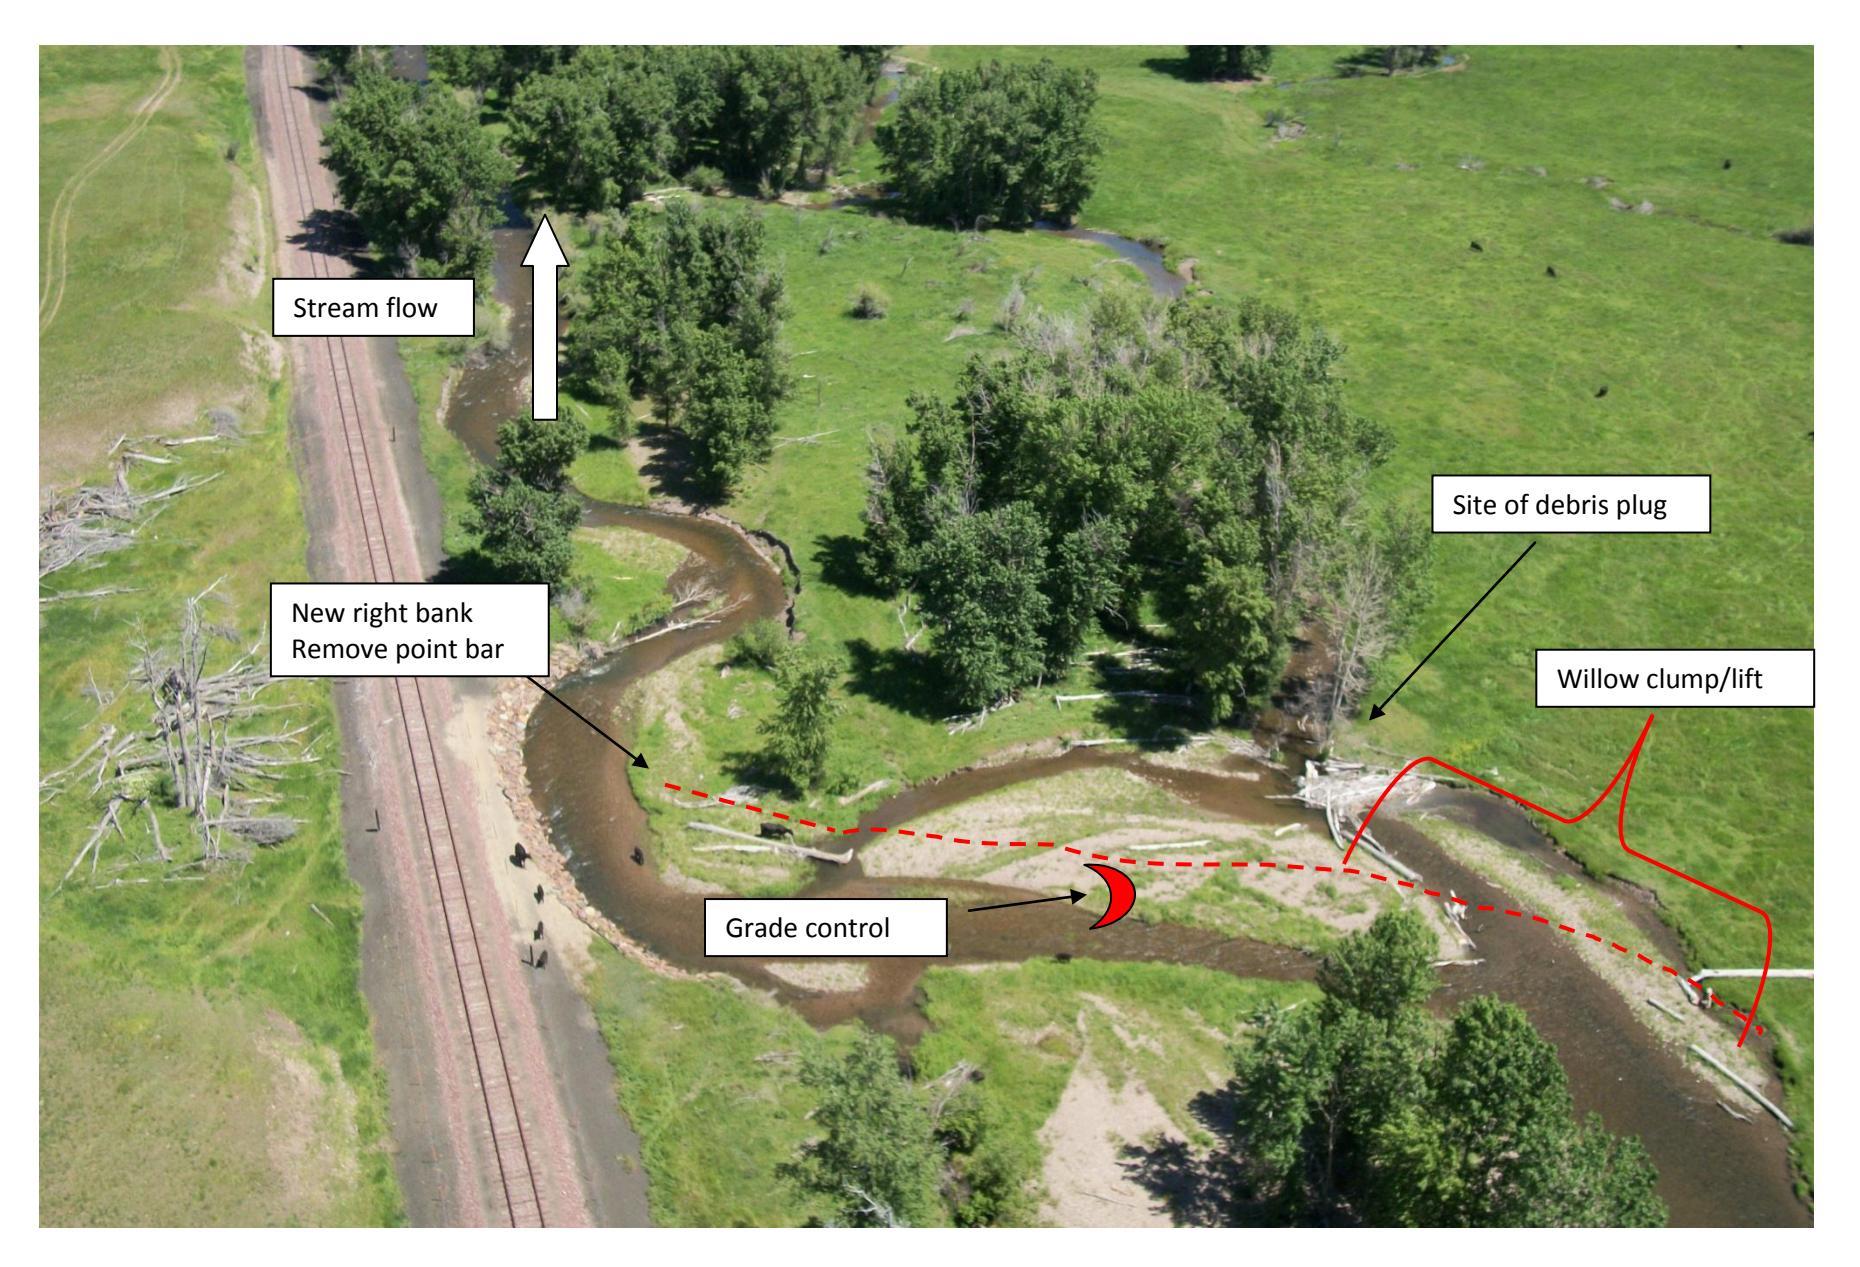
Figure 6. Site # 2 showing conceptual locations of grade control structure, debris plug to eliminate old channel, bank stabilization using willow clump/lift.

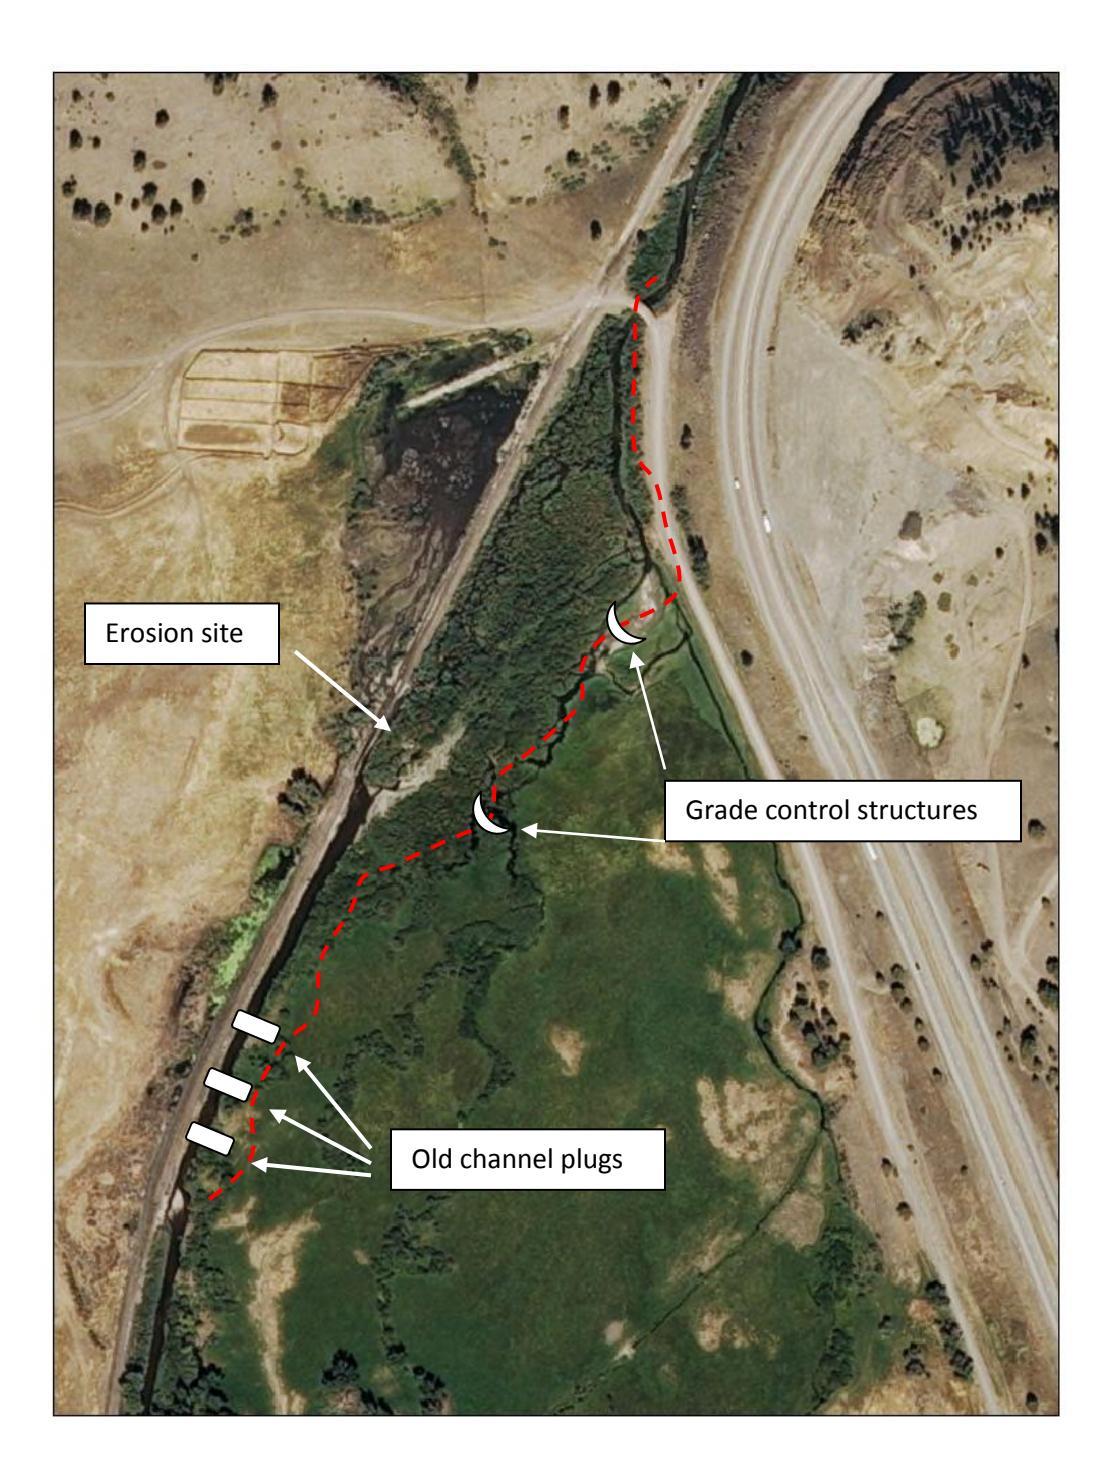
Figure 7. 2011 aerial photo of the lower reaches of LPP near Sieben showing site where channel was abandoned and is eroding, conceptual new channel alignment (red dash line), plug sites for old channel, and grade control locations. Not to scale.

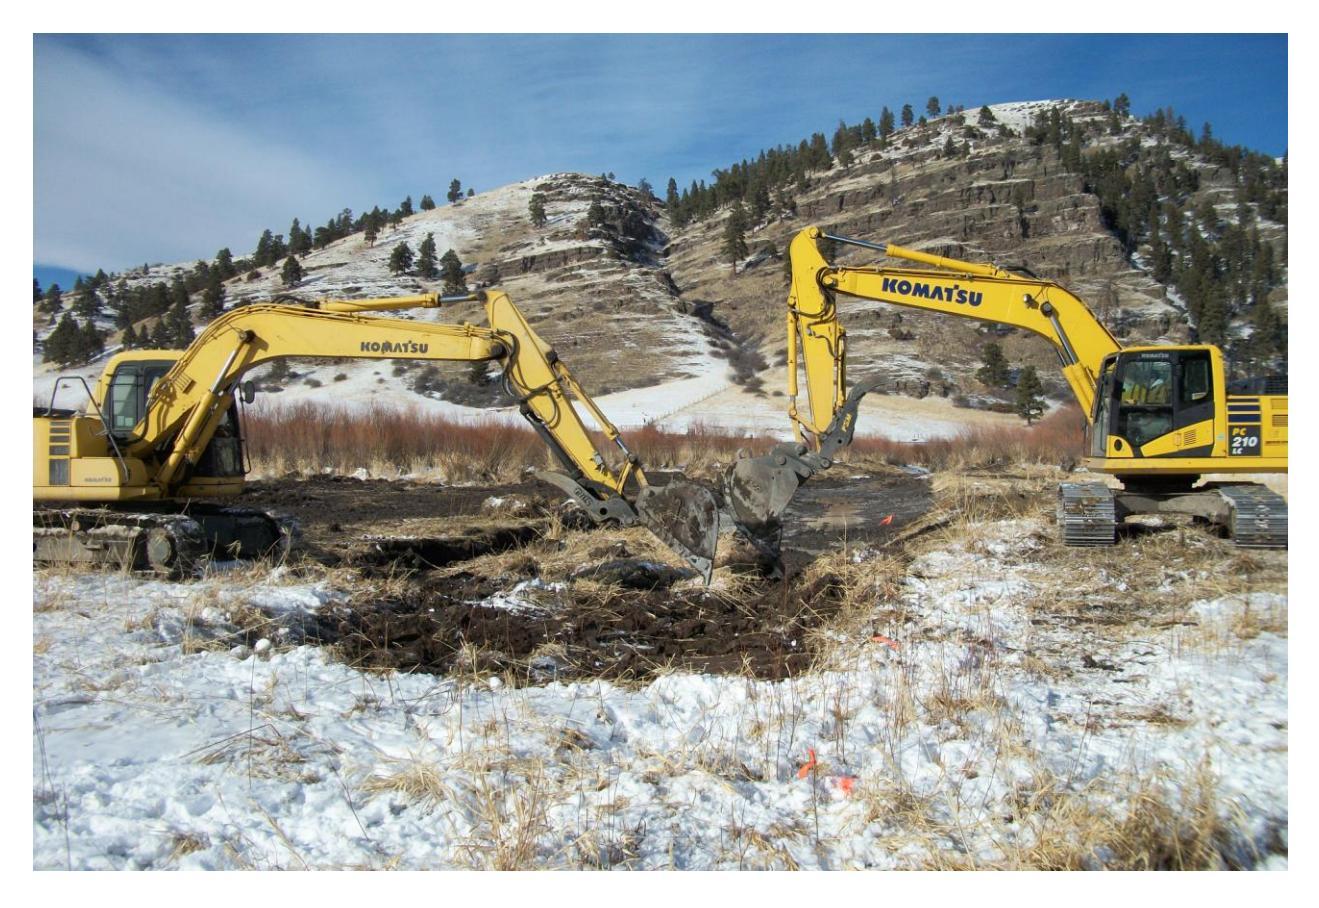
Figure 8. Excavators shaping new channel for Little Prickly Pear Creek, Sieben Ranch, February 2014.

After securing the regulatory permits from MFWP (124), ACOE (Nationwide 27) and Montana DEQ (318, 401), the project began in February 2014 (Figure 8, Figure 9, Figure 10, Figure 11). Frozen ground provided an ideal base to operate heavy equipment but also required additional equipment time to deal with frozen ground.

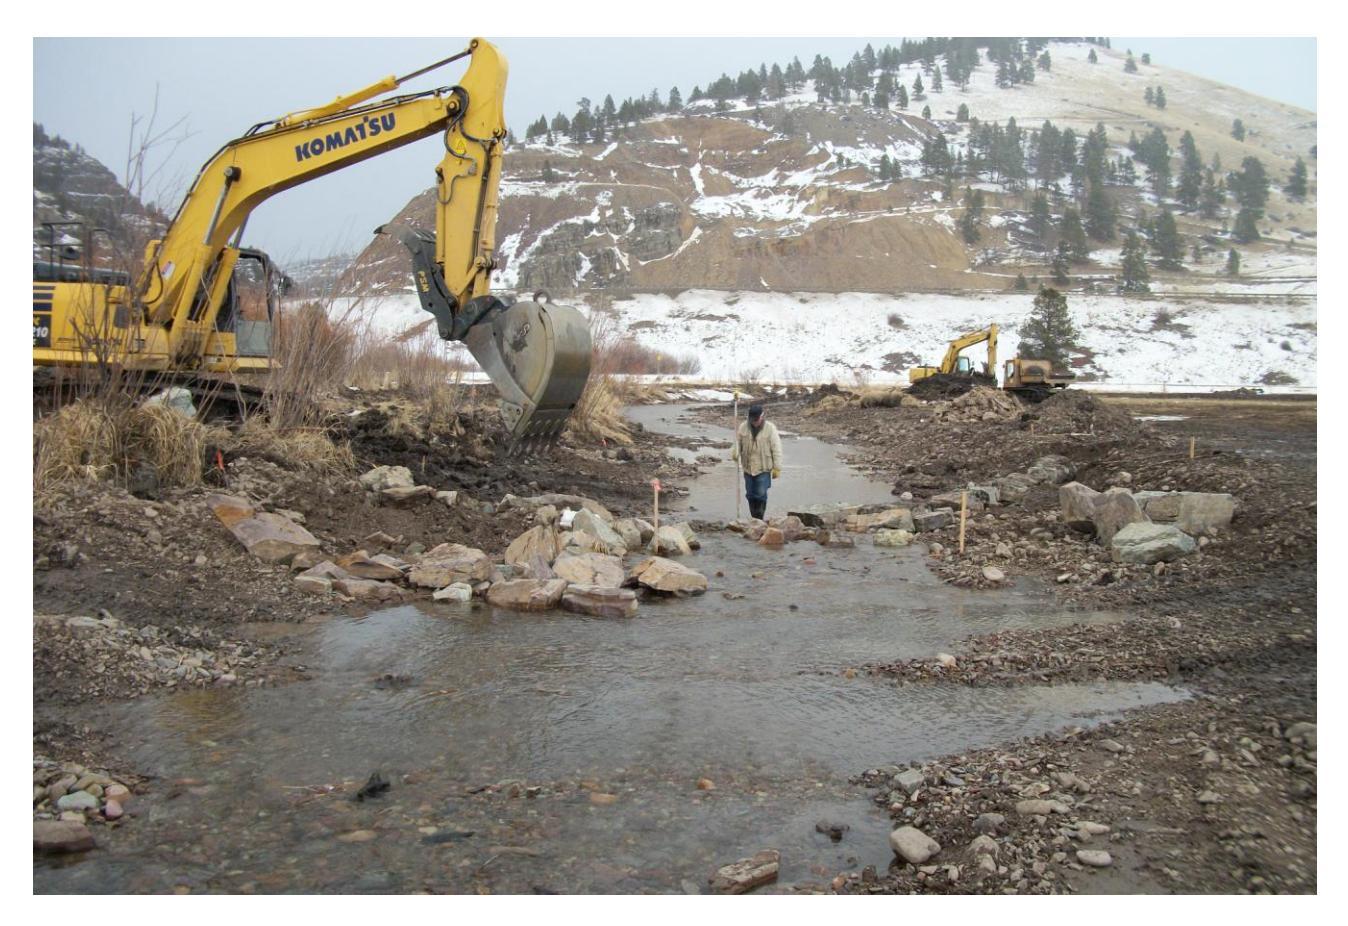
Figure 9. Excavator installing a gradient control cross vane for Little Prickly Pear Creek, Sieben Ranch, February 2014.

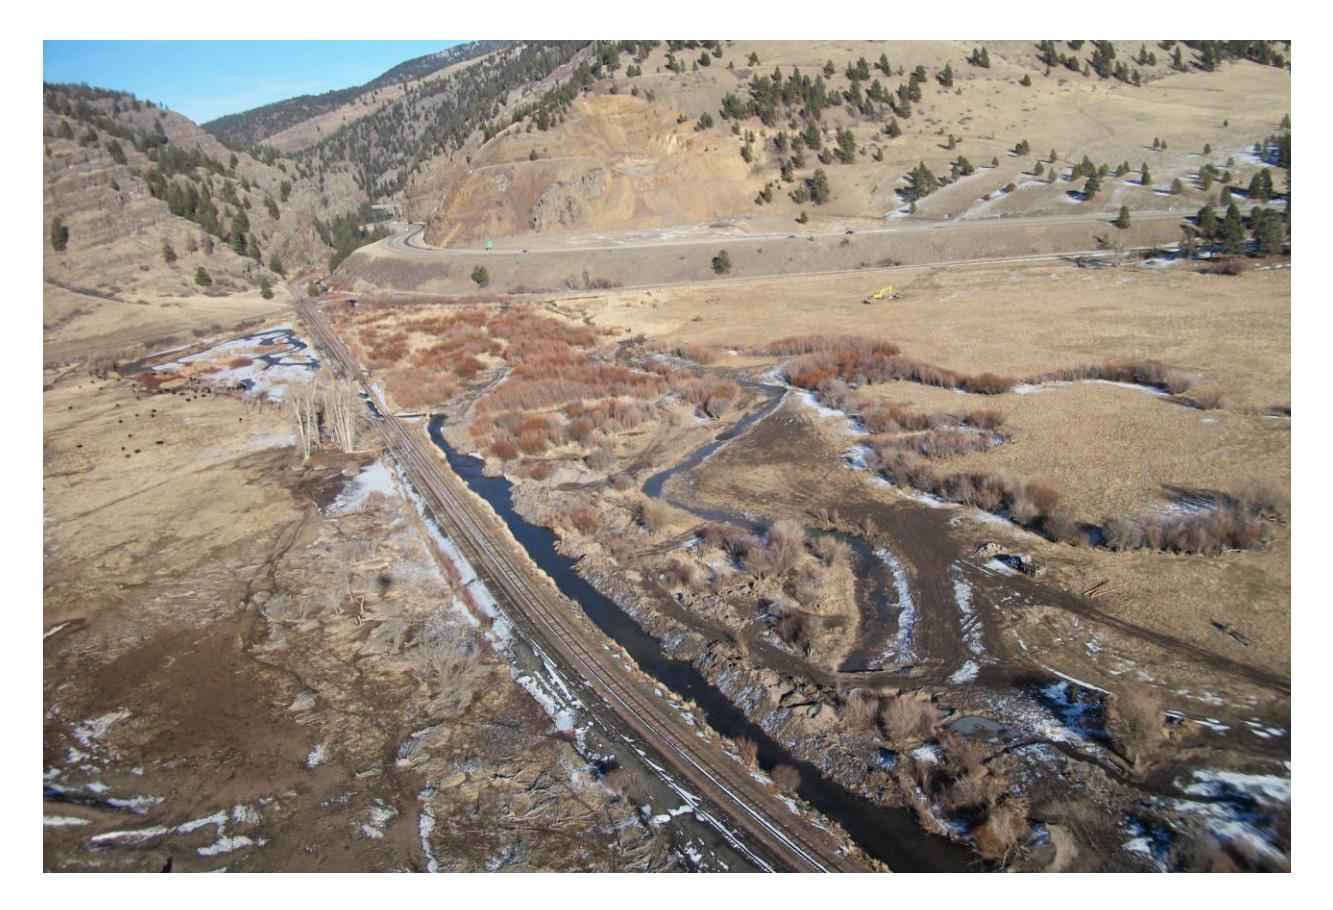
Figure 10. Aerial photo of LPP Creek near Sieben showing the active channel with new channel being constructed. February 2014.

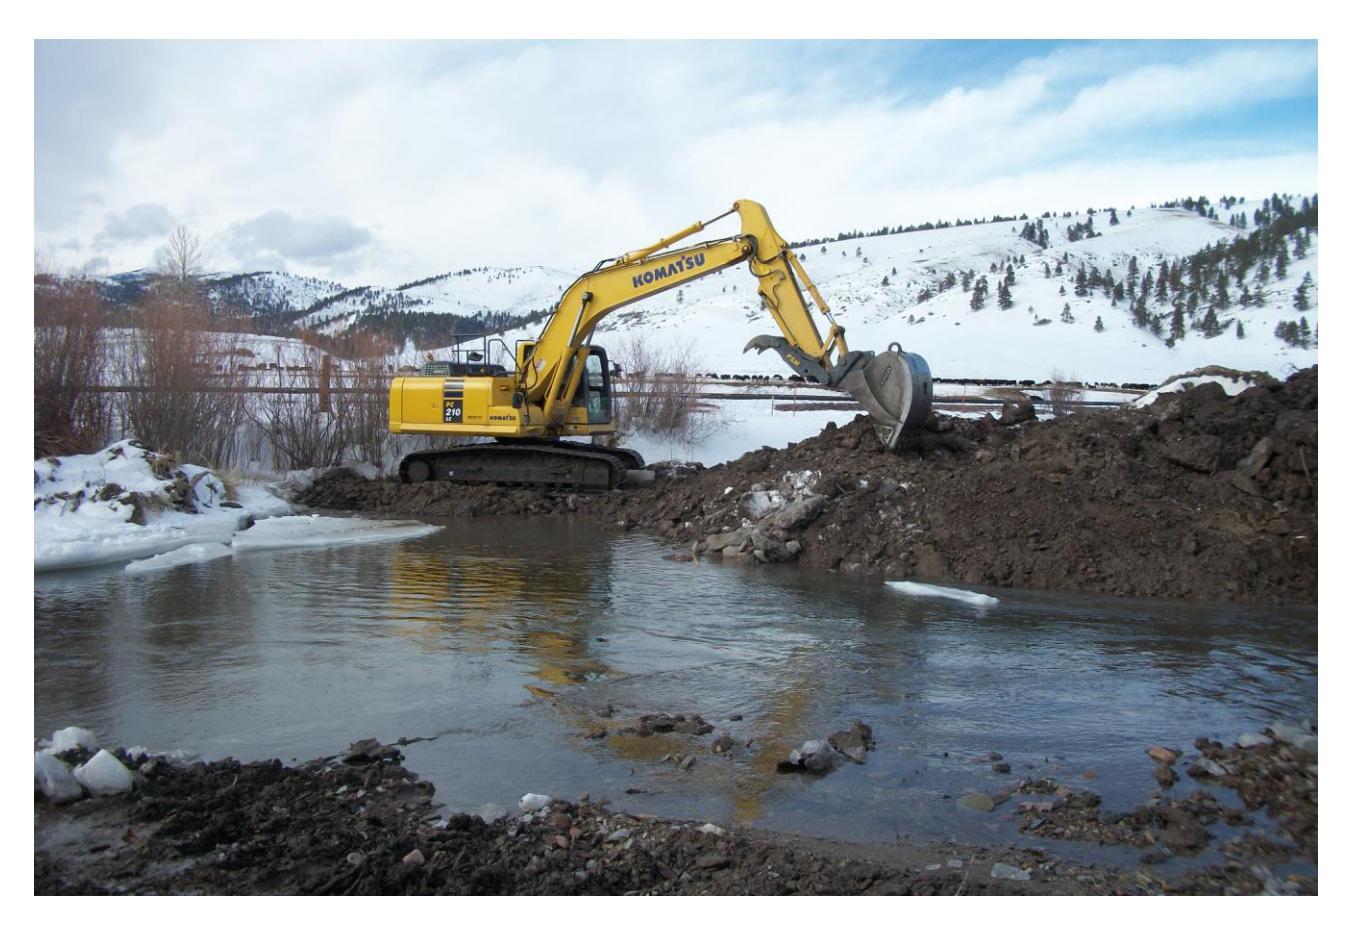
Figure 11. Excavator diverting water into the new channel for Little Prickly Pear Creek, Sieben Ranch, March 2014.

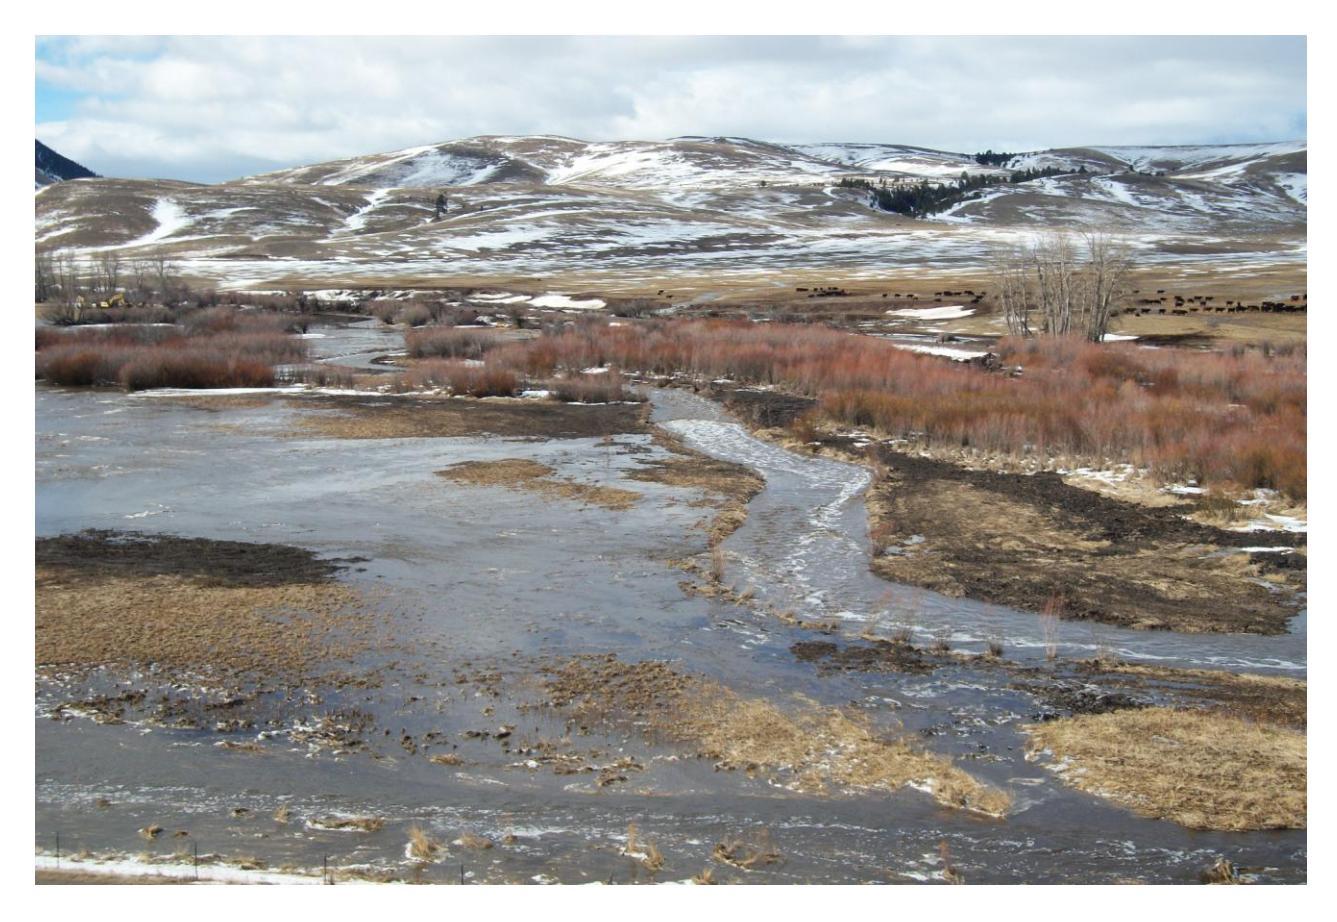
Construction of the 3,000 feet of channel (Site 3) proceeded over the next 45 days. On March 7, 2014, mild air temperatures caused mid level snow to melt and flood the project area (Figure 12). Construction proceeded through the end of March to finish sites 1 and 2. The project was completed in April 2014 (Figure 13-19). A fencing contractor installed 4,700 feet of three starnd high tensile steel electric fence (Figure 20). A water gap was constructed on the west side of the project area (Figure 21). Monitoring for permitting compliance began in October 2014 and will continue for 2 more years.

Figure 12. Photo of LPP Creek near Sieben showing the new channel conveying flood flows. March 2014.

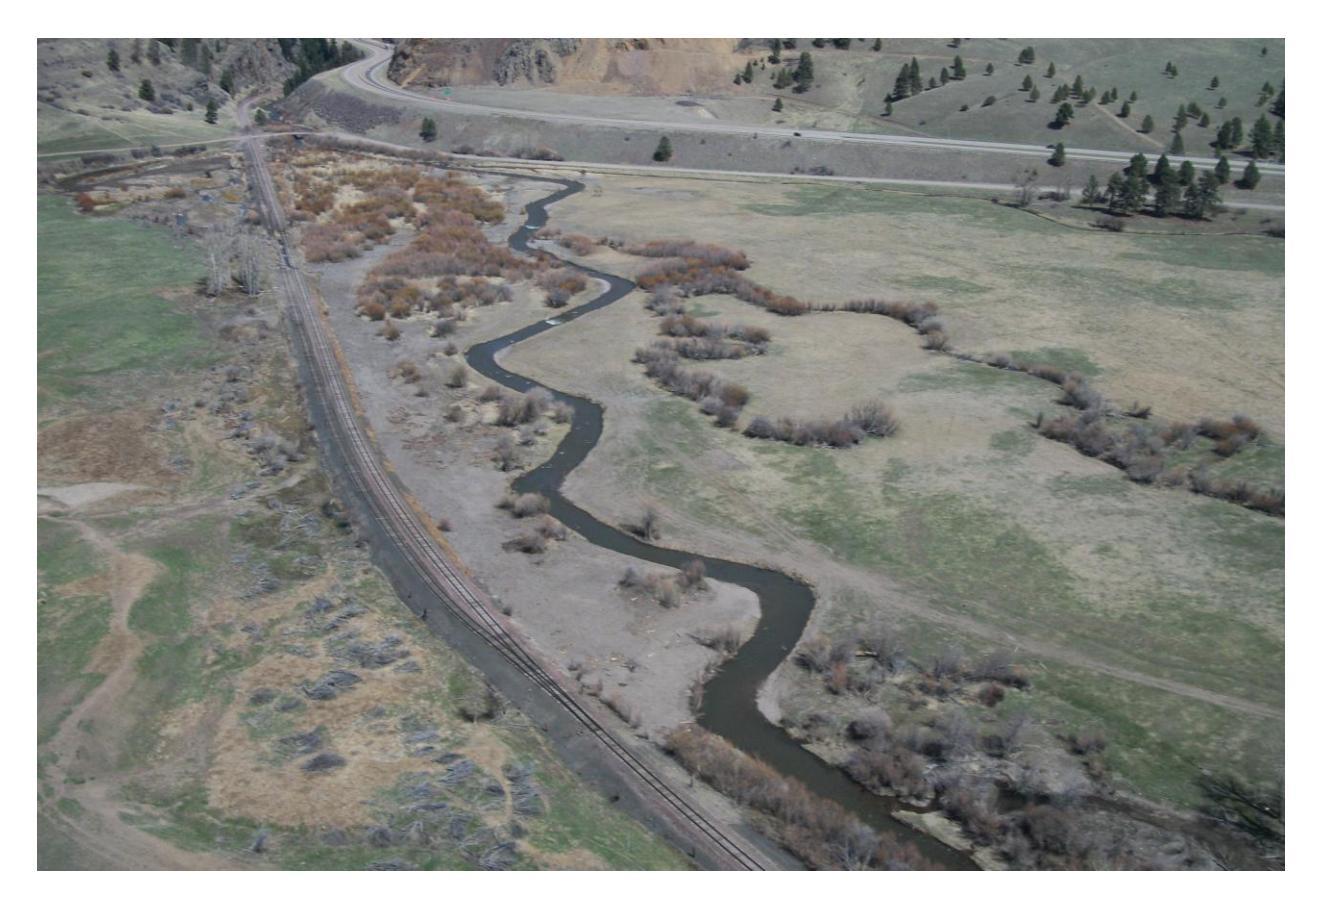
Figure 13. Aerial photo of LPP Creek near Sieben showing the new channel with the old channel decommissioned. April 2014.

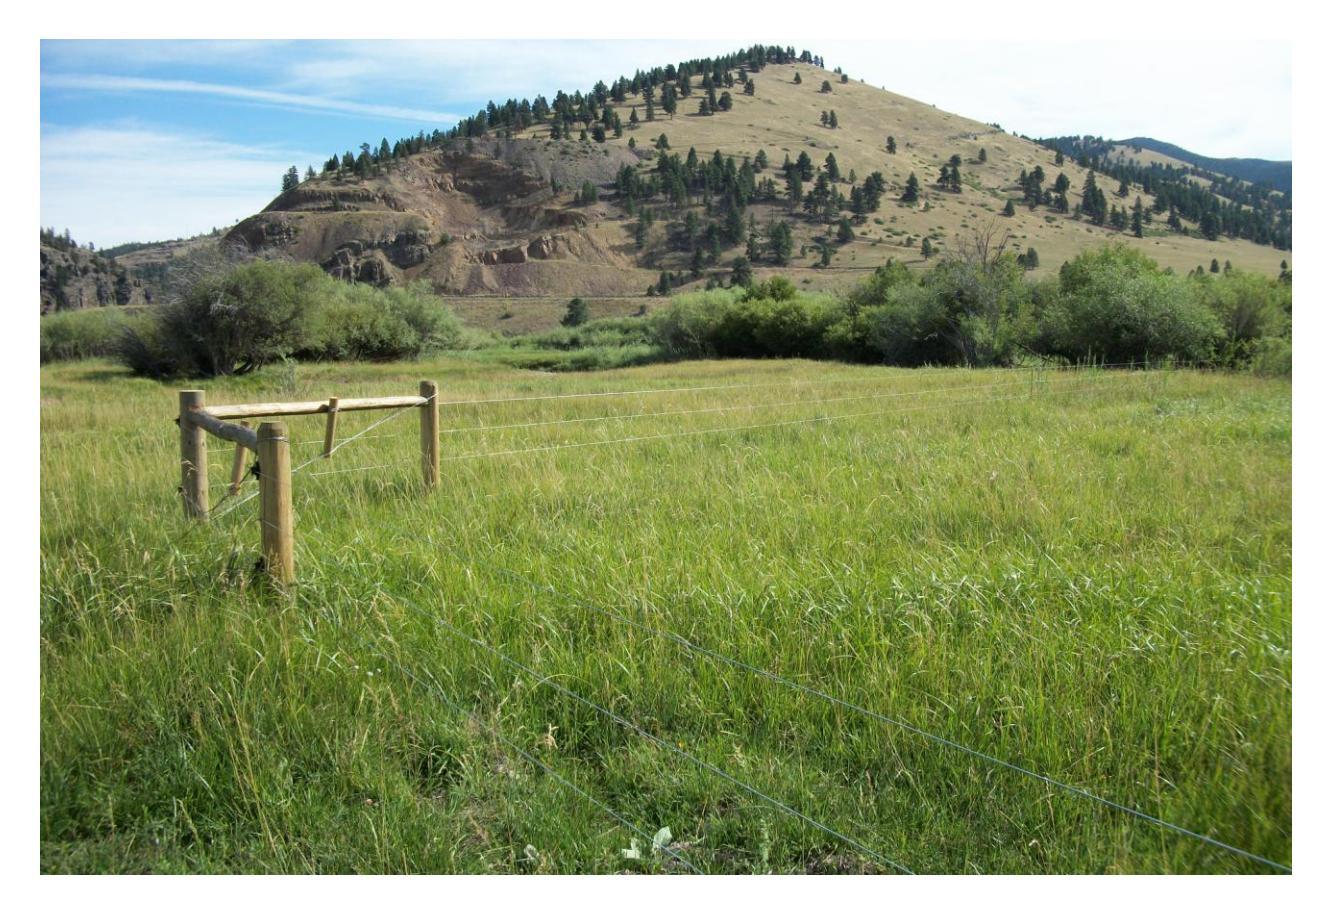
Figure 20. Riparian fence at Little Prickly Pear Creek restoration section, Sieben Ranch, Montana. August 2014.

We proposed to install 3400 feet of three strand high tensile steel wire fence along the east border of the stream corridor (Figure 4). This fence will connect with two existing fences and safeguard the riparian zone from livestock encroachment.

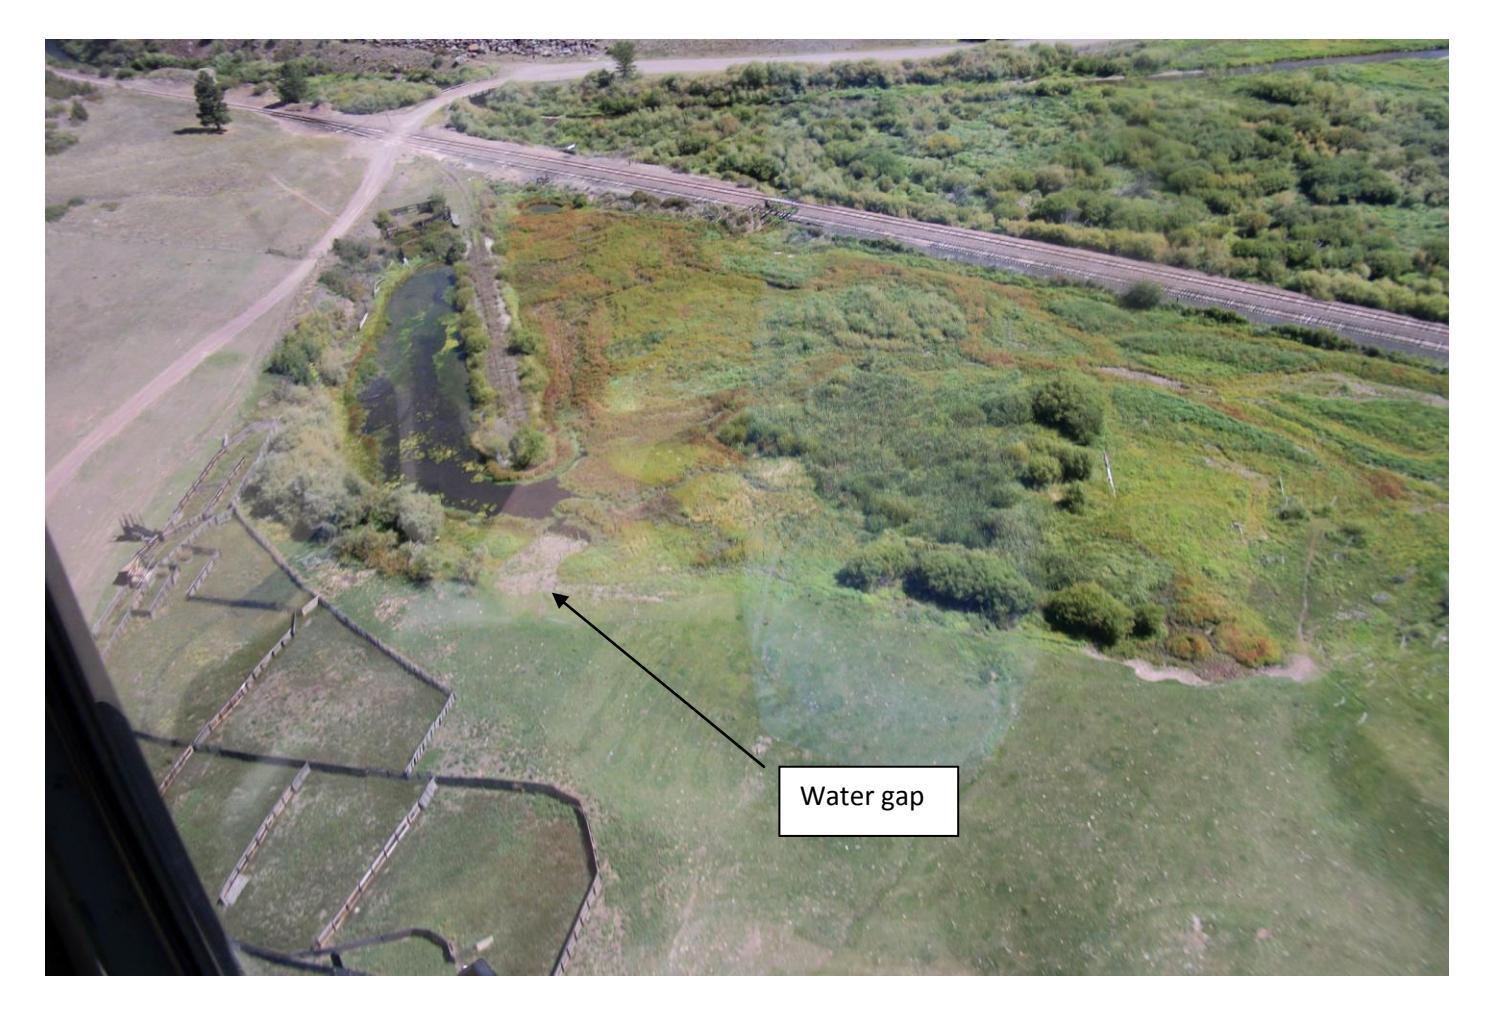
Figure 21. Aerial photo of water gap on west side of project area. Little Prickly Pear Creek, Sieben Ranch, Sept 2014.

We proposed to install 1375 feet of three strand high tensile steel wire fence along the west border of the stream corridor (Figure 4). This fence will connect with existing fences and serve to keep cattle out of a spring, out of a large mud flat created by the 2011 flood, and out of the current stream channels. This fence reach will have a livestock water

gap near the historic railroad siding to provide water for livestock. The water gap would consist of a narrowing fenced area that reaches to the water's edge and is fortified with rock to support the weight of livestock.
