# Lone Pine State Park Pedestrian Bridge Project

Near Kalispell, Montana

FWP # 7196112

Cover Sheet Lone Pine State Park Pedestrian Bridge Project

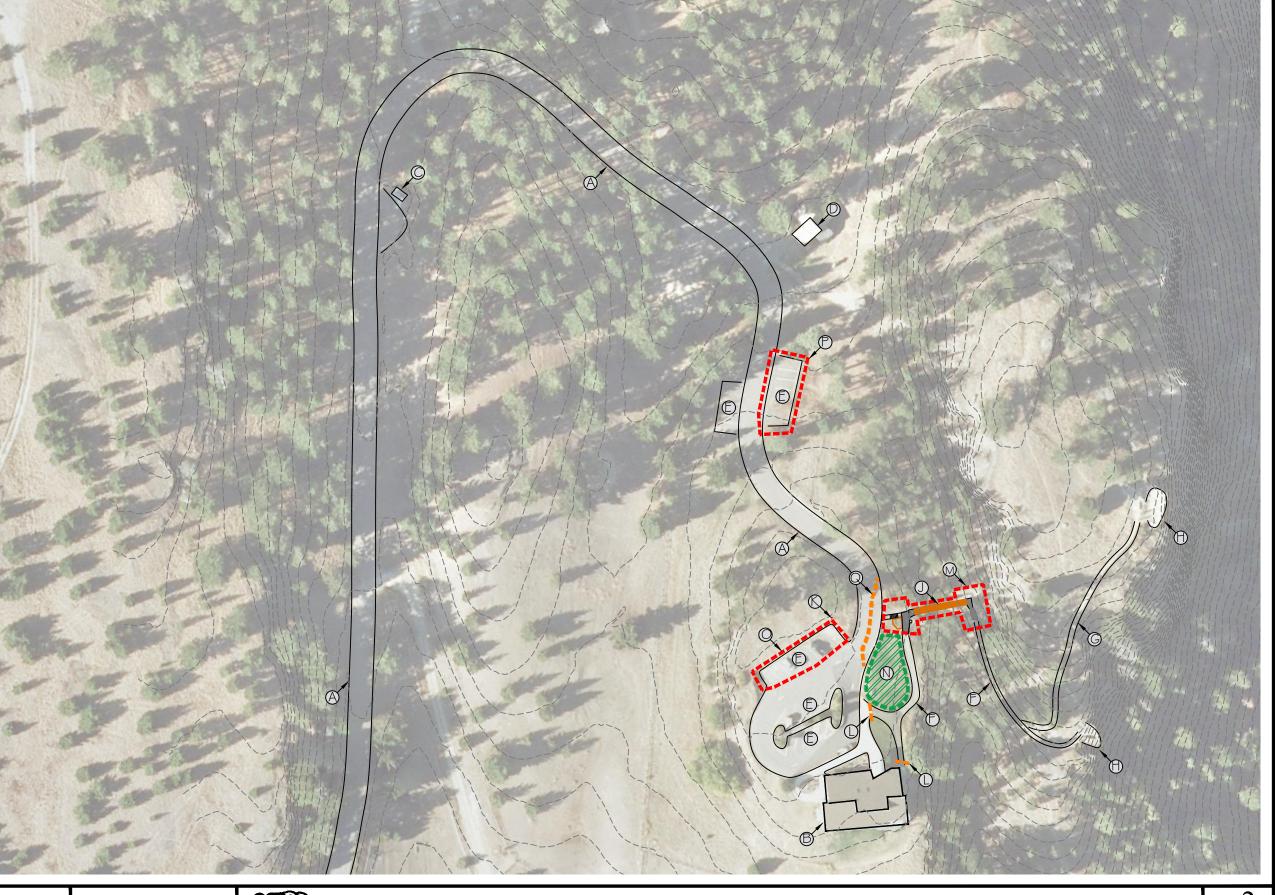
Montana Tish. Project Area Location / Limits
Wildlife & Parks
Lone Pine State Park Pedestrian Bridge Project

- Existing Lone Pine Road
- B. Existing visitor's center
- C. Existing entrance klosk
- D. Existing picnic shelter
- Existing parking area
- Existing paved trail
- Existing gravel trail
- H. Existing lookout platform
- Existing pedestrian bridge location
- Project benchmark location
- F.W.P. trail closure signs at all access points
- M. Limits of disturbance (see note #2 below)
- N. Landscaped \$ irrigated area, do not disturb
- Contractor staging and materials storage area Additional contractor personnel parking
- Q. Maintain at least one open traffic lane

- I. This exhibit shows the limits of contractor access and disturbance.
- 2. Contractor to install temporary orange safety fencing around the "limits of disturbance" area at the bridge site prior to start of demolition. Area to be closed when workers not present.
- 3. Road to have at least one passable lane until abutment and bridge replacement work begins. See special conditions for times of total road closure.

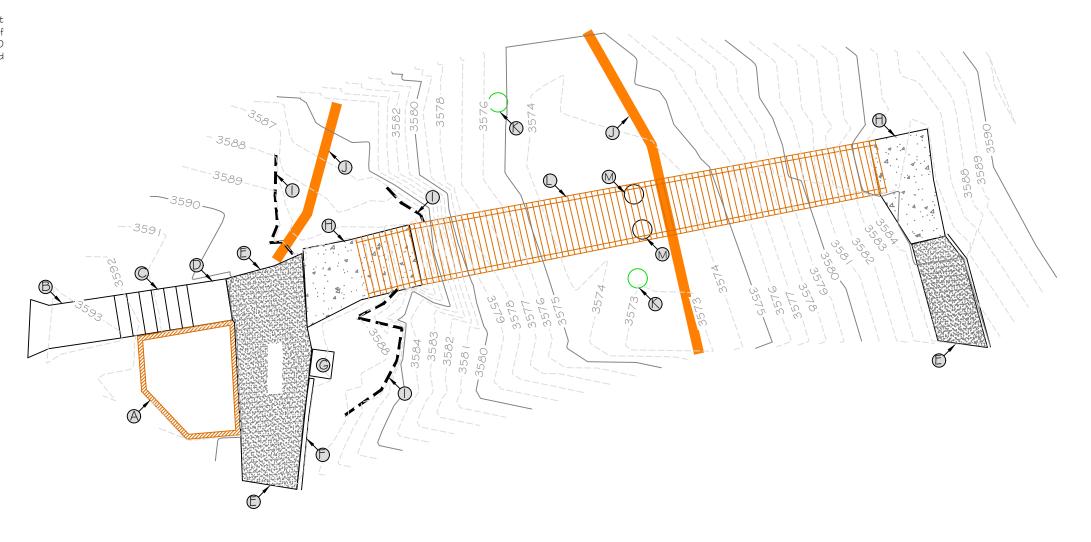
Montana Fish. Existing Condition Siteplan Lone Pine State Park Pedestrian Bridge Project

- B. Existing concrete stair top landing
- C. Existing concrete stairs
- D. Existing concrete stair lower landing
- Existing asphalt trail area
- Existing 6" concrete curb / wall
- Existing informational sign
- Existing concrete bridge landing area
- Existing edge of bedrock outcropping
- Existing walking trail
- Existing large tree
- Existing wooden bridge
- M. Existing bridge support poles

$\begin{array}{cccc} \underline{\text{Temporary}} & \underline{\text{Benchmark}} & \underline{\text{Note:}} & \text{Project} \\ \underline{\text{benchmark is located on top of bolt of}} \end{array}$ light pole painted red, approximately 60 feet west of existing stairs. Assumed elevation is 3600.00

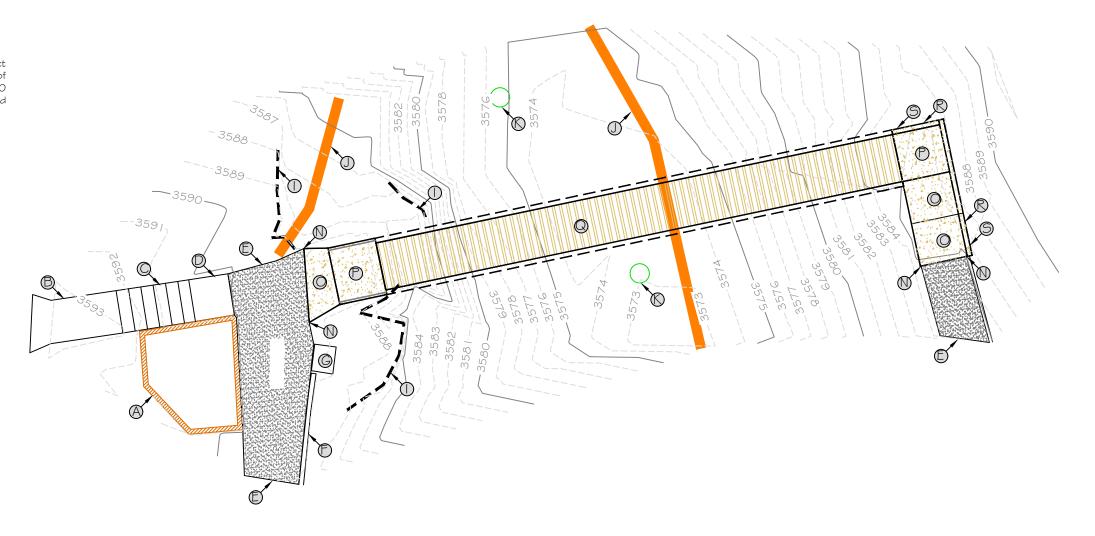
Montana Fish. New Bridge Plan View
Lone Pine State Park Pedestrian Bridge Project

- B. Existing concrete stair top landing
- Existing concrete stairs
- Existing concrete stair lower landing
- Existing asphalt trail area
- Existing 6" concrete curb / wall Existing informational sign
- Existing edge of bedrock outcropping
- Existing walking trail
- K. Existing large tree
- Limit of demolition / new work
- O. Proposed concrete transition apron
- Proposed 5 ft x 5 ft concrete landing
- Q. Proposed 55 ft x 5 ft bridge
- R. Proposed 6" wide x 6" tall curbing S. Proposed hand railing in curbing

light pole painted red, approximately 60 feet west of existing stairs. Assumed elevation is 3600.00

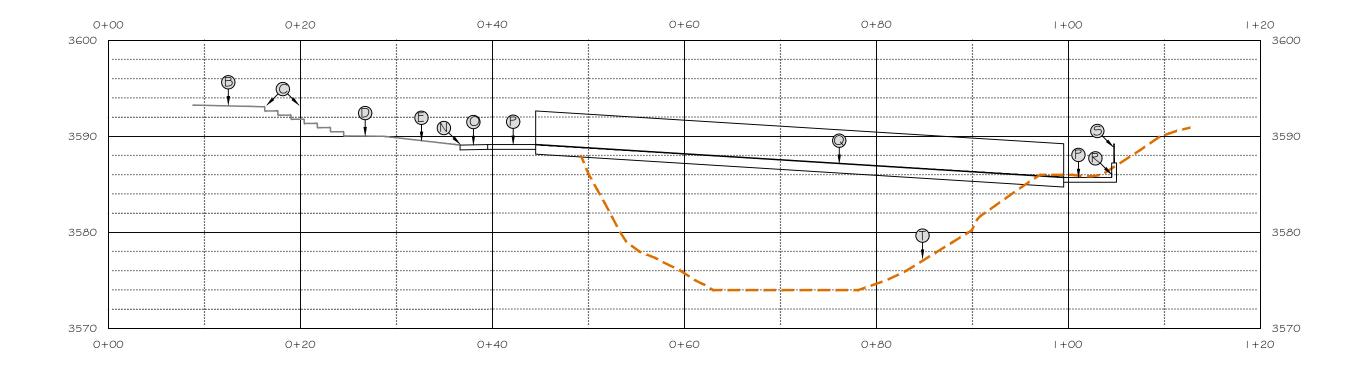
Montana Fish. New Bridge Profile View
Lone Pine State Park Pedestrian Bridge Project

- B. Existing concrete stair top landing
- C. Existing concrete stairs
- D. Existing concrete stair lower landing
- E. Existing asphalt trail area
- I. Existing edge of bedrock outcropping
- N. Limit of demolition / new work
- O. Proposed concrete transition apron
- P. Proposed 5 ft x 5 ft concrete landing
- Q. Proposed 55 ft x 5 ft bridge
- R. Proposed 6" wide x 6" tall curbing
- S. Proposed hand railing in curbing
- T. Existing ground profile

Temporary Benchmark Note: Project benchmark is located on top of bolt of light pole painted red, approximately 60 feet west of existing stairs. Assumed elevation is 3600.00

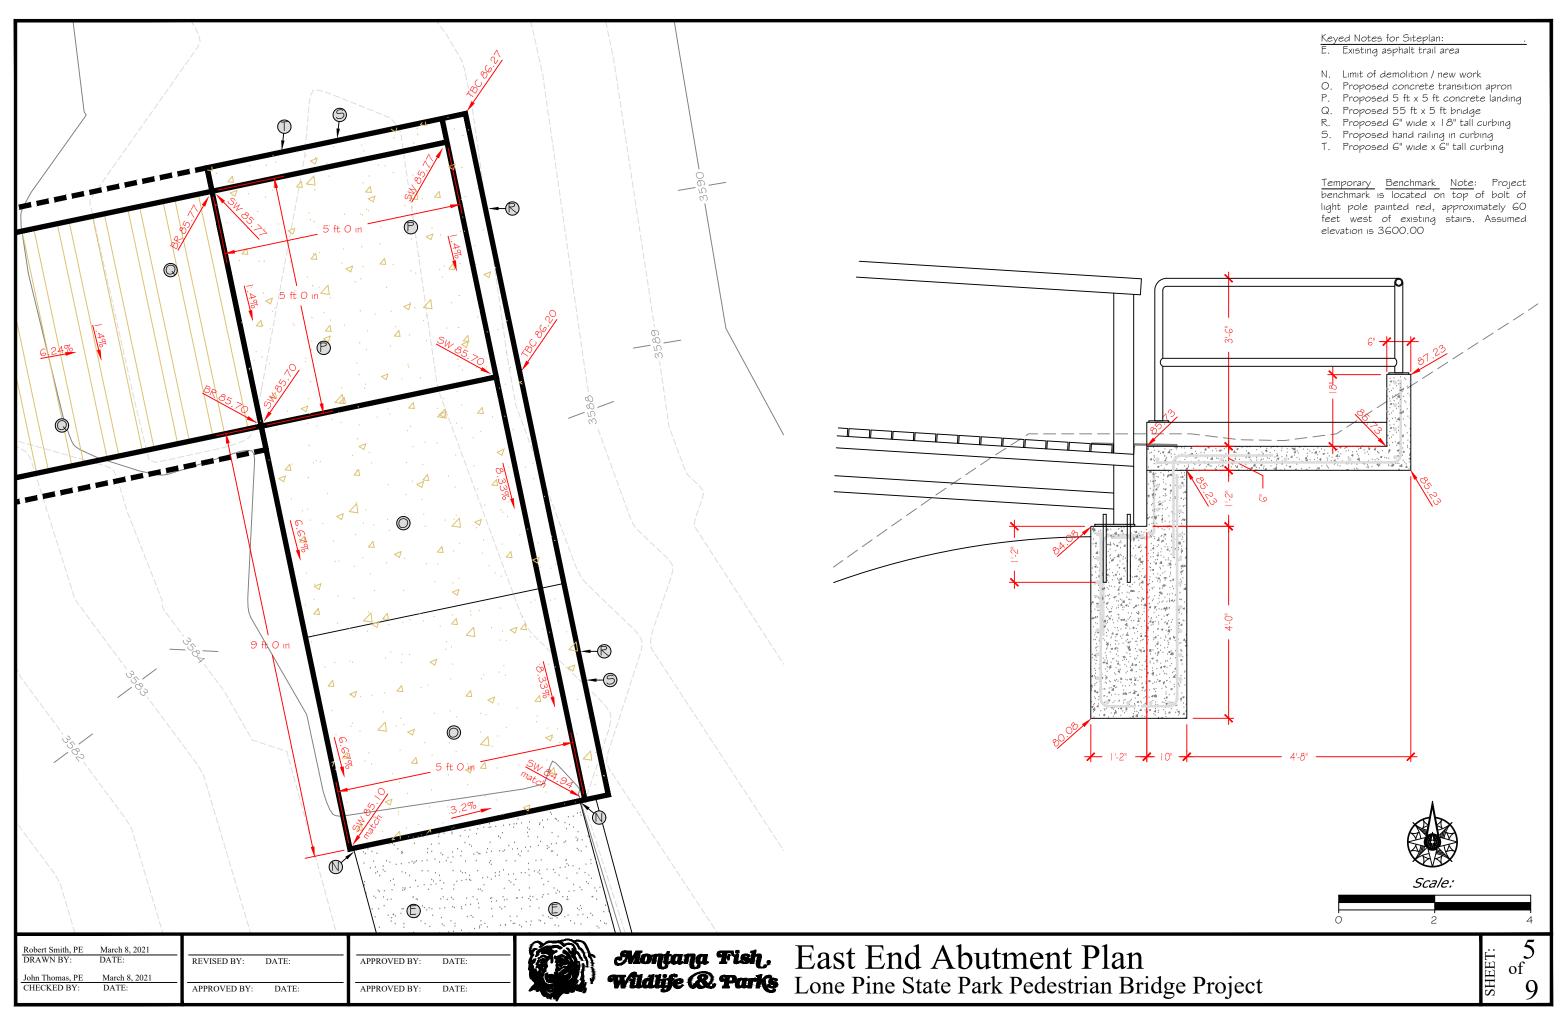
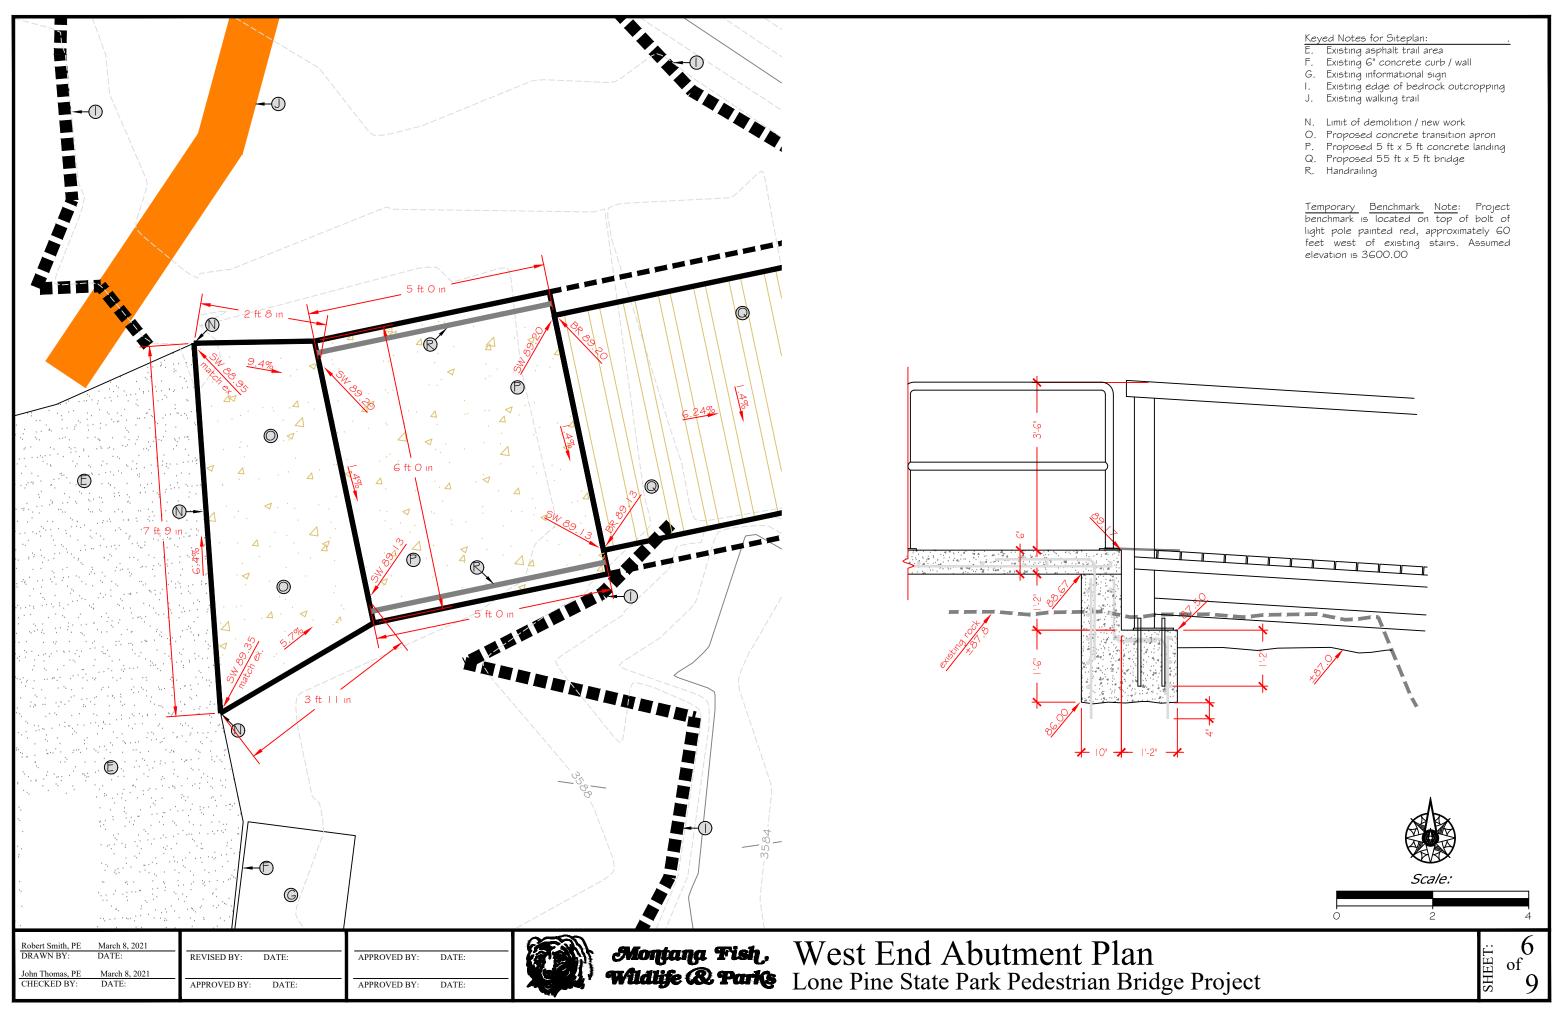
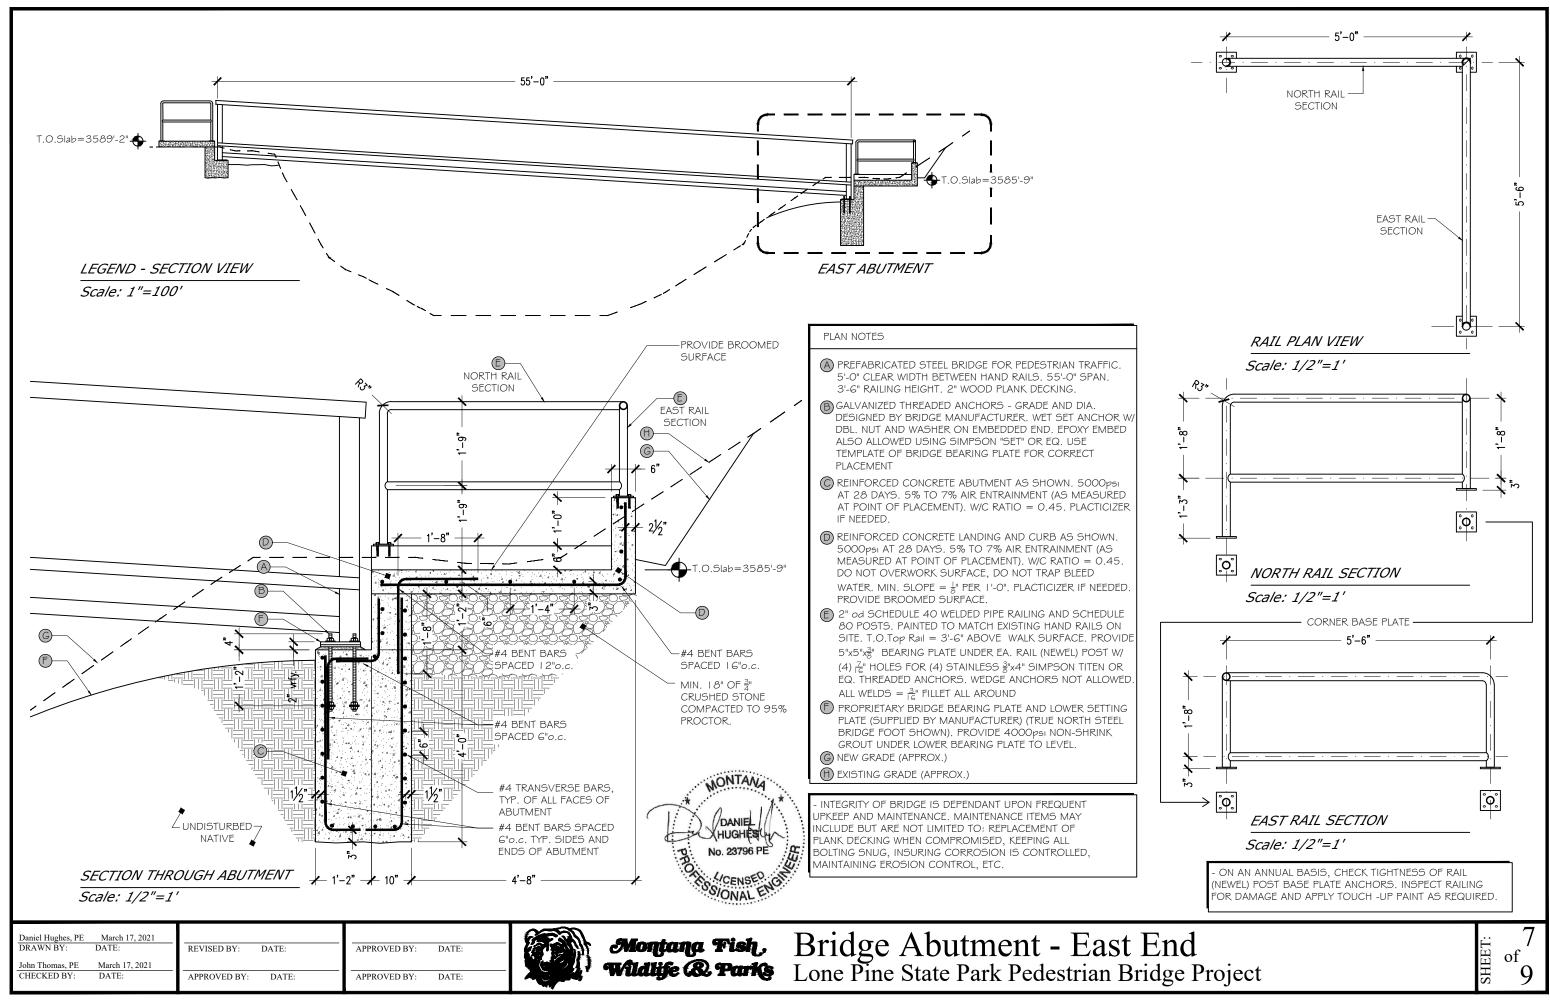
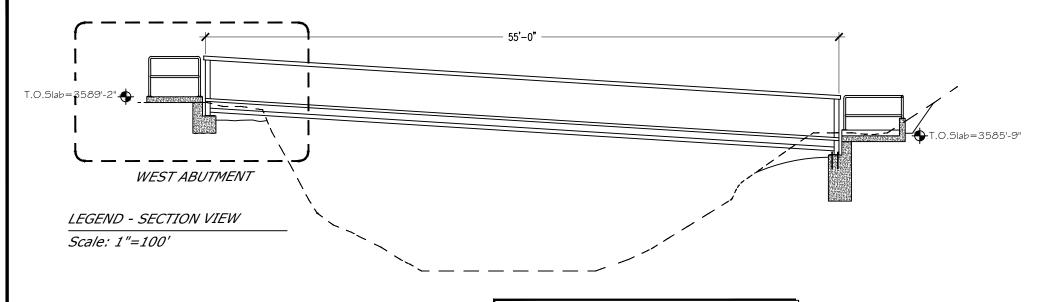
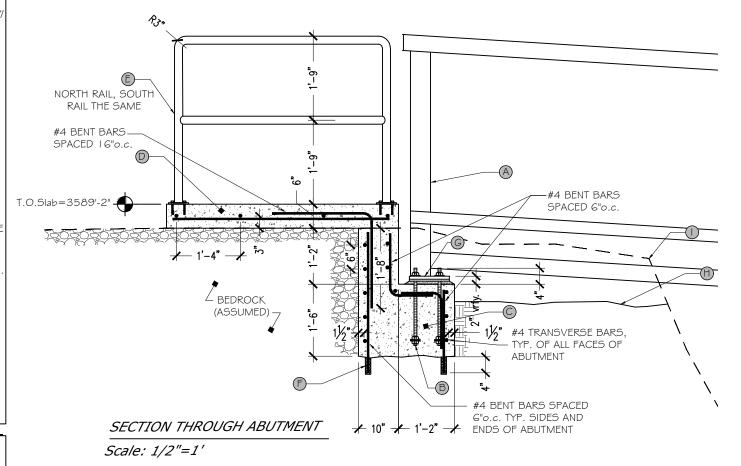
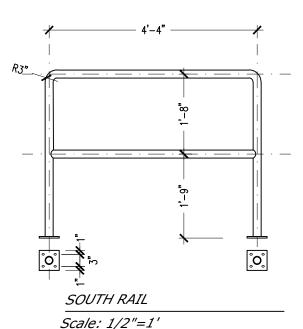
Montana Fish, Wildlife & Parks Bridge Abutment - West End Lone Pine State Park Pedestrian Bridge Project

- A PREFABRICATED STEEL BRIDGE FOR PEDESTRIAN TRAFFIC. 5'-O" CLEAR WIDTH BETWEEN HAND RAILS. 55'-O" SPAN. 3'-G" RAILING HEIGHT. 2" WOOD PLANK DECKING.
- B GALVANIZED THREADED ANCHORS GRADE AND DIA.
  DESIGNED BY BRIDGE MANUFACTURER. WET SET ANCHOR W
  DBL. NUT AND WASHER ON EMBEDDED END. EPOXY EMBED
  ALSO ALLOWED USING SIMPSON "SET" OR EQ. USE
  TEMPLATE OF BRIDGE BEARING PLATE FOR CORRECT
  PLACEMENT

- REINFORCED CONCRETE ABUTMENT AS SHOWN. 5000psi AT 28 DAYS. 5% TO 7% AIR ENTRAINMENT (AS MEASURED AT POINT OF PLACEMENT). W/C RATIO = 0.45. PLACTICIZER IF NEEDED.

- REINFORCED CONCRETE LANDING AND CURB AS SHOWN. 5000ps; AT 28 DAYS. 5% TO 7% AIR ENTRAINMENT (AS MEASURED AT POINT OF PLACEMENT). W/C RATIO = 0.45. DO NOT OVERWORK SURFACE, DO NOT TRAP BLEED WATER. MIN. SLOPE =  $\frac{1}{8}$ " PER 1'-0". PLACTICIZER IF NEEDED. PROVIDE BROOMED SURFACE.

- E 2" od SCHEDULE 40 WELDED PIPE RAILING AND SCHEDULE 8- POSTS. PAINTED TO MATCH EXISTING HAND RAILS ON SITE. T.O.Top Rail = 3'-6" ABOVE WALK SURFACE. PROVIDE 5"x5"x3" BEARING PLATE UNDER EA. RAIL (NEWEL) POST W/ (4) To HOLES FOR (4) STAINLESS To WITTEN OR EQ. THREADED ANCHORS. WEDGE ANCHORS NOT ALLOWED ALL WELDS = To MATCH TO MATCH THE TO ME TO WELDS = TO MATCH TO MATCH

- DRILL BEDROCK AND BRUSH/BLOW HOLE IN PREP FOR EPOXY EMBED. USE EXTERIOR GRADE EPOXY SUCH AS SIMPSON "SET OR EQ.
- © PROPRIETARY BRIDGE BEARING PLATE AND LOWER SETTING PLATE (SUPPLIED BY MANUFACTURER) (TRUE NORTH STEEL BRIDGE FOOT SHOWN). PROVIDE 4000ps NON-SHRINK GROUT UNDER LOWER BEARING PLATE TO LEVEL.

- (H) NEW GRADE (APPROX.)
- (I) EXISTING GRADE (APPROX.)

- INTEGRITY OF BRIDGE IS DEPENDANT UPON FREQUENT UPKEEP AND MAINTENANCE. MAINTENANCE ITEMS MAY INCLUDE BUT ARE NOT LIMITED TO: REPLACEMENT OF PLANK DECKING WHEN COMPROMISED, KEEPING ALL BOLTING SNUG, INSURING CORROSION IS CONTROLLED, MAINTAINING EROSION CONTROL, ETC.

- ON AN ANNUAL BASIS, CHECK TIGHTNESS OF RAIL (NEWEL) POST BASE PLATE ANCHORS. INSPECT RAILING FOR DAMAGE AND APPLY TOUCH -UP PAINT AS REQUIRED.

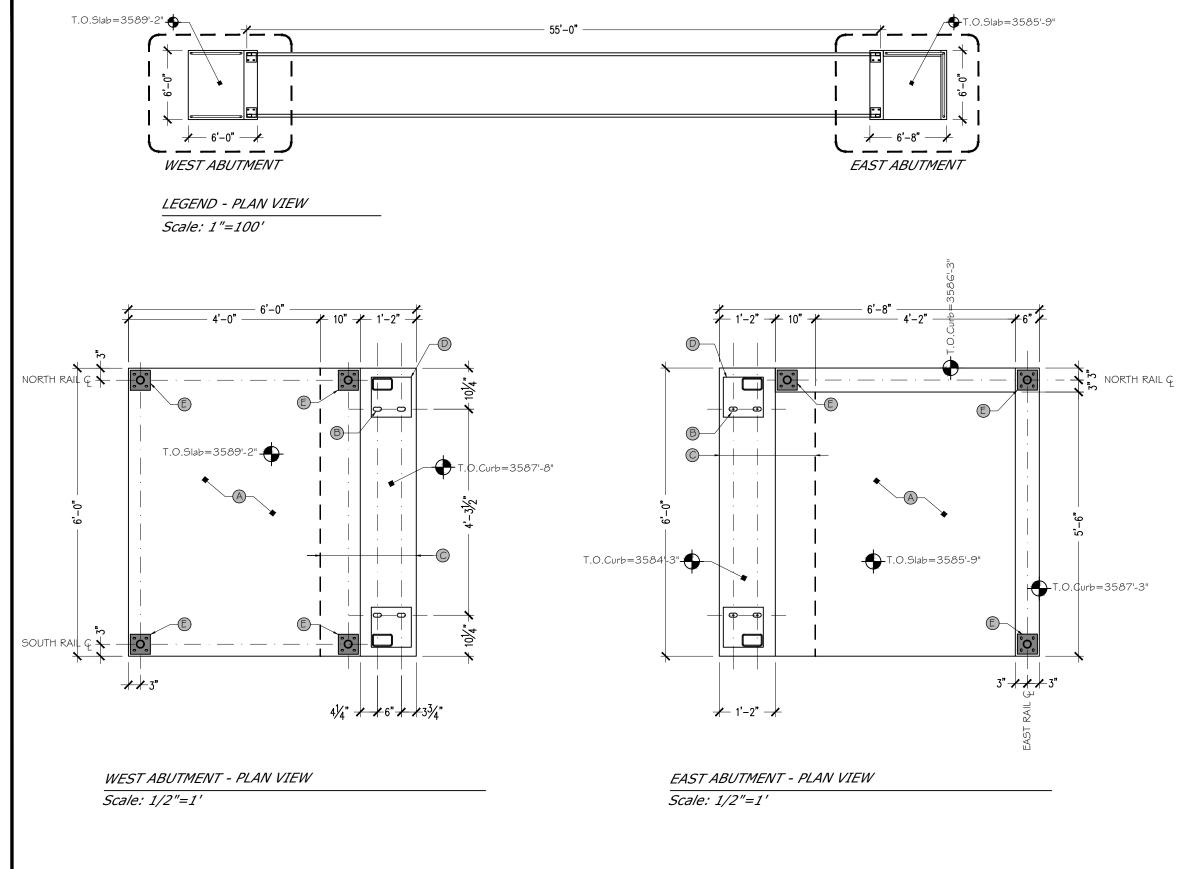
Montana Tish. Bridge Abutments - Plan View Lone Pine State Park Pedestrian Bridge Project

- A REINFORCED CONCRETE LANDING AND CURBS AS SHOWN. 5000psi AT 28 DAYS, 5% TO 7% AIR ENTRAINMENT (AS MEASURED AT POINT OF PLACMENT. W/C RATIO = 0.45. DO NOT OVERWORK SURFACE, DO NOT TRAP BLEED WATER. MIN. SLOPE =  $\frac{1}{8}$ " PER 1'-0". PLACTICIZER IF NEEDED

- B GALVANIZED THREADED ANCHORS GRADE AND DIA. DESIGNED BY BRIDGE MANUFACTURER. WET SET ANCHOR W, DBL. NUT AND WASHER ON EMBEDDED END. EPOXY EMBED ALSO ALLOWED. USE TEMPLATE OF BRIDGE BEARING PLATE FOR CORRECT PLACEMENT

- REINFORCED CONCRETE ABUTMENT AS SHOWN. 5000psi AT 28 DAYS. 5% TO 7% AIR ENTRAINMENT (AS MEASURED AT POINT OF PLACEMENT). W/C RATIO = 0.45. PLACTICIZER

- PROPRIETARY BRIDGE BEARING PLATE (BY MANUFACTURER) (TRUE NORTH STEEL BRIDGE FOOT SHOWN).
- $\mathbb{E}$  5"x5"x $\frac{3}{8}$ " BEARING PLATE UNDER EA. RAIL POST W/ (4)  $\frac{7}{16}$ " HOLES ELONGATED 1/4" FOR (4) STAINLESS 3/8"x4" SIMPSON TITEN OR EQ. THREADED ANCHORS. WEDGE ANCHORS NOT ALLOWED. ALL WELDS =  $\frac{3}{16}$ " FILLET ALL AROUND
