RUBY RIVER RVHA RESTORATION PROJECT

Madison County, Montana

April 2021

Ruby Valley
Hydroelectric Authority

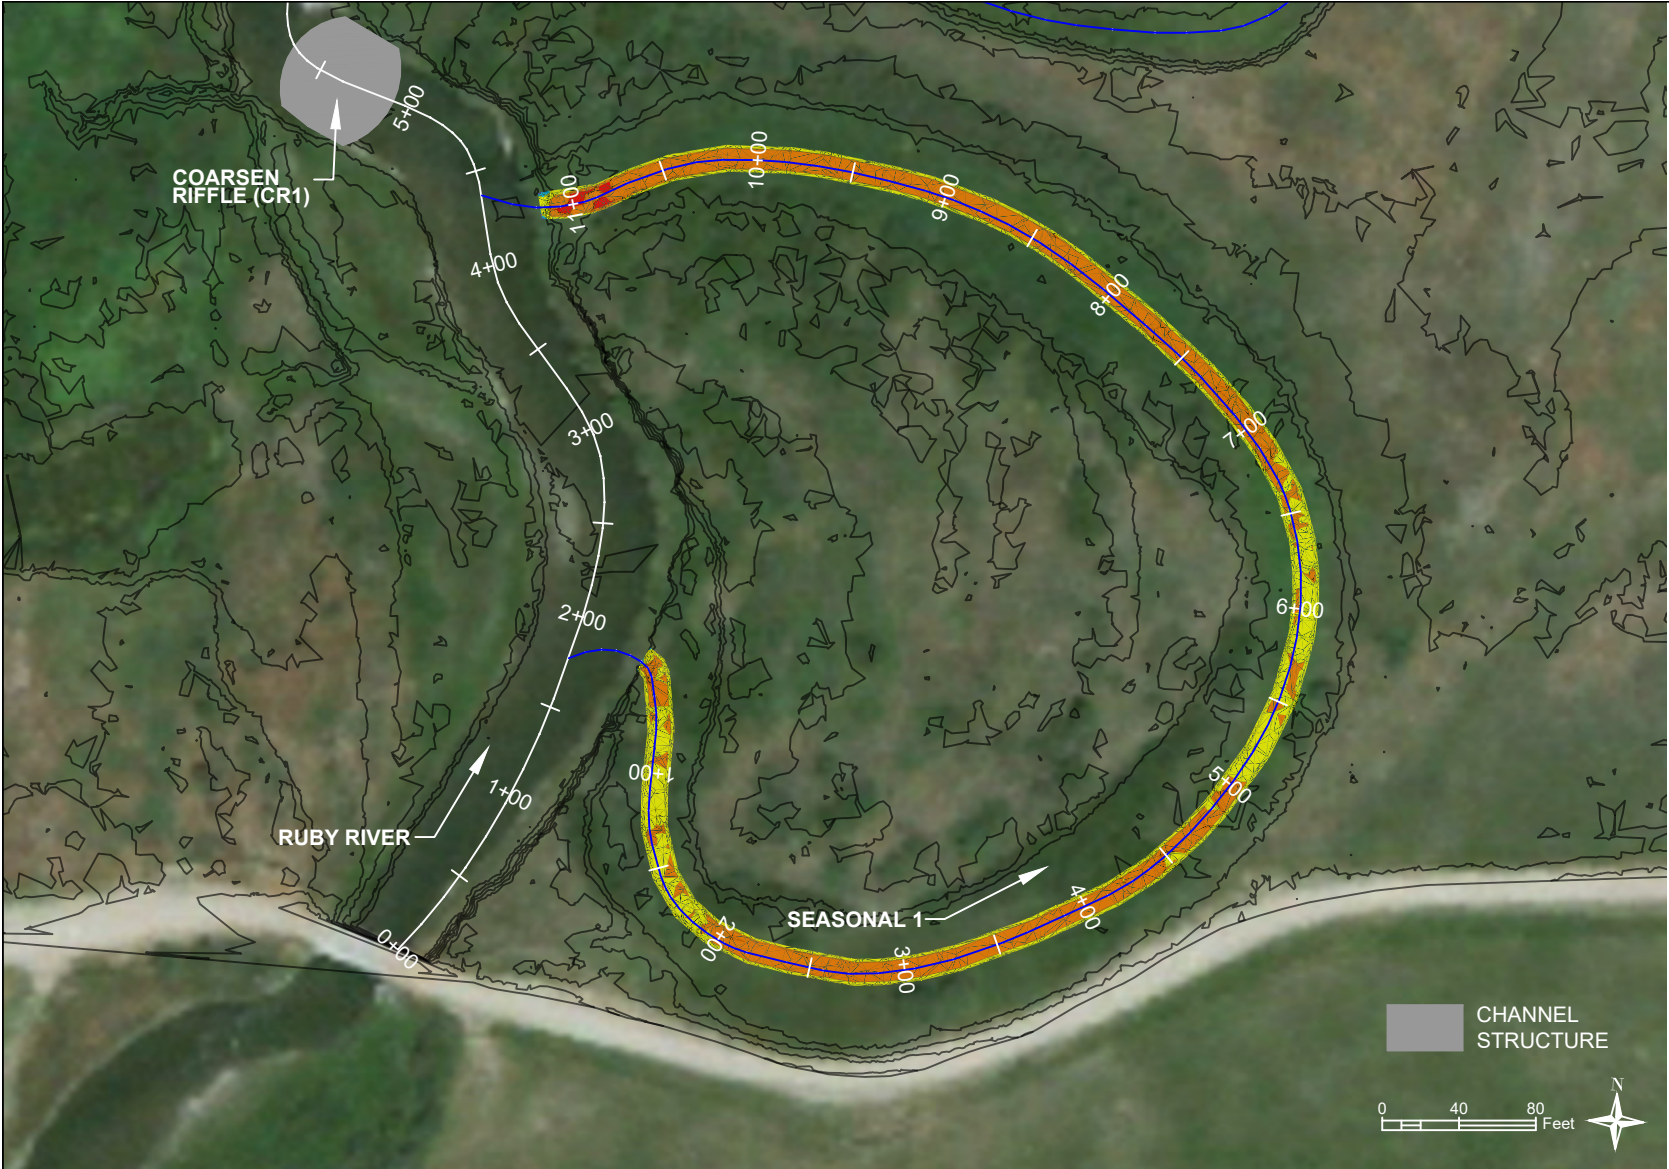
ACTIVATION CHANNEL
SEASONAL 1 DETAILS

SEASONAL 1 - PROFILE VIEW

Activation Channel Details	
Main Channel Start Station	1+78
Main Channel End Station	4+37
Activated Channel Length (ft)	N/A
Constructed Channel Length (ft)	1075
Target Inlet Elevation (ft)	5436.5
Target Outlet Elevation (ft)	5435.0
Activation Stage Above Bed (ft)	2.3
Activation Q (cfs)	480
Days per Year Activated	26
Slope	0.14%

SEASONAL 1
TYPICAL CROSS SECTION

Estimated Earthwork Volumes for Constructed Channel	
Cut (CY)	575
Fill (CY)	0

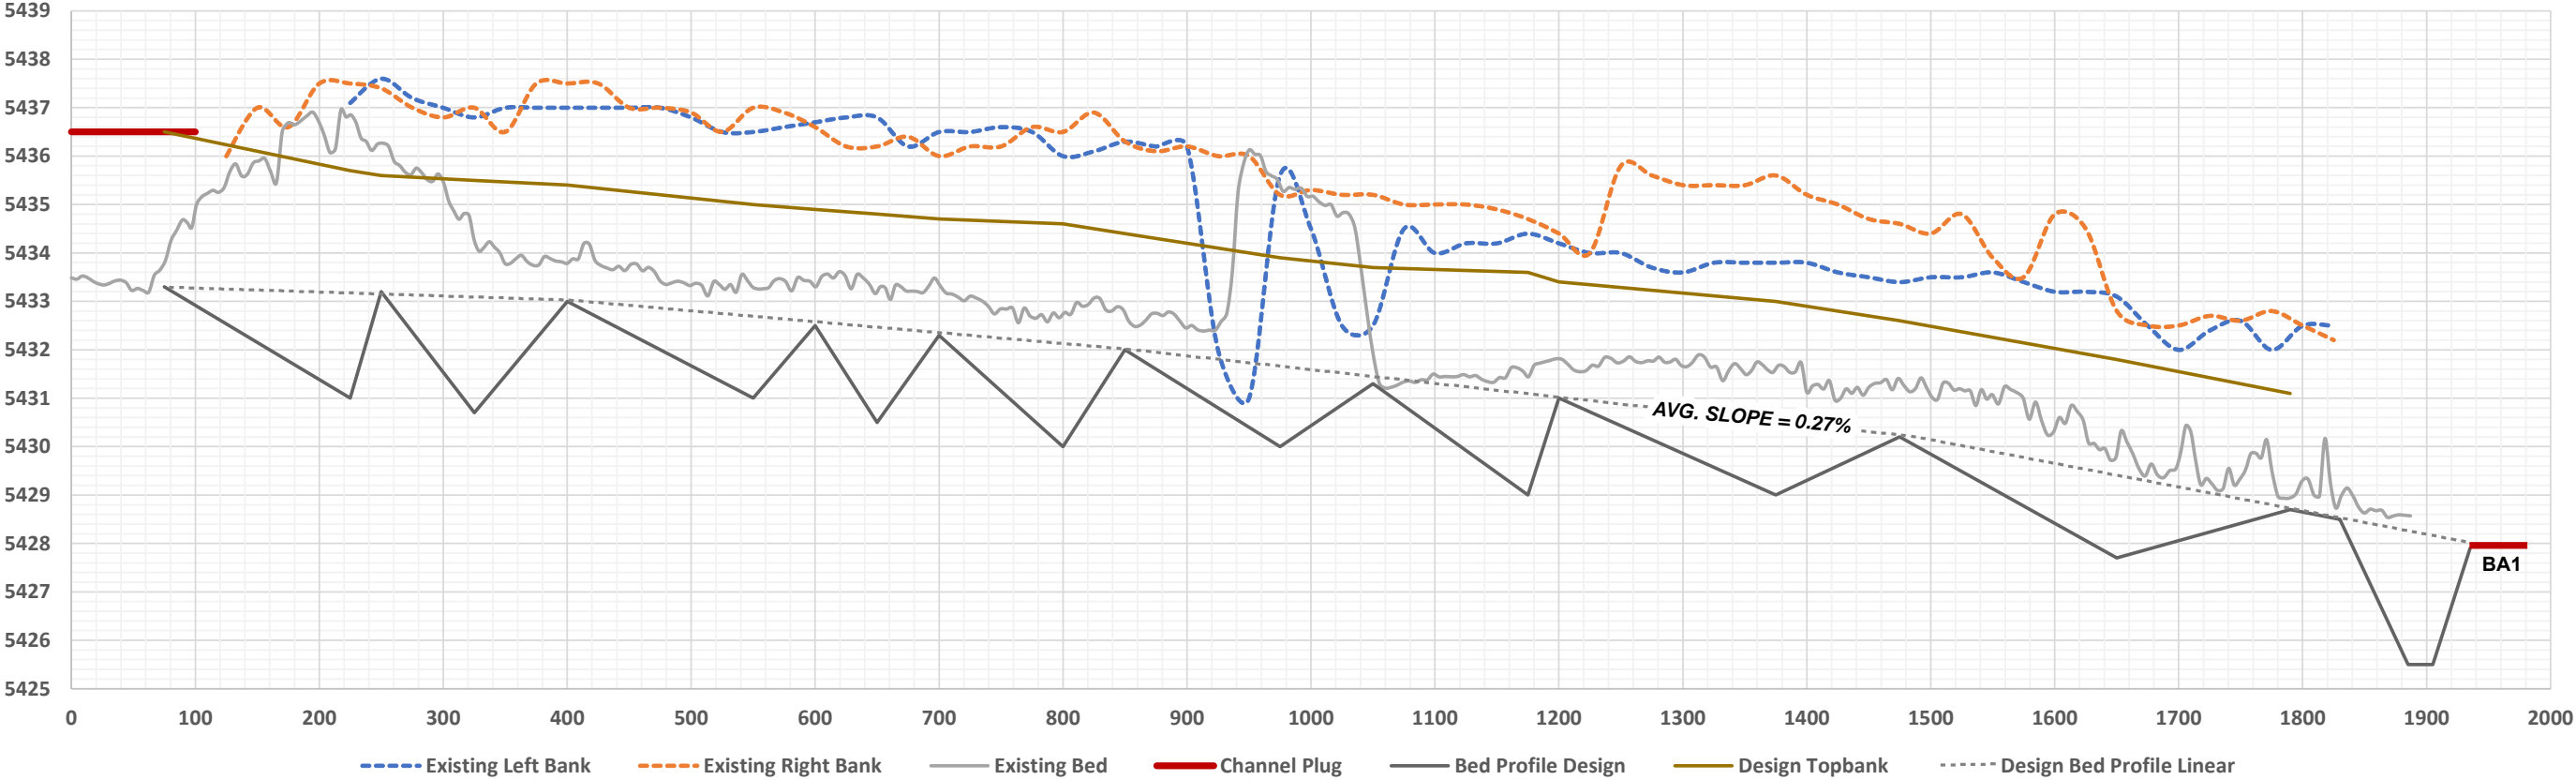
MAIN CHANNEL RELOCATION 1
GRADING nad HABITAT UNITS

RELOCATION CHANNEL HABITAT UNITS

RELOCATION 1 GRADING SCHEDULE

Station	Design Thalweg (ft)	Design TOB (ft)	Channel Feature
75	5433.3	5436.5	Pool Tie-in at entrance
225	5431	5435.7	Max Pool Depth
250	5433.2	5435.6	Riffle Crest
325	5430.7	5435.5	Max Pool Depth
400	5433	5435.4	Riffle Crest
550	5431	5435	Max Pool Depth
600	5432.5	5434.9	Riffle Crest
650	5430.5	5434.8	Max Pool Depth
700	5432.3	5434.7	Riffle Crest
800	5430	5434.6	Max Pool Depth
850	5432	5434.4	Riffle Crest
975	5430	5433.9	Max Pool Depth
1050	5431.3	5433.7	Riffle Crest
1175	5429	5433.6	Max Pool Depth
1200	5431	5433.4	Riffle Crest
1375	5429	5433	Max Pool Depth
1475	5430.2	5432.6	Riffle Crest
1650	5427.7	5431.8	Max Pool Depth
1790	5428.7	5431.1	Riffle Crest
1830	5428.5	Existing main channel TOB	Riffle Tie-in at outlet
1885	5425.5	Existing main channel TOB	Main Channel Max Pool Depth
MC 2480	5425.5	Existing main channel TOB	Main Channel Max Pool Depth
MC 2525	5427.9	Existing main channel TOB	Crest of Bed Aggradation Structure

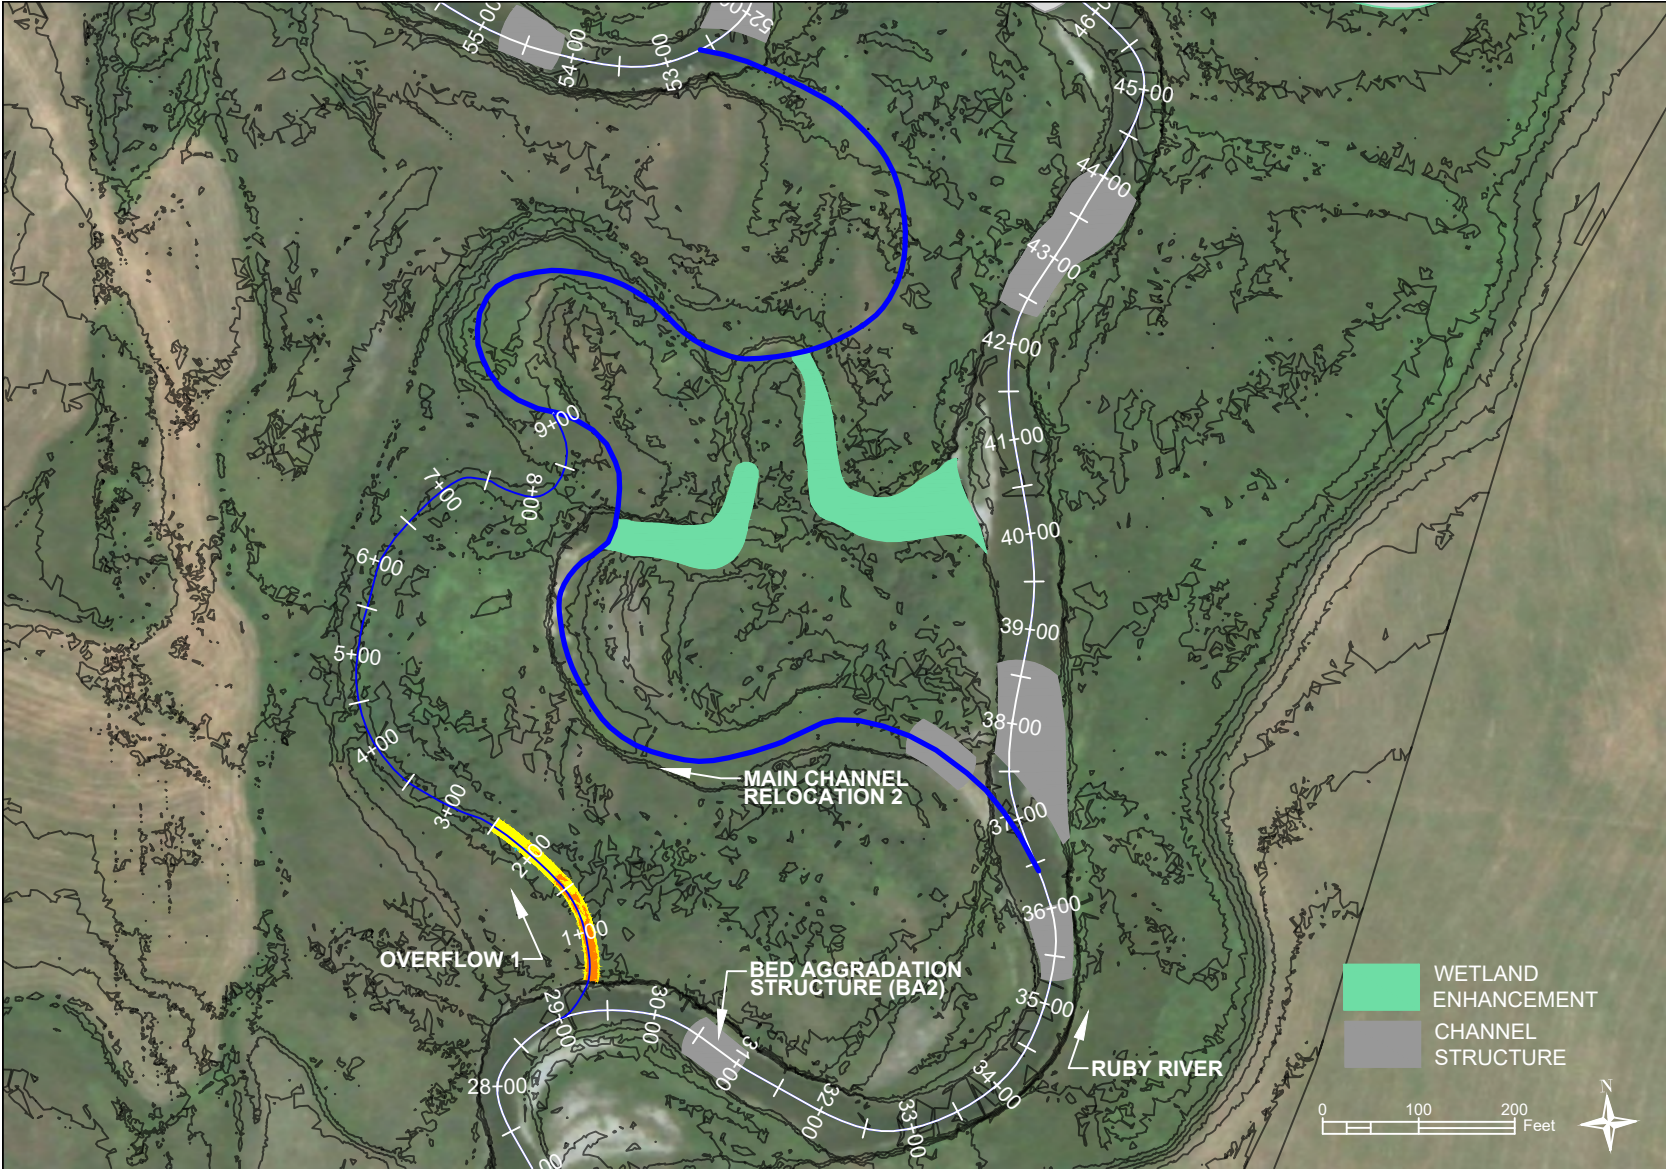
ACTIVATION CHANNEL
OVERFLOW 1 DETAILS

OVERFLOW 1 - PROFILE VIEW

ACTIVATION CHANNEL DETAILS	
MAIN CHANNEL START STATION	29+02
MAIN CHANNEL END STATION	N/A
ACTIVATED CHANNEL LENGTH (FT)	645
CONSTRUCTED CHANNEL LENGTH (FT)	200
TARGET INLET ELEVATION (FT)	5428.5
TARGET OUTLET ELEVATION (FT)	N/A
ACTIVATION STAGE ABOVE BED (FT)	1.9
ACTIVATION Q (CFS)	400
DAYS PER YEAR ACTIVATED	29
SLOPE	0.30%
BED AGGRADATION STRUCTURE BA2 ELEVATION	5426.6

ESTIMATED EARTHWORK VOLUMES FOR CONSTRUCTED CHANNEL	
CUT (CY)	90
FILL (CY)	0

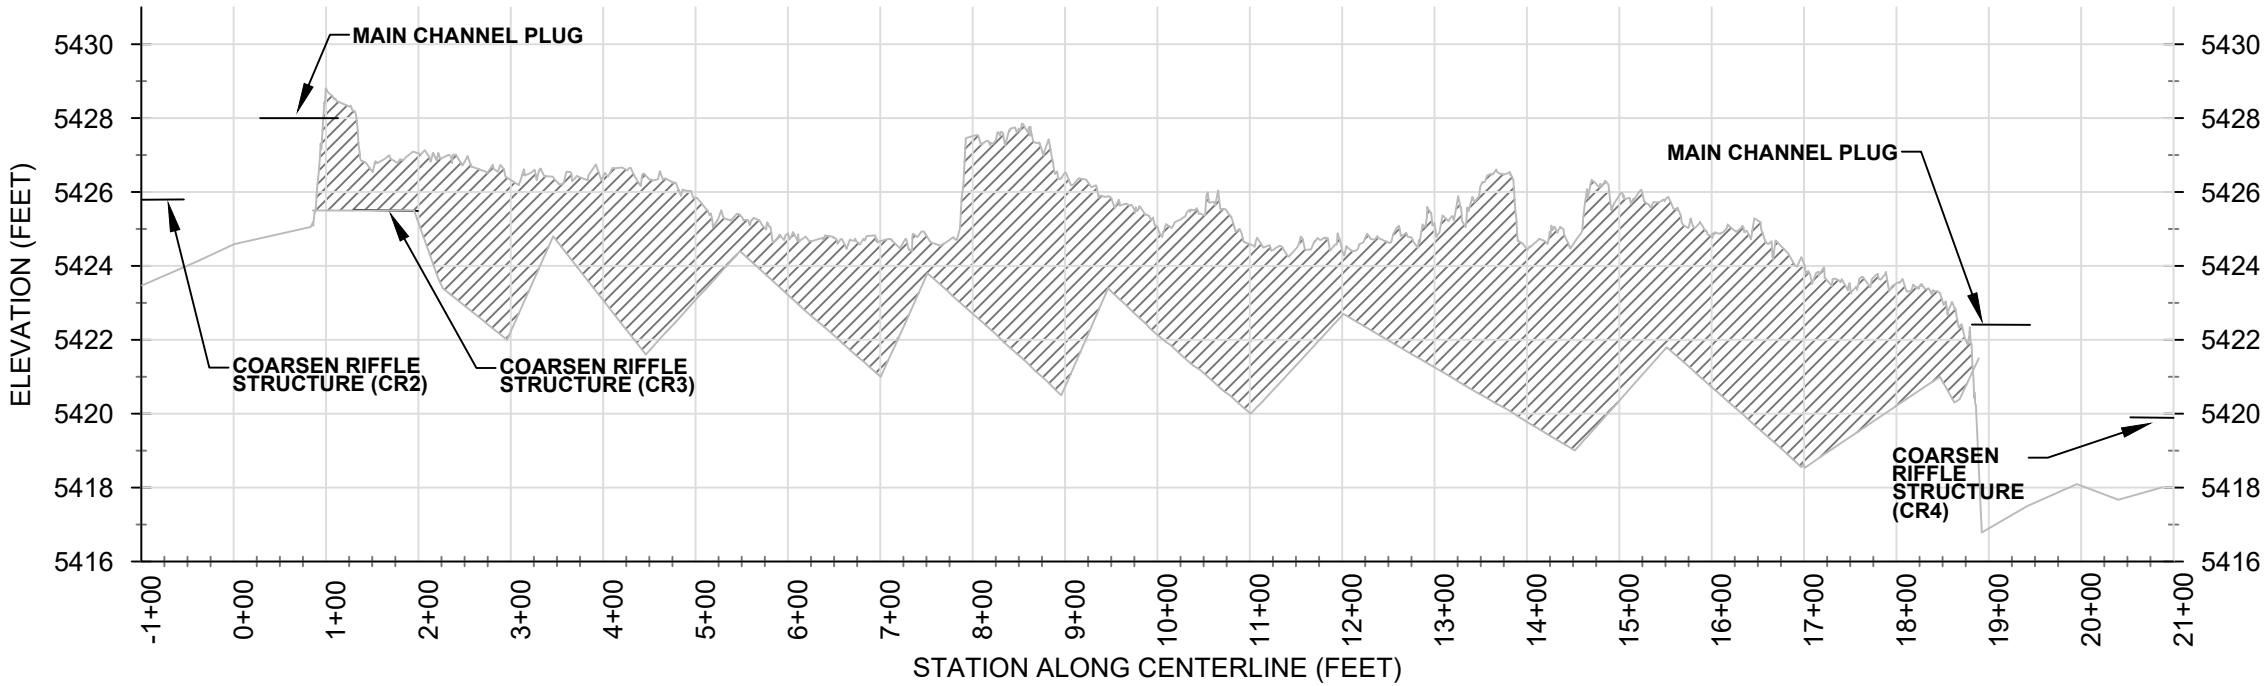
ACTIVATION CHANNEL MAIN CHANNEL RELOCATION 2 DETAILS

Activation Channel Details	
Main Channel Start Station	37+00
Main Channel End Station	52+64
Activated Channel Length (ft)	N/A
Constructed Channel Length* (ft)	1745
Upper Structure Height (ft)	2.5
Lower Structure Height (ft)	N/A
Target Inlet Elevation (ft)	5425.5
Target Outlet Elevation (ft)	5421.0
Activation Stage Above Bed (ft)	0.0
Activation Q (cfs)	0
Days per Year Activated	365
Slope	(on profile)
Upstream Main Channel Plug Elevation	5428.0
Downstream Main Channel Plug Elevation	5422.4
Coarsen Riffle Structure CR2 Elevation	5425.8
Coarsen Riffle Structure CR3 Elevation	5425.5
Coarsen Riffle Structure CR4 Elevation	5419.9

Estimated Earthwork Volumes for Constructed Channel	
CUT (CY)	12855
FILL (CY)	500

MAIN CHANNEL RELOCATION 2 - PROFILE VIEW
