MONTANA DEPARTMENT OF FISH AND GAME

JOB PROGRESS REPORT

State: Montana Title: Southwestern Montana Fisheries Study  
Project No.: F-9-R-22 Title: Evaluation of Stream Improvements on  
Job No.: II-a Prickly Pear Creek  
Period Covered: July 1, 1973 to June 30, 1974 (Field Work: July 1 - January 31, 1973)

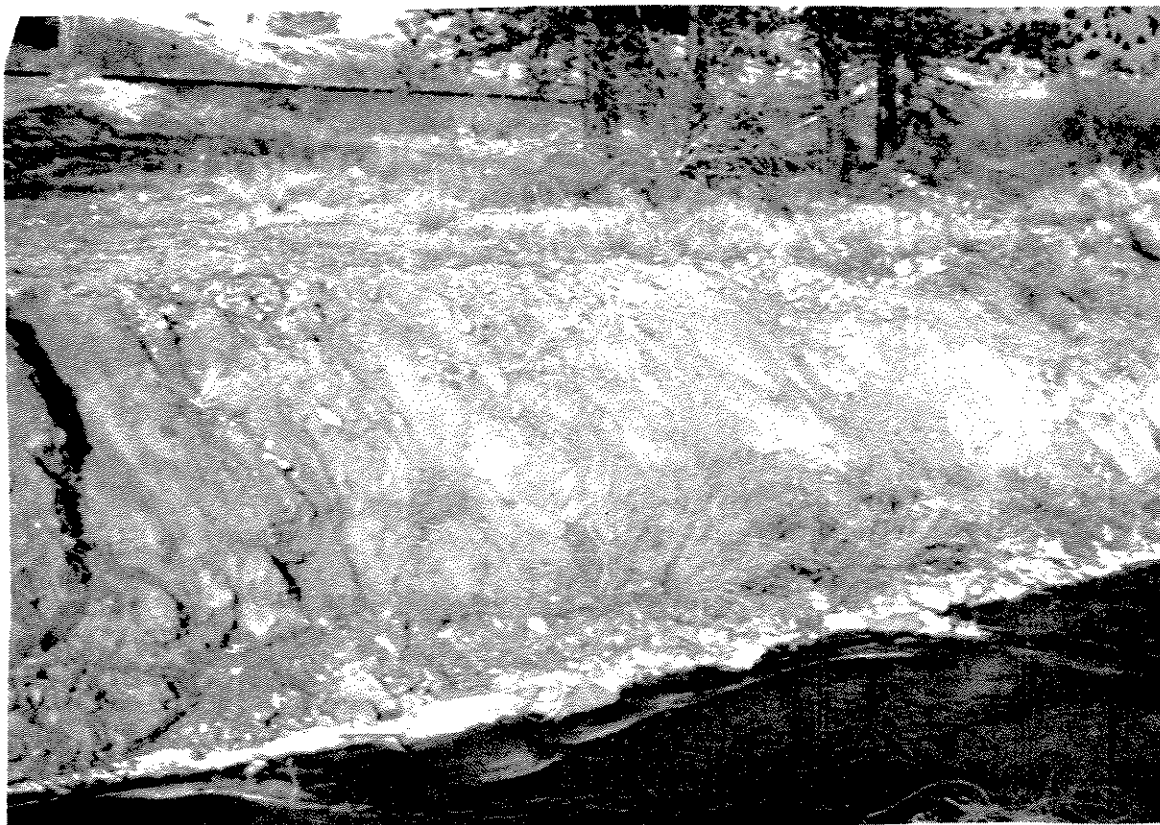
Figure 3. Berm 3 (above) and berm 4 (below) in the summer of 1972

The soil in study area one consisted of sandy loam. Proceeding downstream, study area two was mostly clay which became hard and impermeable during the summer. Areas three and four were composed of clay with large amounts of partially decomposed granite (Figures 3 and 4).

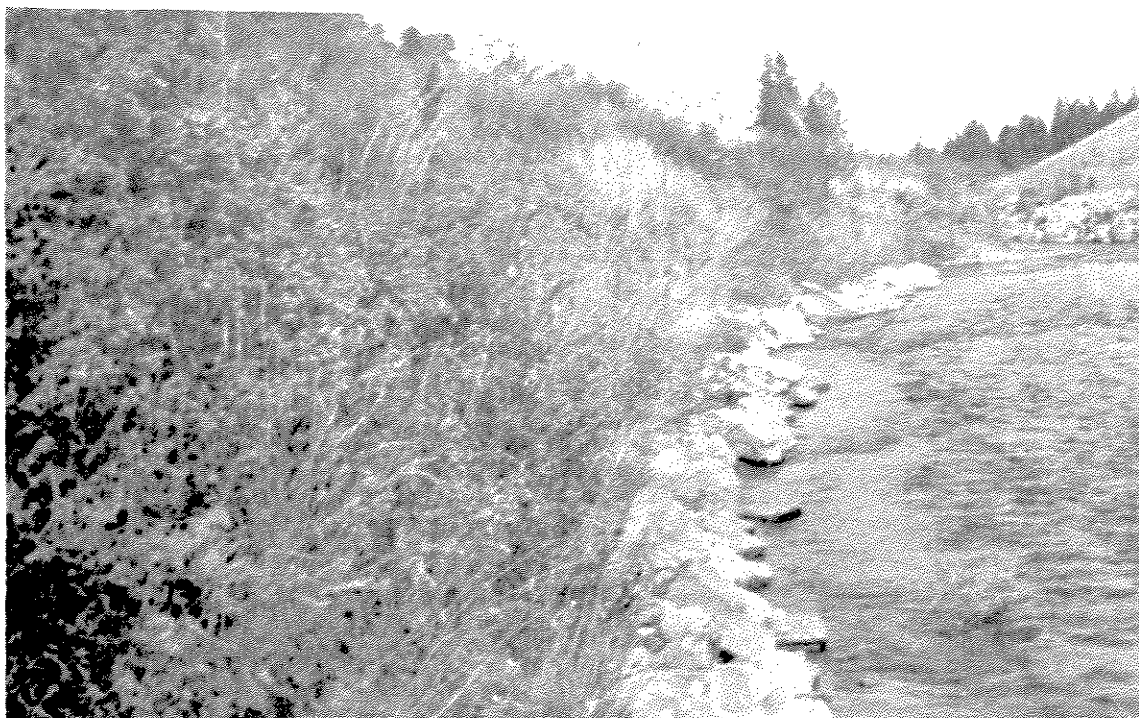
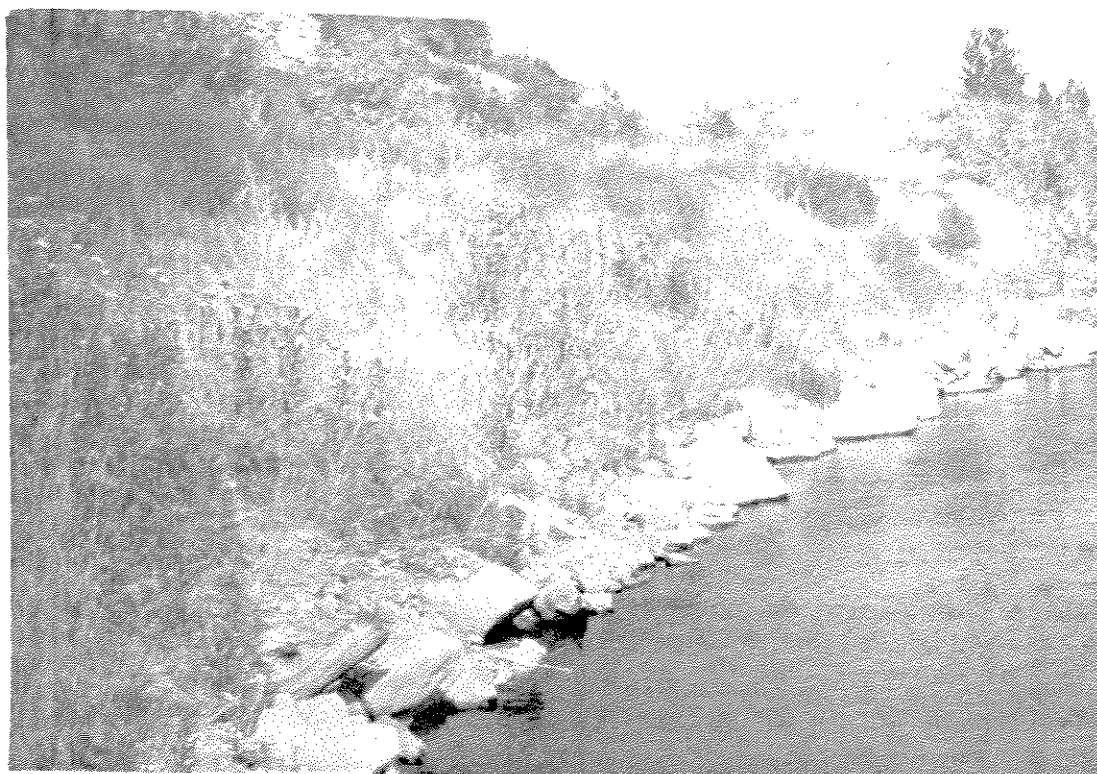
Figure 4. Study area one (above) and area two (below) in the summer of 1972.

In the summer of 1972 and 1973, vegetation from natural seeding became so dense in areas of good soil quality (areas one and two) that it became impossible to

inventory the experimental plants (Figure 4). This indicates that more emphasis should be placed on methods of stabilizing streambanks and improving the soil, so that natural seeding has an advantage, rather than on transplanting to revegetate denuded areas.

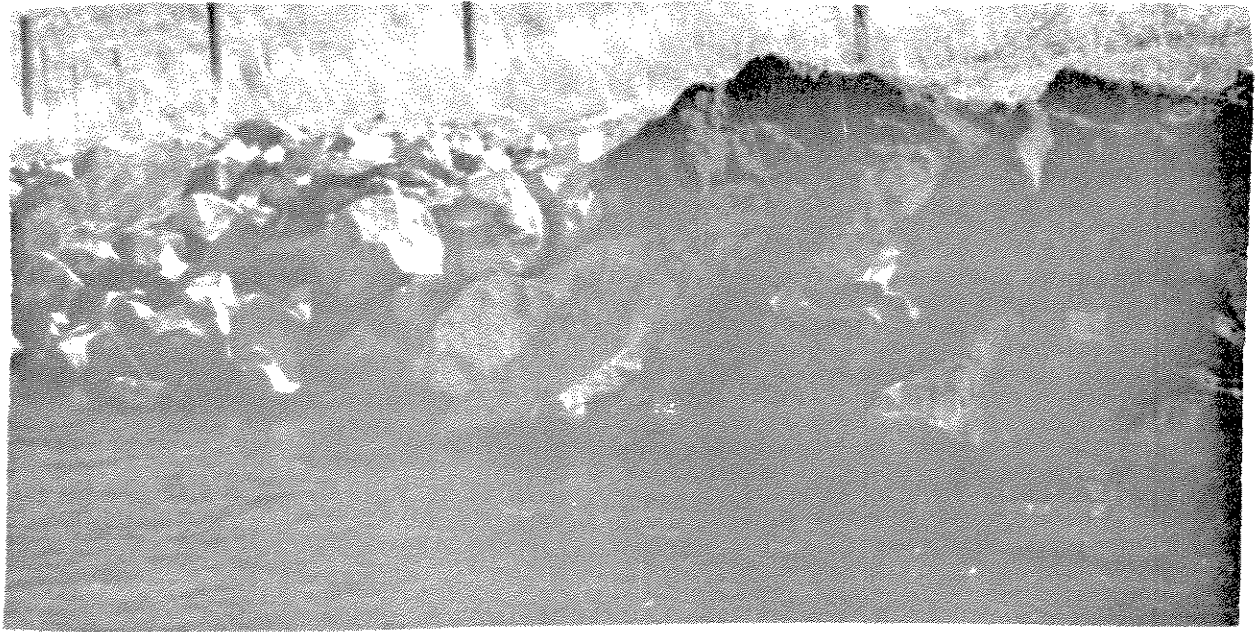
Figure 5. Rip-rap area B (above) in 1971 before completely covered with soil. Rip-rap area B (below) in 1972.

Blanket rip-rap was placed on the outside bends of the new channel to protect the highway grade. In 1971, soil was placed on three rip-rap areas and worked into the spaces between the rocks. Fifty native willow shoots were planted on each of rip-rap areas A and B (114 and 146 feet long, respectively). Area C (140 feet long) was left to natural seeding. In April, 1973, an additional 62 and 120 willow shoots were planted on rip-rap A and B, respectively. In December, 1973, 91 willows were still surviving on Area A, 76 on Area B and only 3 could be found on Area C, which had been left for natural seeding. The apparent high degree of success of these transplanted willows can be attributed to the abundance of moisture in the soil adjacent to the stream at water level and to the time of year they were planted (April). The soil which was mechanically placed on the rip-rap and worked into the spaces between the rocks was washed away, except for that which remained above water line (Figure 5). This technique appears to have no beneficial effect because soil placed between the rocks was not held tightly enough to withstand high water during the spring runoff. Soil placed on the rip-rap was a mixture of loam and clay on all three areas. The willows were planted in spaces protected from the direct force of high water where the shoots could be pushed into moist soil near low water level.
