An Inventory of Irrigation Structures in the Upper Clark Fork River Drainage, Montana

Final Report 2011
USFWS Agreement Number- 601818J270
Will Schreck, Ryan Kreiner, Brad Liermann, and Jason Lindstrom
Montana Fish, Wildlife and Parks

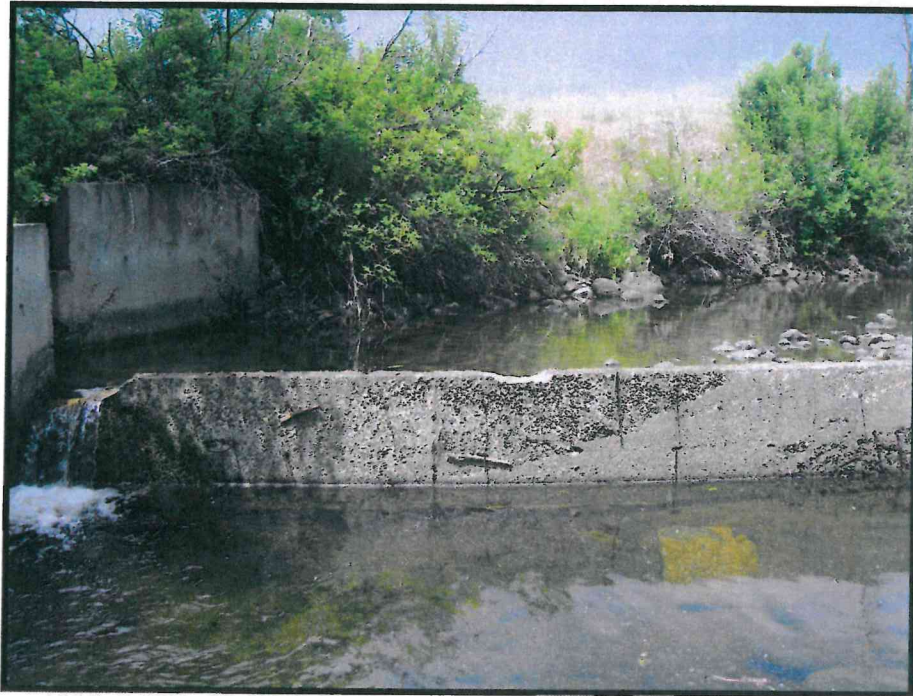
Concrete diversion for ditch at RM 5.5 on Cottonwood Creek, surveyed 2009.
This structure was replaced with a rock v-weir structure in fall 2011.

In the fall of 2011, the privately owned concrete diversion at RM 5.5 was replaced with a passage friendly rock v-weir structure. The project was a coordinated effort among Montana TU and the WRC of the Upper Clark Fork, with assistance also provided by Montana FWP. The project was permitted by the Deer Lodge Valley Conservation District, with input by FWP. Montana TU provided technical assistance and construction oversight, and the WRC contributed funds for material.

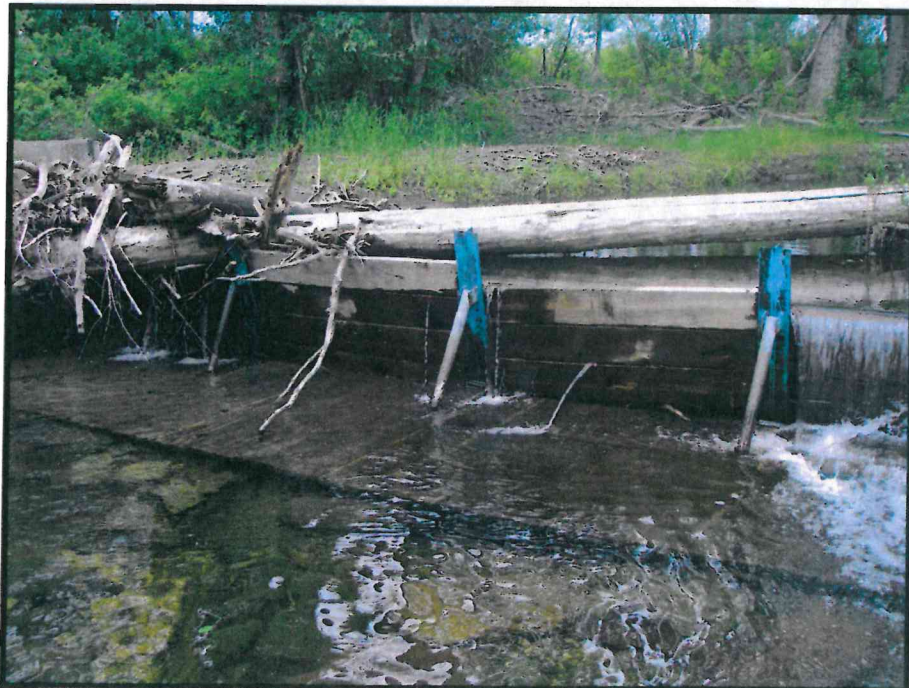
Diversion for ditch at RM 5.4 on Cottonwood Creek, surveyed in 2009.

In summary, none of the structures were found to be complete barriers to fish migration. The diversions at RM 6.0 and RM 5.4 were both pin and plank structures, and appeared to be barriers when all planks were in place. However, on July 15, 2009, at least one plank from each of these diversions had been removed which provided easy passage for fish. The diversion at RM 5.5 was the tallest, most permanent structure and considered most likely to be a seasonal barrier in 2009 (Appendix B). However, on July 15 a 153 mm EB placed below the diversion at RM 5.4 was recaptured above the diversion at RM 5.5. Regardless, in the fall of 2011, the diversion at RM 5.5 was replaced with a passage friendly rock v-weir structure. In 2009, multiple fish also navigated past the two lowest diversions at RM 3.5 and RM 3.0. A final barrier observed during 2009, was the several hundred meters of dry creek bed below the diversion at RM 3.5. This stretch was certainly a barrier for the seven or more days when dry, and may be dry for longer periods during low-water years. Furthermore, when surveyed on June 30, hundreds of trout fry were stranded in pools within this section of creek. Approximately 20 of these fry were positively identified as brook trout, but it is likely a small percentage were westslope cutthroat trout given their presence in this reach of Cottonwood Creek.
