FUTURE FISHERIES IMPROVEMENT PROGRAM GRANT APPLICATION All sections must be addressed, or the application will be considered invalid

Α.	1 Toject No	Lower	Grant Creek R	estoration							
	River, stream, or lake:		Grant Creek,	Grant Creek, 12-digit Hydrologic Unit Codes 170102040103							
	Location:	Township:	13N	Range:	20W	Section: 14					
		Latitude:	46.879677	Longitude:	-114.095970	Within project (decimal degrees)					
	County: _	Missoula

EXISTING CONDITIONS
PHOTO POINTS
LOWER GRANT CREEK RESTORATION PROJECT

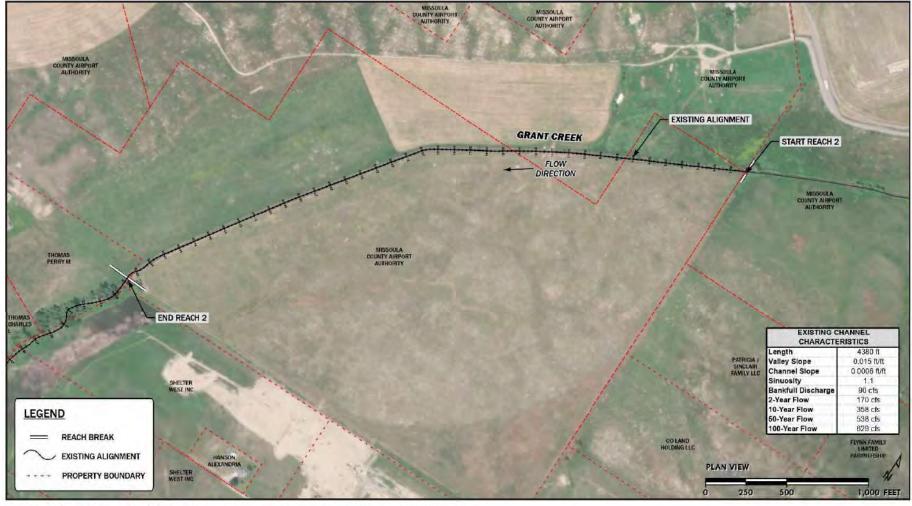
Figure 2-2. Existing conditions and land ownership in lower Grant Creek Reach 2.

Reach 2 extends 0.8 miles on the property of the Missoula County Airport Authority (Figure 2-2). The stream was historically channelized and provides poor geomorphic, hydraulic, and habitat complexity. The reach is devoid of woody riparian vegetation to provide cover, shade, and a source of large wood; vegetation consists of pasture grasses. The lack of riparian vegetation to

stabilize banks and morphologic complexity and large wood to dissipate flow energy has led to lateral and vertical channel erosion and a loss of floodplain connectivity (Figure A-5). Fine sediment loading from erosion has overwhelmed the transport capacity of the channel, contributing to siltation of the bed. Historic vegetation removal and floodplain disconnection have resulted in a floodplain that provides little habitat complexity or diversity. The contemporary morphology of Reach 2 does not allow for natural riverine processes to create complex in-channel and floodplain features, and has led to the degradation of aquatic, riparian, and terrestrial habitat. Typical channel conditions in Reach 2 are shown in Figure 2-3.

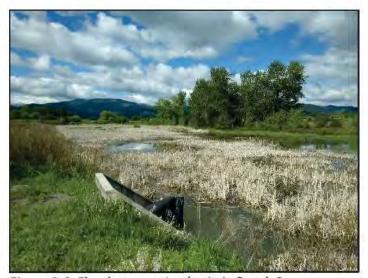
Figure 2-6. Flood attenuation basin in Reach 3.

Flood risk is a continuing concern in Reach 3. In 2008, Missoula County retained HDR Engineering, Inc. to engineer and construct the Grant Creek Restoration and Flood Control Project. The project consisted of constructing two flood attenuation/detention basins upstream and downstream of Hiawatha Road to reduce flood hazard risk to adjacent residential developments (Figure 2-4; Figure 2-6). Erosion near the inlet structure may be contributing to greater streamflow capture to the ponds than was designed (Land et al. 2022). A second component of the project was the construction of a concrete inlet peak flow bypass structure and pipeline upstream of Mullan Road (Figure 2-4). The effectiveness of these projects in ameliorating flood risk is uncertain and was beyond the scope of the Conceptual Restoration Plan.

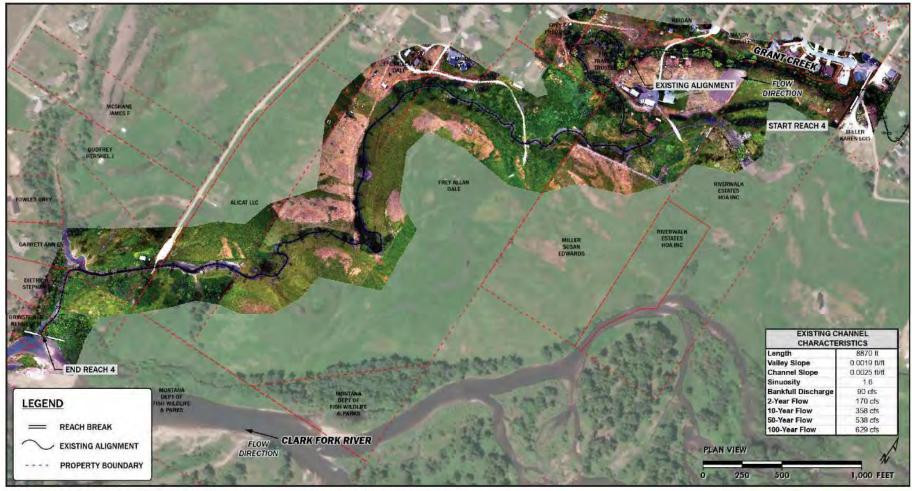
Figure 2-7. Existing conditions and land ownership in lower Grant Creek Reach 4.

Reach 4 begins where the creek exits a large culvert and enters the property of Riverwalk Estates HOA, Inc. The reach extends 1.7 miles downstream to the confluence with the Clark Fork River (Figure 2-7). It is likely that the creek was historically channelized for large sections of Reach 4 to enable agricultural practices and residential development in the floodplain. There are several crossings of varying size in the reach that may potentially impede the downstream transport of woody debris.

The upper 2600 feet of Reach 4 is mostly forested, including mature cottonwoods (*Populus* sp.) and willows (*Salix* sp.), and natural wood recruitment and storage provides some hydraulic and geomorphic complexity (Figure 2-8). The gradient is steeper through this section (Figure A-1), and coarse (cobble-gravel) sediment transport and deposition are active processes, contributing to the development of some riffles, pools, and bars (Figure 2-9). Most of upper Reach 4, where the channel runs adjacent to a suburban residential development, is severely entrenched and provides little floodplain connectivity (Figure A-6). The lack of connected floodplain to dissipate energy during high flows contributes to local erosion of streambanks and further incision of the channel (Figure 2-10). The eroding right bank at Station 133+00 has been stabilized with large concrete slabs and riprap (Figure 2-11). Besides a narrow riparian corridor through upper Reach 4, floodplain vegetation consists mostly of grasses.

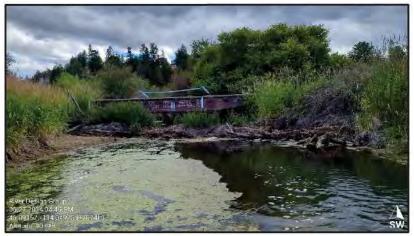
Figure 2-15. Algae growth in lower Reach 4.

Lower Reach 4 is low-gradient, and the degraded channel lacks the capacity to transport the abundant fine sediment load, leading to siltation. Warm temperatures and excess nutrient loading contribute to the growth of algae (Figure 2-15). Floodplain connectivity is generally poor in this section (Figure A-6), although in some areas the channel has begun to develop an inset floodplain (Figure 2-16). Springs contribute perennial flow to lower Reach 4 at Stations 142+00 and 195+00. These areas provide low-energy, hydrologically connected off-channel habitat. Beaver activity is evident in lower Reach 4, including a dam at Station 197+00 that creates a large backwater area (Figure 2-17). Despite some areas of Reach 4 exhibiting characteristics of good aquatic habitat, in general the reach is severely degraded and the natural recovery of riverine processes and high-quality habitat is limited by residential encroachment in the historic floodplain and ongoing agriculture and grazing practices.

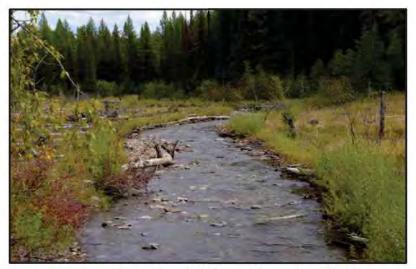
Figure 4-1. Example constructed channel through a riffle feature.

New channel construction will address the general lack of geomorphic and aquatic habitat complexity in the project area. Design channels will incorporate planform variability and morphologic complexity in the form of riffle, run, pool, and glide features that provide diverse habitat and promote hyporheic exchange. Channels will be sized to accommodate the estimated bankfull discharge of 90 cfs. The channel bed profile will be elevated to reconnect historic floodplain surfaces, promote groundwater recharge, and provide flood attenuation. In addition to driving increased hyporheic exchange, channel construction will address water temperature impairments by creating cold water refugia in pools and lowering channel width-to-depth ratios. A reduction in width-to-depth ratios will also increase stream power and sediment transport capacity, thereby reducing siltation. An example constructed channel is shown in Figure 4-1. Specific channel design criteria for Reaches 2 and 4 is described in Appendix B.

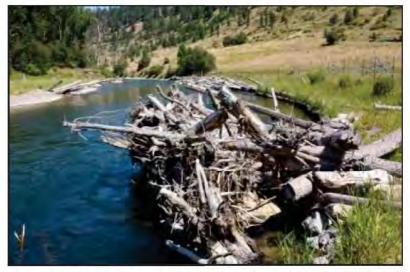
Figure 4-3. Example large wood habitat structure on a side channel of the Kootenai River, Idaho.

Large wood habitat structures will be installed along newly constructed channel margins to maintain pools, create hydraulic complexity, provide cover, and promote woody debris accumulation. Large wood structures consist of multiple tiers of stacked large logs (key members) with attached rootfans (Figure 4-3). Smaller wood and brush are racked between the key members. The structure is backfilled with alluvium to counteract buoyancy and sliding forces. Preferred wood species include the native conifers Douglas fir (*Pseudotsuga menzisii*), western larch (*Larix occidentalis*), ponderosa pine (*Pinus ponderosa*), lodgepole pine (*Pinus contorta*), western redcedar (*Thuja plicata*), Engelmann spruce (*Picea engelmannii*), grand fir (*Abies grandis*), subalpine fir (*Abies lasiocarpa*), western hemlock (*Tsuga heterophylla*), and rocky mountain juniper (*Juniperus scopulorum*).

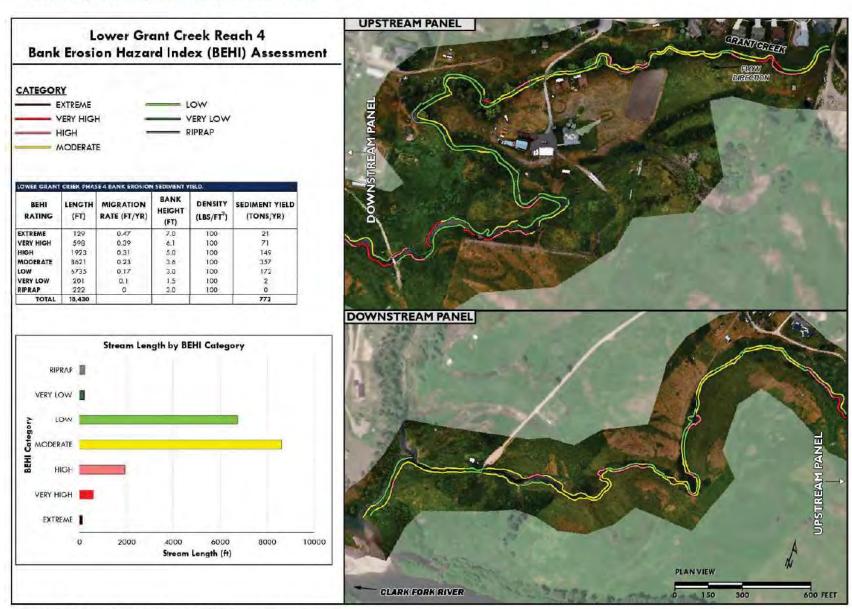
Figure A-7. Grant Creek Reach 4 BEHI assessment results.

BEHI RATING	LENGTH (FT)	MIGRATION RATE (FT/YR)	BANK HEIGHT (FT)	DENSITY (LBS/FT ³)	SEDIMENT YIELD (TONS/YR)
EXTREME	129	0.47	7.0	100	21
VERY HIGH	598	0.39	6.1	100	71
HIGH	1923	0.31	5.0	100	149
MODERATE	8621	0.23	3.6	100	357
LOW	6735	0.17	3.0	100	172
VERY LOW	201	0.1	1.5	100	2
RIPRAP	222	0	3.0	100	0
TOTAL	18,430				772
