Lower Hound Creek Restoration Feasibility

Attachment B. Historical Imagery

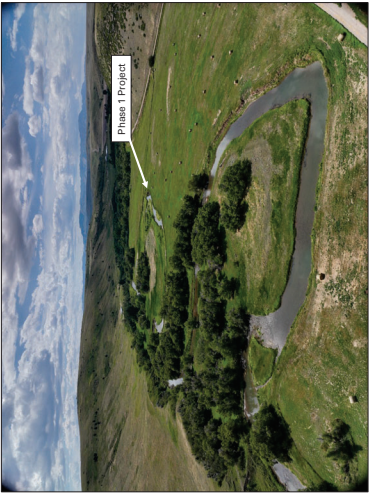
Hound Creek. 2024. From: [obliquus.images](#). Looking southwest (upstream) from the private access road towards the upstream extent of Hound Creek on the McKimby Ranch.
