**FISH COMMUNITIES AND HABITATS IN UPPER SEVENMILE CREEK,  
DAWSON COUNTY, MONTANA**

**May 2007**

**Montana Department of Fish, Wildlife & Parks  
Miles City, Montana 59301**

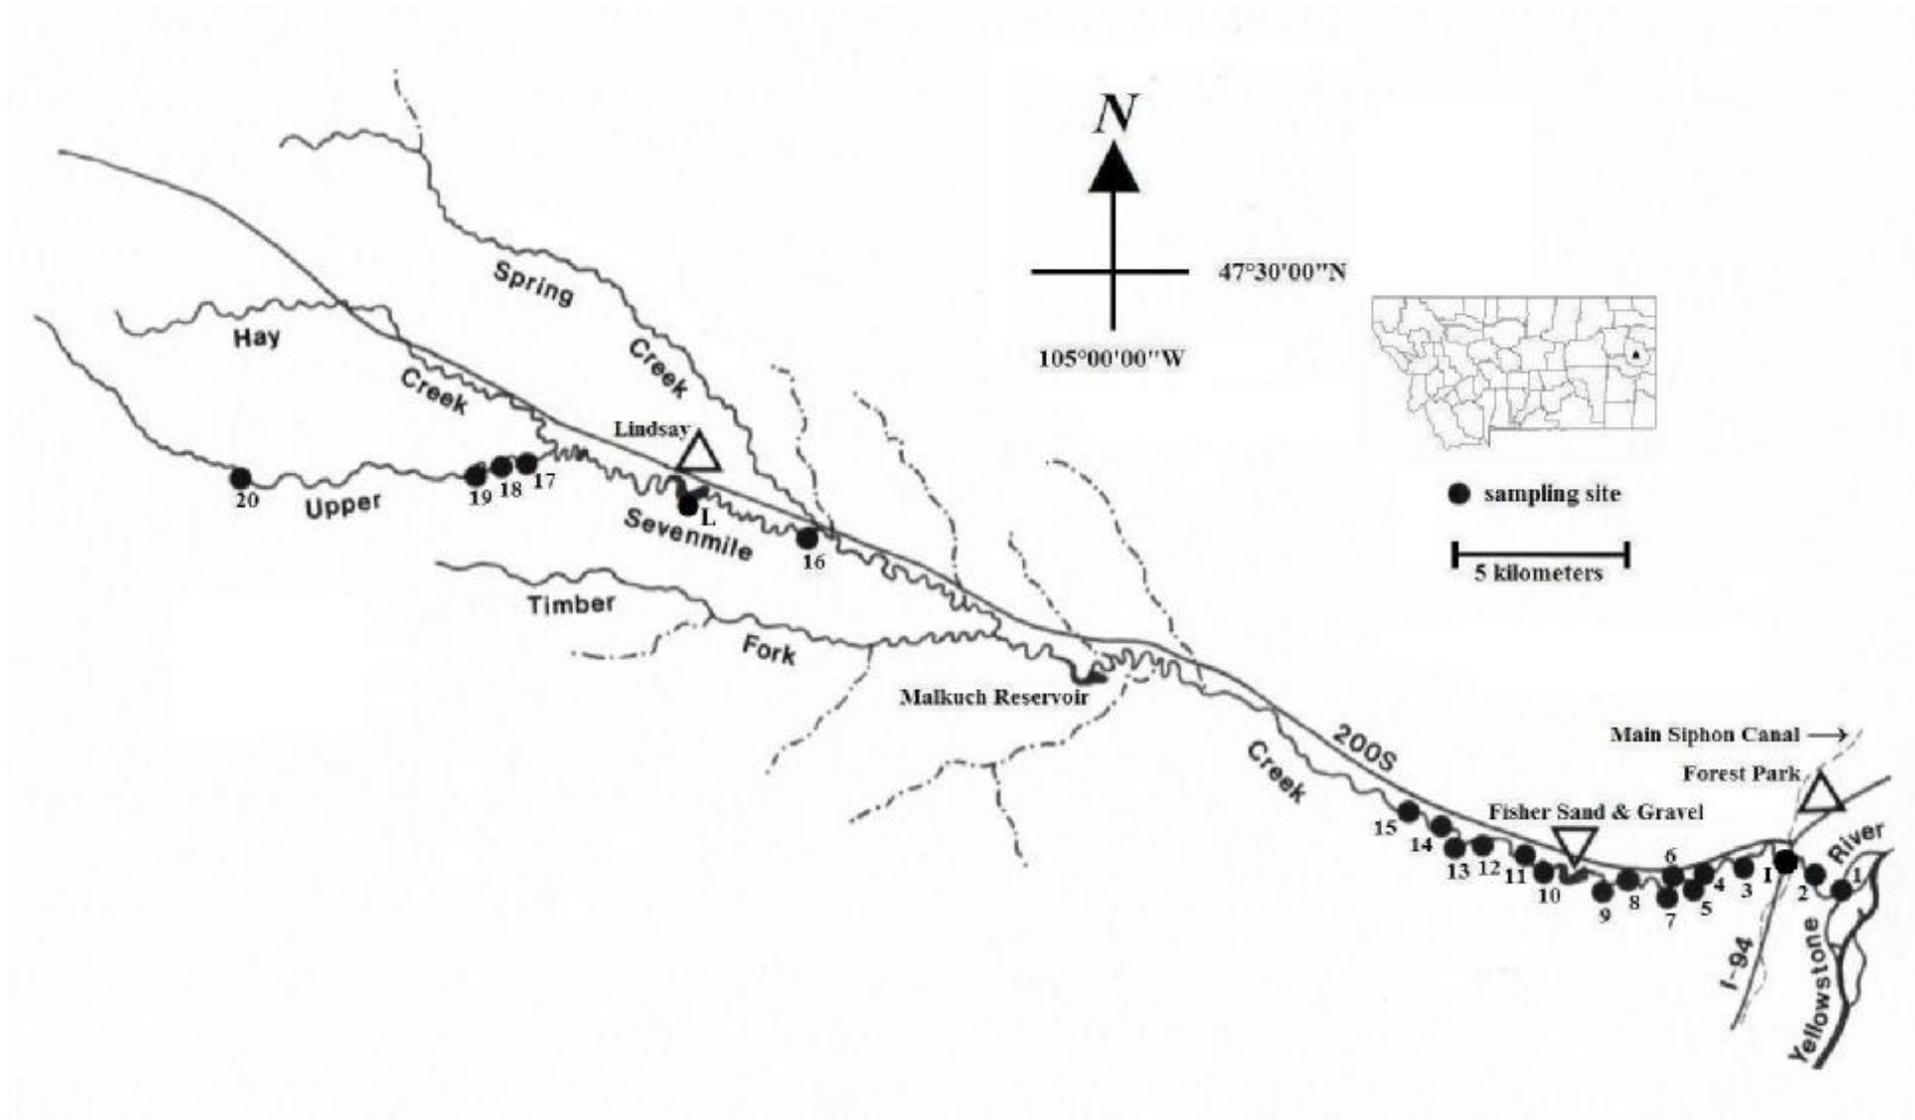
Figure 1. Map of the Upper Sevenmile Creek system, Dawson County, Montana, showing sites sampled in 2006.

Fish populations and habitats were evaluated at 21 sites in Upper Sevenmile Creek from 24 July to 5 August 2006 (Figures 1 and 2, Table 1). A site was defined as a contiguous unit of riffle and pool habitat as defined by Armantrout (1998) (Figure 3b). Only 40-m lengths of very long riffles and pools were included in fish and habitat sampling. Sites 6 and 9 consisted of pools isolated by dry riffles, and sites 16, 19, and 20 consisting of isolated spring pools only (Figure 3c). Sites 5, 7, 17 and 18 were dry during the sampling period (Figure 3d).

On 5 August 2006, at the request of an adjacent business operator, we sampled an additional site at the Interstate 94 overpass (site I in Figure 1 and Table 1) using the capture-removal approach described above.

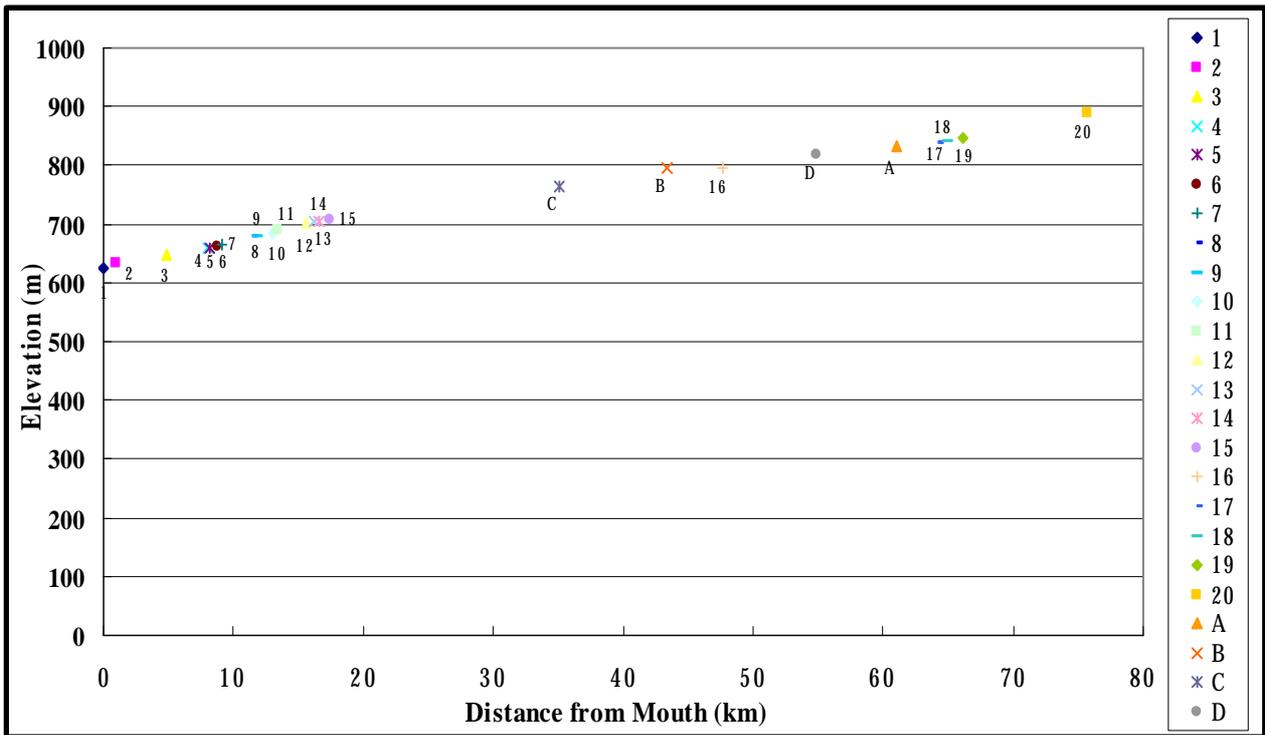
**Figure 2. Sampling profile, Upper Sevenmile Creek, Dawson County, Montana, July-August 2006 (1-20: sampling sites; A, B, C: confluences of Hay Creek, Spring Creek, Timber Fork; D: Lindsay).**

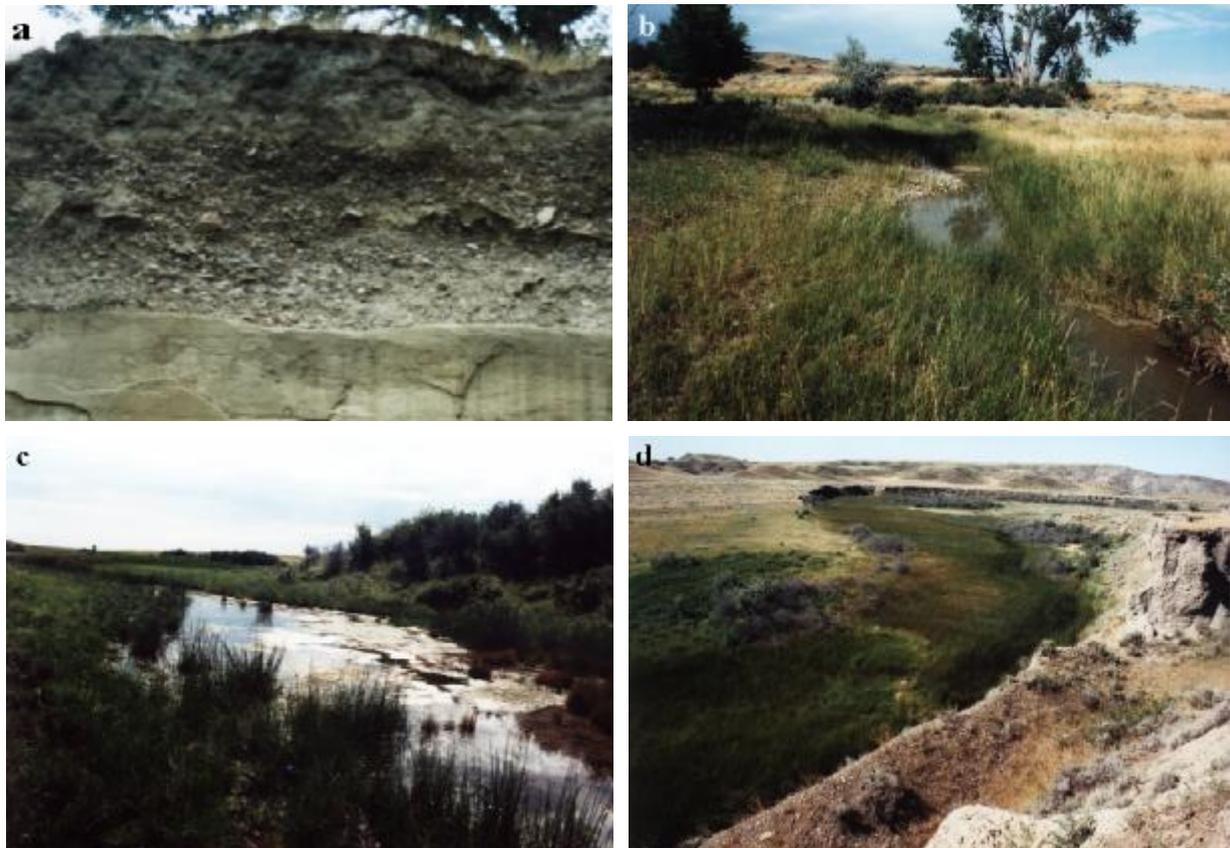
**Figure 3. Upper Sevenmile Creek, Dawson County, Montana, July-August 2006: (a) glacial outwash over bedrock cliff (site 2); (b) low flow riffle-pool unit (site 11); (c) spring pool (site 19); (d) dry channel meandering over moist, densely vegetated floodplain (between sites 5 and 6).**

**Stream Flow.** Upstream of Lindsay, Upper Sevenmile Creek (sites 17-20) consisted of a few densely vegetated spring pools isolated by long sections of dry channel (Figure 3c). This reach of the creek exhibited no active flow during the sampling period and is probably not very responsive to storm events and surface runoff because the associated drainage area is relatively small. The dry channel sections were occupied by terrestrial vegetation, indicating that duration of flow in these channels is brief. Site 18, which contained over 10 cm of water in 2004 and 2005, was dry in 2006. Whether this was due to a change in groundwater regime or a recent surface disturbance was not clear. Downstream of site 17, where flow was evident, it was barely measurable using the buoyant object method, usually less than 0.1 m<sup>3</sup>/s (Table 2). Discharge was highest near the mouth (Sites 1 and 2) due to overflow from the Main Siphon Canal. Where zero discharge was recorded, riffles were either dry or reduced to trickles. Pools at all sites downstream of Lindsay, except sites 5 and 7, retained some water (Figure 3b).

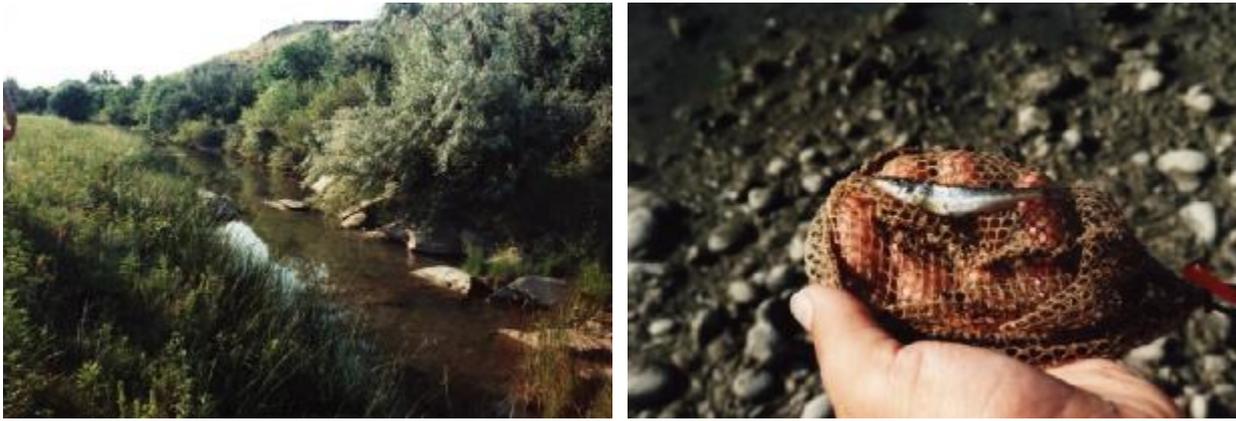
**Figure 4.** Boulders and bedrock slabs in Upper Sevenmile Creek at site 13 (left); sturgeon chub (*Macrhybopsis gelida*) from the Yellowstone River near the mouth of Upper Sevenmile Creek (right).
