**Physical, Chemical and Biological Assessment of
Stoner Creek Watershed
Flathead County, Montana**

**Presented in partial fulfillment of requirements for the degree of
Master of Science in Environmental Studies
University of Montana
August, 2003**

Physical, Chemical and Biological Assessment of Stoner Creek Watershed, Flathead County, Montana

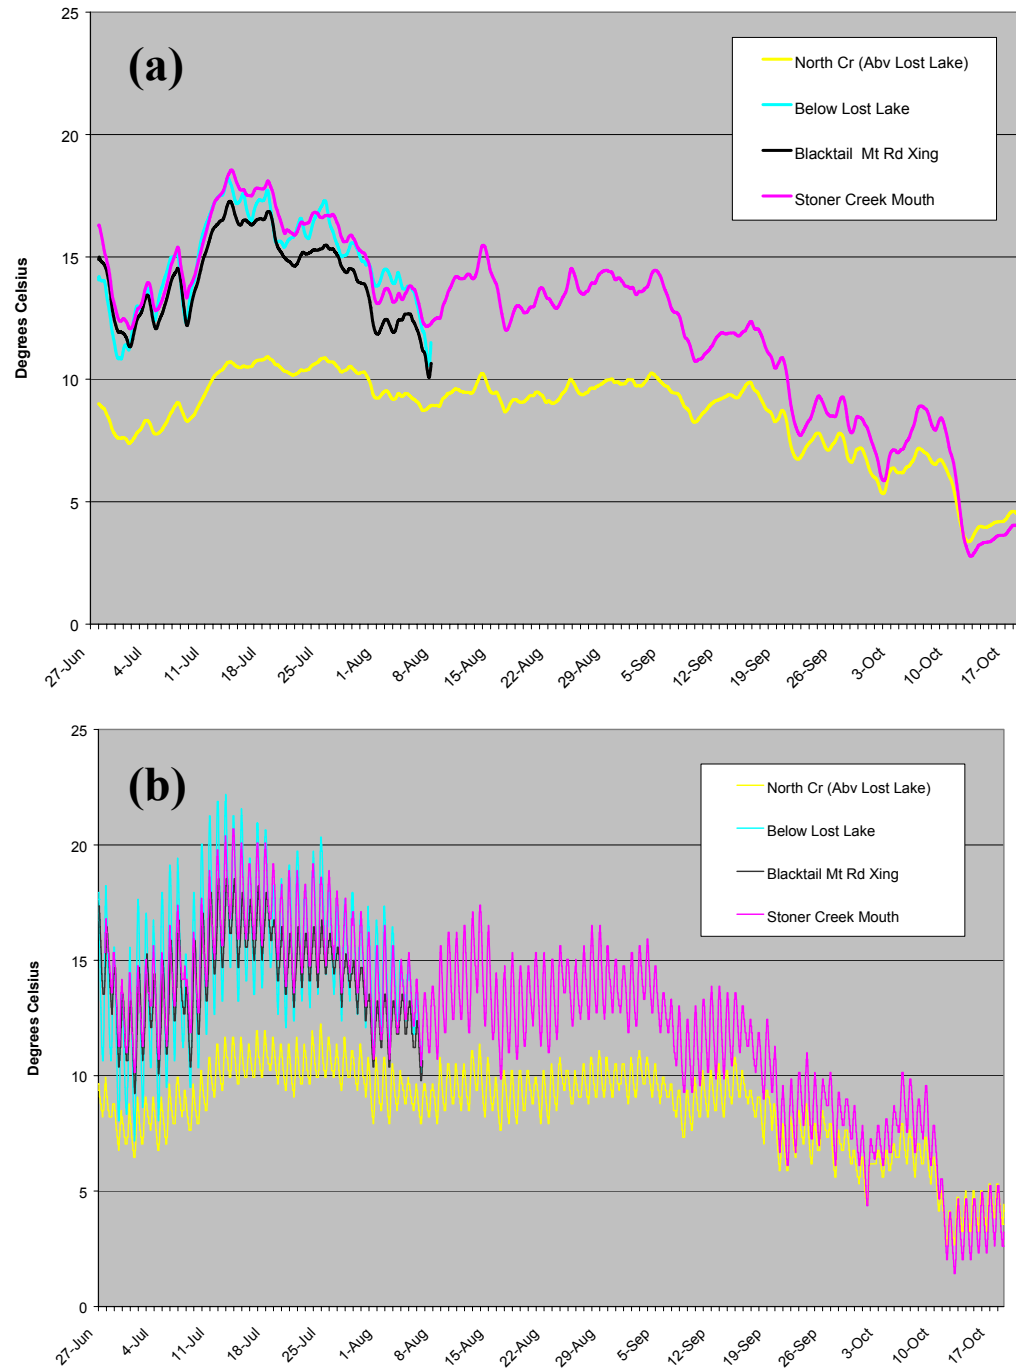
Figure 15. Water temperatures for four sites on Stoner Creek, July-Oct, 2002 as recorded every 15 minutes (b) and as a 24 hour moving average (a).

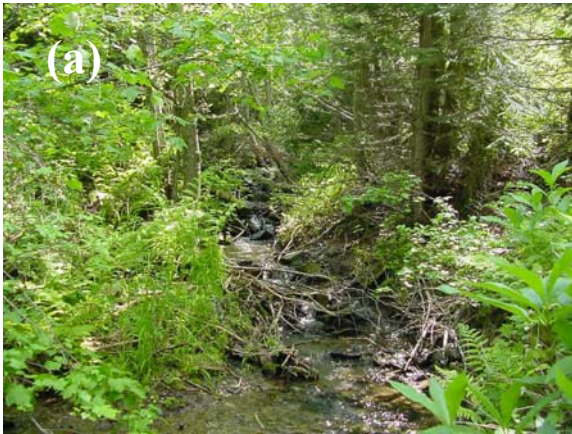
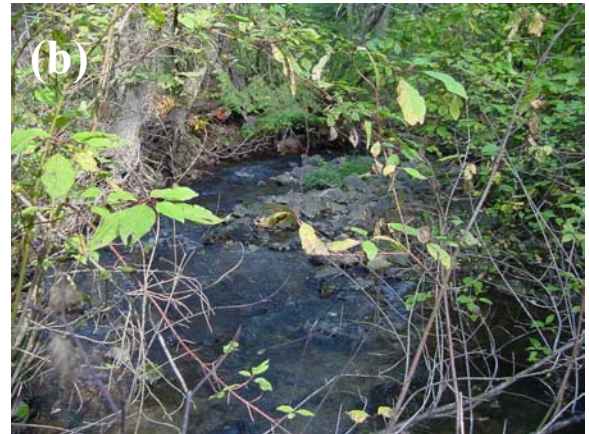
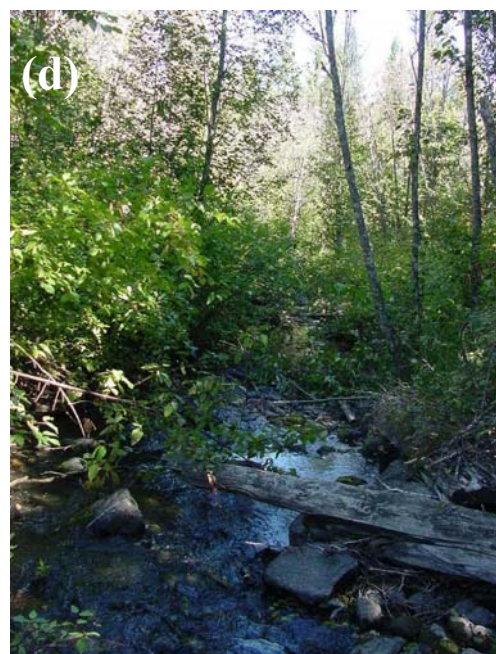
Figure 21. Examples of riparian polygons along Stoner Creek, summer 2002, that received “healthy” ratings in the RWRP Lotic Health Assessment. (See Table 4 and Figure 10 in Appendix A for locations)
