South Fork Horse Creek Fish Passage, Habitat Enhancement, and Entrainment Prevention

Initial Project Assessment

April 20, 2007

Prepared by:
Carol Endicott
MFWP

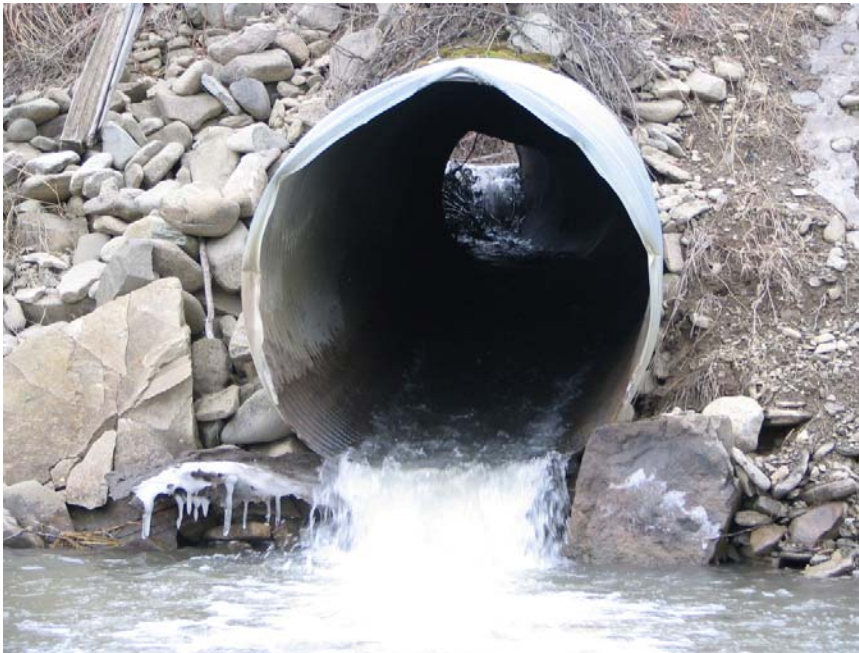
Readily identifiable characteristics that suggest this culvert blocks fish movement include its steep gradient and length. Coarse field measurements suggested the pipe has an 8% slope over its 70 ft length. Within the pipe, the slope varies, as the upper few feet has a steeper slope owing to accumulation of debris (Figure 4-1). The combination of high slope and considerable length probably makes this culvert a passage barrier at most, if not all, flows.

Figure 4-1: Culvert presenting a probable fish barrier on the lower end of the Brumfield property.

Initial evaluations of the culvert under Horse Creek road at the downstream end of the Brumfield property suggest it presents a total to partial barrier to fish passage, especially for smaller fish. Nevertheless, several road crossings occur downstream of this barrier with an unknown potential to block fish movement. The observed culverts are less steep and not as long, which are factors promoting fish passage. Still, the considerable expense associated with modifying or replacing the existing culvert necessitates evaluation of the others. If these are impassable, then the investment on the culvert in question is not justifiable. Therefore, systematic evaluation of these road crossings using a standard approach to evaluate fish passage should occur before proceeding with the current project. As Horse Creek flows through multiple land holdings, involving the Shields Valley Watershed Group is advisable to promote outreach and involvement of other private landowners.

Cost is another consideration associated with replacement or modification of this and other culverts to promote fish passage. Horse Creek Road is a county road; however, Park County does not have sufficient funds to implement the necessary modifications. MFWP's LIP-YCT biologist can assist in acquiring grants to finance this effort.

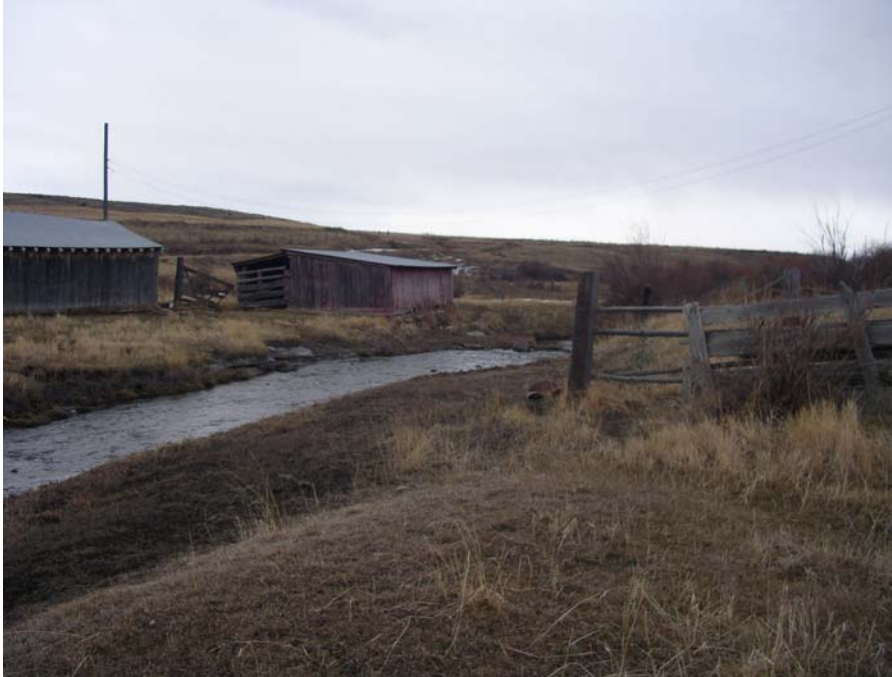
Much of the reach of South Fork Horse Creek flowing through the Brumfield property occupies an old corral where heavy use by livestock has contributed to channel alterations and riparian degradation. This approximately 500 ft long stretch of channel is

overly wide, and has reduced cover of riparian shrubs (Figure 4-2). In addition, the stream abuts a terrace at one location, which is a source of fine sediment to this stream, and ultimately the Shields River (Figure 4-3). Outside the heavily used corral areas, dense shrub cover and a graminaceous understory maintain a narrower, deeper channel, along with associated benefits of stream shading and improved sediment transport (Figure 4-4).

Figure 4-2: Typical view of South Fork Horse Creek where it flows through corrals.

The reach of South Fork Horse Creek flowing through the corrals would benefit from implementation of grazing best management practices to facilitate recovery of habitat. Grazing management practices that control livestock's access to the stream, installation of hardened access points for stock watering, or development of off stream water sources are among the management alternatives. Entities available to assist in the development of a site-specific approach to manage livestock use of the area include MFWP's LIP-YCT and the Natural Resource Conservation Service's district conservationist.

Although a change in grazing management will affect recovery of riparian condition and stream habitat through the corral section of stream, mechanical habitat restoration can expedite this process. Adjacent reaches not subjected to such intense grazing provide excellent internal references for desirable channel dimensions. Moreover, dense willow stands neighboring the site afford a local source of shrubs.

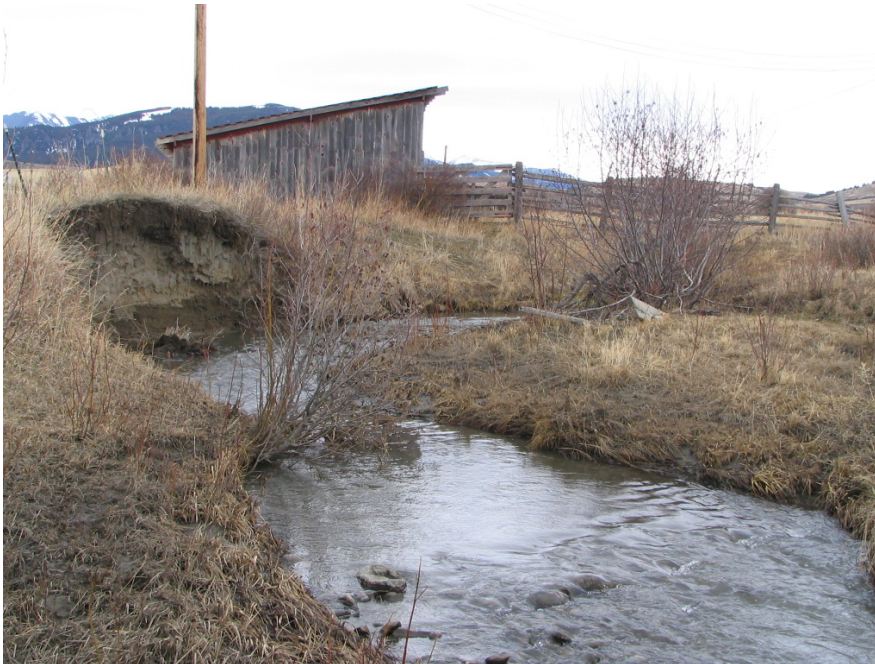
Figure 4-3: Eroding bank contributing fine sediment to South Fork Horse Creek.

Treating the eroding bank within the corrals is also desirable. Figure 5-1 illustrates a conceptual approach to stabilizing banks of this type. Essentially, this method emphasizes restoration the stable bank geometry and the promotion of the functional attributes of riparian vegetation in maintaining bank stability. Associated benefits include improved water quality through shading of the stream and increasing bank line roughness, which will trap fine sediment, thereby reducing siltation.

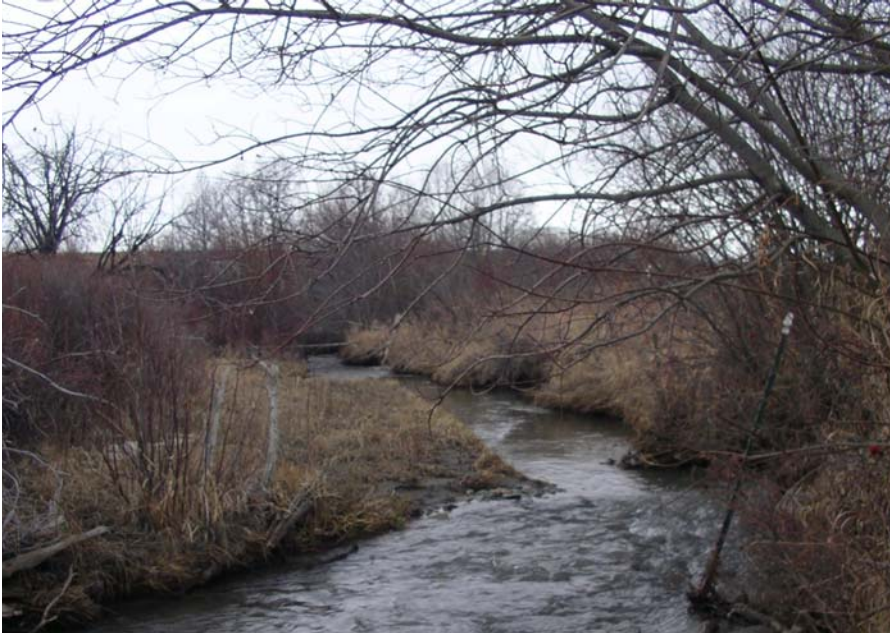
Figure 4-4: Riparian and channel conditions outside of heavily grazed corrals

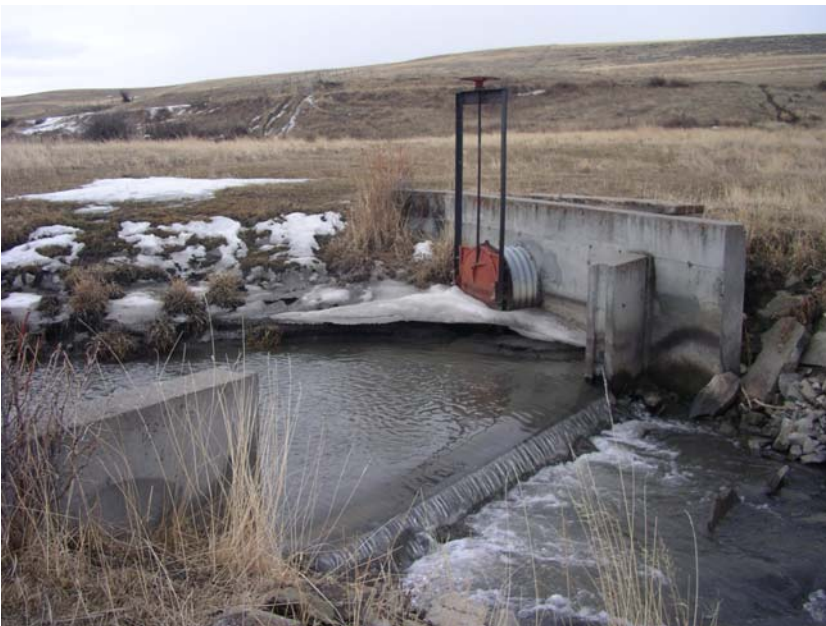
An irrigation diversion was another feature observed on this property. When in operation, fish likely have full access to the ditch through a slide or Waterman gate (Figure 4-5). Entrainment of Yellowstone cutthroat trout into irrigation ditches has an unknown, yet potentially significant population level effect in the South Fork of Horse Creek.

Figure 4-5: Irrigation diversion on South Fork Horse Creek.

Two options exist for preventing or reducing entrainment of Yellowstone cutthroat trout in to the irrigation ditch on this property. Following MFWP guidance on shutting down ditch operations is the least intensive approach. Essentially, this calls for staggering shutdown over three days. The gradual decline in flow will cue fish to move upstream and out of the irrigation ditch. Maintaining the ditch so that it lacks refugia such as pools or boulders is an important corollary activity to this approach.

An alternative to managing cessation of ditch operations is installation of a fish screen that allows delivery of water while blocking fish entrainment. Several options are available including coanda screens, rotating drum screens, and turbulent fountains. In addition, grant funds are available through several sources for installation of these effective solutions to fish loss. Evaluation of fish entrainment at the existing head gate is needed to justify costs.
