Horse Creek Restoration Project

Goffena Property

Initial Project Assessment

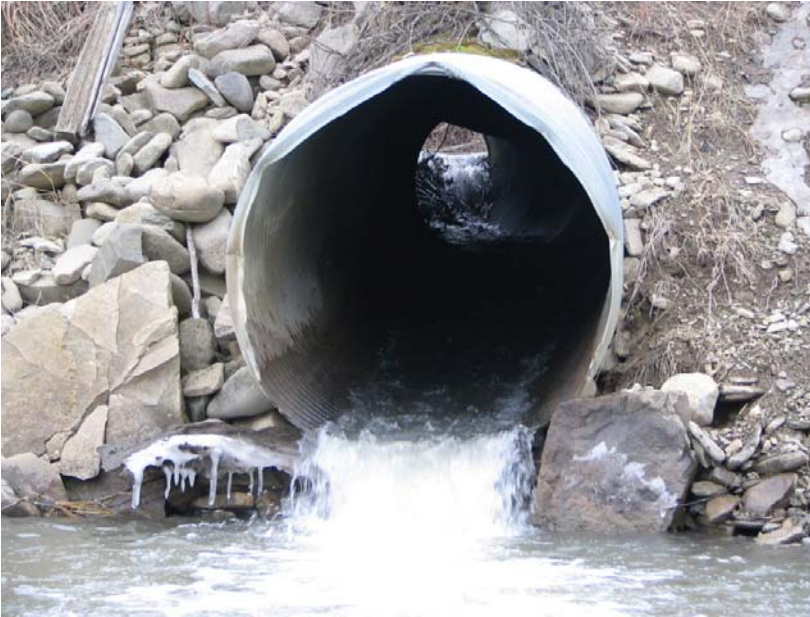
“Readily identifiable characteristics that suggest this culvert blocks fish movement include its steep gradient and length. Coarse field measurements suggested the pipe has an 8% slope over its 70 ft length. Within the pipe, the slope varies, as the upper few feet has a steeper slope owing to accumulation of debris (Figure 4-1). The combination of high slope and considerable length probably makes this culvert a passage barrier at most, if not all, flows.”

Figure 4-1: Culvert presenting a probable fish barrier on the lower end of the Brumfield property.

Mr. Goffena supplied additional background on this culvert and some potential alternatives to improving fish passage and accommodation of flood flows. In the late 1800s, a bridge spanned South Fork Horse Creek at this road crossing. This was replaced with a culvert in the early part of the 1900s. In addition to being a fish barrier, backwatering during flood flows has caused South Fork Horse Creek to flow over the road as recently as 2003. He suggested construction of an overflow channel, which could occur on his property, designed to protect integrity of the road and reduce sediment loading from floodwaters.

As described in the project assessment for the upstream property (Endicott 2007), the culvert under Horse Creek Road is likely a barrier to fish movement, which is inconsistent with the conservation strategy for the watershed with its emphasis on promoting connectivity. Interest from both the upstream and downstream landowners, combined with Mr. Goffena's generous offer to allow use of his property for over flow is promising. After confirming both landowner's desire to proceed, the next steps will be to communicate with the county road department about a potential project, investigate funding opportunities, and develop conceptual plans to promote fish passage while protecting the road and promoting transport of sediment and debris.

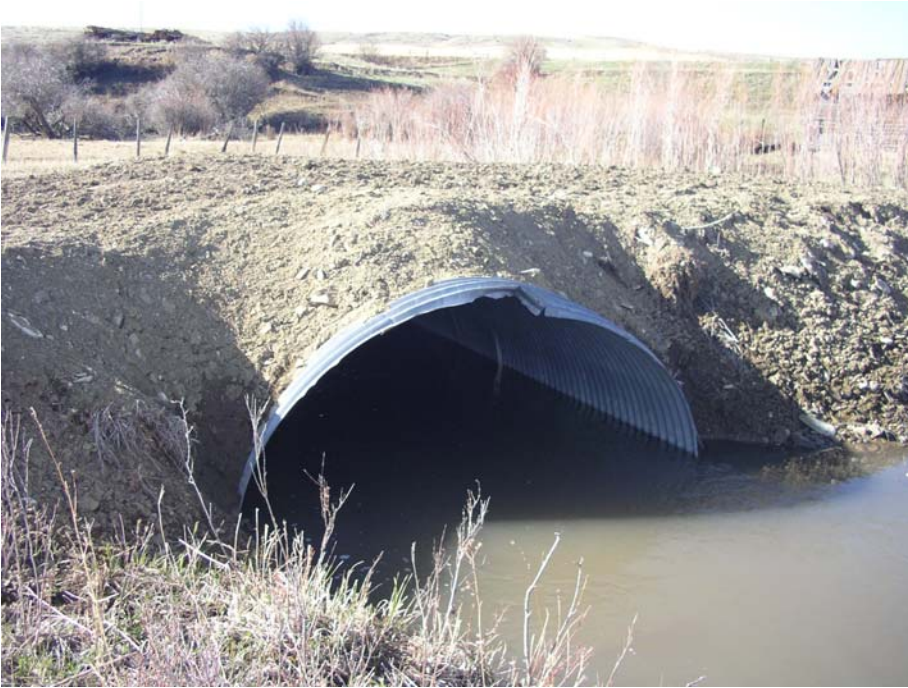
Other culverts on the Goffena property include newly installed culverts crossing the north and south forks just above their confluence. Both are of sufficient size and are placed at an appropriate grade to facilitate fish movement. Nonetheless, including these in the inventory of road crossings, along with measurements allowing evaluation of fish passage potential, is consistent with the draft Shields River watershed Yellowstone cutthroat trout conservation strategy. Seeding the slopes of the road grade is also advisable to decrease sediment loading to Horse Creek.

Figure 4-2: New culvert crossing one of the forks of Horse Creek.

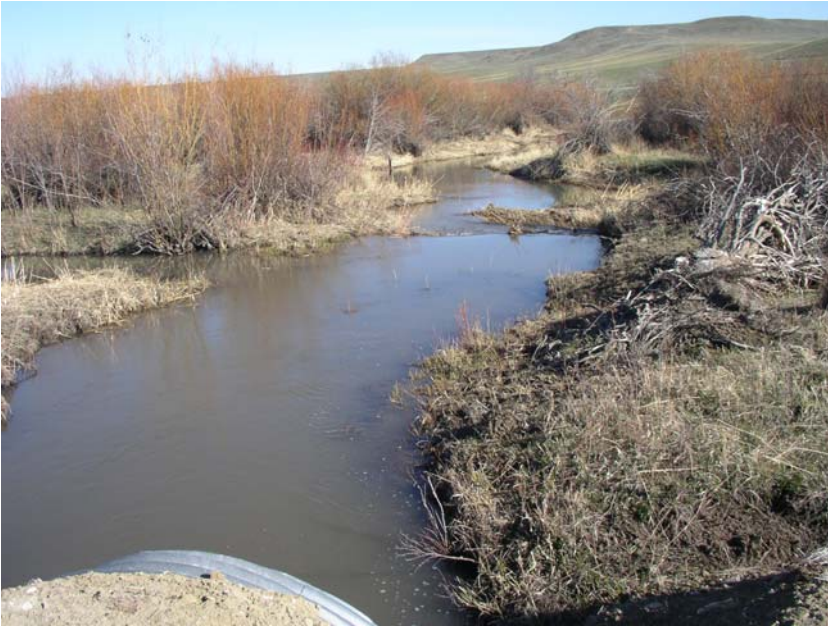
Stream channel and riparian conditions on the Goffena property are varied, but are generally compatible with a healthy fishery. Most of the stream has sufficient herbaceous ground cover and shrub canopy to promote bank stability, filtering of sediment and nutrients, and stream shading (Figure 4-3). Dominant species included thick stands of graminoids including reed canary grass (*Phalaris arundinacea* L.) and sedges (*Carex* sp.), and willows (*Salix* spp.). Historically, this system was likely beaver dominated, as evidenced by fine bank material. The stream channel is mostly a meandering Rosgen C channel. (Delineative criteria for C channels include slight entrenchment and moderate to high sinuosity [Rosgen 1996].) Width-to-depth ratios of C channels can be variable and range from moderate to very high. Relatively high and turbid flows obscured bed features; however, channel dimensions seemed to be stable and the channel did not appear to be overly wide.

Figure 4-3: View of typical stream and riparian conditions on Horse Creek and its forks on the Goffena property.

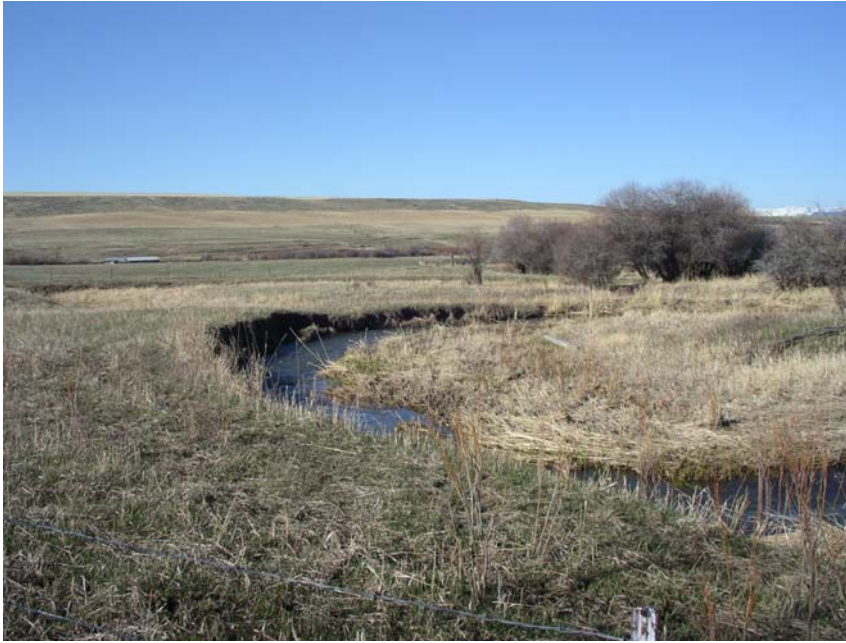
Although riparian condition and the stream channel morphology was typically intact and functioning, localized areas with sub-optimal conditions were present and related to current and past land uses. Several stretches of stream bank were actively eroding, with an absence of a deep root mass being a causal factor (Figure 4-4). These conditions have implications for water and habitat quality. Eroding banks contribute fine sediment and the lack of a willow canopy reduces shading, which leads to warmer summer water temperatures. Likewise, eroding banks do not provide quality habitat for fish along the bank margins. Moreover, if left unchecked, these lateral adjustments can result in an overly wide and shallow channel, which reduces the stream's ability to transport sediment and warms more easily during summer months.

Figure 4-4: Example of bank erosion on the main stem of Horse Creek.

Although the stream morphology and riparian health and function are generally intact, localized areas of eroding bank would benefit from stabilization and riparian plantings. Figure 5-1 illustrates a conceptual approach to stabilizing banks of this type. Essentially, this method emphasizes restoration the stable bank geometry and the promotion of the functional attributes of riparian vegetation in maintaining bank stability. Associated benefits include improved water quality through shading of the stream and increasing bank line roughness, which will trap fine sediment, thereby reducing siltation.

Previous work to stabilize banks on Horse Creek involved armoring banks with rock of varying size. Current guidelines followed by the conservation district require justification for the use of rock in stabilizing banks. As rock is largely absent from naturally stable banks, and vegetation is sufficient in maintaining stability, the “soft” approach, which emphasizes riparian plantings, bank resloping, and use of biodegradable erosion control fabric, is the preferred method.

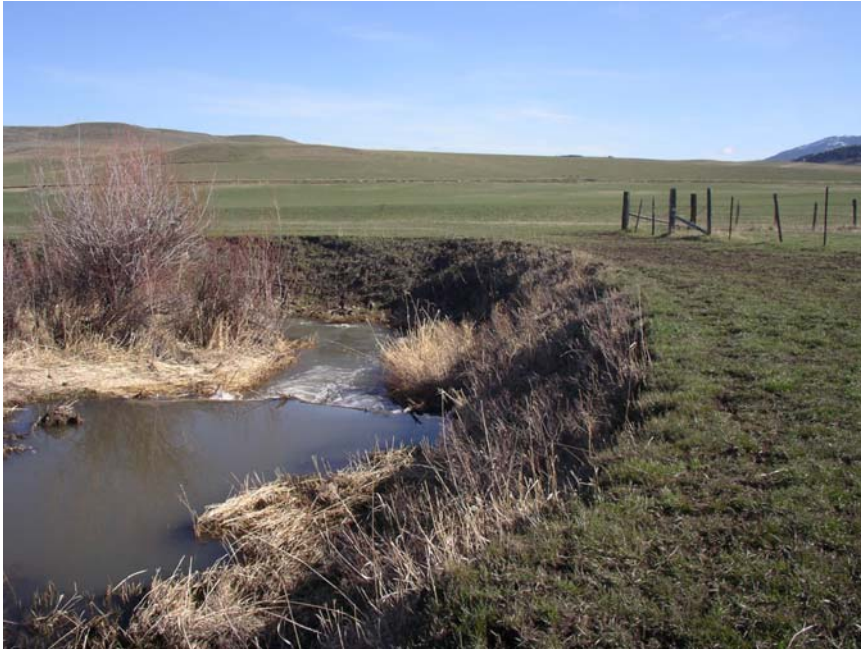
Other features observed on the main stem of Horse Creek included past stream bank stabilization projects and a reach that was channelized prior to the passage of the Montana Natural Streambed and Land Preservation Act or 310 law. The channelized reach was stable and had regained some length. Although not optimal, the relatively short length, combined with the expense associated with renaturalizing the channel, makes this alteration a low priority for restoration. In other cases, eroding banks have been stabilized with rock of varying sizes. The use of boulder size rock that occurred in one reach is among practices no longer likely to be permitted under the 310 law permitting guidelines. In other cases, applying cobble-sized rock at the toe of the bank arrested additional erosion. The use of bank armoring, as opposed to an emphasis on vegetative stability, is unlikely to be permitted under current 310 permitting guidelines.

Figure 4-5: Eroding bank stabilized with application of cobble sized rock at the bank's toe.
