Nixon, Miles, and Brackett Creeks on the Double D Ranch

Initial Project Assessment

Prepared by:
Carol Endicott
MFWP

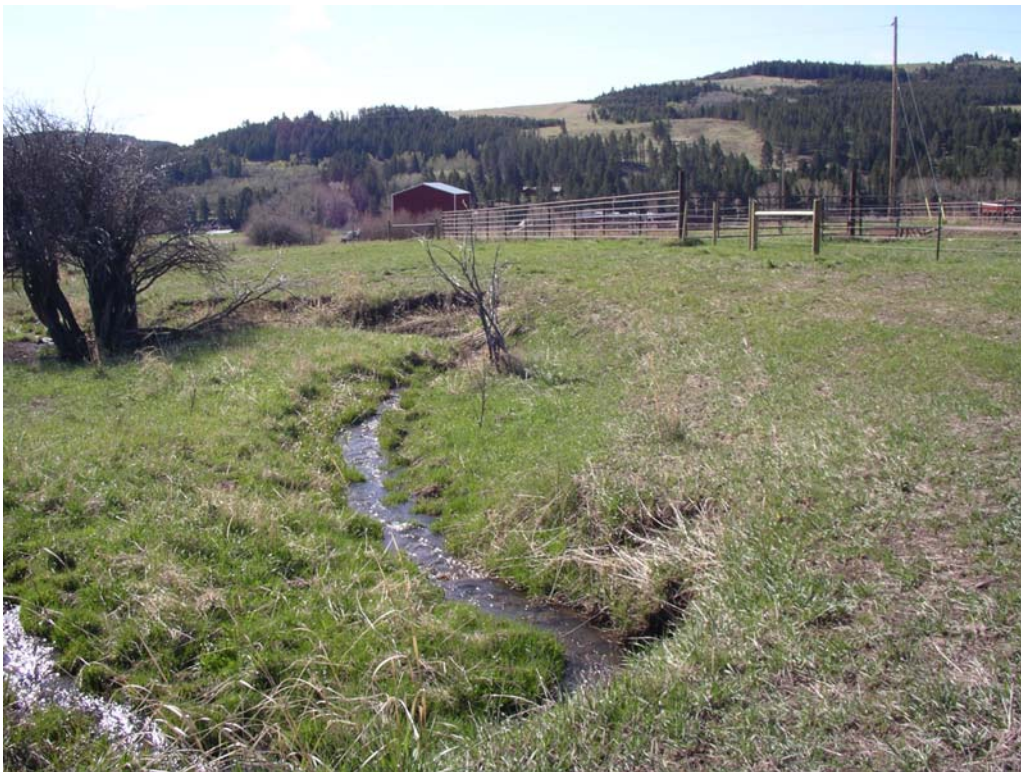
Nixon Creek occupies the northern portion of the Double D Ranch and flows south until its confluence with Brackett Creek near Brackett Creek Road (Figure 2-2). The lower end of Nixon Creek has a relatively narrow and deep, meandering channel that is consistent with Rosgen's E channel classification (Rosgen 1996), although the channel appears to be transitioning to a C channel locally (Figure 4-1). Sedges and grasses are the dominant vegetation type; however, several decadent willows are also present. Eroding banks, although not extensive, occur along many of the outside meander bends and are a source of fine sediment to Nixon Creek and ultimately Brackett Creek.

Fish habitat in this lower reach of Nixon Creek is limited mostly due to a lack of pools. Nixon Creek has a relatively uniform bed, comprised mostly of runs. In contrast, pool habitat increases in higher reaches concomitant with a greater density of riparian shrubs (Figure 4-2). These observations suggest increasing shrub cover should be a conservation goal for Nixon Creek.

Figure 4-1: Lower reach of Nixon Creek north of Brackett Creek Road.

Increasing shrub cover along Nixon and Miles creeks will have a host of benefits affecting habitat and water quality. Two general approaches are applicable on the Double D Ranch. First is the use of conservation plantings where rooted stock is planted in reaches with low shrub cover. Funding is available through a variety of sources for this kind of conservation action. Moreover, this activity has potential to generate considerable in-kind match, as volunteer labor can assist in harvest and planting of willows. The Natural Resources Conservation Service's (NRCS's) Environmental Quality Incentives Program (EQIP) is currently seeking such projects to fund.

Managing livestock along stream margins, and implementing agricultural best management practices to limit their impact on vegetation and banks, is the second set of actions to increase shrub cover along these streams. The NRCS and DNRC have developed a list of agricultural BMPs with potential applicability to ranching operations

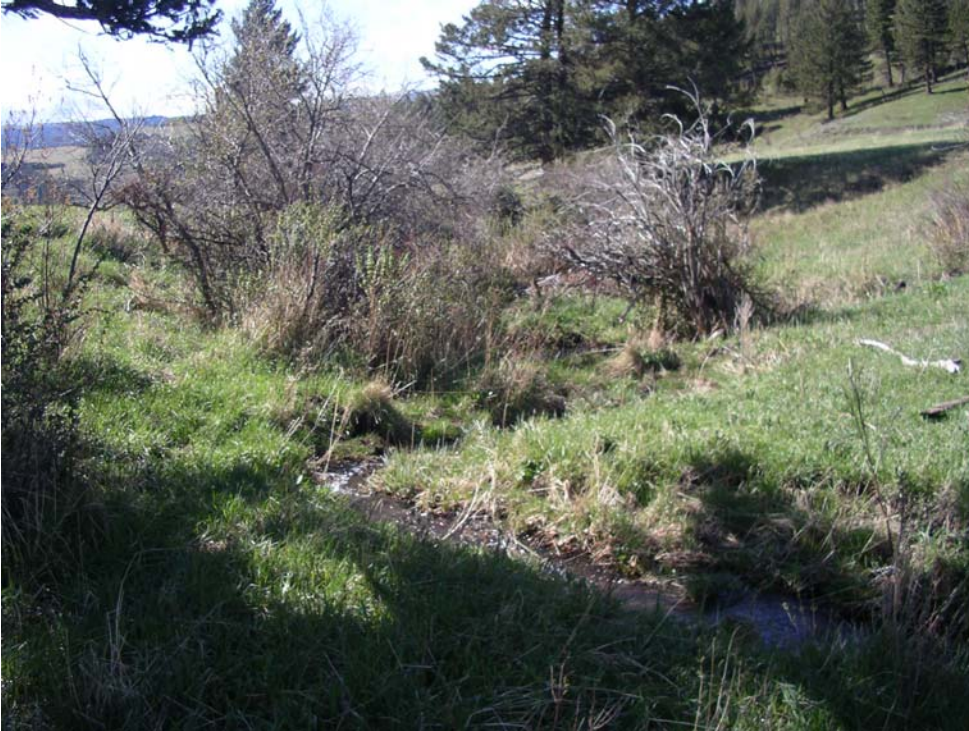
Figure 4-2: Denser shrub cover along higher elevations of Nixon Creek, which contributes to improved instream habitat, bank stability, and shading.

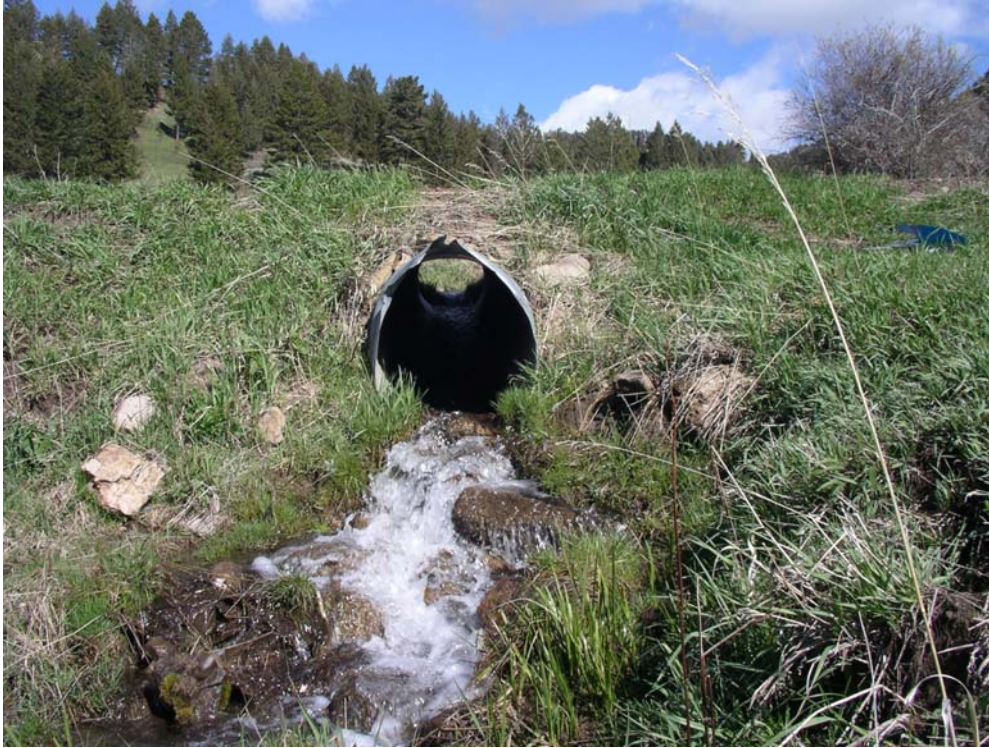
Road crossings are another feature along Nixon Creek with potential to limit Yellowstone cutthroat trout in Nixon Creek by blocking fish passage. These culverts tend to have a steep approach and be placed on a slope, which may present passage barriers (Figure 4-3). Evaluating all road crossings using FishXing (Love and Firor 2001) will be useful in determining potential fish passage and developing solutions.

Figure 4-3: First road crossing on Nixon Creek.

Several road crossings have potential to restrict fish movement through this portion of the watershed. The draft conservation strategy for Yellowstone cutthroat trout in this basin calls for an inventory of all road crossings and evaluation of fish passage potential. Future data collection on Nixon and Miles creeks should include such analysis on their road crossings.

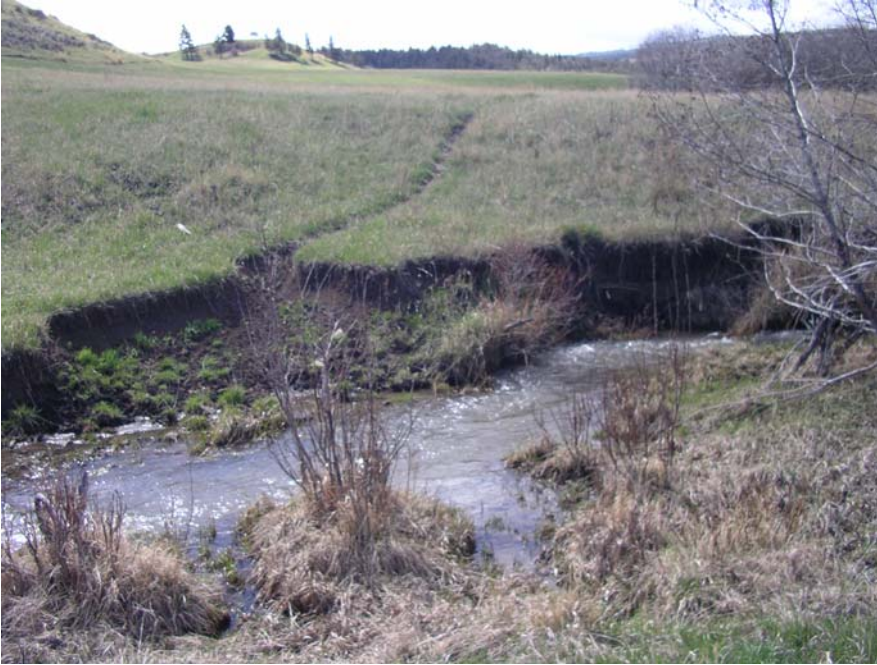
Similar to Nixon Creek, sparse shrub cover and localized areas of eroding banks are notable features on Miles Creek (Figure 4-4 and Figure 4-5). Grasses and sedges dominate the riparian zone; while riparian shrubs tend to be widely spaced, mature plants. Little recruitment or reproduction of shrubs was observable. In several locations, Miles Creek is cutting into its terrace, which is a source of fine sediment.

Figure 4-4: Bank erosion on Miles Creek.

Mechanical bank stabilization on select banks is an appropriate approach on Miles Creek given proposed logging in the basin and the resulting increase in water yield, which will put pressure on existing, unstable banks. In addition, the eroding bank on the left bank of Brackett Creek immediately upstream of the head gate may also be an appropriate candidate for mechanical restoration. A detailed inventory of existing eroding banks, including their dimensions and erodibility, would facilitate planning, cost estimation, and grant preparation. Eroding banks would be prioritized based on the amount of sediment delivered and potential to heal through a passive restoration approach. This type of planning assistance is within the responsibilities of the LIP/YCT biologist.

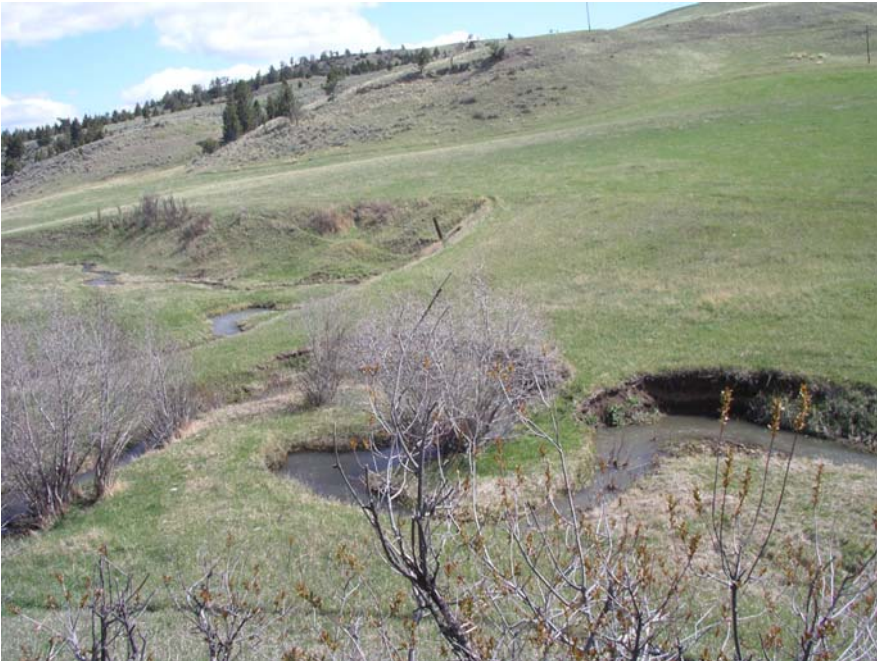
Figure 4-5: View of Miles Creek showing graminoid dominated riparian zone, scattered shrubs, and eroding terrace. The meander is at risk of being cutoff.

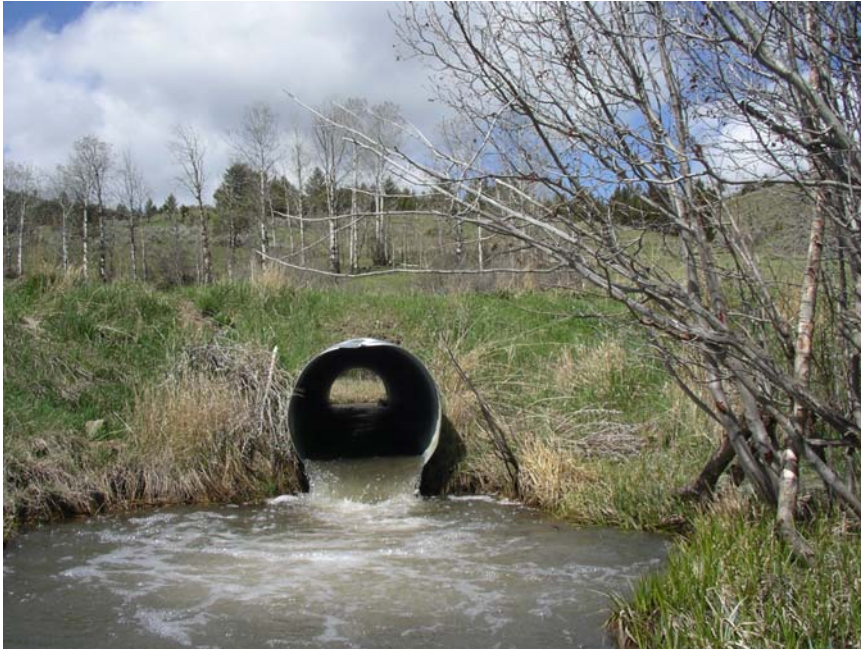
One road crossing occurs over Miles Creek and the associated culvert may present a barrier to fish movement at some flows (Figure 4-6). The culvert is slightly perched, and the resulting drop will be more pronounced at lower stream flows. Evaluating this and all road crossings in the basin is consistent with the Shields Yellowstone cutthroat trout conservation strategy and will inform decision making in terms of promoting fish movement throughout the basin.

Figure 4-6: Culvert under the road crossing on Miles Creek.

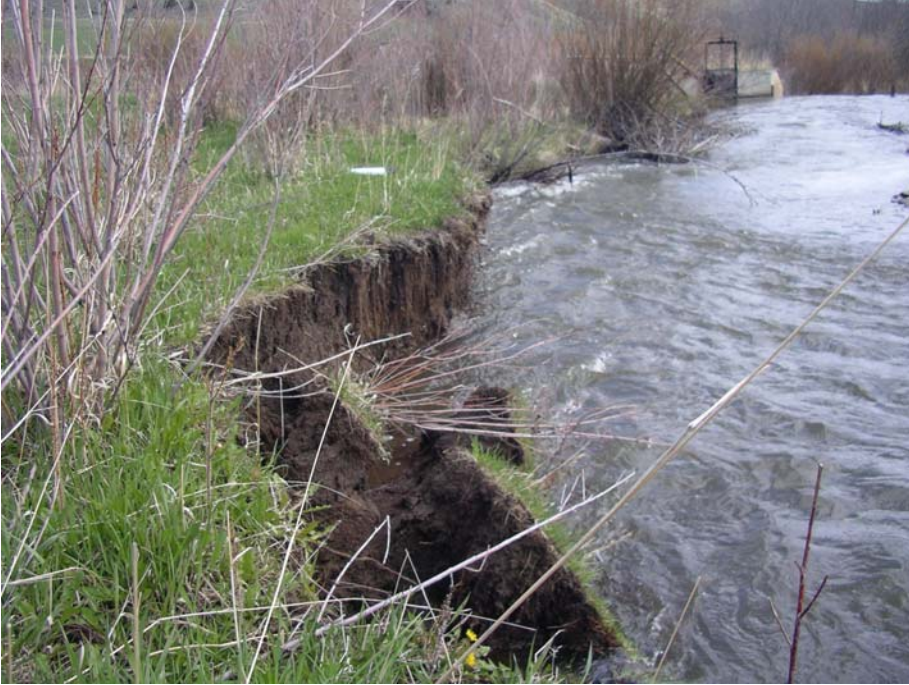
Although this reach of Brackett Creek approaches corrals and barns, a fence controls animal access resulting in well-vegetated and stable banks. An exception is a 50-ft length of eroding bank immediately upstream of an irrigation diversion (Figure 4-7). Stabilizing this bank through methods described in the next section is recommended to reduce sediment loading to Brackett Creek and improve bank line habitat for fish.

Figure 4-7: Eroding bank upstream of irrigation diversion on Brackett Creek.

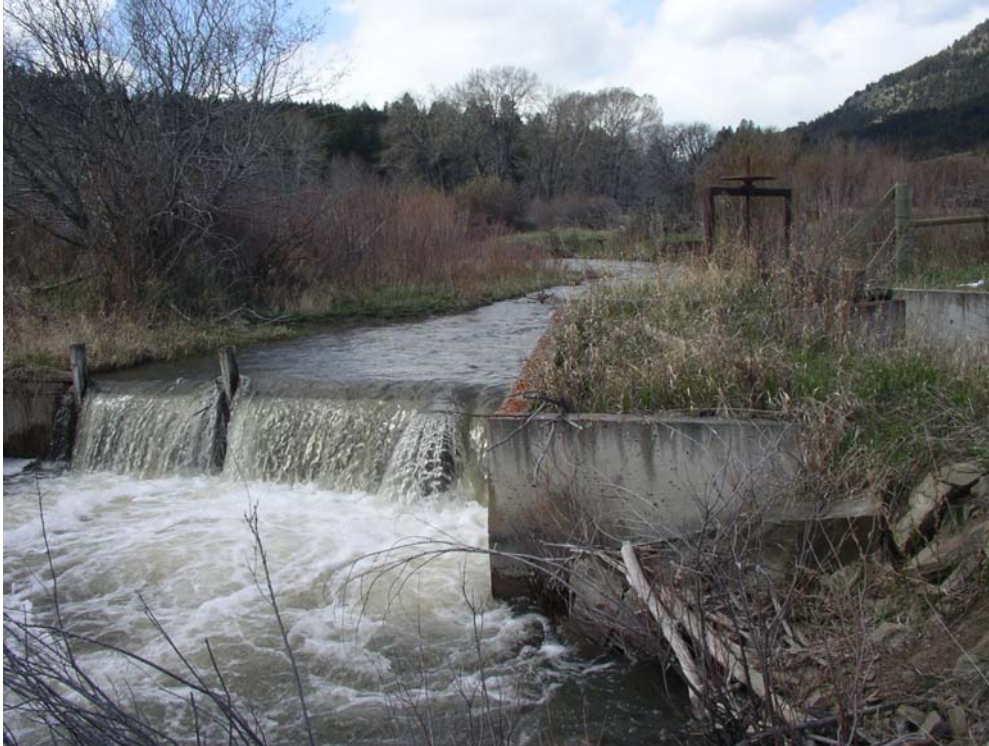
An irrigation diversion lies on the Double D Ranch just above where Brackett Creek leaves the property. Although on the ranch, this ditch serves another downstream irrigator. A concrete diversion dam facilitates delivery of water to the head gate (Figure 4-8), and is potentially a barrier to fish movement. In addition, entrainment of fish is likely through this head gate.

Figure 4-8: Irrigation diversion dam on Brackett Creek on the Double D Ranch.

The irrigation diversion on the Double D Ranch has an unknown potential to entrain fish from Brackett Creek. In addition, the diversion dam presents a possible barrier to fish movement. Further investigation is warranted to evaluate the risks to fish associated with these structures. Solutions to preventing or reducing entrainment include staggering the shut down of irrigation diversion over the course of several days or installing a fish screen. Several options are available to modify the diversion dam to allow passage, such as construction of a fish ladder. Although these structures lie on the Double D Ranch, they supply water to a downstream water use, whose interest in such activities is currently unknown.

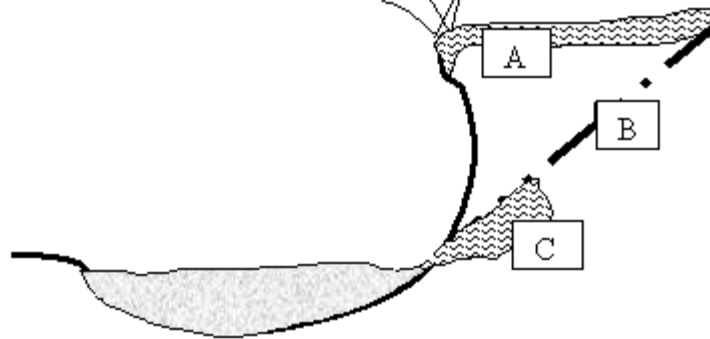
Bank Shaping (typical)

- A. Strip sod and stockpile
- B. Slope bank to 2:1 to 3:1 slope pulling fill away from channel
- C. Lay sod back at toe of slope, near bankfull level
- D. Seed and plant bare root shrubs or sedge plugs, approximately every 3 feet

Figure 5-1: Conceptual approach to stabilizing vertical eroding banks.

Options to stabilize eroding banks vary with severity of the bank erosion and the potential for natural recovery. Some banks may heal with reduced pressure from livestock grazing, in conjunction with conservation plantings. Alternatively, some banks may benefit from mechanical stabilization such as is displayed in Figure 5-1. This "soft" approach to bank stabilization capitalizes on the stabilizing function of riparian vegetation, along with a stable bank geometry. Concomitant with this approach should be a livestock grazing strategy that protects recovery banks and allows for establishment of healthy riparian vegetation.
