## **Brackett Creek, Lazy S Ranch**

Initial Project Assessment and Preliminary Evaluation of Completed Restoration

May 24, 2007

Prepared by:  
Carol Endicott  
MFWP

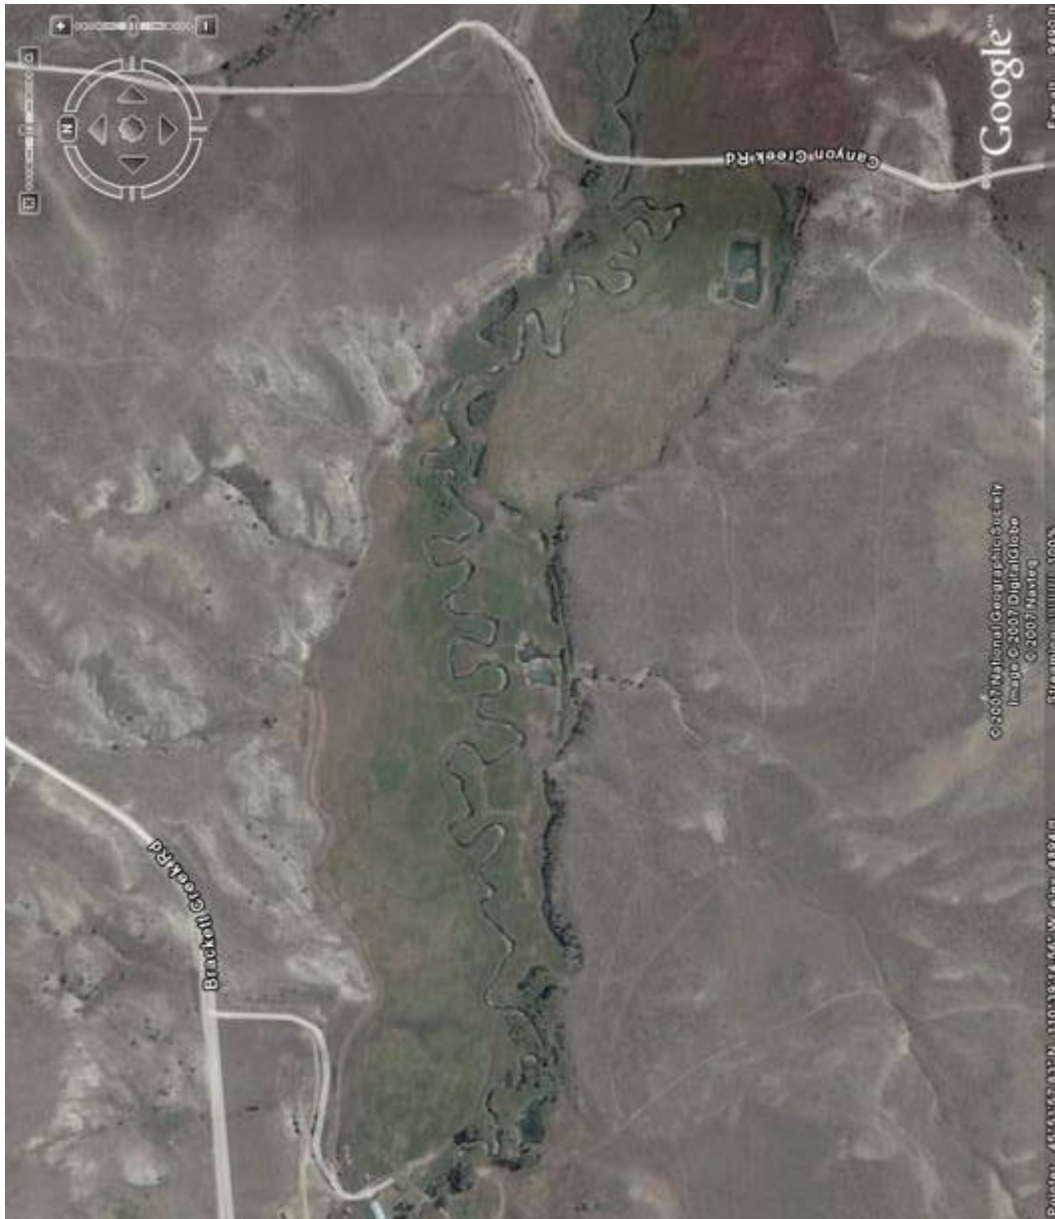
**Figure 3-2: Aerial imagery from 2007 showing constructed/restored channel on Brackett Creek.**

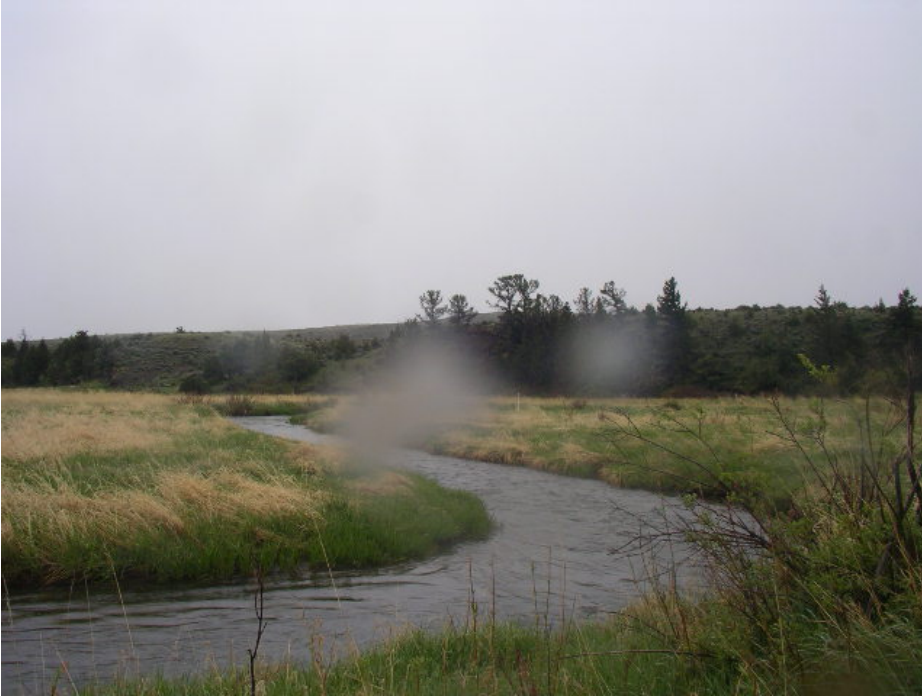
**Figure 4-1: View of the constructed channel in the upper reach of Brackett Creek on the Lazy S Ranch. (Blotches on the photo are raindrops related to cool, wet weather).**

Next, we viewed the constructed channel occupying the floodplain upstream of Canyon Creek Road. Overall, this restored reach represents a striking improvement from conditions in its former location. Its current configuration is a meandering channel with a pool/riffle sequence lined with predominantly stable and undercut banks (Figure 4-1 and Figure 3-2). The deep pools had gradual tail outs providing ideal sized substrate for spawning. In contrast, riffles dominated the former channel with pools being rare and of low quality. Likewise, cobbles dominated the streambed in its former location and provided little suitable spawning habitat. The new channel provides superior habitat for all life history stages, including spawning, and has vastly improved overwintering habitat compared to the former channel.

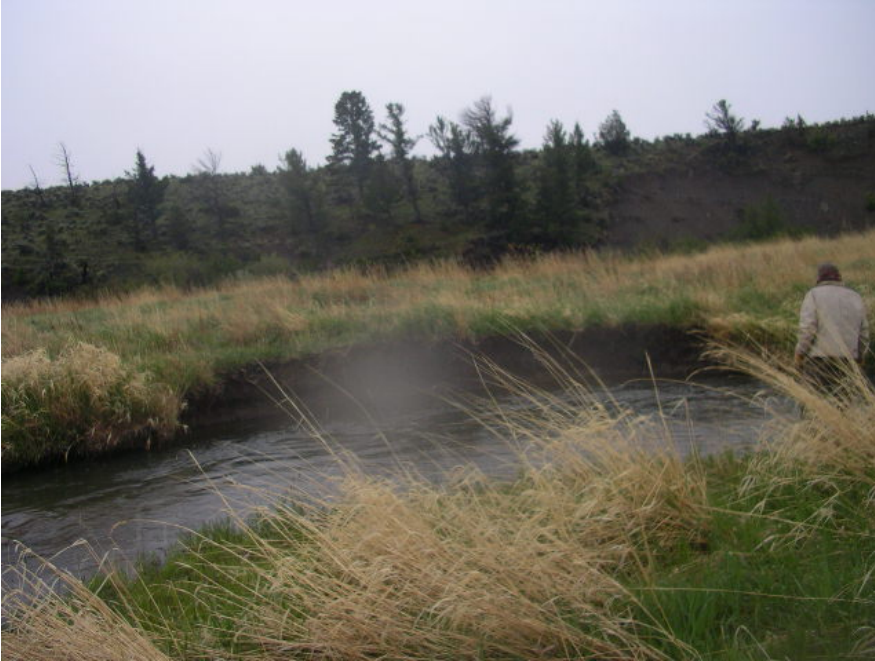
Although the majority of the banks were stable, bank erosion was present on some outer meander bends (Figure 4-2). Erosion was likely the result of a rain-on-snow event that occurred the spring following completion of the new channel. This flood had a calculated recurrence interval of 85 years (Matt Klara, water resources engineer, personal communication). Given the magnitude of the event, and the early stage of vegetative recovery, the new channel withstood this flood remarkably well. Dissipation of flood flows over the floodplain contributed to a decrease in the erosive force of floodwaters. Moreover, improved access to the floodplain, compared to the former channel location, likely lessened the impact of flooding in the reaches below.

**Figure 4-2: Example of localized bank erosion in the constructed channel related to the flood event that occurred in the spring following construction.**

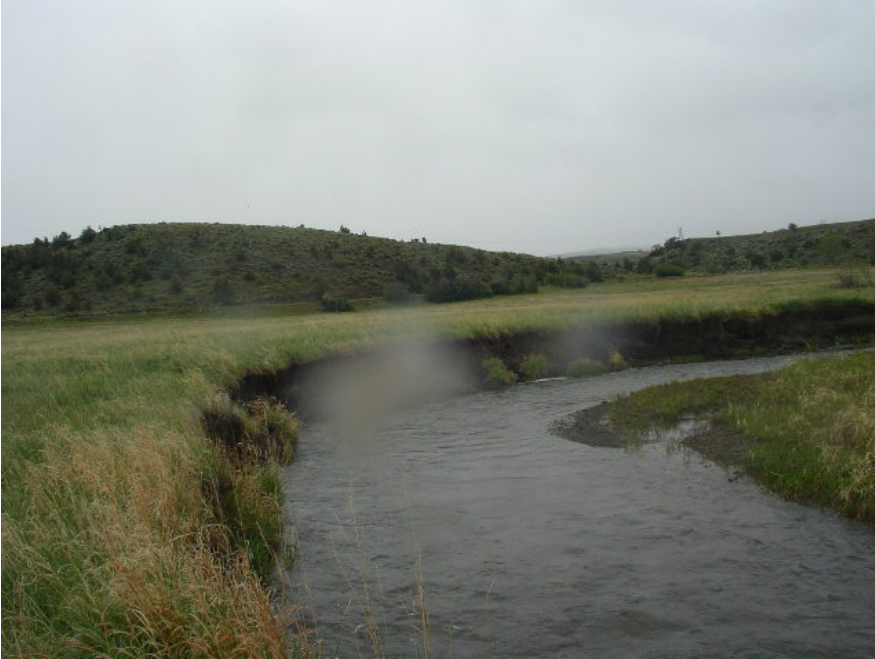
Following evaluation of the restored reach, we viewed stream and riparian conditions in the lower end of the ranch. Previous owners had grazed the stream corridor heavily, resulting in substantial reduction of riparian shrub cover and extensive lengths of eroding bank (Figure 4-3). Despite several years of rest from livestock, banks have not recovered and are still contributing fine sediment to Brackett Creek and ultimately the Shields River. Similar to the upstream reach, wildlife browse pressure has likely prevented recovery of riparian shrub communities.

**Figure 4-3: Example of bank erosion on the lower reaches of Brackett Creek on the Lazy S Ranch.**

Options to stabilize eroding banks vary with severity of the bank erosion and the potential for natural recovery. Often banks may heal with reduced pressure from livestock grazing, in conjunction with conservation plantings; however, banks on the Lazy S Ranch have failed to stabilize despite several years of rest. Alternatively, some banks may benefit from mechanical stabilization such as is displayed in Figure 5-2. This “soft” approach to bank stabilization capitalizes on the stabilizing function of riparian vegetation, along with a stable bank geometry. Figure 5-1 presents a variation on this approach with use of cottonwood logs wired into the toe of the bank. This can be a cost-effective approach as fallen cottonwoods are locally available. Moreover, cottonwoods are a natural feature on Brackett Creek, making this an appropriate option.

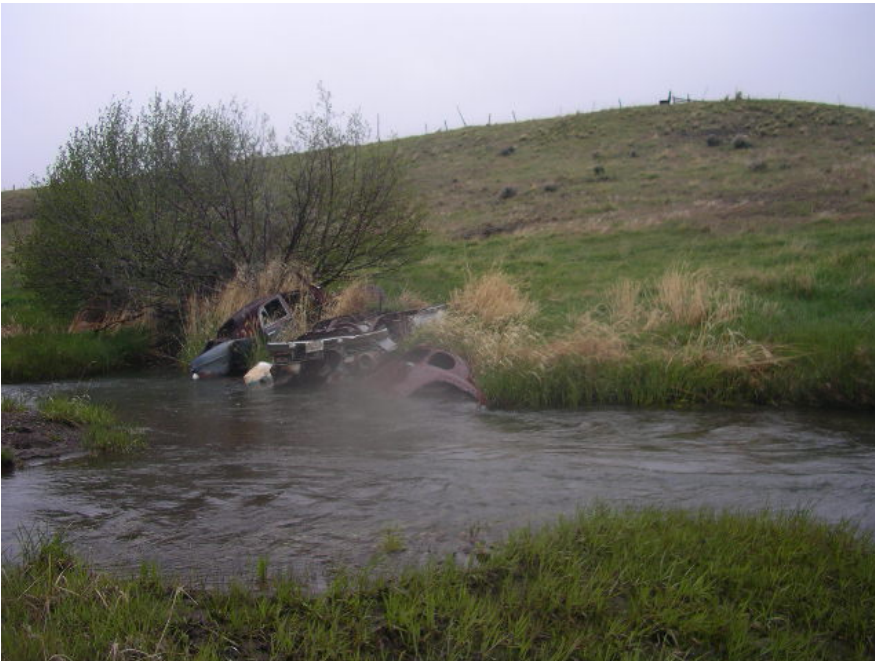
Eroding banks have apparently been a long-term problem on this portion of Brackett Creek. Earlier attempts to stabilize banks included use of car bodies (Figure 4-4). A cursory count indicated over 20 cars used as riprap, most of which were 1940s through 1950s vintage. This approach to bank stabilization has been illegal since the 1970s, with passage of the Montana Natural Streambed and Land Preservation Act or 310 law.

**Figure 4-4: Example of car bodies used as bank armor on the lower portion of Brackett Creek on the Lazy S Ranch.**

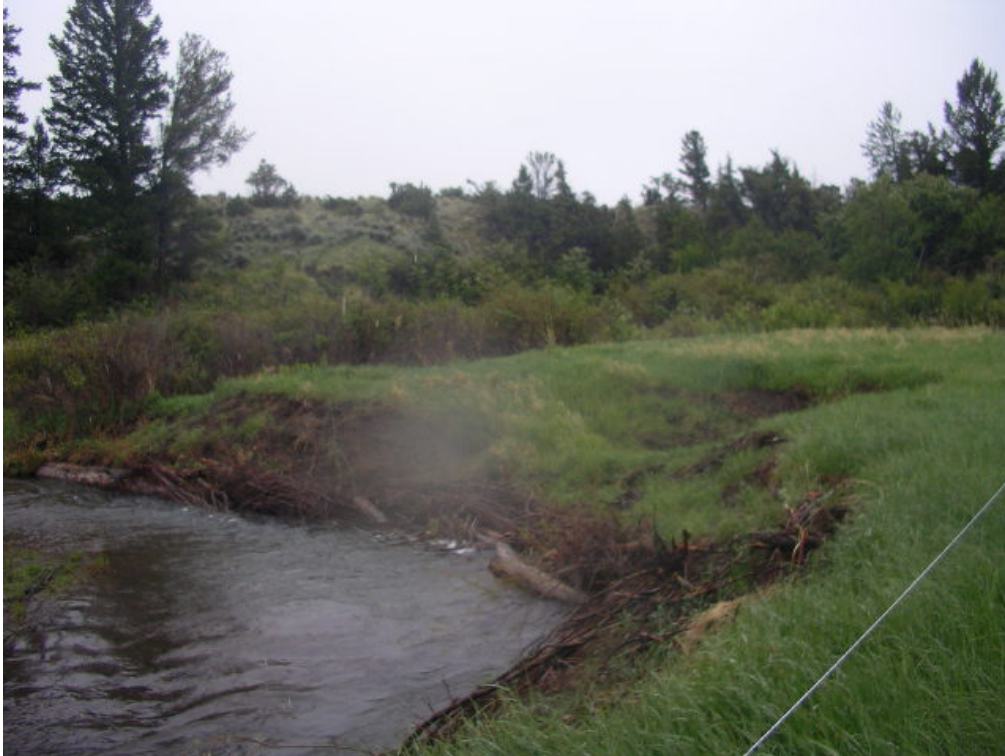
Bank erosion is a significant issue along much of Brackett Creek, both within and above the Lazy S Ranch. Accumulation of excessive amounts of fine sediment on the streambed harms fish by reducing invertebrate production and suffocating redds. Already, the adjacent, upstream landowner has initiated projects to reduce sediment loading on his property (Figure 5-1). Other upstream landowners have expressed interest in implementing such projects. If redd counts indicate significant amounts of spawning occur in Brackett Creek within the Lazy S Ranch, collection of substrate cores quantifying amounts of fine sediment will be useful in evaluating the effect of upstream bank stabilization projects.

**Figure 5-1: Example of a bank stabilization project on an upstream neighbor's property on Brackett Creek.**
