Madison River Drainage Fisheries
and
Madison River Drainage Westslope Cutthroat Trout Conservation
and Restoration Program

2007
Annual Report
to
PPL Montana
Environmental Division
Butte
www.pplmontana.com

by
Pat Clancey
Montana Fish, Wildlife, & Parks
Ennis
July 2008

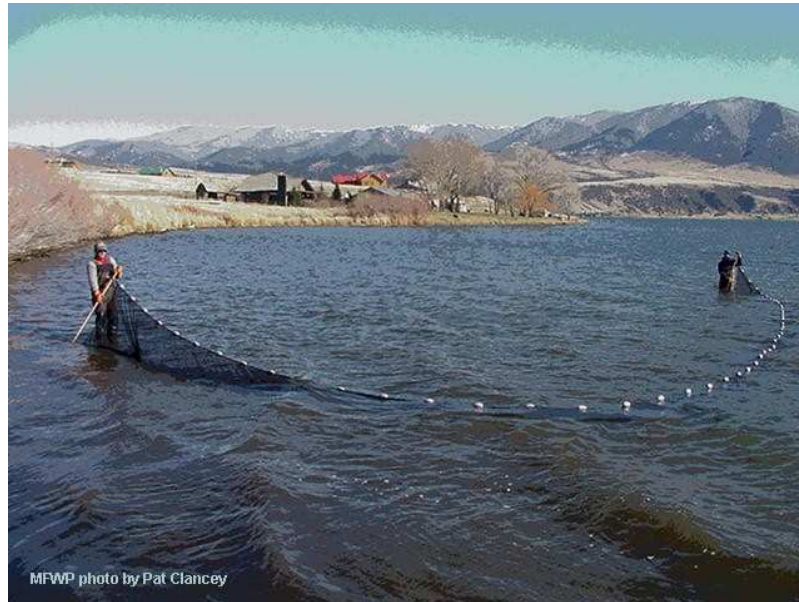
Figure 2. Beach seining in Ennis Reservoir.

A beach seine (Figure 2) is used to monitor index sites in Ennis Reservoir for young-of-the-year grayling and other fish species. Seining is conducted by pulling a 125 x 5 foot fine-mesh net along shallow areas in the reservoir.

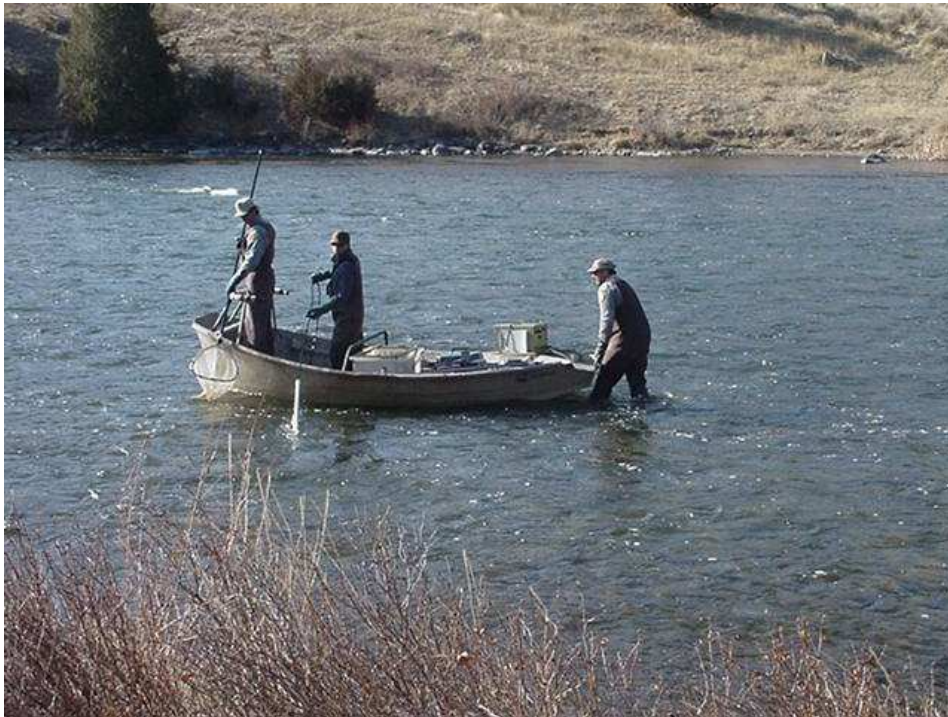
Figure 4. Electrofishing (shocking) in the Norris section of the Madison River.

Electrofishing from a driftboat mounted mobile anode system (Figure 4) is the principle method used to capture Madison River trout for population estimates in several sections of the Madison River (Figure 5). Fish captured for population estimates are weighed and measured, marked with a fin clip, and released. A log-likelihood statistical analysis (MFWP 2004b) is used to estimate trout populations.

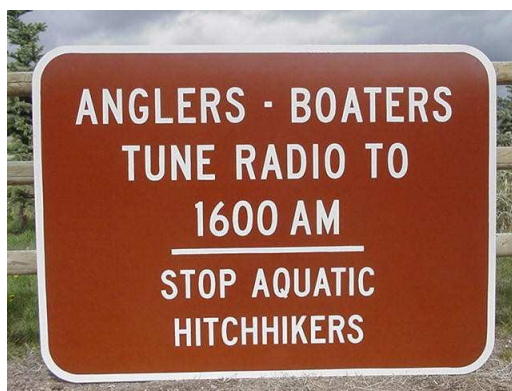
Figure 7. Roadside sign announcing the Traveler Information System at West Yellowstone.

Highway signs announce FWP's West Yellowstone Traveler Information System (TIS) (Figure 7). The five signs are located near major highway intersections in the West Yellowstone area, notifying drivers entering and leaving the area of the TIS system. The TIS notifies anglers and water recreationists of the presence of New Zealand mudsnails in the Madison River and Hebgen Reservoir, and instructs them on methods of reducing the likelihood of transporting New Zealand mudsnails and other ANS to other waters. Additional messages broadcast by the system include messages on whirling disease, zebra mussels, weed control, and TIPMont, the FWP hotline to report hunting & fishing violations. The system broadcasts at the AM frequency of 1600 KHz. Funding for the purchase, installation and signage of the system was provided by a \$9,800 grant from the Pacific States Marine Fisheries Commission as part of an effort to prevent the westward spread of zebra mussels.

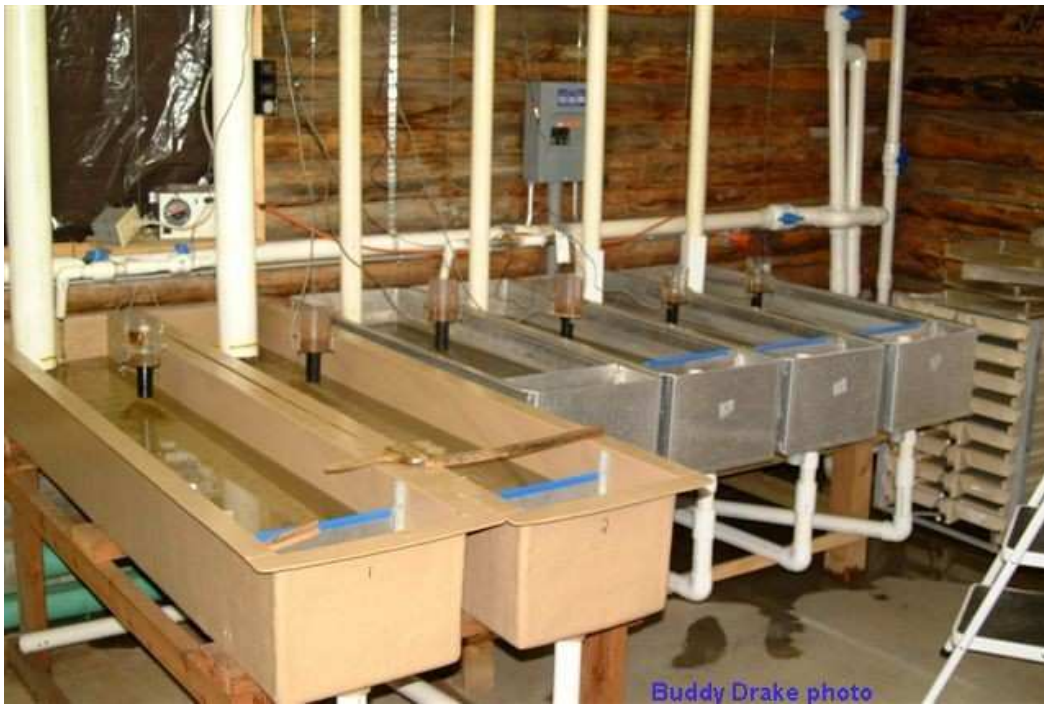
Figure 8. Sun Ranch Hatchery rearing troughs.

Gametes (eggs & sperm) for the Sun Ranch Westslope Cutthroat Trout program were collected from three streams and from the Sun Ranch Pond in 2007. All fertilized eggs were transported to the Sun Ranch Hatchery for incubation and hatching (Figure 8), and a portion of the resulting fry were introduced to the Sun Ranch Brood Pond (Figure 9) to contribute to the Sun Ranch brood development. Fry from the Sun Ranch Pond broodstock were used for introductions in Cherry Creek and stocked into the pond to facilitate development of the Sun Ranch brood.

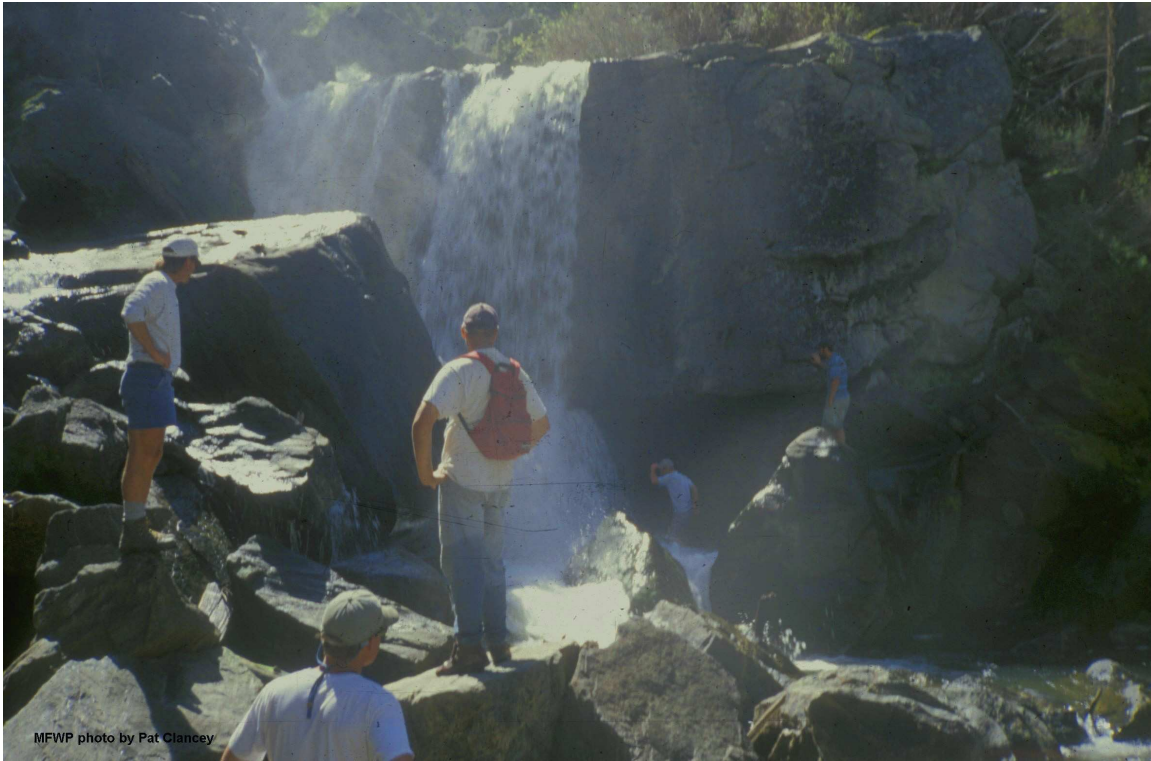
Figure 10. Cherry Creek waterfall at stream mile 8.0. This falls is the downstream extent of the project area.

waterfall approximately 8 miles upstream of the Madison River confluence (Figure 10). The only fish species present in the project area in 2003 were brook trout, rainbow trout, and Yellowstone cutthroat trout (YCT) (Figure 11). The large size of the project area requires that the project be completed in phases. Each phase will be treated for at least two consecutive years. Phase 1 was treated in 2003 & 2004, Phase 2 in 2005 & 2006, and in 2007 a third treatment of the Phase 2 mainstem and the first treatment of all of Phase 3 mainstem and tributaries was conducted.

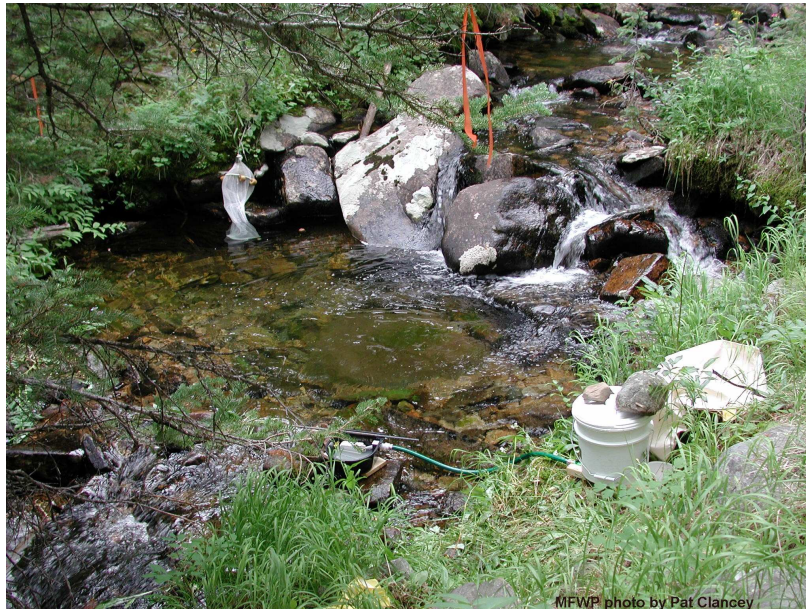
Figure 12. Trickle system and sentinel fish bag on Cherry Lake Creek. The sentinel fish bag is upstream of the CFT application point to monitor the effectiveness of the station above the one shown here.

Stream treatments were made using trickle application systems (Figure 12). The system consists of a 3½ gallon plastic bucket & lid, garden hose, a gate valve, and a commercially available automatic dog watering bowl. A plastic elbow is fixed to a hole drilled in the bottom of the bucket, a short section of garden hose and the gate valve is clamped to the elbow (Figure 13), and a longer section of garden hose attached the assembly to the dog waterer. The bucket is partially filled with filtered stream water, the CFT is added, then the bucket is topped off with filtered stream water and stirred with a wooden dowel. At a predetermined time, the gate valve is opened, allowing the mixture to flow into the bowl, where it then trickles into the stream through a small hole drilled in the bottom of the bowl (Figure 14). Typically, one bucket empties in 3 to 3½ hours. Applications are designed using a 7-hour application period, so the bucket must be refilled and the process repeated once at each application point each day.

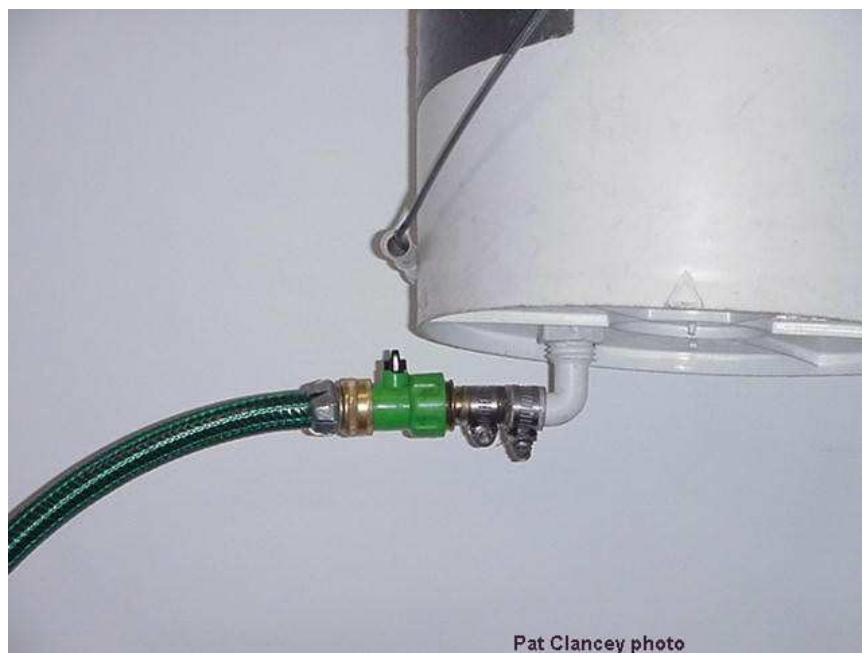
Figure 13. Elbow & gate valve assembly.

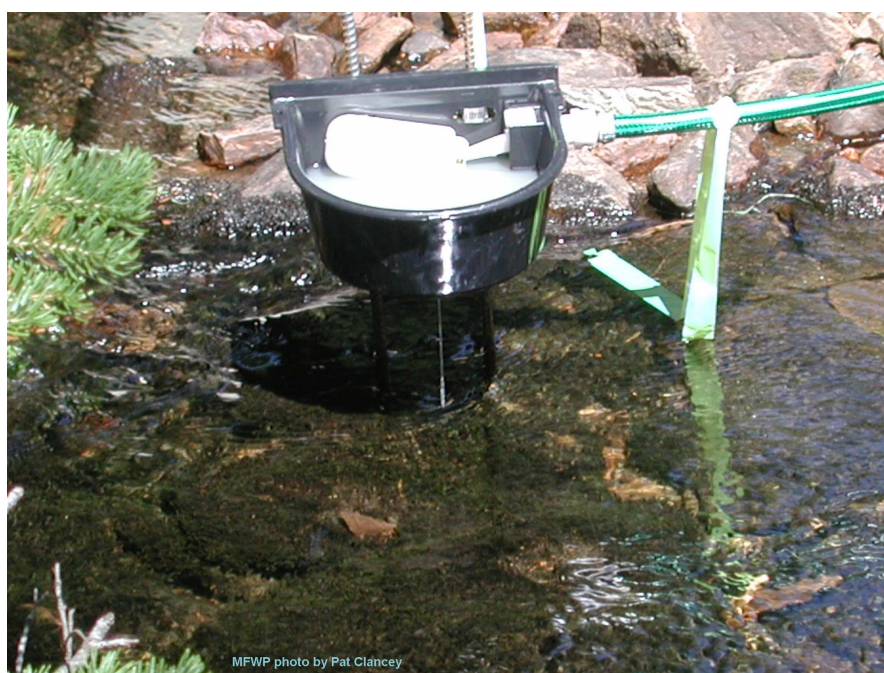
Figure 14. Close-up view of the dog waterer trickling CFT/streamwater mixture into the stream during the Cherry Creek Project.

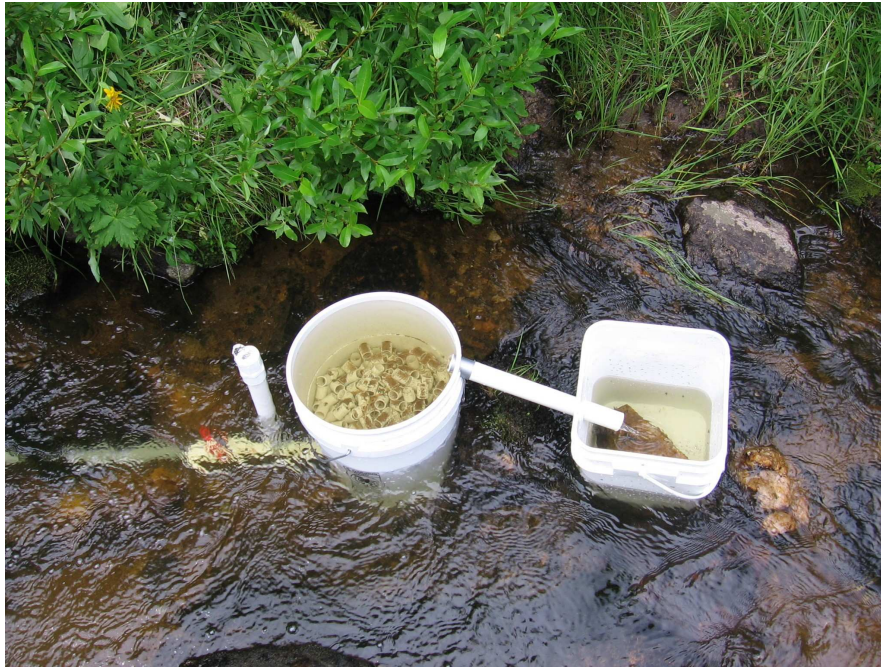
Figure 15. Remote streamside incubator (round bucket) and capture bucket (square bucket) in Cherry Creek

A capture bucket was placed on the outflow of the RSI to capture and enumerate departing fry to allow estimation of survival in the RSI.

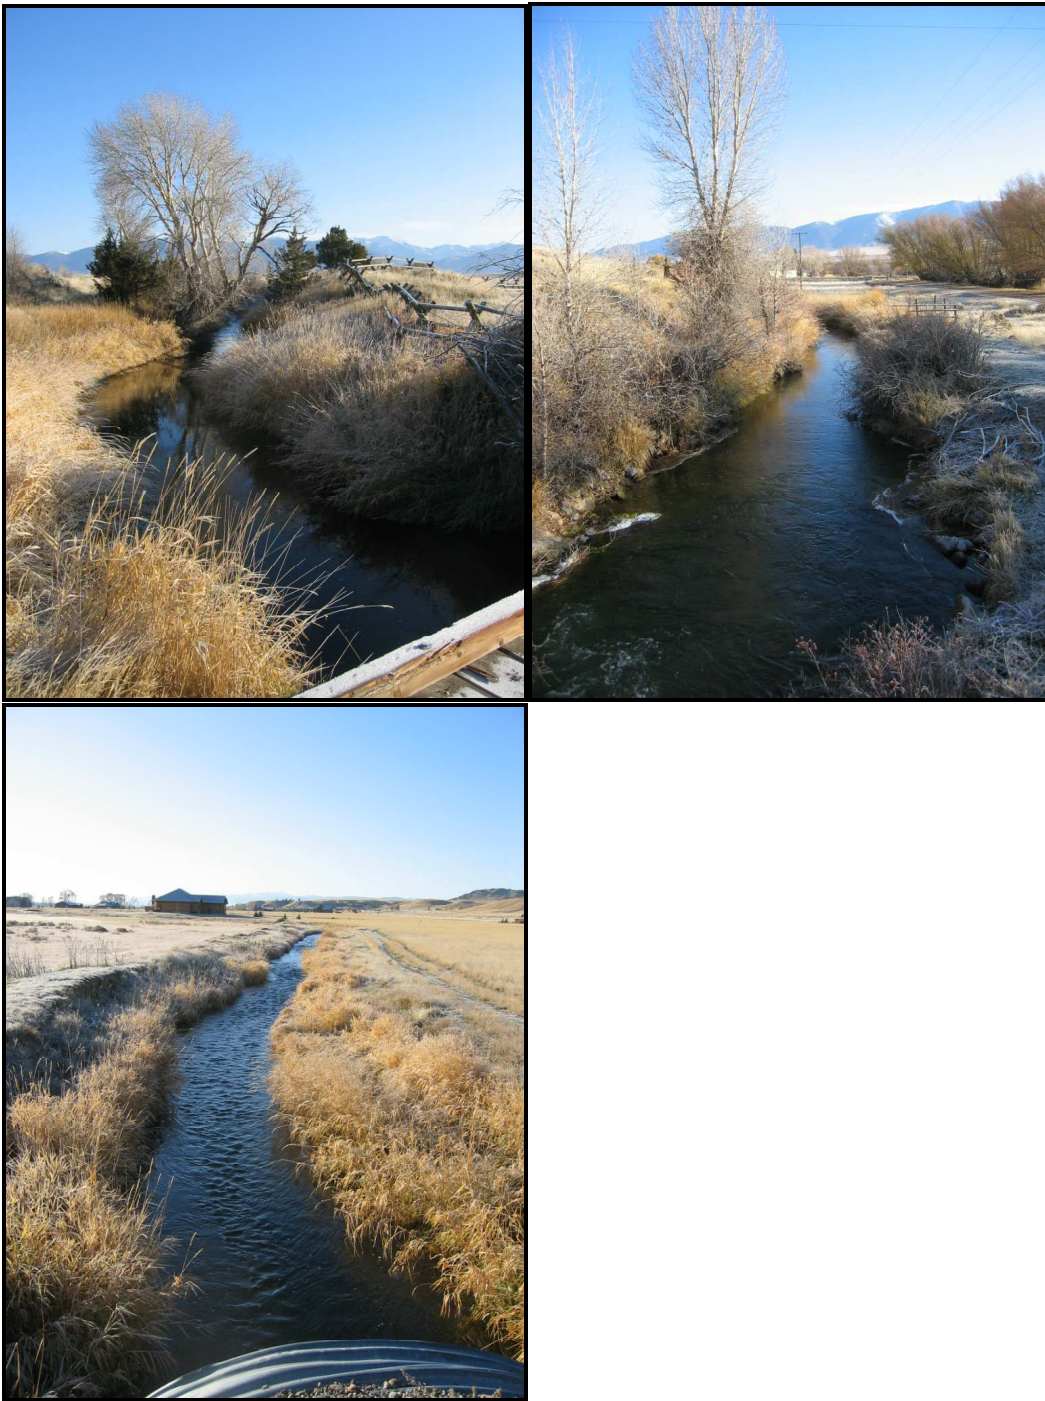
Figure 16. Photos of three sections of the West Madison Canal monitored for fish entrainment. Clockwise from top left – Eight-mile, Willow Ranch, and Range View Road.

In 2007, the West Madison Canal was monitored by electrofishing to determine characteristics of fish entrainment. Three 500-foot sections were established. The sections were called Eight-mile, Willow Ranch, and Range View Road (Figure 16), which are approximately one, four, and six miles respectively below the headgate on the Madison River (Figure 17). Monitoring was conducted eight times from May 16 – October 17. Captured fish were speciated, enumerated, measured for length & weight, examined for disease symptoms, and fin clipped. Fish larger than 6 inches were also tagged with a colored stringer tag. Each of the 3 sections was assigned a specific tag color to determine movement between sections and to determine distribution throughout the ditch during salvage efforts.

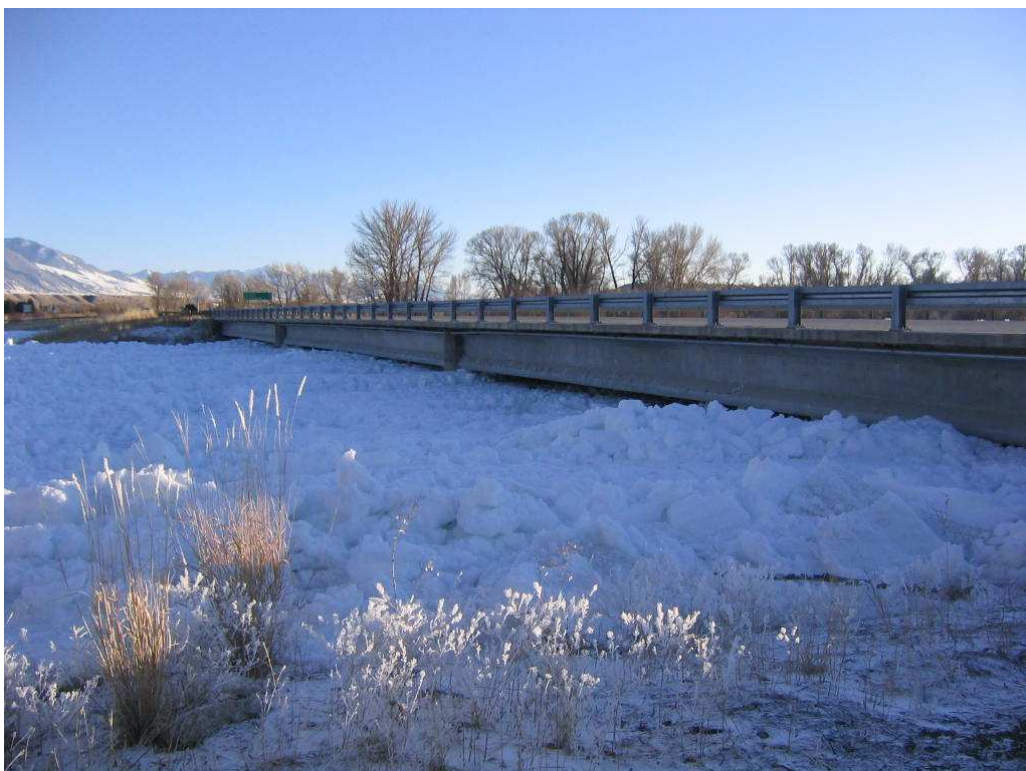
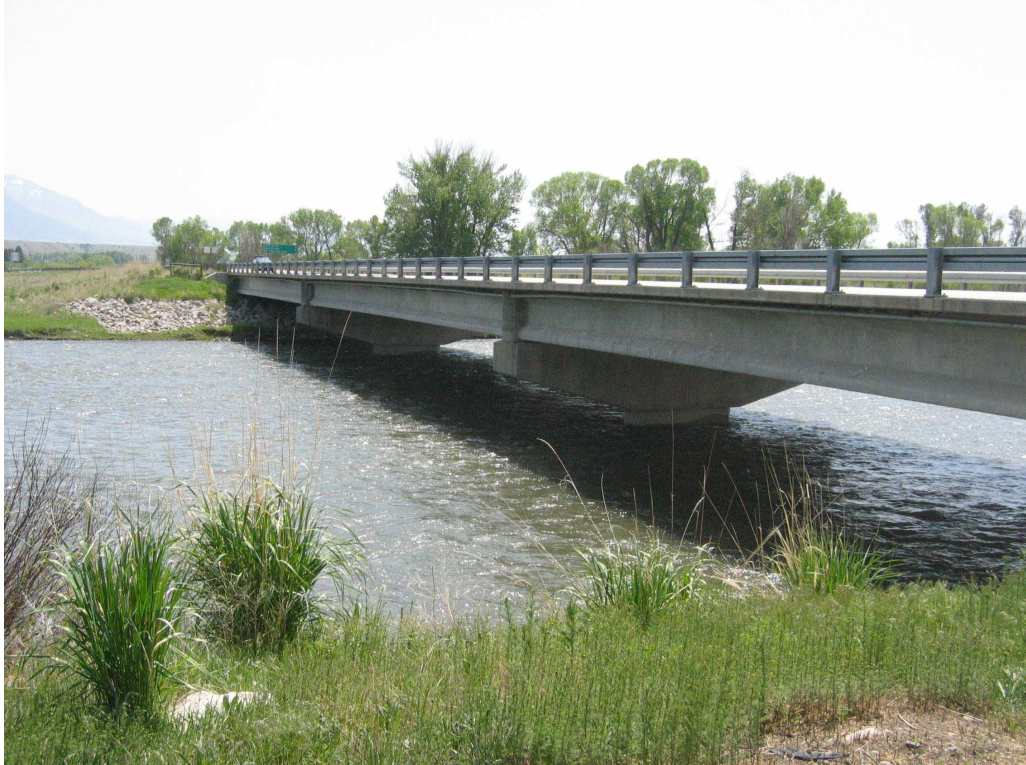
Figure 18. The Madison River at the U.S. Highway 287 Bridge at Ennis, illustrating ice-gorged and ungorged conditions.

Arctic grayling require loose, recently scoured gravels and cobbles to broadcast their eggs over during spawning each spring (Byorth and Shepard 1990). Generally, normal spring runoff creates these conditions, but it is possible that winter and spring ice scour also make such conditions available. The duration and severity of the Madison River ice gorge (Figure 18) may affect the spawning success of the Ennis Reservoir grayling.

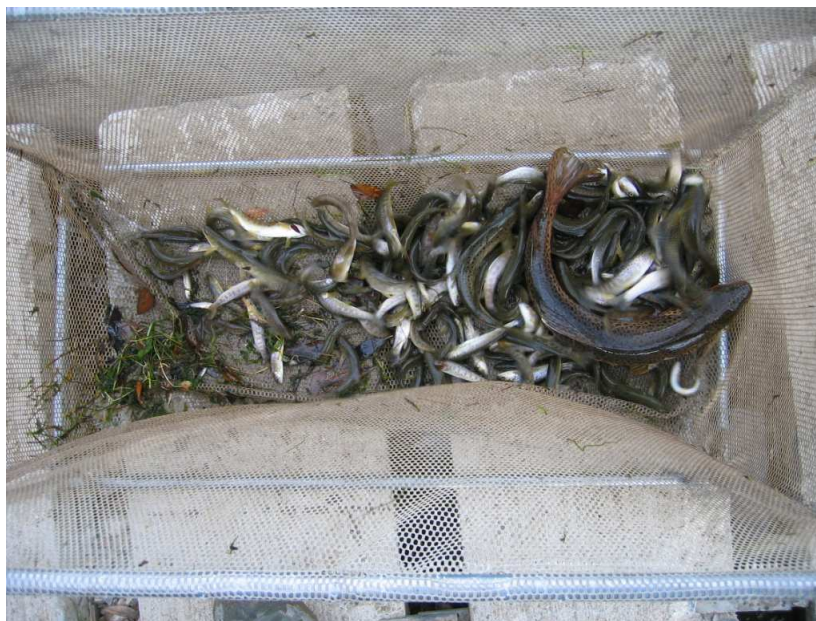
Figure 29. A sample of fish salvaged from the West Madison Canal and released into the Madison River.

In 2007, WMC water right holders allowed FWP access to the ditch to actively monitor fish entrainment. Each of three 500-foot sections were surveyed with electrofishing eight times during the season. A significant increase in entrainment occurred between mid-July and mid-August in each of the two upstream sections, 8-Mile and Willow Ranch, and to a lesser degree in the downstream Range View Road section between mid-August and early September. The 8-mile section showed increasing numbers of fish throughout the season, the number of fish in the Willow Ranch section peaked in August and then decreased through mid October, and the number of fish in the Range View Road section remained low and steady after early September (Figure 30). Figures in Appendix H show species composition and rate of entrainment by date for each of the three sections. Figure 31 illustrates the proportion of brown trout, rainbow trout, and whitefish by size class on the final sample date in October.

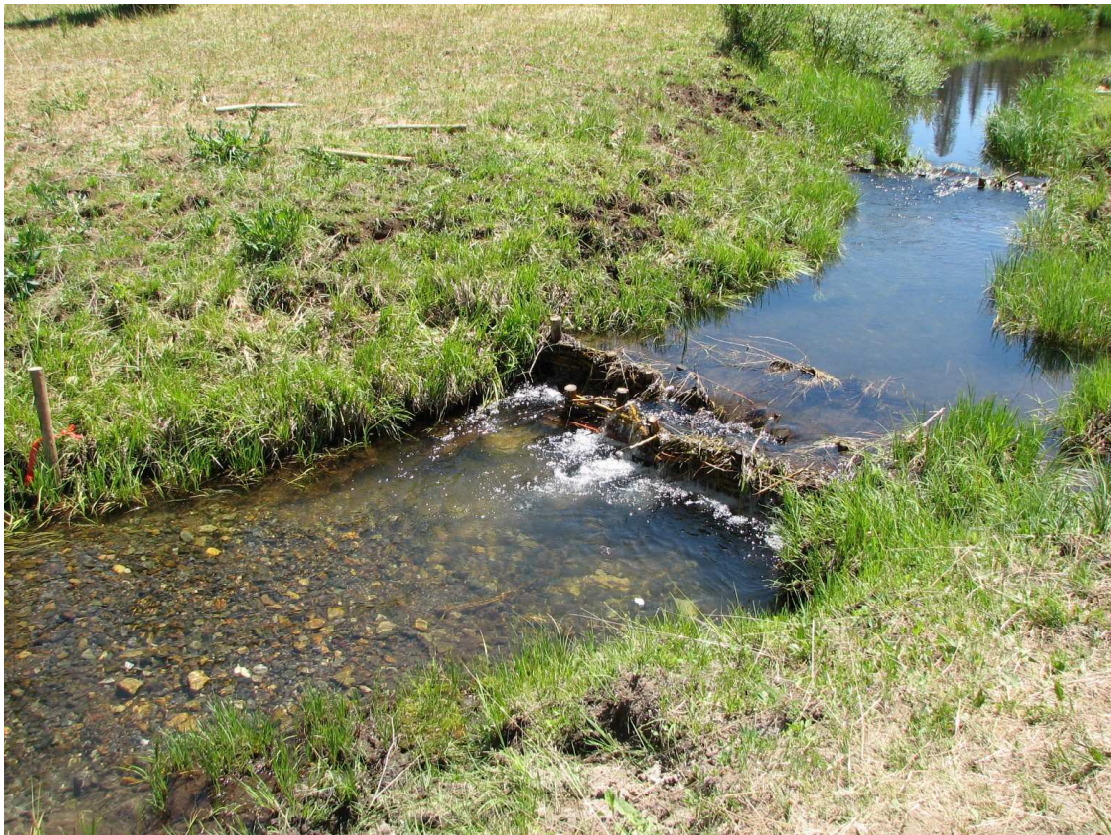
Gazelle Creek, channel spanning structures raising stream bed elevation, August 2007.

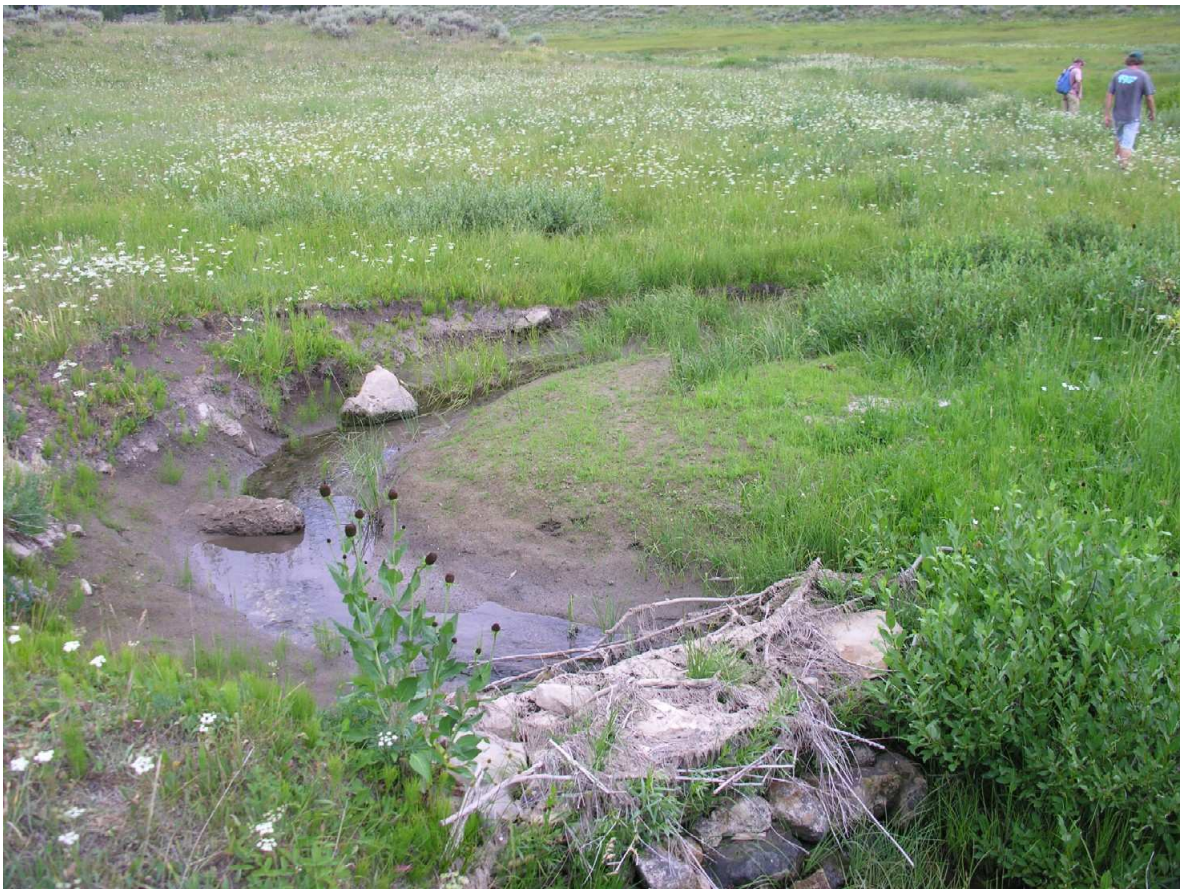
Fine sediment deposit and point bar expansion, Arasta Creek, July 2007. This structure, installed in 2006, was not holding water after spring runoff. It was repaired using burlap to seal the structure

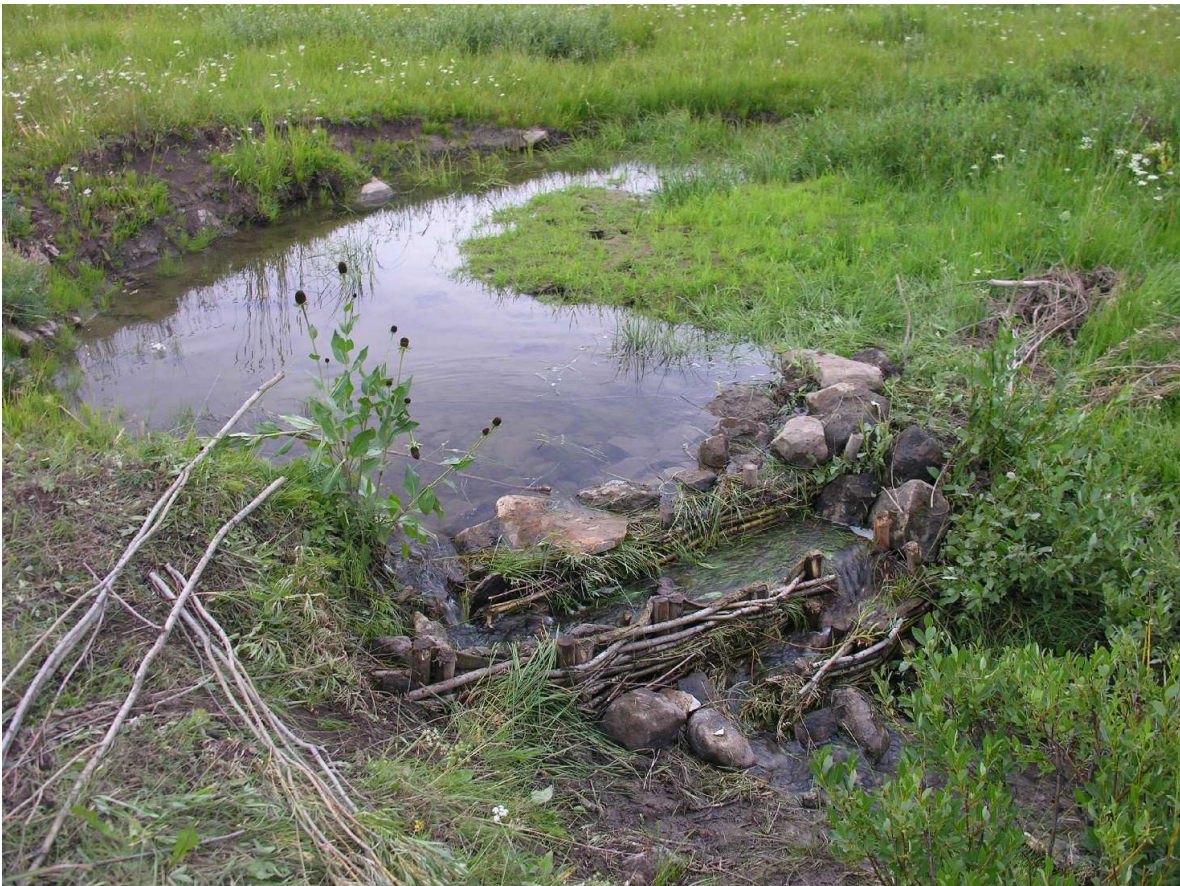
Same structure after repair, August 2007.

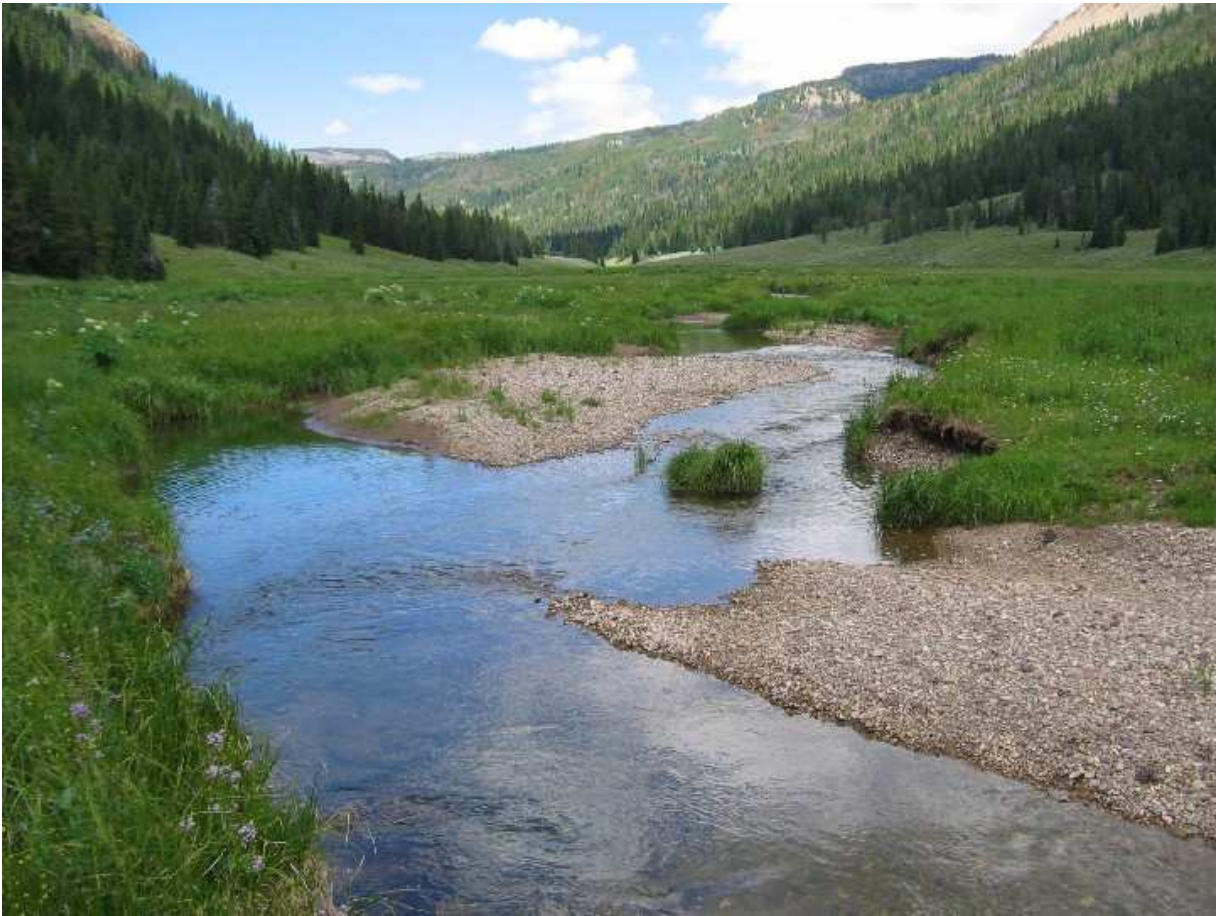
Structure 1 looking upstream at unconsolidated sediments composing bars in Elk River Meadow, 2005.

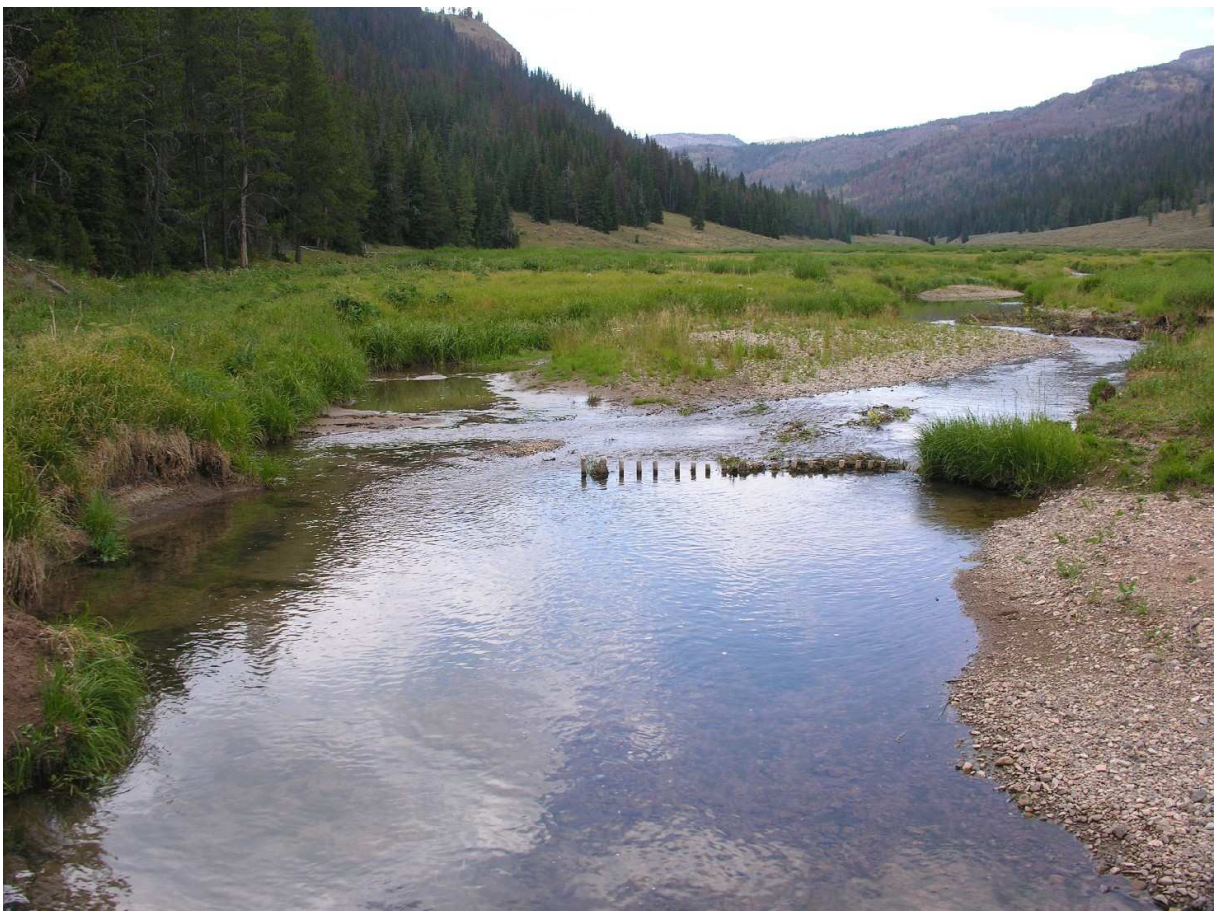
Same view, July 2007. Note the deposition of sediments upstream of wood stakes and new thalweg.

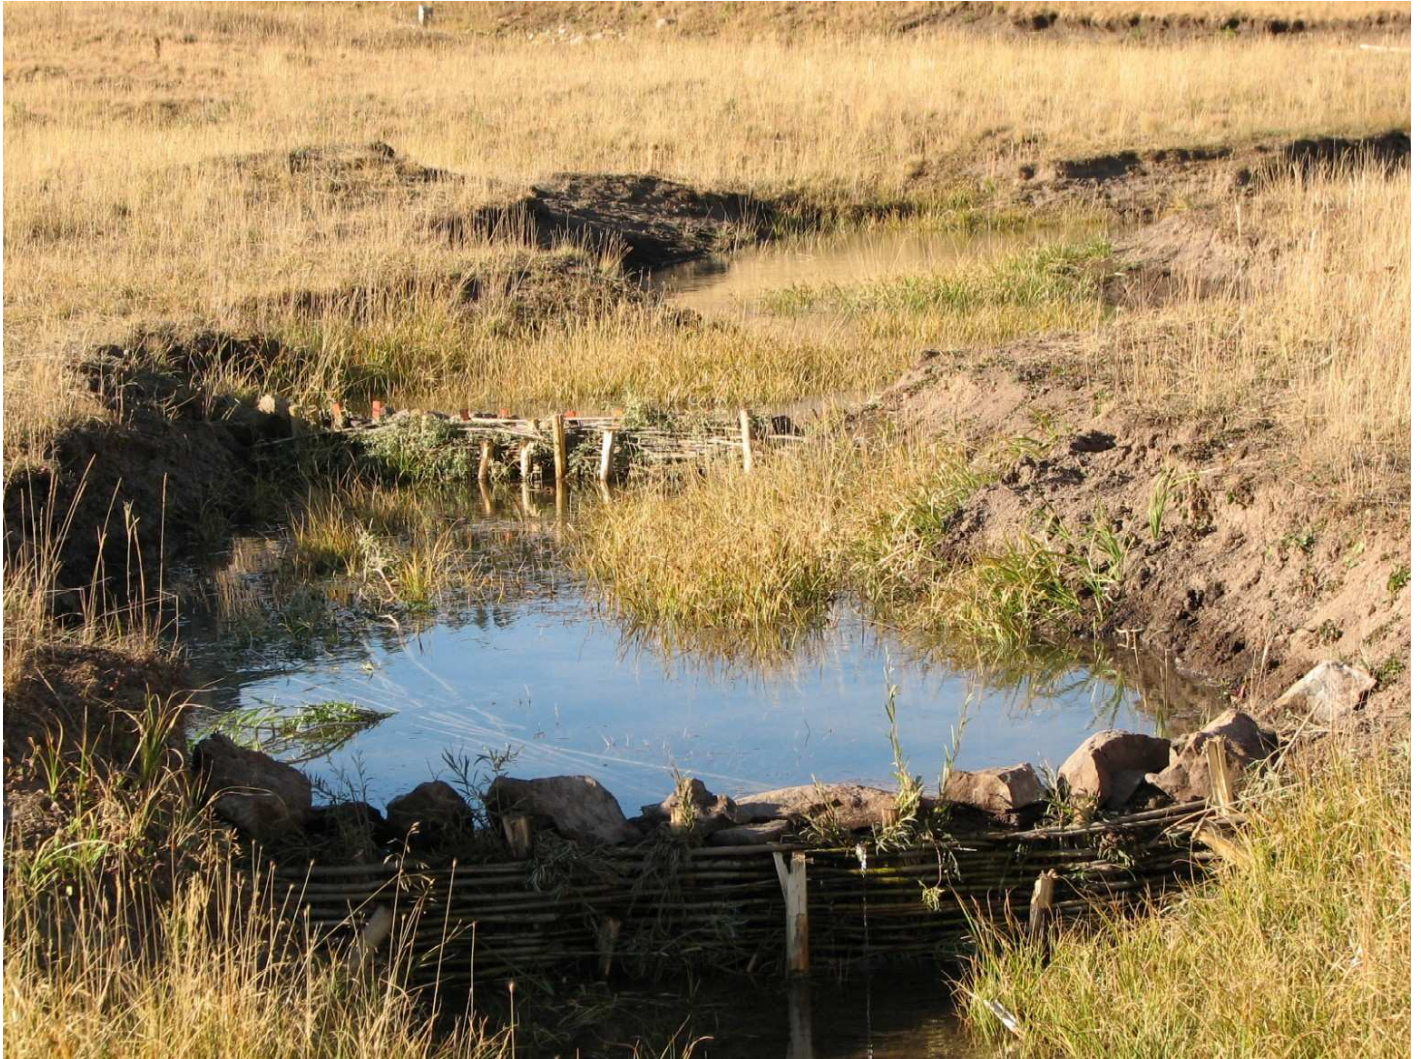
Figure 1. Channel spanning wicker weirs, located about 100 feet downstream of Riffle #6, Tepee Creek, summer 2006.

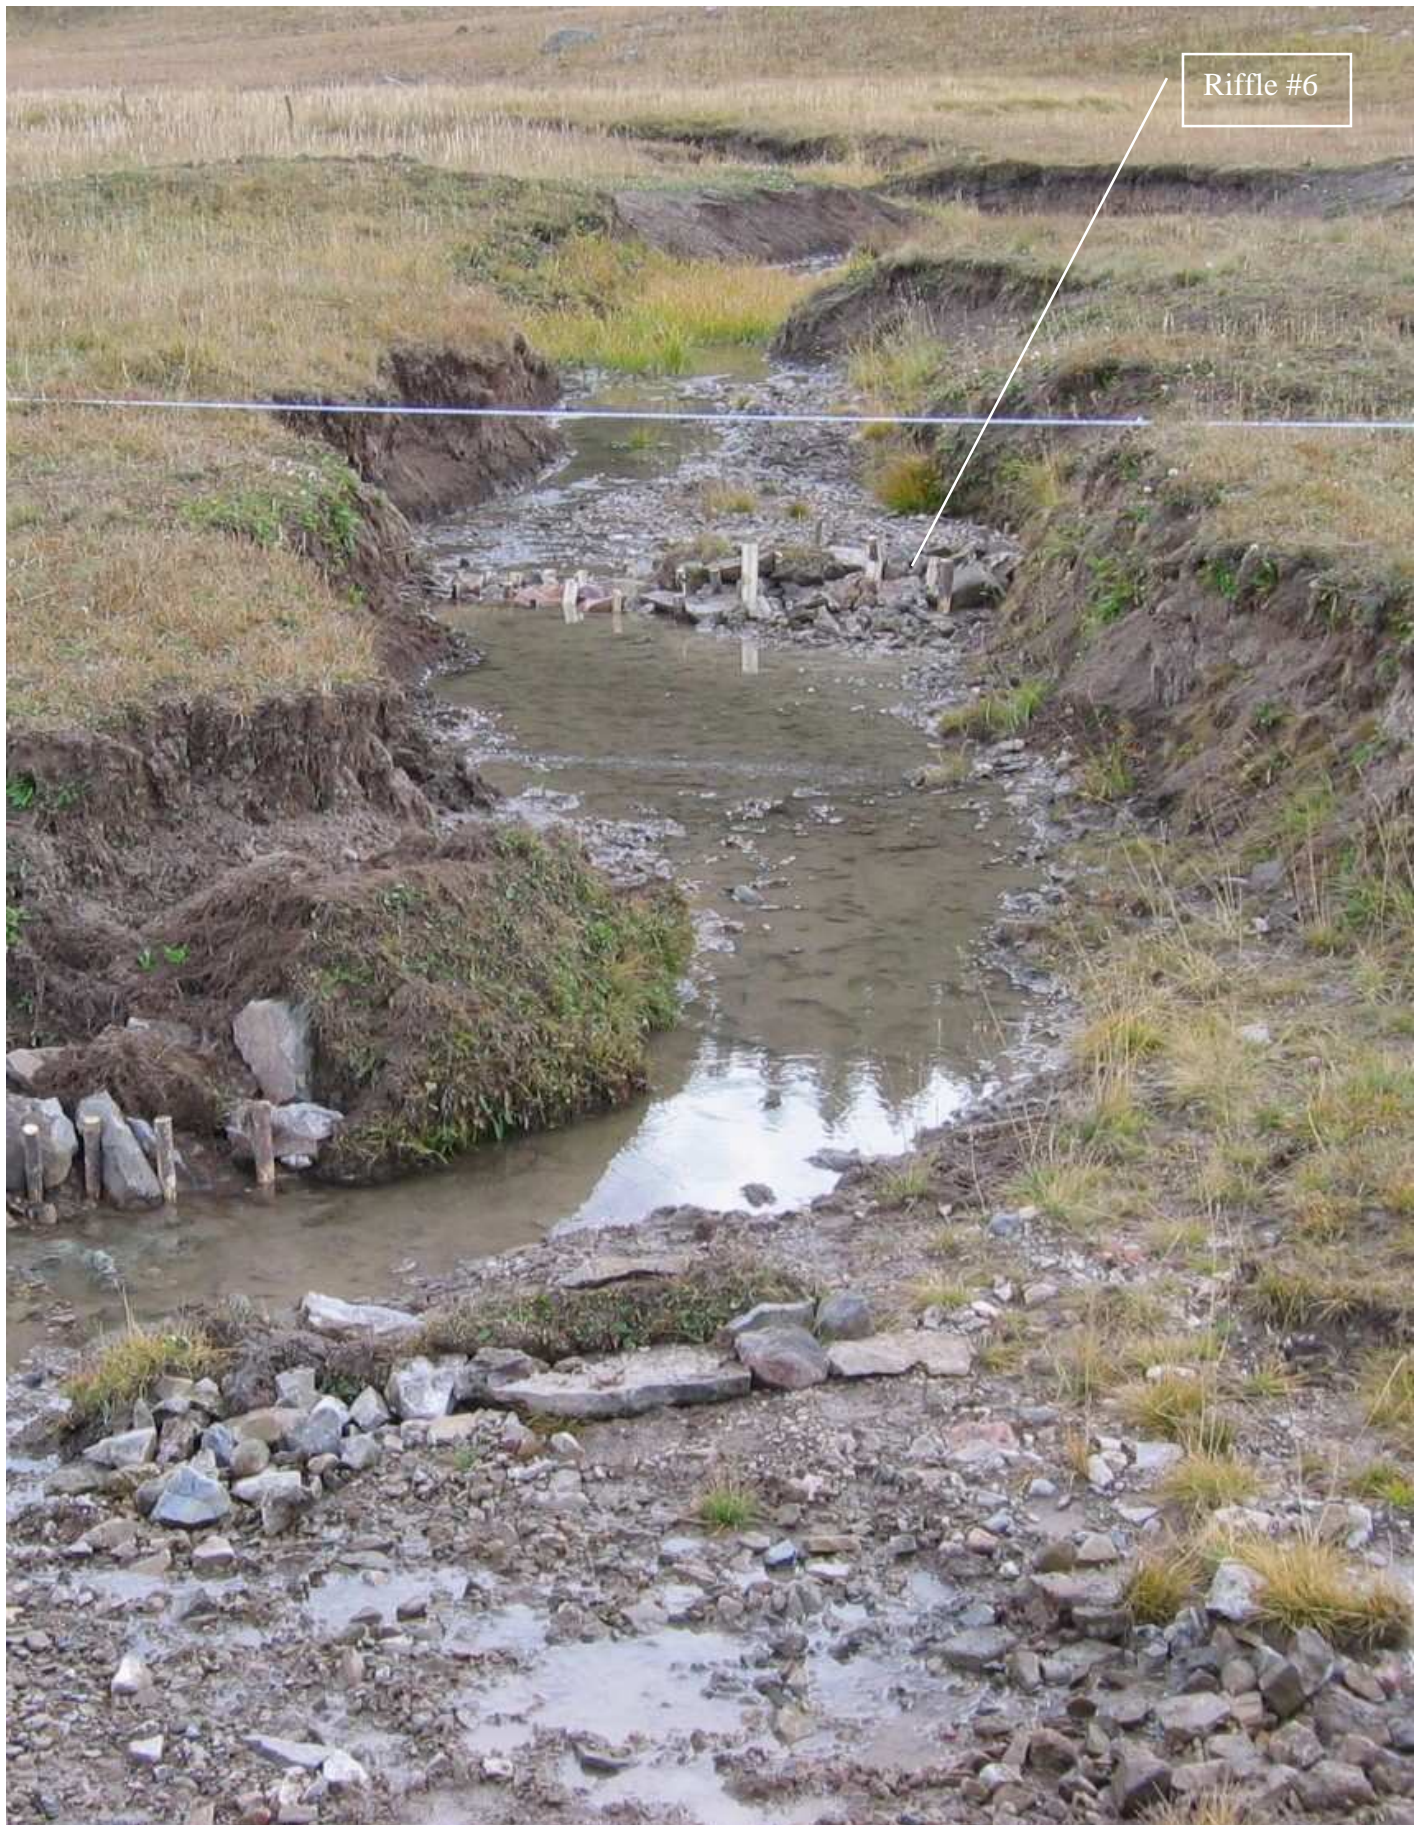
Figure 2. Tepee Creek, Riffle #6, day of installation, 29 September 2004.

Results in 2007 were quite impressive as significant quantities of fine sediment were trapped upstream of the new dam-like structures installed the previous summer. These structures survived intact; however they suffered small breaches that allowed water to leak through, lowering water surface elevations upstream. We repaired these structures using bio-degradeable sandbags and sedge chunks, which was very effective in holding water levels upstream (Figures 2 and 3).
