Madison River Drainage Fisheries
and
Madison River Drainage Westslope Cutthroat Trout Conservation
and Restoration Program

2007
Annual Report
to
PPL Montana
Environmental Division
Butte
www.pplmontana.com

by
Pat Clancey
Montana Fish, Wildlife, & Parks
Ennis
July 2008

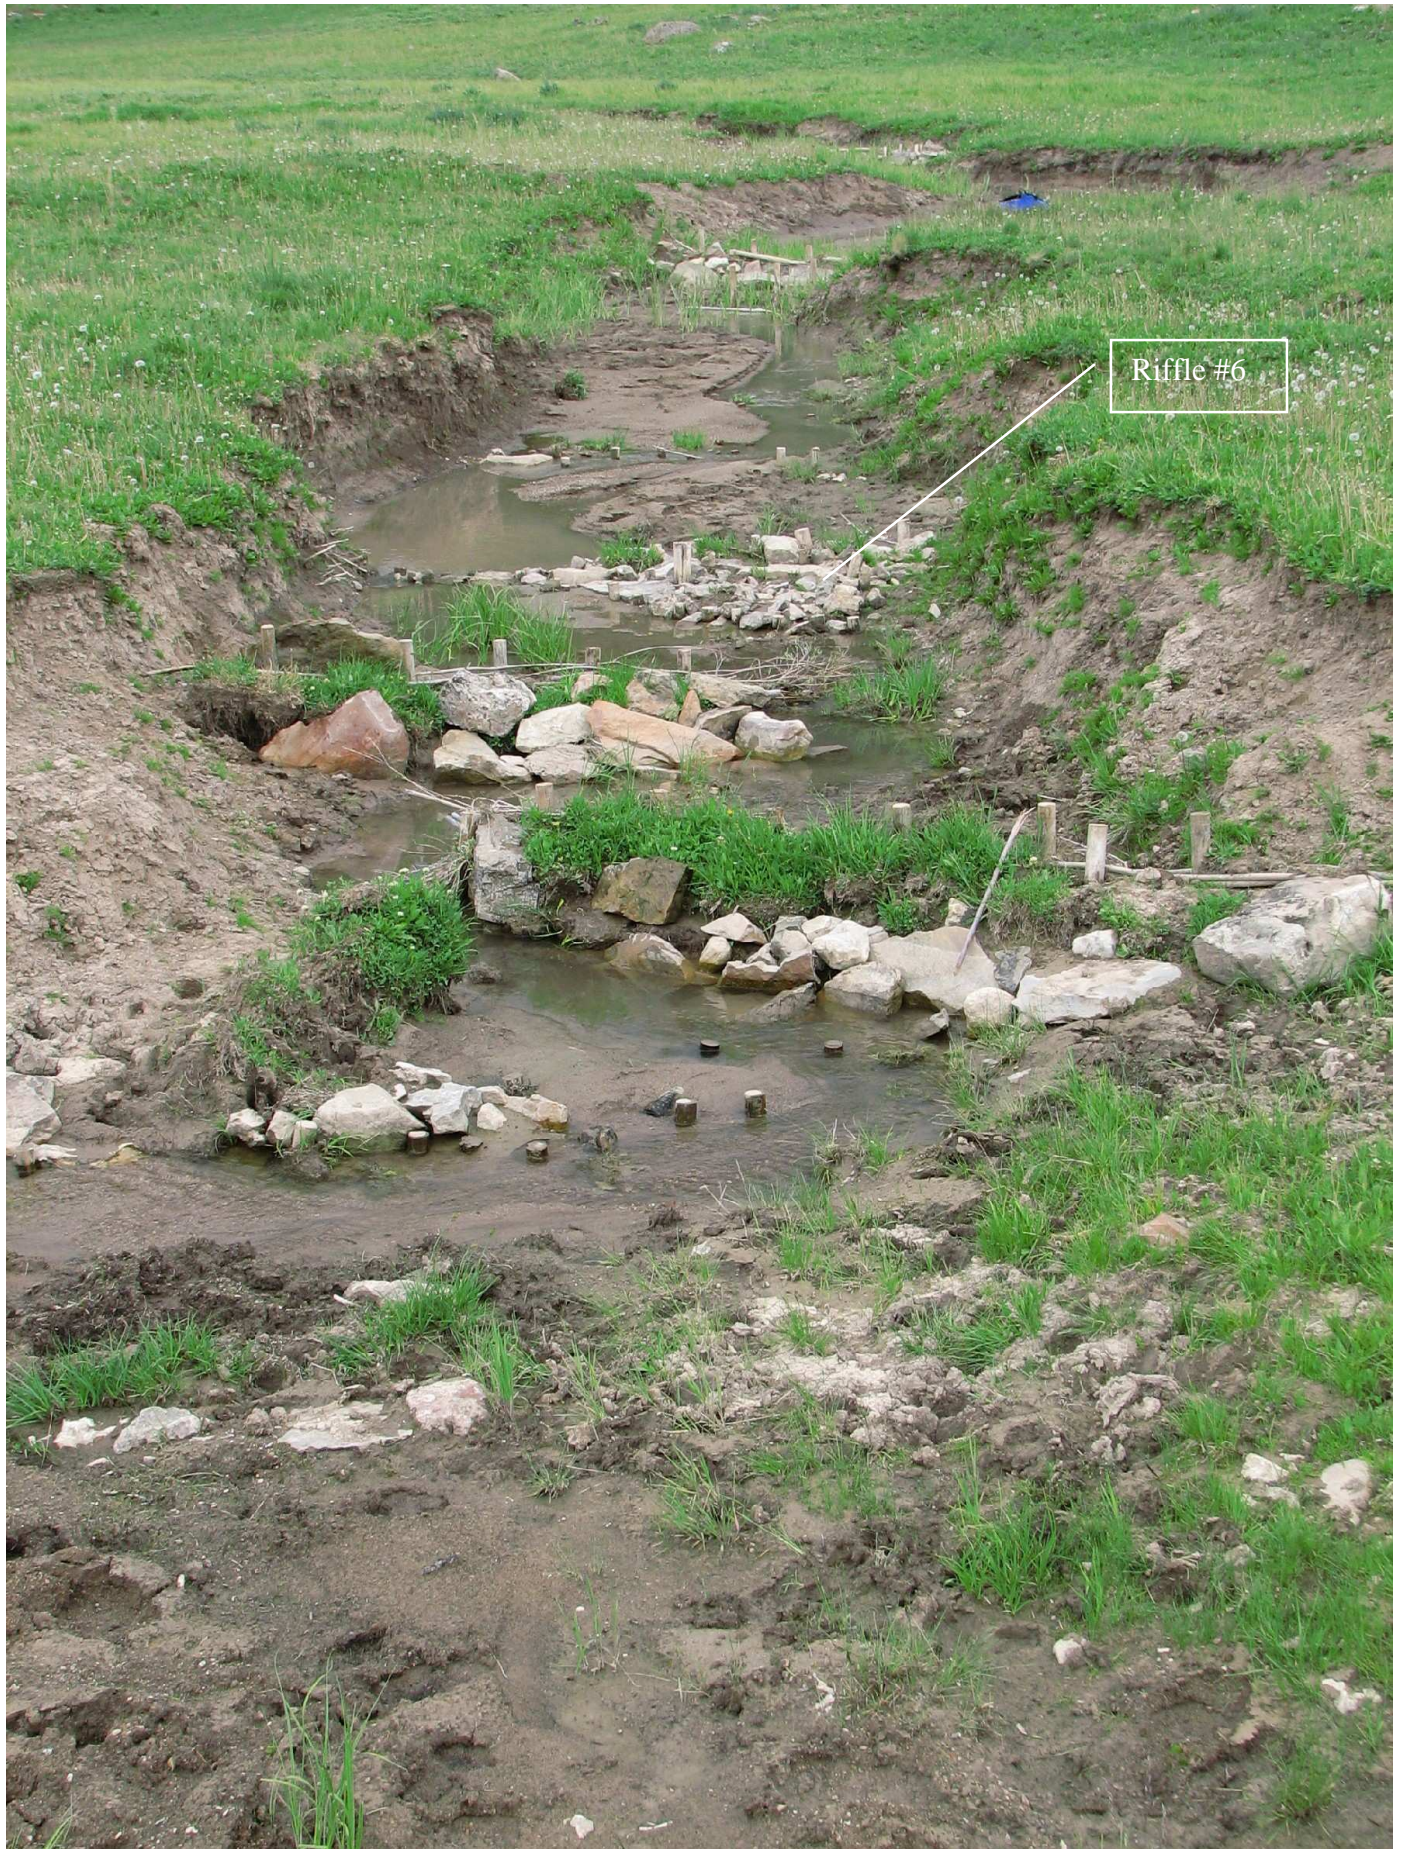
Figure 3. Tepee Creek, view of Baffle #1 (first installed) looking downstream, 14 July 2007.

Results in 2007 were quite impressive as significant quantities of fine sediment were trapped upstream of the new dam-like structures installed the previous summer. These structures survived intact; however they suffered small breaches that allowed water to leak through, lowering water surface elevations upstream. We repaired these structures using bio-degradeable sandbags and sedge chunks, which was very effective in holding water levels upstream (Figures 2 and 3).

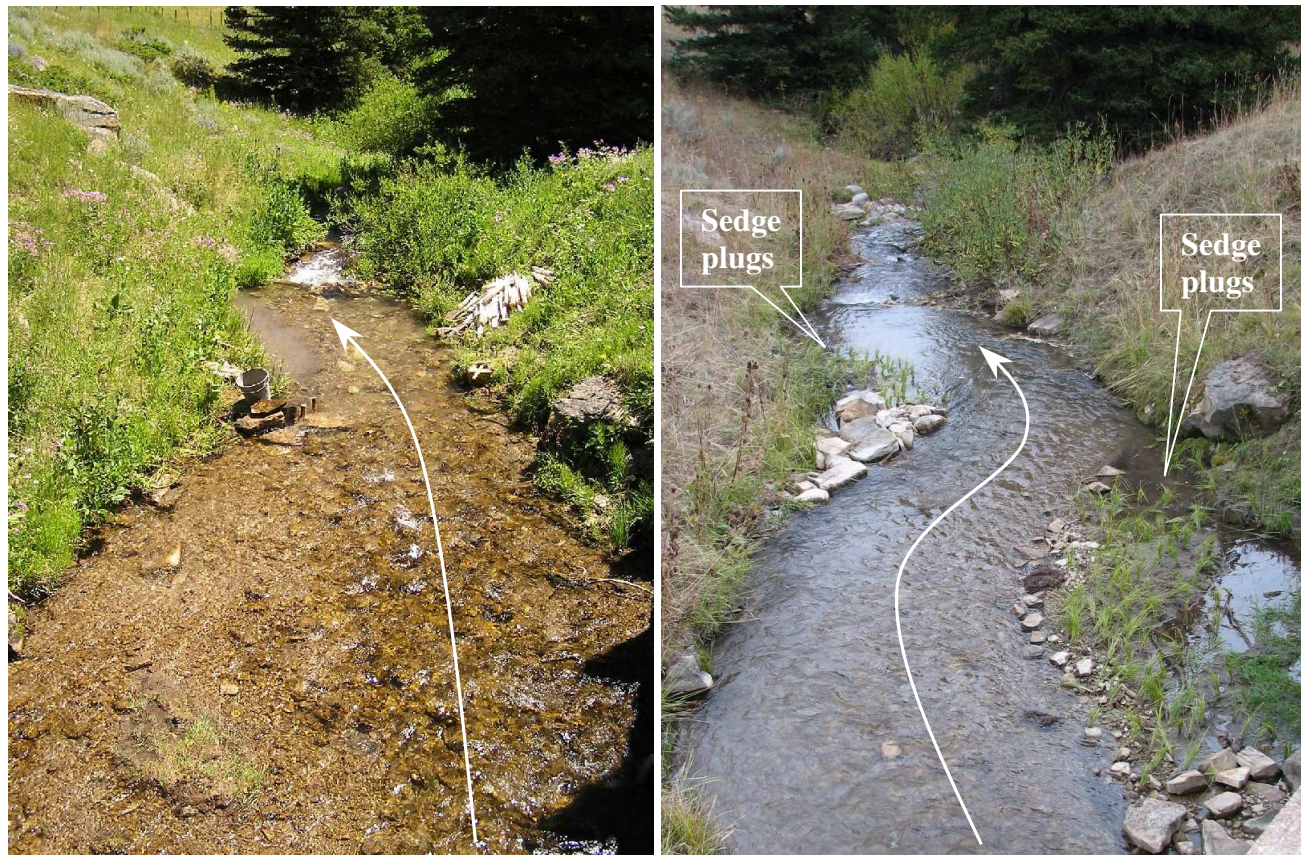
Figure 1. Wigwam Creek immediately downstream of the FS Road 290 bridge; previous to baffle installation (July 2005) at left, and after baffle installation (September 2006) at right.

Baffles installed in Wigwam Creek have been very successful influencing sediment deposition, particularly in their downstream eddy areas. In 2006 and 2007, we purchased sedge plugs and planted them in these areas of deposition to help stabilize these unconsolidated sediments. Sedges appear to thrive in these environments, and continued monitoring will be needed to determine how effective they are in sediment stabilization (Figure 1). Figures 2 and 3 depict how structures have narrowed the Wigwam Creek channel, inducing meandering (sinuosity), creating gravel sorting and pool formation .

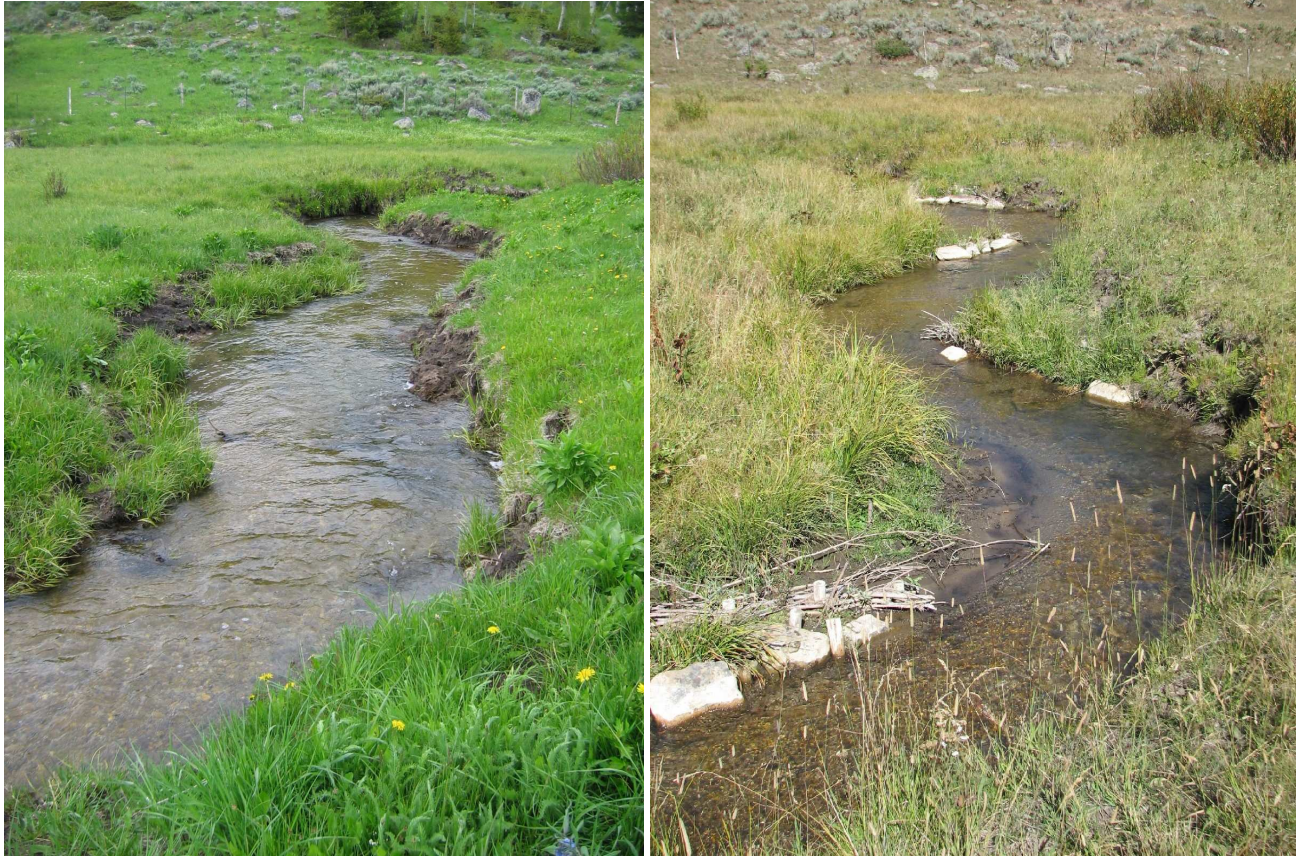
Figure 2. Comparison photos of Wigwam Creek upstream of the bridge. Photo on the left is pre-treatment in 2004, the photo on the right (2007) is after structure installation in the fall of 2006 and one spring run-off event. Note the fine sediment deposition downstream of the structure at lower left, and pool scour immediately downstream. The pasture fence in this reach is old, in disrepair, and slated for replacement in the next year as an exclosure. Due to the nature of local topography and water availability, the project area has had problems with cattle aggregating in the stream and riparian area. Installation of an improved exclosure system should reduce these impacts and further accelerate channel restoration.

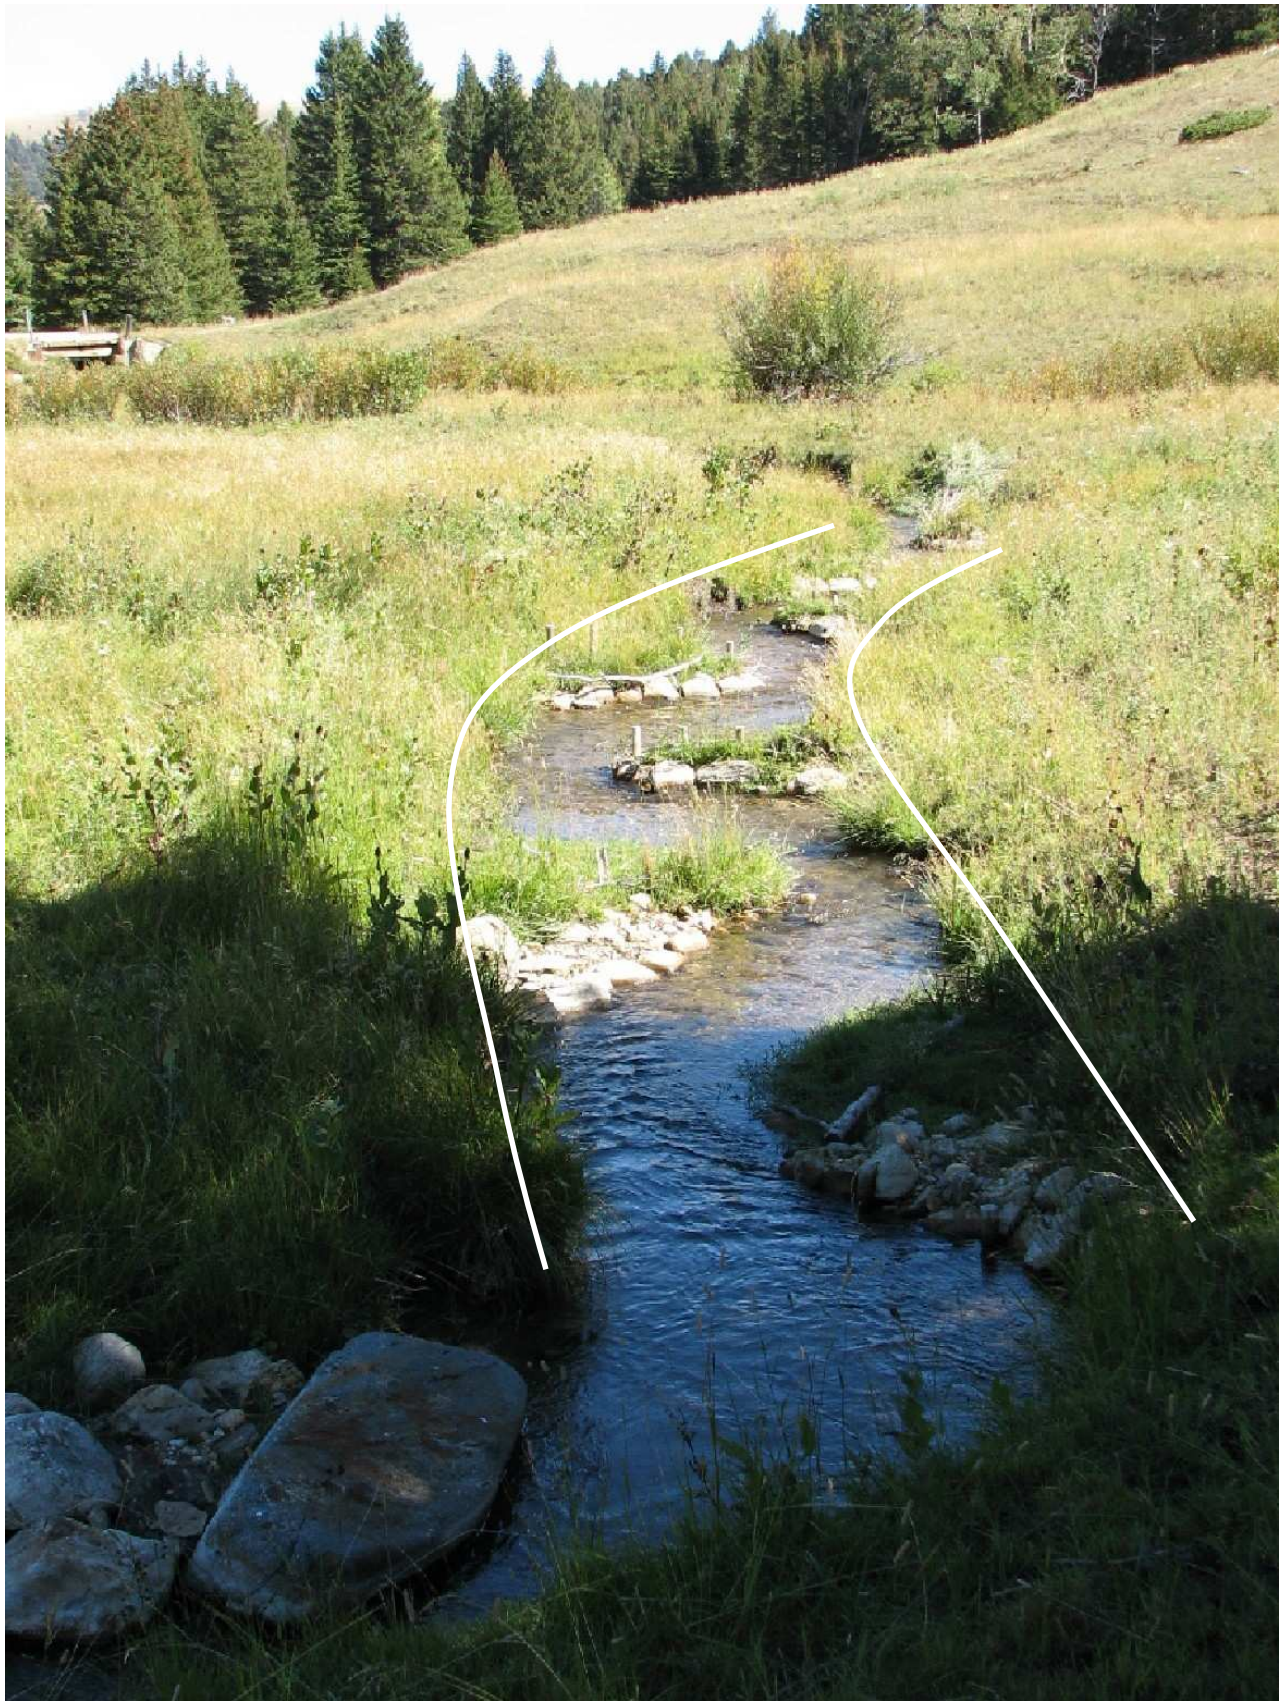
Figure 3. Restored channel segment of Wigwam Creek upstream of the bridge. White lines approximate the pre-treatment location of channel banks. Note how structures have reduced channel width and increased sinuosity. The large rocks at lower left were embedded at the outside bend (at right) of the channel, preventing lateral pool scour and leading to channel straightening. Re-locating these rocks (manually) to the inside of the bend has influenced sediment deposition, point bar formation, and lateral pool scour.
