EVALUATING SHALLOW-FLOW ROCK STRUCTURES AS  
SCOUR COUNTERMEASURES AT BRIDGES

Benjamin P. Dahle

Master of Science

August 2008

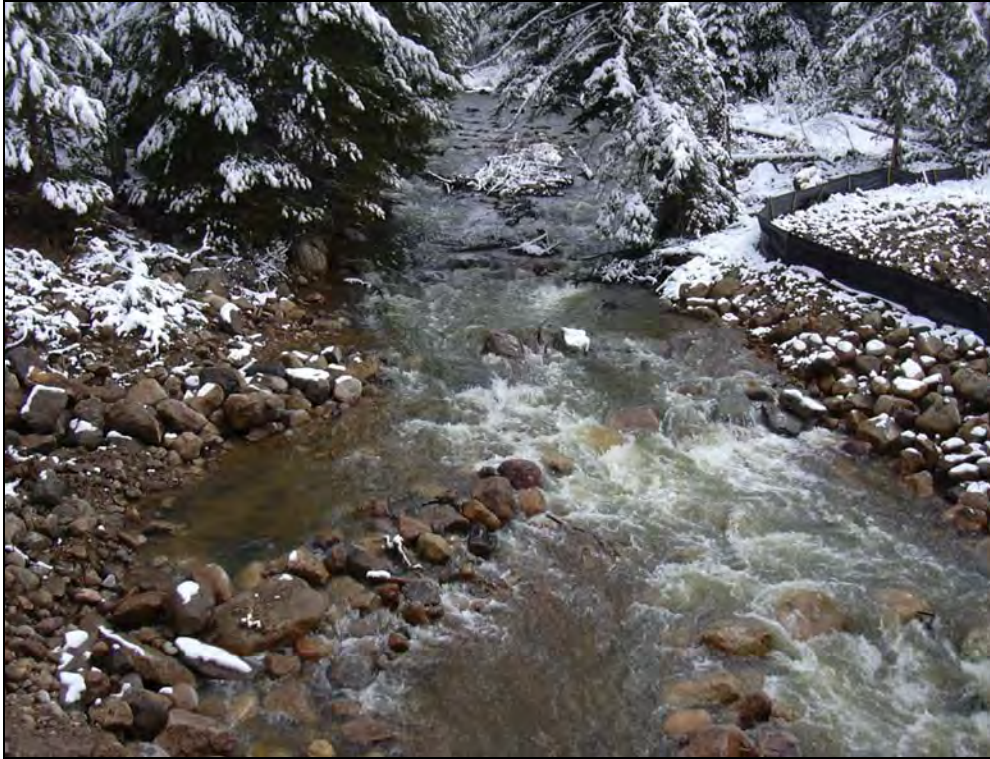
**Figure 2-1. Drop Structure on the North Fork of the Provo River.**

The structures in the study group are classified as weirs, bendway weirs, vanes, cross-vanes, and j-hook vanes. Weirs are divided into two categories, drop structures and porous weirs (also known as vortex weirs). The defining difference between drop structures and porous weirs is that porous weirs are designed to have distinctive chutes or spaces between rocks along the length of the structure whereas drop structures do not. See Figure 2-1 and Figure 2-2 for illustrations of drop structures and porous weirs, respectively.

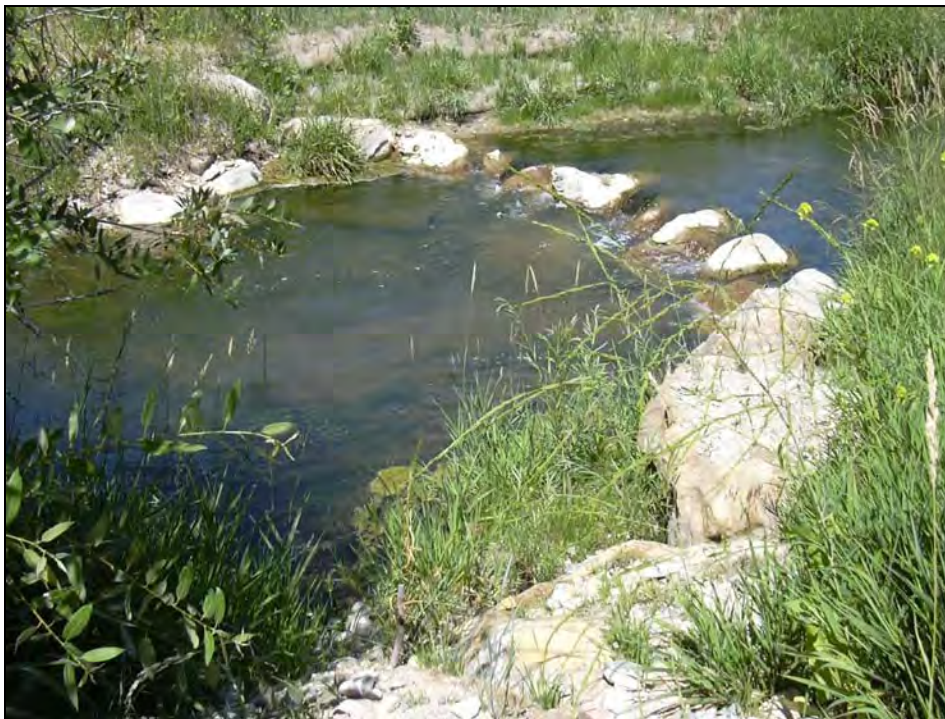
**Figure 2-2. Porous Weir on the San Pitch River.**

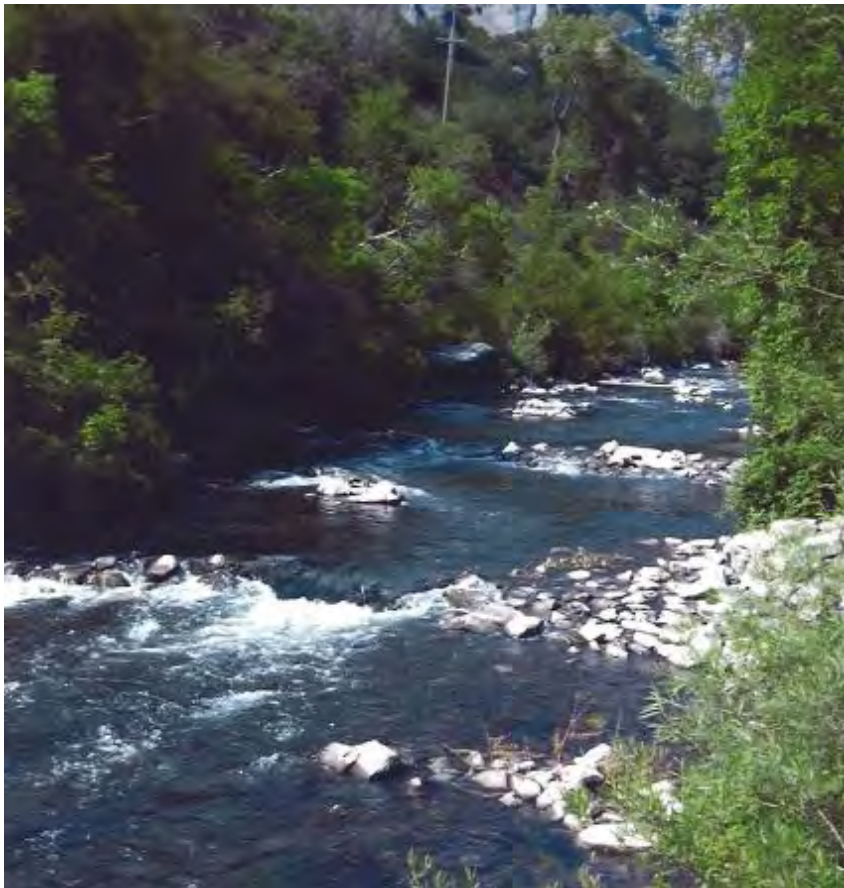
**Figure 2-4. Bendway Weirs on the Provo River.**

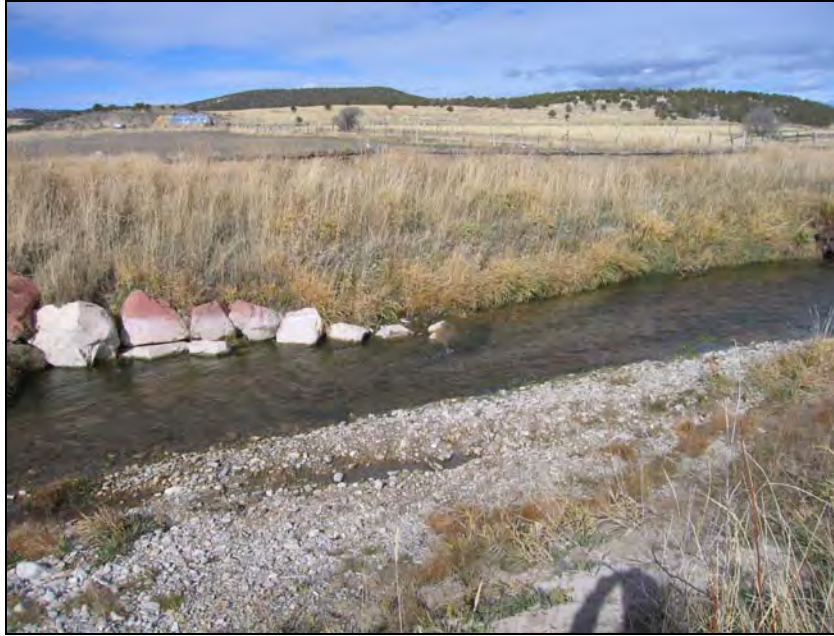
**Figure 2-5. Vane on the San Pitch River.**

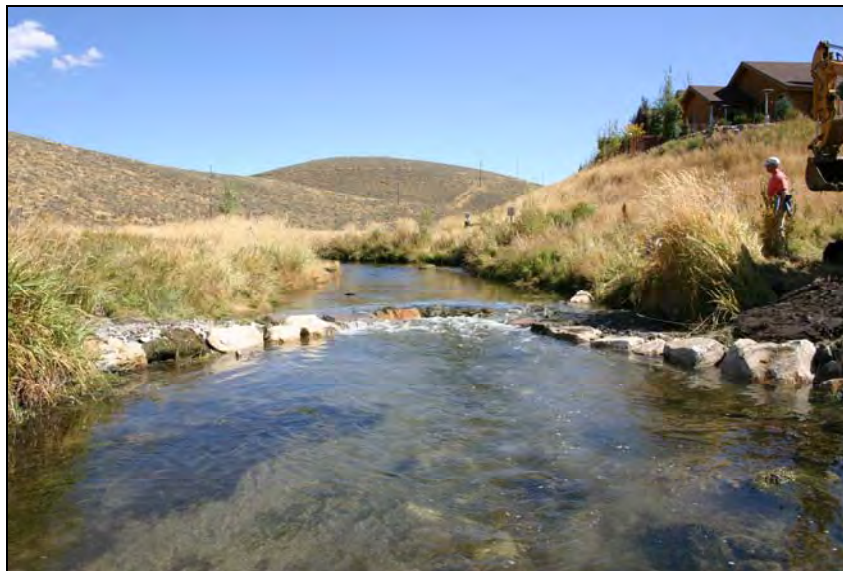
**Figure 2-6. Cross-Vane Near Park City Utah.**

Cross-vanes and j-hook vanes were developed by David Rosgen. Design criteria for these structures are described by Rosgen (1996 and 2001) and Johnson et al. (2002<sup>1</sup>). See Figure 2-6 and Figure 2-7 which illustrate a cross-vane and j-hook vane, respectively.

Cross-vane is a structure developed by David Rosgen use for grade-control (see Figure 2-6).

There are a total of seven cross-vanes as part of the study group as shown in Figure 2-6. These structures were developed by David Rosgen and are easily identified. They have a distinctive design as presented in the Structure Classification and Design Criteria section of chapter 2.

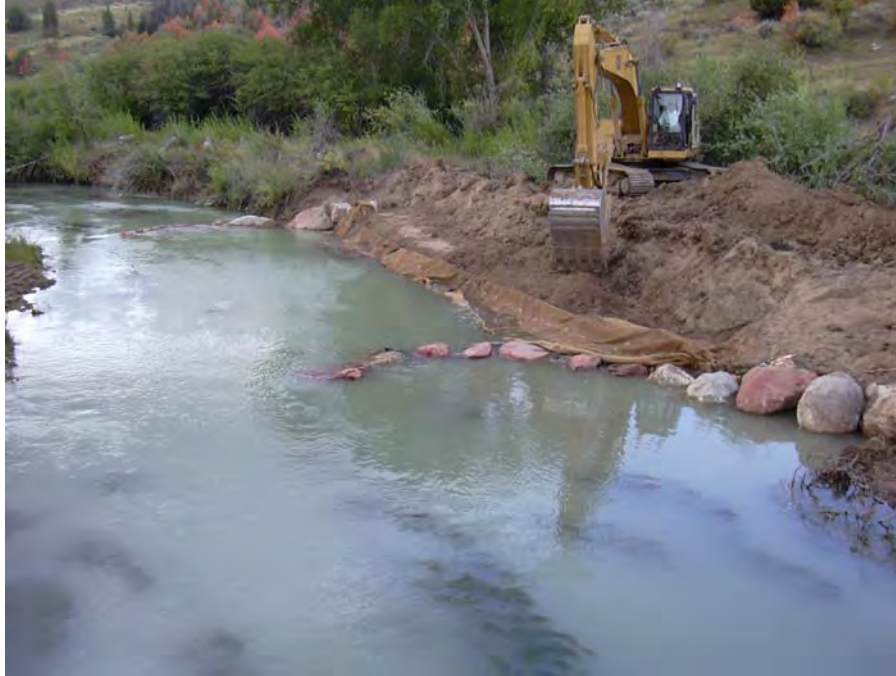
**Figure 2-7. J-Hook Vane on the Spanish Fork River.**

J-hook vane is a structure developed by David Rosgen. J-hook vanes are adapted vanes with a hook in the stream with rock spaces similar to those in porous weirs (see Figure 2-7).

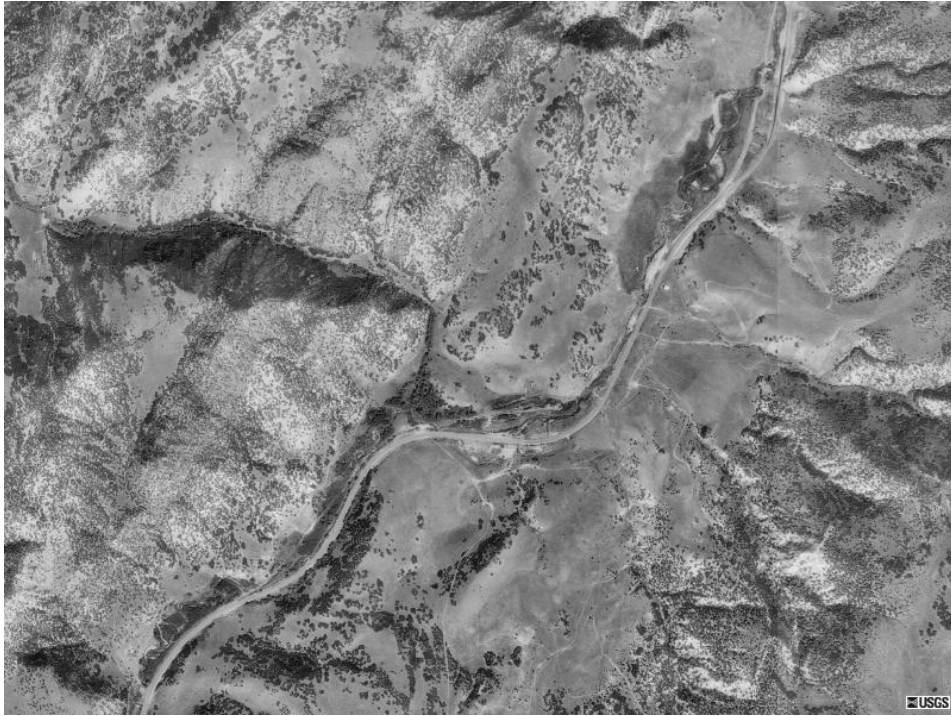
**Figure 3-1. Aerial Photo of Study Site.**

at UDOT, the focus of the modeling effort shifted to the Thistle Creek site in Spanish Fork Canyon. Figure 3-1 and Figure 3-2 show aerial photos of the study site selected on Thistle Creek. The section of the stream has seen many reclamation works over the past few years and work continues. This area is also of interest because it has had erosion problems historically, and is therefore well suited to evaluate the stability of the structures.

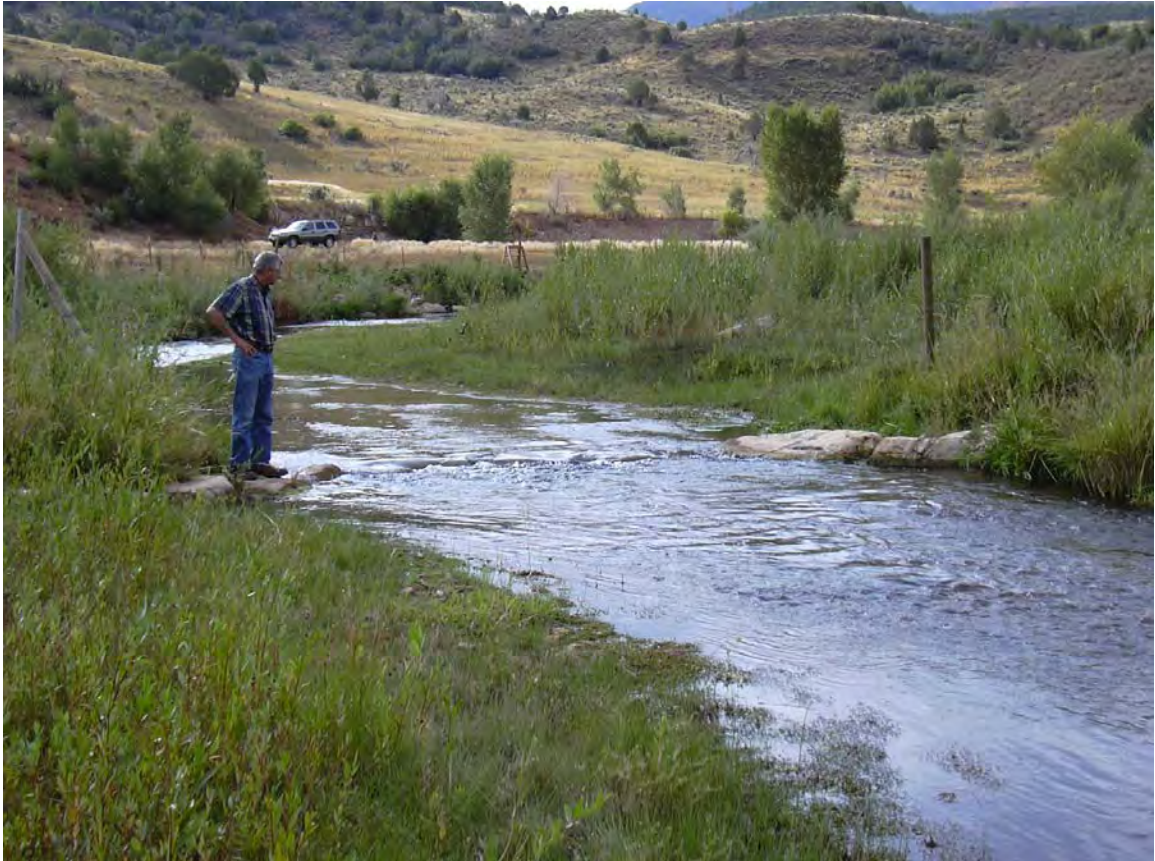
**Figure 3-3. Cross-Vane Structure Observed and Modeled.**

The site chosen for modeling includes many structures including: two cross-vanes, one j-hook and a number of vanes. Figure 3-3 shows the cross-vane modeled. Note the flow approaches the structure mostly on the right side of the channel and moves across the structure. This is reflected in the results of the numerical model.

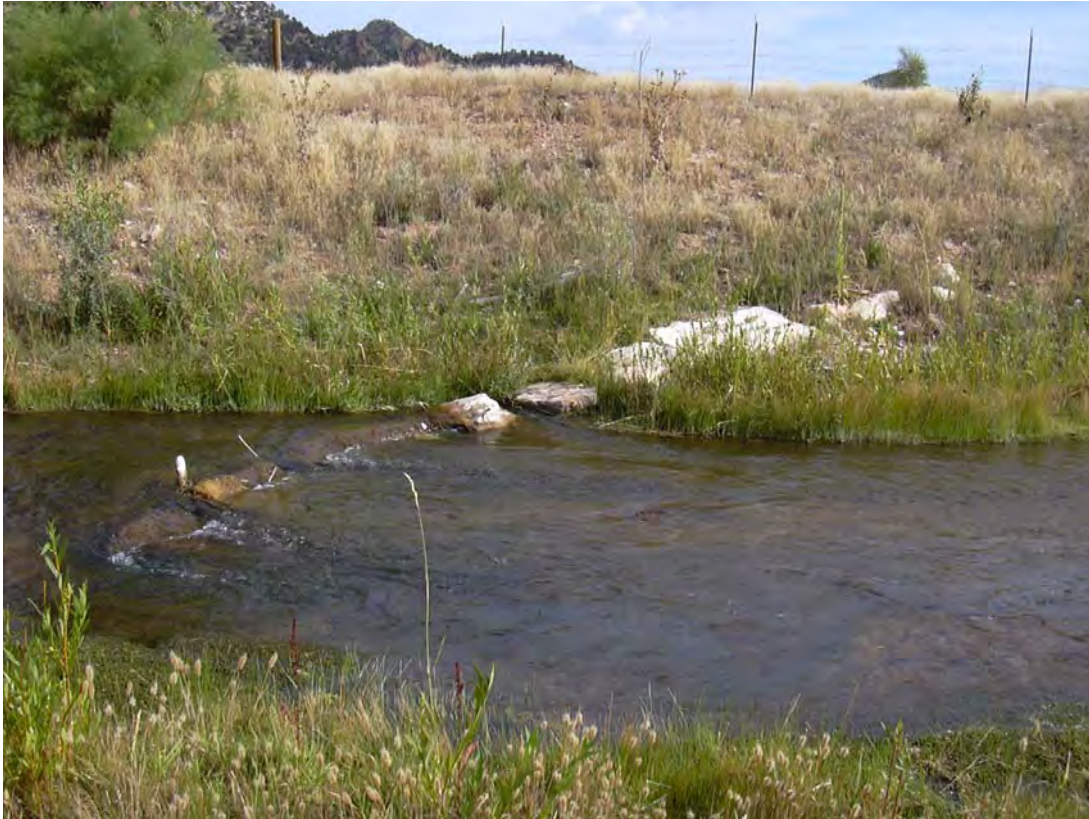
**Figure 3-4. J-Hook Structure Observed and Modeled.**

Figure 3-4 shows the j-hook structure modeled. Flow is from left to right in the picture. This structure is just downstream around a meander bend from the cross-vane. There is another cross-vane between these two structures on the meander bend. This is part of an ongoing restoration after the mudslide near Thistle, Utah. Also of note in this area is one of four experimental installations (in the study group for this paper) of SFS at bridges. The existing installation is located at Utah County State Park upstream of the Spanish Fork River and Diamond Fork confluence. SFS are installed upstream of a pedestrian-trafficked bridge. Figure 3-5 and Figure 3-6 show the relationship of a j-hook being constructed next to this footbridge.

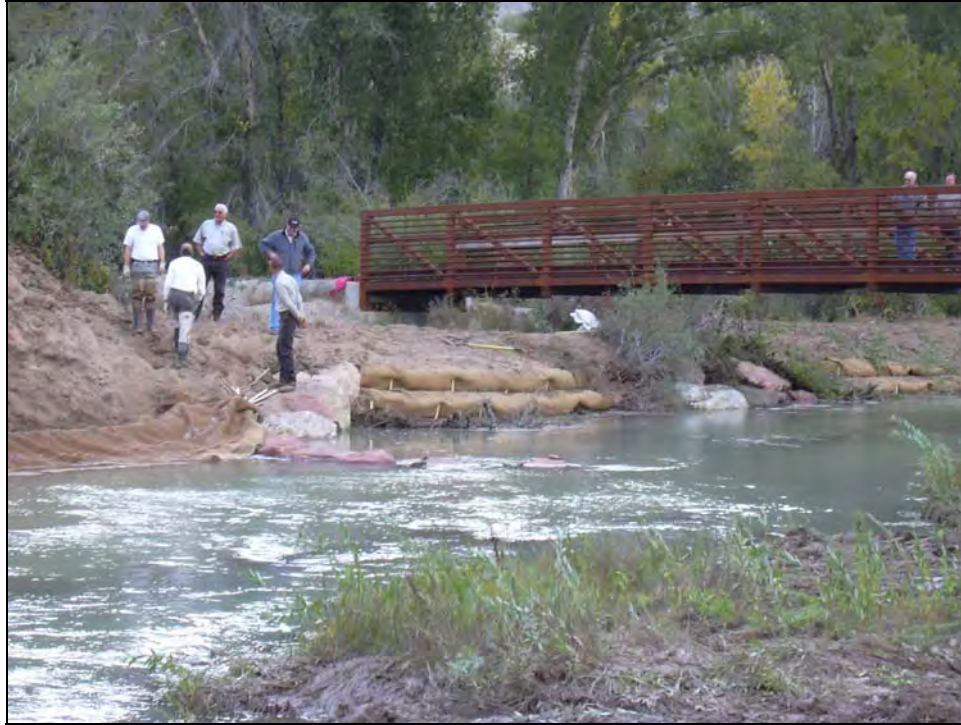
**Figure 3-5. View of Construction of Structure Near Footbridge.**

Numerical models were conducted on a cross-vane and j-hook at Thistle Creek in 2003 and 2004. During this modeling phase, the Utah Department of Wildlife Resources promoted the use of cross-vanes and j-hooks as scour protection countermeasures at bridges (see Figure 3-5 and Figure 3-6). As such, appropriately dated cross-vane and j-hook design methodologies are presented in detail in the proceeding section, followed by an evaluation of the installations.

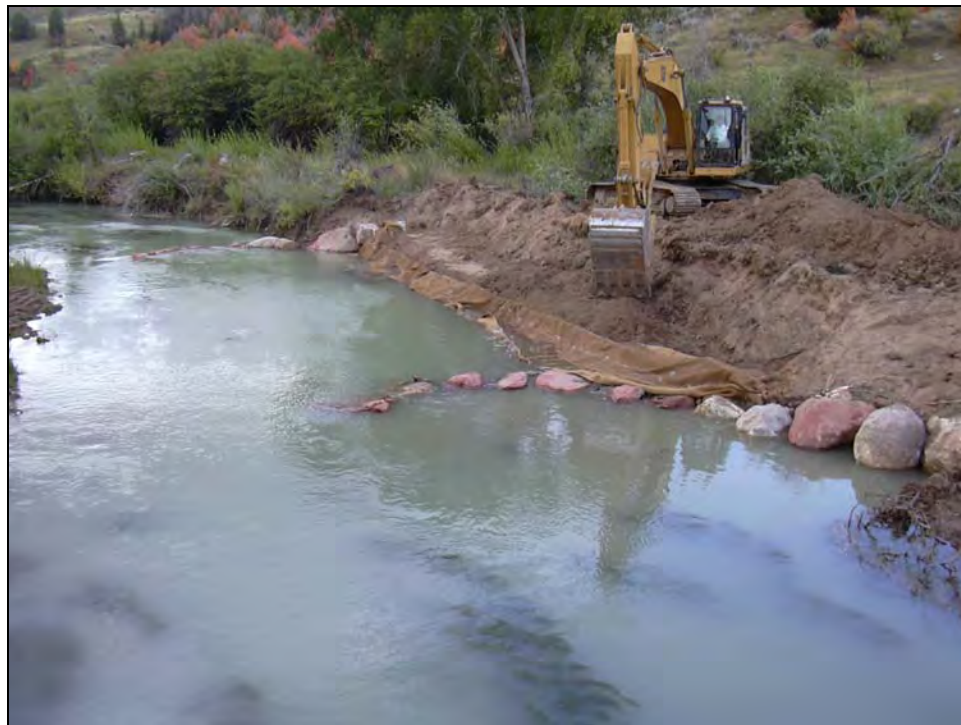
**Figure 3-6. View of Construction From Bridge.**

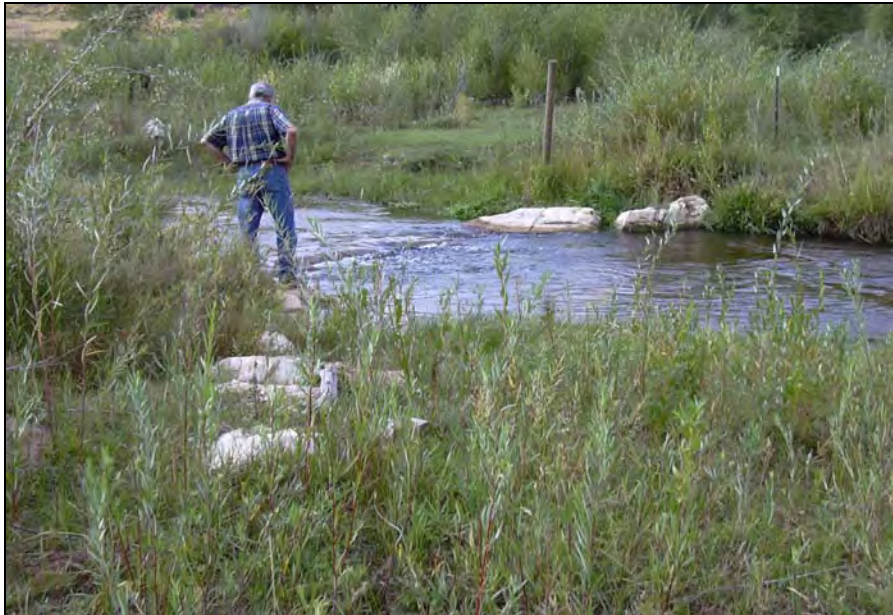
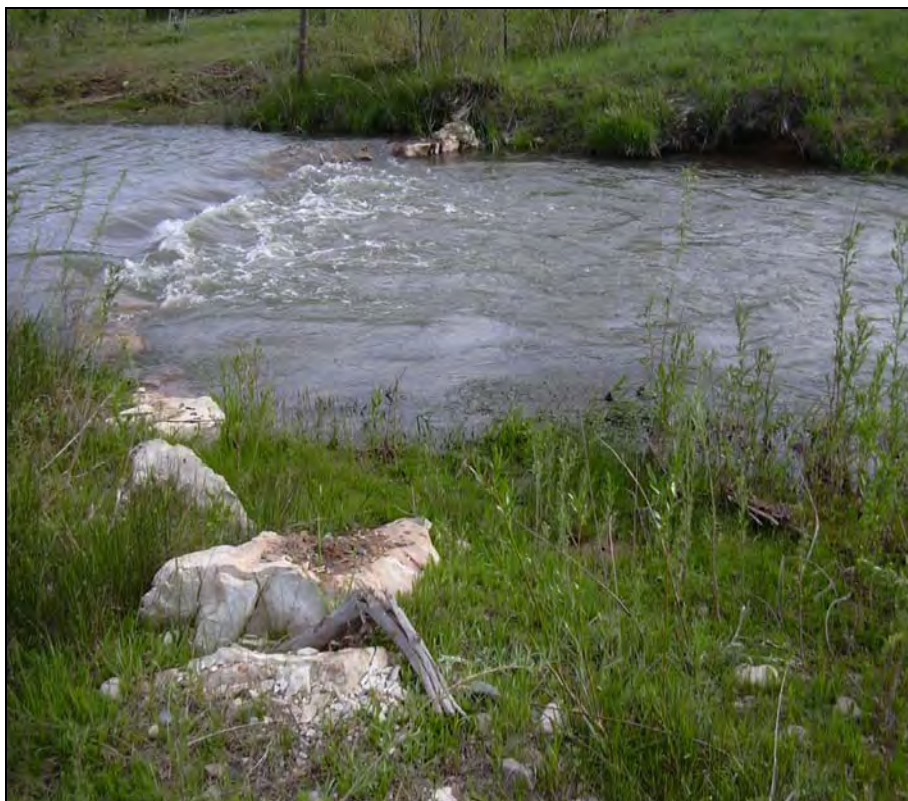
The asymmetrical cross-vane also has erosion problems illustrated in the photos taken in the fall of 2003 and the summer of 2004 during spring runoff (Figure 3-16 and Figure 3-17). In Figure 3-16, two large boulders are visible on the far bank. Figure 3-17 illustrates that due to erosion around the boulder, the left of the two boulders on the bank has shifted and broken. That is why the boulder is not visible in this figure. The erosion is caused by the water moving across the structure from the upstream (north) to the downstream (south) side. The velocity of the water is increased as it runs over the structure and is redirected to the south bank as seen in Figure 3-13.

Rock decay was also observed during the study. As noted above, one of the main boulders broke after shifting due to erosion. The crumbling rock in the foreground of Figure 3-17 illustrates the inferior quality of these materials.

This hydraulic condition was observed during the initial survey and appeared to be aggravated after spring runoff as the bank began to fail after spring runoff in 2004 as seen in Figure 3-16 and Figure 3-17. The cross-vane, rather than redirecting the thalweg to the center of the stream channel to reduce bank scour, is in fact redirecting it toward the bank and inducing scour during base flow conditions.

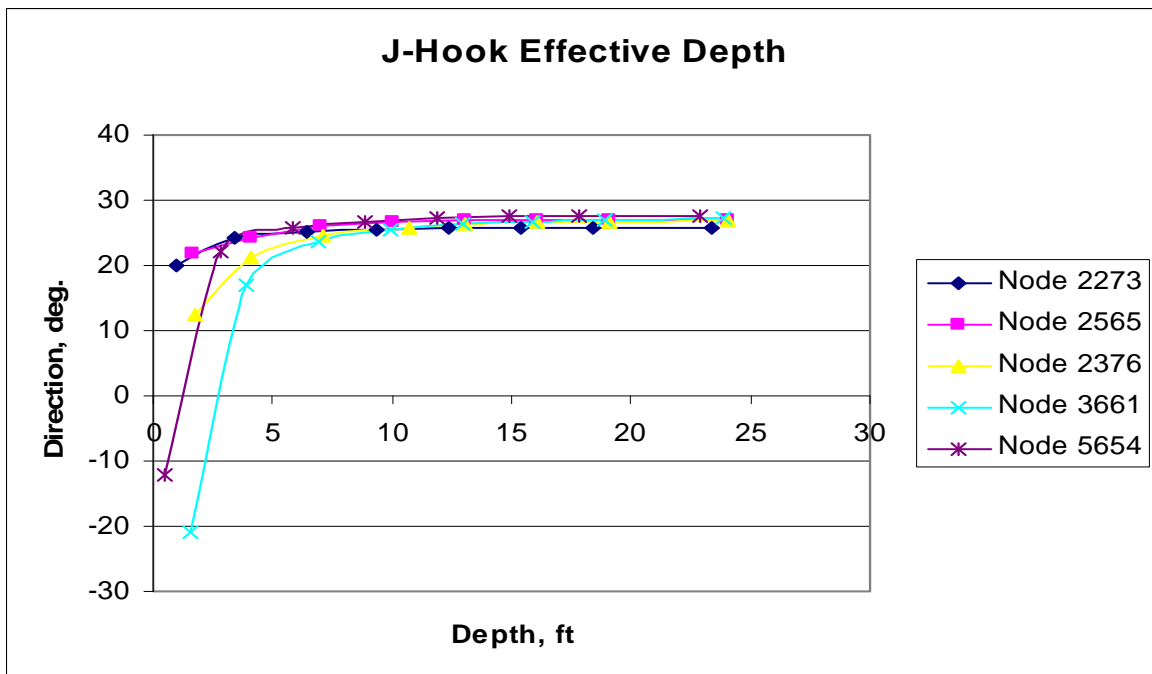
To view the depth verses flow direction, data points were selected across the structure. The depths and directions at that point were recorded for each flow rate. The results are presented in Figure 3-19 and Figure 3-21. To view the change in velocity versus depth, an additional data point was chosen just upstream to correspond with each of the points along the structure. The depth of the upstream point was plotted against the change of velocity between the upstream and downstream points. The results for the second set of data are illustrated in Figure 3-18 and Figure 3-20.

With that observation made, it is important to qualify it. This is for a stream whose base flow is less than one foot deep. It is recommended that these results not be extended to larger rivers without direct evaluation of such situation. As stated in section 3.4.2, these structures have proven to be very sensitive and therefore results cannot be easily extracted. Also of import, is that the model was not calibrated for larger flows. The spring runoff of 2004 was far smaller than a typical spring runoff. Based on the preceding statement, extending the calibration of this model to larger flows also requires caution and judgment.

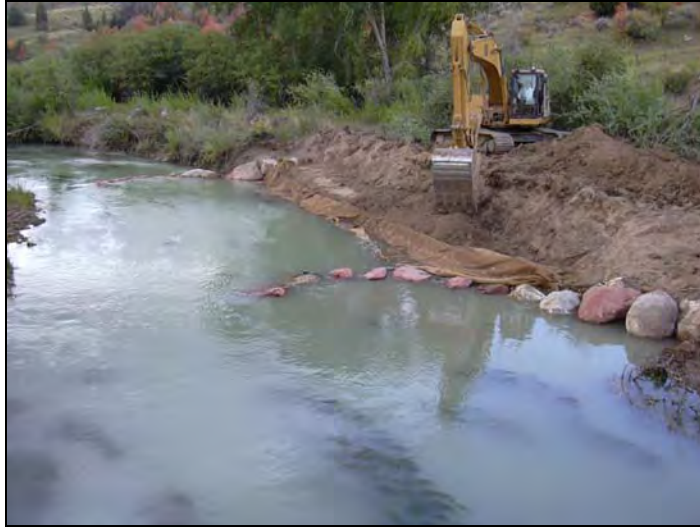
**Figure 4-18. Utah County Park Before Runoff.**

Three structures were placed upstream of a pedestrian bridge at Utah County State Park on the Spanish Fork River in an uncontrolled section of the river. The structures are j-hook vanes. At least one of these structures failed as four of twelve rocks were displaced in the water year of 2004.

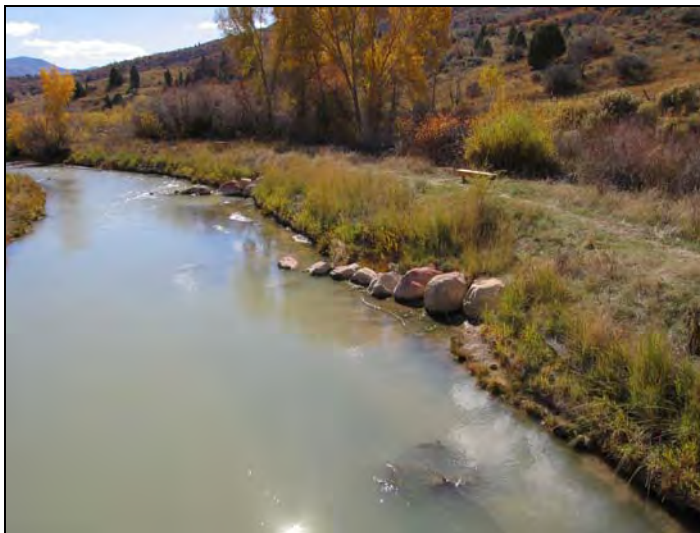
**Figure 4-19. Utah County Park After Runoff.**

The third failure mode observed was failure by dislocation of a structure element caused by drag force of water. This failure mode caused rocks to slide downstream as seen at the Rockport site (for example, see Figure 4-19 and Figure 4-26). The fourth failure mode was dislocation of a structure element caused by debris. Debris, washing downstream impacts the rock, resulting in displacement and failure (see Figure 4-24).

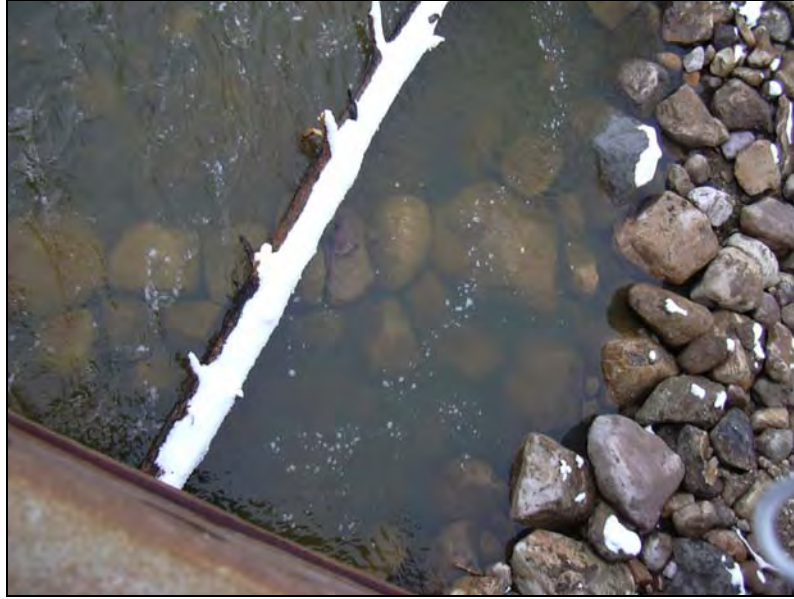
**Figure 4-21. Bendway Weir on the North Fork Provo River Just After Installation.**

Four structures were designed by UDOT and installed on the North Fork of the Provo River in the fall of 2004. These include one bendweir downstream of the bridge (Figure 4-21 and Figure 4-22) and three weirs upstream of the bridge (Figure 4-23 and Figure 4-24). The

structures were installed during low flow in the fall of 2004. Figure 4-21 and Figure 4-23 show the structures several weeks after installation. Photos taken after the following spring runoff are shown in Figure 4-22 and Figure 4-24.

The streambed aggraded up to but not above the bendway weir rocks when comparing the before and after photos of the bendway weir shown above. The bendway weir was not buried by incoming sediment nor were there any displaced rocks so the bendway weir was still functioning.

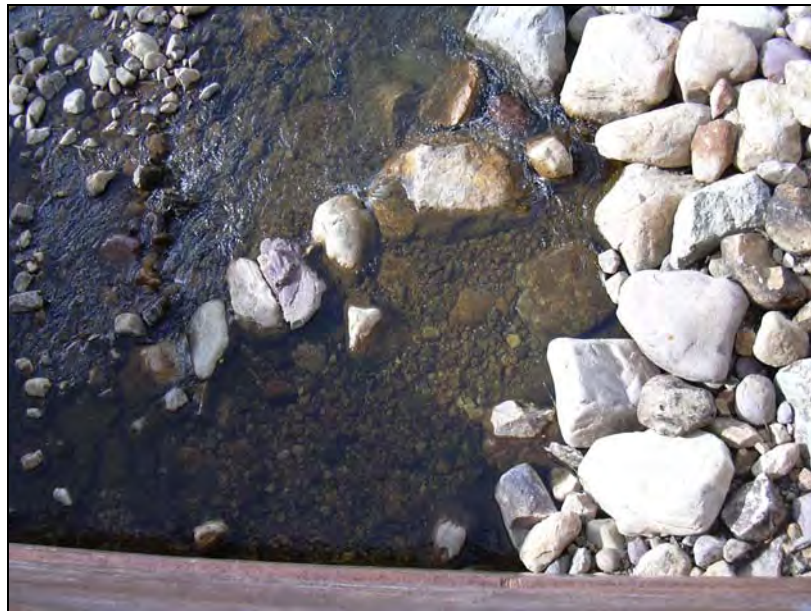
**Figure 4-22. Bendway Weir on the North Fork Provo River After Runoff.**

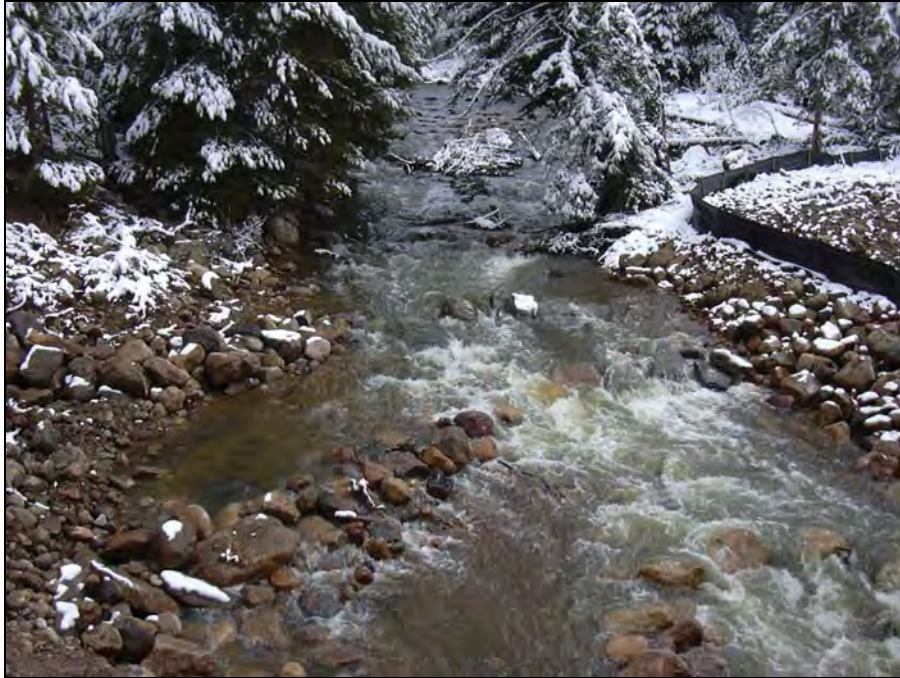
**Figure 4-23. Weirs on the North Fork Provo River Just After Installation.**

All three broad-crested weirs upstream of the bridge failed during the spring runoff in 2005 following installation in 2004 (see Figure 4-23 and Figure 4-24 above). In Figure 4-24 a log was washed downstream through the weirs. The log appears to have contributed to the majority of in-stream structure elements to be displaced. This site has high flow-variability where large deflectors are not advised (URMCC 1995). Debris appears to have played a large role in the failure of the weirs. Laursen et al. (1990) indicated that debris is unpredictable and can induce unwanted scour on hydraulic structures.

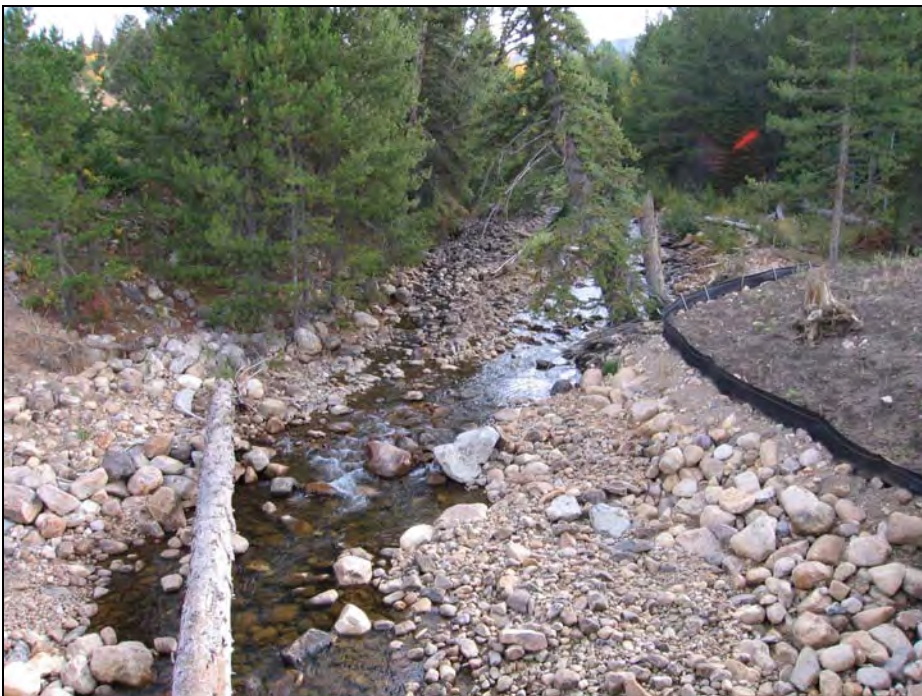
**Figure 4-24. Weir Site on the North Fork Provo River After Runoff.**

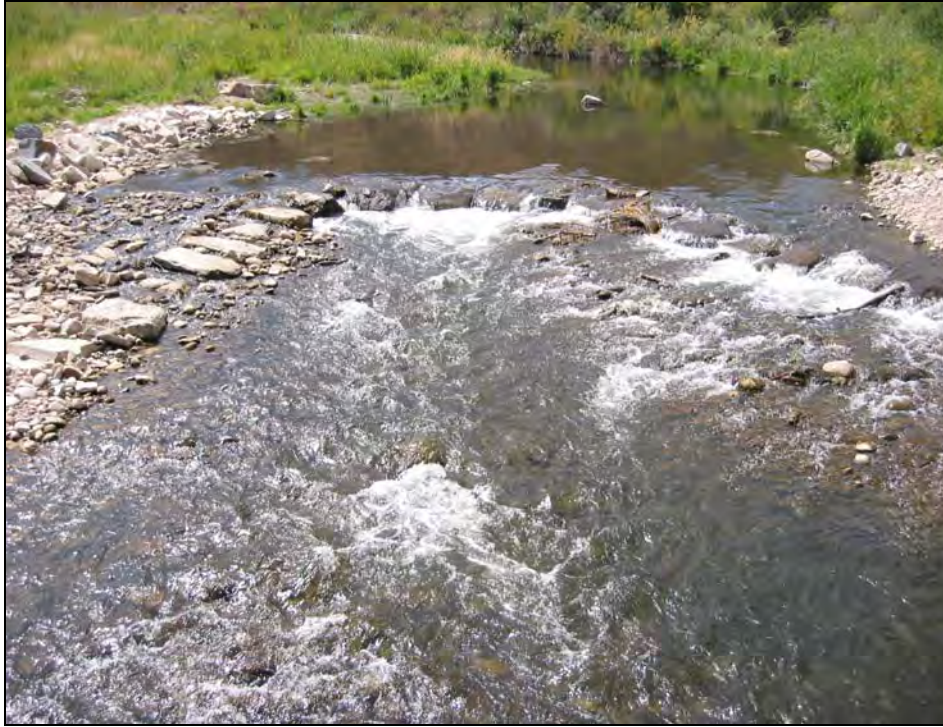
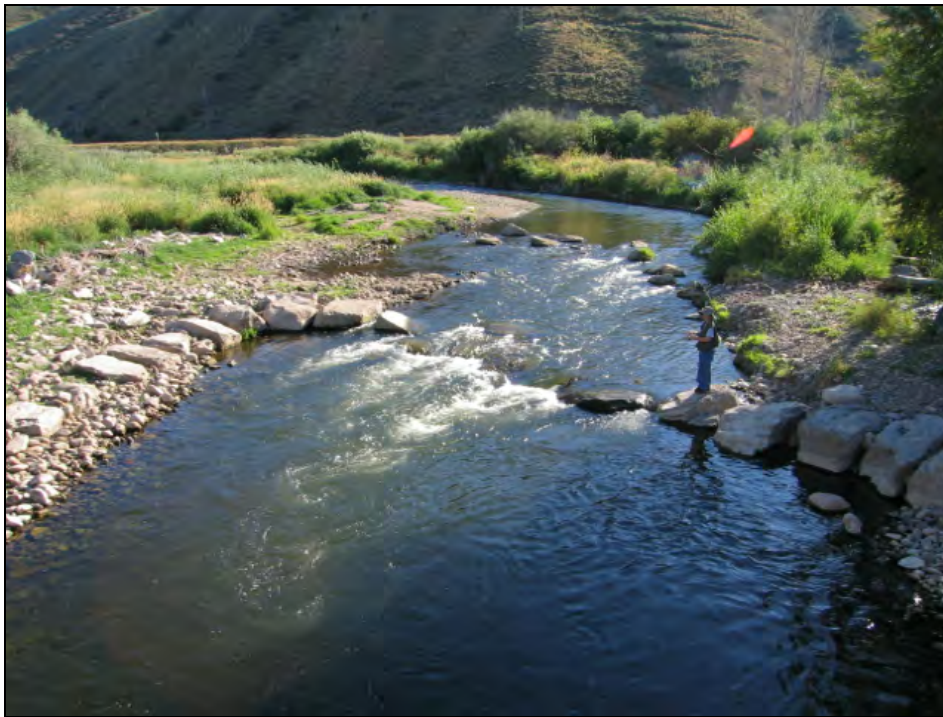
One structure was placed upstream of the bridge at Rockport State Park on the Weber River as shown in Figure 4-25 and Figure 4-26. The structure is a cross-vane placed just upstream of the bridge. The installation did not conform to Rosgen Design Methodology, which dictates the vane arms slope down at a slight angle upstream. In this installation, the vane arms were installed at a slight upstream angle.

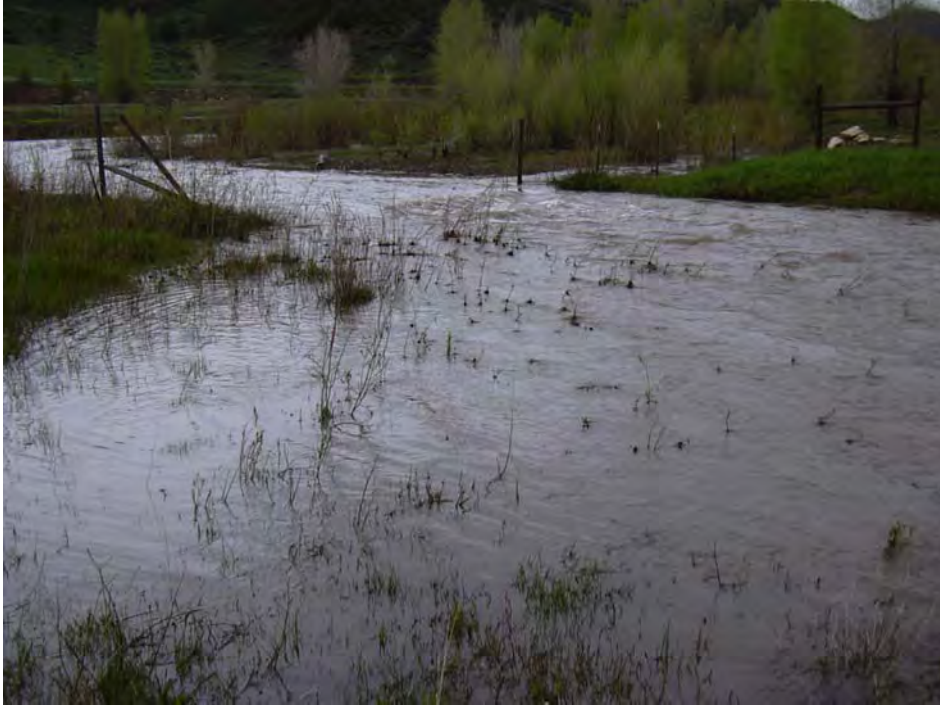
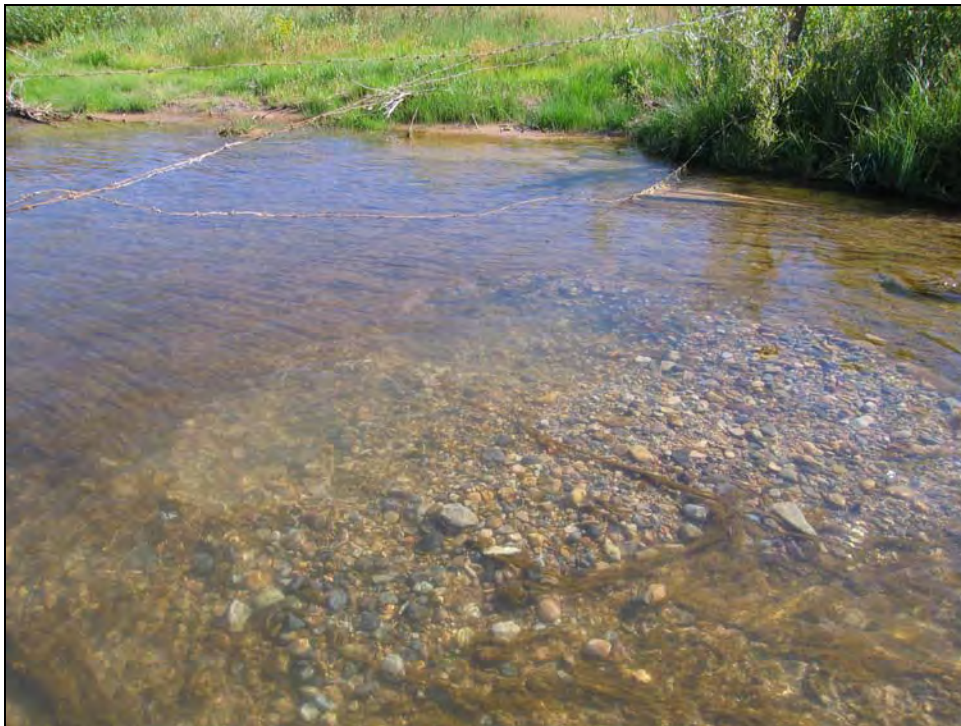
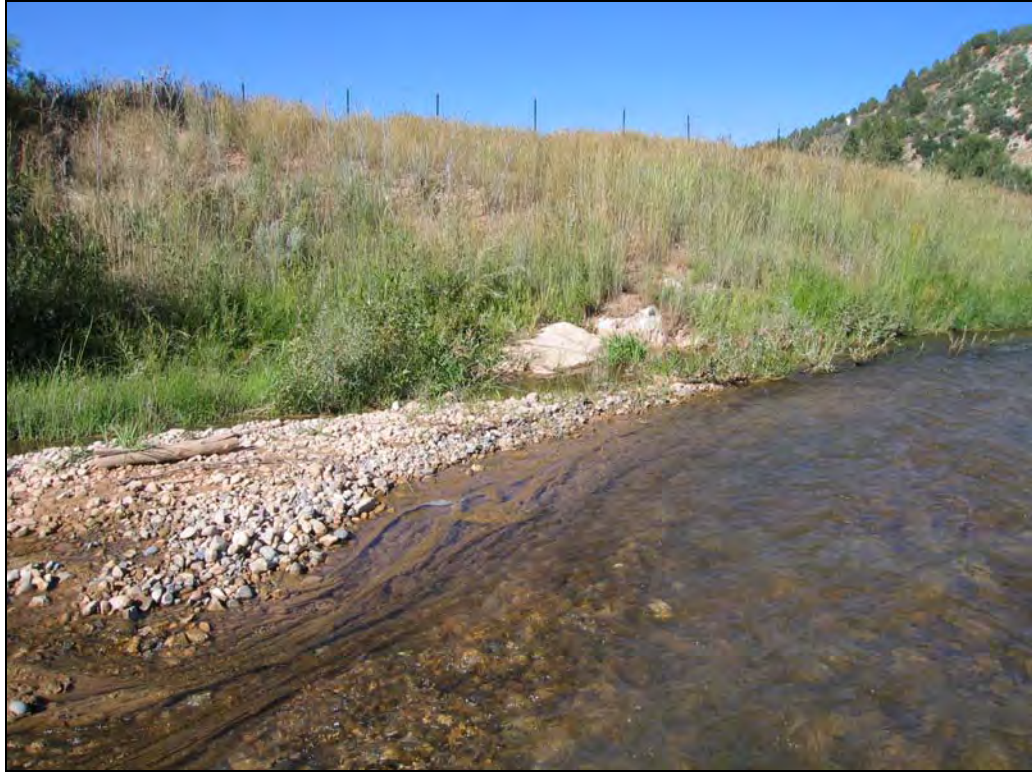
The response of the j-hook and cross-vane was unremarkable under normal flow conditions as compared to spring flows of 2005. In 2005, under average spring flows, both structures were active as water was breaking over the top of them. See Figure 4-27 for cross-vane during 2005 spring runoff. Figure 4-28 and Figure 4-29 were photos taken after 2005 spring runoff.
