Cutthroat Trout Restoration Across Yellowstone's Northern Range

Phase I Completion Report YCR-2007-05

By: Michael E. Ruhl and Todd M. Koel

30 September 2007

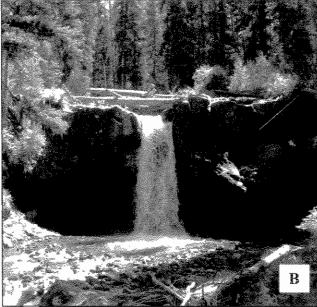
Image 2. A) Lost Creek Falls on Lost Creek. Example of a large prominent barrier to upstream fish movement with unknown fish distribution above and below it. B) Unnamed Waterfall on Amphitheater Creek. Example of a barrier not found in the GIS database that was encountered during sampling. Sampling demonstrated that fish are present below but not above the waterfall.

extent of fish distribution. If fish were captured above the barrier, sampling continued upstream until another barrier was located (Image 2B) or a 200 m reach of stream was sampled without capturing or observing any fish. A similar method was used in streams without previously identified barriers. In those streams, a fish sample was collected from an easily accessible point to document presence and species composition and potential barriers were then sought out. As mentioned above, sampling was halted when a definitive barrier was located or a 200 m reach of fishless stream was sampled. In this manner, upstream extent of fish distribution was estimated.

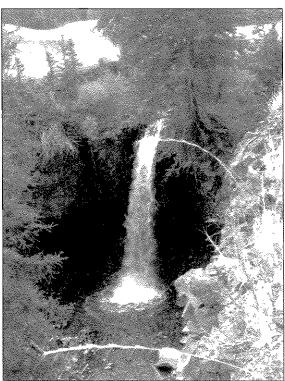
Image 4. Fairies Falls on Amethyst Creek. Example of a well known, prominent barrier to upstream fish movement. Stocking did occur on Amethyst Creek, presumably above the barrier, but 2005 sampling revealed that fish have not persisted in the stream.

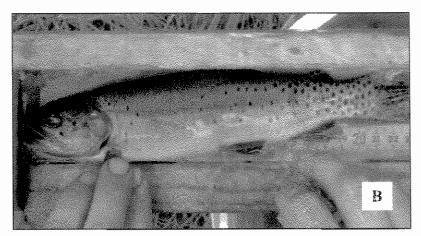
Image 5. A) Unnamed Waterfall on Antelope Creek. B) Example of a genetically pure YCT from Antelope Creek.

As no stocking records are available, this population is of unknown origin but genetic analysis completed during the winter of 2006 revealed that the population is genetically pure YCT. Varley and Schullery (1998) indicated that brook trout may also be present in the system and annual angler survey information supports the claim. However, sampling by fisheries staff from 2000 to present has failed to capture any species other than cutthroat trout. Genetic analysis also revealed that another barrier to upstream fish movement may be present in the very steep 250 m canyon reach of Antelope Creek that occurs immediately before its confluence with the YSR. As with the reach upstream of the waterfall, only genetically pure YCT were found between the canyon and the waterfall.
