**STREAMBANK STABILIZATION WITH RIPRAP AND TREE REVETMENT
IN DEEP CREEK, BROADWATER COUNTY, MONTANA**

Part III of a Final Report
to
The Montana Department of Natural Resources and Conservation
on
Project No. RIT-87-8506:
Stream Restoration on Confederate Gulch and Deep Creek

By Walter V. McClure¹ and Ray J. White²

May 1992

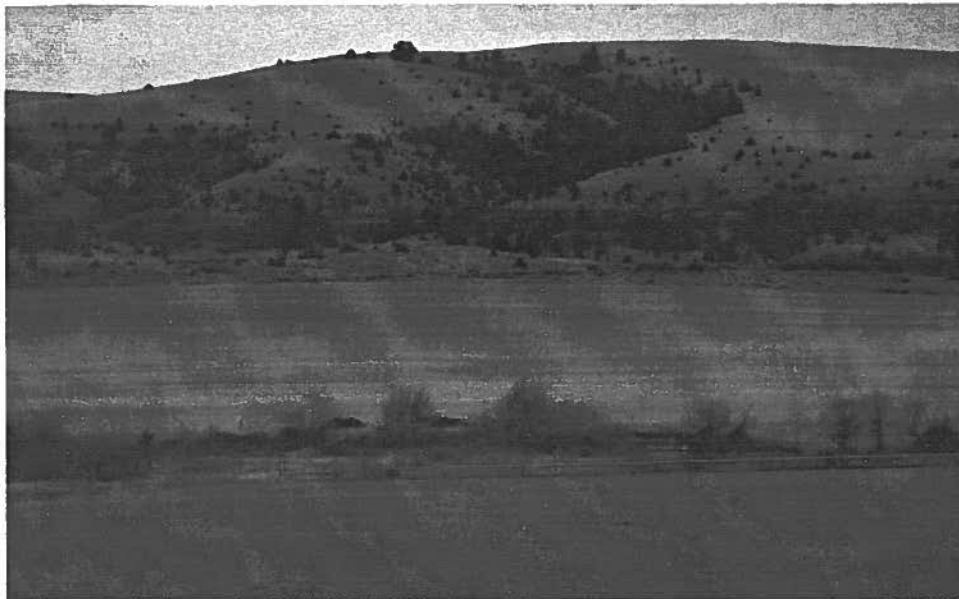
Figure 2. A view southward across Deep Creek valley and part of the study area, March or April 1988. Note riparian vegetation. On the opposite hillside is an irrigation ditch from upstream diversion of Deep Creek. Also on that slope is the juniper grove from which trees were cut for streambank revetment.

Because the study area topography was flat, vegetation sparse, and human use of the land non-conflicting (Figure 2), access for construction of revetments was close to ideal.

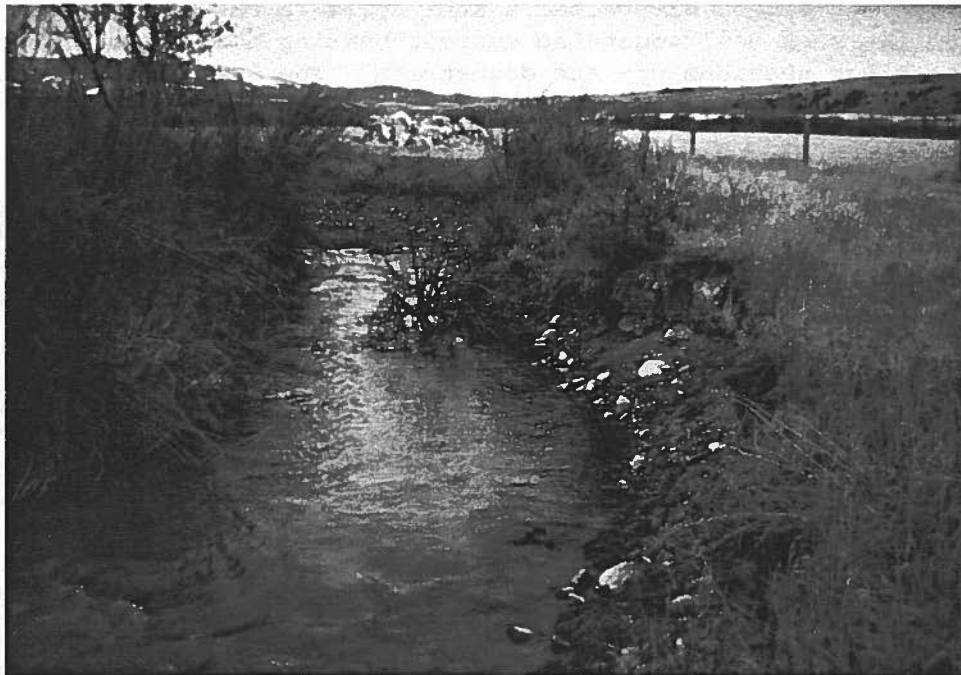
Figure 3. A high, eroding bank, Deep Creek study area, April 1988--bend 16, before its riprapping. Note ungrazed grass atop bank and dense woody vegetation on point-bar bank. In foreground (downstream part of bend) the point-bar bank bears flow and offers juxtaposition of current and dense hiding cover for trout. Most of the high bank has no vegetation at the water line where trout could hide in it, but a toppled juniper tree offers some excellent cover.

1. High, eroding bank of bend 16, also described in Figure 3 caption. View is in the upstream direction in photos 1 through 5.

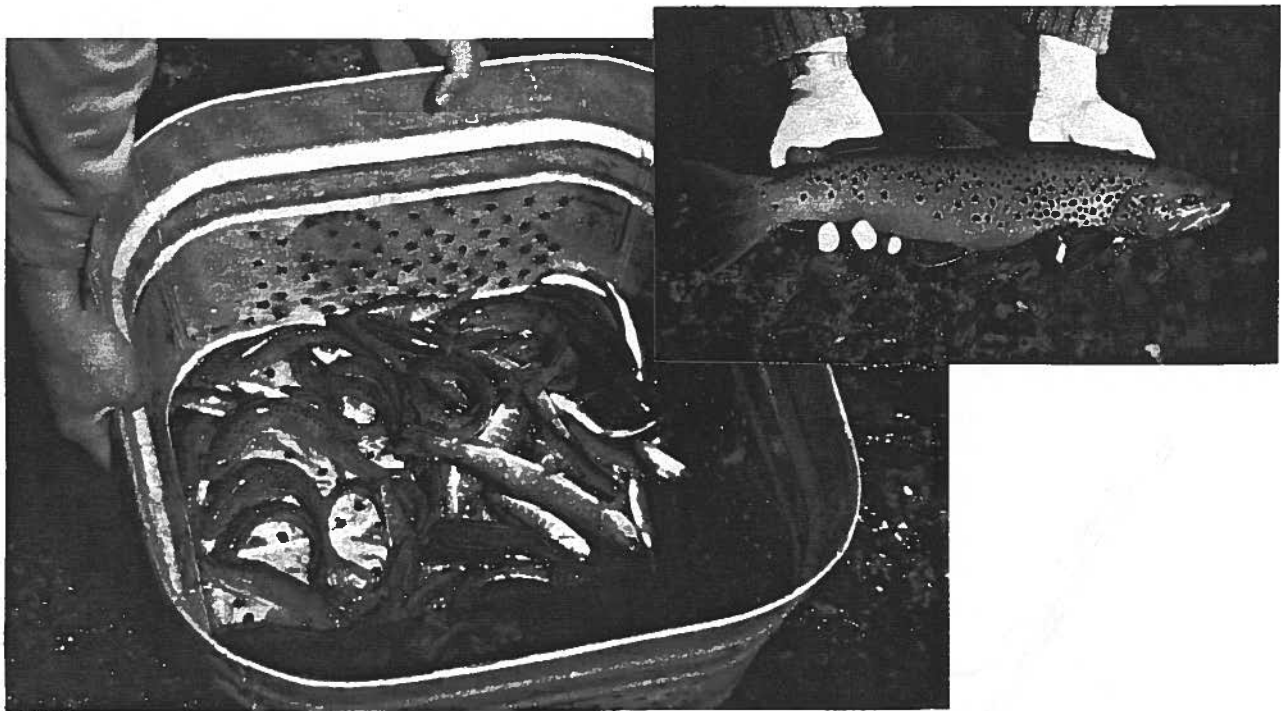
Figure 6. Trout captured by electrofishing, Deep Creek study area, October 1986--when the population was relatively high. All fish in the photos appear to be brown trout, but rainbow trout also occurred. The tub probably contains a catch from 300 meters.

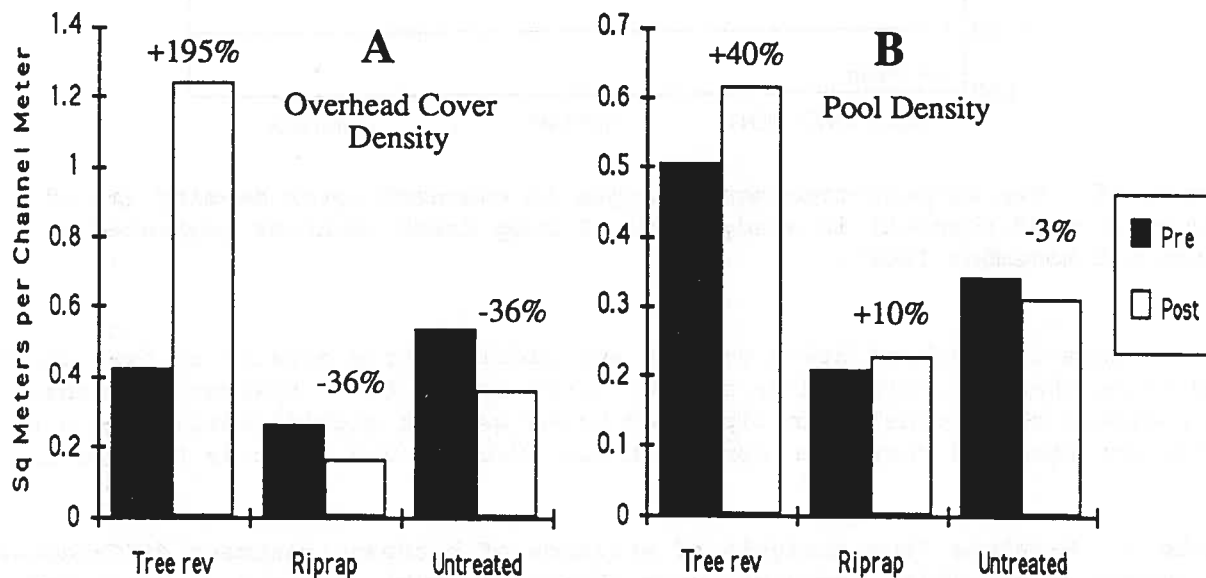
Figure 15. Means of overhead cover (A) and pool (B) density (m² per channel meter) in tree-revetted, riprapped and untreated stream bends during March (about one month pre-treatment) and November (about 6 months post-treatment), Deep Creek, Montana, 1988. Mean percent change shown above each pair of columns. The number of bends in each treatment was 6. For measurement ranges, see Figures 16 and 17 and Appendix D Tables 11 and 12.

Tree revetment immediately increased hiding cover for trout, but in riprapped and control bends, there was slight decrease (Figures 15A and 16). As measured in November 1988, about 6 months after installation, the mean overhead (non-pool) cover density (square meters of cover per meter of channel) of tree-revetted bends had increased 195% ($p = 0.02$) to 1.24 m²/m from a March pre-treatment mean of 0.42 m²/m (Figure 16, Appendix D Table 11); in the 6 bends, the changes were all positive and ranged from 62% to 2075%. As expected, the branches and foliage of the juniper trees in revetment simulated submerged streamside brush and created large amounts of overhead cover.

Total trout numbers (which, due to the population's wide size range may be less descriptive of abundance than biomass) underwent few definite changes. In riprapped bends, trout were significantly ($P = 0.03$) less numerous in June than they had been in March (Table 5, Figure 22A). This decrease in the riprapped bends may have been due to physical disturbance or loss of stream-side during construction. Both could have caused fish to move out of the riprapped bends temporarily. Binns and Eiserman (1979) suggested that a varied stream channel morphology, stable in-stream debris, and variety of substrate sizes are needed for substantial fish production. Generally, riprapping probably creates far less cover diversity than occurs on natural stream banks--and may even reduce the amount of cover on previously rather unvegetated banks, as apparently in our study (Figure 15A).

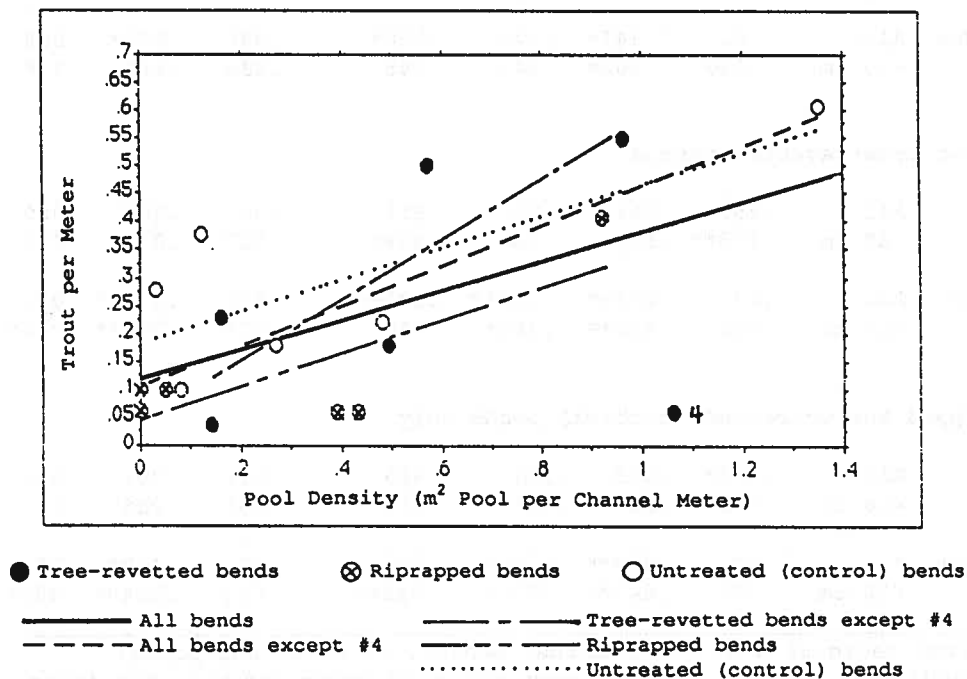
Figure 26. Regressions of total trout numerical density (all species and sizes) in late October 1988 against pool density in study bends in early November 1988, Deep Creek, Montana. Bend 4 omitted as an outlier in some of the regressions.

In regressions of October 1988 trout abundance against overhead cover and pools (measured in early November), it seemed that the relationship for data from tree-revetted bends might be much different than for data from the other bends. In particular, tree-revetted bend 4, which had much cover and pool area but few trout, seemed to lie far outside the relationship, as in Figure 26, which we include as an example. The same was so in many other regressions. Indeed, regressions that omitted bend 4 as an outlier and that omitted all tree-revetted bends generally had much stronger correlation than those that included all data points (Table 9). This and the positions of the tree-revetment data points relative to the others might suggest that trout were negatively affected by some characteristic of the juniper trees, such as their pungent odor. However, omitting tree-revetted bends from the analysis similarly strengthened correlations for March, which was before we installed the junipers. Therefore, the effect of tree-revetted bends on the statistical analysis, if such effect is real and not sampling error, is probably due to some pre-existing characteristic of some of the bends we selected to be treated with tree revetment.

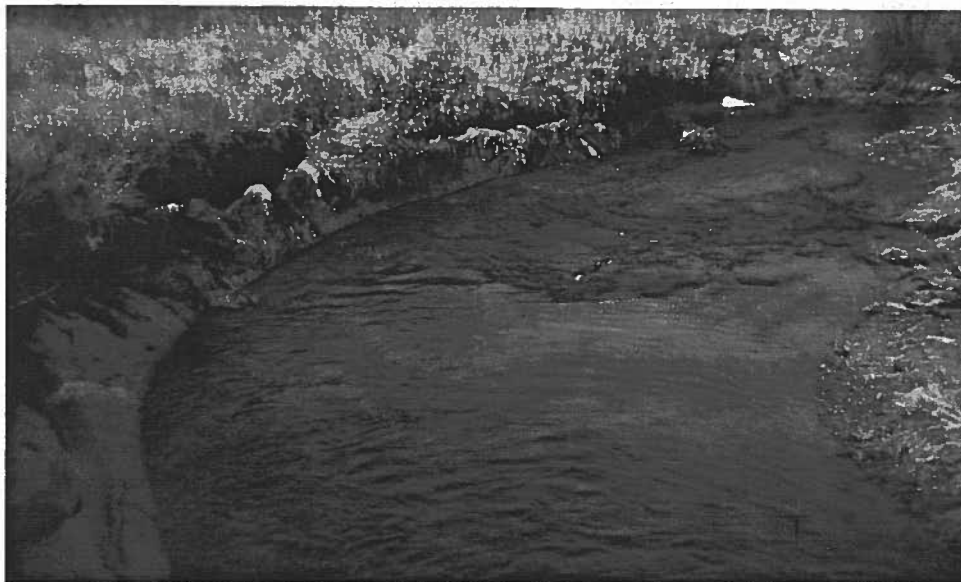
Figure 27. Ice-levered erosion of a stream bank, Deep Creek, spring 1988.

Most streambank erosion in the study area was by ice-levered fracturing during spring thaw (Figure 27). Each winter, ice covered the creek surface throughout the study area more than a meter thick in most places. It filled

In March and April 1988, while supervising construction of bank revetments, author White first saw the massive lever-fracturing of current-bearing banks by the shelf-ice ledges in Deep Creek (Figure 27). Excavation with a backhoe further revealed that the suspended ice ledges were contiguous with a dense ice layer in the soil of the stream banks.

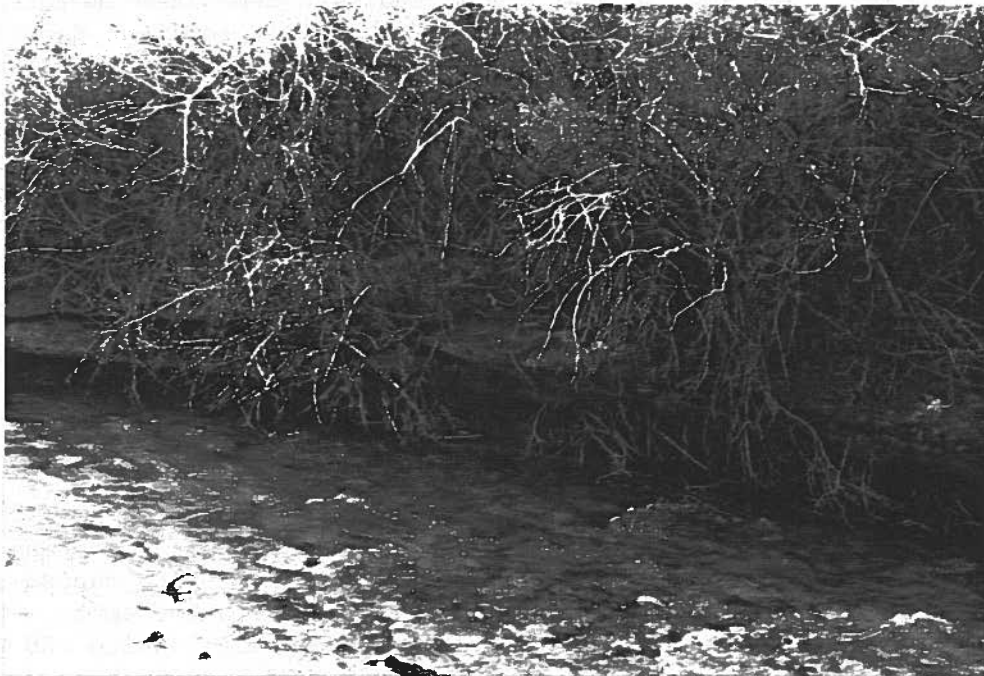
Figure 30. Dense woody vegetation holding a streambank ice shelf in place without bank fracture, until the ice melts away.

The study area's few current-bearing banks that were densely thicketed with bushes held the ice shelves without bank fracture (Figure 30) in all cases that we observed. Obviously, this is a function to be promoted by protecting and restoring healthy riparian vegetation.

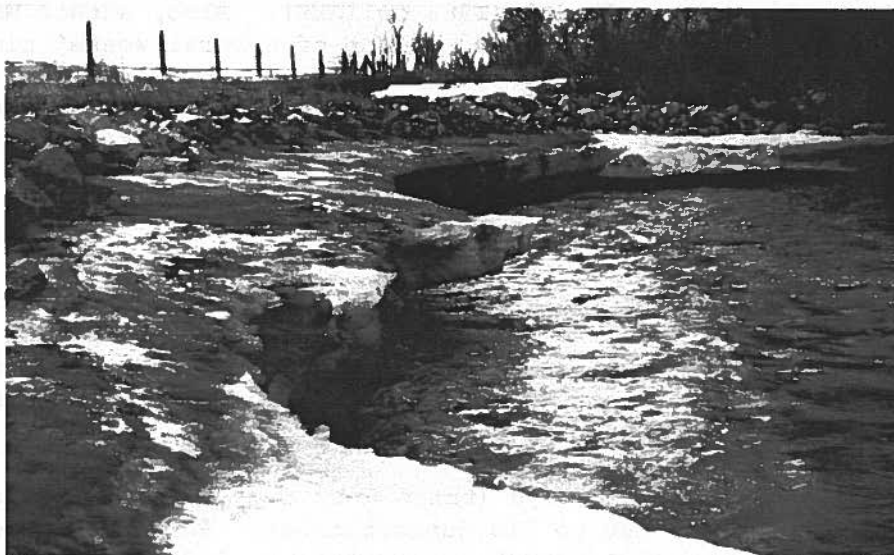
Figure 32. A streambank ice shelf supported by riprap, Deep Creek, Montana, spring 1989.

Such ice-levered fracturing of current-bearing banks did not occur along bends that had been revetted with riprap or trees. The tree revetments supported the ice shelf, allowing it to melt in place (Figure 31). The riprapped bends undoubtedly also increased the banks' structural integrity, enabling them to support the ice shelf until it melted or broke off (Figure 29). We did not observe that ice pulled any riprap into the stream.

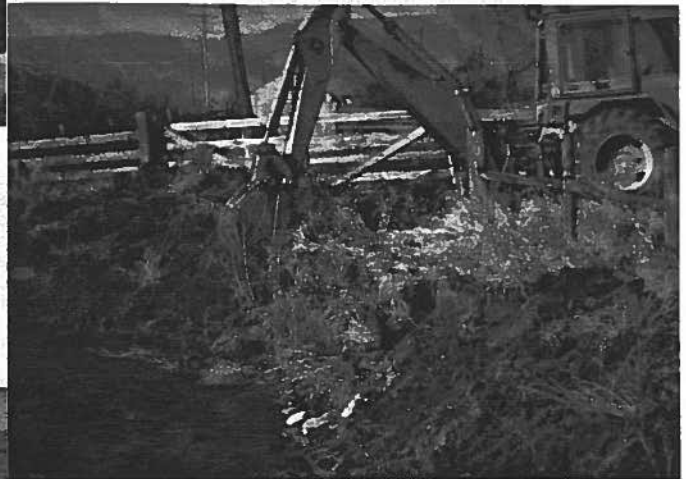
2. Shaping a bank for riprap (bend 3). A plan to "tuck" rocks under overhangs proved impractical, as banks were less even than they had appeared, and installing riprap without pre-sloping would have narrowed the channel.

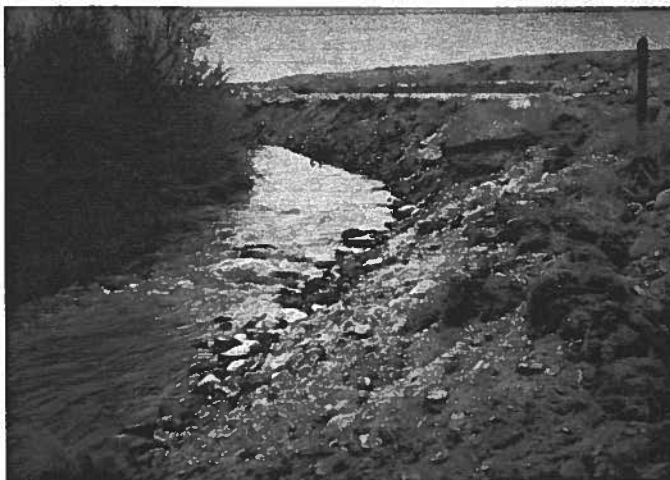
3. Bend 16 after pre-shaping.

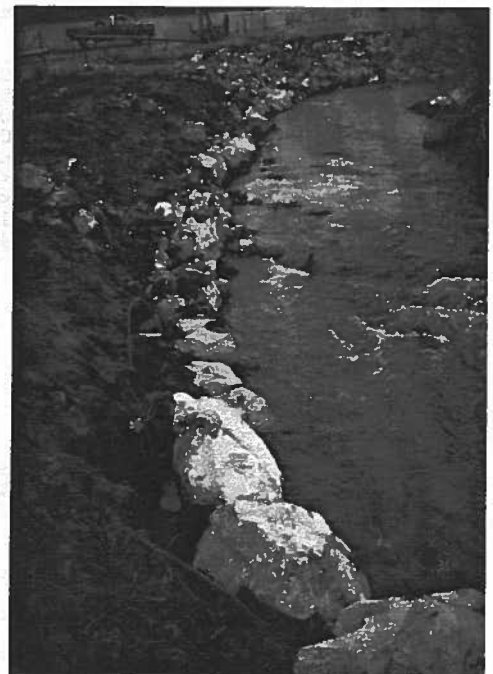
4. The foundation row of large rock at bank slope toe (bend 8). Each rock placed to make overhanging cover for trout and contain smaller rock, on slope above.

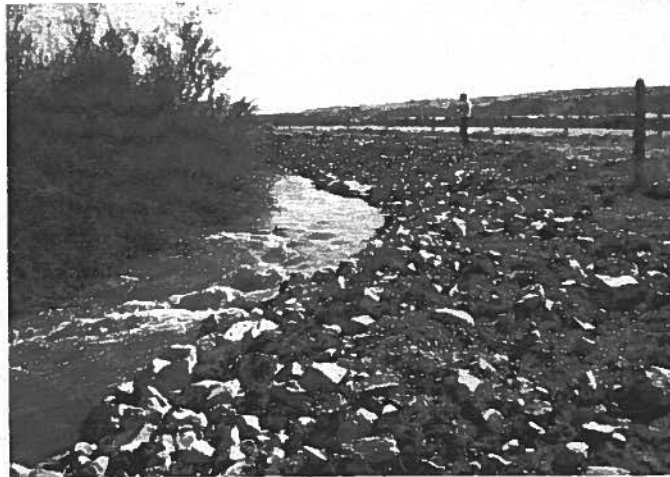
5. Finished riprap (bend 16).

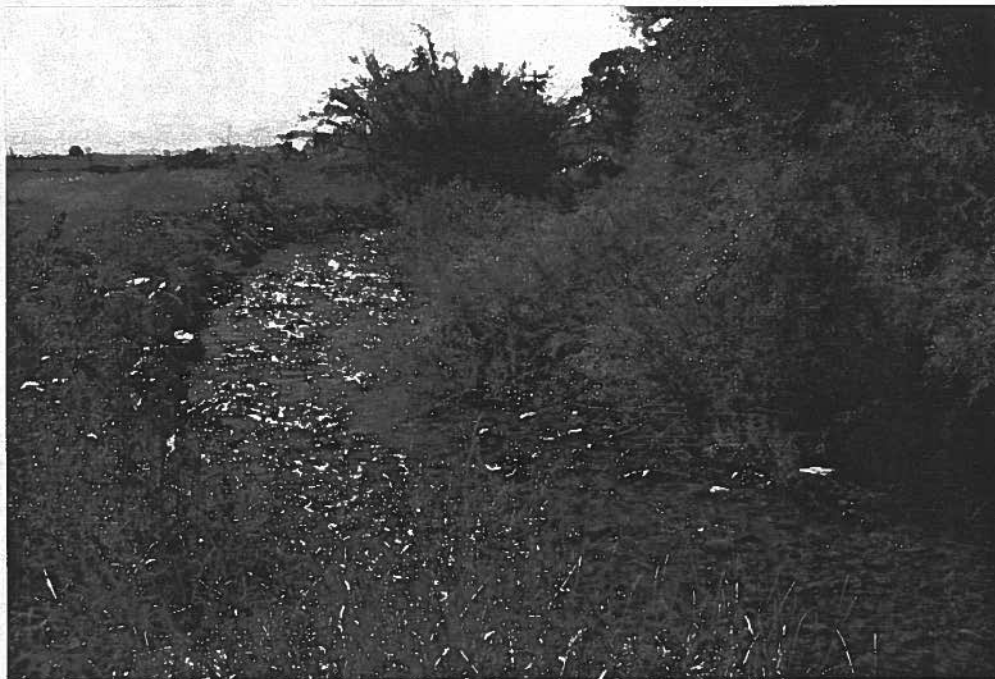
6. A riprapped bend about 1 1/2 years after construction (bend 2, viewed in downstream direction, September 1989). Only the current-bearing (outside) bank is riprapped; stabilizing inner (point bar) banks of bends is unneeded, even where less well vegetated than this--and is unwise from standpoints of cost and fish/wildlife habitat. A common mistake in streambank stabilization, done in the name of fish habitat improvement, is to revet both stream banks, thus often overly constricting the channel, impeding natural processes to which fish are adapted, and destroying or hampering regrowth of bankside vegetation.

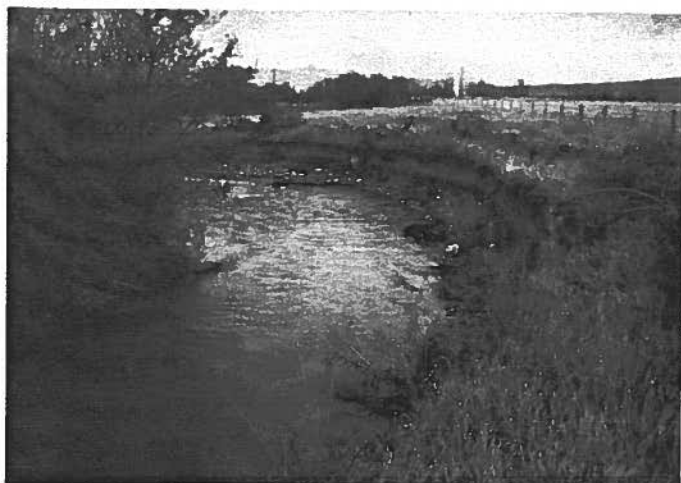
1. Juniper trees staged along the top of the stream bank just before installation (viewed is downstream direction).

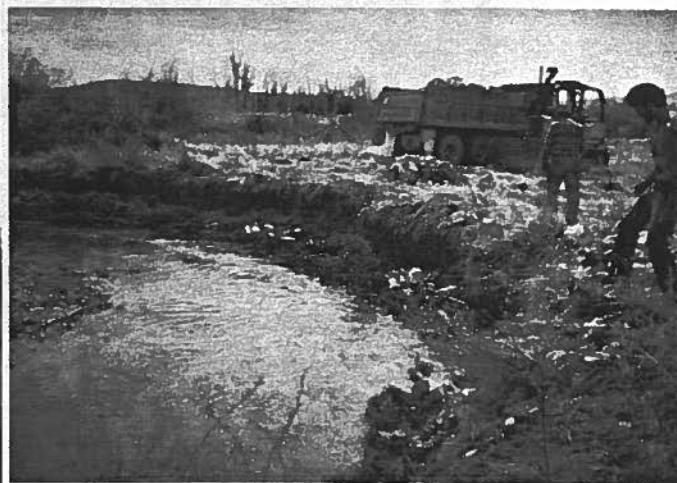
4. Backfilling with field rock.

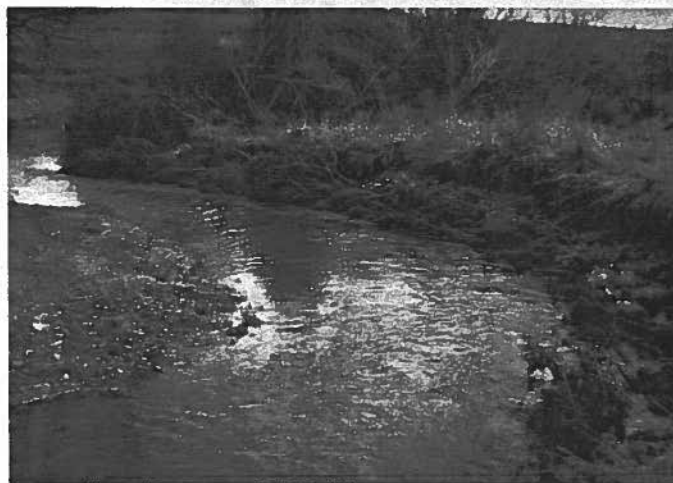
5. The just-completed installation.
