Report on the Phase 1 Bitterroot River Tributary Inventory Project
for
The Fisheries Restoration and Irrigation Mitigation Act
(FRIMA) Program

Fiscal Year 2002

Prepared for:
Montana Department of Fish, Wildlife and Parks

February, 2004

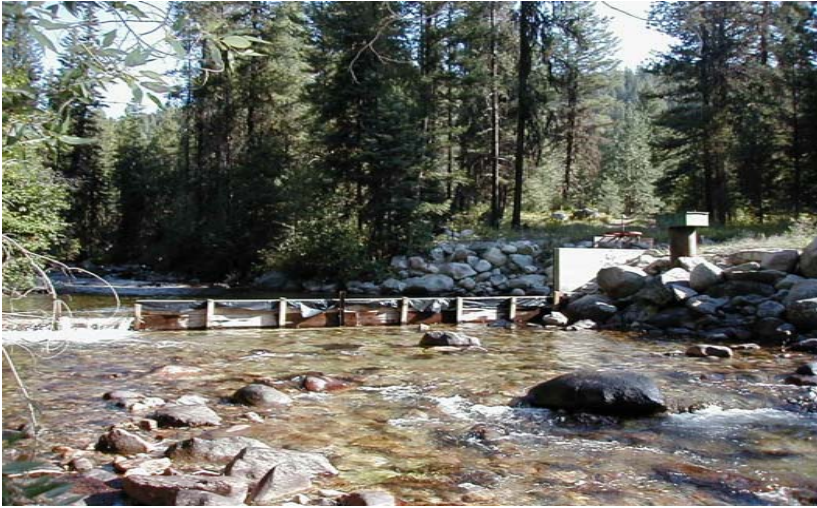
Figure 1A.

The dam is of post and removable plank construction lined with plastic (Figure 1A) and is not believed to be a fish barrier. The headgate housing is concrete with an adjustable steel gate (Figure 1B) that opens directly to a culvert under the access road and discharges to the open cobble and gravel bottomed ditch (Figures 1C, 1D).

The diversion dam does not appear to significantly impact fish passage, therefore no recommendations are made for any modifications at this time.

- No modification of the diversion dam appears necessary with respect to fish passage at this time.
- Although survey efforts did not capture high numbers of trout (very likely impacted by a recent dewatering of the ditch for management/maintenance), reports from local residents and ditch management indicate significant numbers of trout are entrained in the ditch. Therefore, given the size of the ditch, along with its length of diversion, and expressed interest, strong consideration should be given to the cost effectiveness and benefits of screening this ditch.
- Based on discussion with management, and considering the length of this ditch, there may be potential for increasing transport efficiency of the ditch, which could reduce the need for diverting some water.

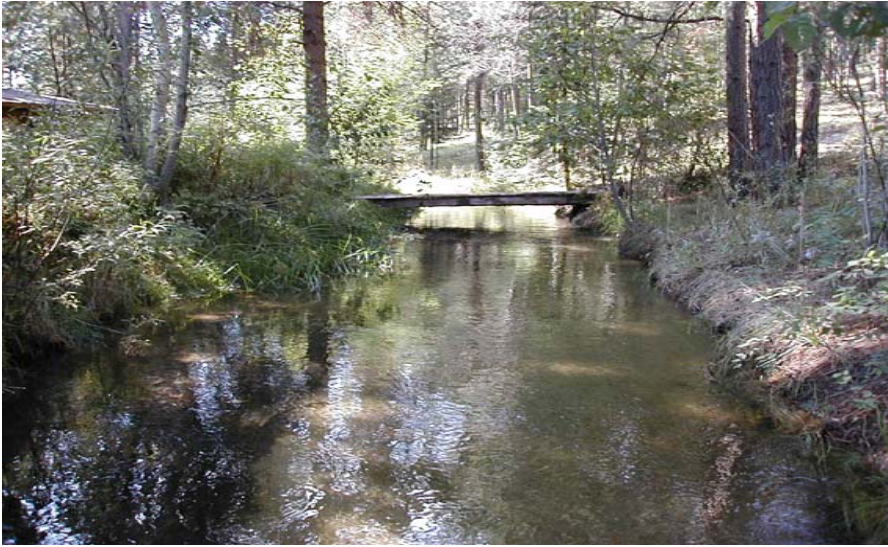
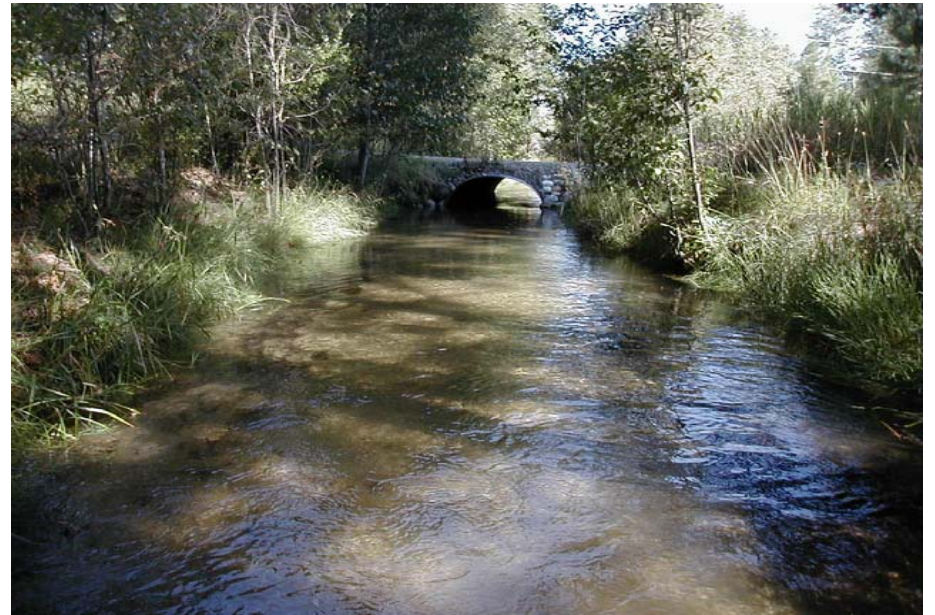
Figure 2A.

The ditch was approximately 6 to 8 feet wide and 1.5 to 2.5 deep throughout the 1000 foot length of the section. Stream flow and discharge data were not obtained. Conductivity was measured at 14.53 *us* and the temperature was 14.8 degrees Celsius. The section was fairly low gradient with slow velocity, good depth, good instream and bank cover, and would be considered good fish habitat. Figures 2A and 2B show the downstream end of the section viewing upstream and downstream, respectively.

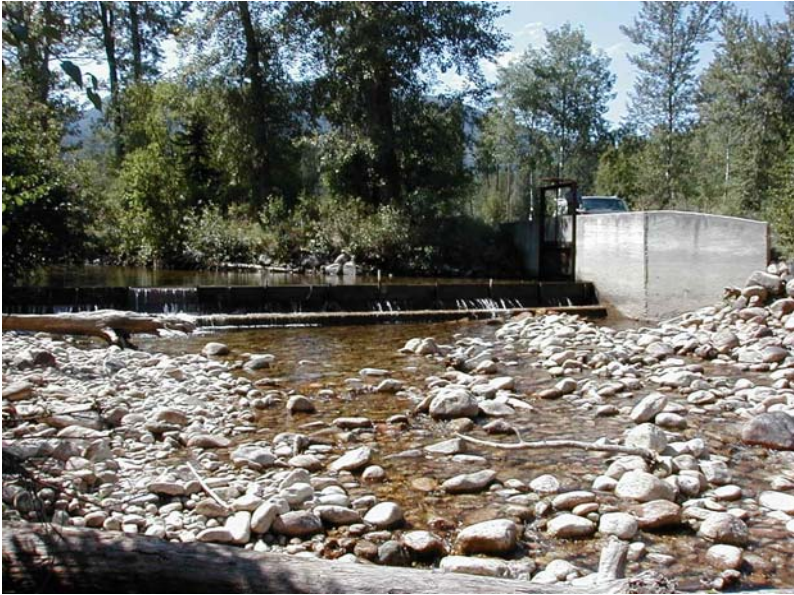
Figure 3A.

The dam is of post and plank construction and may be a partial fish barrier seasonally (Figure 3A). The difference in water surface above and below the structure was 2.1 feet. The headgate housing is concrete with an adjustable steel gate that opens directly into a culvert under the access road (Figures 3B, 3C). The ditch starts at the culvert (Figure 3D).

Although MDFWP has a water lease in Tincup Creek, the creek was significantly dewatered at the ditch's POD. With the amount of water diverted by this ditch relative to the stream flow, and the type of habitat present in Reach 2, it was surprising so few trout were captured in Reach 2. Given the habitat present in Reach 1, the number of trout captured seems significant.

- The diversion dam structure should be more closely evaluated as to possible modifications that would reduce any barrier effect it presently has on the fishery.
- Consideration of a screen on this ditch should be explored.
- Increases in transport efficiency could have potential to reduce the amount of water diverted.

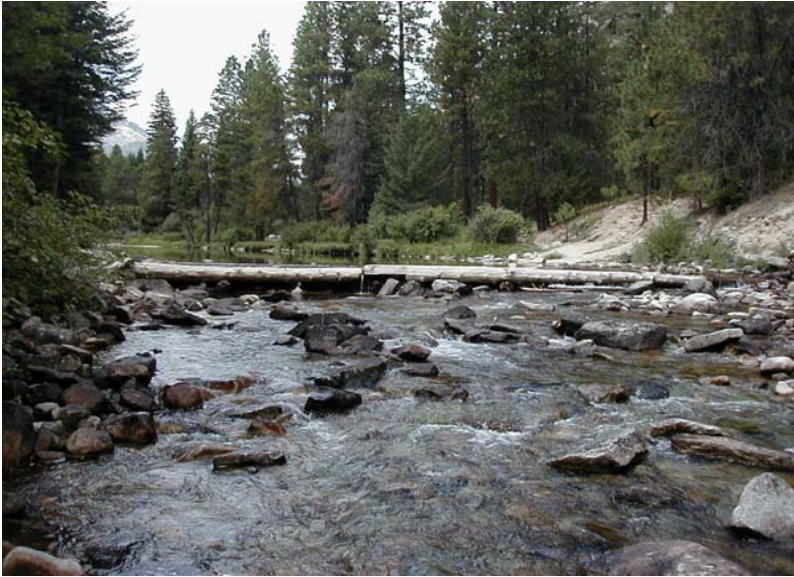
Figure 6A.

The diversion dam is log and boulder construction and may be a partial seasonal barrier (Figure 6A). The headgate housing and spillway is concrete with 2 adjustable steel gates that discharge directly to the ditch (Figure 6B). A cross-section of the ditch near the midpoint of the 1000 foot section was 12.5 wide (wetted width) with an average depth of 0.45 feet. Flow velocity ranged from 0.1-0.3 ft/sec at the edges to 1.6 ft/sec in the middle of the ditch. Discharge of the ditch was measured at 4.9 cfs. Discharge of the creek was measured at 20.2 cfs several hundred feet upstream of the diversion. This section of the ditch was considered to be good to fair fish habitat at this level of flow. Figures 6C and 6D show respective downstream and upstream views of the ditch at the 500 foot midpoint of the section, which has latitude/longitude coordinates N 46 05.965, W 114 15.470. Conductivity was measured at 14.97 *us*, and water temperature was 13.9 degrees Celsius.

BRID is also developing plans, in consultation with the Bureau of Reclamation (BOR), to modify the existing diversion dam with construction of rock v-weirs. This would be expected to eliminate any passage impacts of the existing structure.

- The implementation of the modifications to the diversion dam should be encouraged and assisted if necessary.
- The automation of flow monitoring will yield valuable data for consideration of a fish screen. Headgate automation will be valuable for not only increasing diversion efficiency, thereby conserving water, it would also serve as a safety feature to protect a fish screen if one were installed.
- Screening of this ditch warrants serious consideration. Although brook trout appear to be most numerous, substantial numbers of westslope cutthroat trout are being entrained. The wide range of discharge presents challenges for optimum design, and

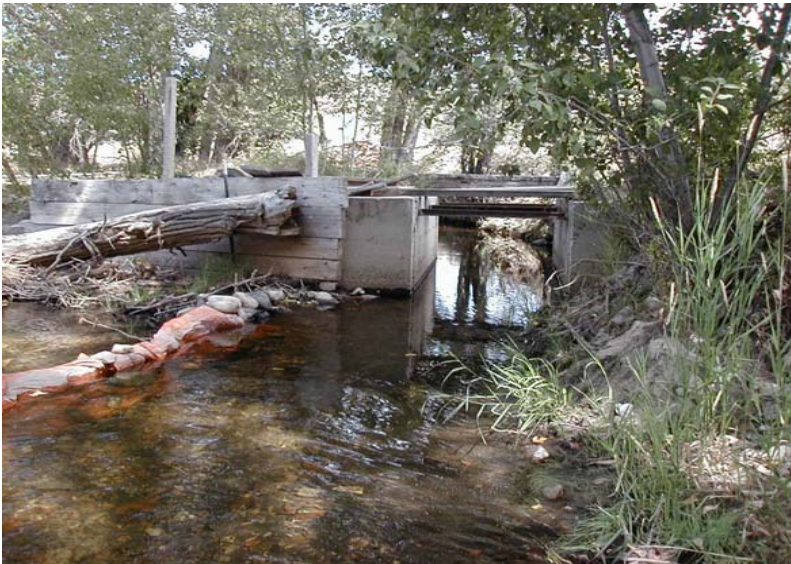
Figure 7C.

adjust the amount of water diverted (Figure 7C). The headgate discharges directly to the ditch (Figure 7D).

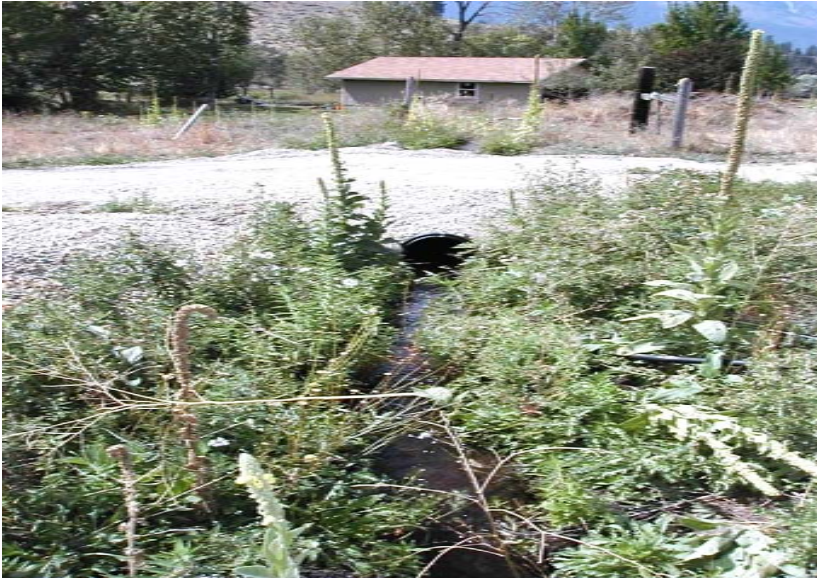
Figure 10A.

The Evans Ditch discharges into the Duth Ditch approximately 375 feet from the Duth Ditch headgate. The ditch runs through a culvert approximately 300 feet upstream from the point of discharge (Figure 10A). A 300 foot section of this ditch, which was 1 to 2 feet wide and 0.5-0.75 feet deep, was surveyed upstream of this culvert (Figure 10B) on August 26, 2003 by a 2 person crew with a backpack unit. No fish were captured or observed.

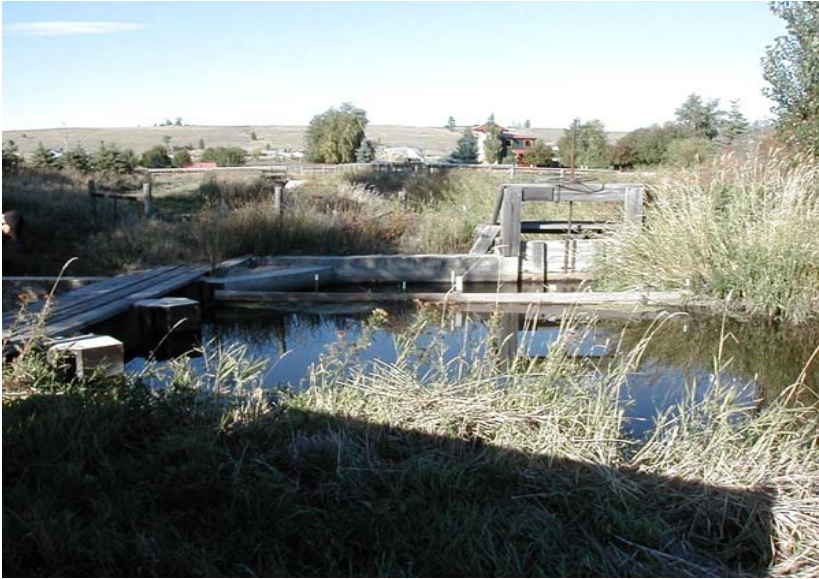
Figure 12A.

The Supply Ditch diversion dam/headgate structure is located 2.6 miles upstream of the mouth. The structure is constructed of concrete, steel, and wood with the headgate located on the north side of the creek (Figure 12A). Although it is difficult to see from

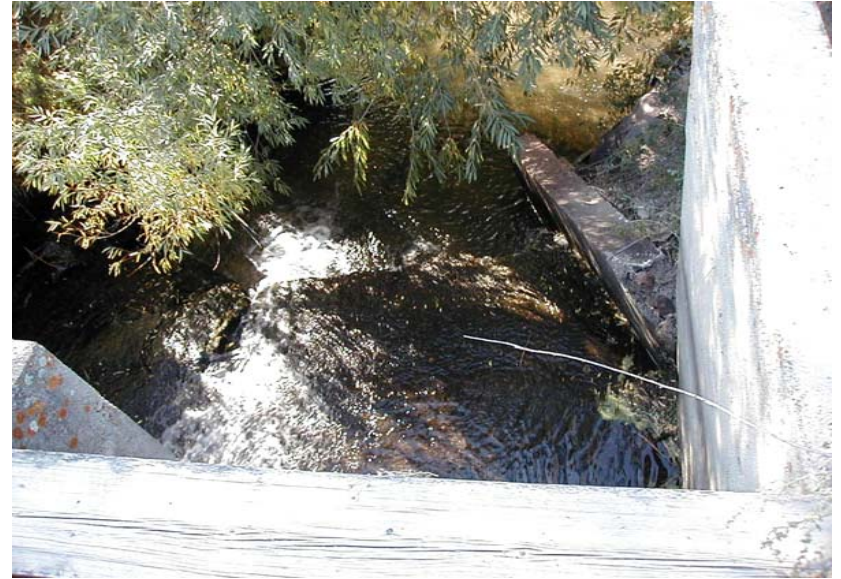
Figure 12B.

the photo (Figure 12B), the vertical drop of the creek at the structure is nearly 15 feet, therefore, the structure is considered a barrier at all flows. Creek and ditch flows intermingle with considerable ponding upstream of the structure (Figure 12C). There is a second concrete and steel headgate on the ditch 150 feet downstream of the headgate at the creek. This 150 foot section was quite deep (over 4 feet) with steep banks and a very soft substrate, and could not be efficiently, nor safely, surveyed with a backpack unit. One brook trout approximately 12 inches long, and two other 4-5 inch fish believed to be trout, were observed in this section, and it was suspected many more were present.

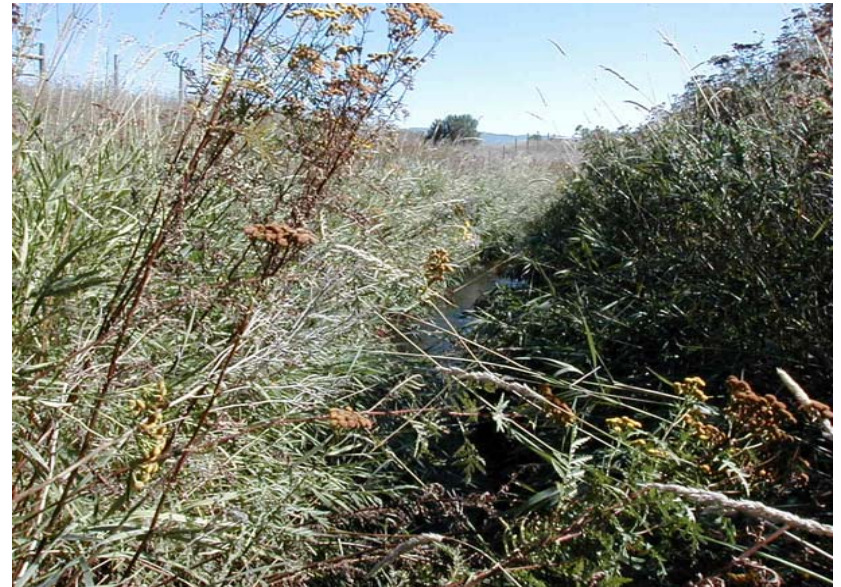
Figure 12D.

The reach that was surveyed extended 850 feet downstream of the second headgate described above, and averaged about 4 feet in width, with depths between 1 and 2 feet. Ditch banks were densely covered with vegetation that extended into the ditch (Figure 12D), making the electrofishing effort difficult to conduct. Figure 12D shows the downstream end of the reach (latitude/longitude at N46 33.842, W114 02.908) viewing upstream. Ditch discharge was not measured due to equipment malfunction. Conductivity was measured at 258 μ S, and temperature at 11.3 degrees Celsius. Conductivity and temperature were also measured in the ditch upstream of the structure at Ambrose Creek Road, with conductivity measuring 235 μ S, and temperature 15.1 degrees Celsius. Conductivity and temperature were measured as well in Three Mile Creek immediately below the structure, with conductivity measuring 241 μ S, and temperature 12.8 degrees Celsius.

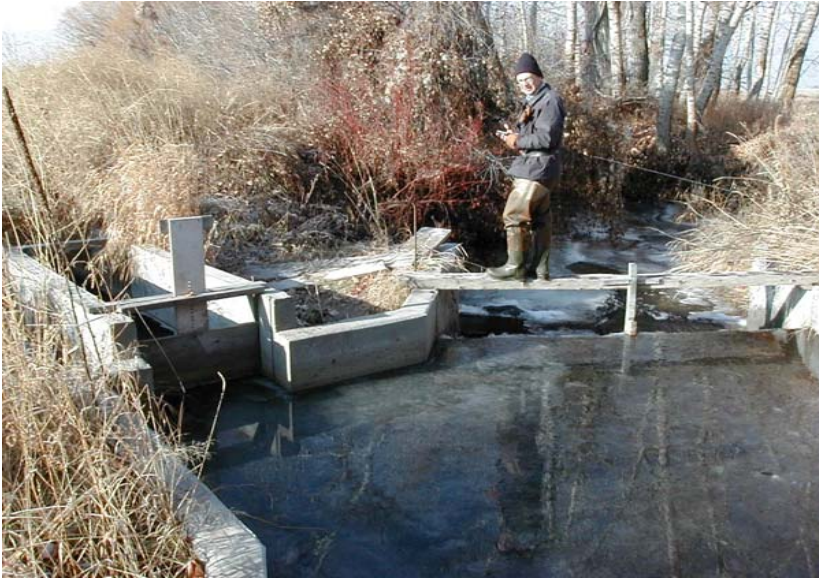
Figure 13A.

The Gates Ditch is located between the Supply and BRID ditches approximately 6.5 miles above the mouth at latitude/longitude N46 34.429, W113 59.223. The diversion dam/headgate structure is constructed of concrete, steel, and wood (Figure 13A) with a vertical drop of three feet (Figure 13B). It is considered a fish barrier at most flow levels. The headgate structure is 3.8 feet wide. Discharge was measured on July 31, 2003 at 1.67 cfs. Depth in the structure was 0.5 feet and the maximum velocity was 1.58 ft/sec.

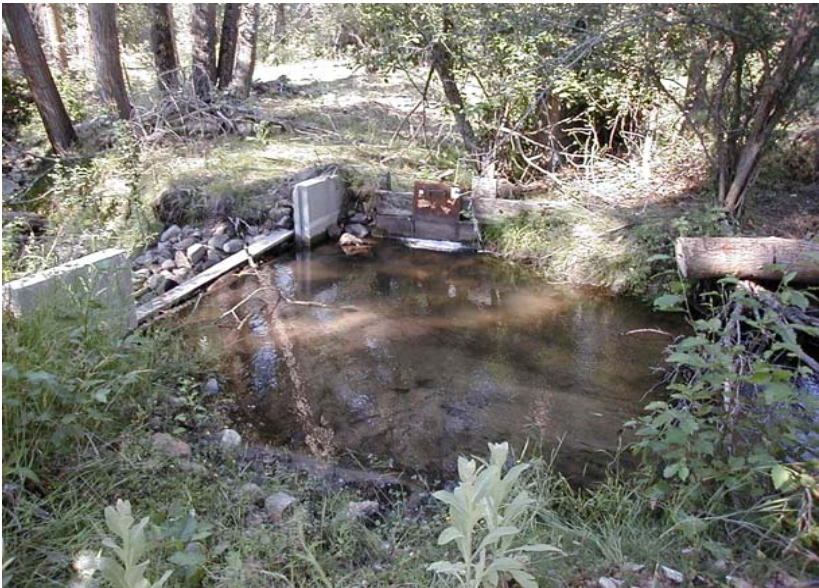
Figure 14A.

The Brown Ditch is located above the BRID Ditch structure approximately 10.3 miles from the mouth at latitude/longitude N46 36.164, W113 56.231. The diversion/headgate structure is constructed of concrete, steel, and wood (Figure 14A). Rock has been placed downstream of the structure reducing the vertical drop and forming steps (Figure 14B). The structure may still restrict upstream passage at low flow levels. The ditch is about 2 feet wide. Discharge was not directly measured, but was visually estimated around 1 cfs. As this ditch is closer to the creek's headwaters where cutthroat populations are higher, the potential for entrainment of native trout seems likely.
