Changes in fish habitat on the Missouri River from Fort Peck Dam to the North Dakota state line: 1956-2009

Montana Fish, Wildlife, and Parks
Region 6 Fisheries

Sara Owen and Jamul Hahn

February 2014

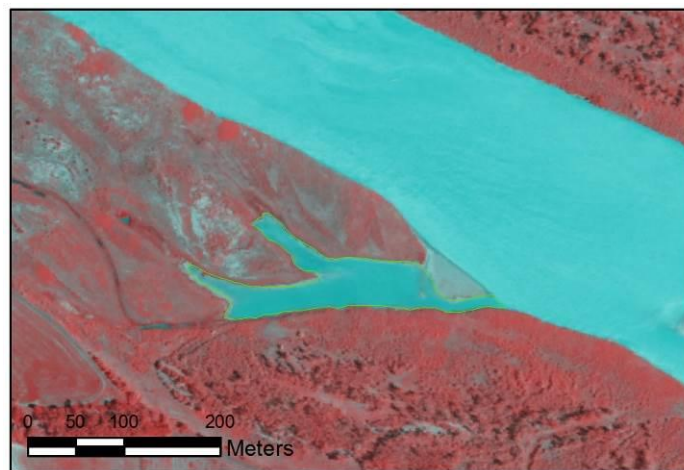
Figure 2. A representative backwater channel of the Missouri River mapped for this project.

Backwaters were typically defined as bodies of water with only a downstream connection to the main river channel and no upstream connection during baseline flows (Yager et al. 2013; Figure 2). In a handful of cases, bodies of water with an upstream connection but no downstream connection (i.e., “dead end” channels) were also classified as backwaters for lack of a better category for placement. Backwaters are typically mapped on the outside shore of a river channel; however, for this project we also mapped backwaters on islands (including sandy, mid-channel bars), as pallid sturgeon have been documented using habitat near islands (Bramblett and White 2001). The island backwater habitats were tagged so that they can be pulled out and analyzed separately in the future if desired.

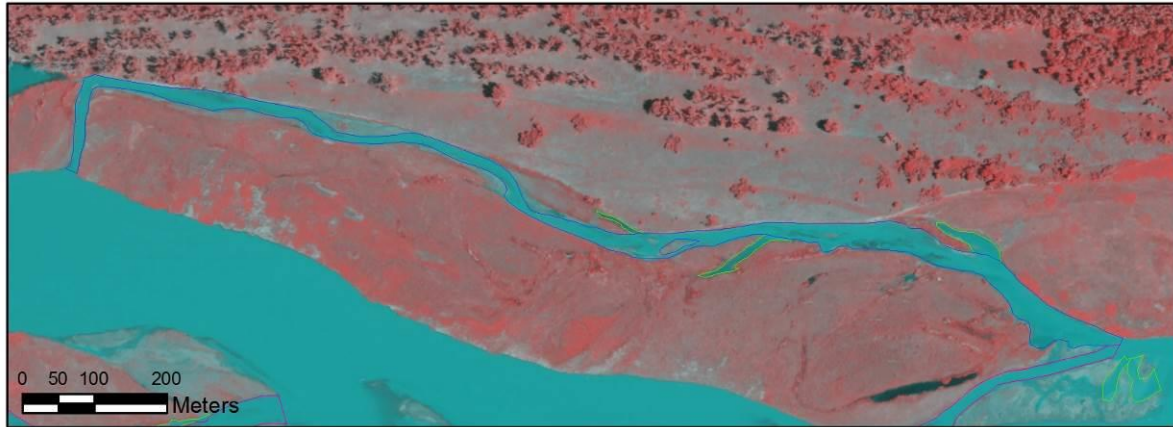
Figure 3. A typical side channel was long and narrow, less than 30m wide.

Side channels were defined as flowing off-channel habitats with both an upstream and downstream connection to the main river channel. Yager et al. (2013) defined side channels as features less than 100m wide. For the purposes of this study, side channels were typically restricted to 30m wide or less (Figure 3). This allowed us to use approximately the same proportion of side channel to main channel width as Yager et al (2013).

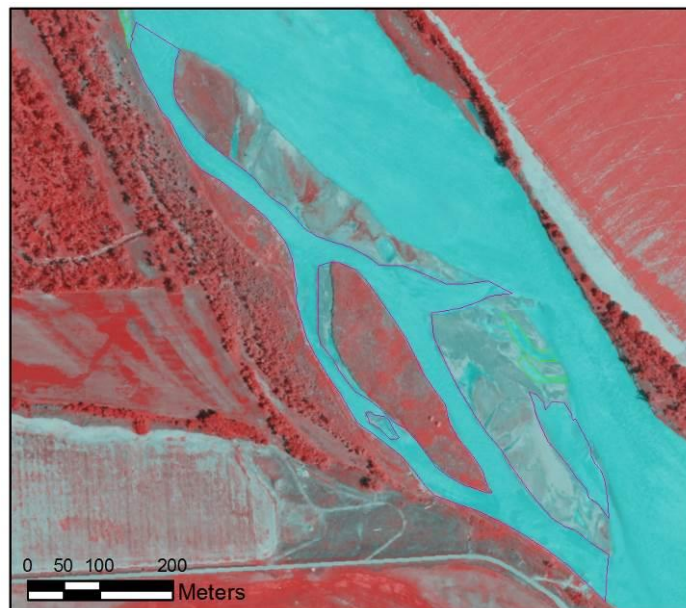
Figure 4. Other channels are secondary channels that are wider than 30m but do not carry a majority of river flow.

In addition to the habitats mapped in Yager et al. (2013), we also mapped other channels that encompassed sinuous channel areas with subclimax seral-stage islands and/or mid-channel bars (Figure 4). Bramblett and White (2001) found pallid sturgeon used these habitats extensively.

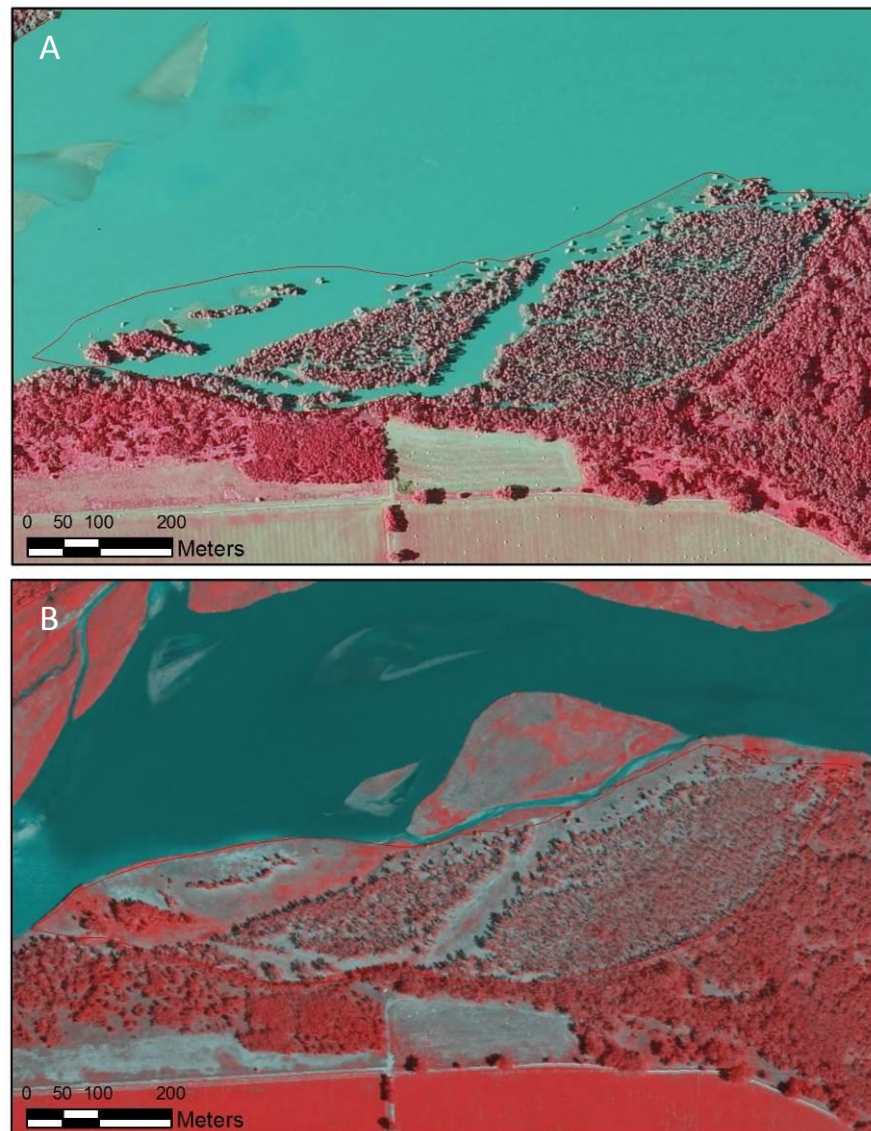
Figure 5. The inundated floodplain category was used only for 2011 imagery (A), but the 2009 imagery was used to delineate the floodplain (B).

We mapped inundated floodplain habitat for 2011 only and identified this habitat as areas where the river overtopped its banks and inundated the riparian floodplain. We included both forested and non-forested habitat. The inundated floodplain category was added to encompass flooded areas that are potential habitat and refugia for fish and other aquatic fauna during flood events

(Ligon et al. 1995, Ward and Stanford 1995, Bunn and Arthington 2002). The edges of the inundated floodplains along the river channel were delineated using the 2009 imagery because they were flooded and not visible in the 2011 imagery.

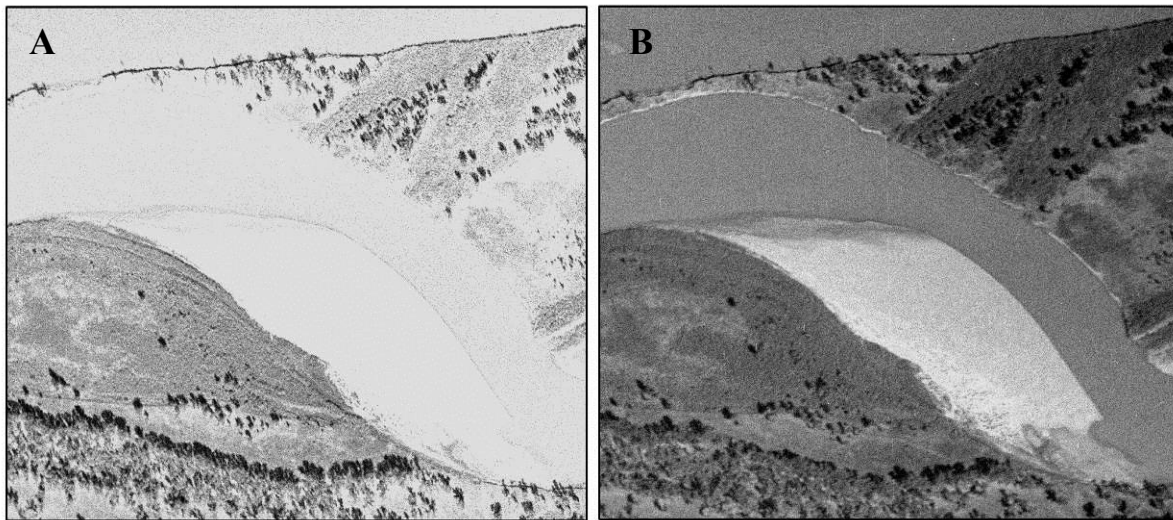
Figure 6. Image quality varied between images, making delineation of off-channel habitat features difficult (A). There was usually enough overlap between images that one of better contrast could be used to identify and delineate habitat features.

All recognizable off-channel habitats (backwaters, side channels, other channels, and inundated floodplains) were interpreted as described above and digitized as polygon features in a geodatabase using ArcMap 10.0. We mapped all features at a scale of 1:4,000. We calculated the area, length, and perimeter of each off-channel habitat feature in ArcMap. In cases where water was shallow over sand, it was difficult to determine if there was a connection to the main channel, and we tended to map conservatively for these questionable areas. These instances were particularly common in the historical imagery. The image quality varied between images and between years, so to improve delineation of habitats, we used overlapping images where available (Figure 6).

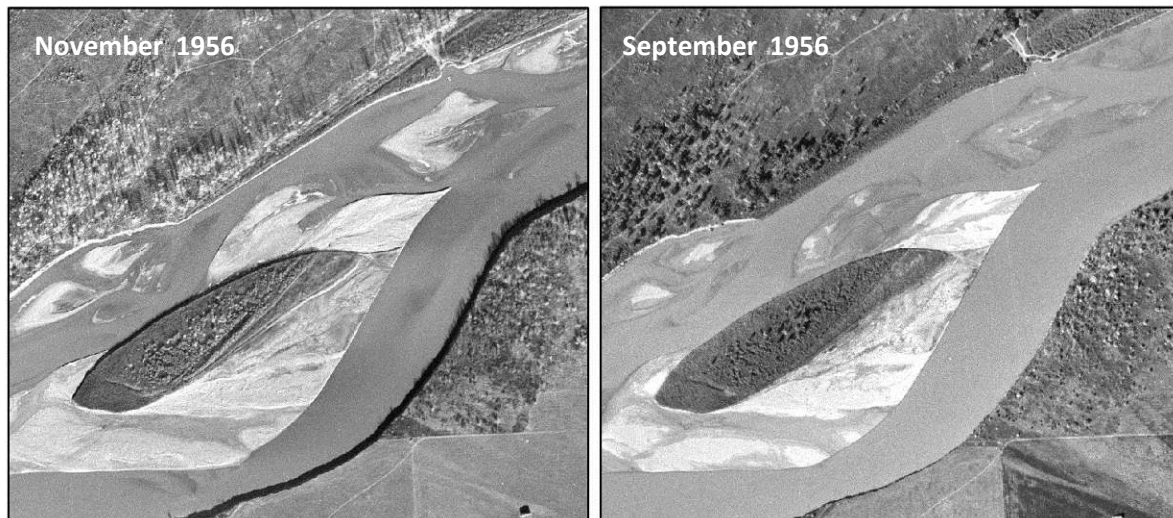
Figure 7. The dates of the historical imagery spanned two years and more than one season within the same year. In some cases the water levels differed between overlapping images. Off-channel features were mapped to the lower water image when possible.

The historical imagery provided additional challenges in mapping the aquatic habitat features. The water levels were different between some images because the imagery was flown over two years and over a period of several months within the same year. It was common to see a feature in one image, but where another image overlapped, the water level was higher and the feature did not exist. In these cases, every effort was made to map the feature to the image that had lower

water (Figure 7). Additionally, due to the orthorectification process, a historical image was more "true" to location in the western half of the image, and tended to drift away from its true location further east in the image. The difference in distance between features was usually no more than 75m. Every effort was made to map features in the western half of the image in order to maintain a more exact geographic location. Usually there was enough overlap between images to allow for this technique; however, there were a few cases where a feature extending across two images did not line up spatially. To preserve the true shape and area of the feature, the feature was mapped as a single polygon in one image, and then mapped as a separate polygon in the other image. The second polygon was moved to line up with the first polygon, and the two were merged into a single feature.

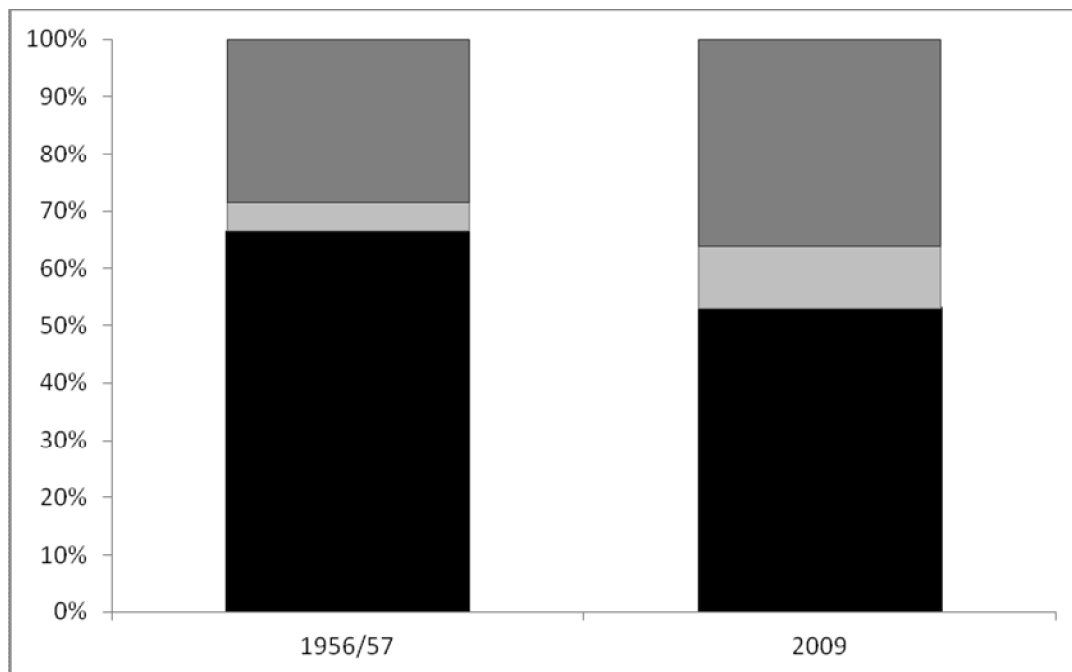
Figure 8. Proportion of habitat features mapped from Fort Peck dam downstream to the North Dakota state line from aerial imagery in 1956/57 and 2009. Black bars are backwater habitats, light grey bars are side channels and dark grey bars are other channels.

We observed a shift in the relative and absolute number of mapped habitat features between the two image years. We observed an increase in the total number of each type of habitat feature in 2009 (Table 1), but the proportion of habitats changed significantly between 1956/57 and 2009 ($\chi^2 = 27.39$, d.f. = 2, $p < 0.001$). In 1956/57, twenty years after Fort Peck dam was completed, backwaters made up 66% of all mapped features. In 2009 backwaters made up 53% of mapped features. Over the same time period, side channels increased in proportion from 5% to 11% of mapped features, and other channels increased from 28% to 36% of all mapped habitat features (Figure 8).

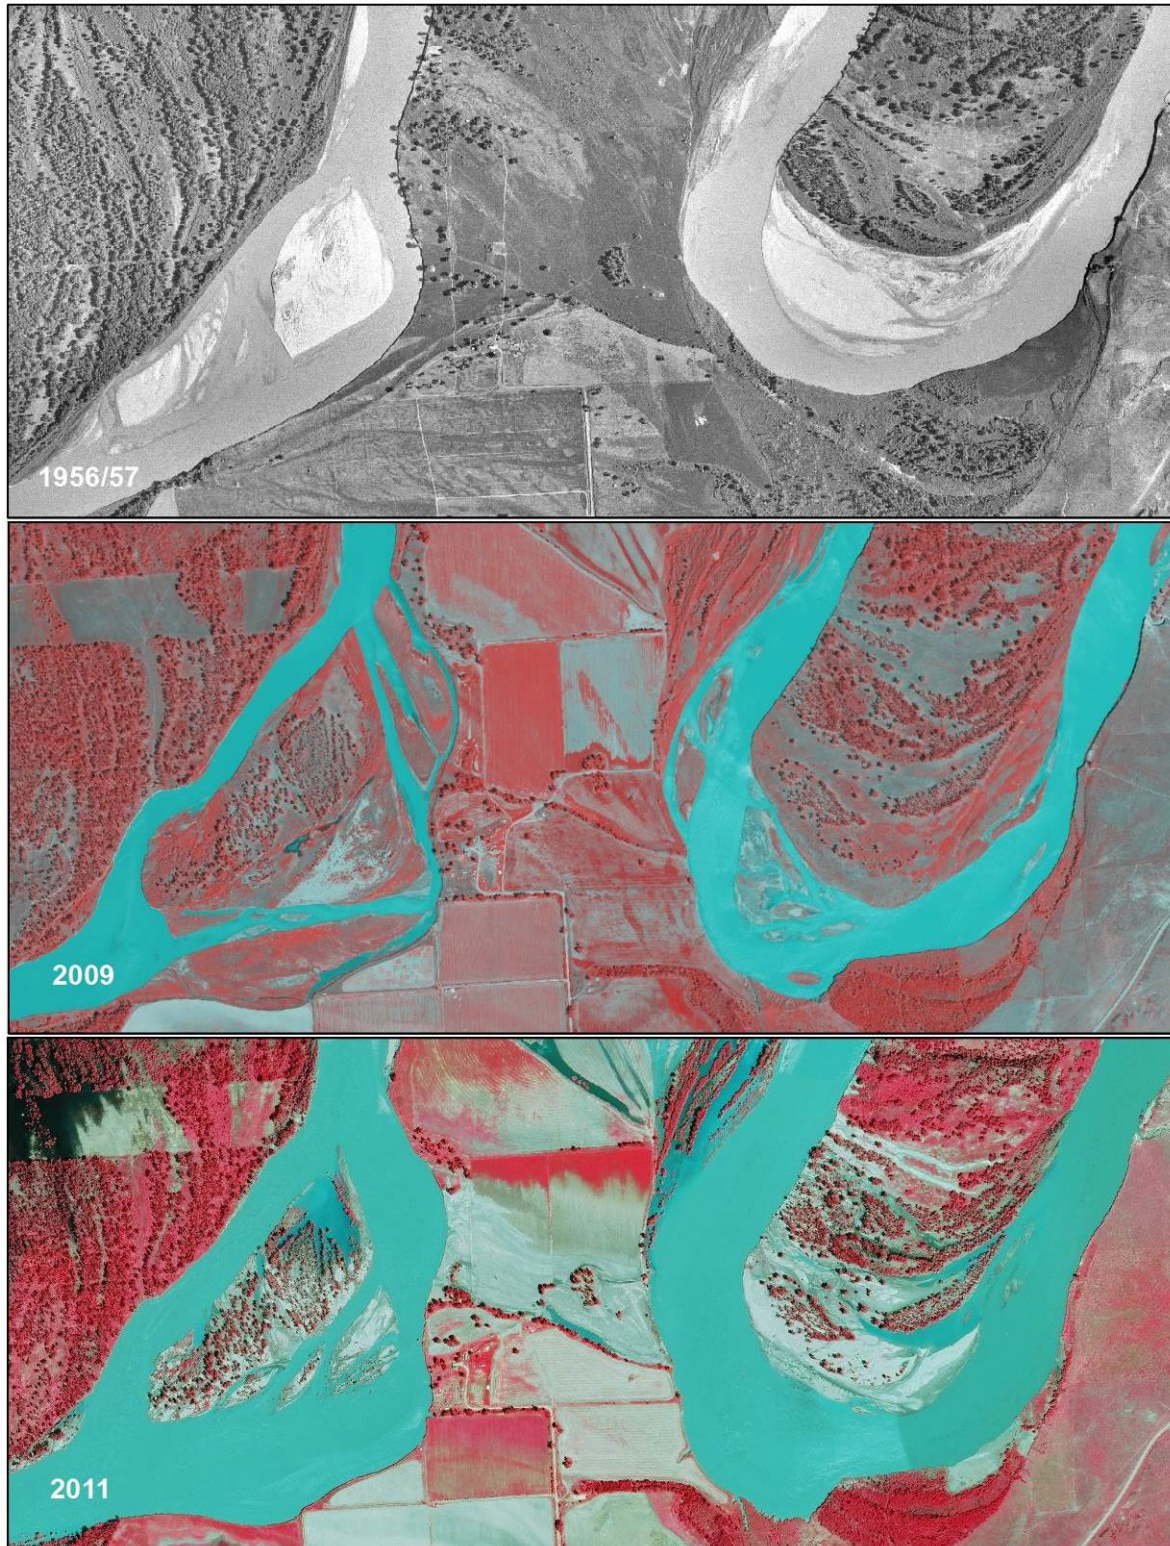
Figure 9. Changes in off-channel aquatic habitat are visible from 1956/57 (top) to 2009 (middle) for part of the study reach. There were additional side channel and backwater features in 2009 that were not present in 1956/57. The flooding of 2011 (bottom) potentially reorganized the channel features again.

The record flows of 2011 (USACE) may have reorganized the Missouri River below Fort Peck dam, inundating floodplains, depositing sediments, and scouring new off-channel habitat features (Figure 9). Additional analysis, using the 2013 NAIP, may provide insight into whether the flooding was able to negate some of the impacts of the dam and provide additional off-channel habitats. Bramblett and White (2001) found very few tagged pallid sturgeon in the Missouri River between the confluence of the Yellowstone River and Fort Peck dam, leading them to

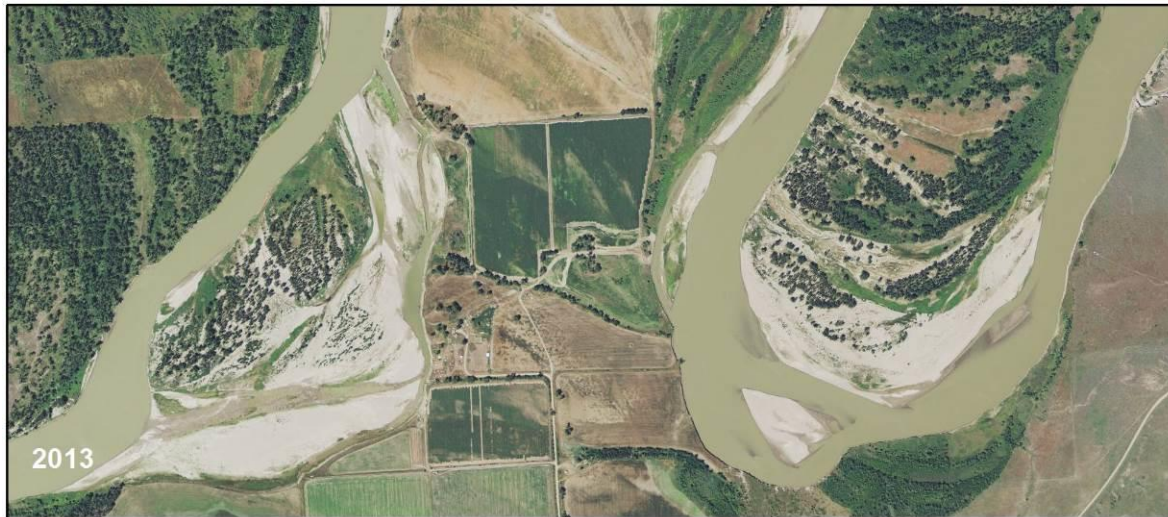
Figure 10. The 2013 imagery of the same area as Figure 9 shows the river channel was reorganized after the 2011 floods. What was a side channel feature in 2009 (left side of image) has been cut off on the upstream end and is now a backwater channel in 2013.
