Cedar Creek Monitoring Report

Yellowstone River Basin

2015

January 2016
Montana Fish, Wildlife & Parks
Scott Opitz

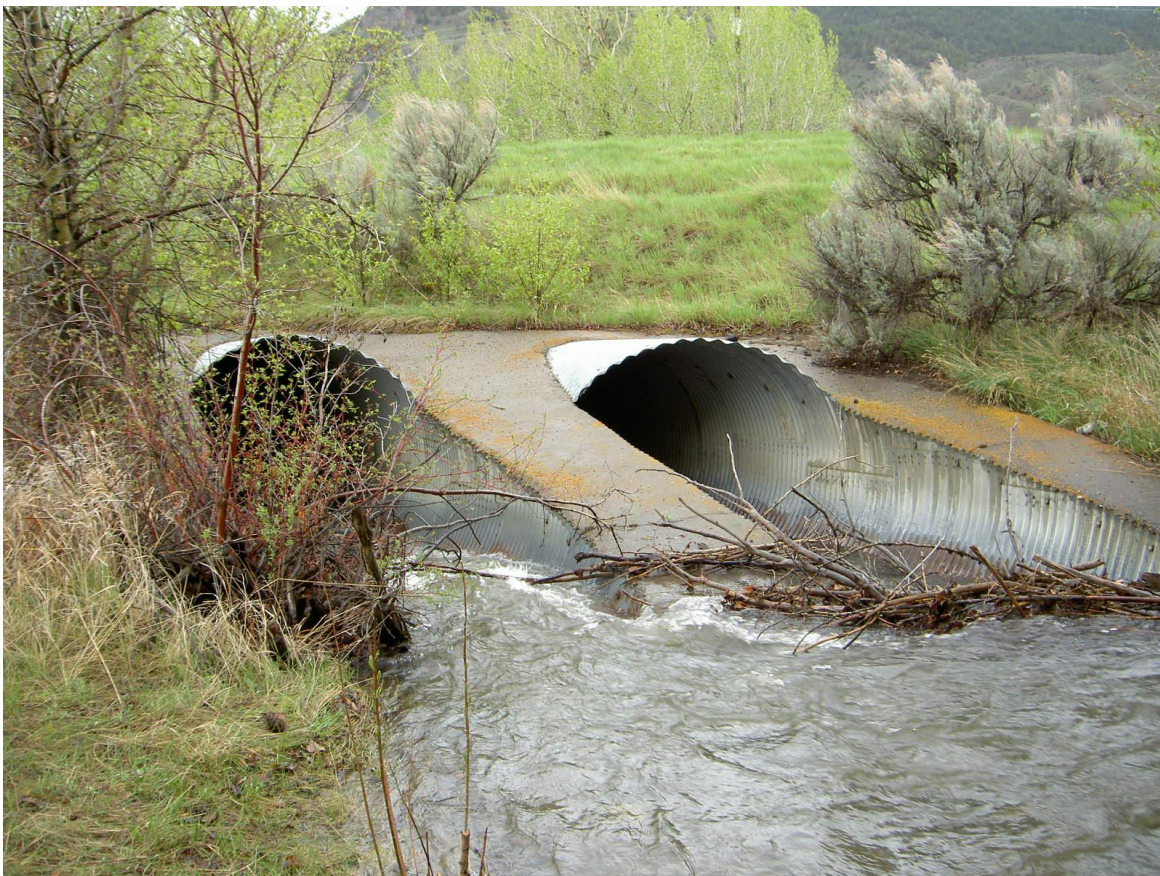
• Figure 1: Upstream entrance of the two culverts under HWY 89 South that were replaced. Photo courtesy of Montana Dept. of Transportation.

Since 1969, Side-by-side culverts located under HWY 89 South have limited access and movement of YCT for spawning in Cedar Creek (Berg 1975; Figure 1). The culverts were 148-feet long, 6.2-feet in diameter, and were on a 4.4% slope. Clancy (1988) determined that limited access to the tributary for Yellowstone cutthroat trout was affecting the Yellowstone River population. In an attempt to improve access for fish, a fish ladder was placed in the north culvert in 1981 (Clancy and Reichmuth 1990; Figure 2). Initially, fish were able to use the new ladder and move upstream of the culverts to spawn and only used the culvert with the fish ladder to do so (Belford and Gould 1989). Over time the ladder and culverts themselves began to fail. In addition to the failing infrastructure the culverts had become perched on the downstream end as the result of down cutting and further limited passage of YCT.

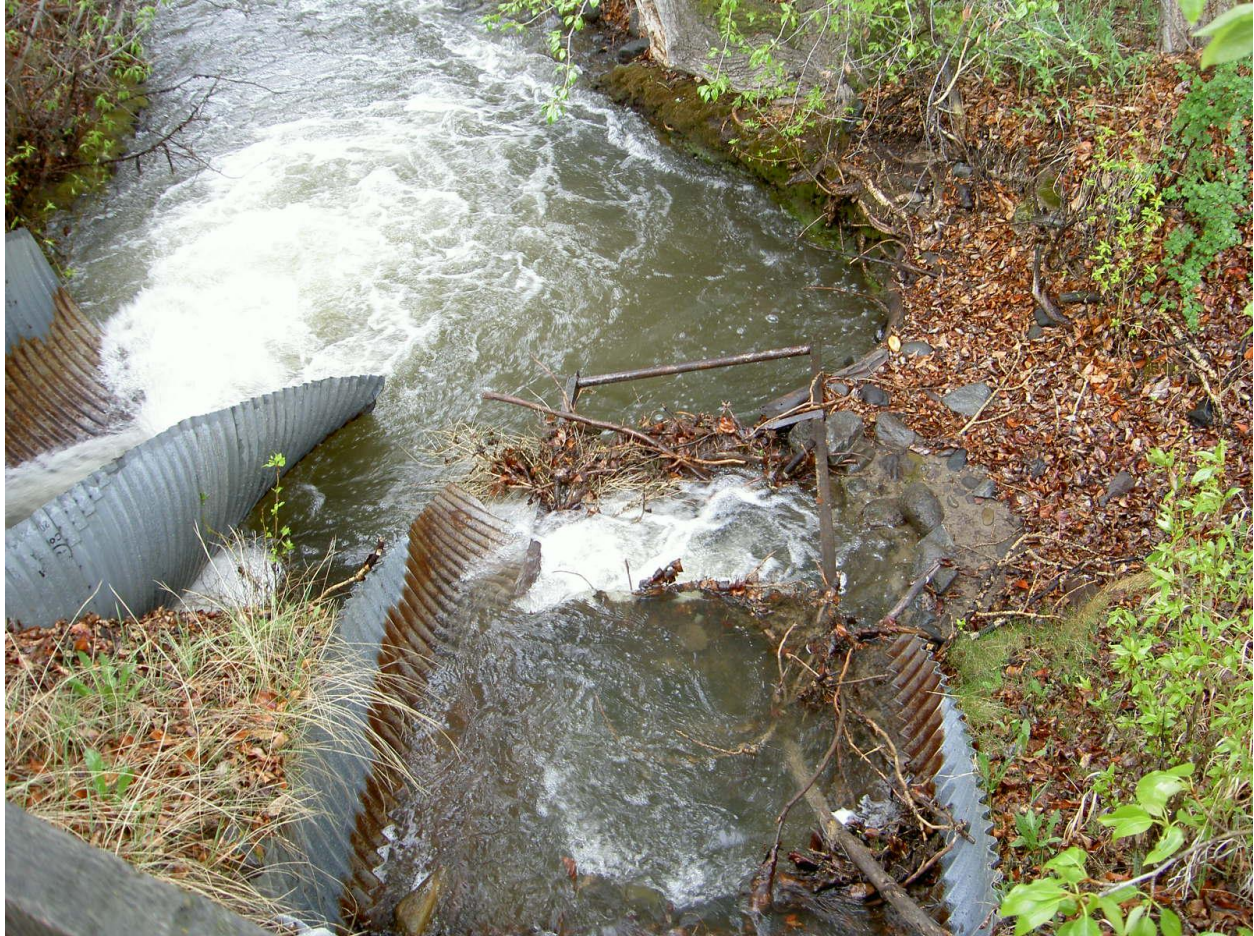
• Figure 2: Downstream end of the two culverts under HWY 89 South. You can see part of the historic fish ladder frame in the culvert on the right. Photo courtesy of Montana Dept. of Transportation.

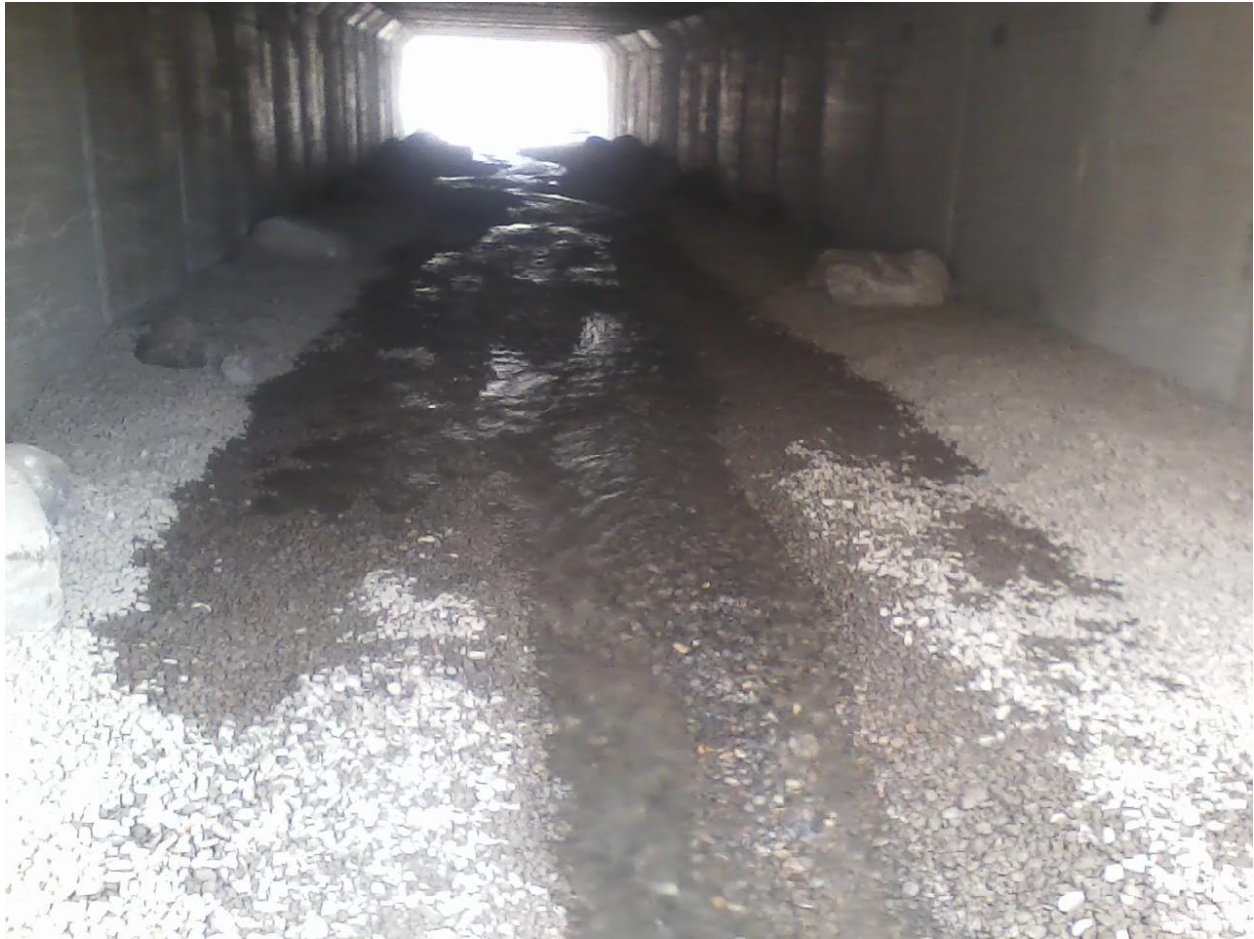
for adequate fish passage. The structure is a 162-foot long concrete box culvert that is 12-feet wide and 16-feet tall. The structure is countersunk two feet into the stream bed to ensure long-term fish passage and more natural movement of bed load through the structure (Figure 3).

• Figure 3: View from inside the new box culvert following construction, looking upstream.

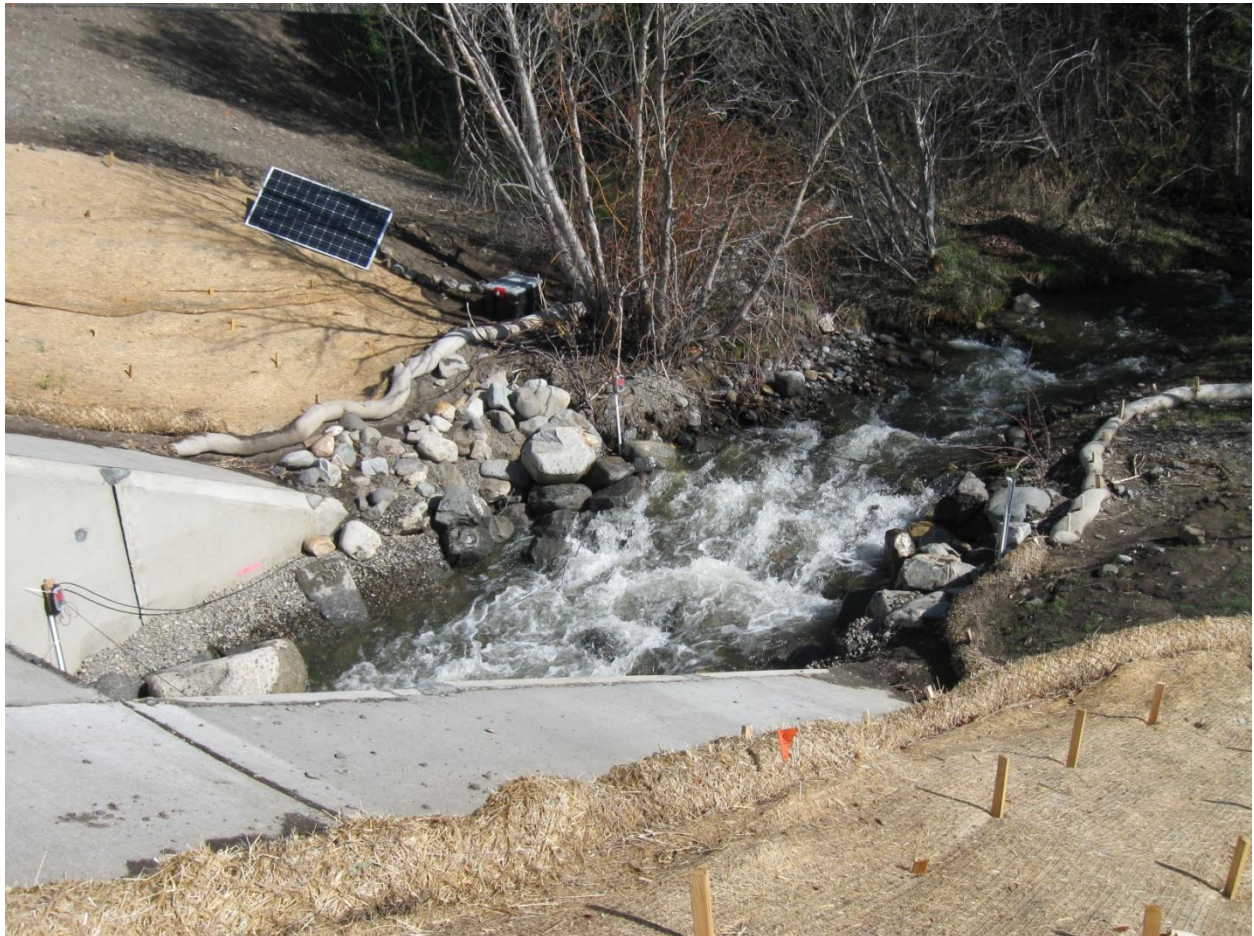
An antenna system was set up on the upstream end of the new structure to ensure that only fish that had passed through the entire structure were detected. It consisted of two antennas approximately 20 feet apart that were connected to a PIT tag reader that recorded the detection of PIT tags as fish passed through the antennas (Figure 4). The downstream antenna was located just inside the mouth of the box culvert. The use of two antennas allowed for the determination of direction of fish movement, either up or downstream from the structure. The reader was powered by two 6 volt, deep cell batteries that were charged through the use of a solar panel.

• Figure 4: View of the PIT tag station looking upstream from the top of the new structure.

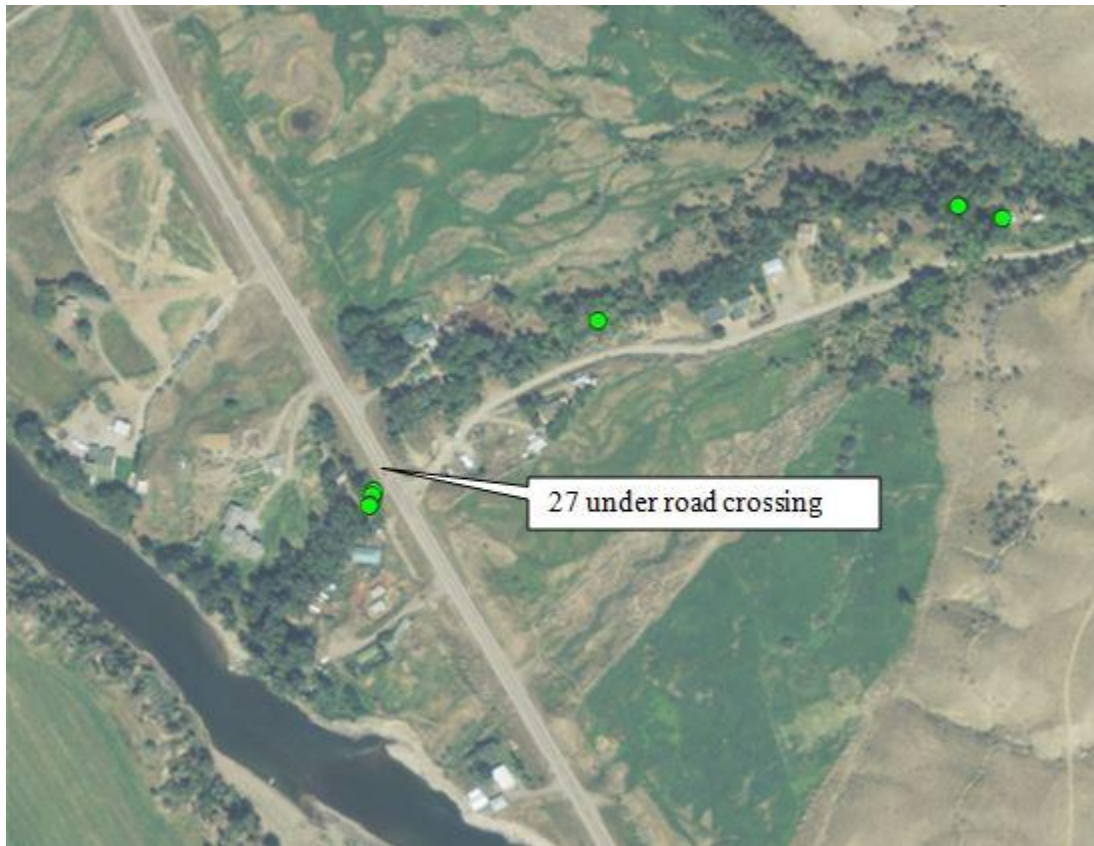
A total of 36 redds were observed and most, 27, were located inside the box culvert in small patches of gravel (Figure 5). As a result acquiring GPS coordinates for these redds was not possible. The majority of redds observed outside of the box culvert were located in a large deposit of gravel at the outlet of the box concrete culvert. The number of redds counted in this area are likely an underestimate, as the degree of which the gravel was disturbed suggested superimposition of redds. Only three redds were observed upstream of the box culvert, although YCT were present upstream of the structure. One factor that may have contributed to this limited number of redds was that during all sampling events, flows were high enough to obscure the streambed and potentially, spawning fish (Carol Endicott, FWP, personal communication).

• Figure 5: Aerial view of Cedar Creek with the location of observed redd indicated by green dots. The majority of the observed redds were inside the new box culvert as indicated on the photo.
