Foster Gulch Flood Repair

PPL-Montana MOTAC project 754-11

January 2012

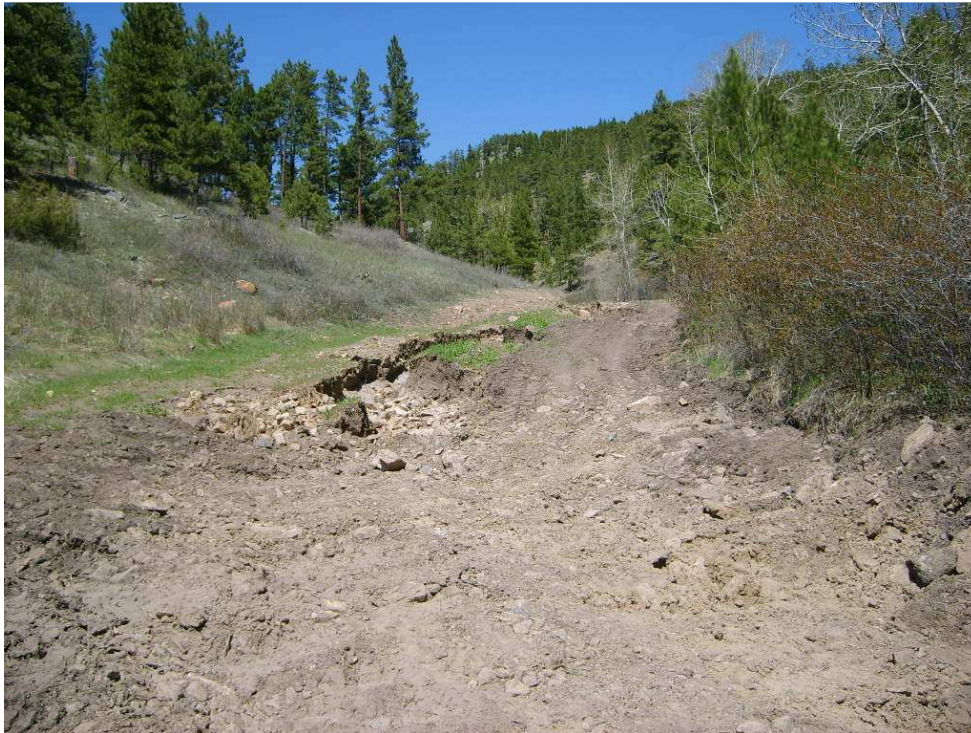
Figure 2. Foster Gulch washout along the shoulder of the main access road approximately 100 yds from the confluence with Little Wolf Creek. July 2009.

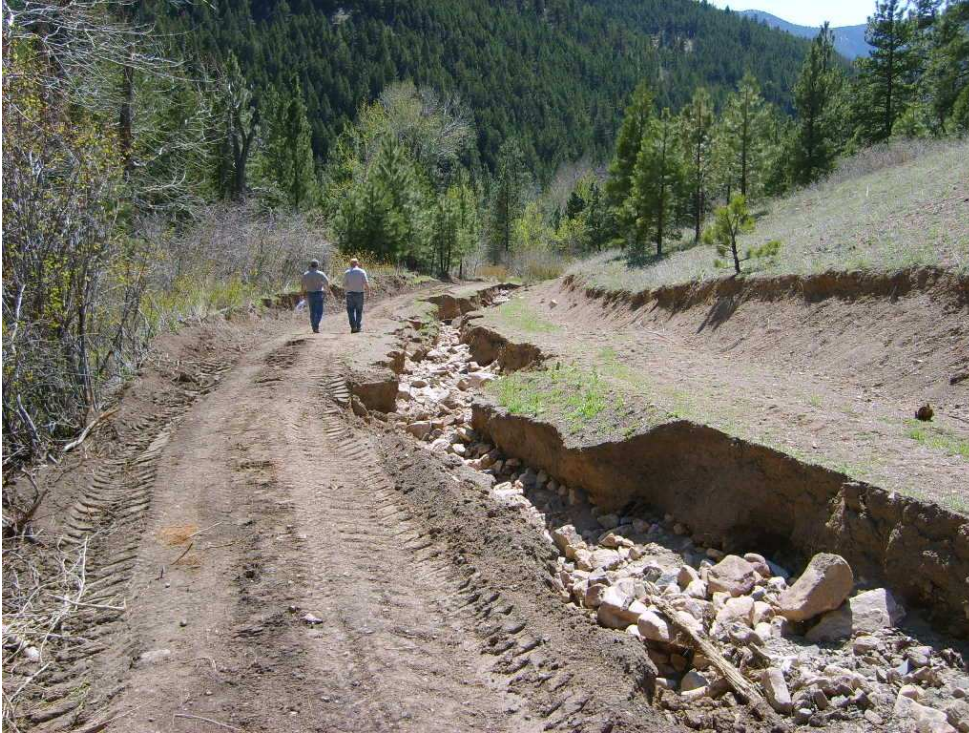
Figure 3. Foster Gulch washout in the center of the main access road approximately 300 yds from the confluence with Little Wolf Creek. July 2009.

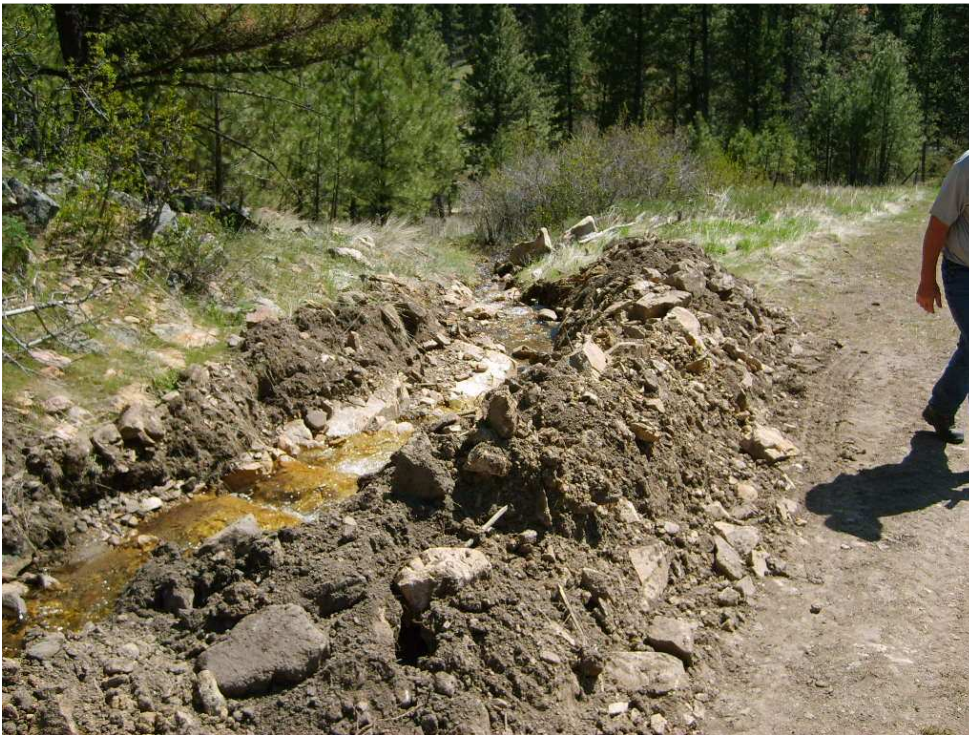
Figure 4. Foster Gulch stream at diversion site. July 2009.

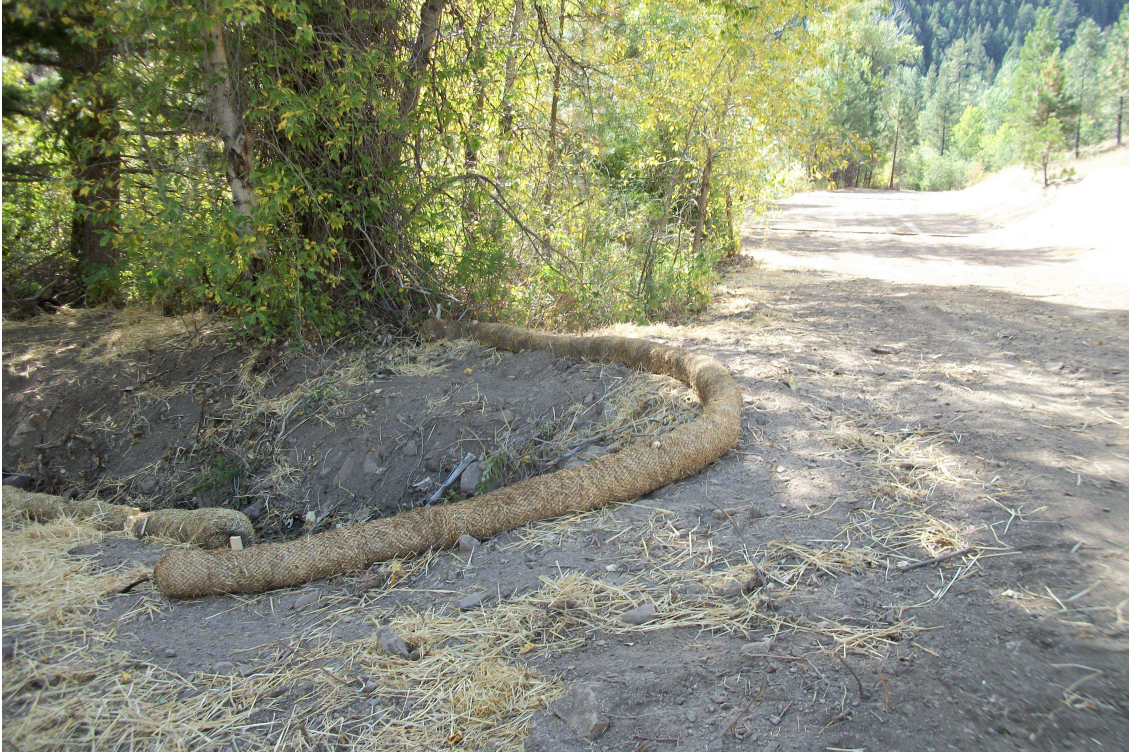
Figure 5. Upper stream crossing after new culvert and BMPs installed. Foster Gulch, October 2011.

Lewis and Clark County constructed three water bars and delivered them to the site on September 6. Montana Fish, Wildlife & Parks facilitated the purchase of culverts and erosion control materials and delivered them to the site on September 7. Implementation began on September 7 and continued through September 15 (Figure 5, Figure 6, Figure 7). Fish, Wildlife & Parks made three trips back to the site between September 20 and October 10 to apply seed, spray water on seeded areas to facilitate germination, install erosion control devices, construct a gate near the approach entrance and take photographs. During these visits, the stream was functioning properly at both crossings and at the county road crossing downstream.

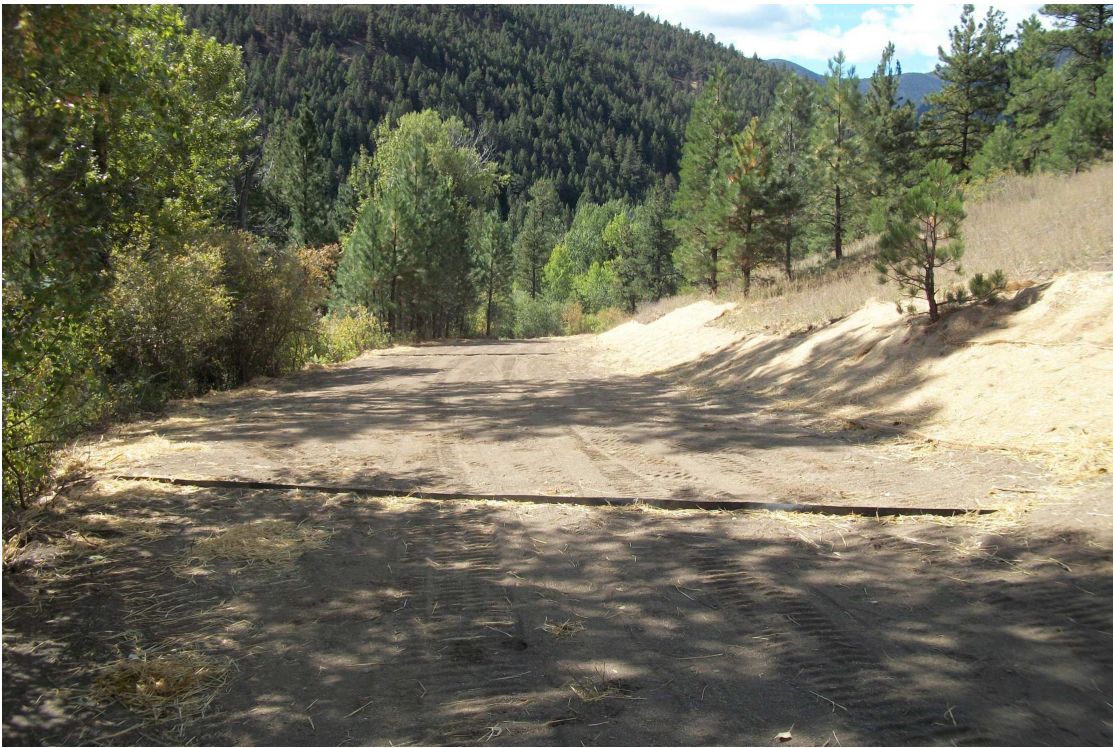
Figure 6. New road grade with wash-out repaired and water bars installed, Foster Gulch October 2011.

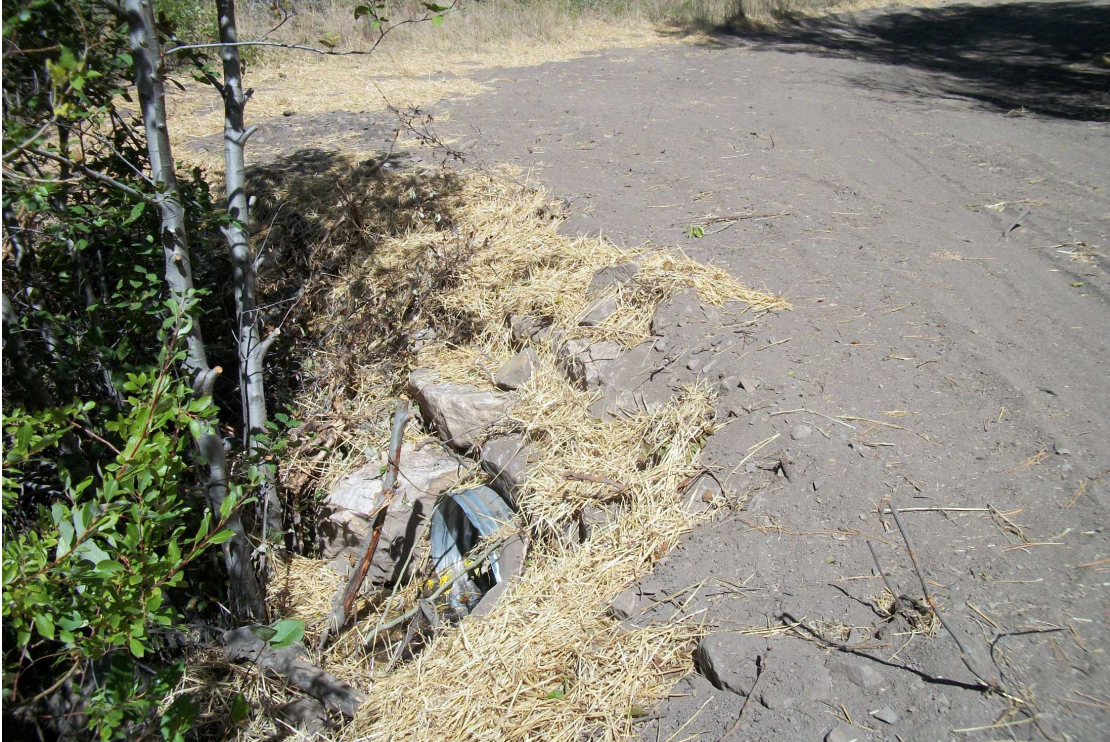
Figure 7. Lower stream crossing after new culvert and BMPs installed. Foster Gulch, October 2011
