Missouri River Riparian Fence and Livestock Water on the Sterling Ranch
near Craig, Montana

PPL-Montana MOTAC project 756-11, 756-12,

March 2013

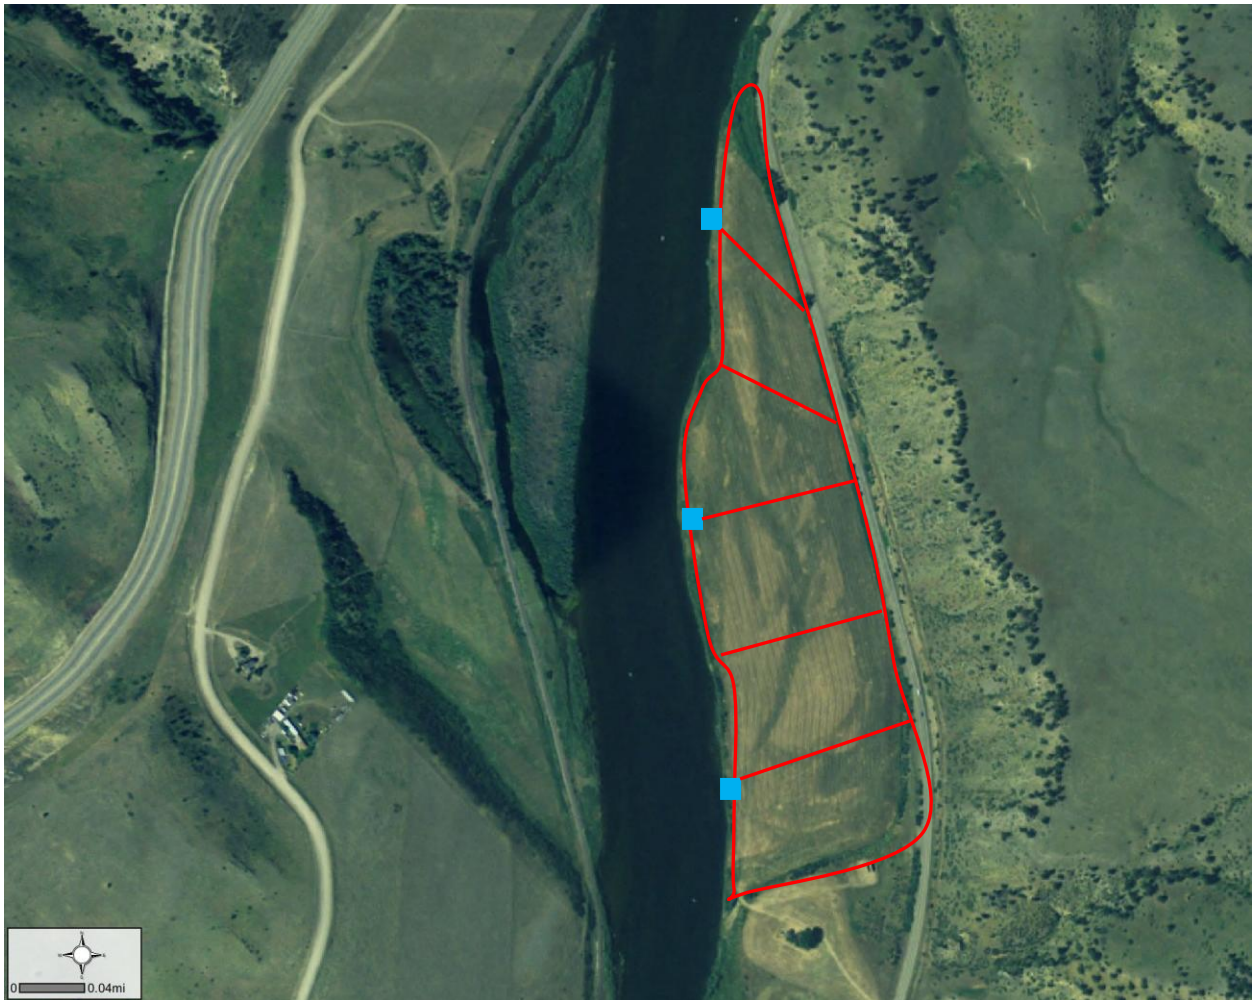
Figure 7. Bross pasture with proposed stock water gaps. Sterling Ranch, Craig, Montana.

The MiG and K-line strategy was proposed for the North Pivot (Figure 3), Craig (Figure 4) and South Pivot (Figure 5) sites. The two remaining pastures, Rumney (Figure 6) and Bross (Figure 7), would be changed by installing a permanent single strand high tensile steel wire electric fence along the Missouri River. Up to 6 paddocks were proposed for the Bross pasture which would be managed using the rest rotation method. Three water gaps would be installed in the Bross pasture where cattle could get water from the Missouri River. Use of the Rumney pasture would be similar to the Bross pasture with 10 paddocks and 4 water gaps. Water gaps at these two fields would be narrow to prevent cattle from loafing on the river bank or seeking refuge in the river during hot weather. High voltage electric fence prevents cattle from herding at water gaps.

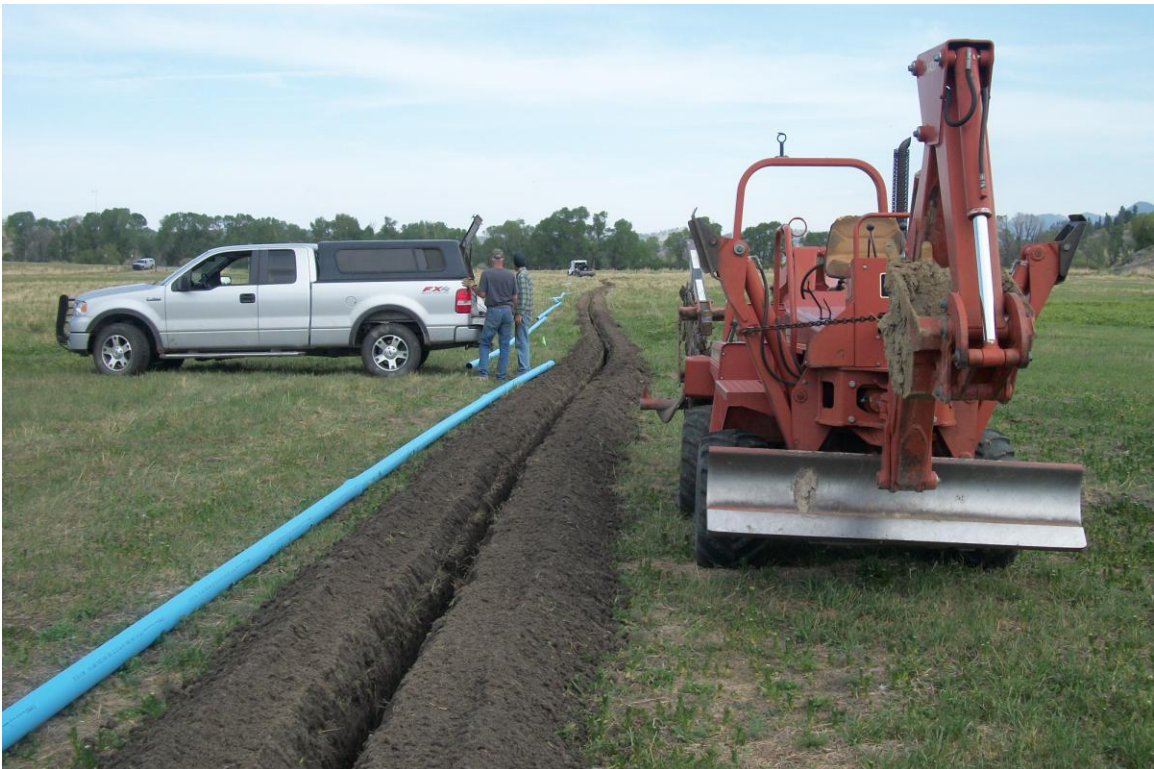
Figure 9. Installing mainline water pipe at Craig field, Sterling Ranch, Craig Montana 2012.

In 2012, the perimeter fences, paddock fences and water main lines with risers were installed at the North Pivot, Craig, and South Pivot fields (pictures, Figures 8-15). Problems arose with rupturing on the water mainline in the Craig pasture approximately 200 yards past the pump station. The line had to be excavated and replaced due to improper installation. By fall 2012 all three of these pastures functioned properly including providing MiG grazing for cattle and sheep and raising surplus hay.

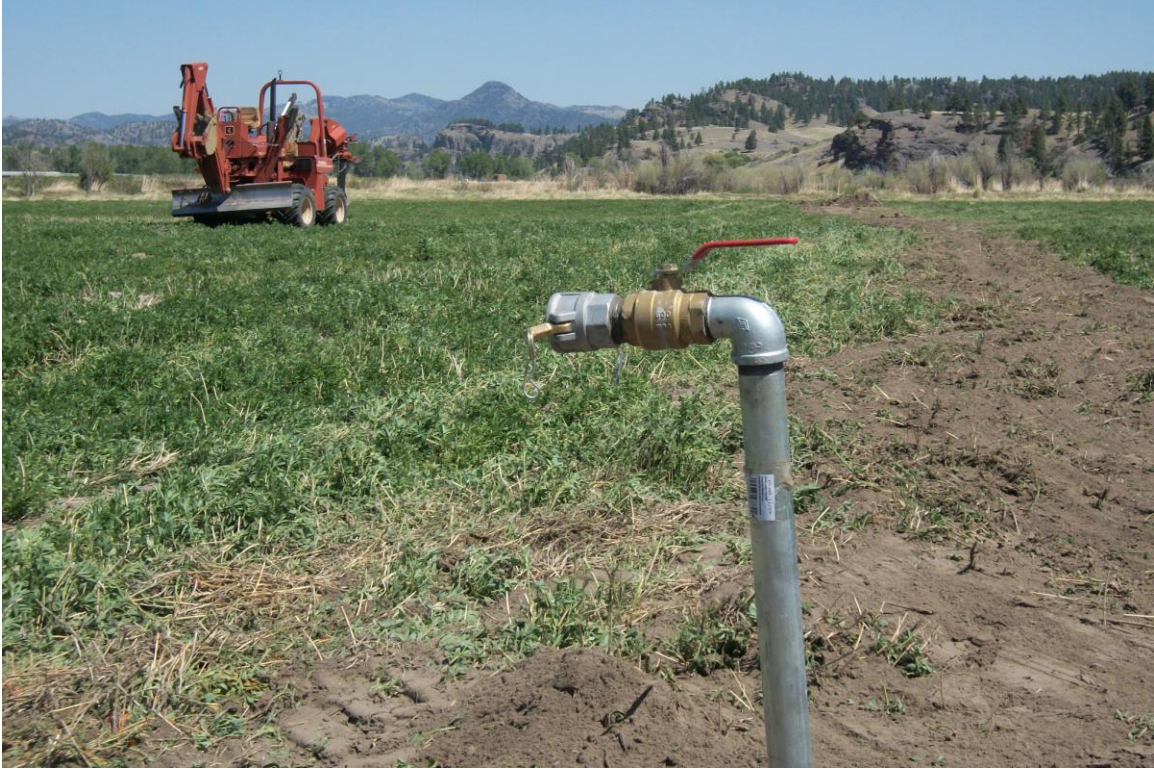
Figure 10. Riser line for livestock water and irrigation at Craig field, Sterling Ranch, Craig Montana 2012.

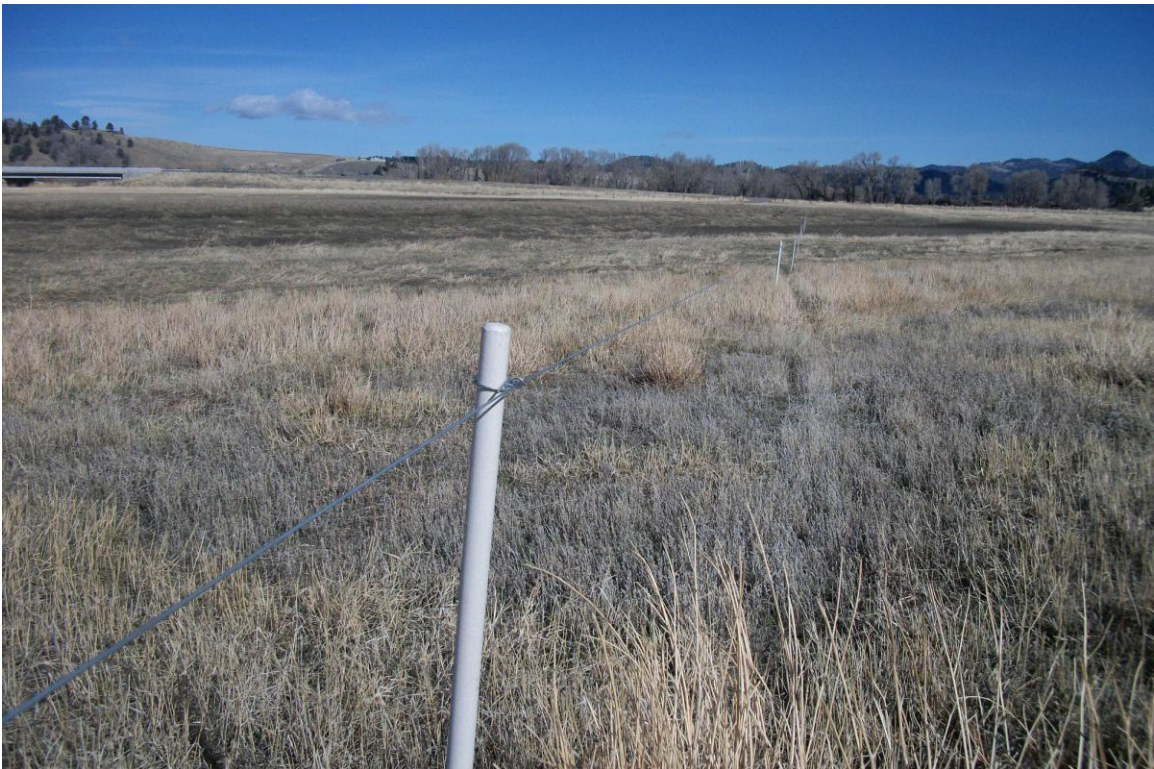
Figure 11. High tensile steel electric fence at Craig field, Sterling Ranch, Craig Montana 2012.

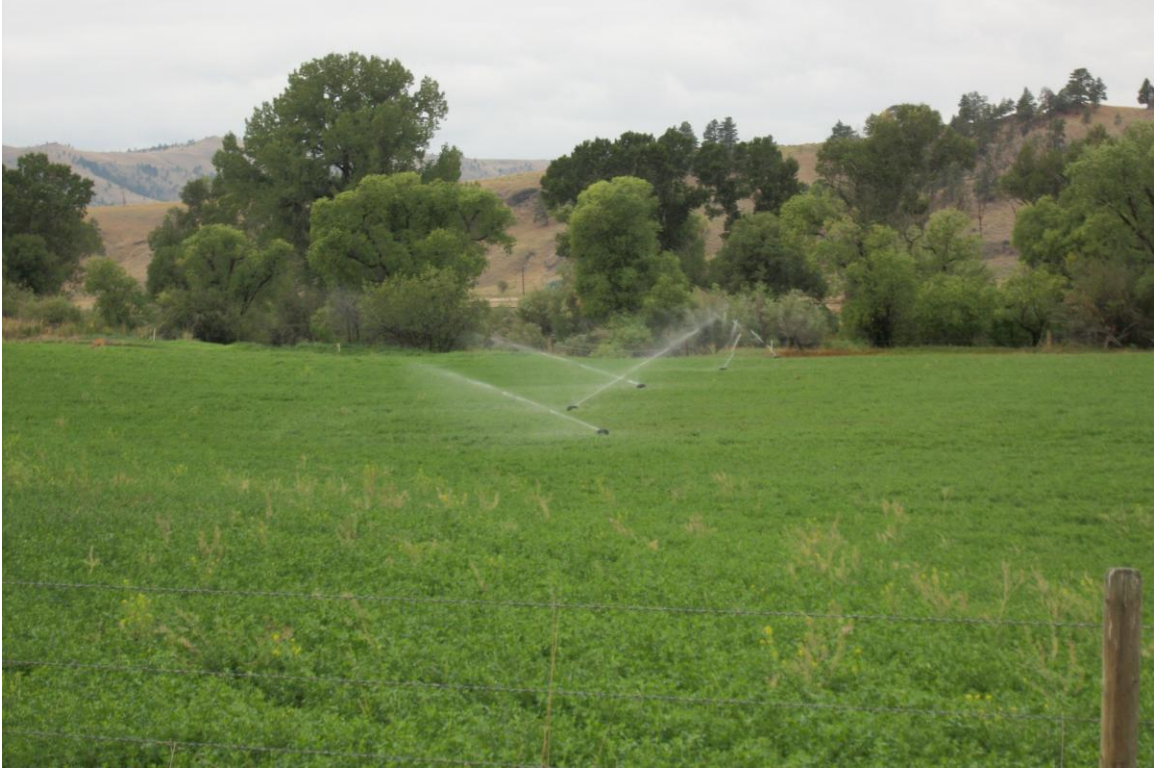
Figure 14. K-line irrigation system in North Pivot field, Sterling Ranch, Craig Montana 2012.

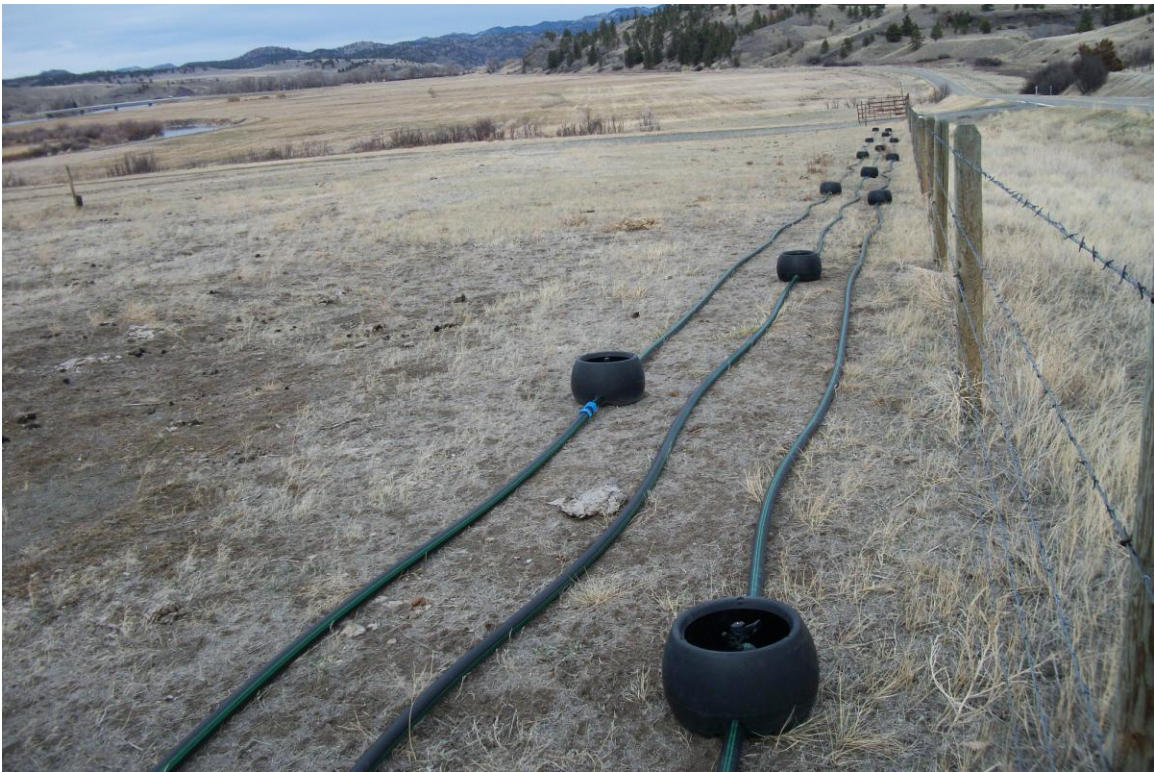
Figure 15. K-line irrigation system stowed for winter in Craig field, Sterling Ranch, Craig Montana 2012.

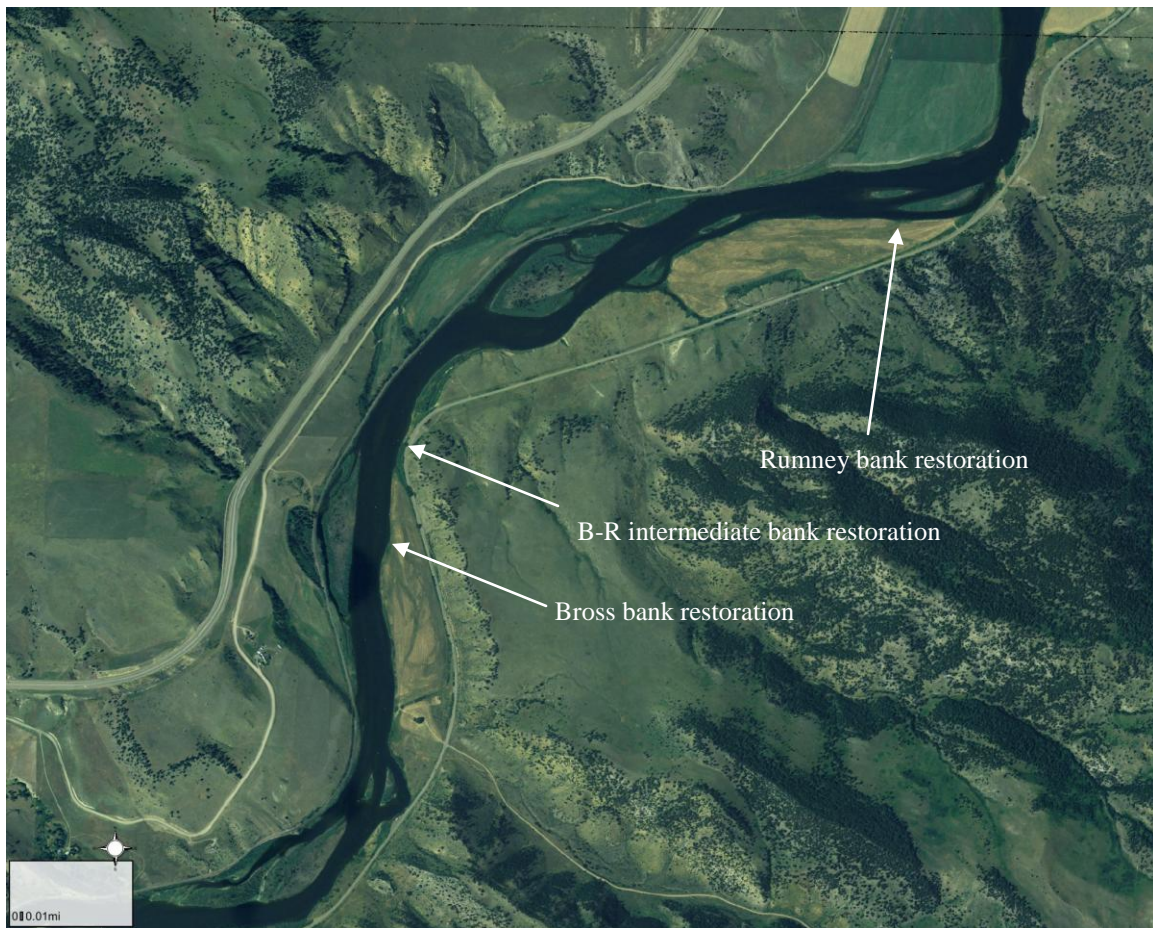
During the survey for the alignment layout of riparian fences at the Bross and Rumney pastures, the landowner discovered three areas of bank erosion (Figure 16). The landowner recommended repairing these sites before installing the fences, so the fences would not be compromised by further erosion. Montana FWP was able to secure funding for the bank repair. Due to drought conditions and high risk of fire in the summer and fall of 2012, the bank repair and fencing at the Bross and Rumney pastures was temporarily suspended. It wasn't until the second week of October that sufficient rainfall occurred in this area which eliminated the fire risk. During the months of January and February 2013, the contracting firm Stream Works implemented bank restoration at two sites (Figure 17, 18, 19, 20). The intermediate site between Bross and Rumney (Figure 21) will be implemented in early 2013. The remaining perimeter fences and paddock fences will be installed in the Bross and Rumney pastures after the bank restoration is complete.

Figure 16. Missouri River bank restoration sites at Bross pasture, intermediate Bross-Rumney pasture and Rumney pasture. Sterling Ranch, Craig, Montana.

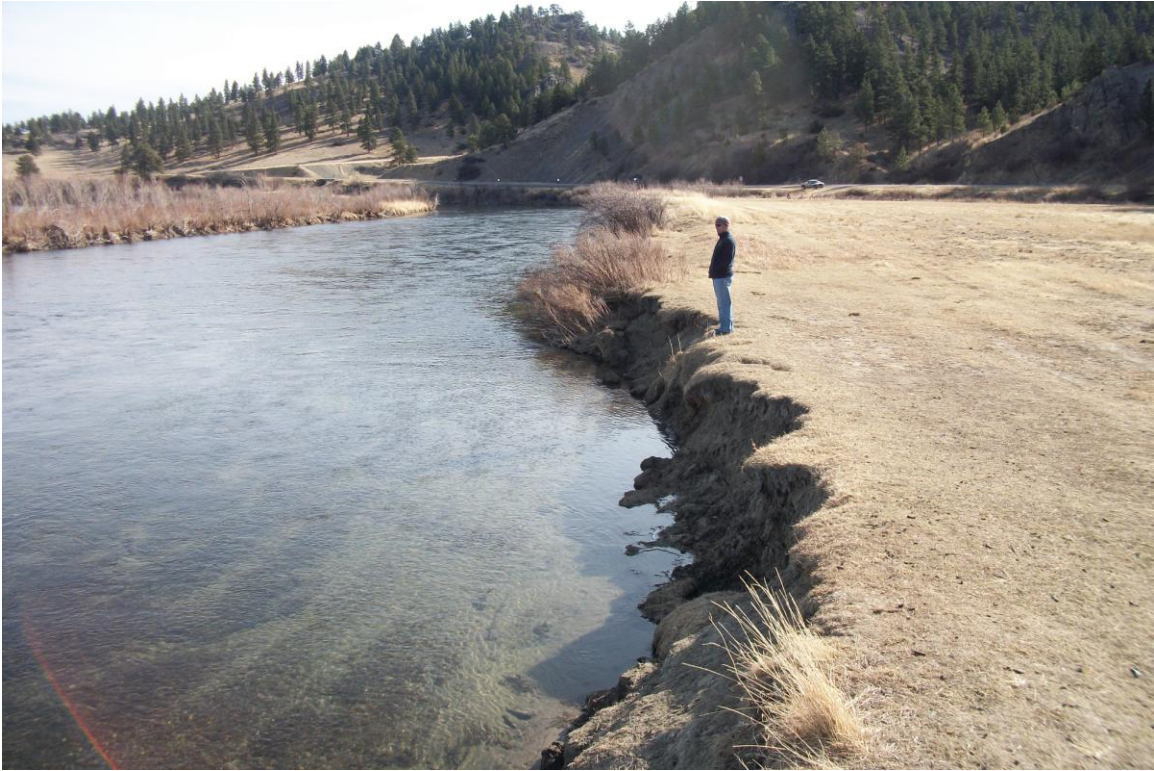
Figure 17. Missouri River bank erosion at Rumney pasture, Sterling Ranch, Craig, Montana, 2012.

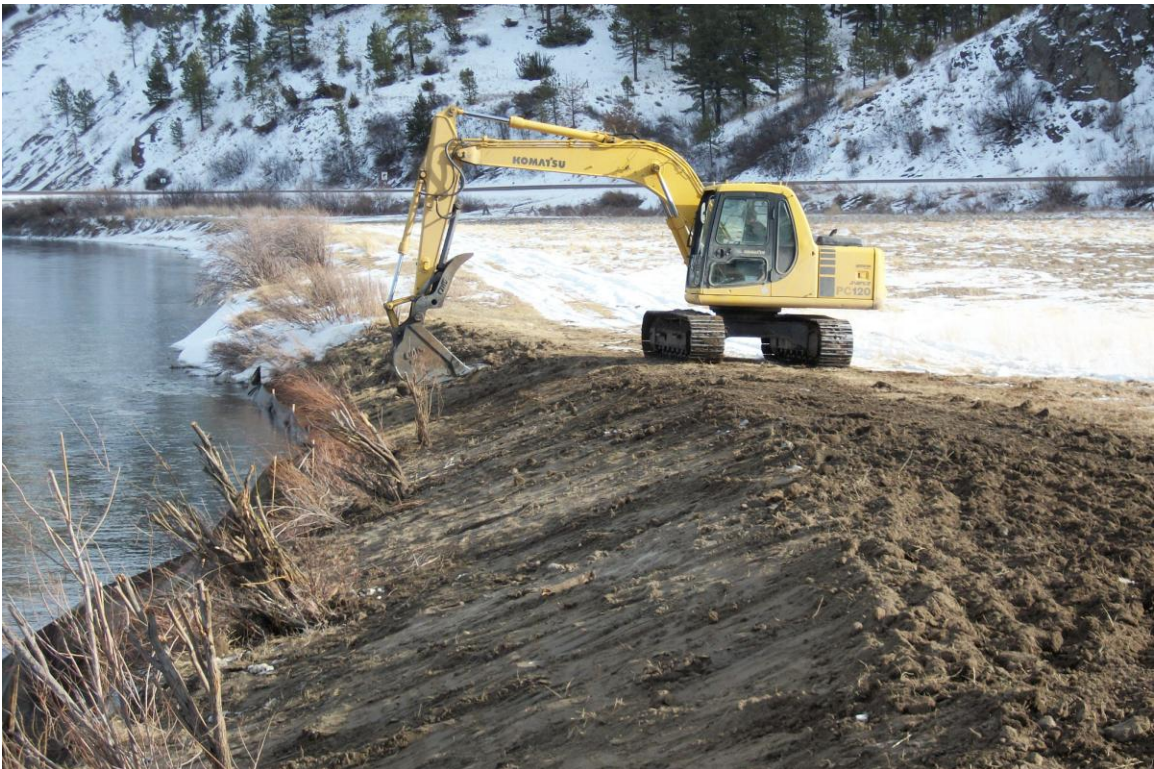
Figure 18. Missouri River bank restoration at Rumney pasture, Sterling Ranch, Craig, Montana, 2013.

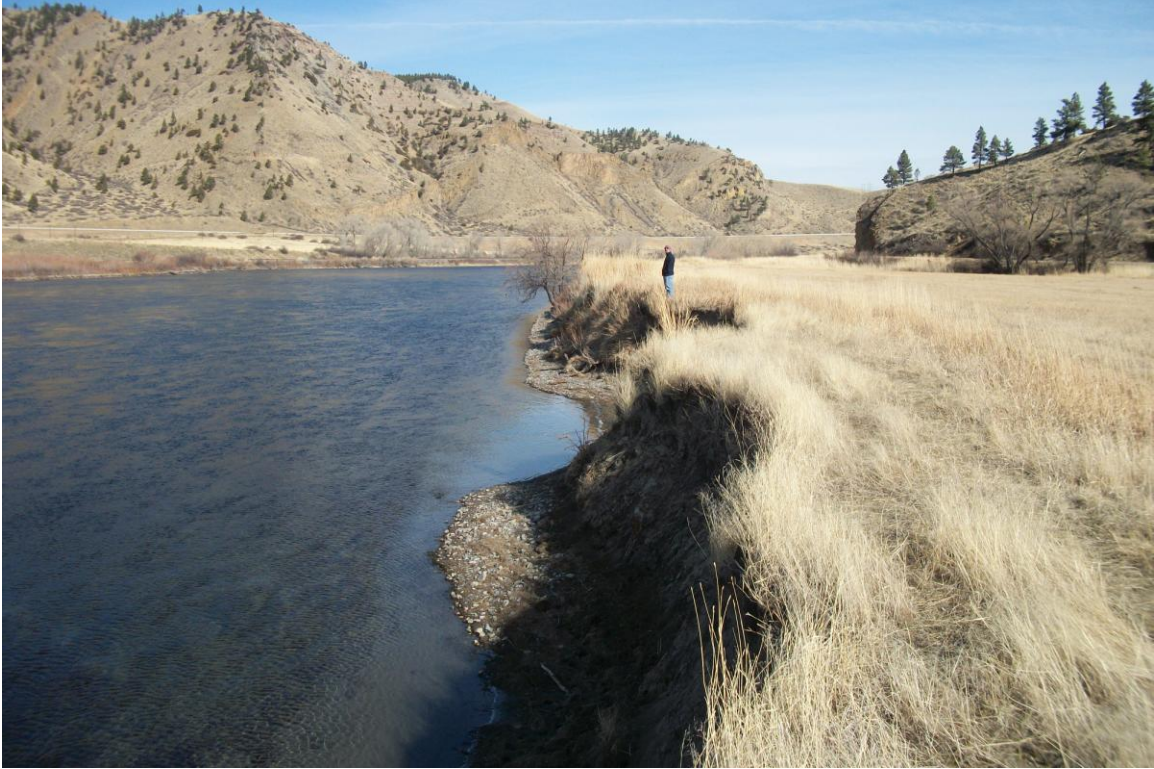
Figure 19. Missouri River bank erosion at Bross pasture, Sterling Ranch, Craig, Montana, 2012.

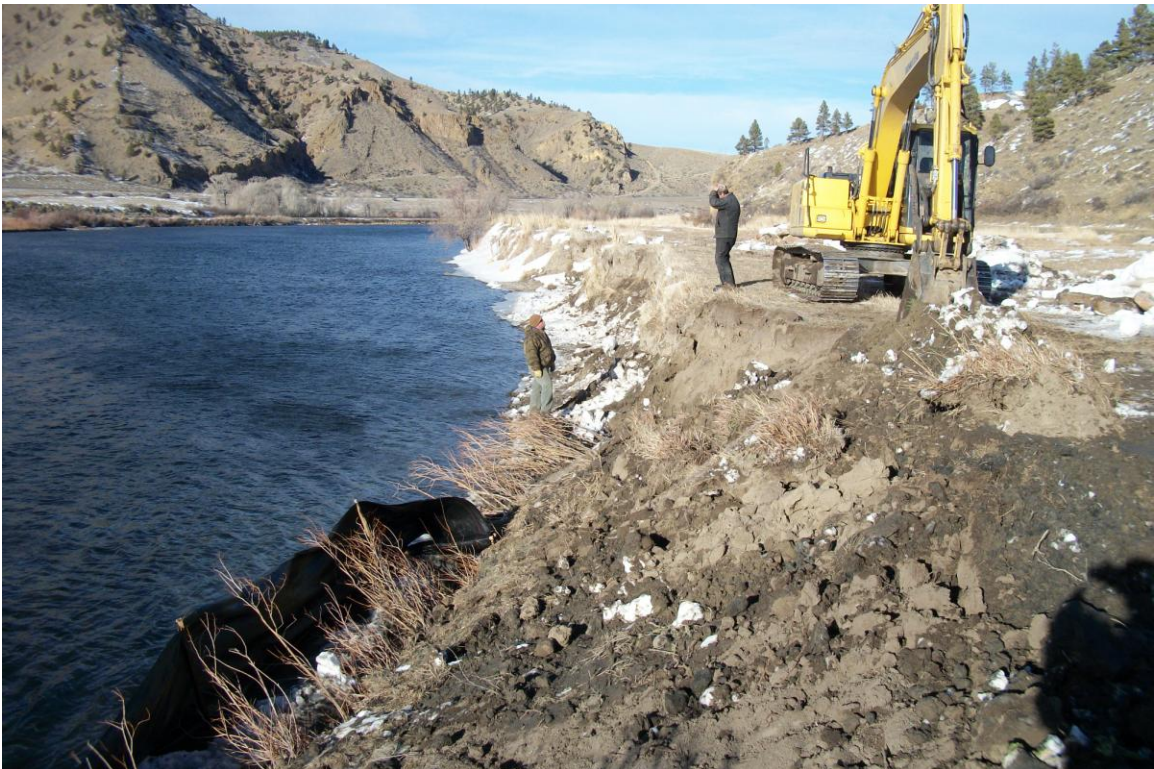
Figure 20. Missouri River bank restoration at Bross pasture, Sterling Ranch, Craig, Montana, 2013.

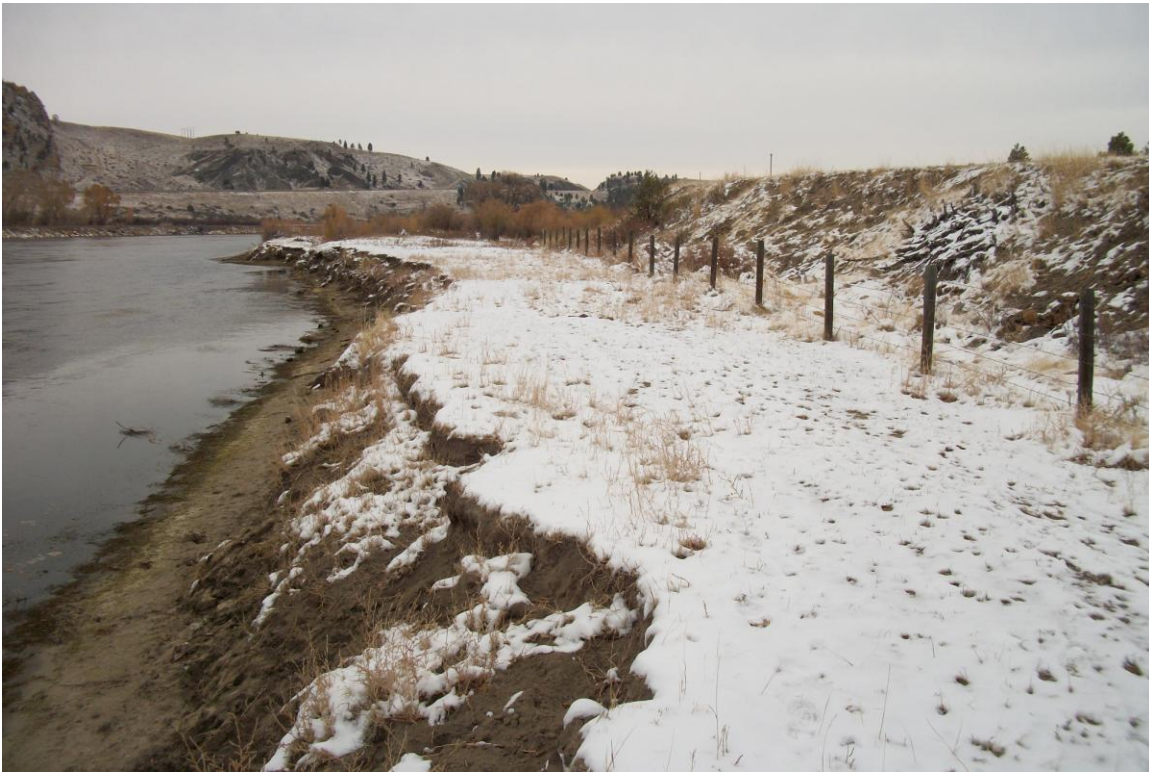
Figure 21. Missouri River bank erosion at intermediate site between Bross and Rumney pastures. Sterling Ranch, Craig, Montana, 2012.
