**Little Prickly Pear Creek  
Post-Flood Event Restoration  
At Sieben Ranch**

Status Report for Northwestern Energy  
FERC Project 2188

Project #2019-21

December 2019

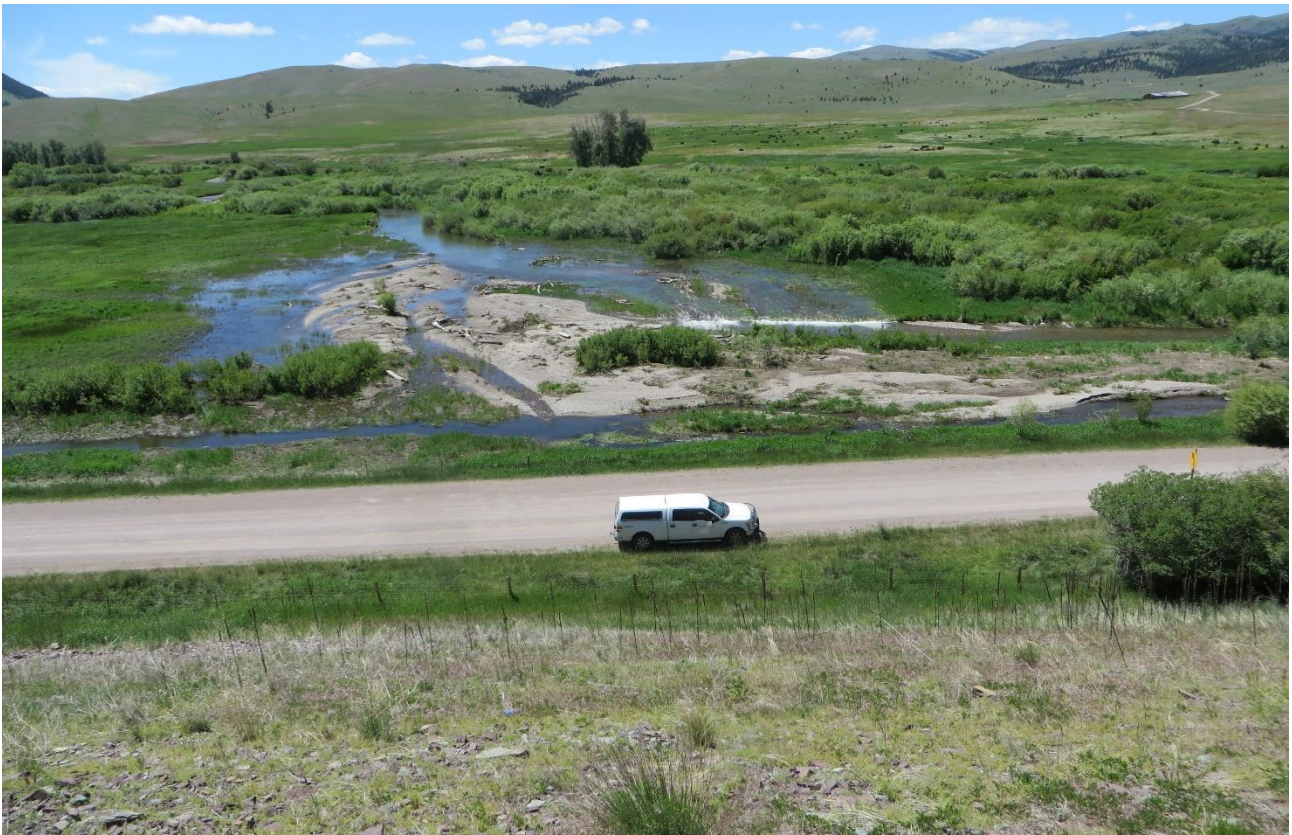
Based on an assessment by Northwestern Energy's restoration consultant, the unravelling of the constructed stream channel on the Sieben Ranch during the 2018 spring run-off appeared to be a chain of events that possibly started downstream of the constructed channel. A survey of the impacted stream reach showed the existing stream channel bottom downstream of the constructed reach was almost a foot lower than when construction ended in 2014. This elevation change indicated a headcut may have started downstream and advanced through the project area. The third (most downstream) former rock cross-vane apparently failed on the right bank of the channel, which added over a foot of gradient differential to any advancing headcut. This differential caused a cascade effect upstream, taking out the second rock cross-vane, which caused a large amount of eroded sediment to plug the stream channel down valley creating the alluvial fan at the bottom of the constructed reach.

**Photo 3. Little Prickly Pear Creek after 2018 flood event. June 14, 2018.**

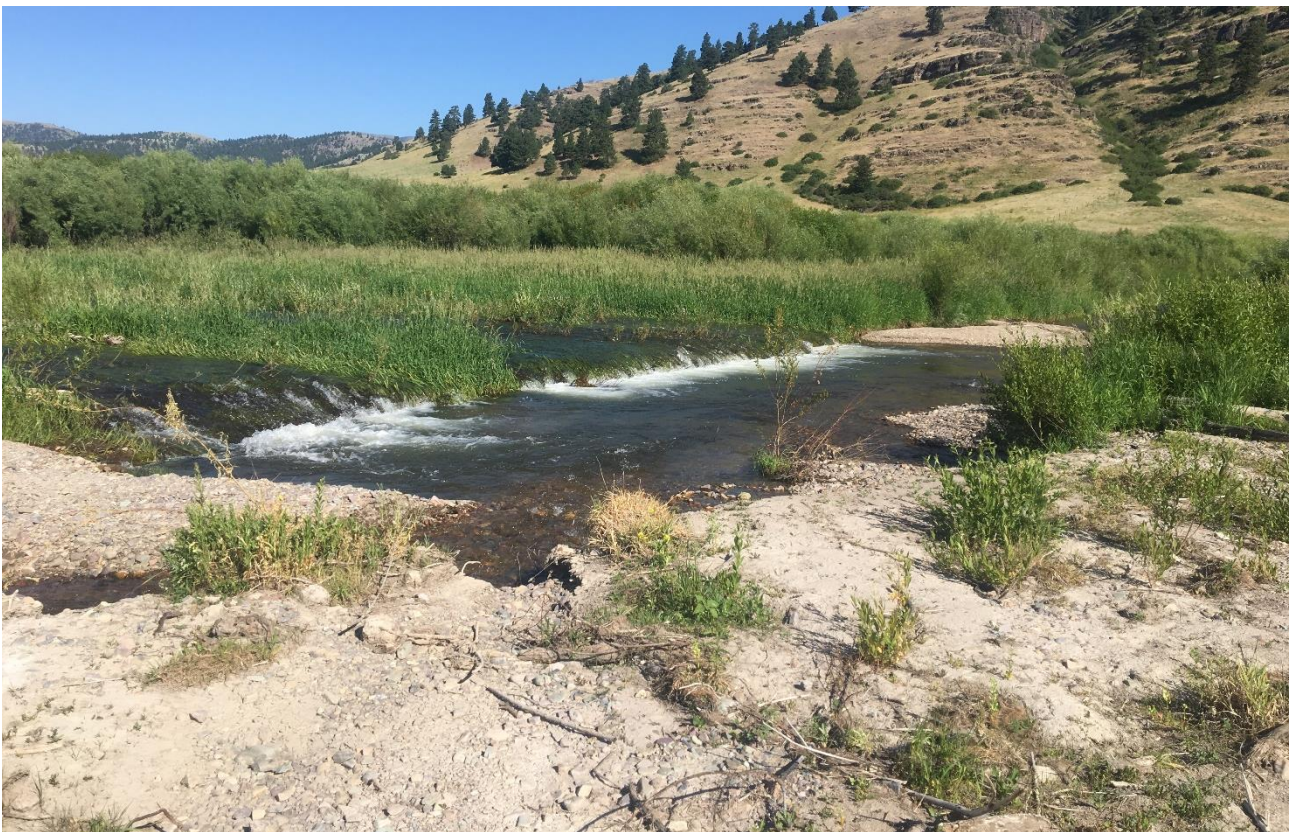
**Photo 4. Little Prickly Pear Creek after 2018 flood event. July 16, 2018.**

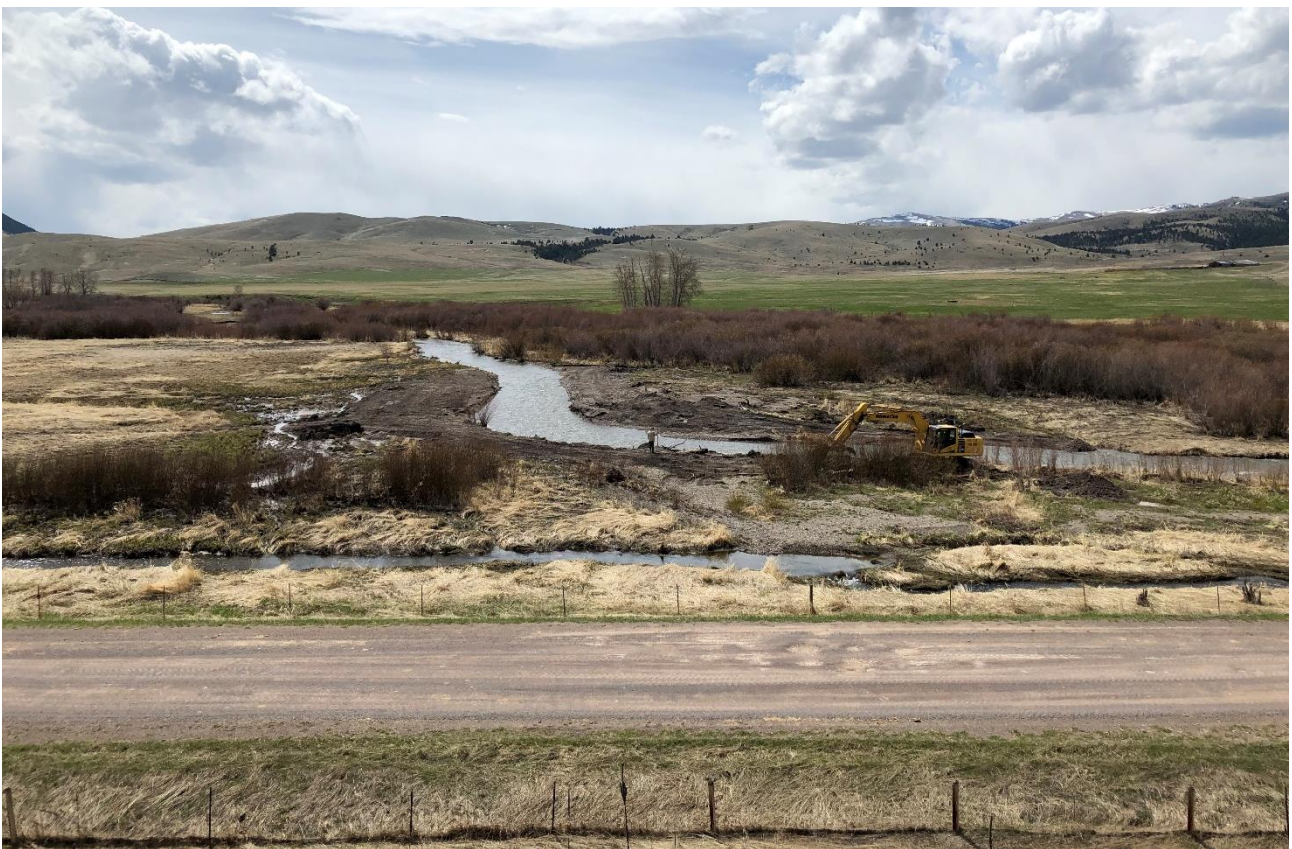
**Photo 6. Little Prickly Pear Creek after 2018 flood event, during restoration. May 1, 2019.**

The restoration approved by the MoTAC and permitted by the appropriate agencies was completed in late April and early May 2019. The restoration and maintenance consisted of removal of the stream channel plug and stabilizing and redefining the existing channel. Rock grade control structures were also constructed in two areas of active headcuts to prevent further channel down cutting. Rock grade control structures were constructed with 2 ft minus rock and built to the stream grade to prevent a similar occurrence from happening in the future.

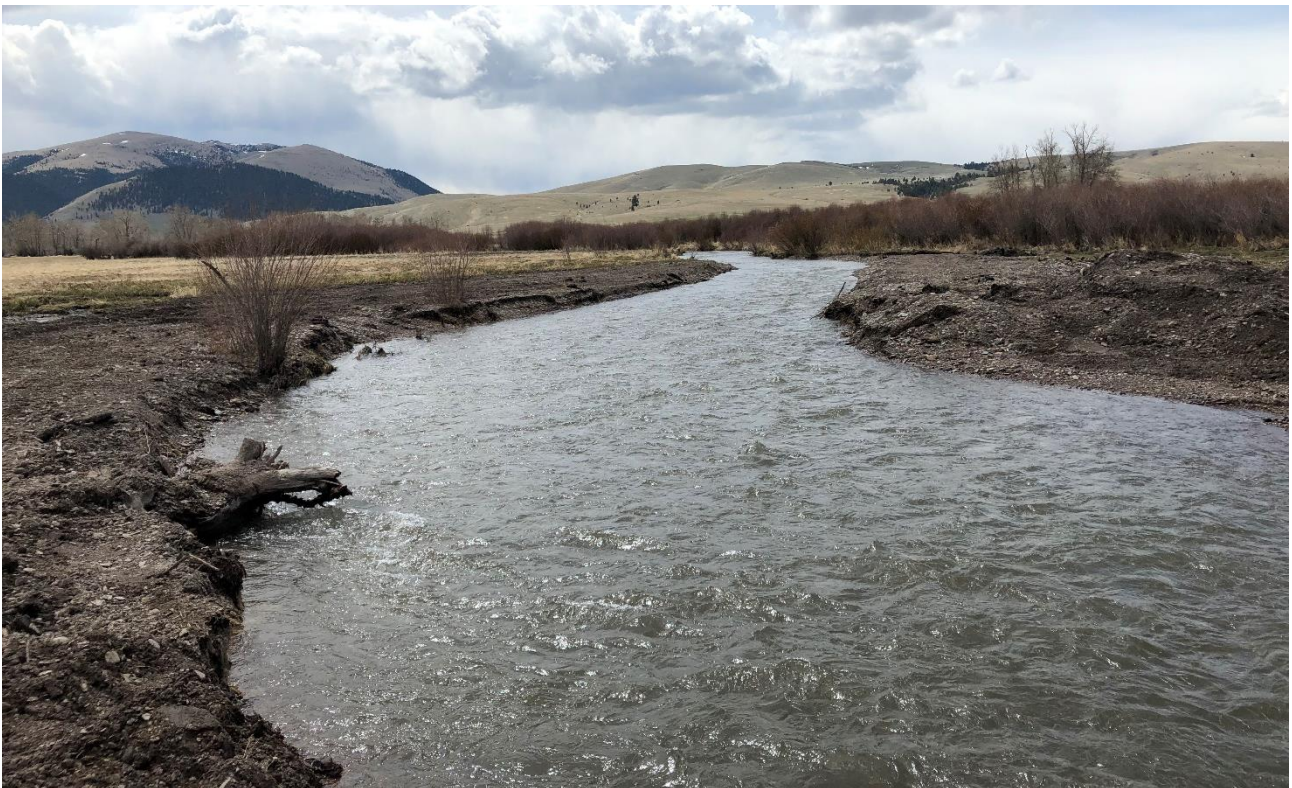
**Photo 8. Little Prickly Pear Creek after 2018 flood event, during restoration. May 1, 2019.**

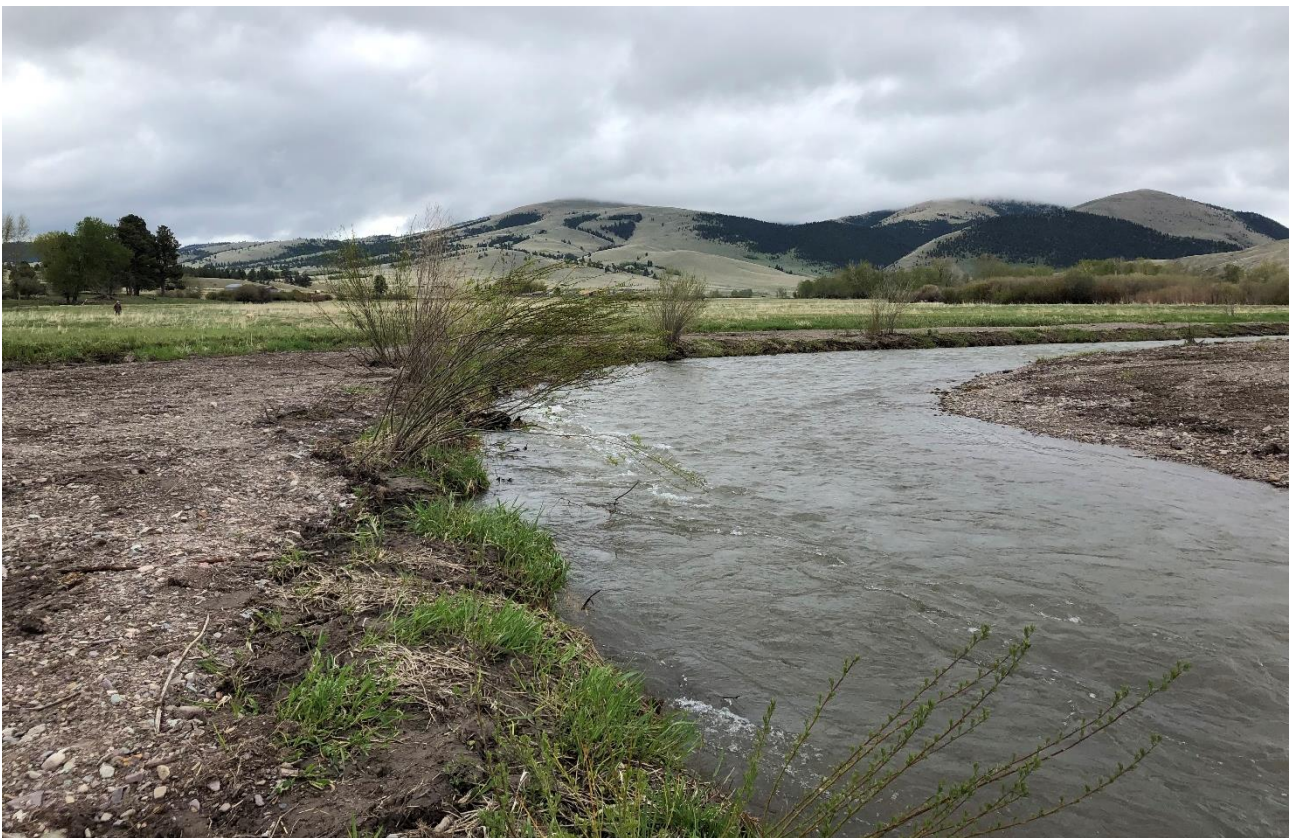
**Photo 10. Little Prickly Pear Creek after 2018 flood event, after restoration. May 21, 2019.**
