Future Fisheries Improvement Program Legislative Report | 2019-2020

Summary of Program activities from November 1, 2018 to October 31, 2020.

Fish Management Bureau

Fisheries Division

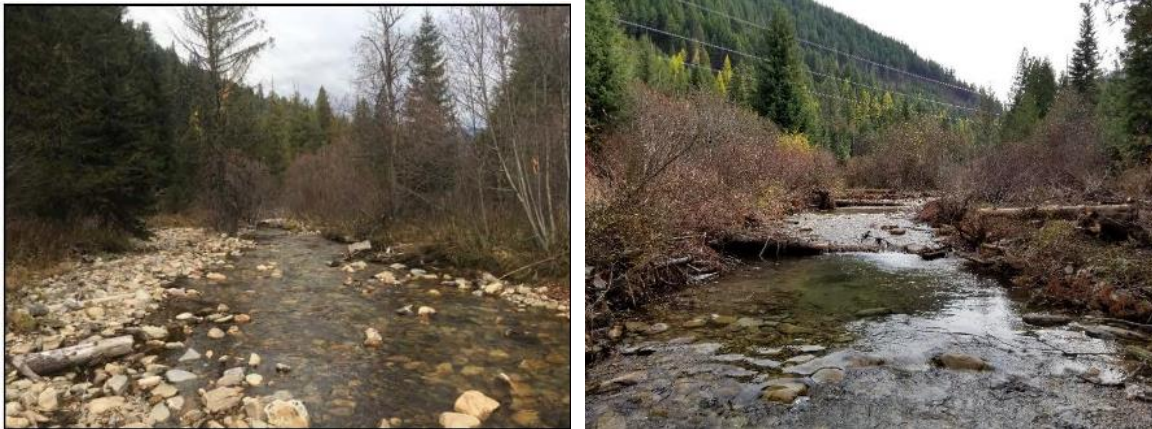
FIGURE 6. CROW CREEK BEFORE (L) AND AFTER (R) CONSTRUCTION. PHOTOS COURTESY OF LOWER CLARK FORK WATERSHED GROUP AND RIVER DESIGN GROUP. NOTE HABITAT STRUCTURE ADDED TO THE RIGHT SIDE OF THE AFTER PHOTO.

goal was to restore a degraded segment of stream and floodplain and improve native fish habitat. Improved habitat is intended to improve the carrying capacity of native salmonids in this portion of Crow Creek, similar to phase 1. **COMPLETED; \$23,000 (EXPENDED \$17,898), LOWER CLARK FORK WATERSHED GROUP.**

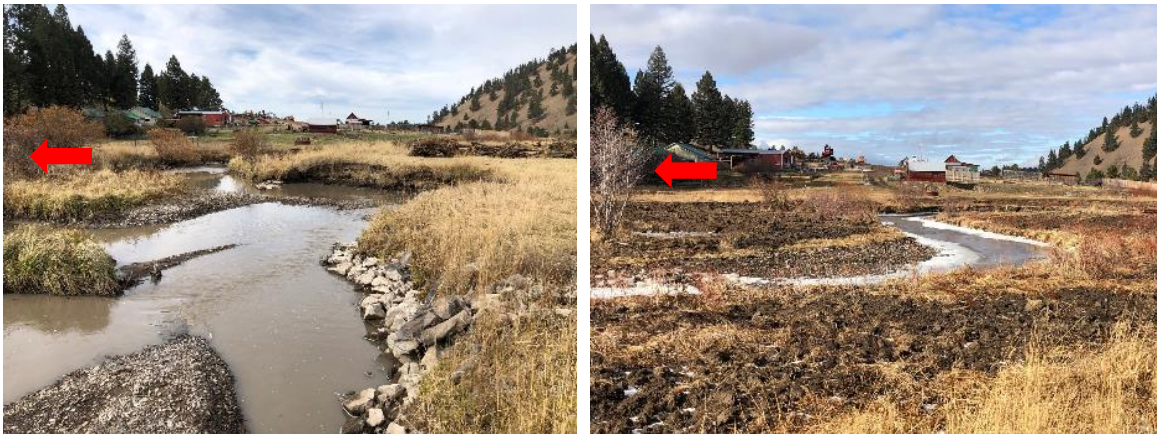
FIGURE 7. NEVADA CREEK BEFORE (L) AND AFTER (R) CONSTRUCTION. PHOTOS COURTESY OF BIG BLACKFOOT CHAPTER OF TROUT UNLIMITED. THE RED ARROW IS FOR REFERENCE POINT IN BOTH PHOTOS.

This project was considered phase 3A and continued the restoration downstream. Approximately 4,700 feet of Nevada Creek was tied into phase 2 and the channel was restored to proper dimensions. Habitat was improved by increasing overhead and in-stream cover, sediment inputs are expected to be reduced, floodplain connectivity should improve, vegetation growth should increase, and a grazing management system will be implemented. The location is in a highly visible reach of Nevada Creek and the previous projects had important demonstration value. **COMPLETED; \$49,000 (\$53,900 EXPENDED WITH 10% OVERAGE), BIG BLACKFOOT CHAPTER OF TROUT UNLIMITED (BBCTU).**

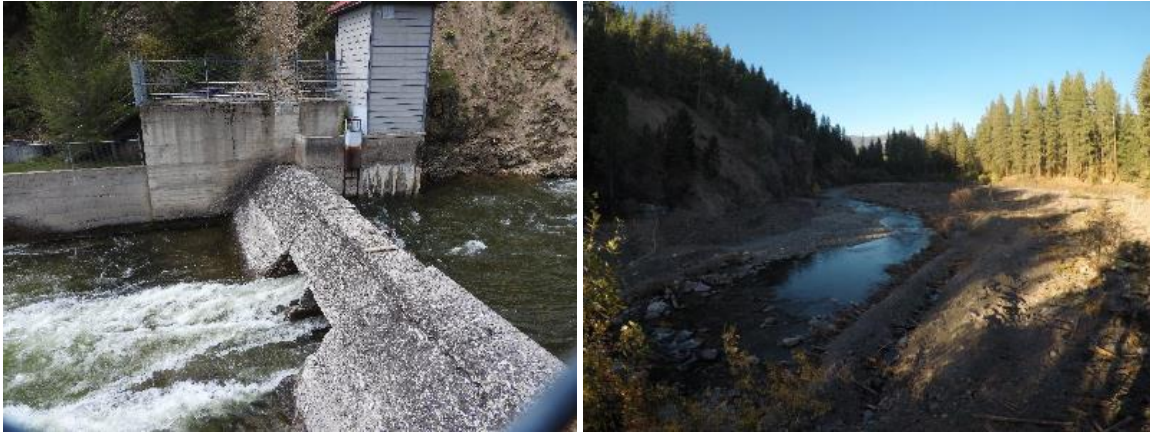
FIGURE 8. RATTLESNAKE CREEK BEFORE (L) AND AFTER (R) DAM REMOVAL. THE FORMER DAM SITE IS IN THE BOTTOM LEFT AREA OF THE AFTER PHOTO. AFTER PHOTO COURTESY OF MONTANA TROUT UNLIMITED.

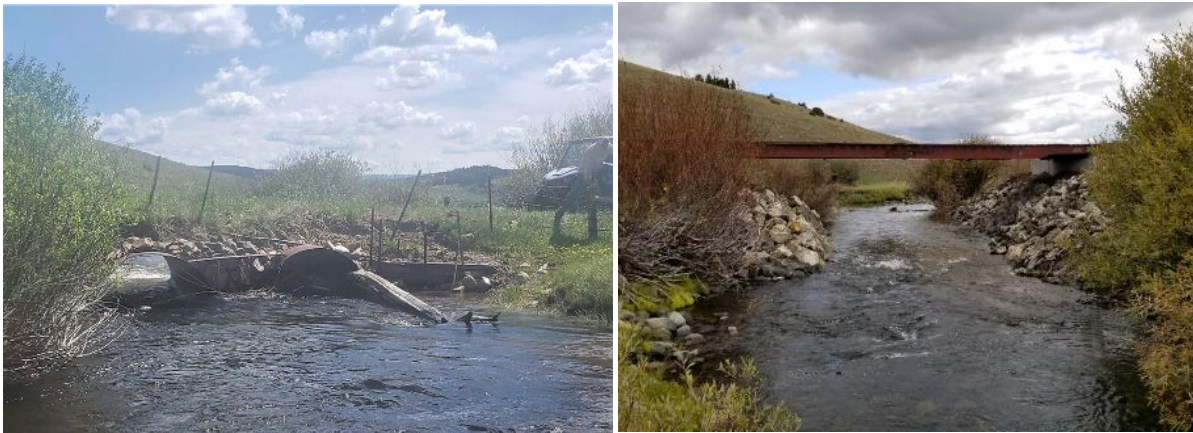
FIGURE 9. ROSS FORK ROCK CREEK BEFORE (L) AND AFTER (R) THE PROJECT; REPLACING UNDERSIZED CULVERTS WITH A RAIL CAR FARM BRIDGE. PHOTOS COURTESY OF TROUT UNLIMITED.

Ross Fork Rock Creek (Granite County) is a tributary to Rock Creek and supports populations of westslope cutthroat trout and bull trout and is considered critical bull trout habitat. An inventory of instream structures identified this project as the only major upstream fish passage barrier on Ross Fork. This project removed two undersized, 5' wide culverts that were located 0.5 miles downstream of the U.S. Forest Service boundary (Figure 9). The culverts were undersized and a velocity barrier at critical times of the year. The undersized culverts were replaced with a farm bridge made from a railcar and eco-blocks. Two rock weirs were constructed to maintain streambed stability. The goal was to reconnect an additional 15 miles of spawning and rearing habitat and refugia in Ross Fork. This project is expected to benefit both resident and fluvial populations of bull and westslope cutthroat trout. **COMPLETED; \$21,400, TROUT UNLIMITED.**

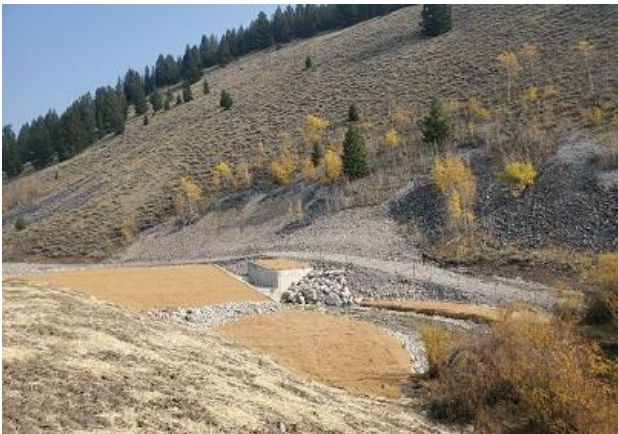
Selway Creek (Beaverhead County) is a tributary to Bloody Dick and Horse Prairie creeks upstream of Clark Canyon Reservoir and supports populations of non-native trout and native western pearlshell mussels. This project installed a fish barrier to re-establish a genetically pure westslope cutthroat trout population in 48 miles of stream (Figure 10). In the next phase, non-native fish will be removed and westslope cutthroat trout will be reestablished, which would make the Selway watershed among the strongest cutthroat trout strongholds in the upper Missouri River basin. The goal was to conserve and protect native westslope cutthroat trout. **COMPLETED; \$80,000, FWP.**

FIGURE 10. SELWAY CREEK BARRIER AFTER CONSTRUCTION.

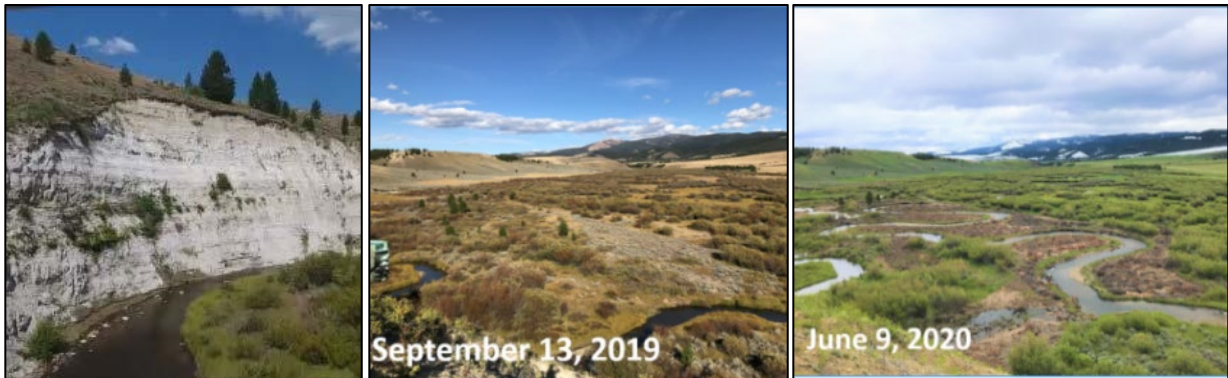
FIGURE 11. FRENCH CREEK CHANNEL RECONSTRUCTION BEFORE (L AND CENTER) AND AFTER (R). THE STREAM CHANNEL WAS MOVED AWAY FROM THE HIGHLY EROSIVE HILLSIDE (L PICTURE). PHOTOS COURTESY OF BIG HOLE WATERSHED COMMITTEE.

This project addressed mining-related damages due to an unnatural dike that has been confining the stream channel and leading to significant erosion and sediment deposition. Reference stream conditions were used to construct 4,000 feet of unconfined stream channel in the floodplain away from the hillslope (Figure 11). Native sods and willows were used to construct the banks of the new channel and bioengineering techniques were used at meander bends. The goal was to enhance fish habitat by reducing a major sediment source that impacts spawning substrate and water quality. **COMPLETED; \$40,000, BIG HOLE WATERSHED COMMITTEE.**

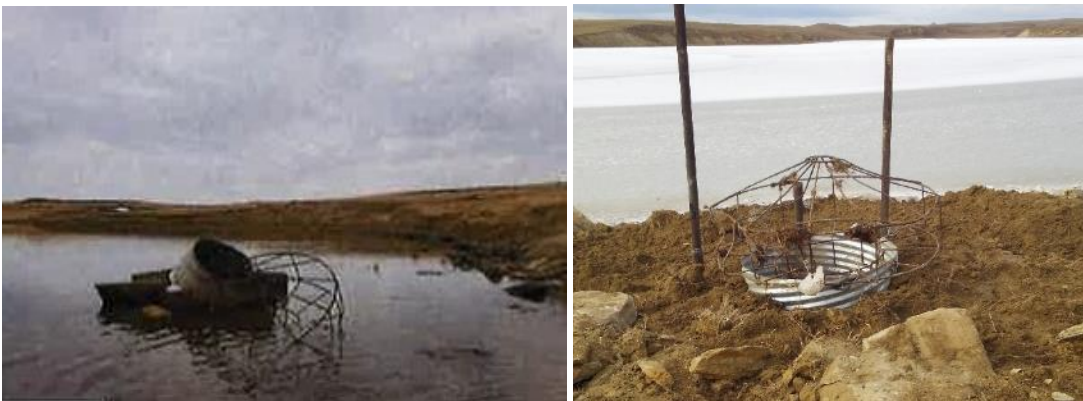
Haughian Bass Reservoir spillway repair (015-2019)

FIGURE 12. HAUGHIAN RESERVOIR SPILLWAY PIPE BEFORE (L) AND AFTER (R) CONSTRUCTION. BEFORE PHOTO COURTESY OF PAT HAUGHIAN.

Haughian Bass Reservoir is a 45-acre impoundment on private property in northern Custer County in the Cheery Creek drainage. It is managed within the Region 7 Pond Fishing Program, open to public access through landowner permission since 1975. This reservoir is larger than most ponds in the area and supports an above average quality fishery with largemouth bass, smallmouth bass, yellow perch, and northern pike. Many fish species naturally reproduce but there is some stocking. The existing spillway and concrete foundation were damaged due to shifting ice, and sandbags were placed around the damaged pipe to reduce water loss and minimize additional damage. Failure to repair the pipe could have compromised the spillway and reduced water depth by 3-4 feet, putting the reservoir in risk of winter kill. A head cut also threatened the integrity of the dam. The spillway pipe was excavated and repaired and the headcut was filled (Figure 12). The goal was to retain the high quality fishery and reduce the risk of a winter kill. **COMPLETE; \$4,583.20 (\$2,659 EXPENDED), LANDOWNER.**

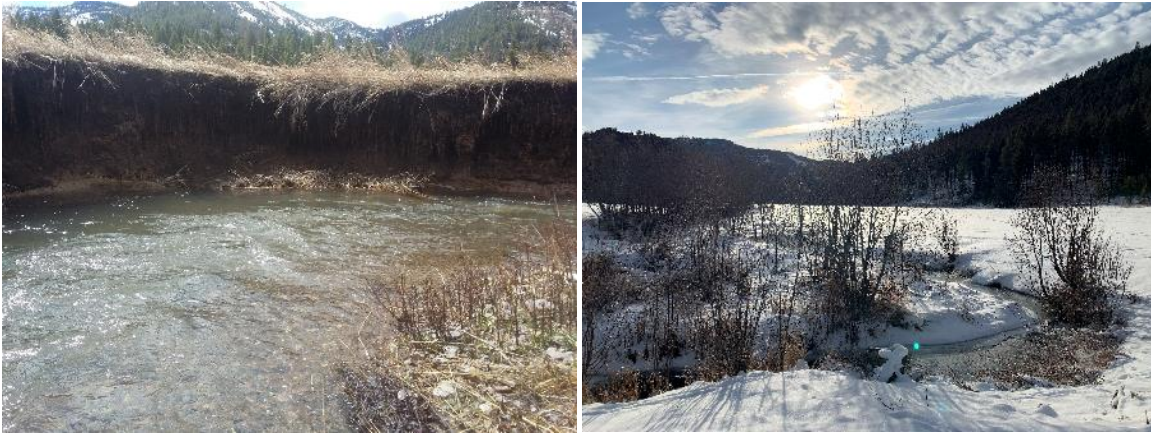
FIGURE 13. MILLER CREEK BEFORE (L) AND AFTER (R) CHANNEL RECONSTRUCTION AND REVEGETATION. BEFORE PHOTO COURTESY OF CLARK FORK COALITION.

Miller Creek (Missoula County) is a tributary to the Bitterroot River near Lolo that supports populations of westslope cutthroat trout and brook trout. It is considered a stronghold for native fish in the lower Bitterroot and several of its tributaries contain pure strain westslope cutthroat trout. These important tributaries enter Miller Creek within a six mile area, and this project addressed one of those six miles of stream. The project area was degraded due to past logging and agricultural practices and was actively eroding. The floodplain was disconnected, fine sediment was entering the stream, habitat diversity was reduced, and there was little riparian cover. This project addressed these problems and returned the project area to its natural function (Figure 13). In this one mile reach, the applicant designated a woody riparian vegetation expansion corridor and installed bed aggradation structures (with cobble, large wood, vegetation, or beaver dam analogs), channel shaping / realignment, riparian planting, habitat structures, and floodplain wetlands. The goals were to reduce water temperatures and sediment while enhancing aquatic and terrestrial habitat, thereby increasing wild fish populations. The stream is listed for temperature and sediment impairments (Clean Water Act section 303(d) list) and property is under a conservation easement and will not be grazed. This project has landowner support and value as a demonstration project. **COMPLETED; \$28,400, CLARK FORK COALITION.**

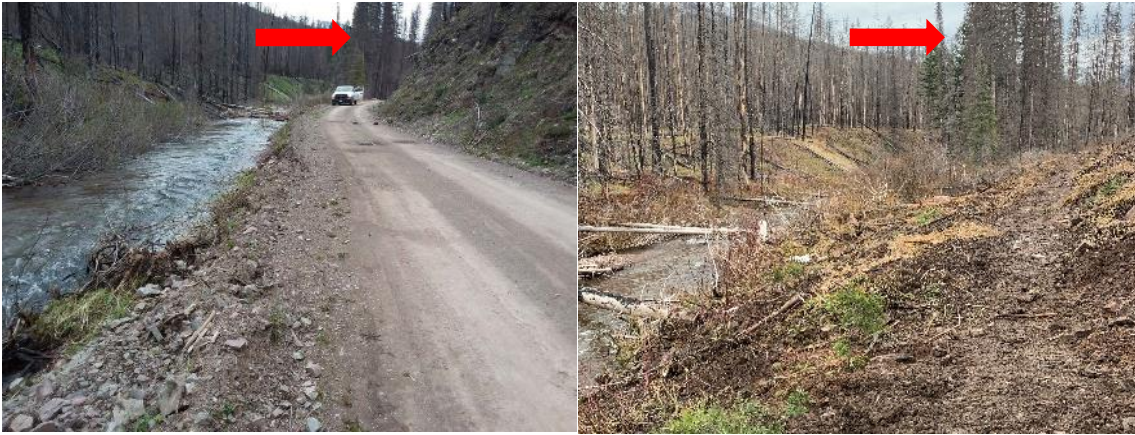
FIGURE 14. MORELL CREEK ROAD BEFORE (L) AND AFTER (R) DECOMMISSIONING. BEFORE PHOTO COURTESY OF BIG BLACKFOOT CHAPTER TROUT UNLIMITED. RED ARROWS DENOTE THE SAME TREES IN EACH PHOTO.

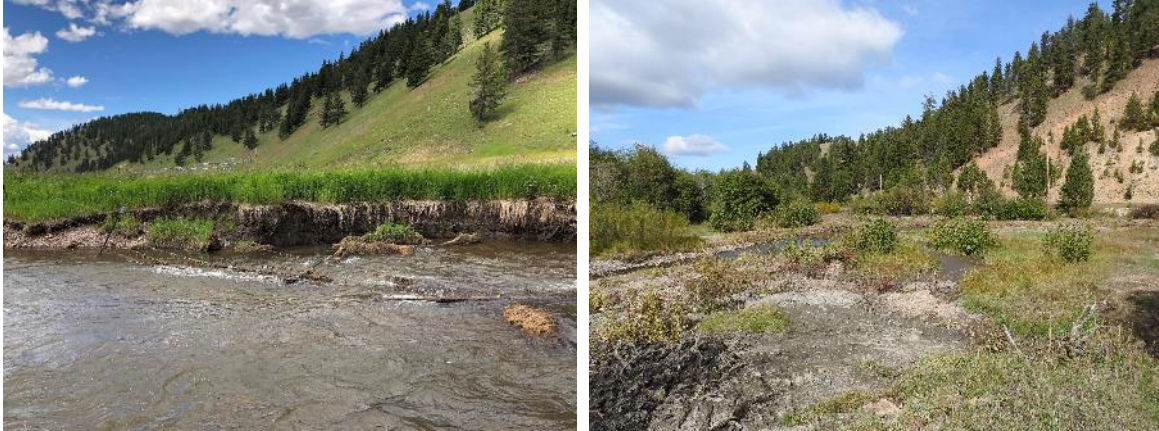
FIGURE 15. NEVADA CREEK BEFORE (L) AND AFTER (R) RESTORATION. NOTE THE REDUCTION IN CHANNEL WIDTH AND THE FLOODPLAIN AREA DEVELOPED. BEFORE PHOTO COURTESY OF BIG BLACKFOOT CHAPTER OF TROUT UNLIMITED.

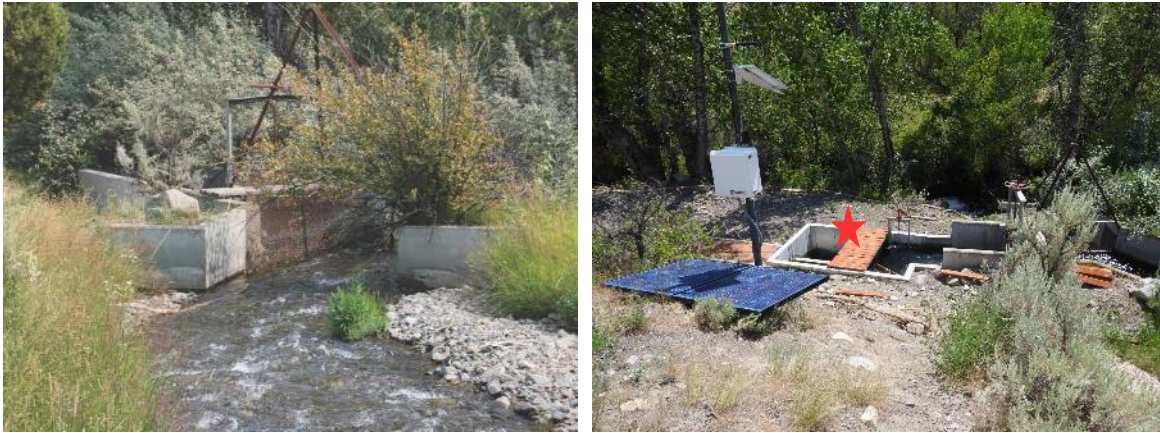
Reese Creek (Park County) is a tributary to the Yellowstone River near the northern boundary of Yellowstone National Park that supports both a resident population of Yellowstone cutthroat trout at its headwaters and a migratory spawning population that originates in the mainstem Yellowstone River. This project improved the headgate, incorporated a fish screen, and installed a pipeline between the existing diversion and intake pond, decreasing the necessary diverted flow volume and salvage seepage losses, providing additional instream flow to Reese Creek. Between 1.3 and 3.84 cfs will be saved from seepage, for 4.3 cfs (spawning) or 1.6 cfs (remainder of the year) of flow (Figure 16). The goal of this project is to ensure minimum instream flows are available in Reese Creek year-round, which should increase survival of Yellowstone cutthroat trout fry and increase recruitment to the Yellowstone River. **COMPLETED; \$20,000 (TOTAL INVESTMENT \$75,000 INCLUDING A PREVIOUS GRANT), TROUT UNLIMITED.**

FIGURE 16. REESE CREEK DIVERSION BEFORE (L) AND AFTER (R) RESTORATION. THE PROJECT INCLUDED INSTALLATION OF A FISH SCREEN AND PIPELINE (DENOTED BY STAR). BEFORE PHOTO COURTESY OF TROUT UNLIMITED.

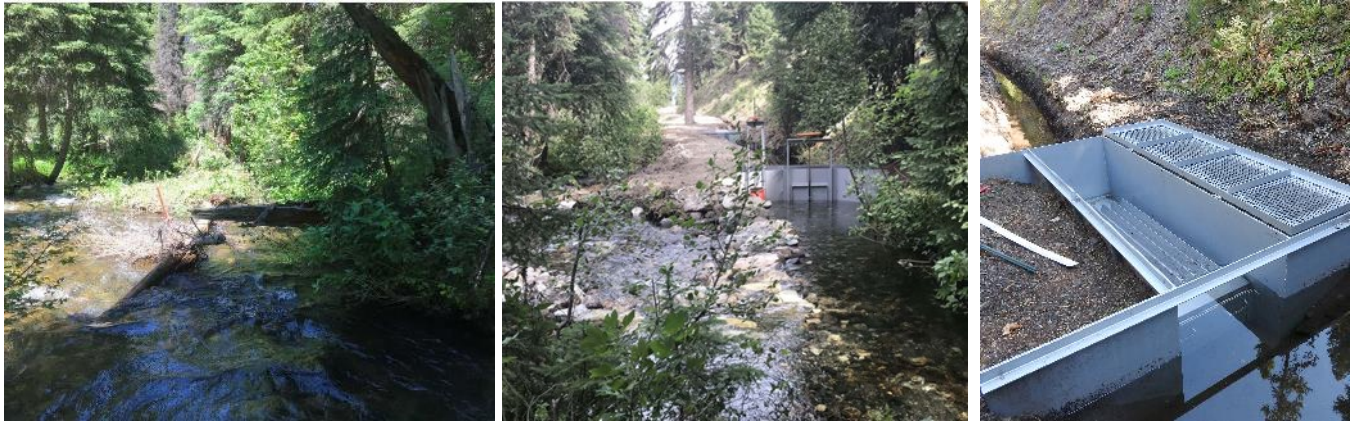
Wilson Ditch is located on the upper West Fork Bitterroot River (Ravalli County), above Painted Rocks Reservoir. The West Fork Bitterroot supports populations of bull trout, westslope cutthroat trout, and brook trout. The Wilson Ditch was silted in after fires in the upper watershed, but water users decided to reactivate the ditch, which is located in an important area for bull trout spawning. This project screened the Wilson Ditch, the highest diversion on the West Fork Bitterroot, and updated the diversion (Figure 17). The screen can accommodate 1.7 cfs, approximately 15% of baseflow. A

Corrugated Water Screen was used, which is a relatively new fish screen type in Montana that is known for having a relatively low cost and maintenance requirement. This project prevents native trout entrainment in the ditch, which is top priority for bull trout conservation in the Bitterroot. The irrigator assumed primary maintenance responsibilities, but Trout Unlimited and the U.S. Forest Service will contribute. **COMPLETED; \$30,630, TROUT UNLIMITED.**

FIGURE 17. WILSON DITCH BEFORE (L) AND AFTER (CENTER) AFTER DIVERSION UPGRADE. PHOTOS COURTESY OF TROUT UNLIMITED. A CORRUGATED WATER FISH SCREEN WAS INSTALLED IN THE DITCH (R).

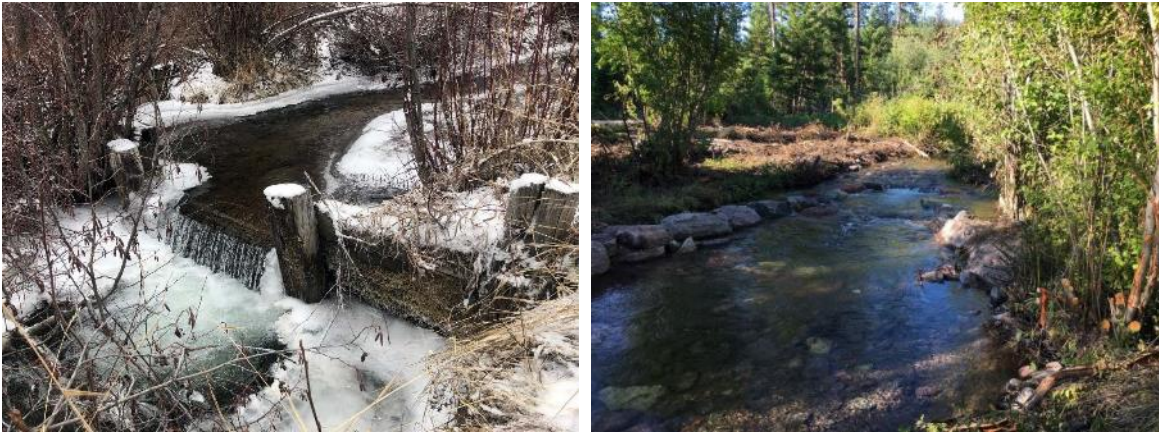
Boles Creek (Missoula County) is a tributary to Placid Lake near Seeley Lake that supports adfluvial and fluvial bull trout populations, with genetically pure westslope cutthroat trout populations in the headwaters. The stream is designated critical bull trout habitat. This project upgraded an existing irrigation diversion near stream mile 1.5 to eliminate entrainment of native trout and improve migration corridors and channel integrity. Recent sampling indicated that bull trout were entrained in existing ditches. The applicant replaced the existing wooden dam used to divert water with a rock cross-vane set at elevation to allow fish passage, stream channel function, and bedload movement (Figure 18). A fish screen was installed to keep fish out of both ditches of the existing diversion.

FIGURE 18. BOLES CREEK DIVERSION BEFORE CONSTRUCTION (L) AND AFTER CONSTRUCTION (R), USING A ROCK CROSS-VANE TO DIVERT WATER AND MAINTAIN FISH PASSAGE. BEFORE PHOTO COURTESY OF BIG BLACKFOOT CHAPTER OF TROUT UNLIMITED.

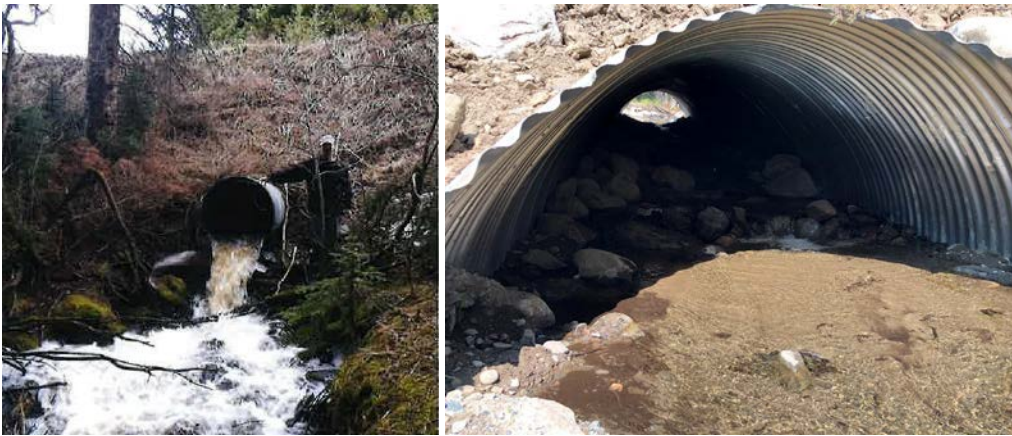
FIGURE 19. EAGLE CREEK UNDERSIZED CULVERT BEFORE CONSTRUCTION (L) AND LARGER ARCH CULVERT (R) AFTER CONSTRUCTION. BEFORE PHOTO COURTESY OF THE U.S. FOREST SERVICE.

Eagle Creek (Park County) is a tributary to the Yellowstone River near Gardiner. An in-channel pond and five road culverts excluded nonnative species and also fragmented Yellowstone cutthroat trout (YCT) along its 6.6 stream miles. The applicant replaced two upstream perched culverts with larger, sunken culverts that can pass aquatic species, increasing secure YCT habitat by an additional 2.8 stream miles (Figure 19). A lower barrier was maintained, with the goal of securing additional habitat for YCT while protecting them from non-native species. **COMPLETED; \$43,780, U.S. FOREST SERVICE.**

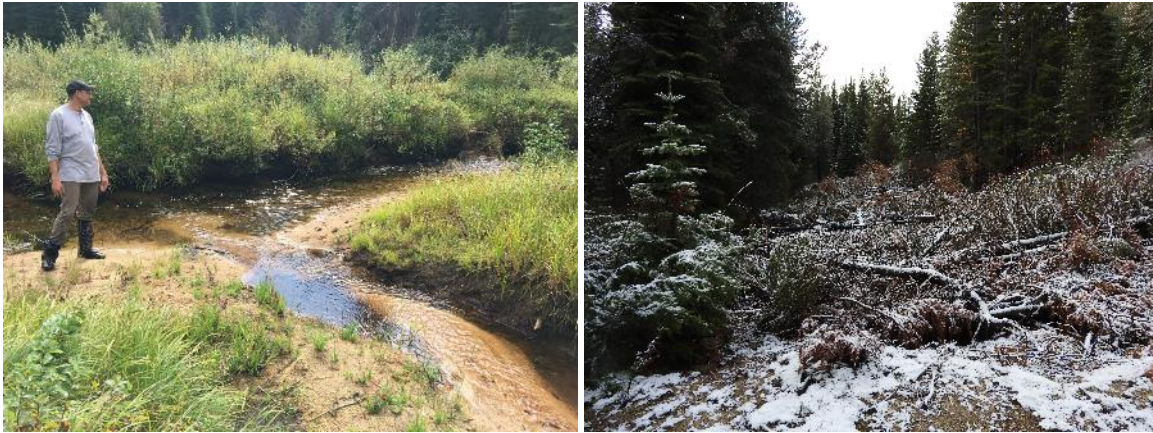
FIGURE 20. WEST FORK OF LOLO CREEK AND LEE CREEK BEFORE RESTORATION (L) AND AFTER (R) ROADS WERE DECOMMISSIONED. BEFORE PHOTO COURTESY OF CLARK FORK COALITION.

Lee and West Fork Lolo creeks (Missoula County) are located within the West Fork Lolo Creek drainage of Lolo Creek. Lolo Creek is a tributary to the Bitterroot River located near Lolo. This project is a continuation of other work done in the Lolo Creek watershed, addressing forest lands that were formerly under Plum Creek Timber Co. ownership that have a large network of roads and failing culverts. Westslope cutthroat trout, brown trout, and brook trout are present in the project area. Low densities of bull trout may be present in the drainage. The project decommissioned roads and removed passage barriers (Figure 20). Twenty-five culverts, including five that are partial fish passage barriers, were removed in 2020. The goal was to remove sediment inputs, improve natural stream function, and improve fish passage. **COMPLETED; \$30,500, CLARK FORK COALITION.**

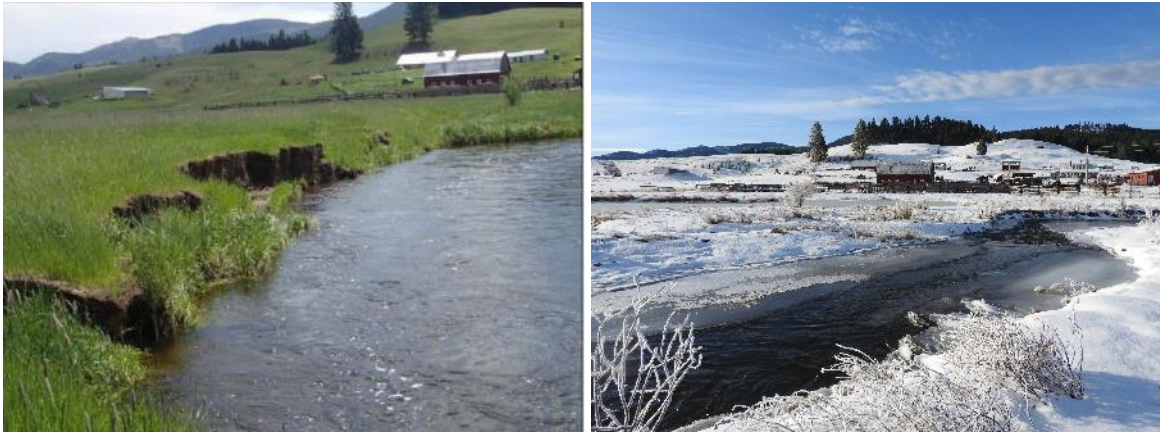
FIGURE 21. NEVADA CREEK PHASE 4 BEFORE (L) AND AFTER RESTORATION (R). BEFORE PHOTO COURTESY OF BIG BLACKFOOT CHAPTER TROUT UNLIMITED.

Approximately 7,100 feet of Nevada Creek channel was restored to proper dimensions (Figure 21). Habitat was improved by increasing overhead and in-stream cover, sediment inputs were reduced, floodplain connectivity was improved, vegetation growth was encouraged, and a grazing management system will be implemented. Western pearlshell mussels were also found in the project area.

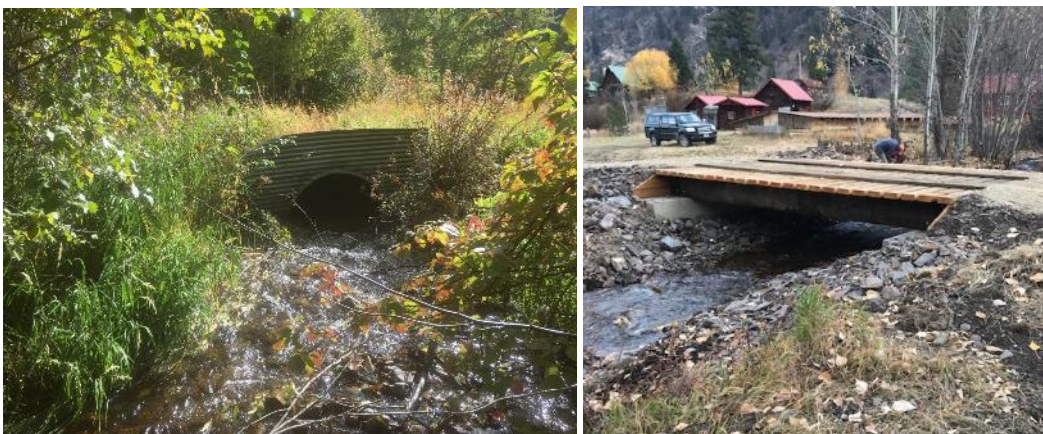
FIGURE 23. BREWSTER CREEK BEFORE (L) AND AFTER (R) RESTORATION. AN UNDERSIZED CULVERT WAS REPLACED WITH A FARM BRIDGE. PHOTOS COURTESY OF TROUT UNLIMITED.

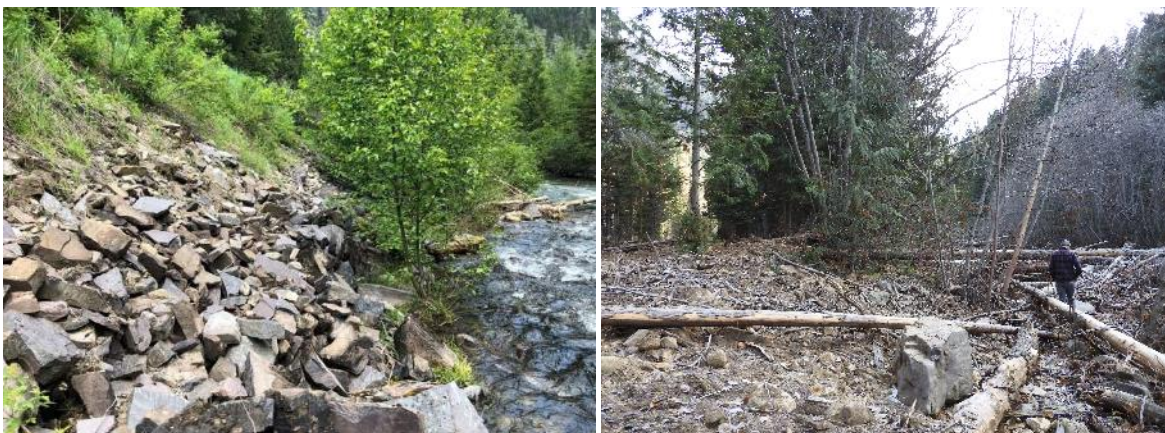
FIGURE 24. CEDAR CREEK BEFORE RESTORATION (L), WITH RIP RAP ALONG THE CREEK. AFTER (R) RESTORATION, WITH THE ROAD RELOCATED AND INSTREAM FISH HABITAT ADDED. BEFORE PHOTO BY TROUT UNLIMITED.

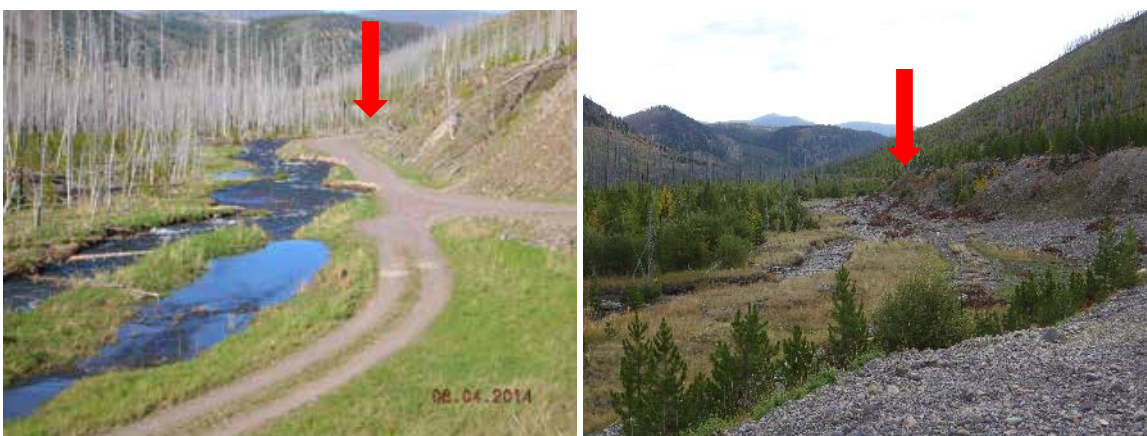
eroded into the stream. Sediment was identified as a limiting factor for bull trout habitat and therefore this project, which involved eliminating a chronic source of sediment to Copper Creek, was a priority for restoration. This project decommissioned approximately one mile of road adjacent to Copper Creek (Figure 25). The goal was to re-establish floodplain connectivity and function, restore the riparian corridor, and eliminate a chronic source of sediment while maintaining public access. At inspection, the road was functioning well and kept the floodplain intact.

FIGURE 25. COPPER CREEK BEFORE RESTORATION (L), WITH THE STREAM ERODING THE ROAD. THE ROAD WAS MOVED TO THE SIDESLOPE AND OUT OF THE FLOODPLAIN (R). RED ARROWS DENOTE COMMON FEATURES. BEFORE PHOTO COURTESY OF BIG BLACKFOOT CHAPTER OF TROUT UNLIMITED.

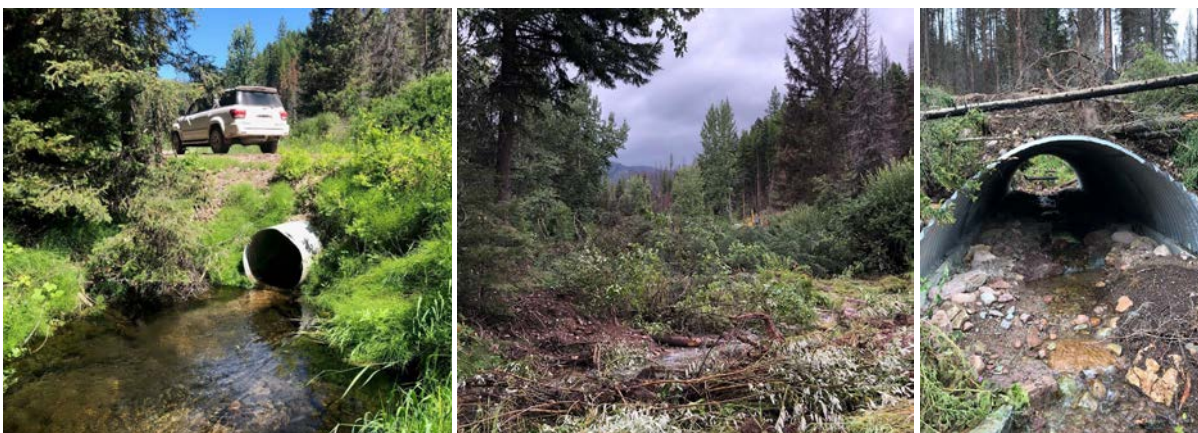
FIGURE 26. COTTONWOOD CREEK AND NORTH FORK COTTONWOOD CREEK. BEFORE RESTORATION, AN UNDERSIZED CULVERT IMPEDED FISH PASSAGE (L). THE ROAD WAS DECOMMISSIONED AND REROUTED (CENTER), AND A NEW CULVERT WAS INSTALLED (R). PHOTOS COURTESY OF BIG BLACKFOOT CHAPTER OF TROUT UNLIMITED.

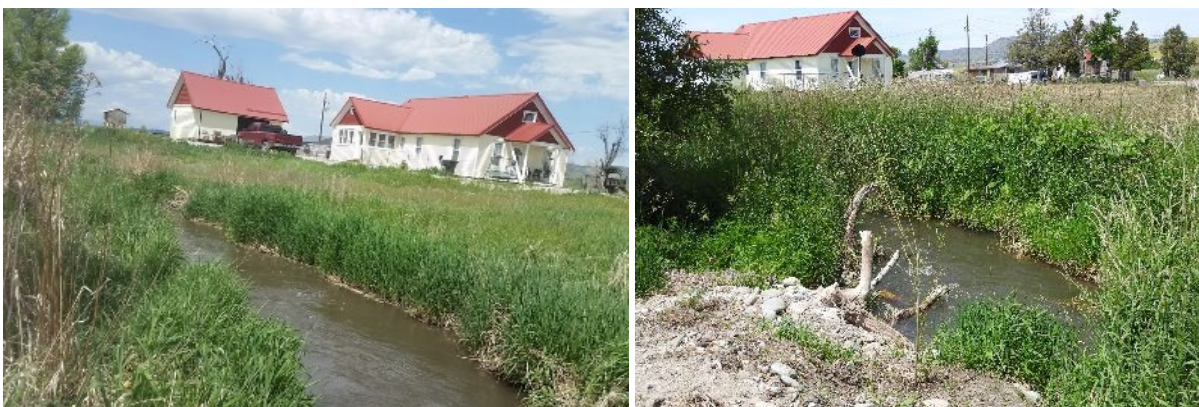
FIGURE 27. DRY CREEK BEFORE RESTORATION (L) WITH LITTLE STRUCTURE AND FLOODPLAIN ACCESS. AFTER RESTORATION (R), HABITAT STRUCTURE AND PLANTINGS WERE IN PLACE TO ADD DIVERSITY TO THE HABITAT. BEFORE PHOTO COURTESY OF TROUT UNLIMITED.

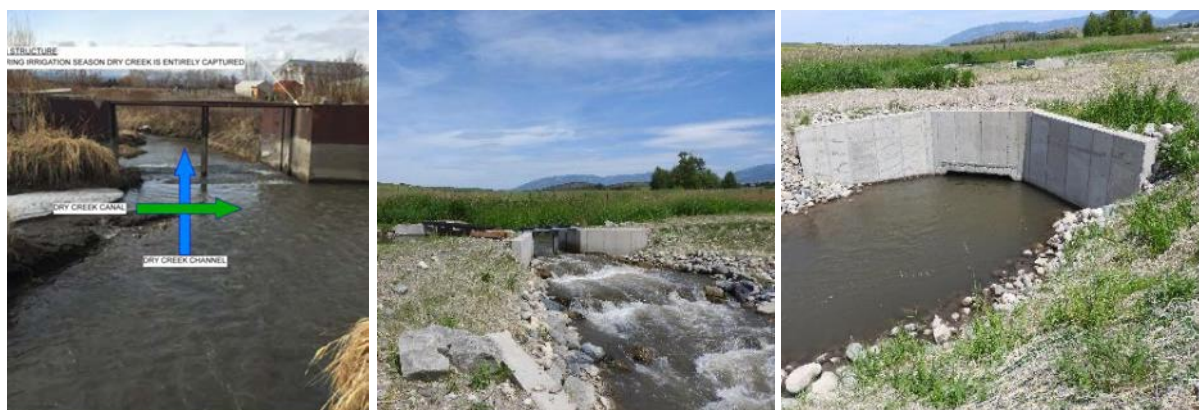
Dry Creek is a tributary to the East Gallatin River and supports populations of brown trout, mountain whitefish, and rainbow trout (Gallatin County). Dry Creek was seasonally disconnected from the East Gallatin for decades, as the stream captured by a large canal during irrigation season. Upstream fish migrations were blocked by the canal and downstream migrations were intercepted by the canal. This project installed a fish bypass that directed Dry Creek under the canal crossing (Figure 28). The goal was to reconnect the lower reaches of Dry Creek with the upper reaches and expand habitat access to a tributary stream that may be important spawning and rearing habitat and summer refugia.

FIGURE 28. DRY CREEK FISH PASSAGE BEFORE RESTORATION (L), WHERE THE CREEK WAS INTERCEPTED BY THE DITCH. THE PROJECT INSTALLED NEW IRRIGATION INFRASTRUCTURE (MIDDLE) AND BUILT A CULVERT TO ROUTE THE STREAM UNDERNEATH THE DITCH (R). BEFORE PHOTO COURTESY OF TROUT UNLIMITED.

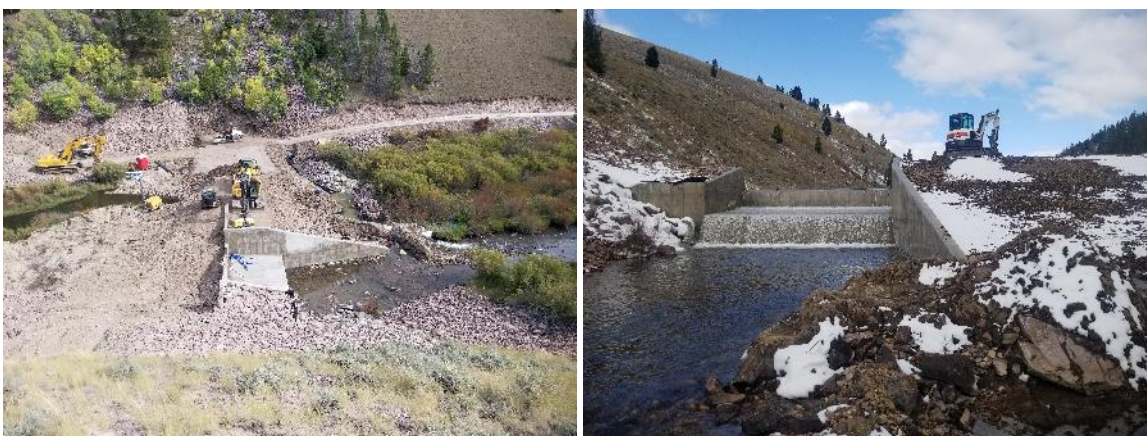
FIGURE 29. FRENCH CREEK BARRIER IN CONSTRUCTION (L) AND AFTER COMPLETION (R). THE NEXT PHASE OF THIS PROJECT WILL BE TO REMOVE NON-NATIVE FISH AND REINTRODUCE ARCTIC GRAYLING AND WESTSLOPE CUTTHROAT TROUT.

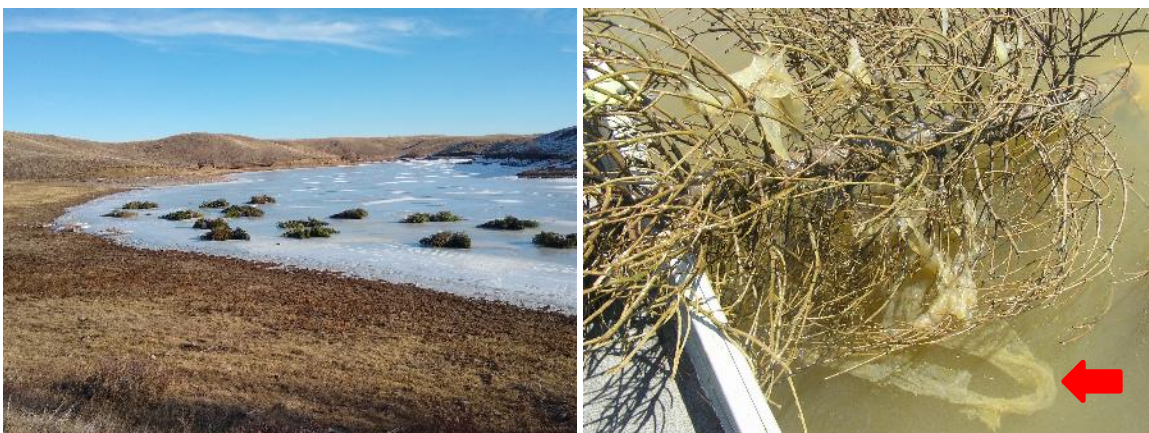
FIGURE 30. FRESNO RESERVOIR HABITAT STRUCTURES PLACED ON THE ICE (L) SO THEY WILL SINK AT ICE OFF. YELLOW PERCH REPRODUCTION A YEAR AFTER INSTALLATION (R; RED ARROW DENOTES EGG SKEINS).

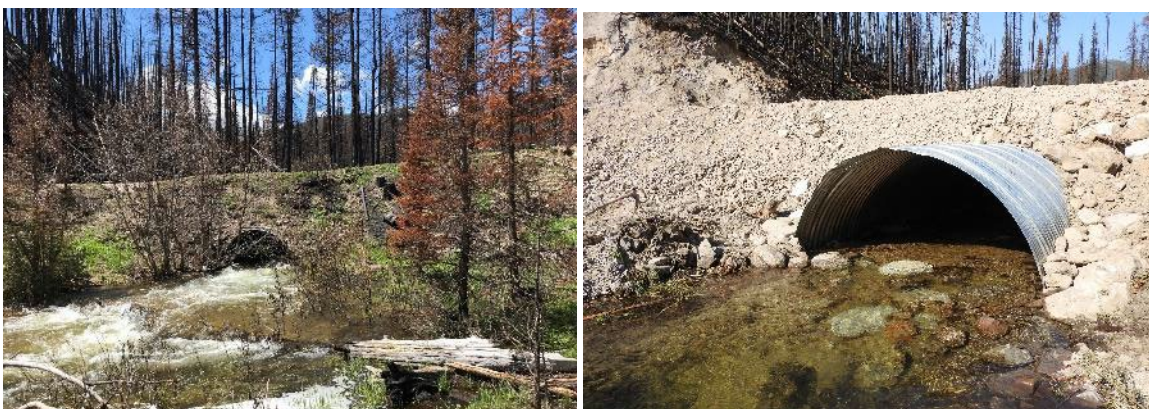
FIGURE 31. AN UNDERSIZED CULVERT IMPAIRED FISH PASSAGE ON GREEN CANYON CREEK (L) AND WAS REPLACED WITH A LARGER CULVERT (R). BEFORE PHOTO BY TROUT UNLIMITED.

Green Canyon Creek, a tributary to Copper Creek in the Rock Creek watershed near Phillipsburg (Granite County), supports populations of bull trout, westslope cutthroat trout, and mountain whitefish. This project replaced an undersized culvert at a road crossing that was perched and a partial fish barrier, which was at risk of failure from post-fire debris loading (Myers Fire). Environmental DNA (eDNA) sampling found bull trout below this undersized culvert but not above, indicating that the project could open additional habitat to bull trout. Approximately three miles of Green Canyon Creek were reconnected with this project. The undersized culvert was replaced with an 84" pipe and rock grade control structures and natural bed material to provide year-round passage while also preventing potential catastrophic impacts of a road washout associated with post-fire debris (Figure 31).

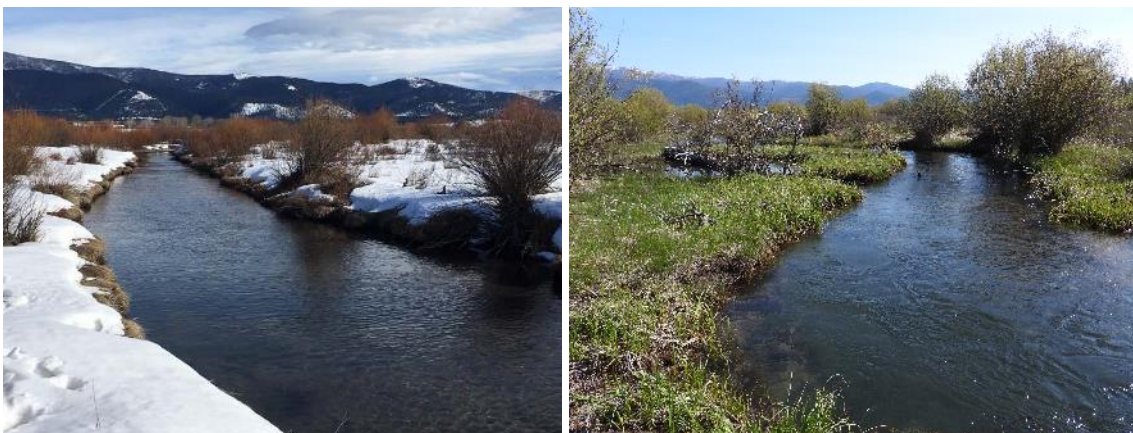
FIGURE 32. LINCOLN SPRING CREEK BEFORE RESTORATION WAS CHANNELIZED, WIDE AND UNABLE TO PROPERLY TRANSPORT SEDIMENT (L). THE PROJECT RESTORED THE STREAM CHANNEL TO A NATURAL WIDTH (R), IMPROVED STREAM COMPLEXITY, AND CREATED ADDITIONAL FLOODPLAIN ACCESS. BEFORE PHOTO BY BIG BLACKFOOT CHAPTER OF TROUT UNLIMITED.

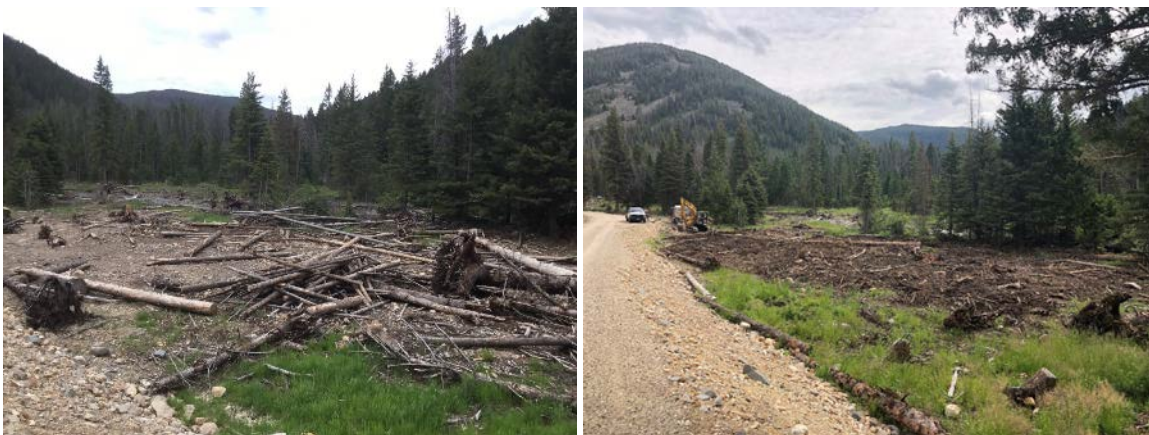
FIGURE 33. ONTARIO CREEK WAS AFFECTED BY MANY ROADS WITHIN THE FLOODPLAIN (L). THIS PROJECT DECOMMISSIONED THE UNAUTHORIZED ROADS AND MOVED THE MAIN ROAD OUT OF THE FLOODPLAINS. PHOTOS COURTESY OF THE U.S. FOREST SERVICE.

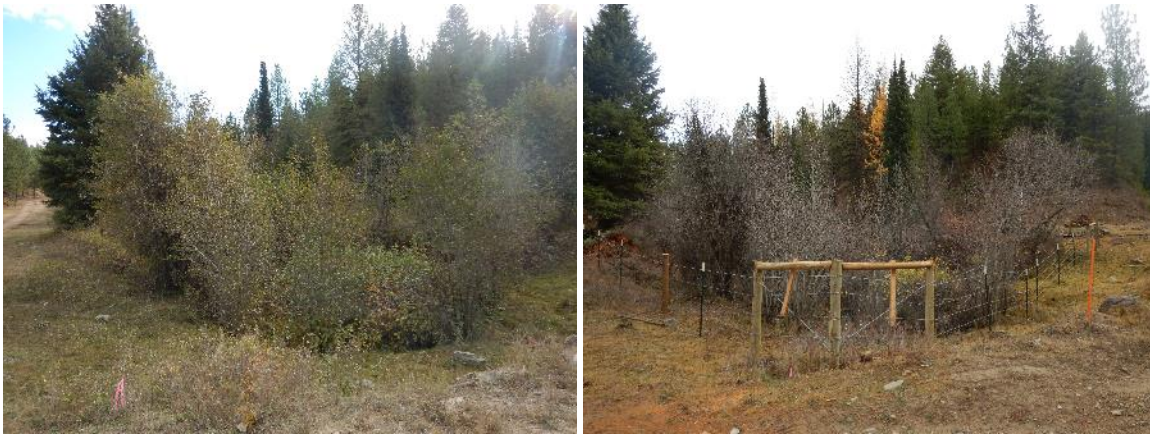
Loneman Creek (Sanders County) is a tributary to the Little Thompson River and contains westslope cutthroat trout. The Little Thompson River was impacted by sediment, nutrients, and water temperature. The project area was negatively impacted by cattle, which had unrestricted access to the creek. This project installed exclusion fencing to allow the stream to recover and improve habitat, shade, and reduce temperatures, nutrients, and sediment (Figure 34). The goal was to encourage recovery of the stream and riparian areas, improve water quality, and enhance aquatic habitat.

FIGURE 34. LONEMAN CREEK BEFORE (L) AND AFTER (R) RIPARIAN FENCING WAS INSTALLED. PHOTOS COURTESY OF THE LOWER CLARK FORK WATERSHED GROUP.

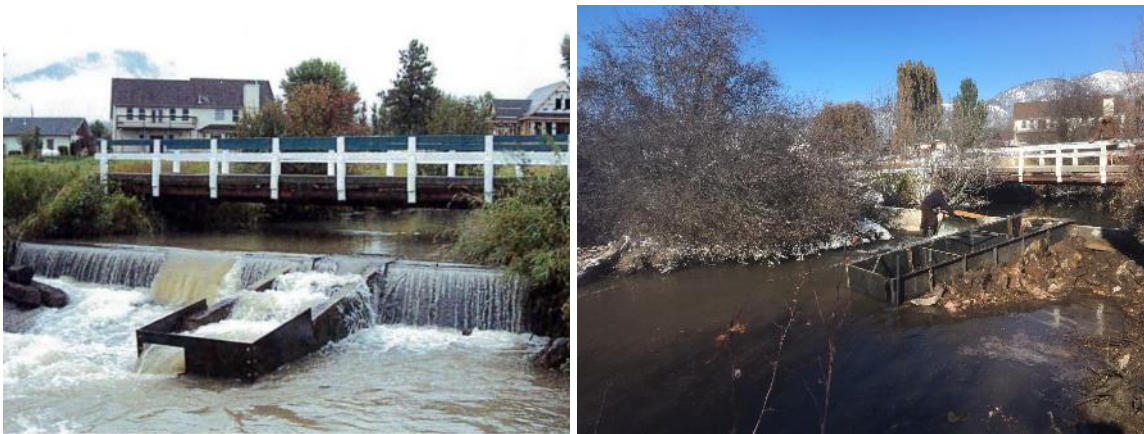
FIGURE 35. MILL CREEK FISH LADDER BEFORE (L) AND AFTER IT WAS REPLACED FOR FUNCTIONALITY (R). AFTER PHOTO COURTESY OF TROUT UNLIMITED.

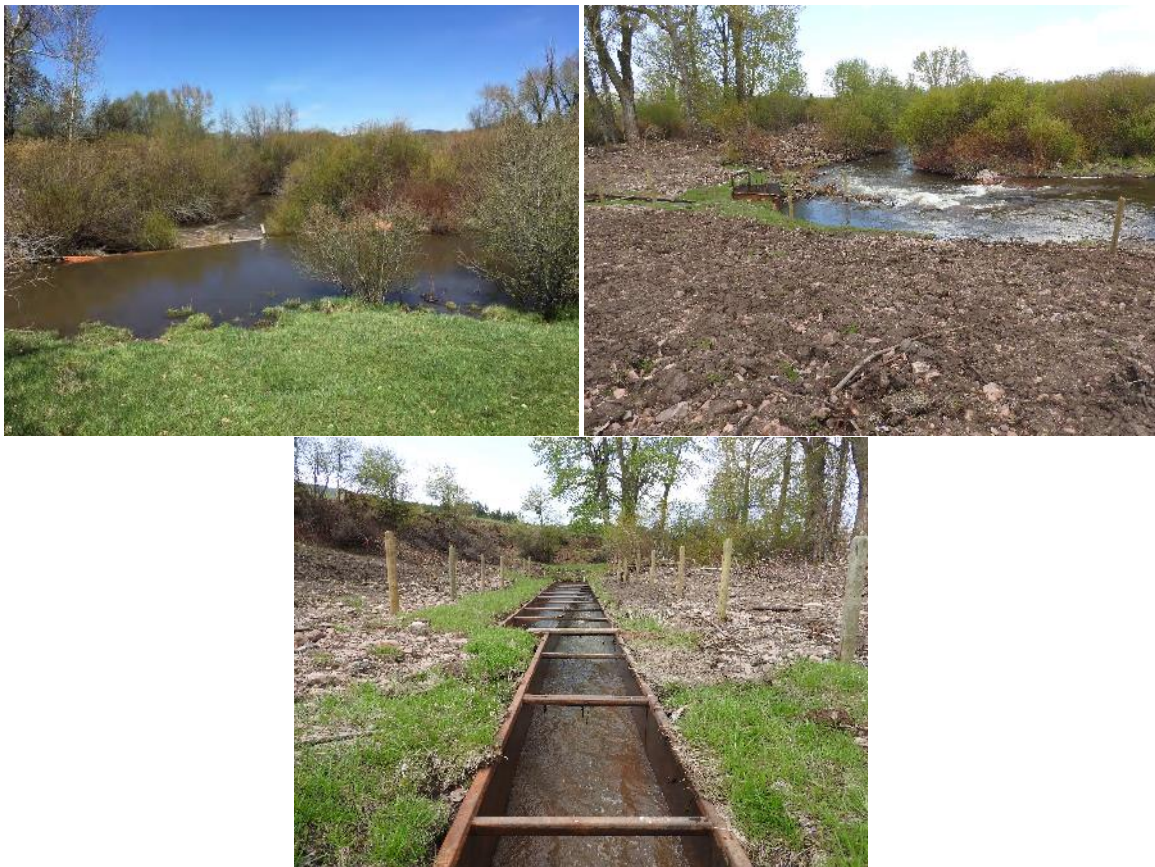
FIGURE 36. NEVADA CREEK DIVERSION BEFORE (TOP L) CONSTRUCTION. THE IRRIGATION DIVERSION WAS UPGRADED (TOP R) AND A FISH SCREEN WAS INSTALLED (BOTTOM) BEHIND THE HEADGATE. BEFORE PHOTO COURTESY OF BIG BLACKFOOT CHAPTER OF TROUT UNLIMITED.

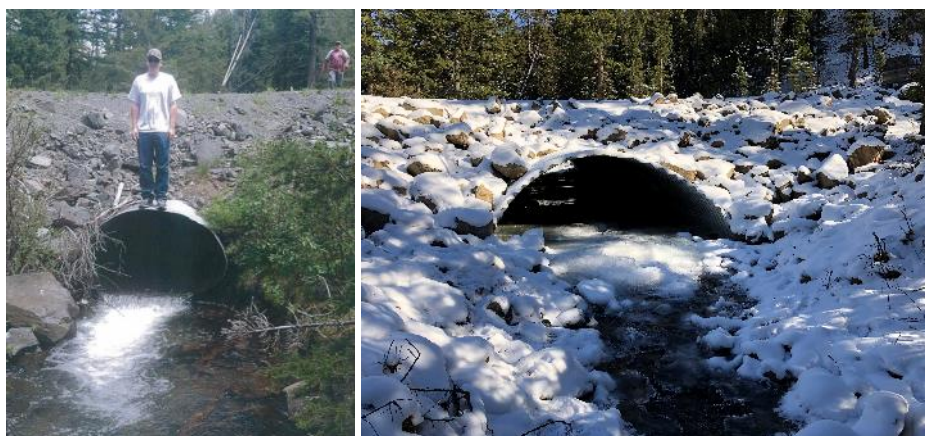
FIGURE 37. NORTH FORK COTTONWOOD CREEK HAD AN UNDERSIZED CULVERT (L) THAT WAS REPLACED WITH A LARGER CULVERT (R), WHICH ENHANCED FISH PASSAGE AND STREAM FUNCTION. BEFORE PHOTO COURTESY OF CLARK FORK COALITION.

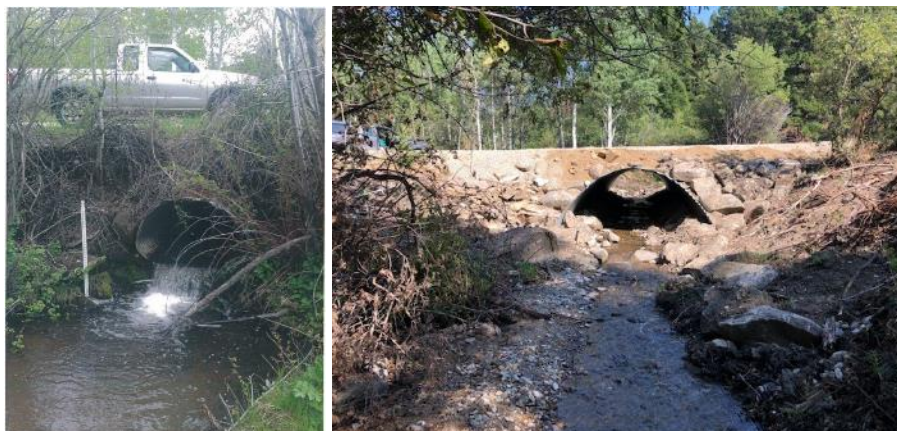
FIGURE 38. AN UNDERSIZED CULVERT ON NORTH FORK DRY COTTONWOOD CREEK (L) WAS REPLACED WITH A LARGER ARCH CULVERT FOR FISH PASSAGE (R). BEFORE PHOTO COURTESY OF CLARK FORK COALITION.

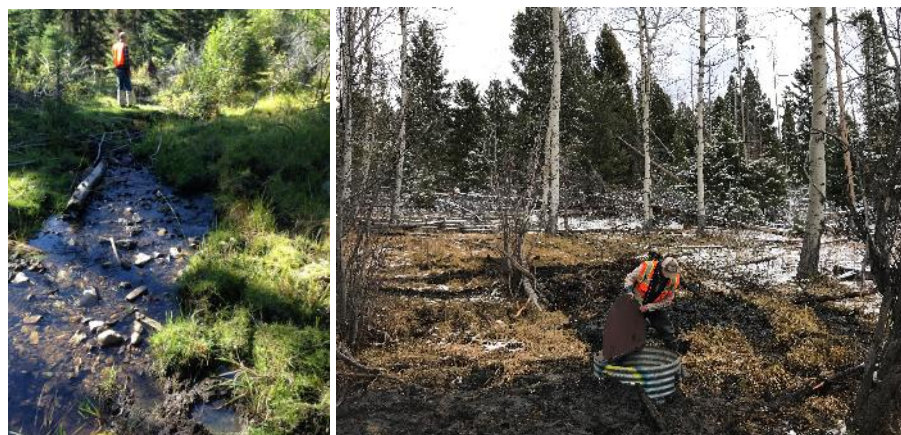
FIGURE 39. NORTH FORK DRY COTTONWOOD CREEK BEFORE THE PROJECT (L), WITH RIPARIAN DAMAGE. THE PROJECT INVOLVED TREE FELLING AND OFF STREAM WATER (RIGHT) TO DISCOURAGE CATTLE FROM USING THE STREAM. PHOTOS COURTESY OF CLARK FORK COALITION.

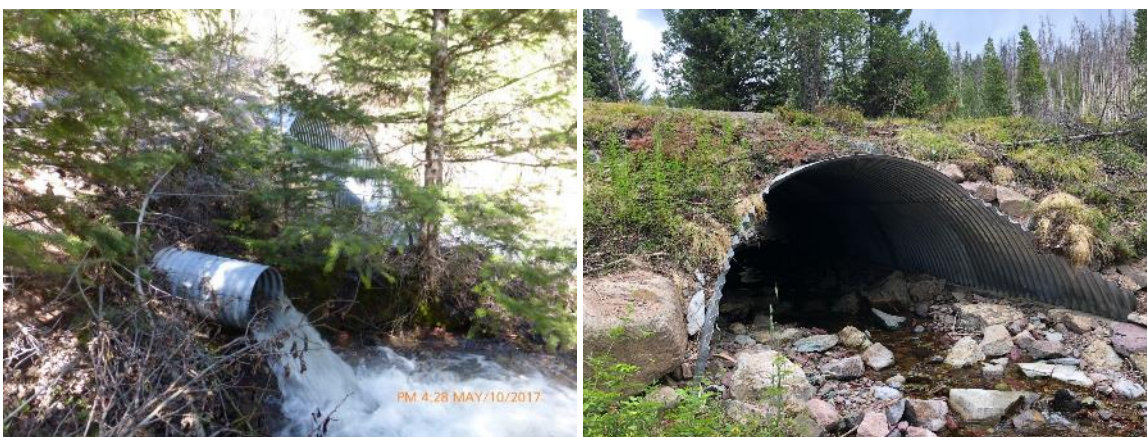
FIGURE 40. THIS PROJECT, ON NORTH FORK KEEP COOL CREEK, REPLACED AN UNDERSIZED CULVERT THAT WAS A BARRIER AT MOST FLOWS (L) WITH A LARGER CULVERT THAT IMPROVES FISH PASSAGE AND CONNECTIVITY (R). BEFORE PHOTO COURTESY OF BIG BLACKFOOT CHAPTER OF TROUT UNLIMITED.
