Future Fisheries Improvement Program Legislative Report | 2019-2020

Summary of Program activities from November 1, 2018 to October 31, 2020.

Fish Management Bureau

Fisheries Division

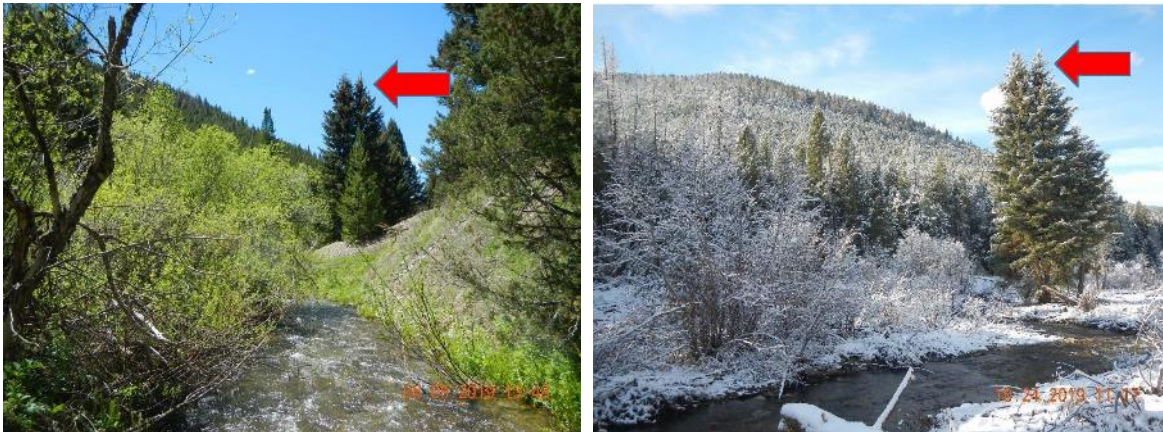
Poorman Creek is a tributary to the Blackfoot River and supports populations of pure westslope cutthroat trout and bull trout (Lewis & Clark County). Poorman Creek is a high priority stream and is considered critical bull trout habitat. This project took place on U.S. Forest Service property where the stream and riparian area was highly modified by past mining activities. The stream was channelized, large wood and pools were lacking, and waste rock deposits eliminated a floodplain, restricted floodplain area, and confined the channel. This project restored the disturbed reach of Poorman Creek and its floodplain. Tailings were removed, a new channel was constructed, large wood was incorporated to improve habitat quality, and an undersized stream crossing was upgraded (Figure 41).

FIGURE 41. POORMAN CREEK BEFORE (L) AND AFTER (R) RESTORATION. THE ARROWS NOTE THE TREE SIMILAR TO BOTH PHOTOS. MINE TAILINGS WERE REMOVED AND THE STREAM CHANNEL AND FLOODPLAIN WERE RESTORED. PHOTOS COURTESY OF BIG BLACKFOOT CHAPTER OF TROUT UNLIMITED.

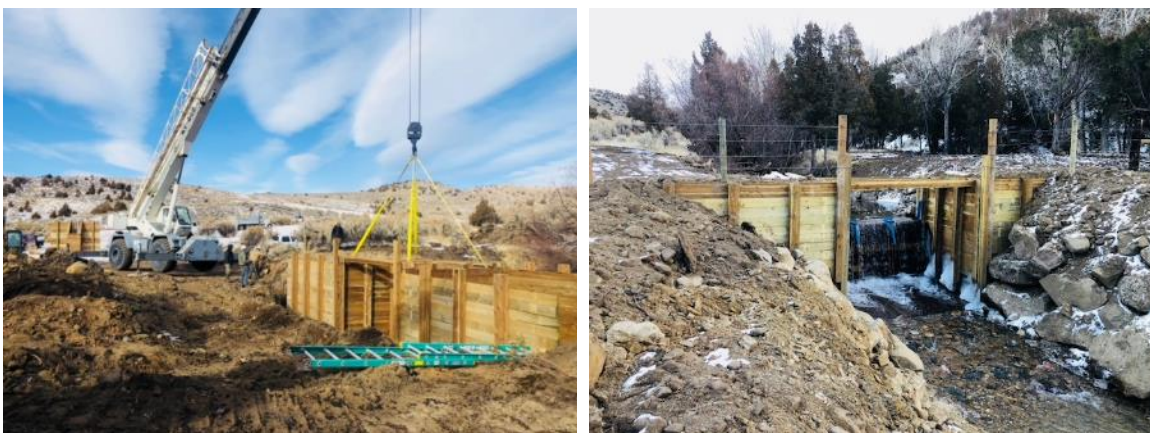
Ramshorn Creek (Madison County) is a tributary to the Ruby River. After completion of this project, the area would eventually support populations of westslope cutthroat trout and Rocky Mountain sculpin above the barrier and brook trout, brown trout, and rainbow trout below the barrier. The fish passage barrier was installed in conjunction with an irrigation delivery structure that ensures delivery of water and reduces maintenance and avoid channel manipulation. This project is in the Ruby watershed and is an essential component in implementing native fish restoration in Ramshorn Creek and its tributaries. The goal was to conserve an important population of westslope cutthroat trout in the Ruby watershed.

FIGURE 42. THE RAMSHORN CREEK FISH BARRIER DURING CONSTRUCTION (L) AND AFTER COMPLETION (R).

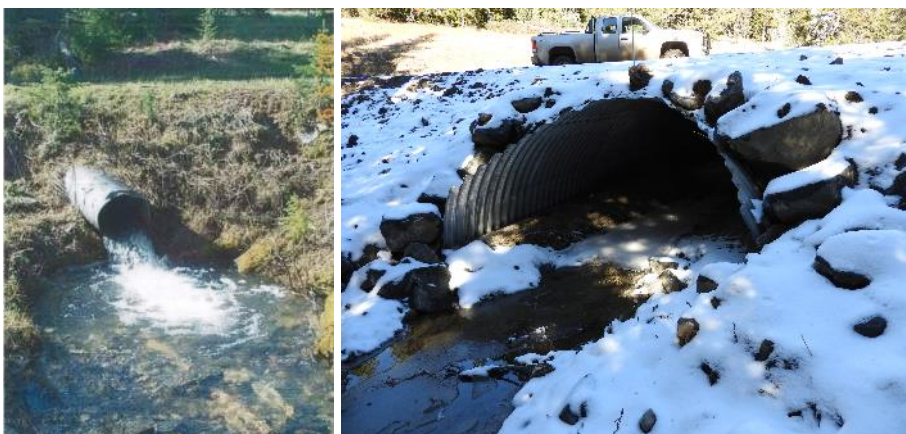
FIGURE 43. THIS PROJECT ON TURKEY CREEK REPLACED AN UNDERSIZED CULVERT (L) WITH A LARGER CULVERT THAT PROVIDES CONNECTIVITY AND FISH PASSAGE (R). BEFORE PHOTO COURTESY OF THE U.S. FOREST SERVICE.

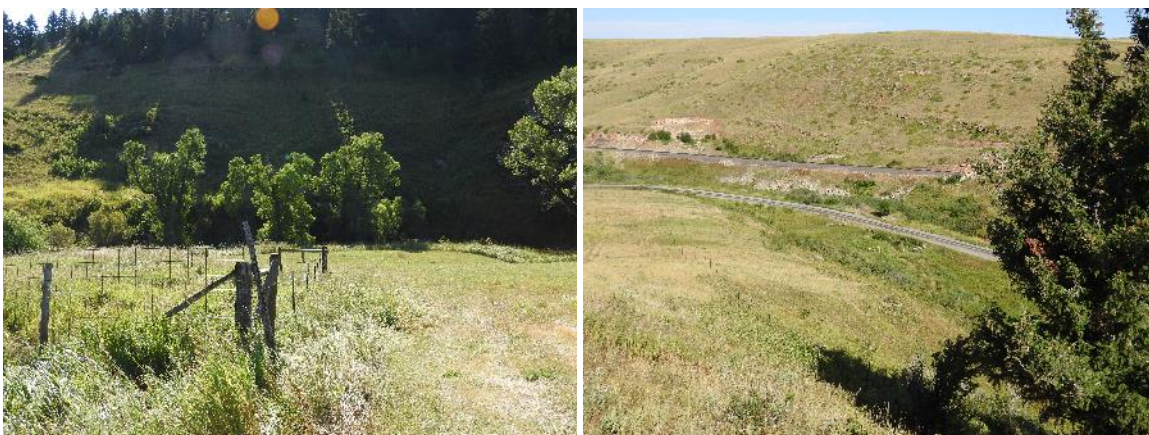
Williams Creek (Judith Basin County) is a tributary to Big Otter Creek near Raynesford. It supports populations of brown trout, brook trout, and rainbow trout. Cattle accessed the stream and this project installed riparian fencing to control livestock access, constructed a water gap, and developed a spring for off-stream water (Figure 44). The goals were to improve fish habitat through riparian growth, reduced sedimentation, and overall stream health.

FIGURE 44. WILLIAMS CREEK AFTER RESTORATION. FENCING WAS INSTALLED TO KEEP LIVESTOCK FROM ACCESSING THE STREAM.

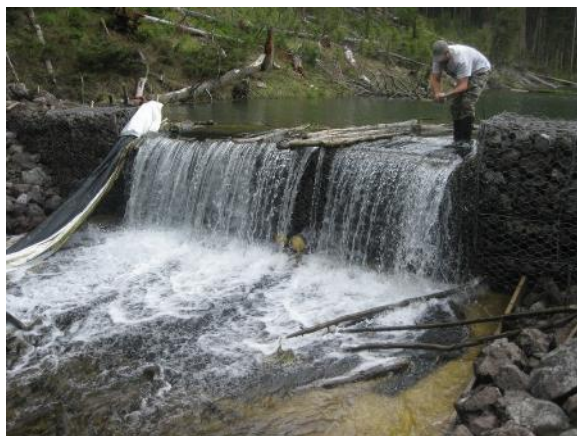
The barrier is gabion structure fortified with concrete and has a concrete apron to prevent scour of a pool (Figure 47). It was built in 2010, and in 2011, the rainbow trout fishery upstream of the barrier was eradicated with rotenone. Approximately 1,000 embryos obtained from an existing population of westslope cutthroat trout in the Smith River watershed were raised in remote site incubators placed in Lake Creek annually from 2012 to 2014. Monitoring in 2017 found a self-reproducing population of westslope cutthroat trout upstream of the barrier.

FIGURE 47. LAKE CREEK FISH BARRIER ONE YEAR AFTER CONSTRUCTION.

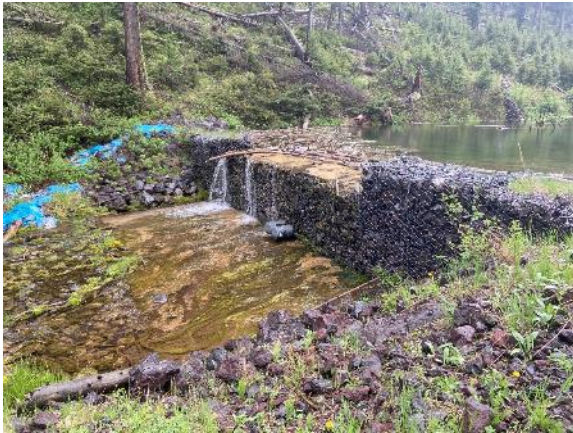
On June 6, 2020, Carl Young visited the fish barrier. He noted some wear of concrete; however, the apron was intact and did not provide a vantage for fish to leap (Figure 48). A substantial amount of

FIGURE 48. THE LAKE CREEK FISH BARRIER ON JUNE 6, 2020.

large woody debris had accumulated along the upstream face of the barrier (Figure 49). The jam of logs upstream of the barrier posed a potential threat during high flows. Logs washed over the barrier could become stuck on the apron and provide enough complexity for fish to breach the barrier, or to cause damage to the barrier. He returned within a few days with equipment to clear out the accumulated wood.

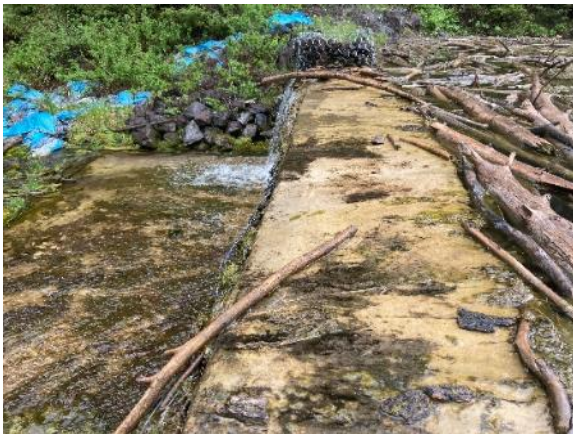
FIGURE 49. TOP OF LAKE CREEK FISH BARRIER SHOW WEAR AND ACCUMULATIONS OF WOODY DEBRIS.

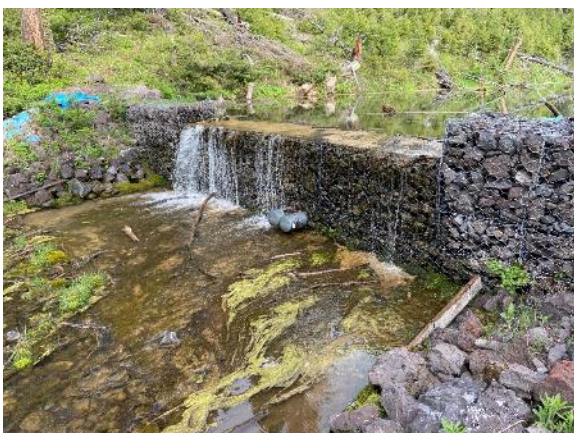
FIGURE 50. LAKE CREEK BARRIER AFTER REMOVAL OF WOODY DEBRIS.

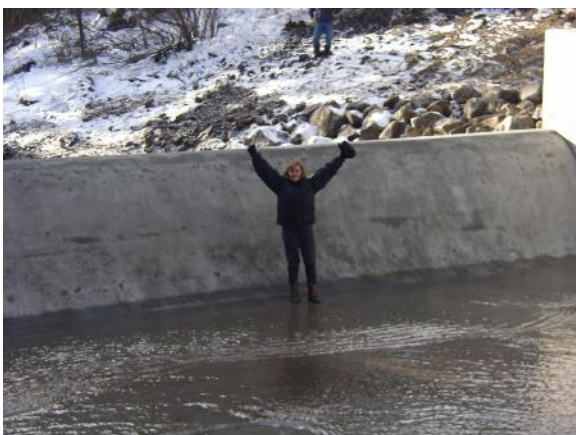
FIGURE 51. LOWER DEER CREEK AFTER CONSTRUCTION AS WATER WAS FILLING BEHIND THE STRUCTURE.

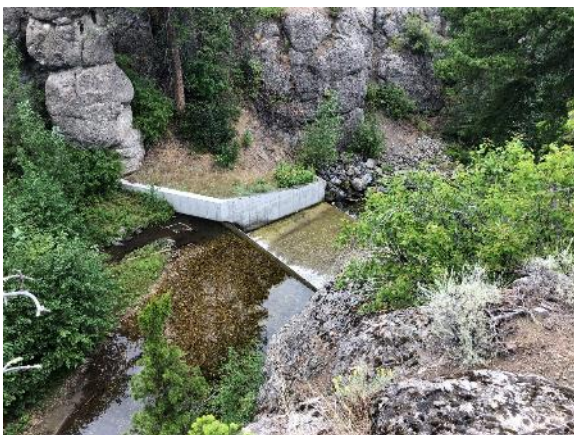
The barrier was in excellent condition, with no evidence of wear (Figure 55 and Figure 56). No maintenance was required, and the apron was free of woody debris. Slight scour was apparent at the downstream end of the concrete apron, but this was minor and did not provide sufficient depth to promote leaping or threaten the structure.

FIGURE 55. VIEW OF THE LOWER DEER CREEK BARRIER FROM TOP OF CANYON.

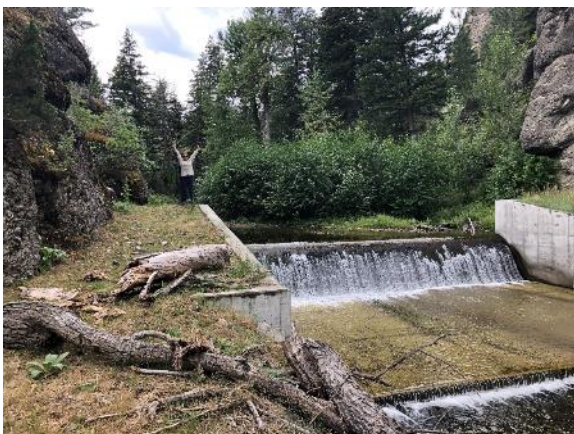
FIGURE 56. LOWER DEER CREEK BARRIER FRONT VIEW. LOGS WERE DEPOSITED ON WINGWALLS DURING FLOODING IN 2011.

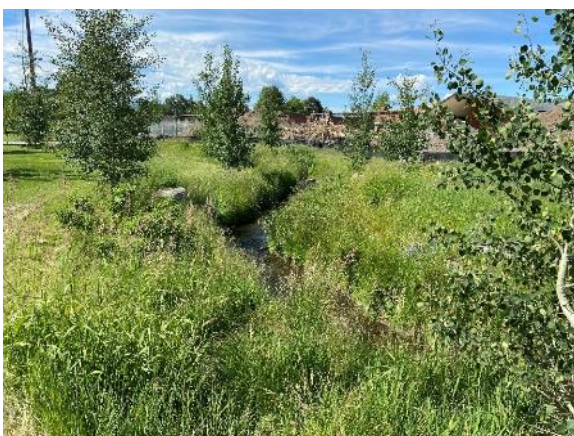
FIGURE 62. VIEW OF MANDEVILLE CREEK SHOWING RIPARIAN BUFFER AND RESTORED CHANNEL.

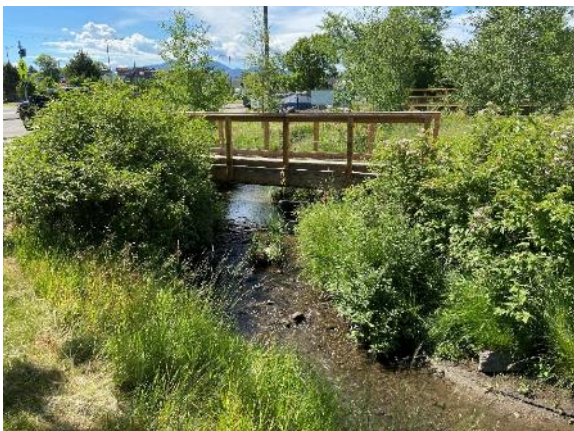
An added aesthetic was installation of attractive footbridges that allowed pedestrians to cross Mandeville Creek (Figure 63). Near the bridge, the channel profile of a natural riffle/pool sequence was evident and a significant improvement from the uniform ditch the stream formerly occupied.

FIGURE 63. FOOTBRIDGE OVER A RESTORED SECTION OF MANDEVILLE CREEK SHOWING A RIFFLE/POOL SEQUENCE.

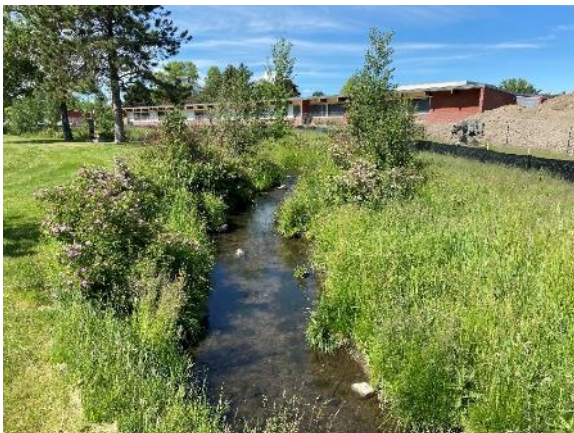
The upgrades to the school and restoration of Mandeville Creek is occurring in phases and is not yet complete. The final photos show silt fence installed between the stream and stockpiled soil and the remaining stretches of channelized stream (Figure 64 and Figure 65). The uniform, silt-dominated streambed is evident in the unrestored reaches and a marked contrast to most of the stream, which has been restored.

FIGURE 64. LOWER, UNRESTORED REACH OF MANDEVILLE CREEK SHOWING SILT FENCE TO PREVENT SEDIMENT LOADING INTO THE STREAM.

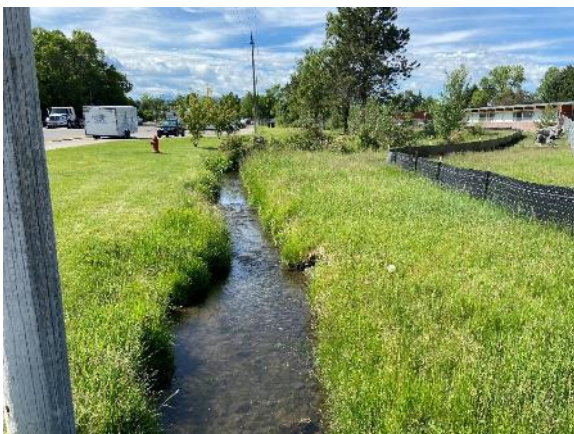
FIGURE 65. LOWER, UNRESTORED REACH OF MANDEVILLE CREEK ON THE BOZEMAN HIGH SCHOOL CAMPUS.

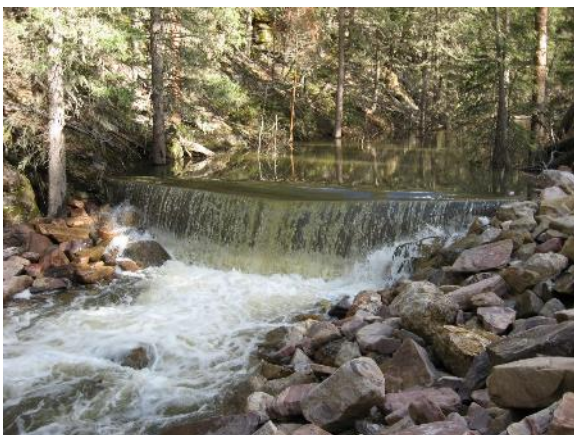
cutthroat trout have been nearly extirpated from the Judith River watershed, with an estimated 1% of the historically occupied waters still supporting genetically unaltered fish (Shepard et al. 2003). In 2007, a barrier was constructed that would provide over 20 miles of protected habitat from nonnative fishes (Figure 66).

FIGURE 66. SOUTH FORK JUDITH RIVER BARRIER.

The barrier is a flat-fronted weir, with a notch intended to provide for transport of large wood and bedload. The photo at relatively high flows shows the standing wave behind the jet of water that had allowed passage of rainbow trout at another barrier. The ability of rainbow trout or other nonnative trout to breach this barrier is currently unknown.

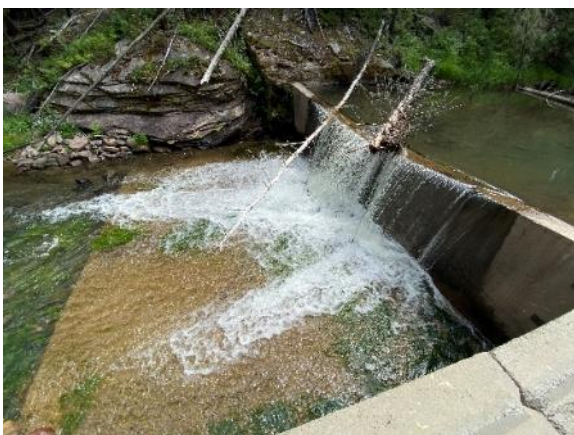
On July 23, 2020, Carl Young visited the barrier. He found it to be in good condition with little evidence of wear (Figure 67). He cleared what little debris was present, but overall, the barrier appeared to be stable with no obvious features that would allow for fish passage. The rock armoring featured in Figure 66 appears to be replaced with a wing wall on the left bank and bed rock is present on the right bank. This apparent retrofit has likely eliminated roughness that trout could use to breach the barrier.

FIGURE 67. SOUTH FORK JUDITH RIVER FISH BARRIER ON JULY 23, 2020.

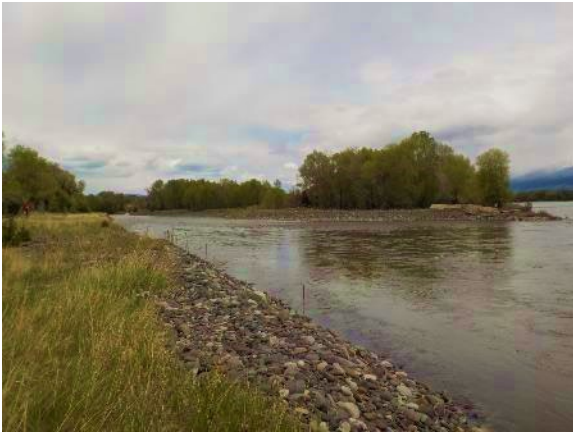
FIGURE 71. TRAPEZOIDAL CHANNEL GEOMETRY, COBBLE BANKS, AND JERSEY BARRIERS ABANDONED ON THE UPSTREAM END OF MID-CHANNEL BAR.

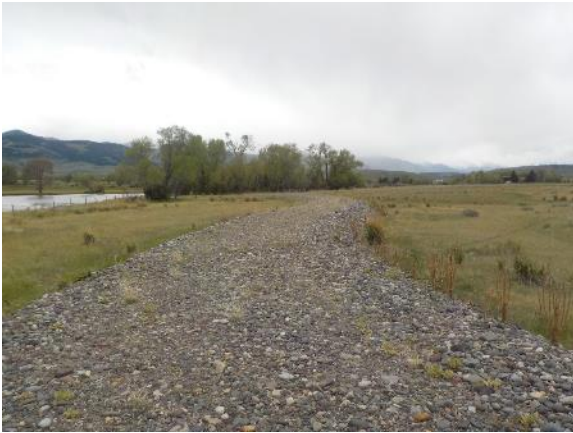
Aggradation of bedload in the project reach had been among the factors requiring channel modifications to deliver water to the canal. Dredging to ensure enough water was conveyed to the canal diversion produced substantial amounts of cobble and gravel, and these spoils were applied to roads on the adjacent properties (Figure 73). These road grades are at considerably higher elevation than typical ranch roads, reflecting the need to dispose of the continued supply of cobble and gravel from the channel in the project area. The dynamic nature of the channel through this active reach of river has decreased the tendency for aggradation within the channel in its current configuration, so dredging has not altered the channel in the project area over the past few years.

FIGURE 73. ELEVATED ROADBED MADE FROM SPOILS FROM YEARS OF DREDGING IN THE PROJECT AREA.

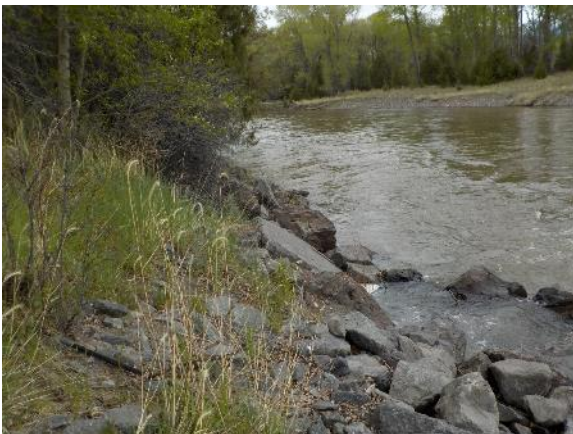
The second half of the project reach began at an area of slight channel inflection, and this reach was covered in riprap (Figure 74). The landowners reported they had the riprap installed in the 1990s after flooding eroded 8 feet into their property. They owned the property when the planting project occurred and watered the cottonwood trees and willow/alder bundles. Only 3 cottonwoods survived despite substantial effort to irrigate all plantings. Rebar in the bank remained as evidence of where willow/alder bundles were planted but did not survive (Figure 75).

FIGURE 74. BANK ARMORING IN THE PROJECT AREA.

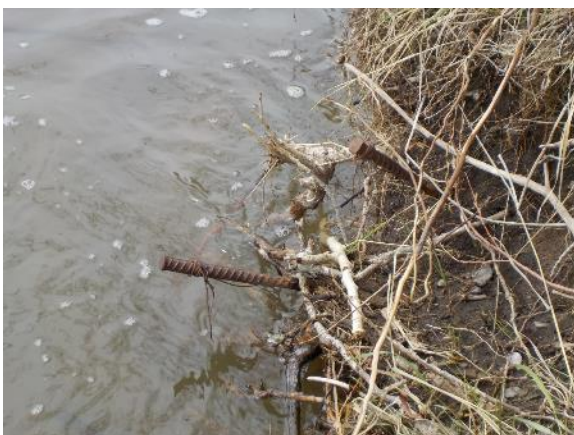
FIGURE 75. REBAR USED TO ANCHOR WILLOW/ALDER BUNDLES INTO BANKS.

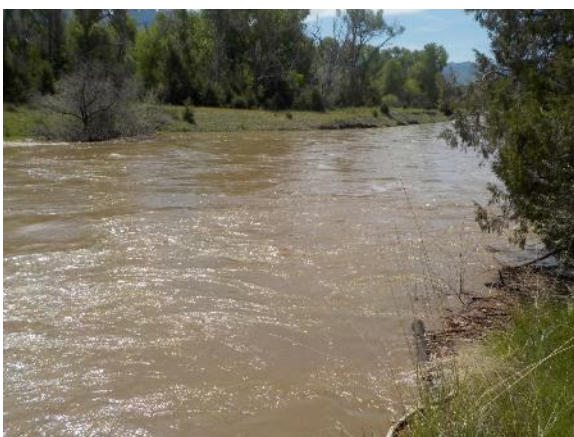
Peak flows the first week of June 2020 provided an opportunity to see the conditions planting would experience during high water. On June 2, 2020, Carl Young photographed the project area again when flows were approaching flood stage. The river was several feet higher than it was in May, and the areas that had been planted were under water. Plantings on these 45 ° banks would need to be able to withstand sheer stress and inundation during high flows.

FIGURE 76. PROJECT REACH ON JUNE 2, 2020 DURING HIGH FLOWS

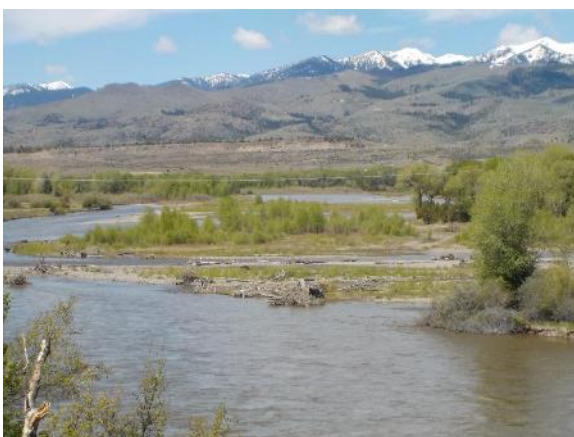
Cottonwoods and sandbar willow are disturbance driven species and recruit naturally from seed on recent alluvial bar deposits as illustrated in Figure 77. Along the Missouri River, cottonwoods established following floods of recurrence intervals of 10 years, which deposited alluvial bars at low enough elevation to remain moist enough to provide for establishment of seeds, but were high enough to allow cottonwoods to survive floods and ice jams in subsequent years (Scott et al. 1997). Cottonwood and willow seeds are light and windborne, and have few reserves for growth, so landing on the recently flooded alluvial bars and racing the declining limb of the hydrograph with root development is how they survive. Once established, these plants build floodplains by trapping sediment during high flows. By slowing flood flows, they allow for deposition of more alluvial bar habitat, and natural stands of cottonwoods and willows are often present in arcuate bands, with the older trees and shrubs at higher elevations.

FIGURE 77. EXAMPLE OF NATURAL RECRUITMENT OF COTTONWOOD AND WILLOWS ON A RECENT ALLUVIAL BAR HABITAT ON THE YELLOWSTONE RIVER.

The site characteristics were unsuitable for establishment of cottonwoods, willows, dogwood, or alders. As the project area is a low terrace (Thatcher et al. 2009) and not a recent alluvial bar, the setting is too high for natural colonization of cottonwood or sandbar willow. The proposed intent of the application was to emulate natural colonization; however, the plants were placed at varying elevations on a sloped, comparatively high bank in a relatively straight reach, as compared to low

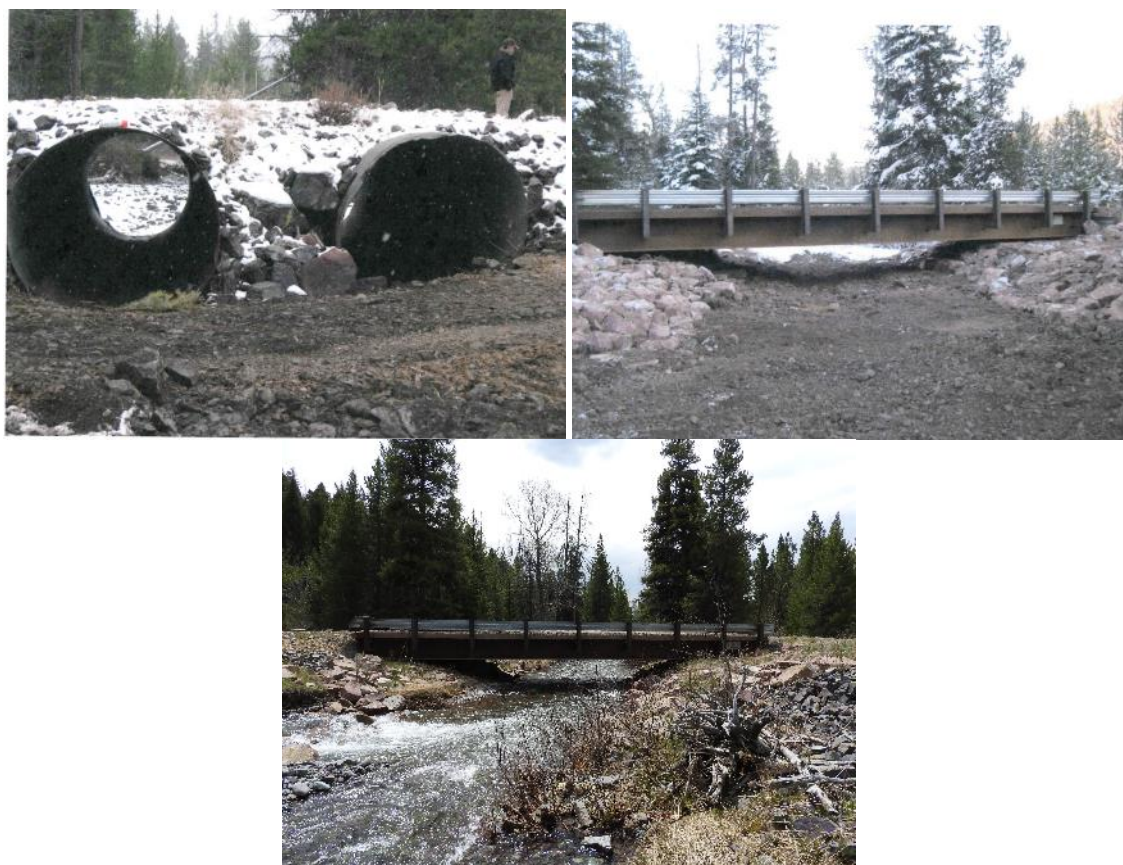
Arrastra Creek (Lewis and Clark County), a tributary to the upper Blackfoot River, supports spawning runs of bull trout and genetically pure westslope cutthroat trout. Other salmonids present include brown and brook trout. Twin culverts associated with a road crossing located approximately 3.3 miles upstream from the mouth were a barrier to fish movement. This project replaced the existing culverts with a full span bridge, and was completed in 2005 (Figure 78). In 2019, the bridge remained functional and intact. There was more riprap than desired and some downstream erosion, but fish passage was maintained.

FIGURE 78. ARRASTRA CREEK BEFORE (TOP LEFT), AFTER (TOP RIGHT), AND IN 2019 (BOTTOM).

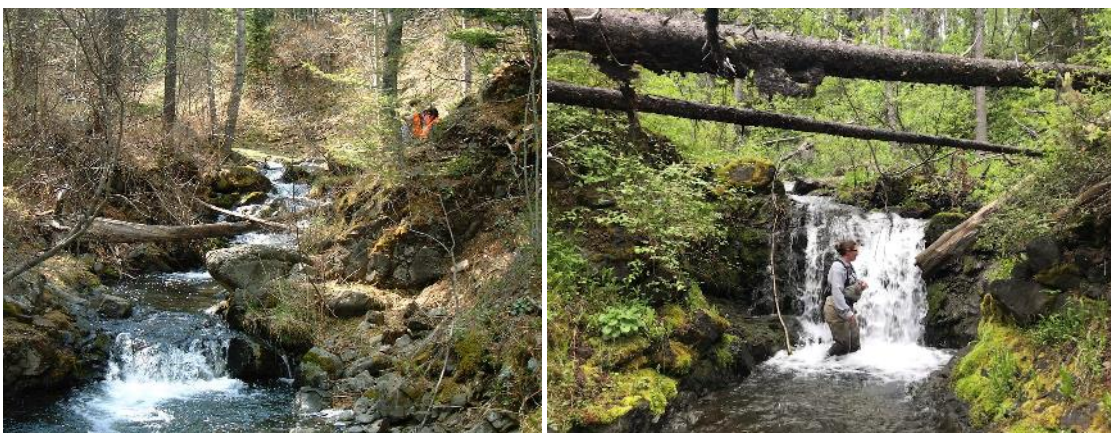
Big Coulee Creek (Choteau County) supports a remnant, pure population of westslope cutthroat trout. This project created a migration barrier from a natural waterfall to protect the genetic integrity of this population and prevent invasion by non-native brook trout (Figure 79). The waterfall barrier was enhanced in 2002 and 2004, and nonnative brook trout were mechanically removed by electrofishing from 1997 to 2008. Brook trout were found above the barrier in 2015, and intensive annual electrofishing for removal of brook trout has been completed from 2015 to 2020. Since 2015, annual barrier checks have been performed to reduce the plunge pool below the falls and clear out debris from the stream immediately downstream of the falls. Total annual catch of brook trout is declining over the last several years; only 8 individuals were captured in 2019. In 2020, the barrier appeared to be functioning under the current flow conditions.

FIGURE 79. BIG COULEE CREEK BEFORE (L) AND AFTER RESTORATION (R; 2020).

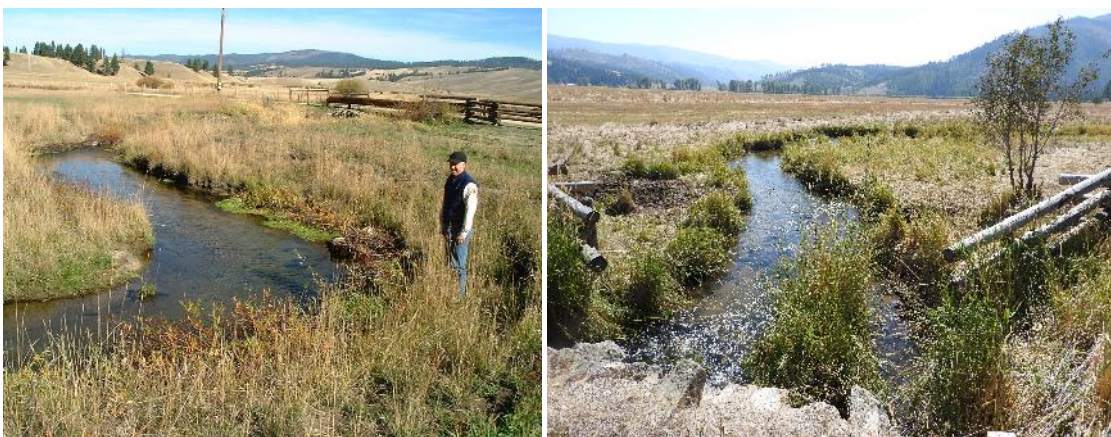
Cameron Creek (Ravalli County), a tributary to the East Fork Bitterroot River, supports a mixed salmonid fishery, including documentation of fluvial bull trout. A 450-foot reach of the stream was channelized and flowed in a ditch paralleling the highway. This project moved the ditched channel away from the highway and reconstructing an appropriate dimension, pattern and profile, and it was completed in 2010 (Figure 80).

In 2020, most of the channel appeared to be functional. The riparian area was primarily composed of grasses. A livestock crossing was present, but there appears to be some level of grazing throughout. Overall the project appears to be successful, but additional willow colonization is desirable. The impact of wildlife browse is not known.

FIGURE 80. CAMERON CREEK AFTER RESTORATION WAS COMPLETED (L; 2010) AND IN 2020 (R).

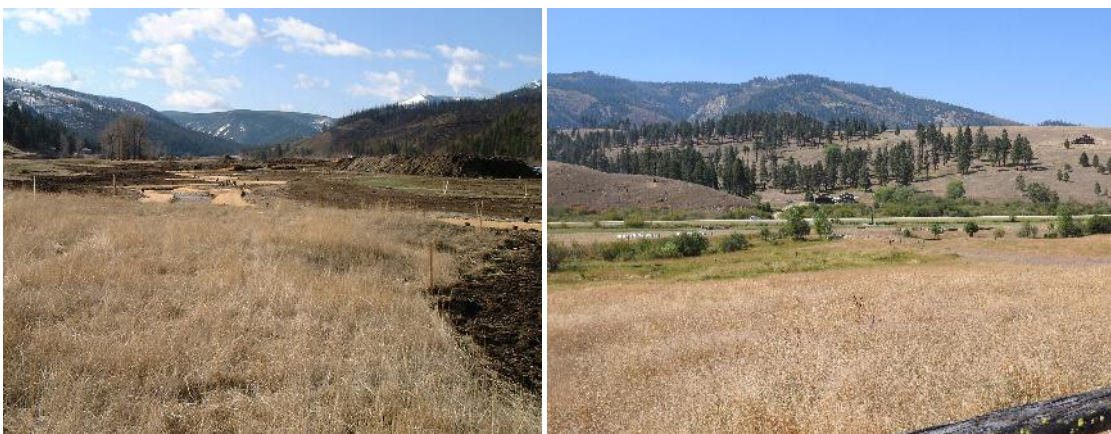
Camp Creek (Ravalli County) was channelized due to highway construction. The stream supports populations of westslope cutthroat and brook trout. This project involved reconstructing the stream and returning the stream to the old channel. The project restored approximately 1.75 miles of stream and was completed in 1999 (Figure 81). In 2020, the riparian condition looked decent around the culvert sites, but the riparian area was overgrazed upstream of the project site. Overall the riparian has a good number of trees and vegetation. However, the multiple culvert installation is not functioning as installed. From aerial imaging, it appears the channel has shifted slightly and is now moving through the culverts at an angle (occured after 2005), likely causing instability and erosion.

FIGURE 81. CAMP CREEK AFTER CONSTRUCTION (L; 1999) AND IN 2020 (R).

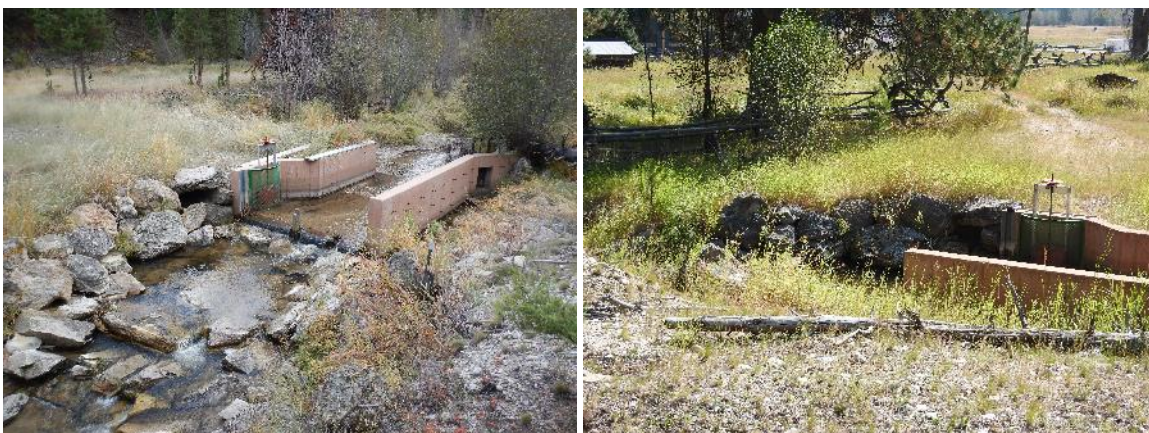
Coal Creek (Ravalli County), a tributary to the West Fork of the Bitterroot River, supports populations of both bull and westslope cutthroat trout. The stream was damaged by grazing, and the project involved construction of approximately 1 mile of jackleg fence to exclude cattle from approximately 0.5 miles of stream. The project was completed in 1999. In 2013 the site was monitored and found to have a mildly incised channel but stable and vegetated streambanks. In 2020 it was very similar to 2013 conditions and the riparian was in good condition (Figure 82).

FIGURE 82. COAL CREEK IN 2013 (L) AND IN 2020 (R).

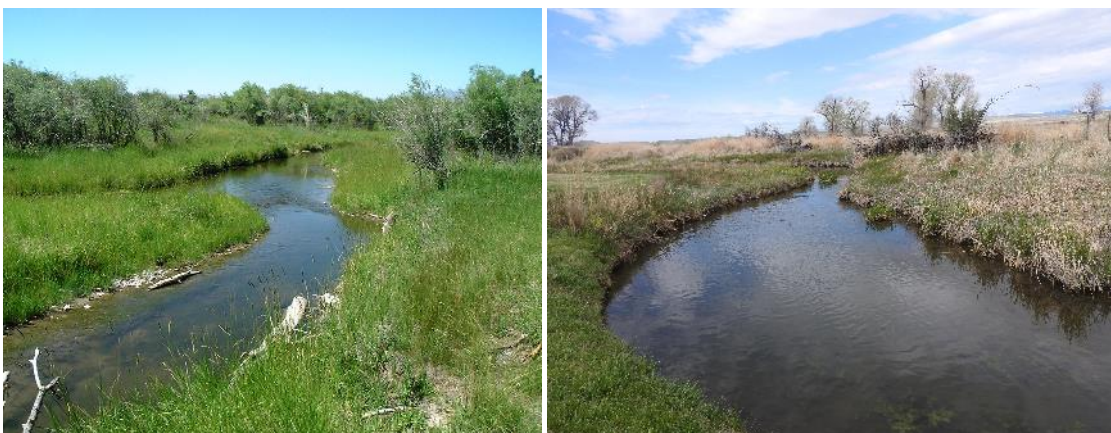
When monitored in 2019, the stream had adjusted over time and became wider. It doesn't transport sediment as desired and the channel is now oversized for the streamflow. The channel width is too wide to transport sediment and maintain the stream channel. A lesson learned is ensuring proper stream width for the typical streamflows. Grazing management has been successful.

FIGURE 83. DARNUTZER SLOUGH CHANNEL RESTORATION PROJECT AFTER CONSTRUCTION (L) AND IN 2019 (R). IT HAS WIDENED SINCE CONSTRUCTION.

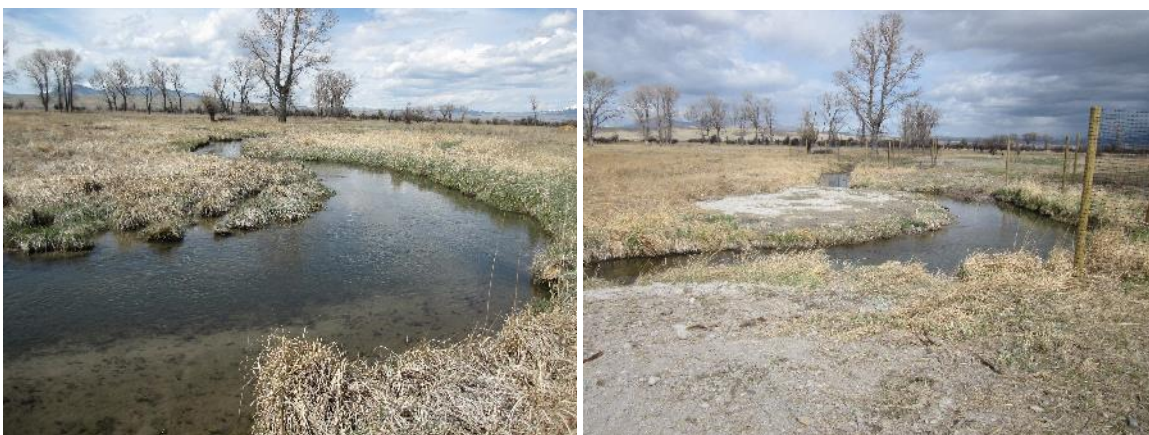
FIGURE 84. DARNUTZER SLOUGH BEFORE CONSTRUCTION (L) AND IN 2019 (R). THE STREAM WIDENED AFTER CONSTRUCTION BUT IS BEING REPAIRED BY THE LANDOWNER.

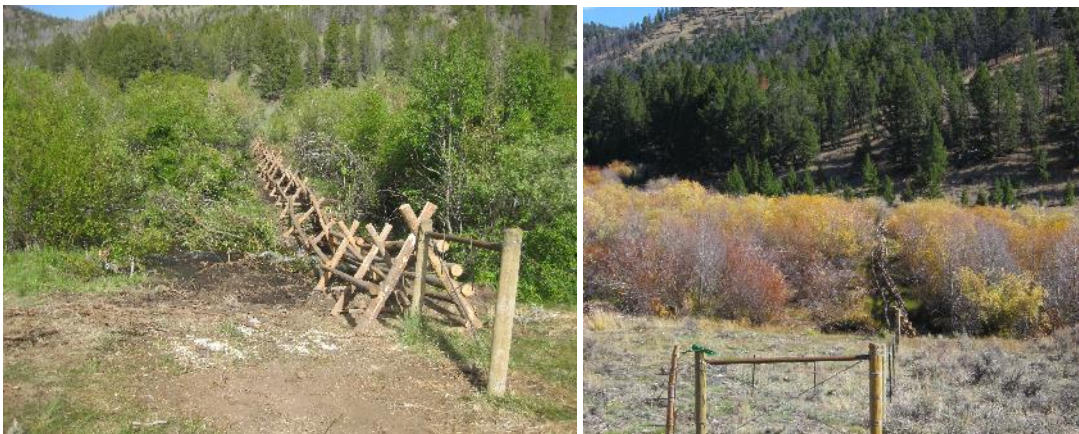
FIGURE 85. JOHNSON CREEK FENCE AFTER CONSTRUCTION (L; 2014) AND IN 2020 (R). THE FENCE AND RIPARIAN AREA REMAINS INTACT.

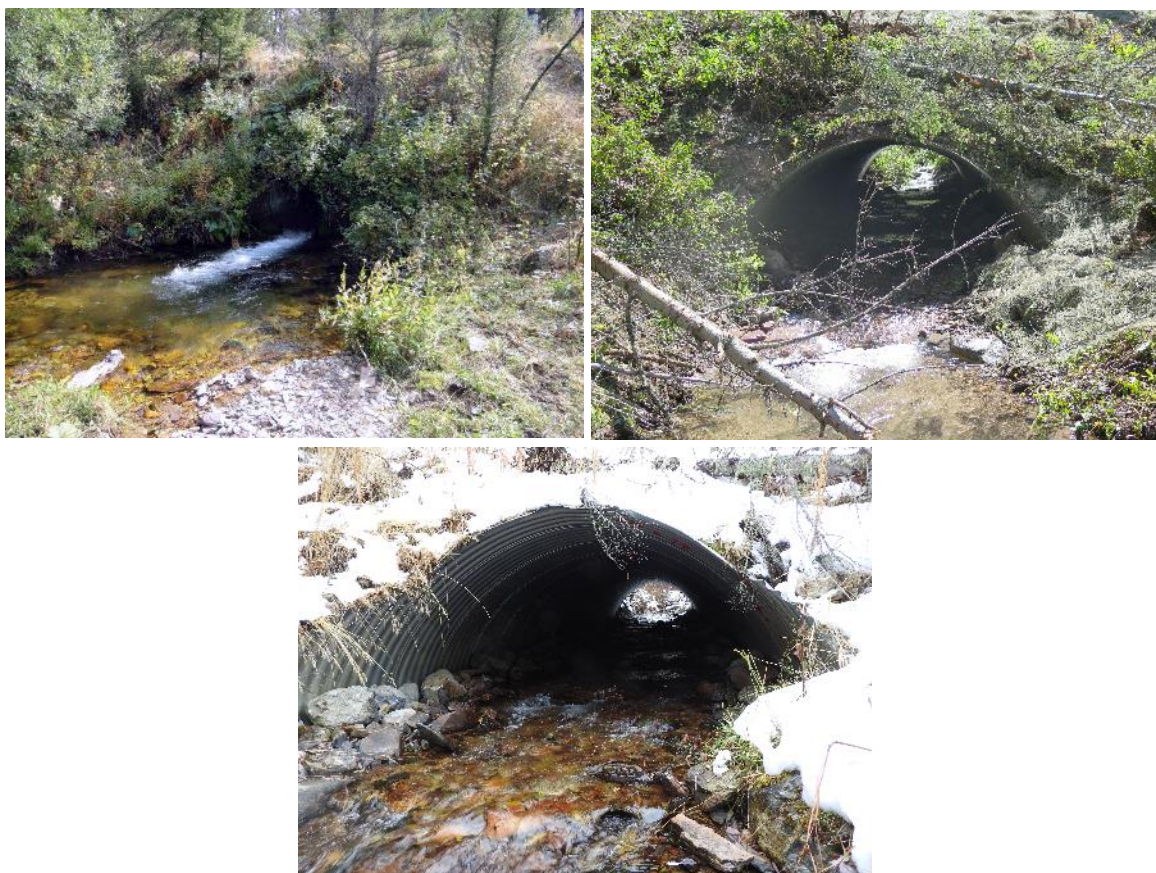
Gleason Creek (Powell County) is a tributary to Nevada Creek located on U.S. Forest Service property near the community of Finn. The stream supports a slightly hybridized population of westslope cutthroat and possibly some limited bull trout use. An existing U.S. Forest Service road culvert on the stream acted as a partial upstream barrier to migrating fish. This project replaced the existing 48-inch culvert with a 137-inch span by 87-inch rise corrugated steel arch pipe (Figure 86). A series of 4 rock weirs were installed inside the new pipe to maintain the stream grade. It was completed in 2014.

In 2020, the site was monitored and noted to be in excellent condition. It has remained intact and is visually similar to its 2014 completion photographs. It continues to maintain unobstructed fish passage.

FIGURE 86. GLEASON CREEK FISH PASSAGE PROJECT BEFORE (TOP LEFT), AFTER (TOP RIGHT; 2014), AND IN 2020 (BOTTOM).

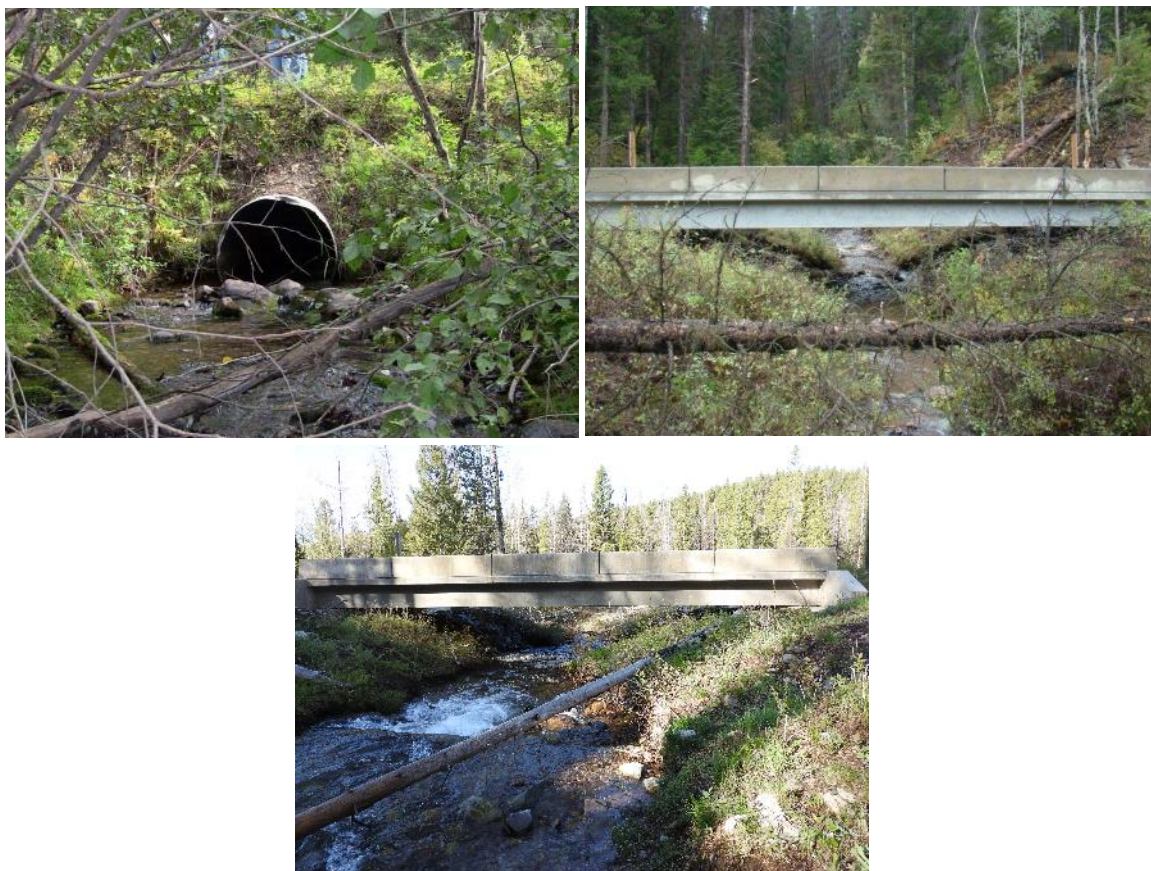
Klondike Creek (Lewis and Clark County) is a tributary to Beaver Creek and ultimately the Blackfoot River located near the town of Lincoln that supports genetically pure westslope cutthroat trout. An existing road culvert on the stream was undersized, acted as a seasonal upstream migration barrier, and caused impairments to the stream channel. This project replaced the existing undersized culvert with a concrete bridge set on concrete footings (Figure 87). It was completed in 2013. In 2019, the project appeared functional, even after a recent fire that impacted the surrounding area.

FIGURE 87. KLONDIKE CREEK CULVERT TO BRIDGE PROJECT BEFORE (TOP LEFT), AFTER (TOP RIGHT; 2013), AND IN 2019 (BOTTOM).

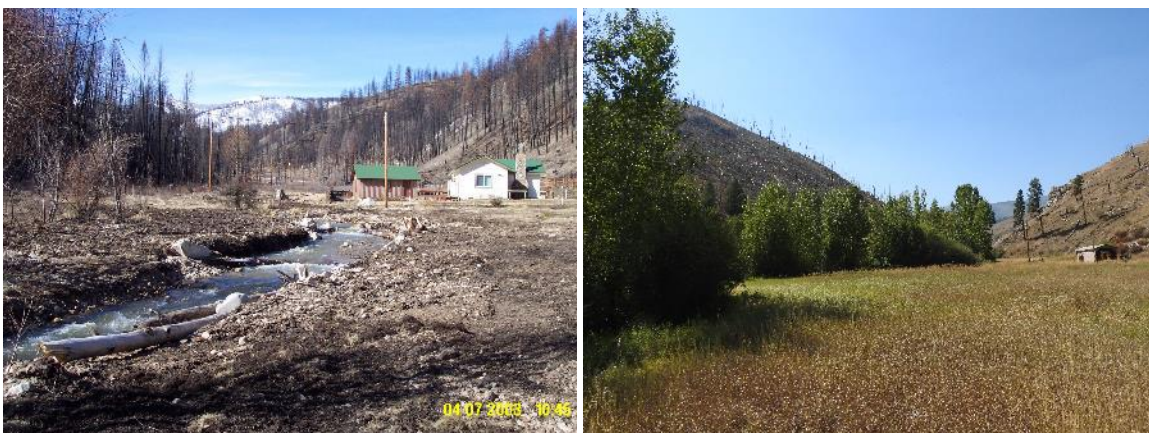
Laird Creek (Ravalli County) supports a mixed salmonid fishery. Fires in 2000, followed by thunderstorms, caused changes to the stream channel that reduced fish habitat. This project returned the channel to the low point in the valley and stabilized it with a series of rock and log grade controls (Figure 88). It was completed in 2003. In 2010, the riparian condition looked good with medium grazing compliance. In 2020, the riparian area was so vegetated it was difficult to find the photopoints or assess the condition of the stream. It is clear that the project is functioning from a vegetation standpoint. Fish data were not collected as part of this monitoring.

FIGURE 88. LAIRD CREEK AFTER CONSTRUCTION (L; 2003) AND IN 2020 (R).

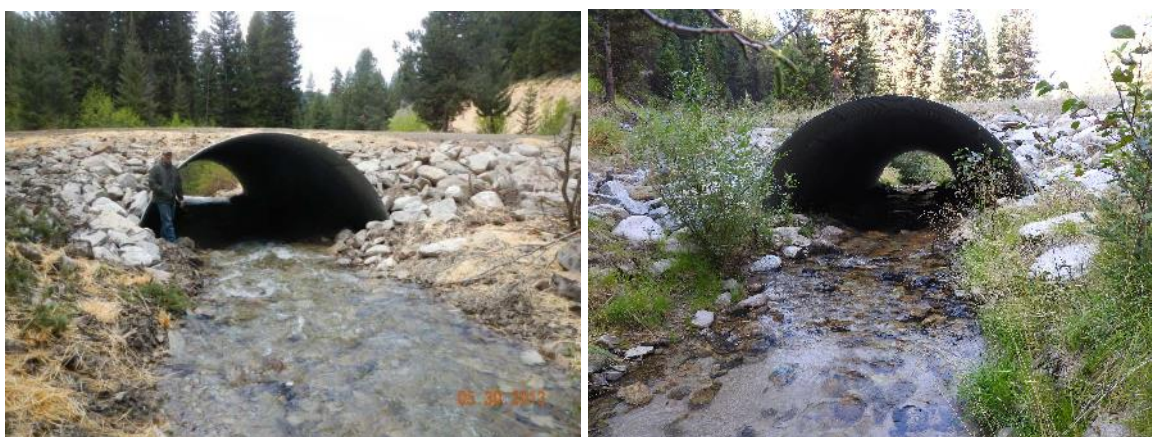
Little Boulder Creek (Ravalli County) is a tributary to Painted Rocks Reservoir that supports bull trout and westslope cutthroat trout. An existing U.S. Forest Service road culvert was determined to be, at least, a partial barrier for upstream fish passage. This project replaced the existing undersized culvert with an open bottom arch bridge that spans the bankfull channel width (Figure 89). It was completed in 2013. In 2020, the culvert looked similar to the installation; the structure is functional, grade control structures are intact, and fish passage is unrestricted.

FIGURE 89. LITTLE BOULDER CREEK AFTER CONSTRUCTION (L; 2013) AND IN 2020 (R).

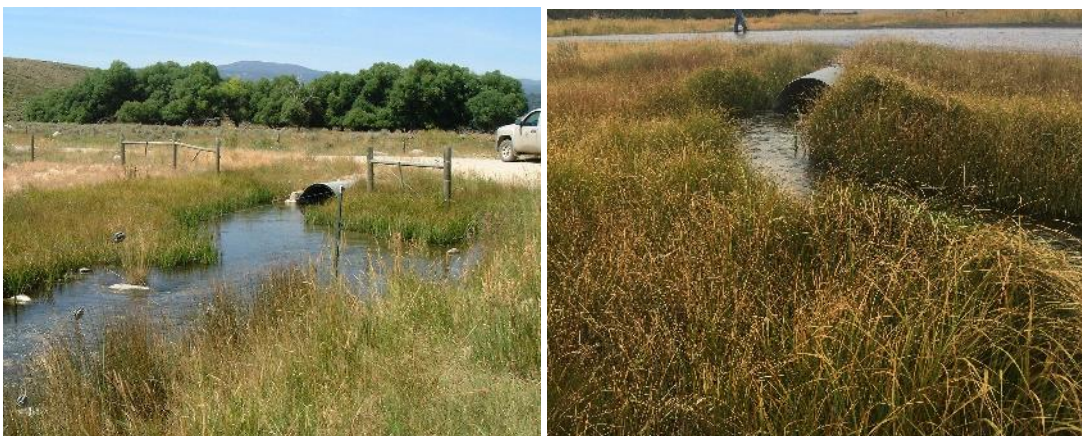
FIGURE 90. MADISON SPRING CREEK IN 2009 (L) AND 2020 (R). THE STREAM HAS ADJUSTED BUT THE RIPARIAN AREA IS IN GOOD CONDITION.

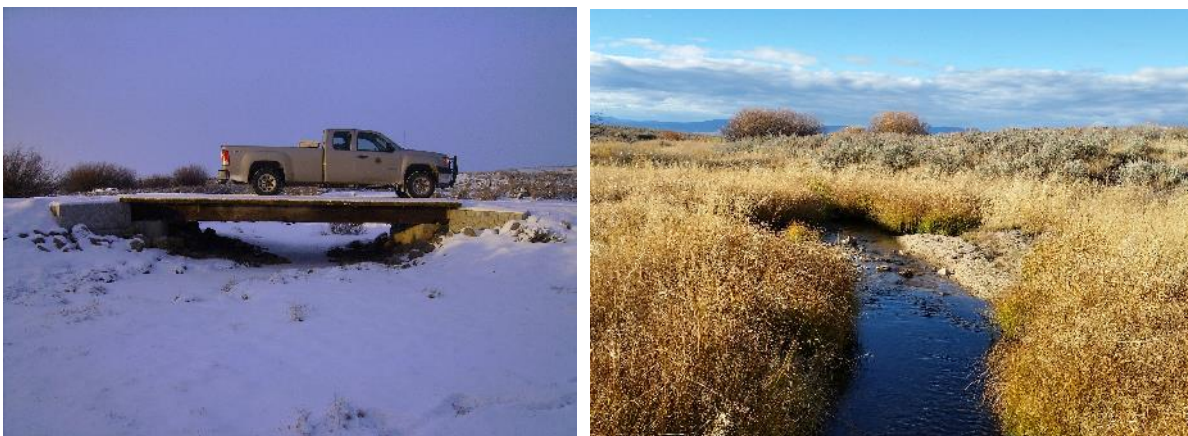
(Figure 91). Additionally, the project installed a hardened water gap and replaced an existing road ford with a bridge. It was completed in 2014.

In 2020, FWP staff noted that juvenile willows in the grazing enclosure are popping up and not getting grazed off each year. This photo below is the location of the former ford across the creek that the bridge replaced.

FIGURE 91. MCVEY CREEK AFTER CONSTRUCTION (L; 2014) AND IN 2019. THE RIPARIAN AREA HAS IMPROVED OVER TIME.

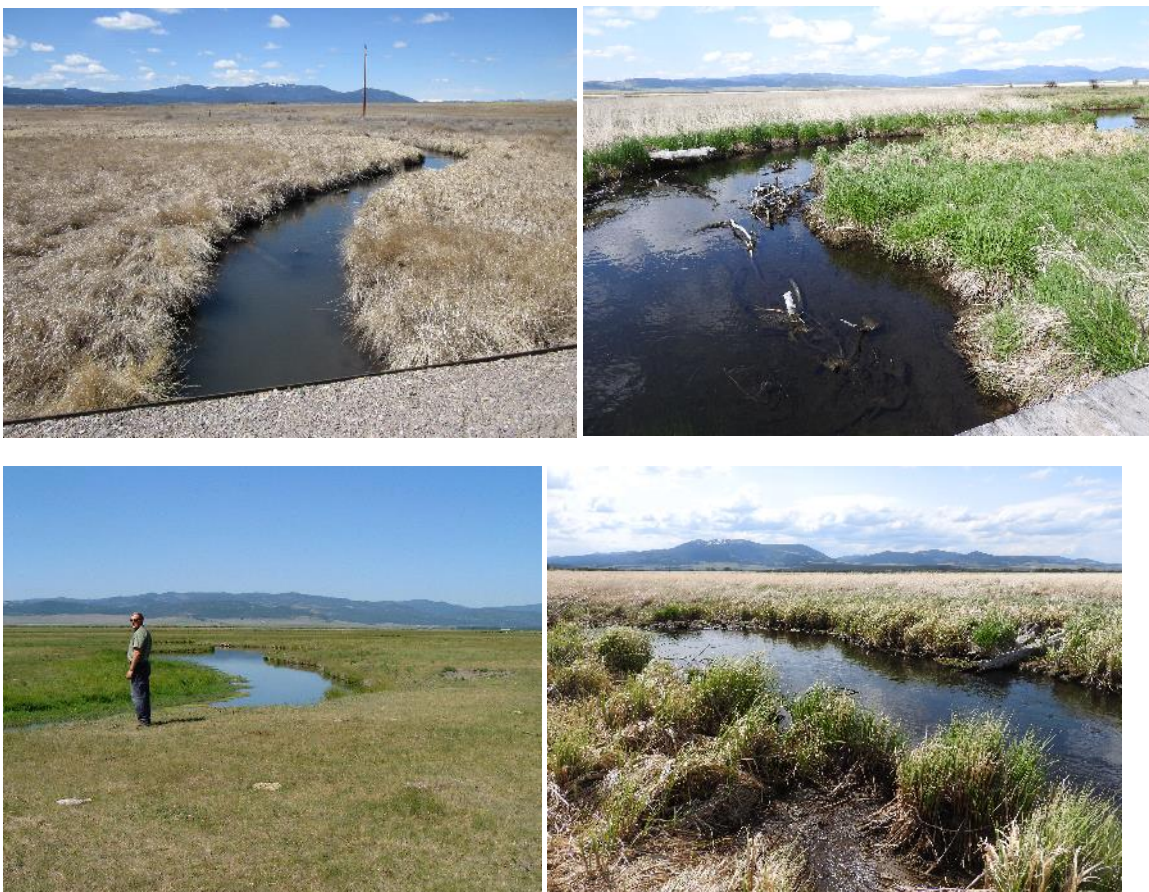
Nevada Spring Creek (Powell County) was a highly degraded spring creek that enters the Blackfoot River north of Helmville. The stream was previously channelized and became wide and shallow with very little fish habitat, especially for spawning. This project restored over 9,000 ft of Nevada Spring Creek (2001) and then extended the restoration downstream for an additional 10,240 ft (2003). The restored channel was narrower and deeper and was managed as a riparian grazing enclosure (Figure 92).

In 2019, the stream remained functional, with the exception of most of the woody species. It had widened in some places. Willows and woody vegetation had not been established. Overall, the project has been successful but additional woody vegetation and woody recruitment is desired.

FIGURE 92. NEVADA CREEK BEFORE (TOP LEFT [2013]; BOTTOM LEFT [2001]) AND AFTER (TOP AND BOTTOM RIGHT; 2019).

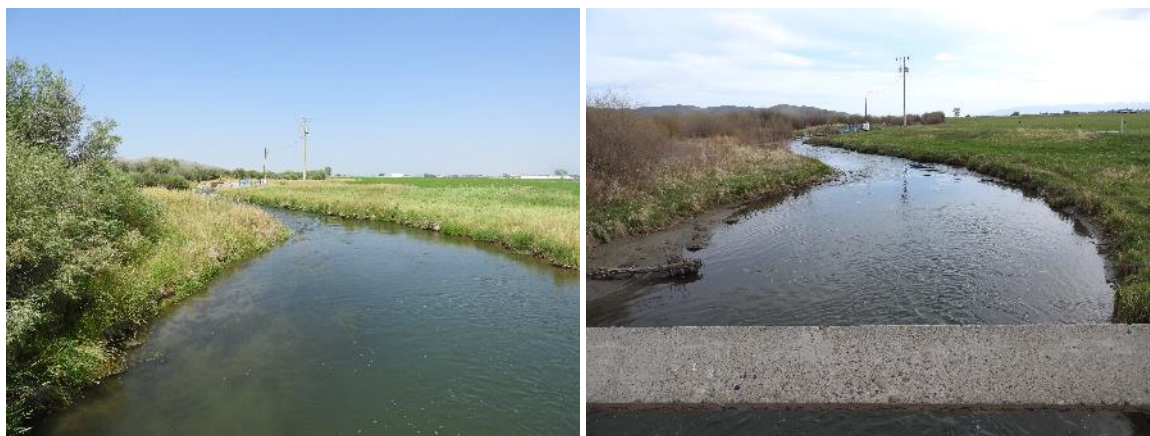
Poindexter Slough (Beaverhead County) is 4.7-mile-long channel of the Beaverhead River, located near Dillon, fed by a combination of groundwater and water diverted from the river. The project area supports a very popular fishery for rainbow trout and brown trout. FWP surveys on this slough documented a steady decline in trout numbers over the last 12 years. This decline was attributed to impaired riparian conditions and the loss of instream habitat, primarily as a result of stream flow management restricted high spring flushing flows. The slough was traditionally fed by groundwater returning from flood irrigation. As landowners converted from flood to sprinkler irrigation, groundwater inputs decreased, and the slough was supplemented with more water from the Beaverhead River to meet water rights. The diverted water deposited sediment into the slough, which filled pools and inundated riffle habitat. To effectively mobilize and transport these fine sediment deposits, a larger head gate at the top of the slough was installed. Appropriately sized channel dimensions were achieved, and backwatered reaches were eliminated in most of the project area (Figure 93). The project was completed in 2016.

The project was visited in 2019 with FWP staff. Fisheries biologist Matt Jaeger is controlling the headgate and flushing flows. Although the project is successful overall, the channel was built slightly too wide and sediment has accumulated in places. The lesson learned was to build the channel slightly narrower than expected. Poindexter Slough remains a popular, public fishery near Dillon.

FIGURE 93. POINDEXTER SLOUGH AFTER CONSTRUCTION (L; 2016) AND IN 2019 (R).
