Future Fisheries Improvement Program Legislative Report | 2019-2020

Summary of Program activities from November 1, 2018 to October 31, 2020.

Fish Management Bureau

Fisheries Division

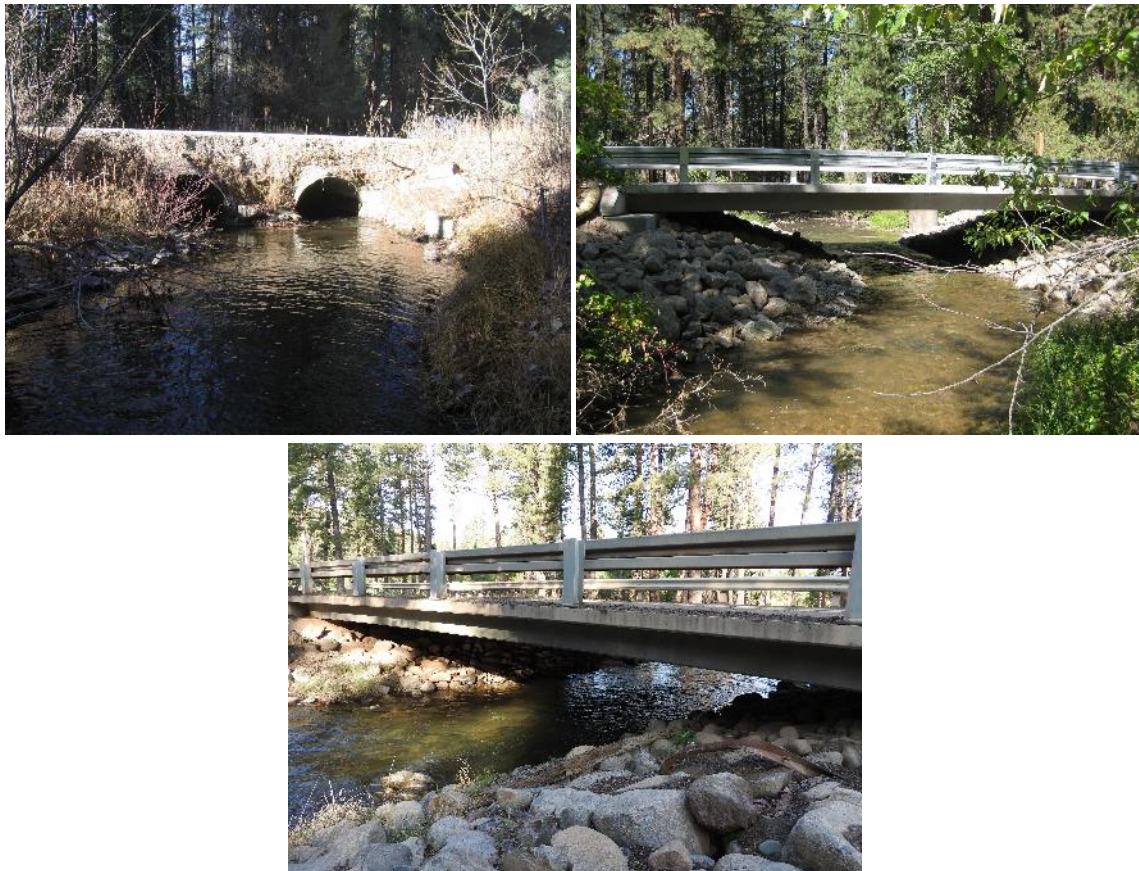
FIGURE 94. POORMAN CREEK BEFORE (TOP LEFT) AND AFTER CONSTRUCTION (TOP RIGHT; 2009). THE BRIDGE WAS IN GOOD CONDITION IN 2020 (BOTTOM).

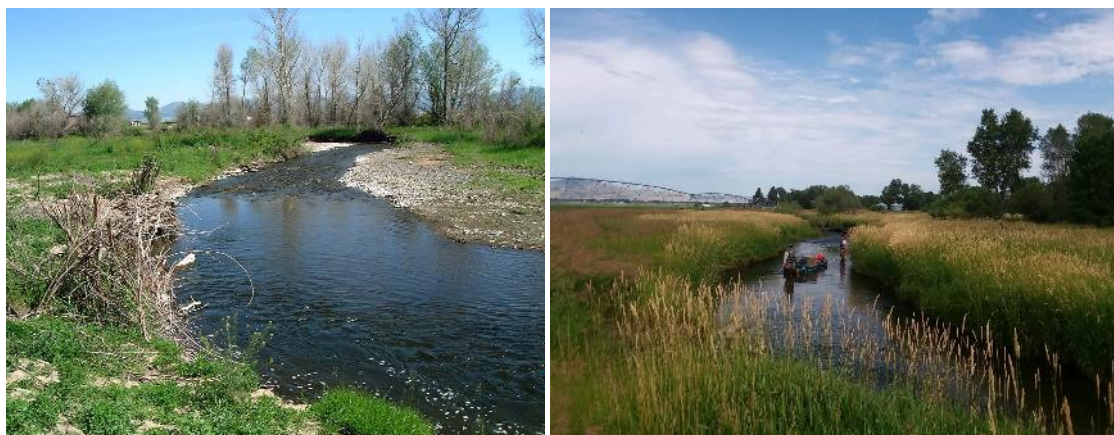
Prickly Pear Creek (Lewis and Clark County) located in the Helena valley supports a mixed trout fishery. The reach that flows through the Burnham Ranch suffered from a variety of problems caused by adjacent land management practices. In 2001, a restoration project was completed on the Burnham section. The owner entered into a Conservation Reserve Program (CRP) agreement with the Natural Resources Conservation Service (NRCS) that resulted in cattle being excluded from streamside areas for a minimum of 10 years to allow riparian areas to recover. This project installed riparian fencing and native material revetments, revegetated selected areas with willow clumps, and re-aligned and narrowed of portions of the channel to facilitate sediment transport and improve fish habitat (Figure 95). Approximately 2,100 ft of stream was treated.

FIGURE 95. PRICKLY PEAR CREEK AFTER COMPLETION (L; 2001) AND AFTER CONSTRUCTION (R; 2020).

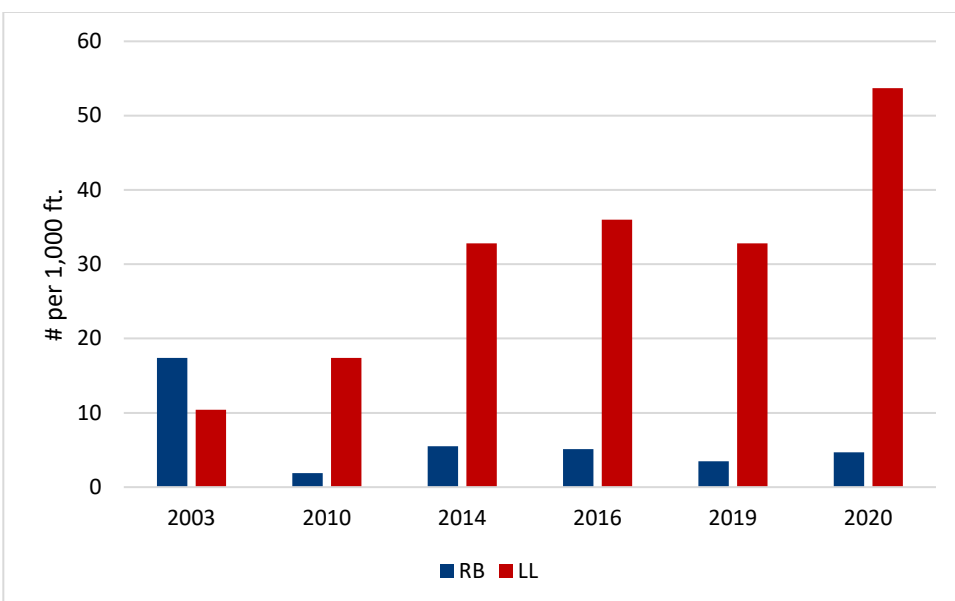
FIGURE 96. POPULATION SURVEY (CATCH PER UNIT EFFORT; FISH PER 1,000 FT.) FOR RAINBOW (RB) AND BROWN (LL) AT THE BURNHAM RANCH SECTION ON PRICKLY PEAR CREEK, 2020. DATA COURTESY OF ADAM STRAINER, FWP.

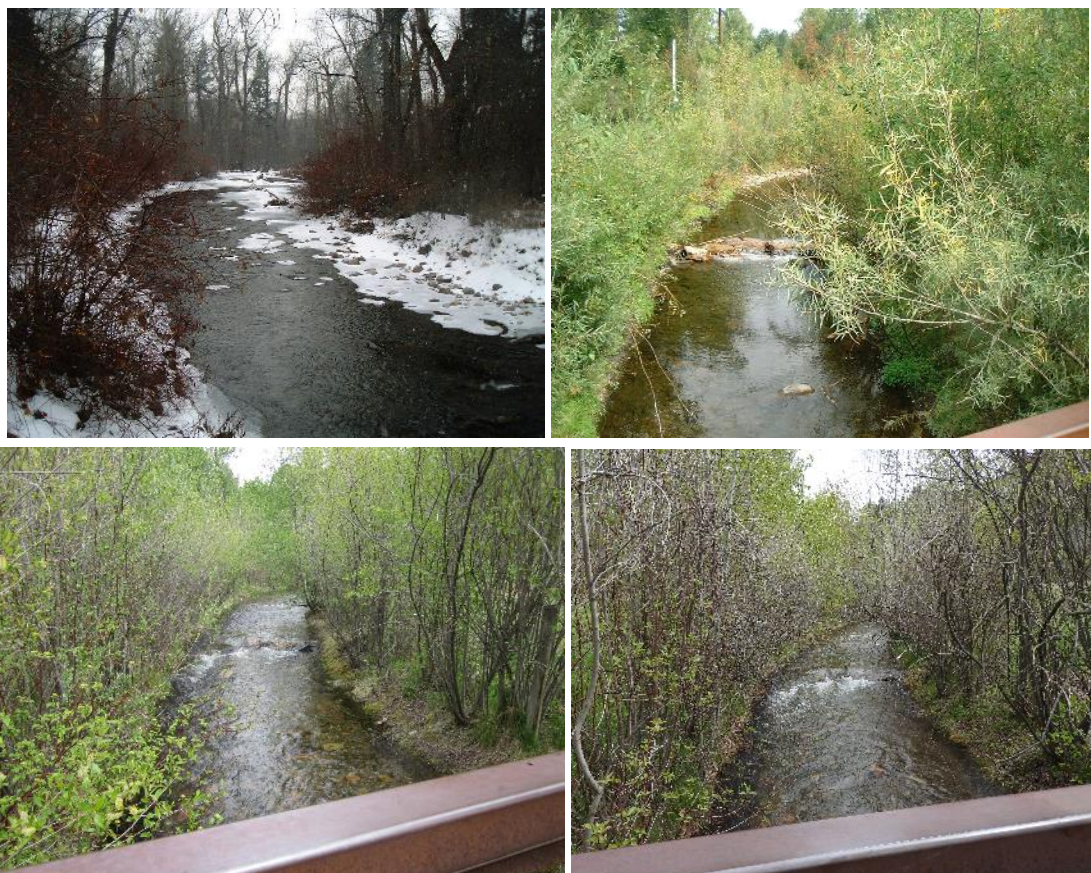
This project was visited in 2020 and looked very similar to monitoring completed in 2015 (Figure 97). There is high riparian stability and established vegetation. There is significant woody debris present in the main channel and accumulating in the side channel.

FIGURE 97. RATTLESNAKE CREEK CHANNEL RESTORATION BEFORE CONSTRUCTION (TOP LEFT), AFTER CONSTRUCTION (TOP RIGHT; 2009), 2015 (BOTTOM LEFT), AND IN 2020 (BOTTOM RIGHT).

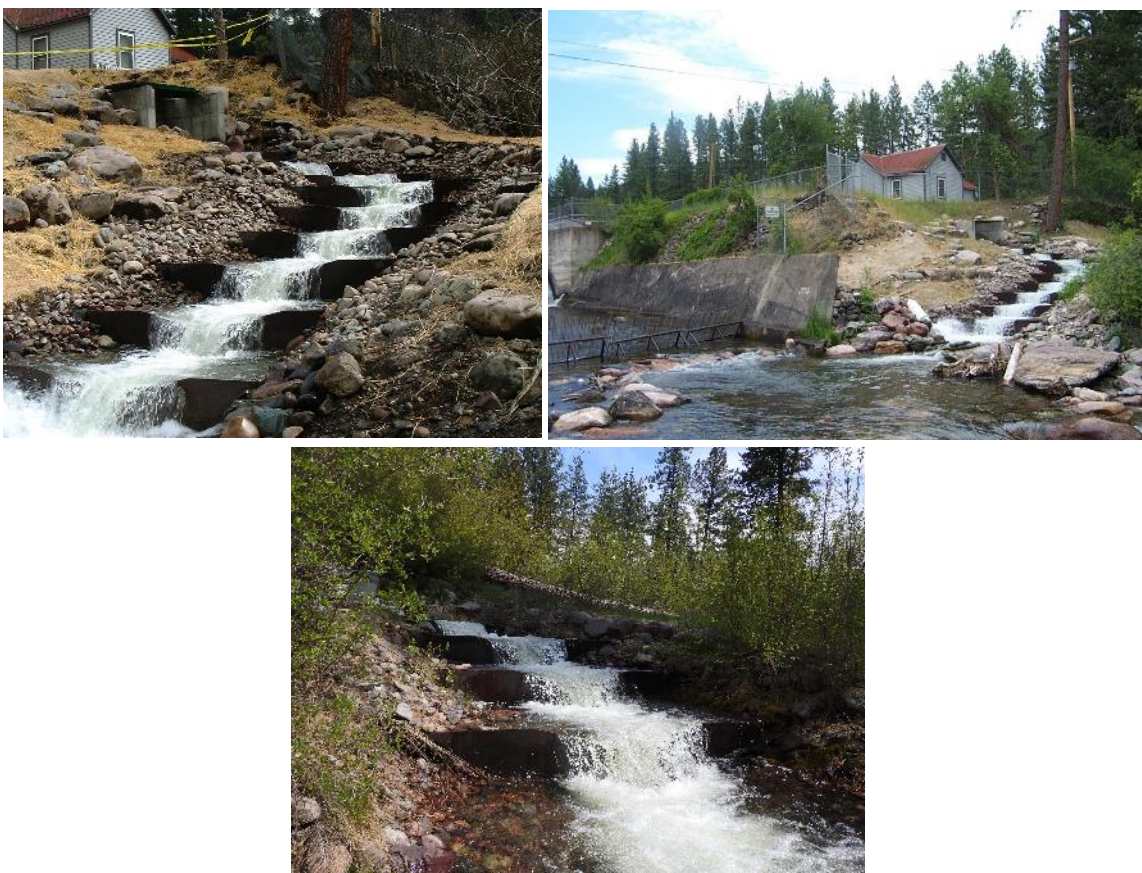
Rattlesnake Creek (Missoula County) supports important spawning runs of both bull and westslope cutthroat trout from the Clark Fork River. A ten-foot-high diversion dam that supplied water for the city of Missoula prevented migrant fish from gaining access to the upper 15 miles of Rattlesnake Creek. This project constructed a fish ladder that allowed migrant spawners to move upstream (Figure 98). The project was completed in 2003; FWP staff have monitored passage periodically.

In 2020, the project site was visited in preparation for dam removal (008-2019). Because removal of the dam will provide unrestricted fish passage, this project will be removed and considered obsolete (expired).

FIGURE 98. RATTLESNAKE CREEK FISH LADDER AFTER CONSTRUCTION (TOP LEFT; 2003), IN 2014 (TOP RIGHT) AND IN 2020 (BOTTOM). THE FISH LADDER WAS REMOVED IN 2020 WITH THE REMOVAL OF RATTLESNAKE DAM.

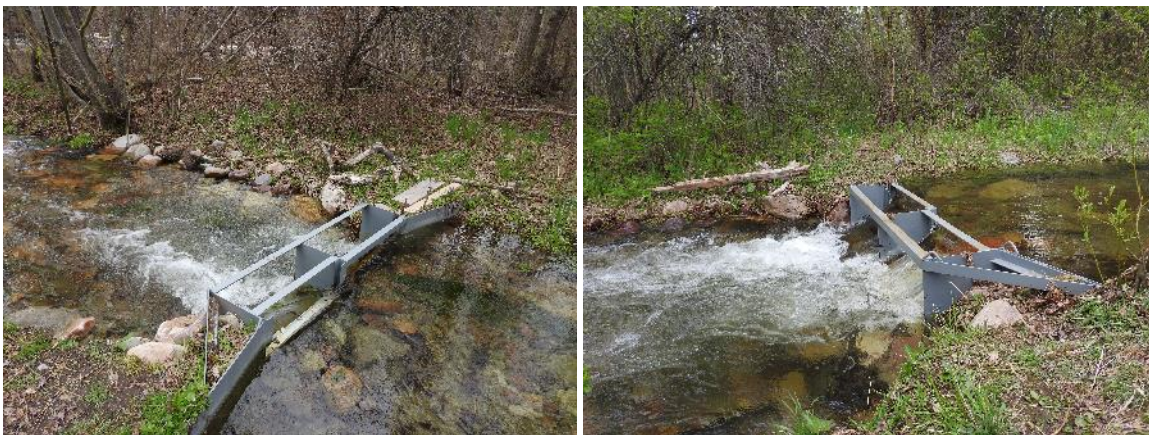
The site was monitored in 2020 and the screen appeared to be in good condition and functional. Vegetation at the site has been established and there are several enclosures for woody plants. The headgate inlet still has some bank erosion but overall the project appears to be successful.

FIGURE 99. RATTLESNAKE CREEK FISH SCREEN AFTER CONSTRUCTION (L; 2015) AND IN 2020 (R).

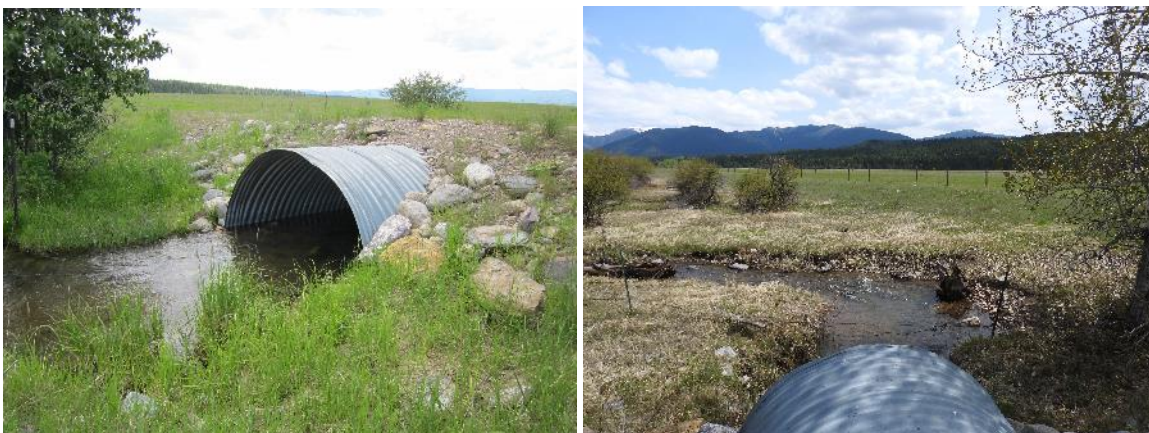
One of the most important tributaries to the North Fork of the Blackfoot River supports a mixed salmonid fishery that includes bull and westslope cutthroat trout. A stream ford located about four miles upstream from the mouth was unstable and a significant source of sediment to the stream. This project replaced the ford with a pipe arch culvert (Figure 101). The project was completed in 2008.

The project site was visited in 2019, in conjunction with 014-2001. The culvert remains in place and is functional. There is some downstream erosion present.

FIGURE 101. ROCK CREEK CULVERT IN 2013 (L) AND 2019 (R). THE CULVERT IS INTACT BUT THERE IS SOME DOWNSTREAM EROSION.

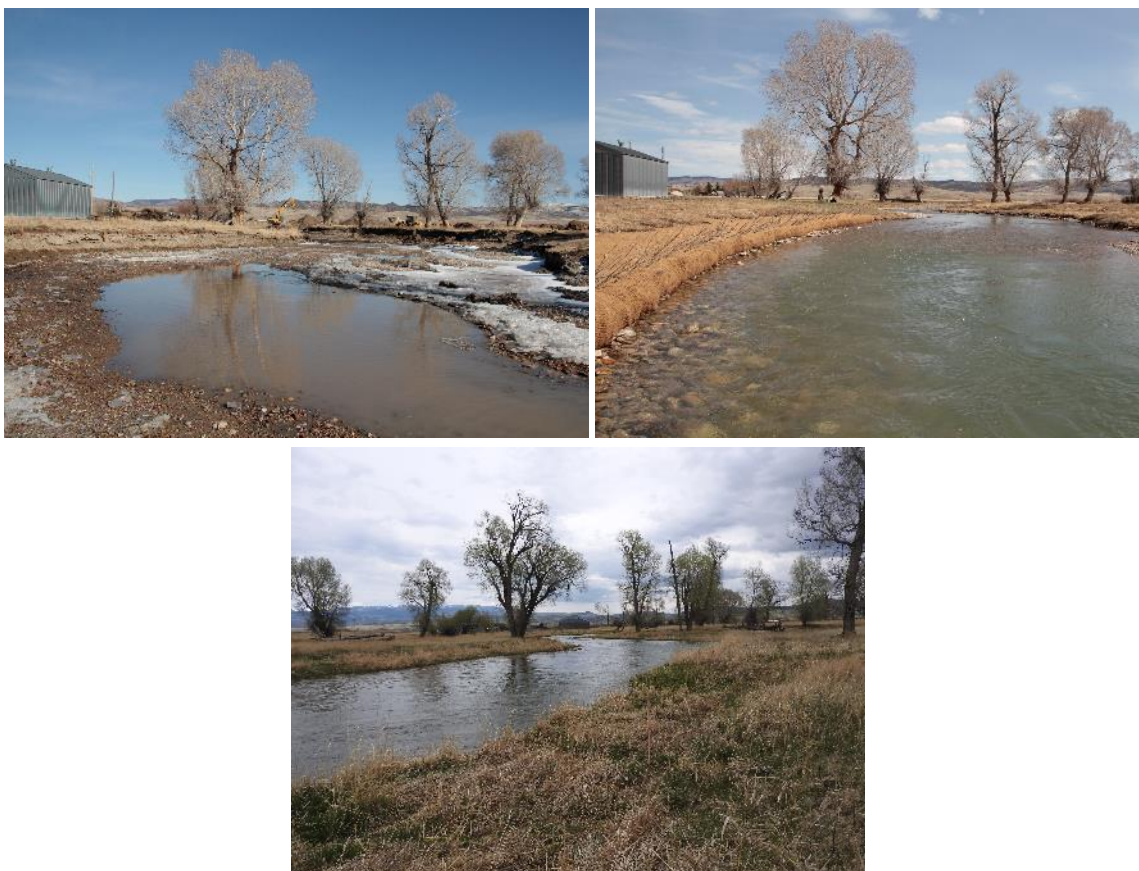
The Ruby River (Madison County) located downstream from Ruby Reservoir, supports a mixed trout fishery. Portions of the river located on the Miller Ranch historically were straightened and the riparian vegetation removed to make more room for farming. This project reconstructed the straightened channel to increase sinuosity from 1.2 to 1.8 by lengthening the channel from approximately 2,000 feet to 3,500 feet. The project also relocated an existing feedlot away from the river channel, installed about 7,000 feet of riparian fencing and constructed a bridge (Figure 102). It was completed in 2015.

In 2019, the project site was visited as part of the FFIP project tour. The site was in good condition and functional. The riparian area has been maintained and livestock management has been successful.

FIGURE 102. RUBY RIVER CHANNEL BEFORE CONSTRUCTION (TOP LEFT), AFTER CONSTRUCTION (TOP RIGHT; 2015), AND IN 2019 (BOTTOM).

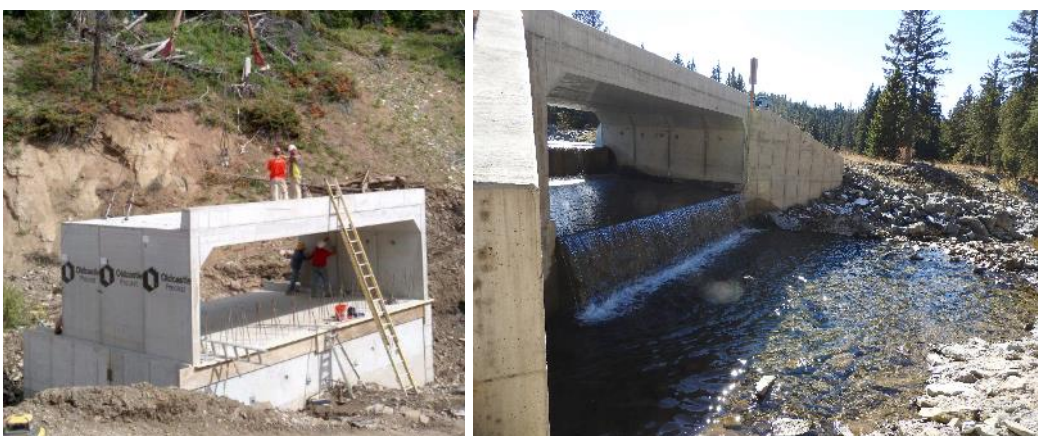
FIGURE 103. SHIELDS RIVER BARRIER BEING INSTALLED (L) AND AFTER CONSTRUCTION (R; 2019).

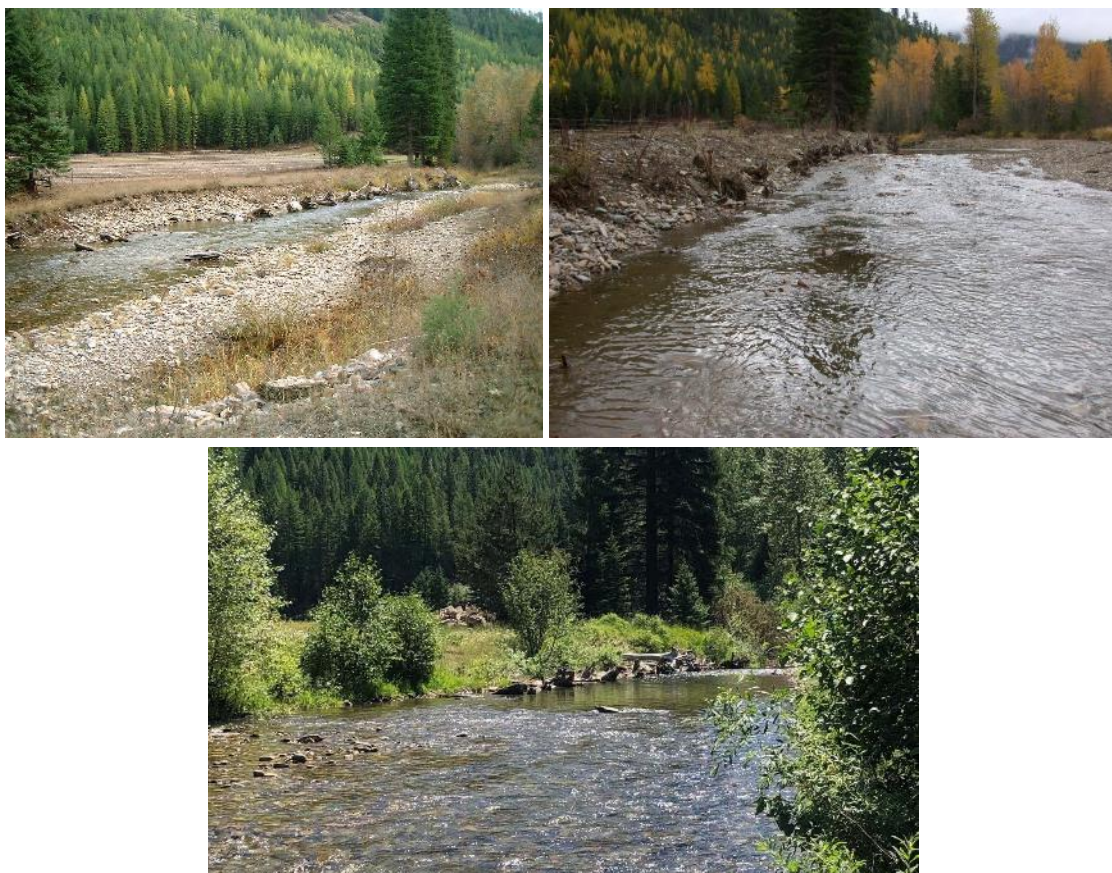
Silver Butte/Fisher River (Lincoln County) supports cutthroat trout and some bull trout. The stream was unstable in the project area due to past grazing and land use. This project stabilized the bank using rock vanes, J-hook weirs, and rootwads. Riparian fencing was also installed (Figure 104). The project was completed in 2001.

In 2020, FWP staff visited the site and spoke with the landowner's son, visiting the project on the east side of Silver Butte Creek. The lower two-thirds of the project is in good shape with the installed rootwads intact and some natural alder becoming established. Some of the installed rootwads in the upper third of the project area have been undercut and are perched above the water surface. The landowner's son said a tree fell at the upper end of the project site this spring, which ended up somewhat protecting the upper end of the site. There is some concern about the upper 1/3 of the project site, but currently it does not look like there is significant erosion. For a project that is 19 years old, it has been successful overall.

FIGURE 104. SILVER BUTTE/FISHER RIVER BEFORE CONSTRUCTION (TOP LEFT), AFTER CONSTRUCTION (TOP RIGHT; 2001), AND IN 2020 (BOTTOM). MOST OF THE PROJECT REMAINS INTACT BUT THERE IS SOME EROSION.

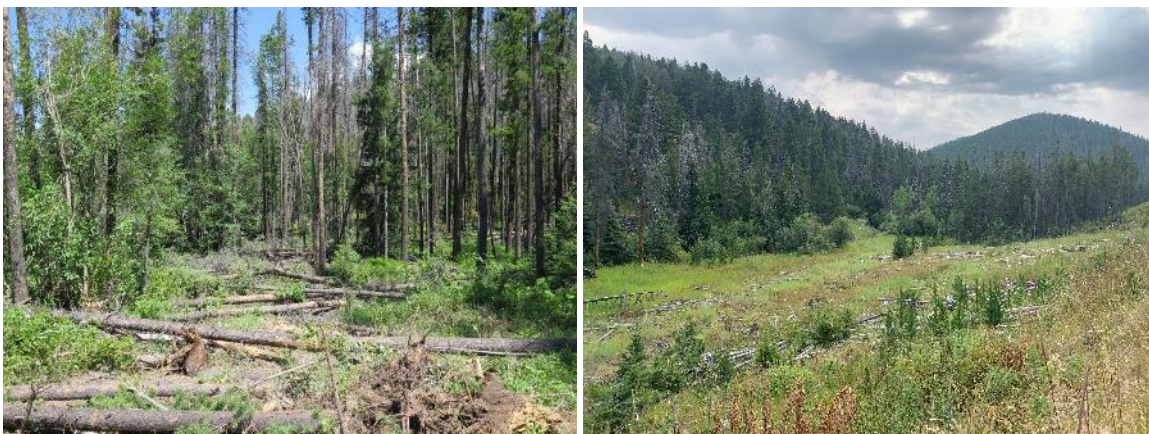
In 2020, the site was functional and recovering. There were some weeds in the area but overall the project is functioning as intended. The new road is intact and old road has vegetation established.

FIGURE 105. SOUTH FORK POORMAN CREEK AFTER CONSTRUCTION (L; 2014) AND IN 2020 (R).

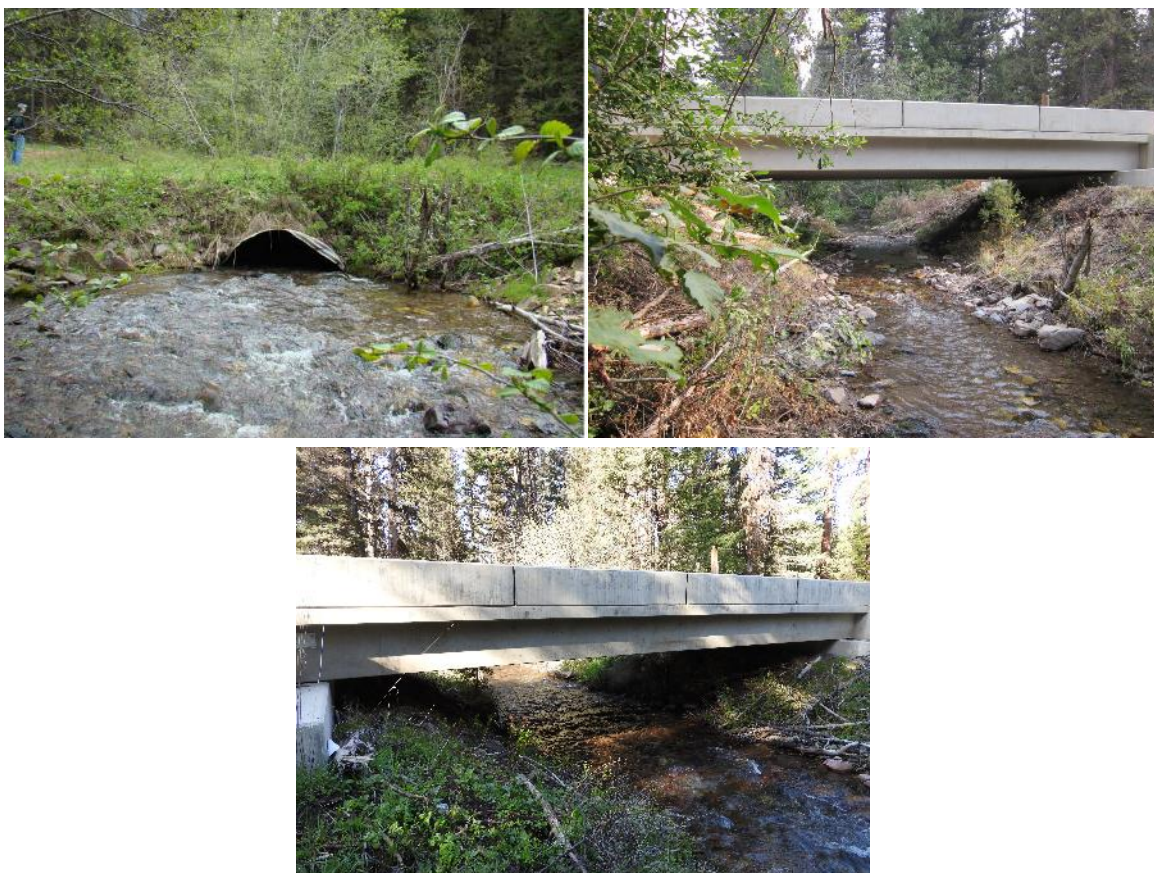
Theodore Creek (Lewis and Clark County) is a tributary to Beaver Creek and supports fluvial, genetically pure westslope cutthroat trout. Bull trout were also historically found in the system. This project replaced an undersized culvert that impeded fish passage during high flows with a pre-stressed concrete bridge structure that created year-round connectivity and natural stream conditions (Figure 106). This project was completed in 2015.

In 2019, this project appeared to be functional and having no sign of erosion. The stream profile has been maintained and the grade control is intact. Fish passage is unobstructed.

FIGURE 106. THEODORE CREEK BEFORE THE BRIDGE WAS INSTALLED (TOP LEFT), AFTER CONSTRUCTION (TOP RIGHT; 2015) AND 2019 (BOTTOM).

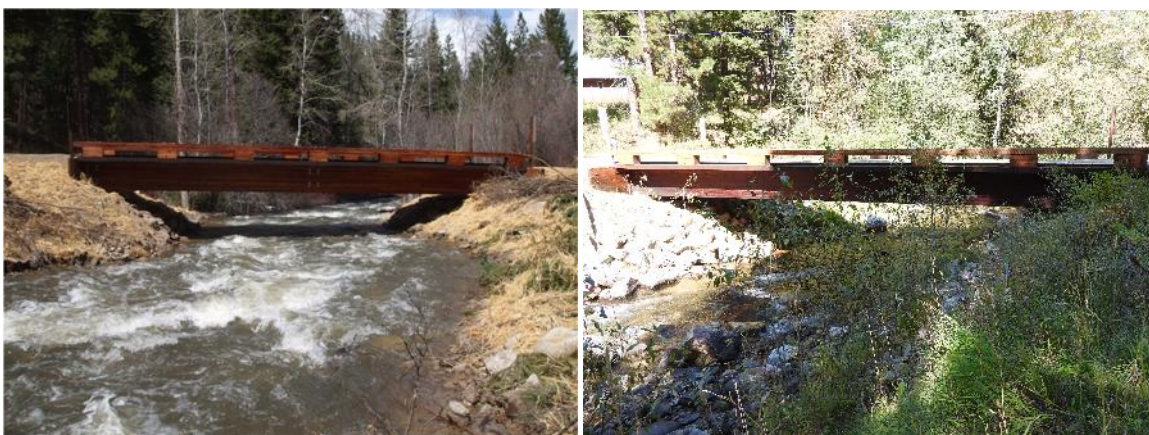
Warm Springs Creek (Ravalli County), a tributary to the East Fork Bitterroot River near Sula, supports westslope cutthroat trout and bull trout populations. The cutthroat trout are hybridized with rainbow trout in the lower reaches of the stream and are genetically pure in the upper reaches. A U.S. Forest Service culvert located about one mile upstream from the mouth acted, at least, as a partial migration barrier to the upstream movement of juvenile trout and adult bull trout. This project replaced the existing undersized and perched culvert with a 50-foot bridge (Figure 107). It was completed in 2011.

In 2020, the site was monitored. The bridge is in good condition and stream is functional. Vegetation is established immediately upstream and downstream and there was no visible erosion. Fish passage is unobstructed.

FIGURE 107. WARM SPRINGS BRIDGE AFTER CONSTRUCTION (L; 2011) AND IN 2020 (R).

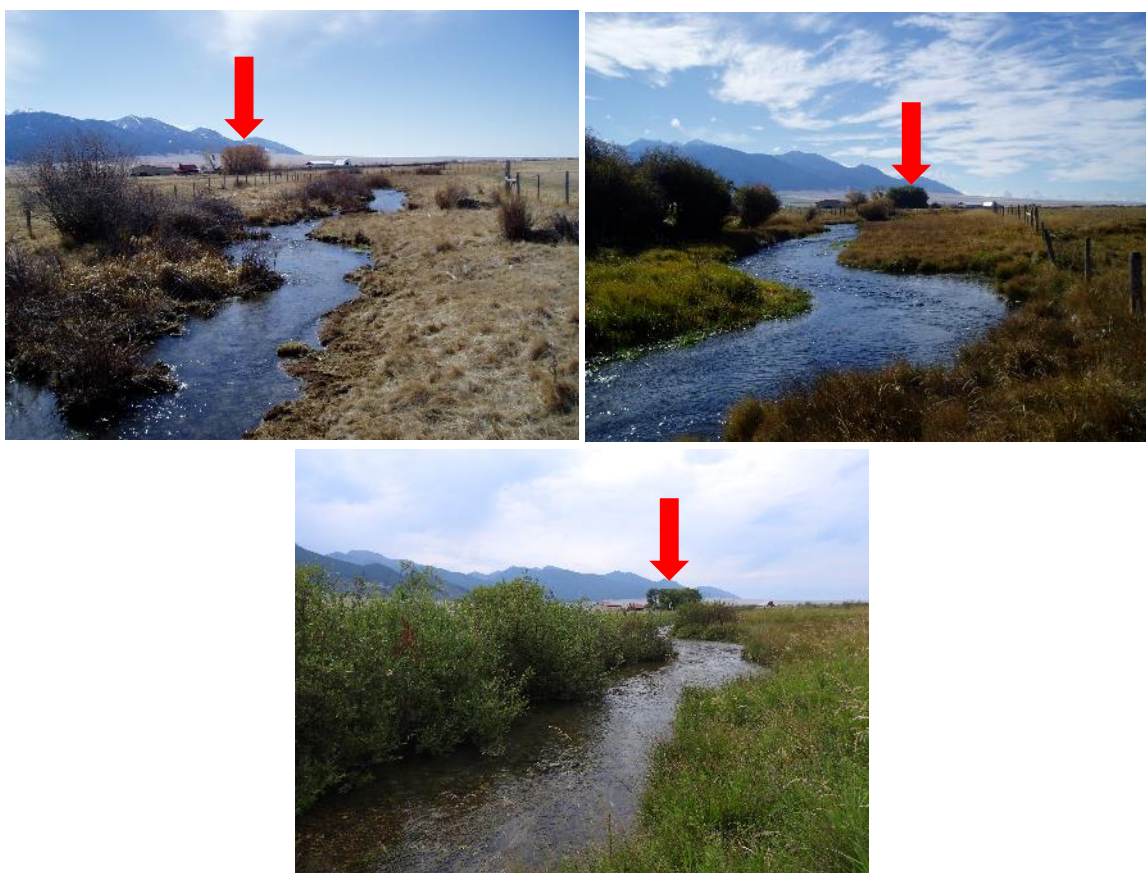
Willow Spring Creek (Jefferson County), located on the Joe Adams property, is an important spawning stream for Jefferson River rainbow trout. A lack of suitable spawning sites was limiting the fishery. Spawning habitat was improved by importing gravel into the spring creek as well as into several smaller tributaries. The project also included channel improvements and riparian fencing. About 4,500 ft of channel was treated (Figure 108). It was completed in 2005.

In 2020, the site was visited with FWP biologist Ron Spoon, who has been collecting redd data on this stream and population data on the Jefferson river. Overall the project is in great condition with a healthy riparian area. The fencing is intact, and vegetation is healthy. There are some invasive weeds in and out of the riparian area. There has been some predation by pelicans, so flagging has been used to dissuade them from taking spawning fish.

FIGURE 108. WILLOW SPRINGS CREEK BEFORE (TOP LEFT), AFTER CONSTRUCTION (TOP RIGHT; 2005) AND IN 2020 (BOTTOM). RED ARROWS DENOTE COMMON FEATURES.

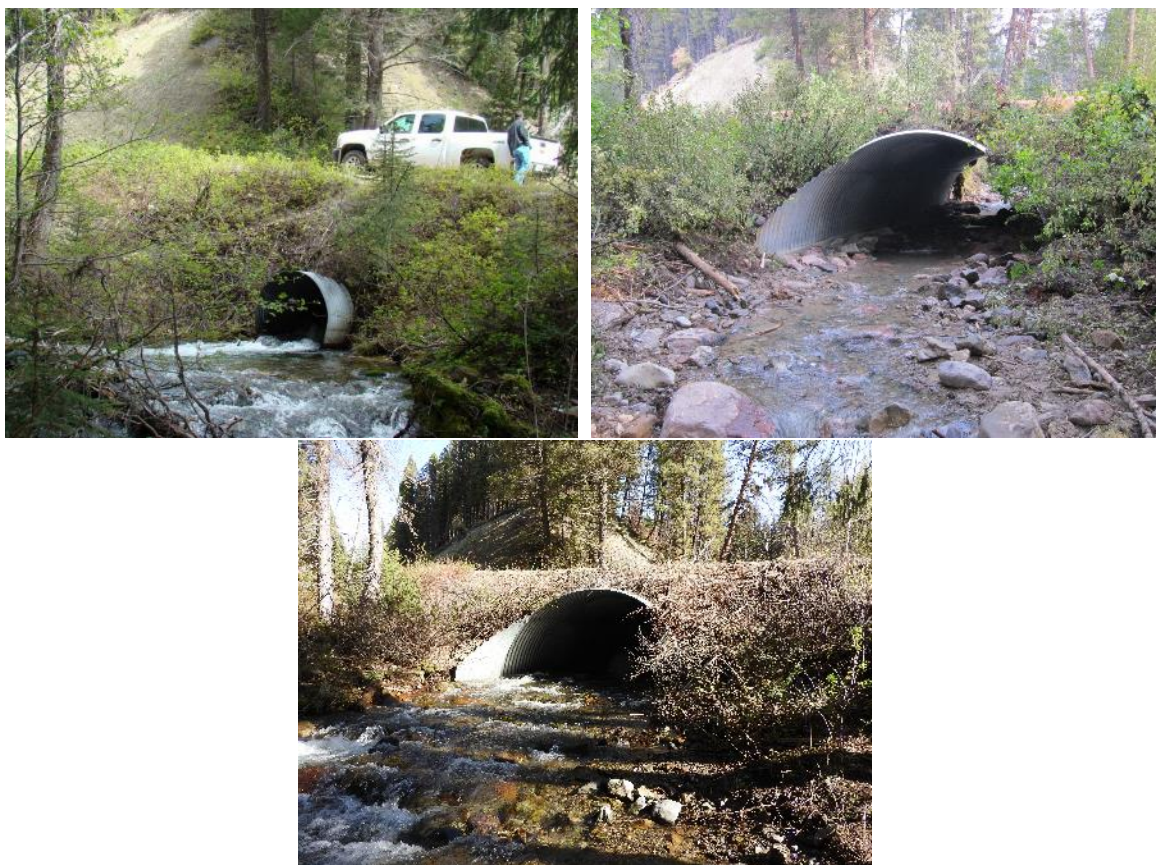
Yukon Creek (Lewis and Clark County) is a tributary to Beaver Creek and supports fluvial, genetically pure westslope cutthroat trout. This project addressed an existing stream crossing that was undersized, impeded fish passage during high flows, and impaired the channel. The existing 60-inch culvert was replaced with a bottomless arch structure large enough to pass 100-year flood events. The goals of this project were to develop a stable stream crossing that would correct road drainage problems, eliminate delivery of excessive sediment, provide fish passage, and restore natural channel morphology to the site (Figure 109). It was completed in 2015.

In 2019, the site was monitored. The project was intact and functional. Fish passage continues to be unobstructed, grade control structures are in place, and the stream looks similar to site completion.

FIGURE 109. YUKON CREEK FISH PASSAGE BEFORE CONSTRUCTION (TOP LEFT), AFTER CONSTRUCTION (TOP RIGHT; 2015), AND IN 2019 (BOTTOM).
