Habitat Assessment for Miller Creek Missoula County, Montana

October 2018

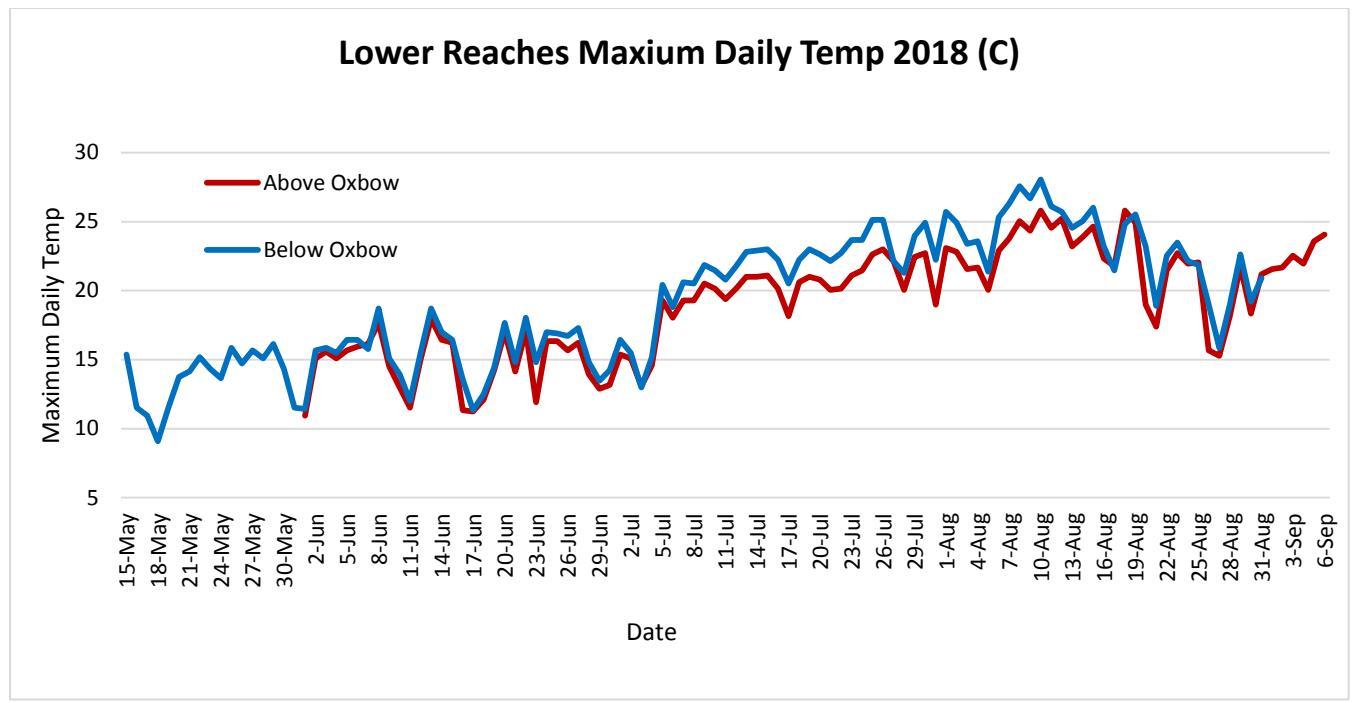
Miller Creek 2018 Temperature Data Summary													
Site	Papah	Seasonal Maximum												
Site	Reach	Date	Value°C	Days> 15 C	Days> 21 C									
Spooner Creek (sites averaged)	Upper	8/12/2018	12.5	0	0									
Wustner (sites averaged)	Middle-upper	7/25/2018	15.1	2	0									
MPG	Middle-upper	7/25/2018	15.8	18	0									
Above Oxbow	Lower	8/10/2018	25.8	82	38									
Below Oxbow	Below Lower	8/10/2018	28.6	85	46

Figure 27: Maximum daily temperature recorded on the lower reaches of Miller Creek in summer, 2018.

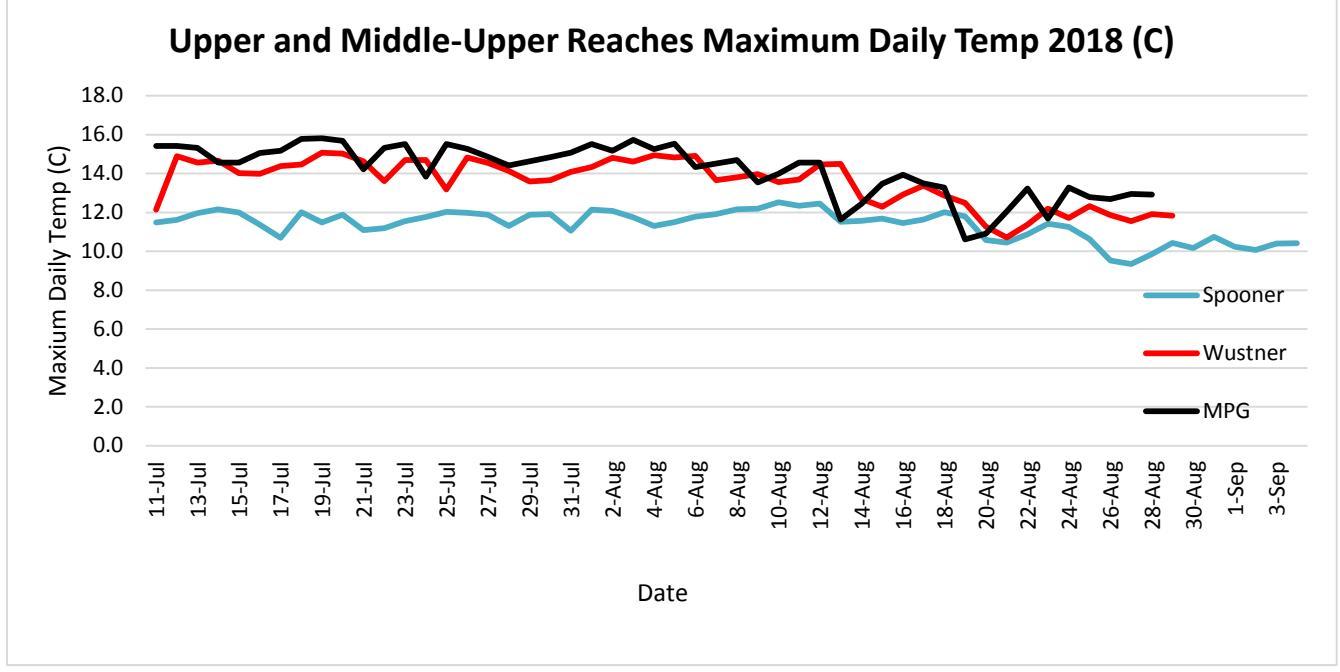
Figure 28: Maximum daily temperatures recorded on the upper and middle-upper reaches of Miller Creek in summer, 2018.

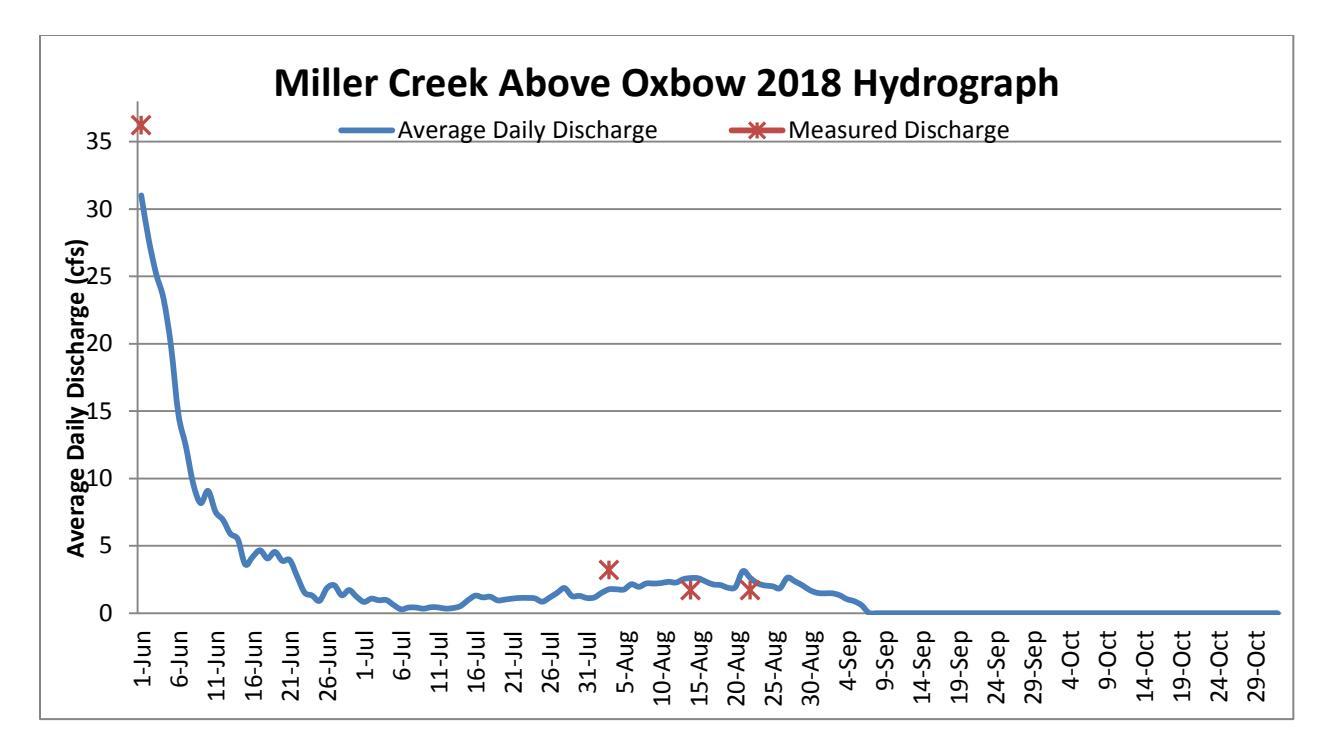
Figure 29: Hydrograph showing daily discharge at a Miller Creek flow monitoring site in the lower reach of the assessment.

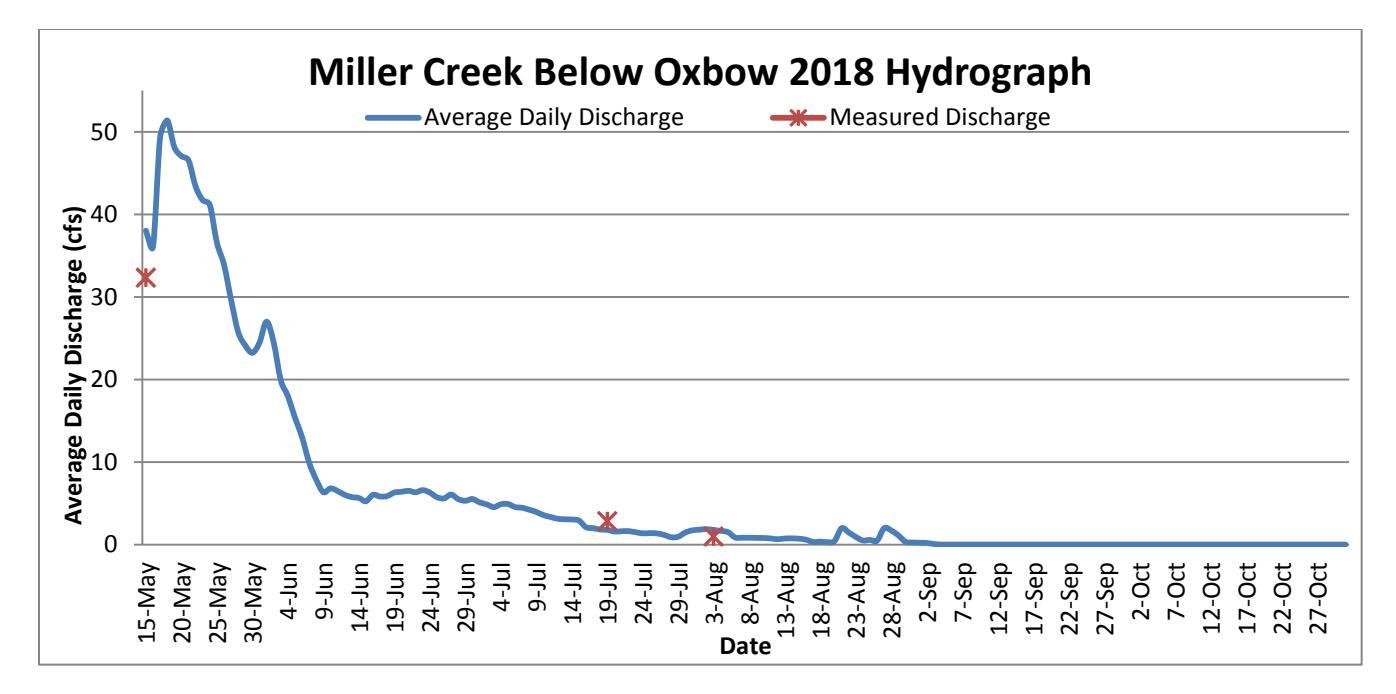
Figure 30: Hydrograph showing daily discharge at a Miller Creek flow monitoring site below the lower reach of the assessment.

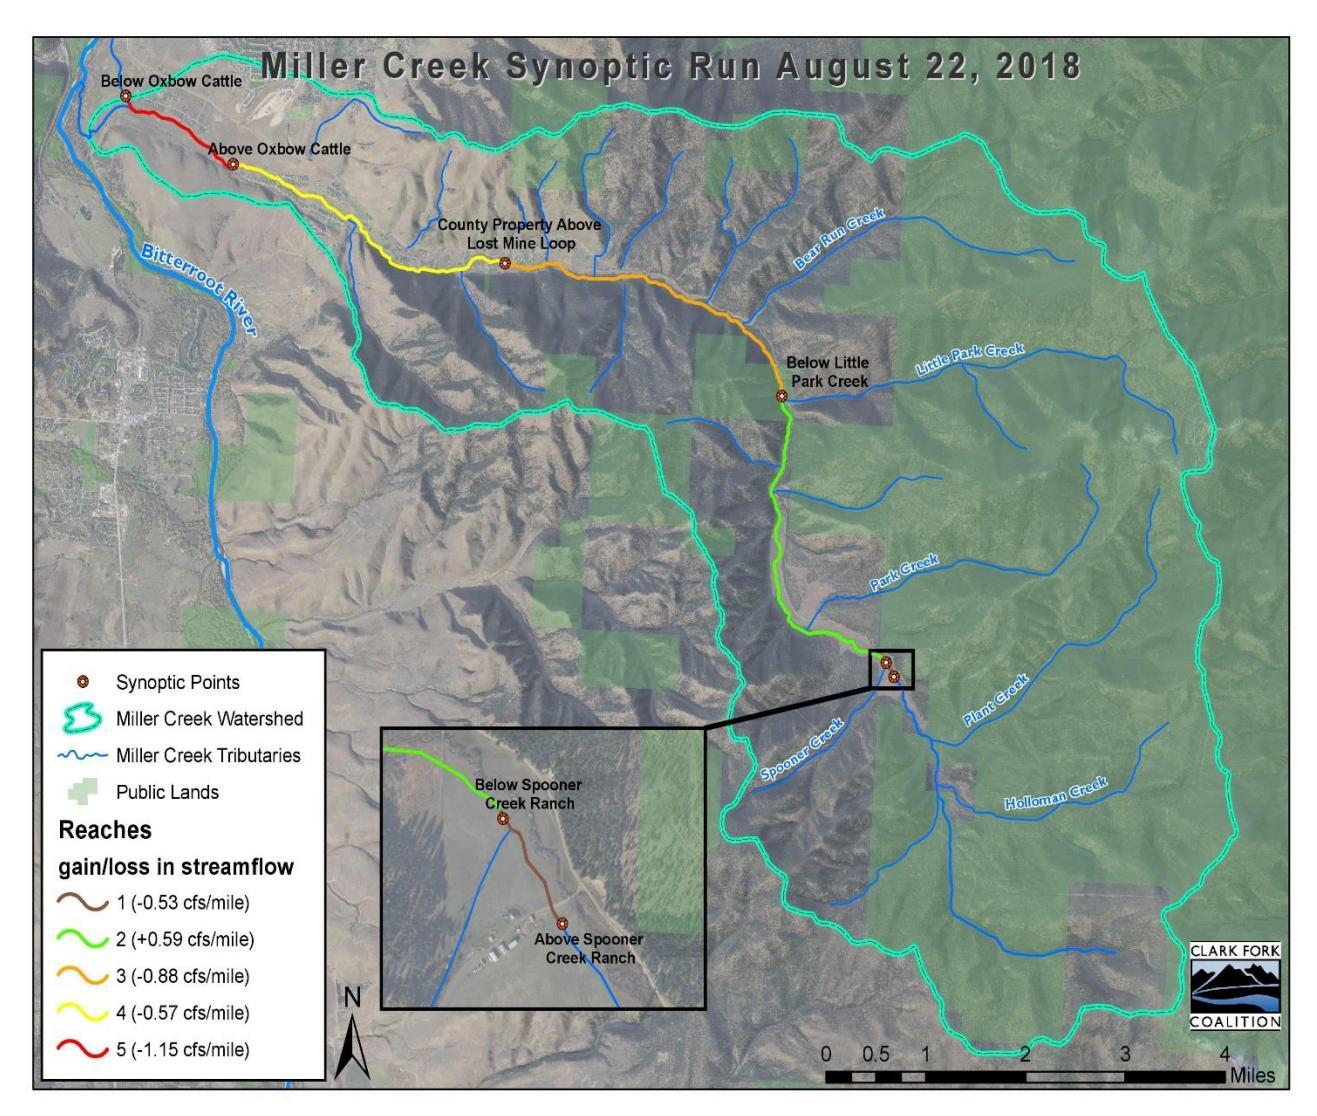
A synoptic monitoring run was performed on August 22, 2018. The purpose of the synoptic run was to assess baseline flows during low flows, and show the inputs and outputs of the creek from the upper to lower reaches. The following map and table illustrate the flows at the end of August.

Figure 31: Map of Miller Creek synoptic flow run, August 2018.

Miller Creek Synoptic Run August 22, 2018									
Site	Discharge								
Spooner Creek Ranch Above Spooner Creek	4.6								
Spooner Creek Ranch Below Spooner Creek	4.5								
Below Little Park Creek	6.5								
County Property Above Lost Mine Loop	3.4								
Above Oxbow	1.7								
Below Oxbow	0.5

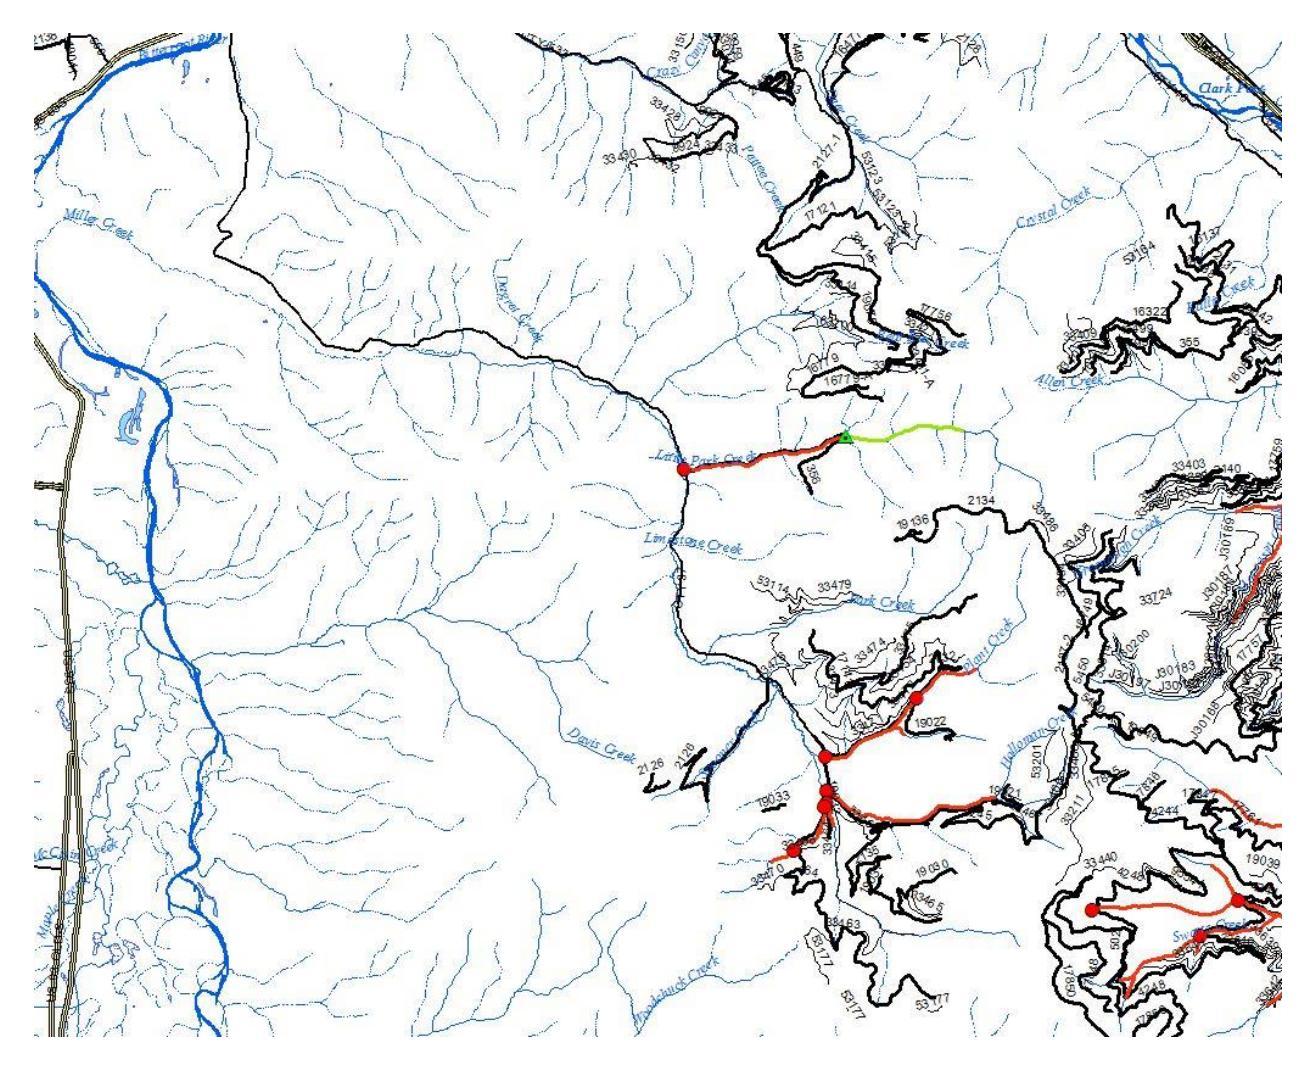
Figure x. Fish passage survey results for all USFS stream crossings in the Miller Creek watershed (red = total barrier, green = no barrier).
