REPORT ON THE EFFECTS OF 90 MW AND 50 MW  
PEAKING POWER TEST SPILLS ON LAKE HELENA,  
THE CAUSEWAY, HAUSER LAKE, AND TROUT CREEK.

Test Spills from Canyon Ferry Dam

Occurring 7/21-7/23, 1981.

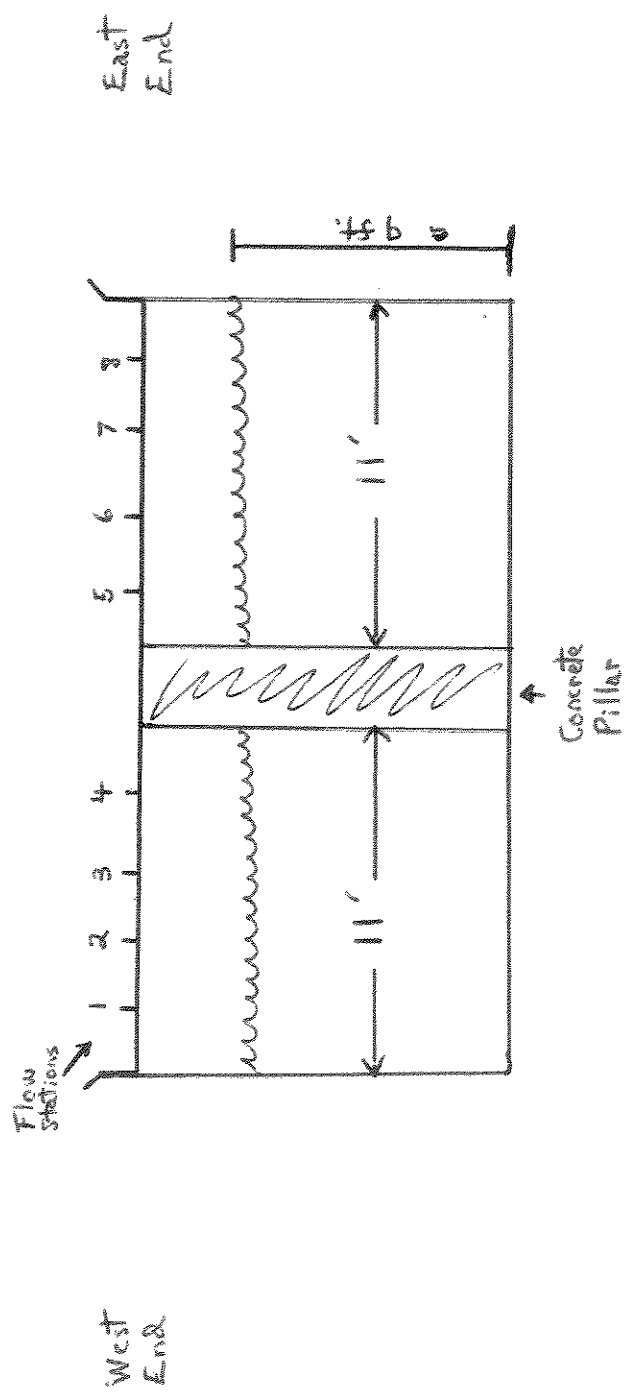
# Lake Helena Causeway Dimensions

Rectangular concrete - Water depth varied from 8.8-9.8 ft. at various levels. See photo #11.
