Report on Field Trip, June 13 to 17, 1955, to Study  
Culverts Blocking Spawning Cutthroat Trout at Hungry  
Horse Reservoir, Montana

Field Notes on Culverts at Hungry Horse Reservoir, Montana, June 13, 1955

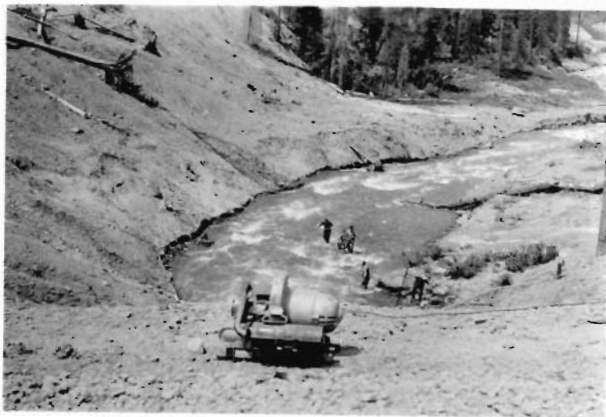
Figure 13

Felix Creek - Montana Biologists  
Preparing to Shock the Pool.

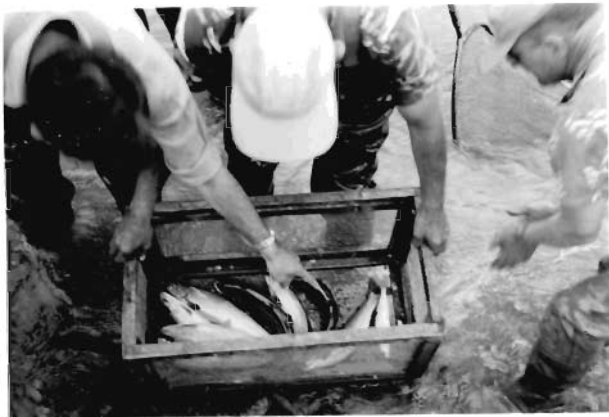
Figure 14

On June 14, Stefanich, Gaffney, Knox, Rosewitz, and I arrived at Felix Creek about noon. Stefanich feels that Felix Creek is the stream most in need of improvement. After lunch we set up the generator on the roadside (Figure 13) and the men got into their waders and went to work below the outlet of the culvert (Figure 14). Within an hour

Felix Creek - Crew in  
action below outfall.

Mr. Stefanich believes the best solution would be to remove the Felix Creek culvert and replace it with a bridge or a rectangular culvert (say 6' high by 15' wide in cross section) with a baffled bottom that would cut the velocity of high water and concentrate the flow of low water into a small channel deep enough for fish to swim through. Another possibility would be to build a series of baffles or dams below the outlet so that the first one would break the velocity at the outfall. These dams could have submerged orifices for fish passage or grooves in their centers for the same purpose. The culvert should have some baffles say 12" high at the center with 6-inch gaps between them to cut the velocity further. Or, as Mr. Holmes suggested, perhaps one dam with a fish ladder in it would be cheaper to construct and be just as efficient.

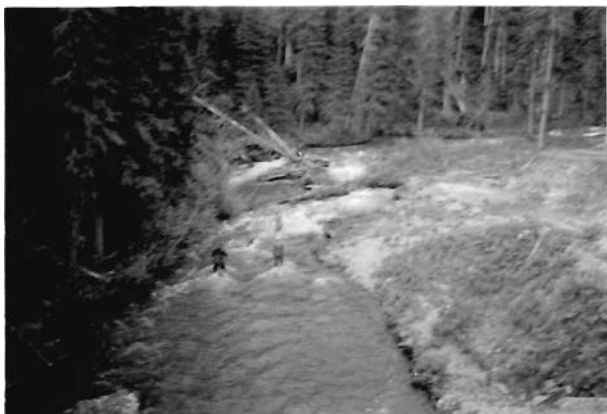
Figure 15-a

they had 7 female (12"-14" long) (Figure 15), and one male cutthroat trout (18" long) and two Rocky Mountain whitefish (10" long). The big male (Figure 16) had a large mouth, yellow sides, bright red dentary slash, and was very ripe. The females were darker with smaller heads, with silver and rose sides, gray-green above with characteristic dark spots, and they were not ripe yet, i.e., they were just beginning to soften a little--no eggs could be extruded--they were "green" but beautiful fish. I saw two fish drift past the dippers below the pool and would guess that perhaps 4 or 5 got away. It is my rough estimate that not over 15 trout were resting in the hole and that this might constitute at least half of the total population that would enter this little creek from the reservoir to spawn. However, I cannot say for sure how many fish slipped by the netters, nor can I say for sure that the entire bottom of the pool was covered by the electric field, although I feel we did as thorough a job as was possible under the rather difficult conditions involved. I have also learned since returning to Portland that the shocking machine may have been selective of larger fish. Stefanich said no fish had ever been taken above the culvert to his knowledge. We shocked 3 pools above the culvert very thoroughly and didn't get a fish of any kind. No other streams were sampled with the shocker.

Felix Creek - Cutthroat trout and mountain whitefish taken by dip net after shocking pool.

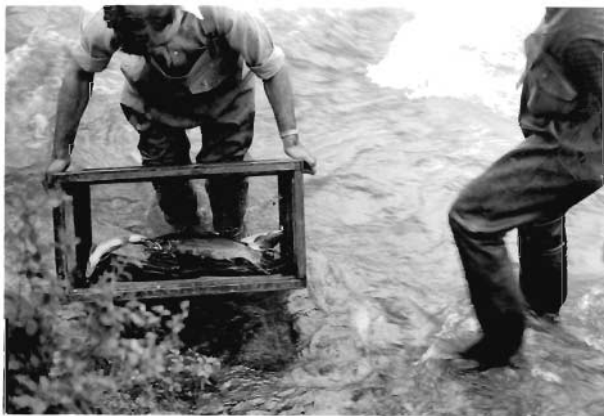
Figure 15-b

Felix Creek - Looking upstream during shocking operations.
