Report on the stabilization of Lyons Creek road after the flood of 2008

Grant Grisak
Montana Fish, Wildlife & Parks
4600 giant Springs Road
Great Falls, Mt. 59405

December 2009

(PPL-Montana MOTAC Project 779-09)

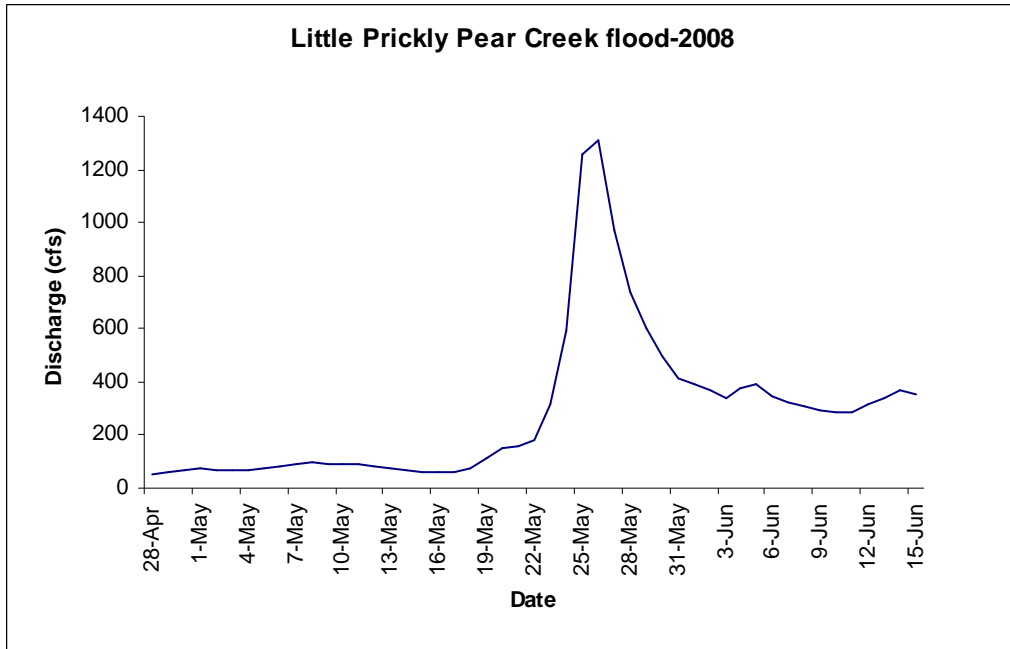
In 2008 central Montana received a number of unusually high rain events along the Rocky Mountain and Big Belt mountains which created flood conditions in the Dearborn River and Little Prickly Pear Creek. Flows in Little Prickly Pear (LPP) Creek reached 1310 cfs on May 26, which was the fourth highest flow on record for this site (Figure 1). There were several incidents of isolated flooding in the LPP subdrainage with reports of washed out roads and culverts in both Lyons Creek and Little Wolf Creek. The major damage sustained in Lyons Creek was located 1.35 miles upstream from the mouth. The eroded site was the base of a spur road in section 19 (DNRC) that provided access to a private residence in section 20 (Figure 2). The site measured 97.5 feet long by 2.5 feet (avg width) by 2.5 feet (avg depth) indicating approximately 22.5 yds³ of road material had eroded into Lyons Creek (Figure 3, Figure 4).

Figure 1. Discharge of Little Prickly Pear Creek April-June 2008.
