Future Fisheries Improvement Program Monitoring

2016

Livingston Fisheries Office

Montana Fish, Wildlife & Parks

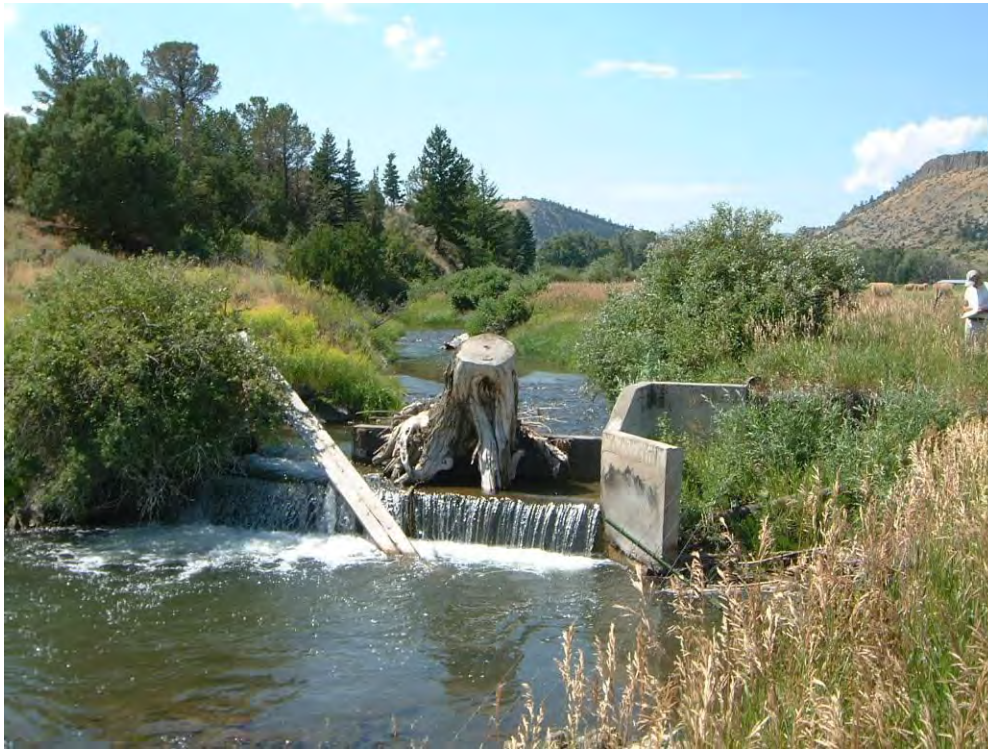
The second alteration was abandonment of an irrigation diversion that was at least a partial barrier to the upstream movement of fish (Figure 2-10). In the early 2000s, opening passage to allow Yellowstone cutthroat trout to move freely throughout the watershed was a management priority, so rerouting the stream away from the diversion was desirable. Since then, the presence of rainbow trout in the adjacent Shields River and Brackett Creek has changed the conservation strategy for Yellowstone cutthroat trout, with protecting the genetic integrity of Yellowstone cutthroat trout being the highest priority.

Figure 2-10. Irrigation diversion blocking fish passage on Brackett Creek (2003).

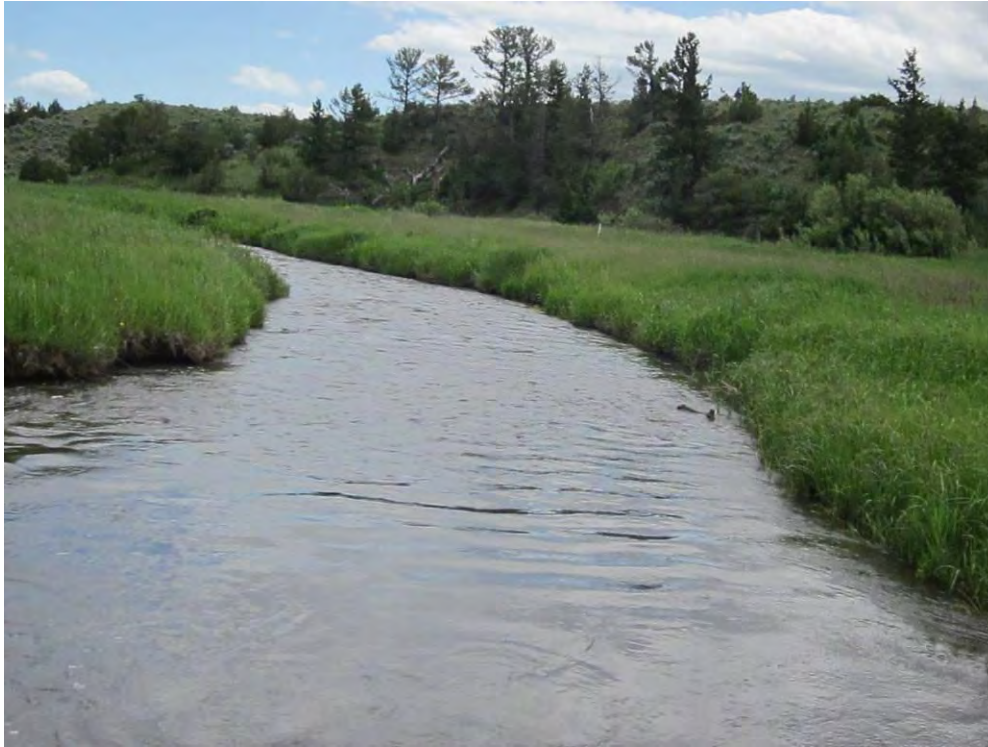
Although bank erosion was a significant feature along the re-naturalized reach, substantial portions of stream were stable, with dense sedges providing protection from elevated flows (Figure 2-15). These reaches were narrower and deeper than areas with eroding banks, and were consistent with the channel morphology designed for this re-naturalization project.

Figure 2-15. Reach of re-naturalized channel showing banks stabilized with sedges, and narrower channel.

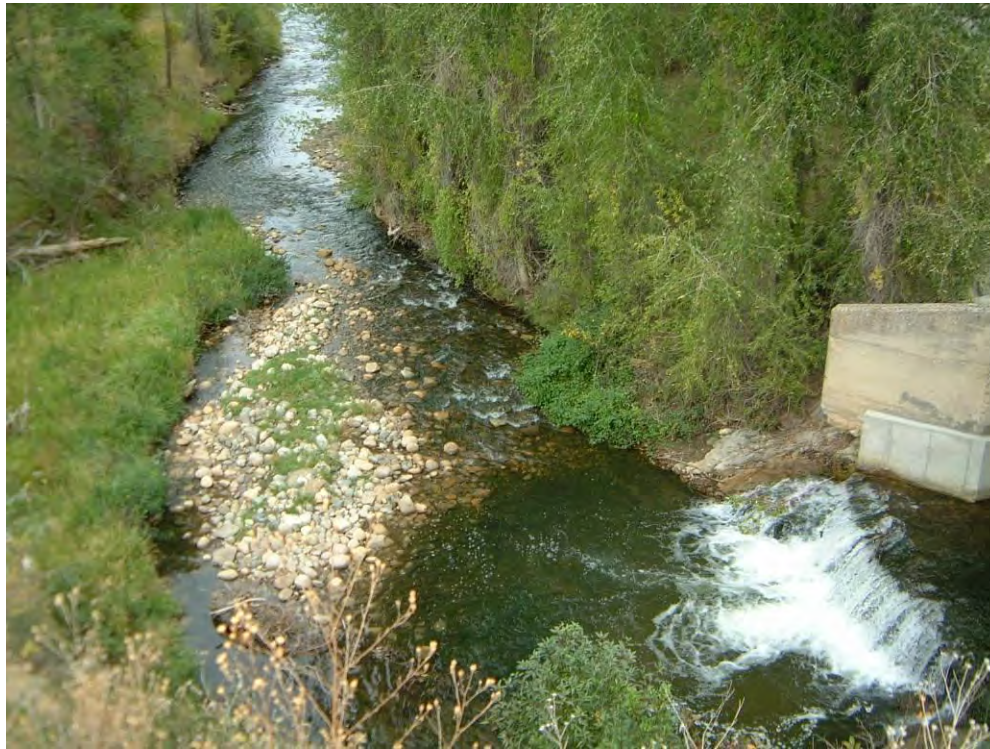
Pre-project photos illustrate the features that limited the ability to swim through the structure (Figure 2-16). An abrupt drop downstream of the outlet of the concrete box culvert was likely a leap barrier. In addition, rapid laminar flow and shallow water depths potentially presented a velocity barrier to the fish that were capable of leaping into the culvert.

Figure 2-16. Impassible culvert on Clear Creek.

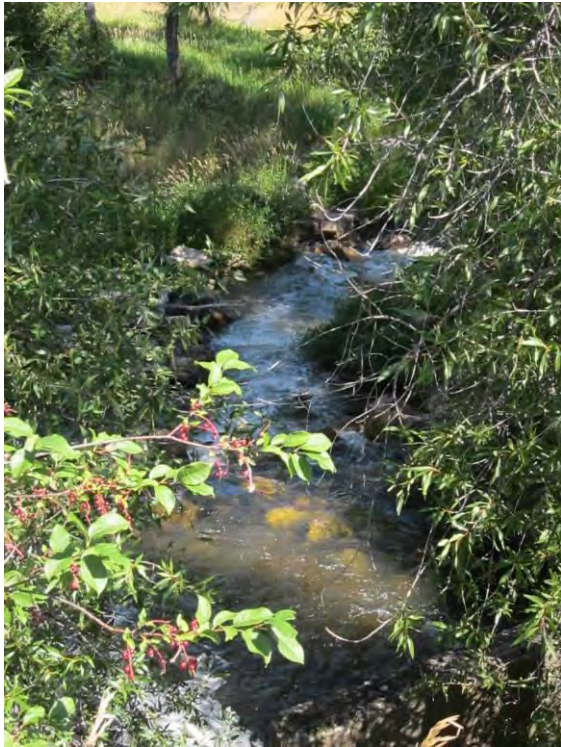
On July 24, 2016, Shannon Bockmon visited the Clear Creek fish passage project. Dense riparian vegetation obscured much of the stream; however, the step-pools were visible, and rocks armoring the stream banks remained in place (Figure 2-18). Although some of the rocks forming the step-pools had moved, the channel modifications were still functioning to provide fish passage. The stream has not rescored a plunge pool at the outlet of the box culvert, and the streambed is at the same grade as the floor of the culvert (Figure 2-19).

Figure 2-18. View of step-pool sequence providing passage on Clear Creek.

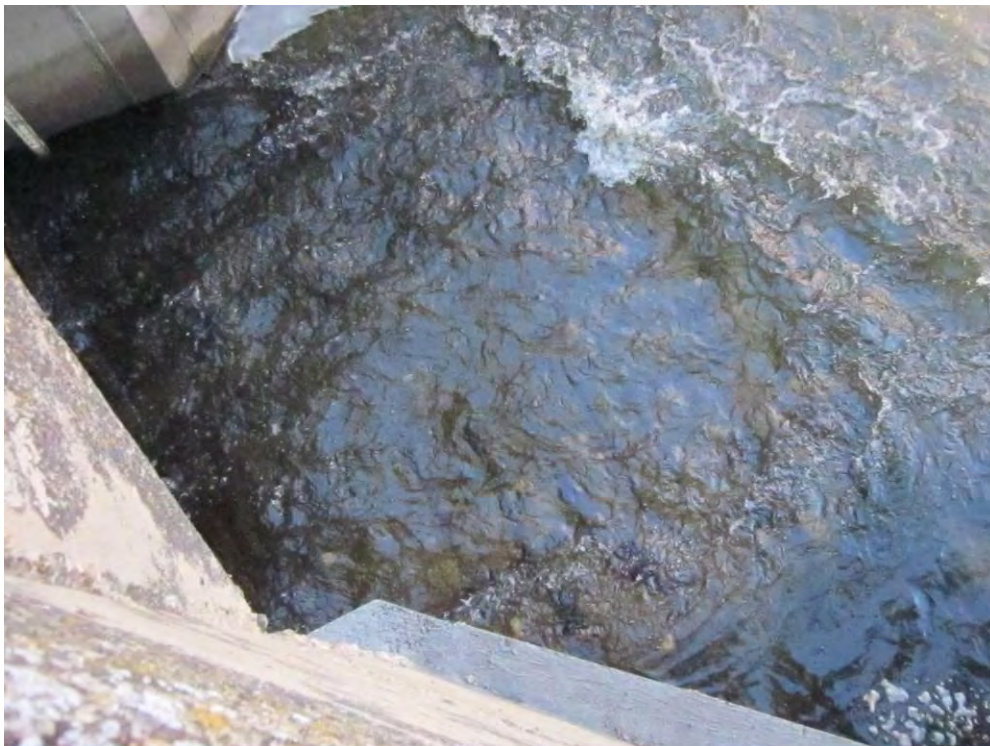
Figure 2-19. Outlet of box culvert on Clear Creek

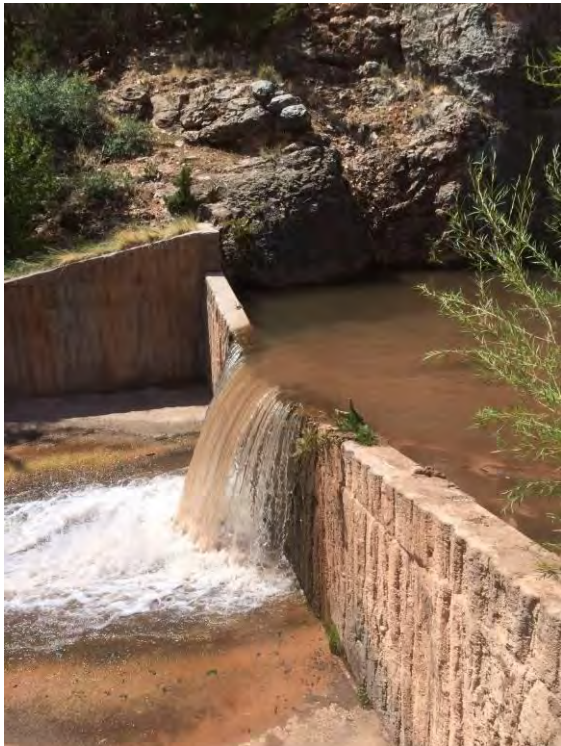
The Crooked Creek barrier showed slight signs of wear, but no structural instability. No scouring of the concrete of the apron, or splash pad, was evident (Figure 2-21). In the first decade after construction, bed load had been relatively slow to fill in behind the front wall of the weir, with fine sediment being the dominant particle size, and water remaining deep behind the wall for several years. By 2016, larger material had accumulated within the impounded portion of the stream, and it is now possible to walk across the accumulated cobble and gravel (Figure 2-22).

Figure 2-22. View upstream of the face of the weir showing accumulation of cohesive bed load.

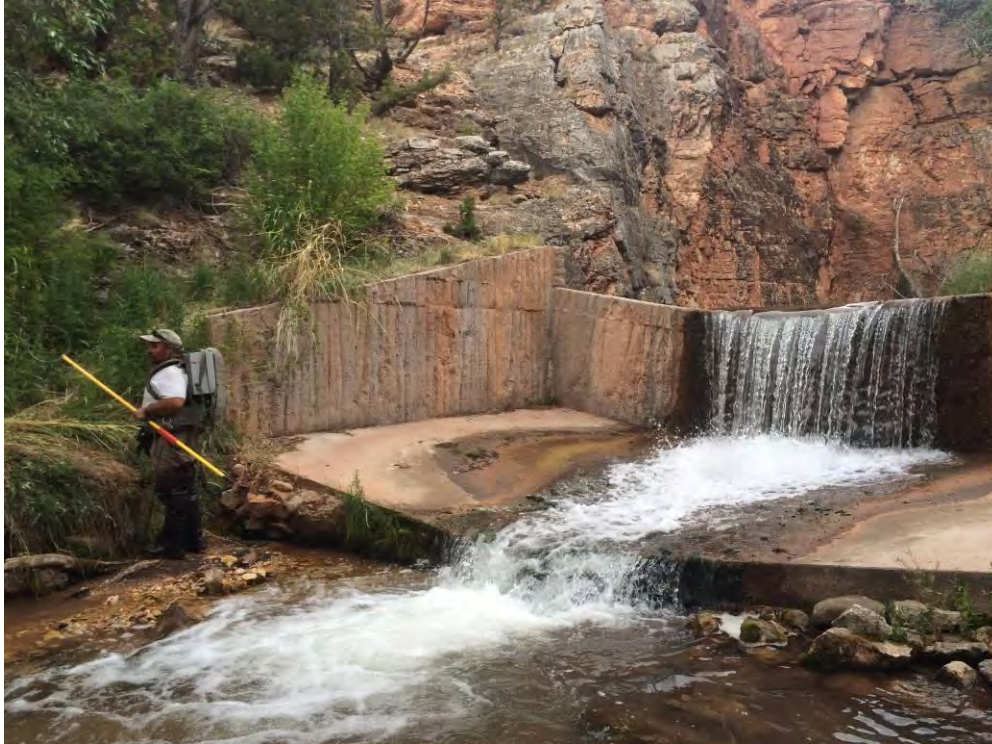
Formation of a plunge pool at the downstream end of the apron was a concern, as the turbulence could allow fish a vantage to leap over the weir. The streambed on the downstream end of the apron remained well armored with large boulders (Figure 2-23). The combination of the lack of pool habitat, and shallow, high velocity flows on the apron is desirable in preventing fish from being able to pass over the barrier.

Figure 2-23. Downstream end of apron showing lack of a plunge pool.

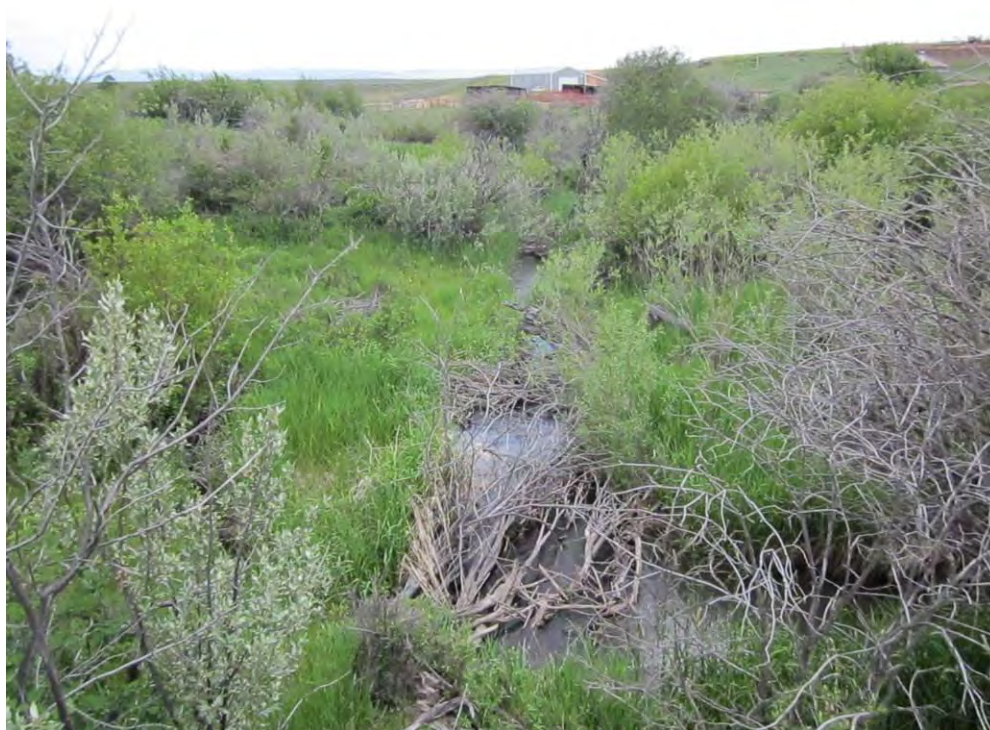
sedges covered the stream banks (Figure 2-26). The channel was a narrow and deep, which are features that promote transport of sediment. The streambed is mostly fine sediment; however, this is likely the result of a limited supply for gravel recruitment, and not necessarily related to sediment inputs from upstream.

Figure 2-26. Recovered riparian area and stream channel on Daisy Dean Creek.

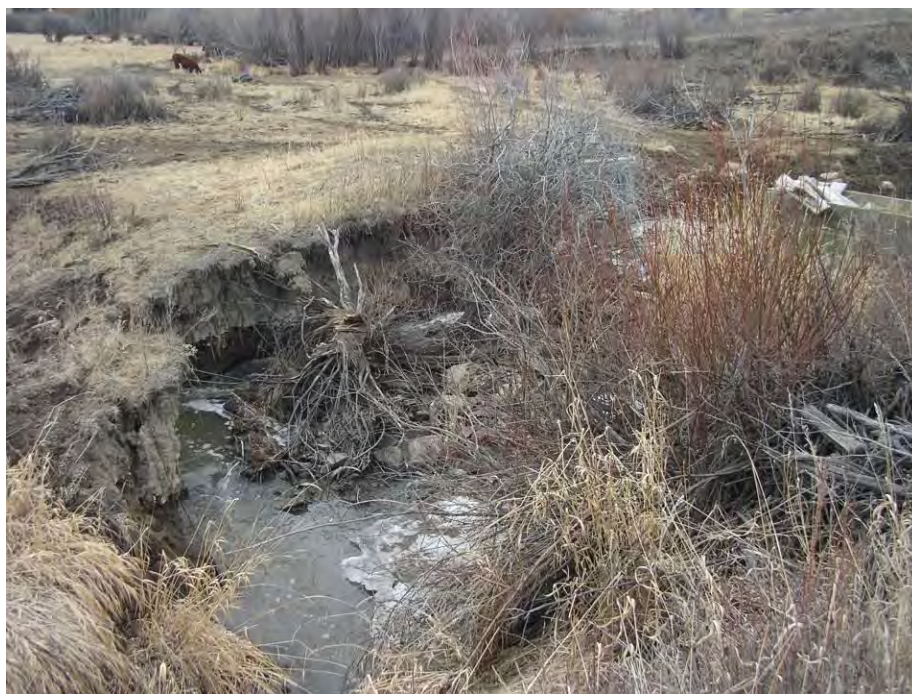
A landowner applied for FFIP funding to reduce sediment loading, and improve riparian health and function, reaches of Elk and Daisy Dean creeks that had experienced considerable channel down cutting, and degradation of the riparian area (Figure 2-27). Specific actions included installation of riparian fencing and off-channel stock water, and sloping vertical banks caused by down-cutting, and installing sod mats to stabilize the altered banks (Figure 2-28).

Figure 2-27. Example of channel down cutting, and a vertical bank slated for sloping.

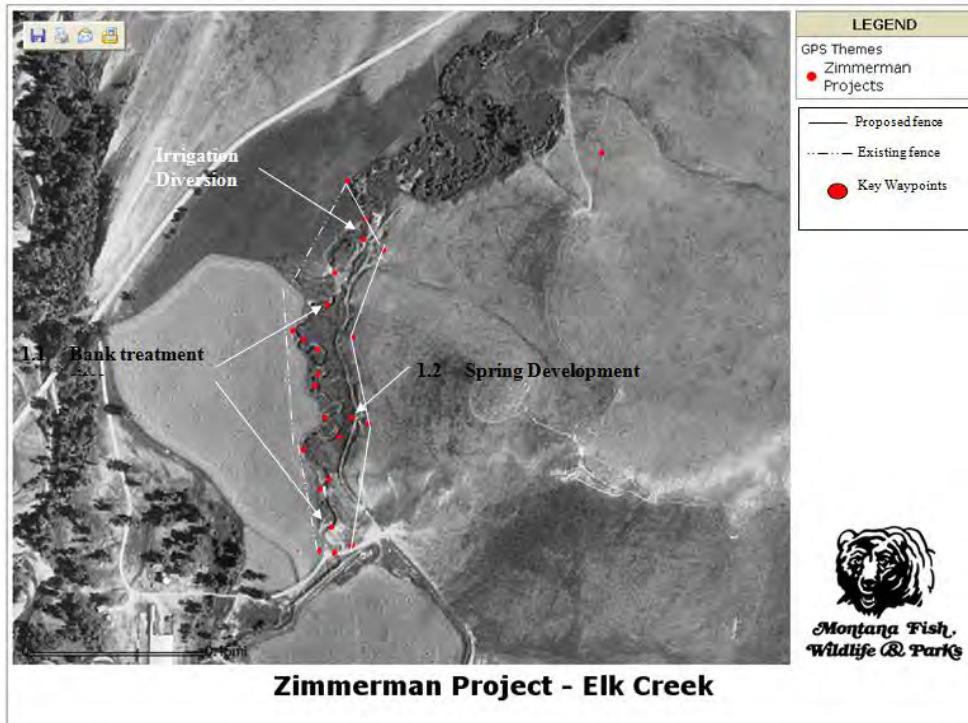
Figure 2-28. Plan view of actions implemented in Elk Creek.

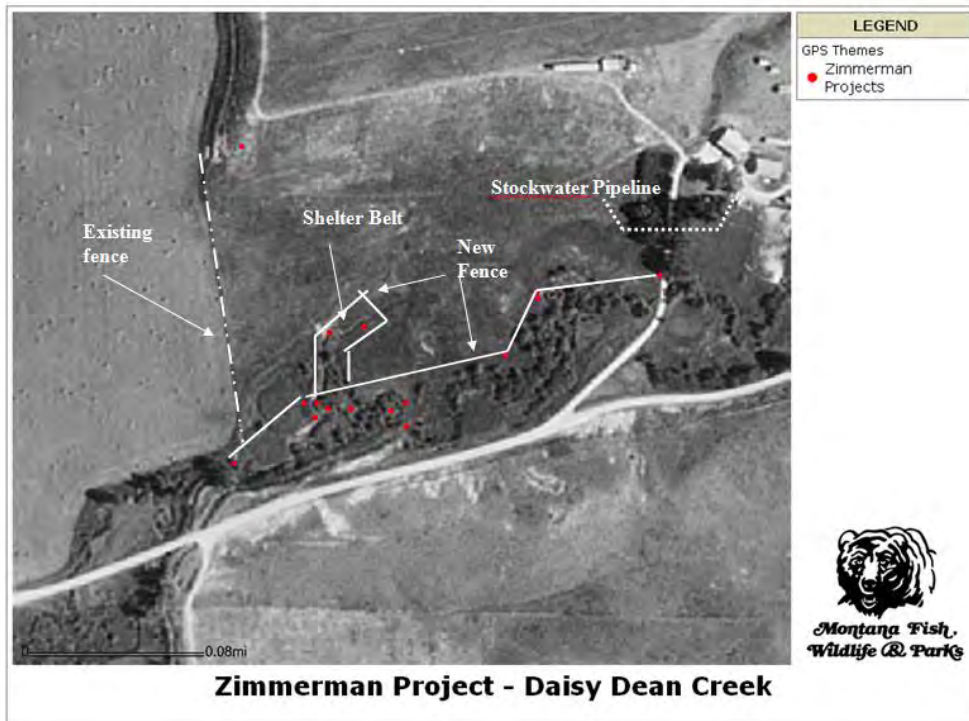
Figure 2-29. Plan view of actions implemented in Daisy Dean Creek.

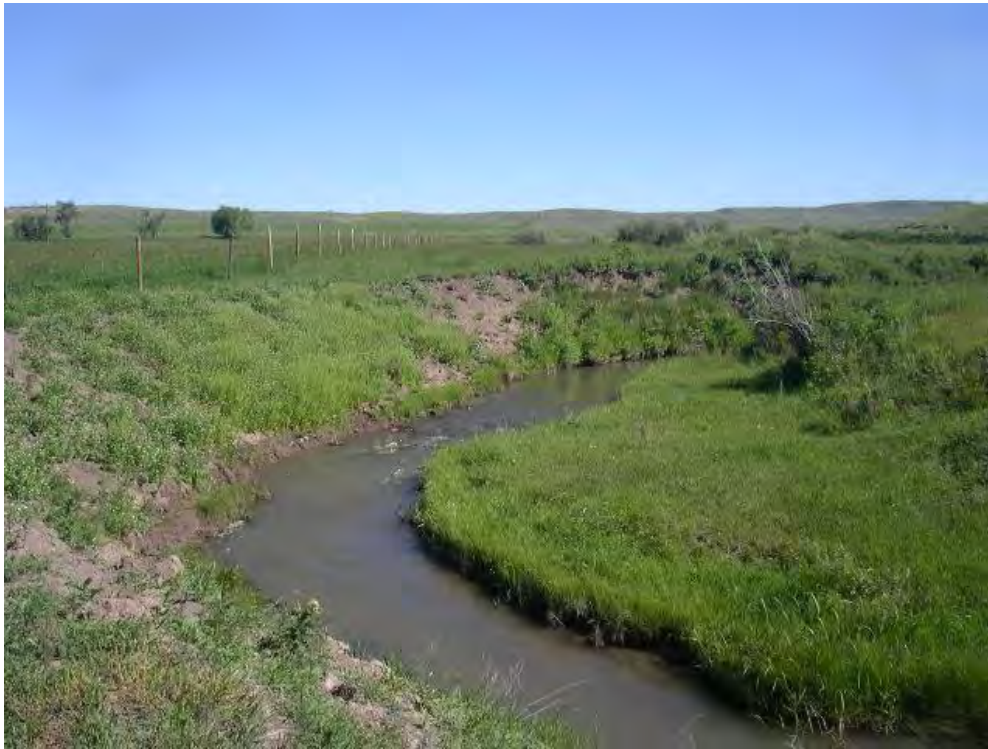
On 6/20/2007, another site visit allowed evaluation of the state of the projects with more time for the vegetation to recover. The bank sloping eliminated the bare, vertical walls, and vegetation was becoming established on the sloped banks, and within the riparian area (Figure 2-31). As expected for a recently disturbed site, weeds had colonized the sloped banks; however, these plants were holding soil much better than the pre-restoration condition.

Figure 2-31. Riparian fencing, sloped banks, and early stage recovery of riparian vegetation on Elk Creek in June 2007.

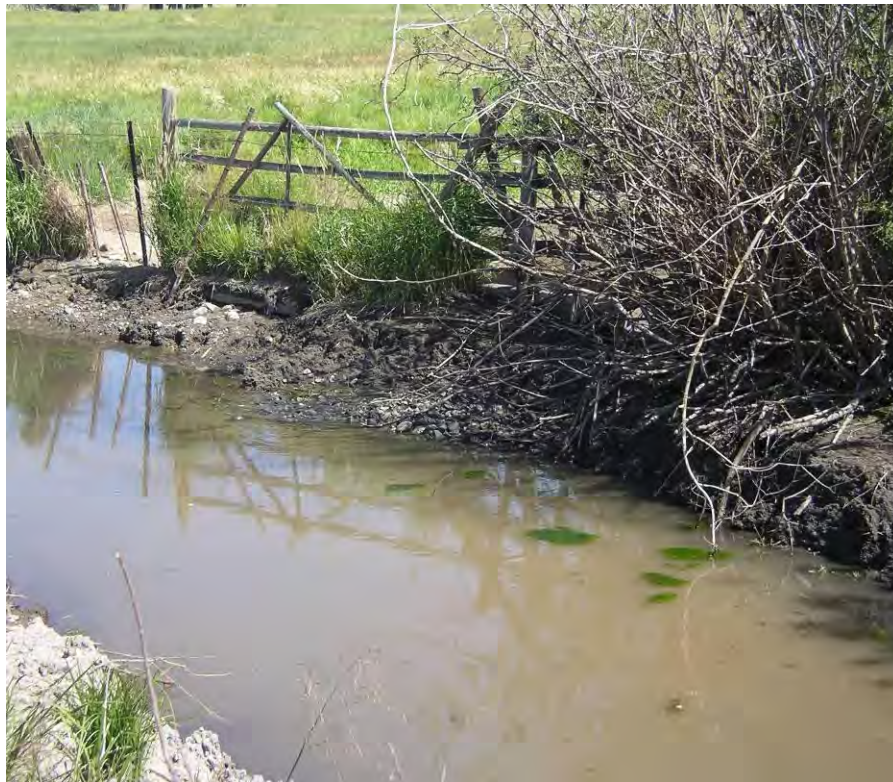
Emigrant Spring Creek is an unmapped stream that joins the Yellowstone River between Emigrant and Corwin Springs. Before restoration, livestock had considerable negative effect on riparian health and function, substrate composition, stream morphology, and habitat for fish (Figure 2-33). Field surveys found low numbers of Yellowstone cutthroat trout and rainbow trout spawning in Emigrant Spring Creek,

Figure 2-33. Emigrant Spring Creek before restoration.

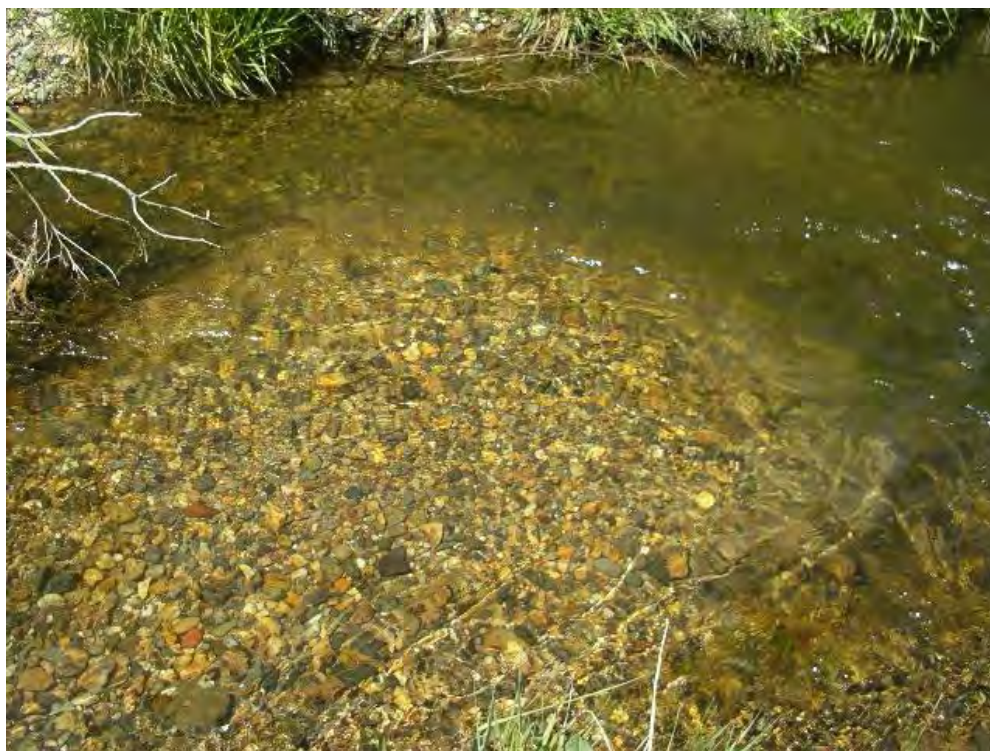
Emigrant Spring Creek, and the great size of some of the redds suggested superimposition of several redds (Figure 2-34). Most of the redds were downstream of the restored reach, although “test redds” or digs, were found throughout the restored reach (Figure 2-35). For much of the stream, bed material was suitable for spawning, the riparian area was functioning, and the channel was stable. The light grazing pressure did not have an appreciable effect on stream conditions.

Figure 2-34. Example of newly constructed redd in Emigrant Spring Creek in 2007.

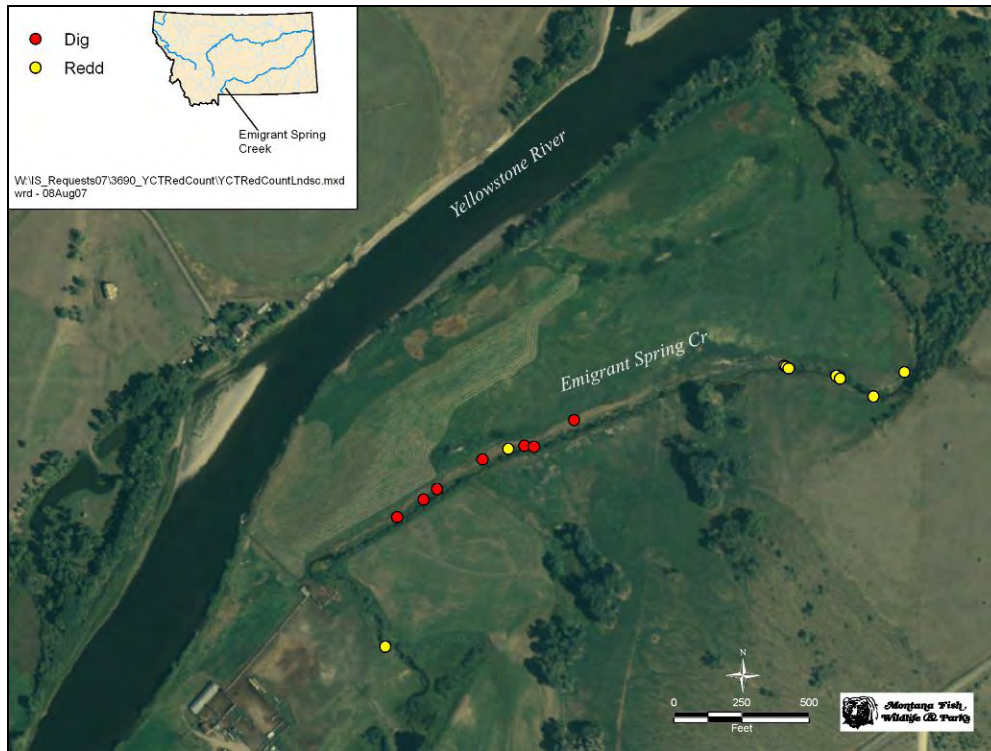
Figure 2-35. Map of redds and digs (“test redds”) on Emigrant Spring Creek, June 2007.

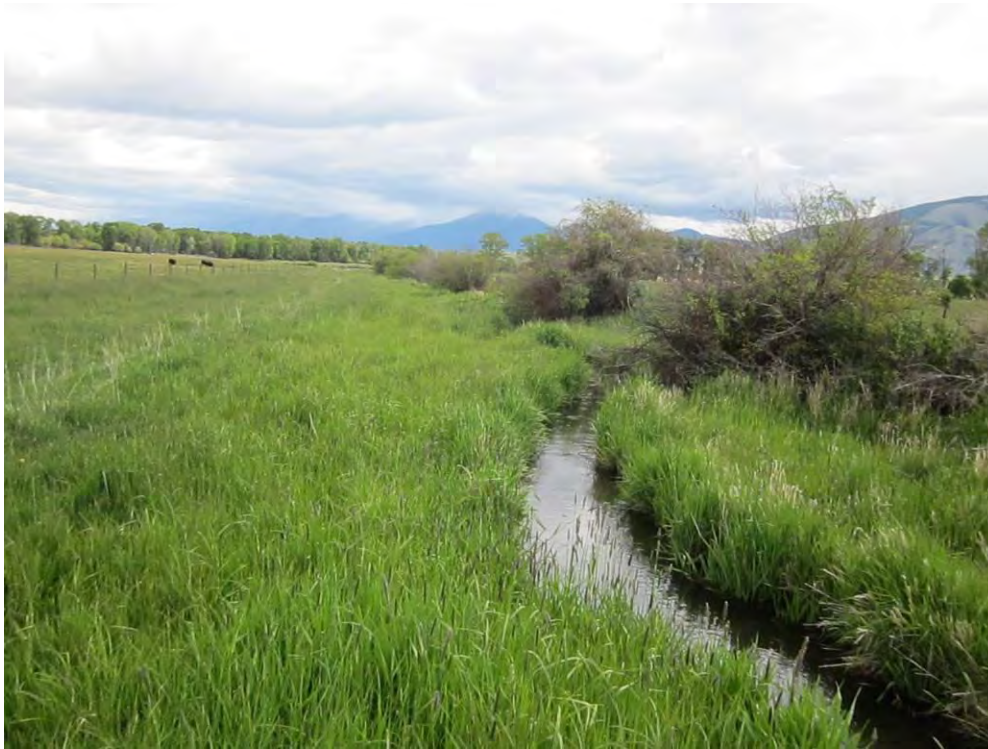
On May 26, 2016, FWP field observers Shannon Bockmon and Carol Endicott walked the length of the riparian enclosure and restored reach. Riparian vegetation, primarily sedges, which are typical of spring creeks with saturated soils, remained dense, and effective at protecting stream banks from erosion (Figure 2-36). The grazing management plan allowed for grazing within the riparian enclosure. Manure within the enclosure indicated cattle grazing occurred within the riparian enclosure; however, grazing pressure was light, and there was no evidence of hoof shear, or other disturbance to stream banks. Sandhill cranes had a nest adjacent to the stream, within the dense sedges.

Figure 2-36. Example of restored reach showing the narrow and deep channel, and dense sedges stabilizing banks.

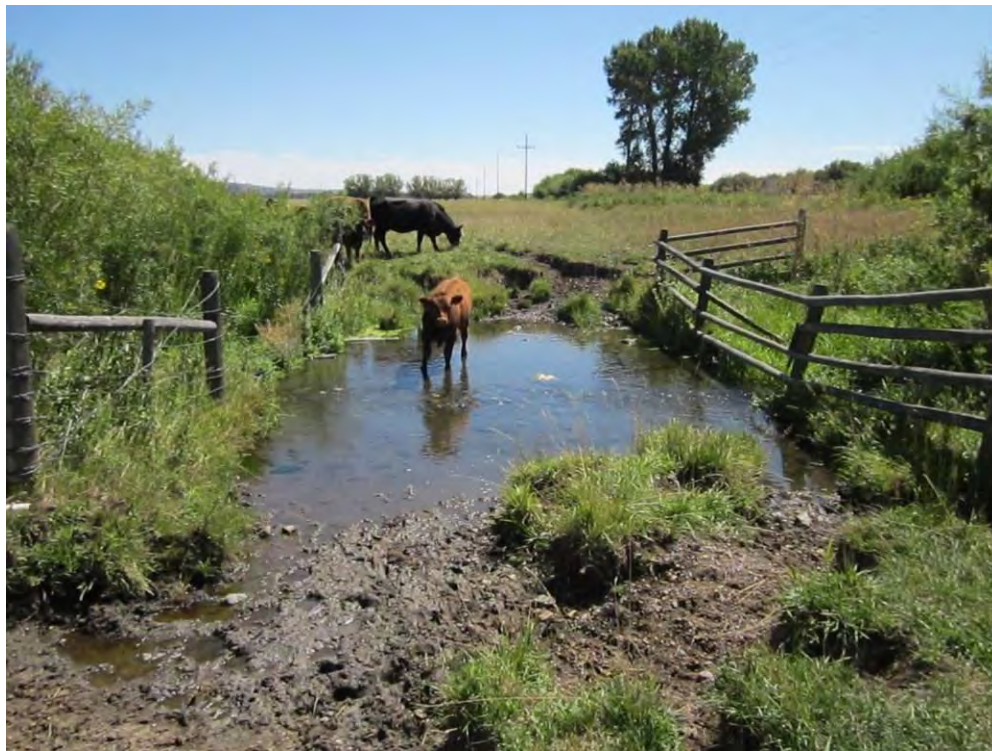
Figure 2-42. Water gap on Esp Spring Creek.

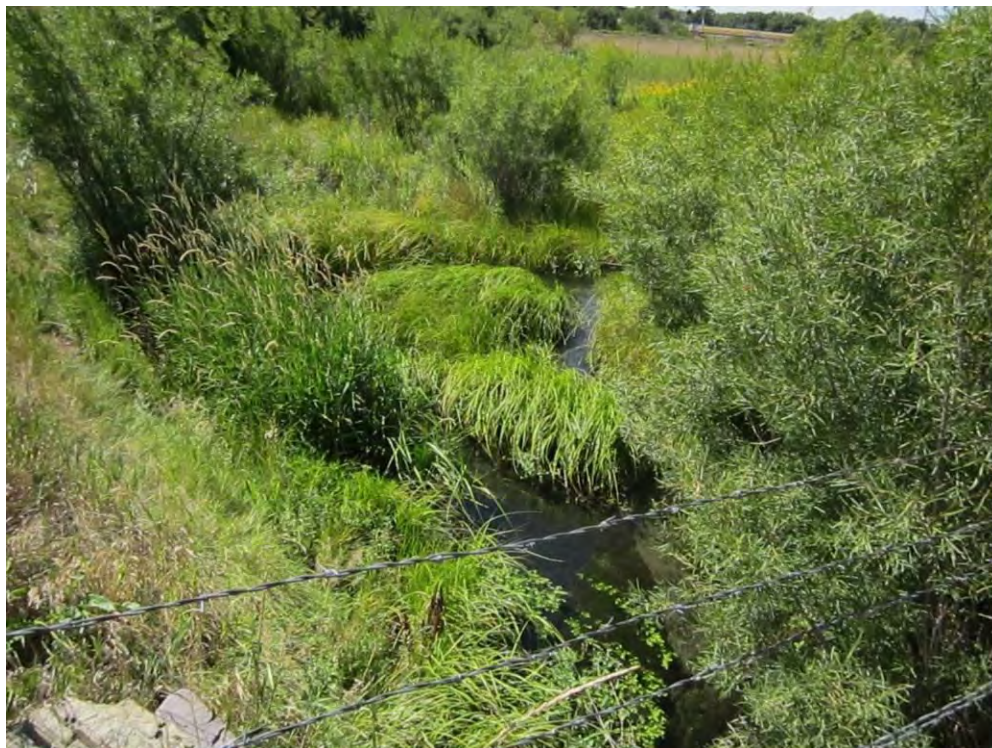
Channel reconfiguration, riparian area recovery, and availability of spawning habitat continued to meet the goals for high quality habitat. Dense willows occupied the riparian area, and substantially exceeded what was present pre-project (Figure 2-43). Restored and fenced reach of Esp Spring Creek. Fencing livestock off the channel, except for at a water gap (Figure 2-42), promoted riparian health and vigor. Hardening with addition of gravel would decrease sediment loading from this discrete location. Likewise, the channel retained the constructed plan form and width-to-depth ratios. The stream supported numerous areas with high quality spawning gravel (Figure 2-44). Macrophytes occupied much of the stream; however, stream flow is sufficient to limit growth of aquatic plants, and flush sediment through the stream.

Figure 2-43. Restored and fenced reach of Esp Spring Creek.

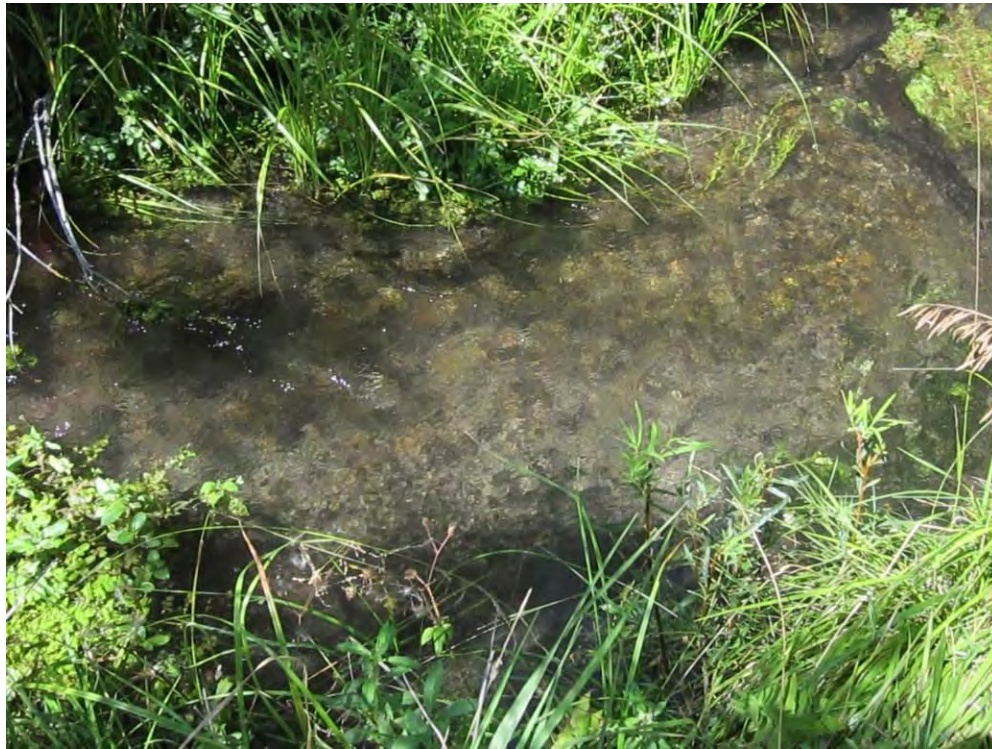
Figure 2-44. Patch of spawning gravel

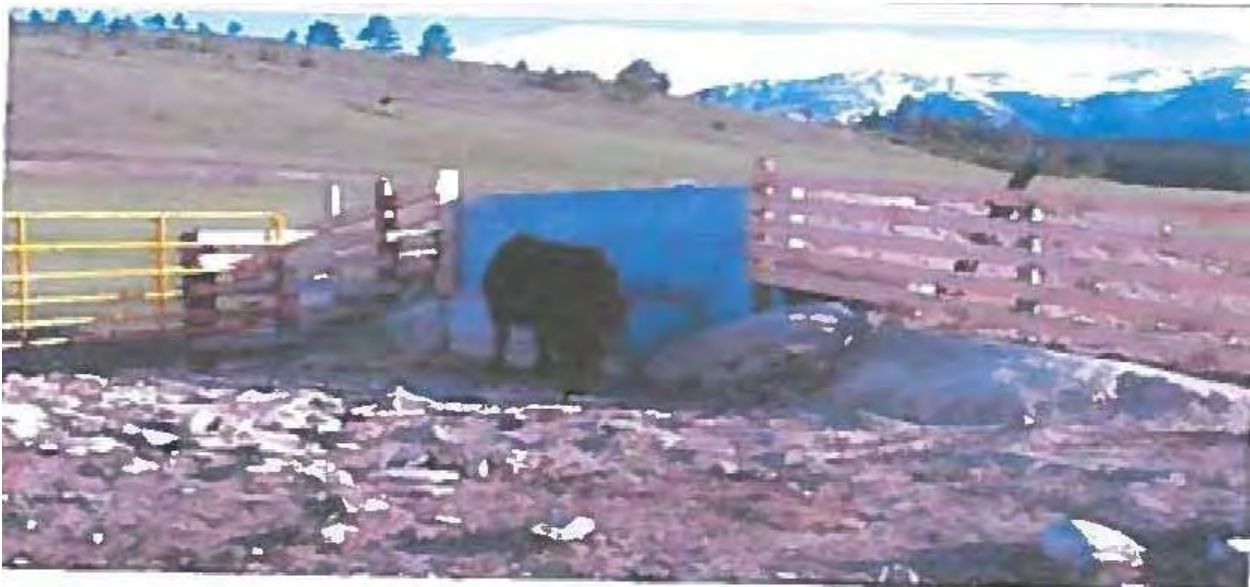
The goal was to improve water quality, by decreasing nutrient, sediment, and thermal loading to Fishtail Creek. This project entailed moving a corral off-stream, and providing stock water at the new location. The corral experienced heavy use by livestock, and had considerable accumulation of manure, and negligible vegetation to trap sediment or nutrients before entering the stream (Figure 2-45). Runoff from the new corrals would be diverted away from the stream. Other components included installation of watering devices within the new, off-channel corrals.

Figure 2-45. View of the corral that was on Fishtail Creek.

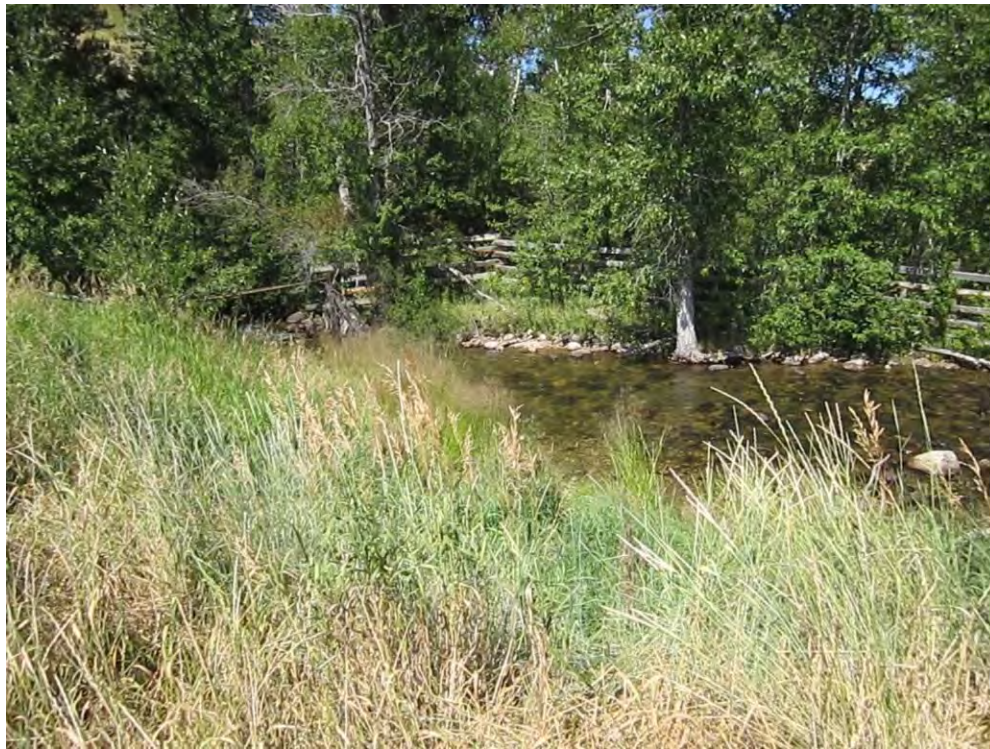
On August 11, 2016, Shannon Bockmon, accompanied by the landowner, evaluated the Fishtail Creek corral relocation project. The corral had been moved, and the berm that redirected runoff away from the stream had been constructed, and remained functional. The riparian area had improved substantially since project implementation, and aspens were beginning to recruit (Figure 2-45). Weeds remained a problem within the footprint of the former corral, although efforts to control weeds are ongoing. The landowner found the off-channel watering devices to be superior to watering stock from the stream. With the exception of last winter, the holding tank has not frozen. Determination of whether the watering device has a heated element to keep stock water from freezing would be useful. These features are optional in commercially available livestock waterers.

Figure 2-46. Former location of corrals on Fishtail Creek.

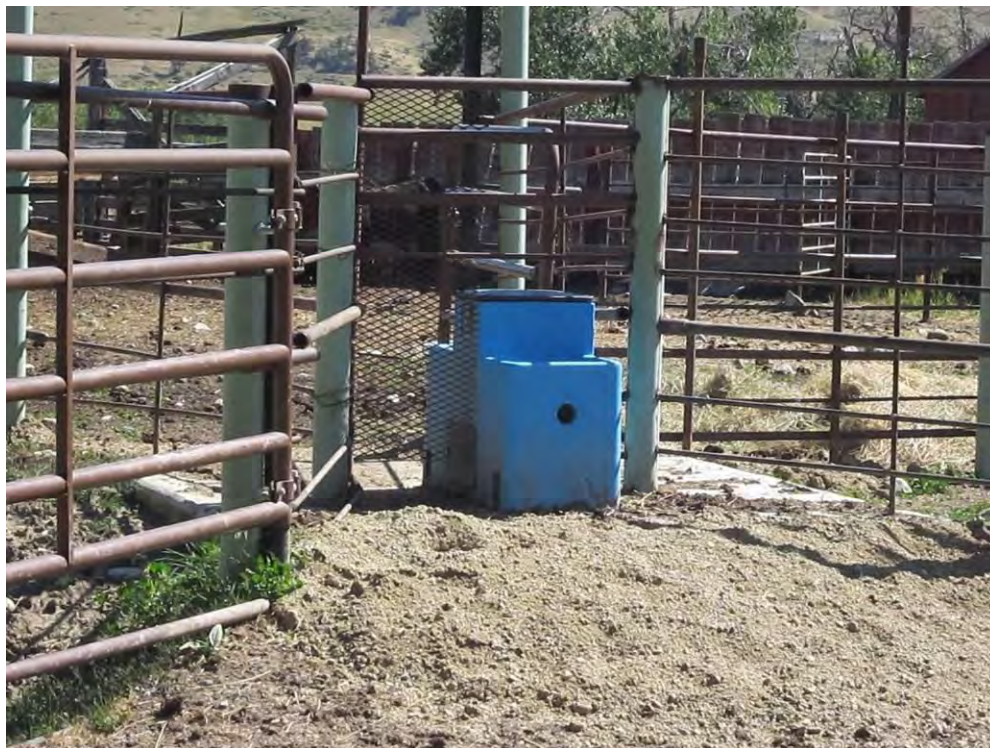
Figure 2-47. Off-stream livestock watering device in the corral adjacent to Fishtail Creek.

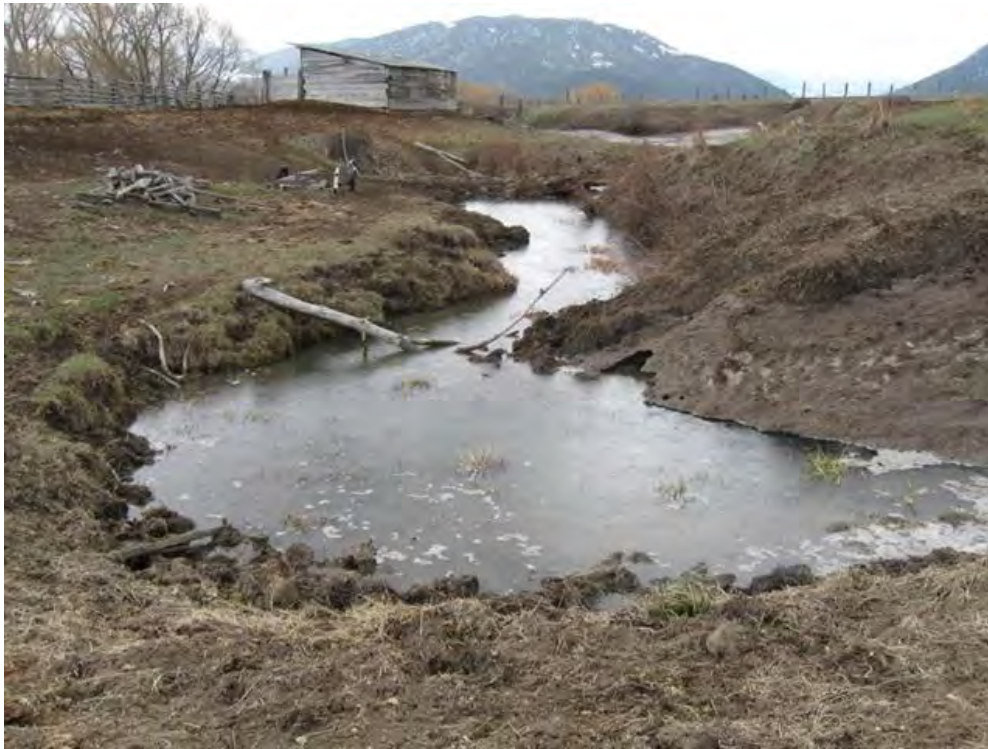
Livestock use in the project area had been heavy for decades, resulting in severe degradation of riparian health and function, extreme siltation, and a lack of channel definition for much of its length (Figure 2-48). The deep accumulation of mud within the existing channel made electrofishing challenging, as fieldworkers wading the stream would get bogged in the mud. In addition, actively eroding terraces were contributing large quantities of fine sediment (Figure 2-49). Decades of accumulation of manure adjacent to the stream was a source of nutrients, which further contributed to degraded water quality.

Figure 2-48. Pre-restoration view of Fleshman Creek.

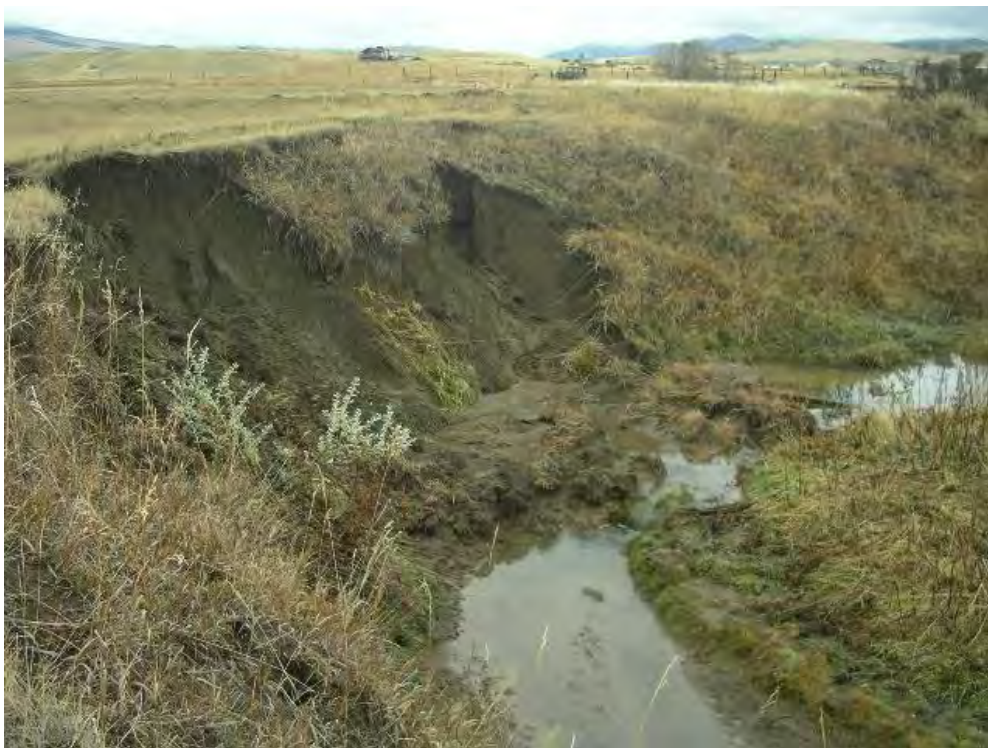
Figure 2-49. Example of an eroding terrace on Fleshman Creek within the project area.

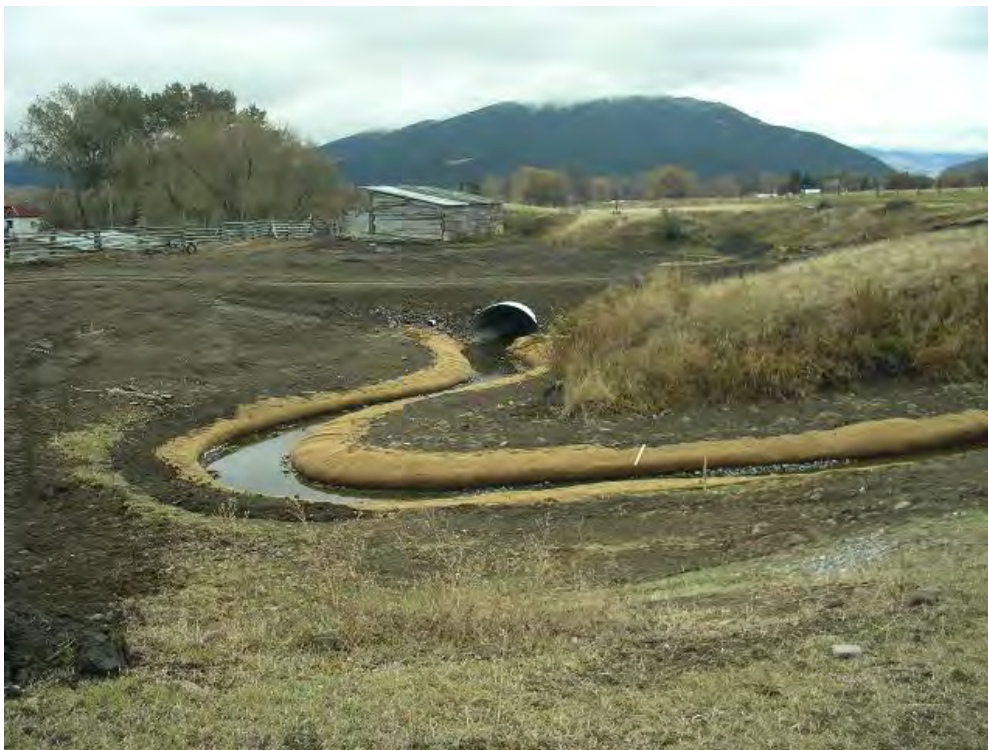
Figure 2-50. Example of newly constructed channel on Fleshman Creek and stream crossing with bottomless arch culvert and overflow pipes.

The road crossings were effective in allowing the producer to move cattle, while protecting the riparian zone and stream channel. The bottomless arch culverts were effective in providing stream habitat under the crossing, fish passage, and debris conveyance. Yearly inspection of the overflow pipes in spring, before runoff, is recommended, as plant growth can obscure the pipes, and limit their ability to convey high flows.

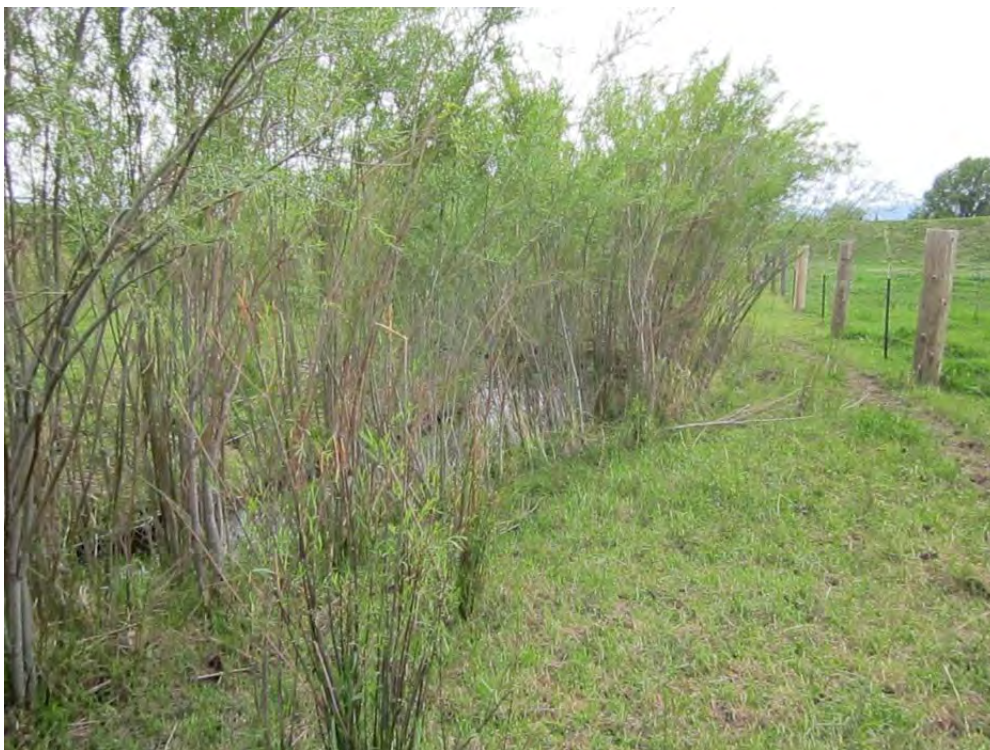
On June 2, 2016, Shannon Bockmon and Carol Endicott visited the Fleshman Creek restoration project, and documented remarkable improvement from pre-project conditions, and evidence that the restoration efforts were effective in restoring Fleshman Creek. The riparian fencing was in place (Figure 2-51), as were the off-channel water sources.

Figure 2-51. Riparian fencing installed to control livestock around Fleshman Creek.

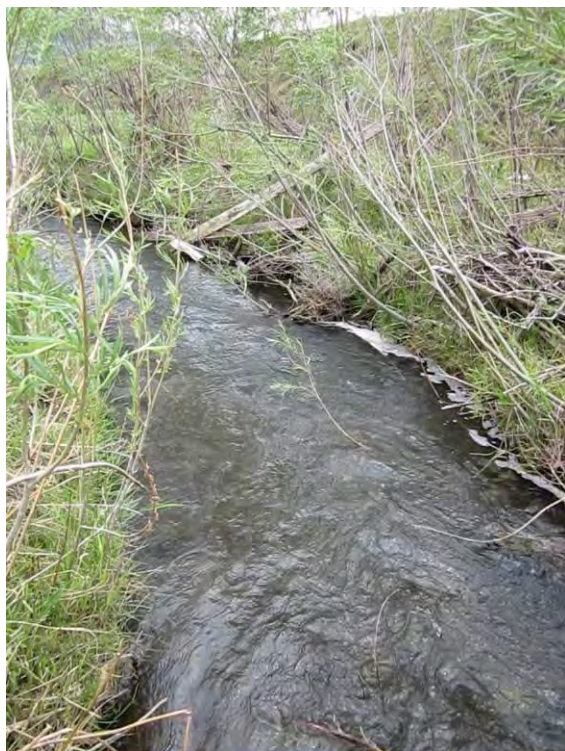
The channel was relatively narrow and deep, and other than the formation of desirable, undercut banks, minimal lateral movement had occurred since the channel was constructed in 2009 (Figure 2-52). Willow survival and recruitment was impressive, with well established stands of willows exceeding 9 feet occurring along most of the stream. In the few locations where willows had not become established, the coir fabric and seeding was effective in creating a stream bank that was indistinguishable from a natural bank (Figure 2-53).

Figure 2-52. Example of constructed riffle, established willows, and undercut banks on Fleshman Creek.

Although the current condition was a marked improvement from pre-project conditions, livestock were having a small, but noticeable effect on stream banks. Localized areas of bank trampling and stock trails were present at several locations. Consultation with NRCS on the grazing management strategy developed for this site, and evaluation of modifications to limit trailing are warranted to protect the investment.

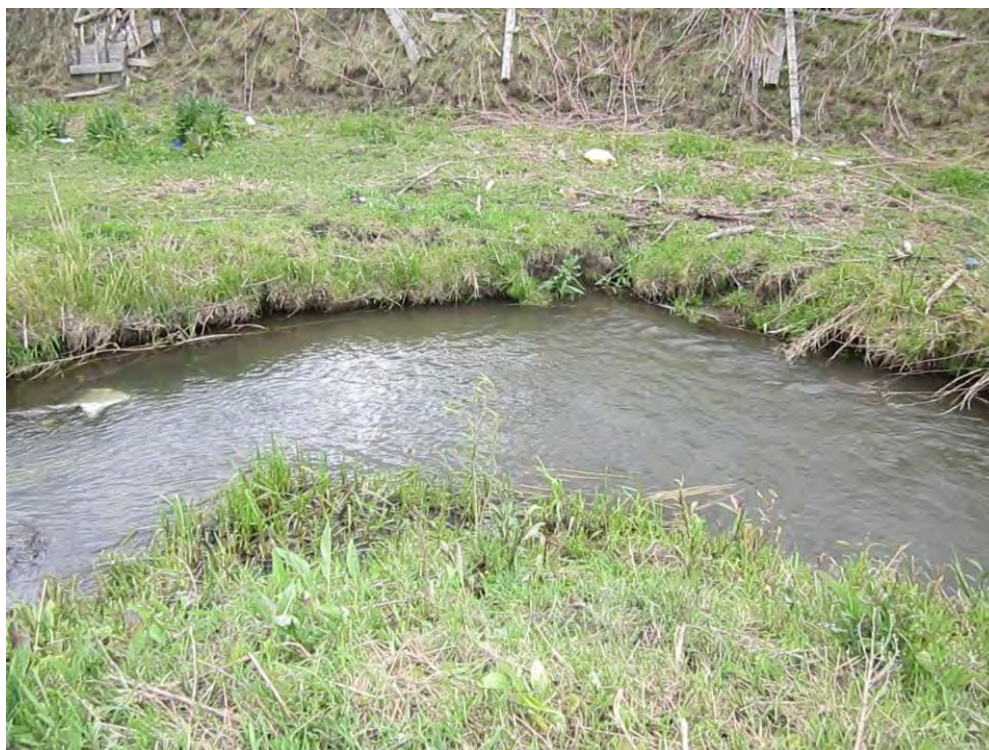
Figure 2-53. Outer meander bend showing stable bank constructed with coir fabric encapsulated soil lifts. (Note that photo was taken in early June, and ground cover was beginning to grow for the season.)
